Accident - BP-Texas City Refinery Explosion and Fire

**Professional Development Hours (PDH) or
Continuing Education Hours (CE)
Online PDH or CE course**

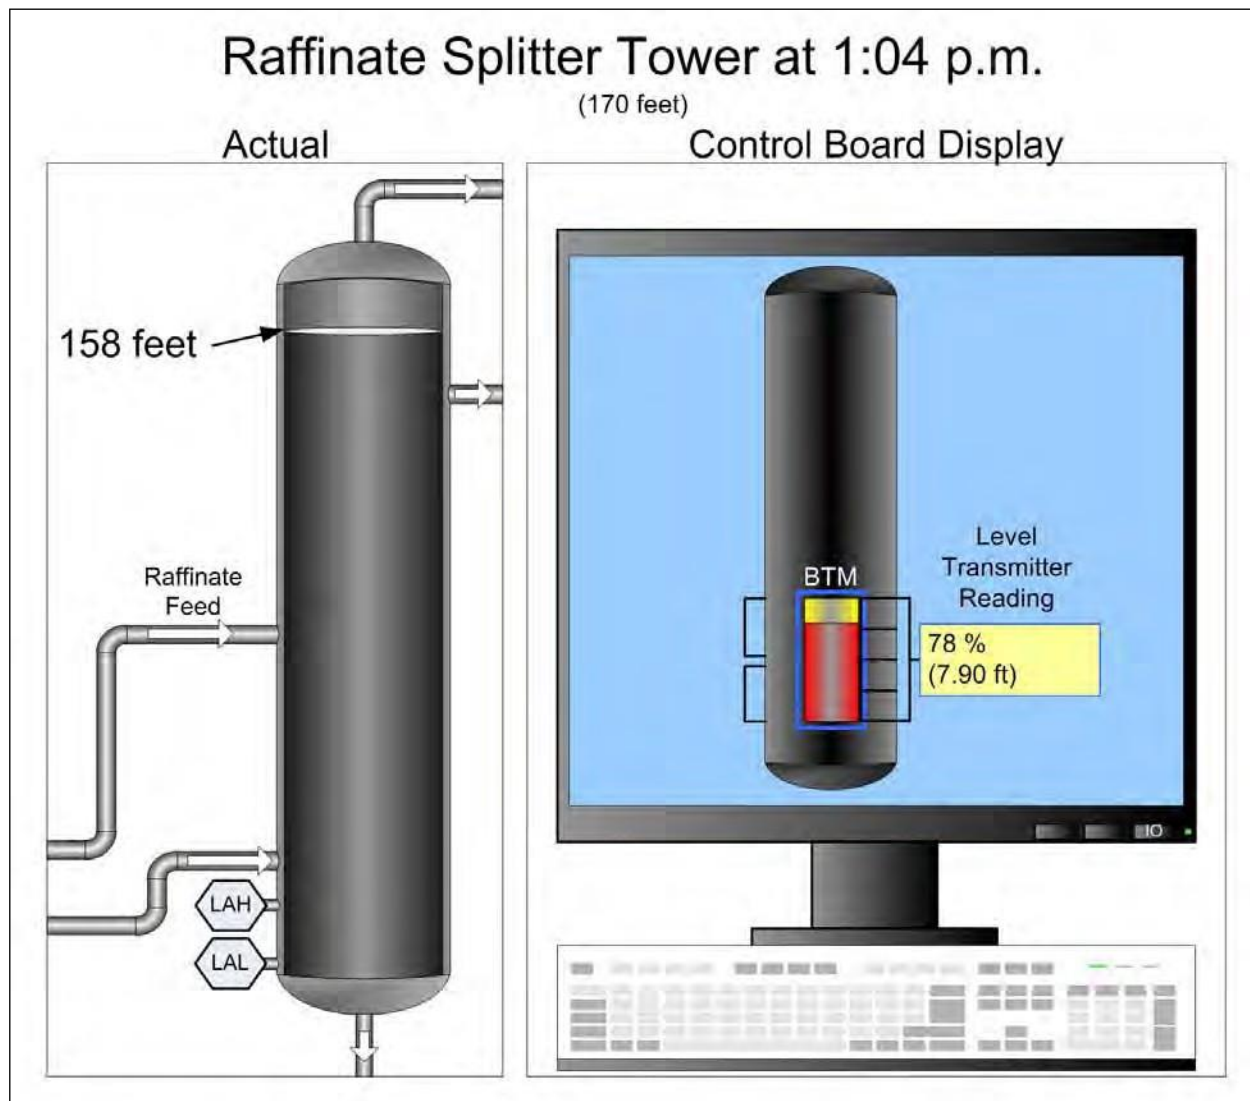
Figure 6. At 1:04 p.m. the liquid level in the tower was 158 feet (48 m), but the computerized control system indicated to operators that the level was at 78 percent of the level transmitter (7.9 feet, or 2.4 m, of liquid in the tower).

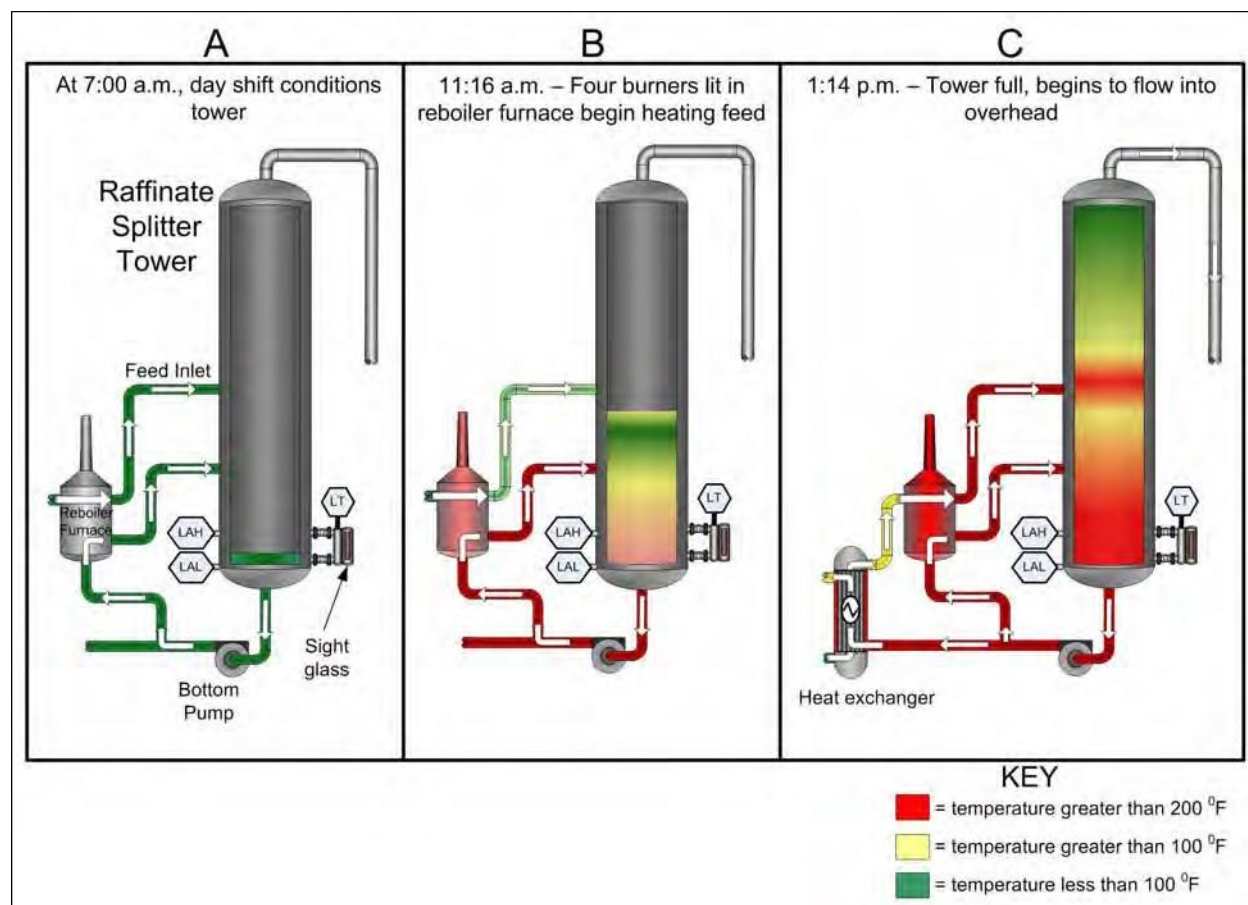
At 1:14 p.m., sub-cooled⁴³ hydrocarbon liquid flowed out of the top of the raffinate splitter tower and into the vertical overhead vapor line, due to overfilling and rapid heating of the column (Figure 7).

Figure 7. Heating of feed in the splitter tower

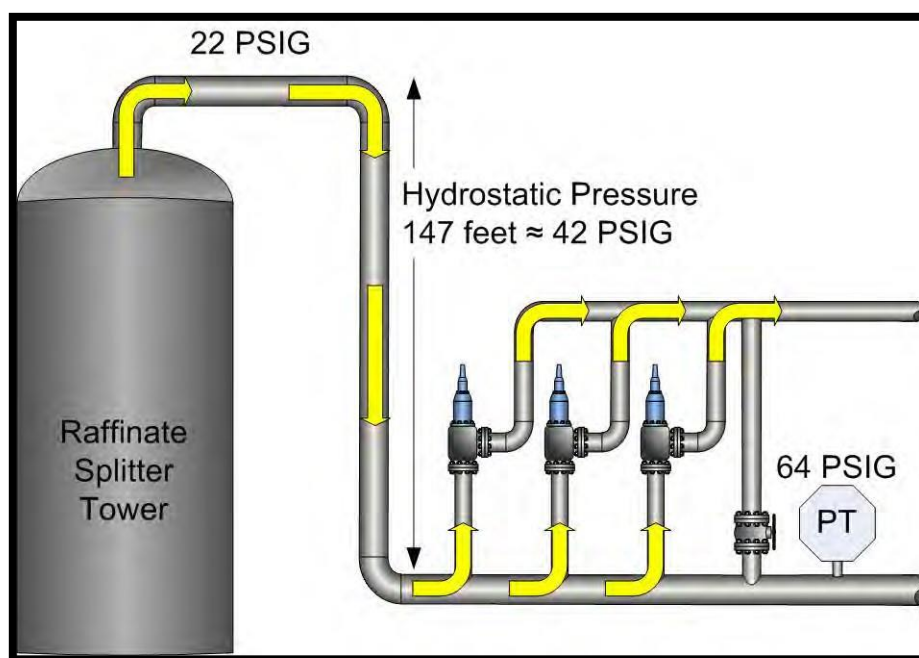
Figure 8. Hydrostatic head of liquid in overhead piping leads to the three relief valves opening

The minimum closing (blowdown) pressure for the three safety relief valves to stop flowing was 37.2 psig (256.5 kPa). Computerized control system data indicate that all three safety relief valves were fully open and flowing at capacity for slightly longer than six minutes. An average pressure of 61 psig (421 kPa) at

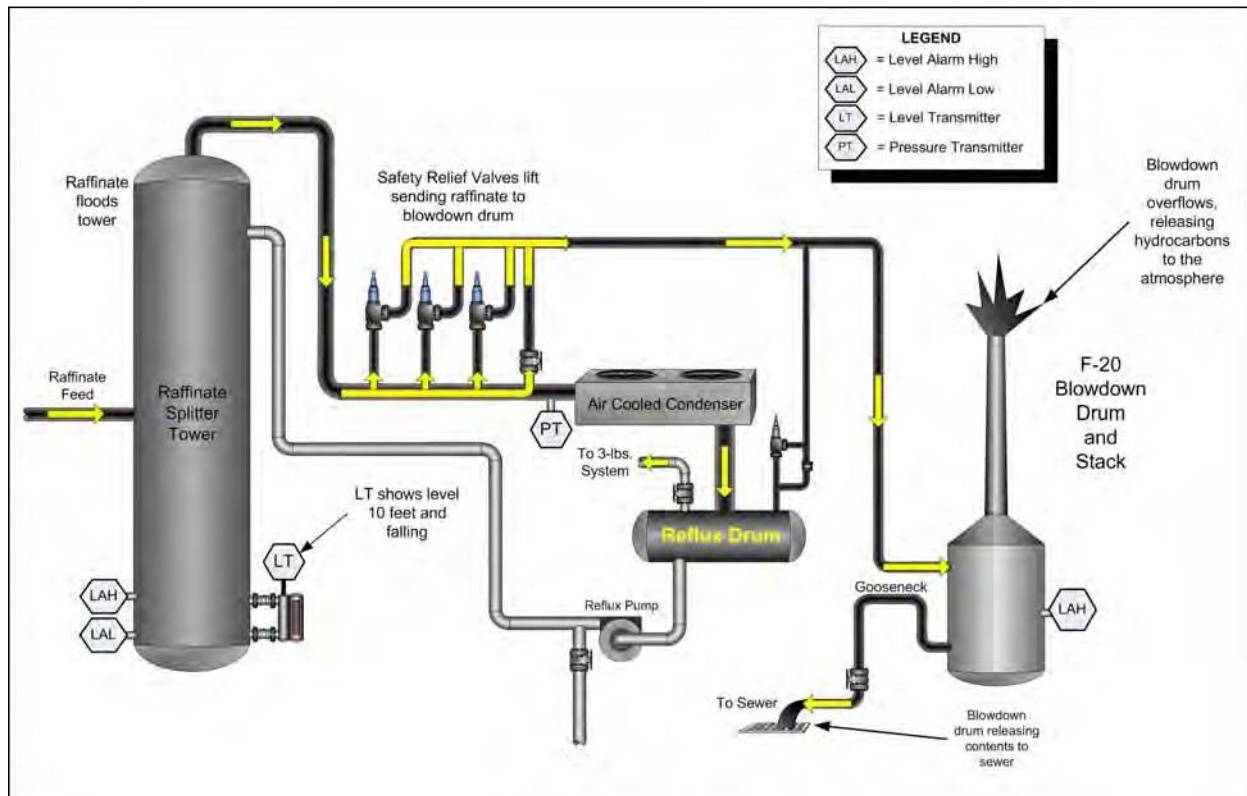
Once the blowdown system filled, flammable liquid discharged to the atmosphere from its stack as a geyser and fell to the ground (Figure 9). Shortly after the ISOM operators began troubleshooting the pressure spike, they received, via radio, the first notification that the blowdown drum was overflowing. In response to the radio message, the Board Operator and Lead Operator used the computerized control system to shut the flow of fuel to the heater, while the other operators left the satellite control room and ran toward an adjacent road, Avenue F, to re-direct traffic away from the blowdown drum, as required by BP's "Emergency Response Procedure A-7."

Figure 9. Tower overfills and blowdown drum releases hydrocarbons

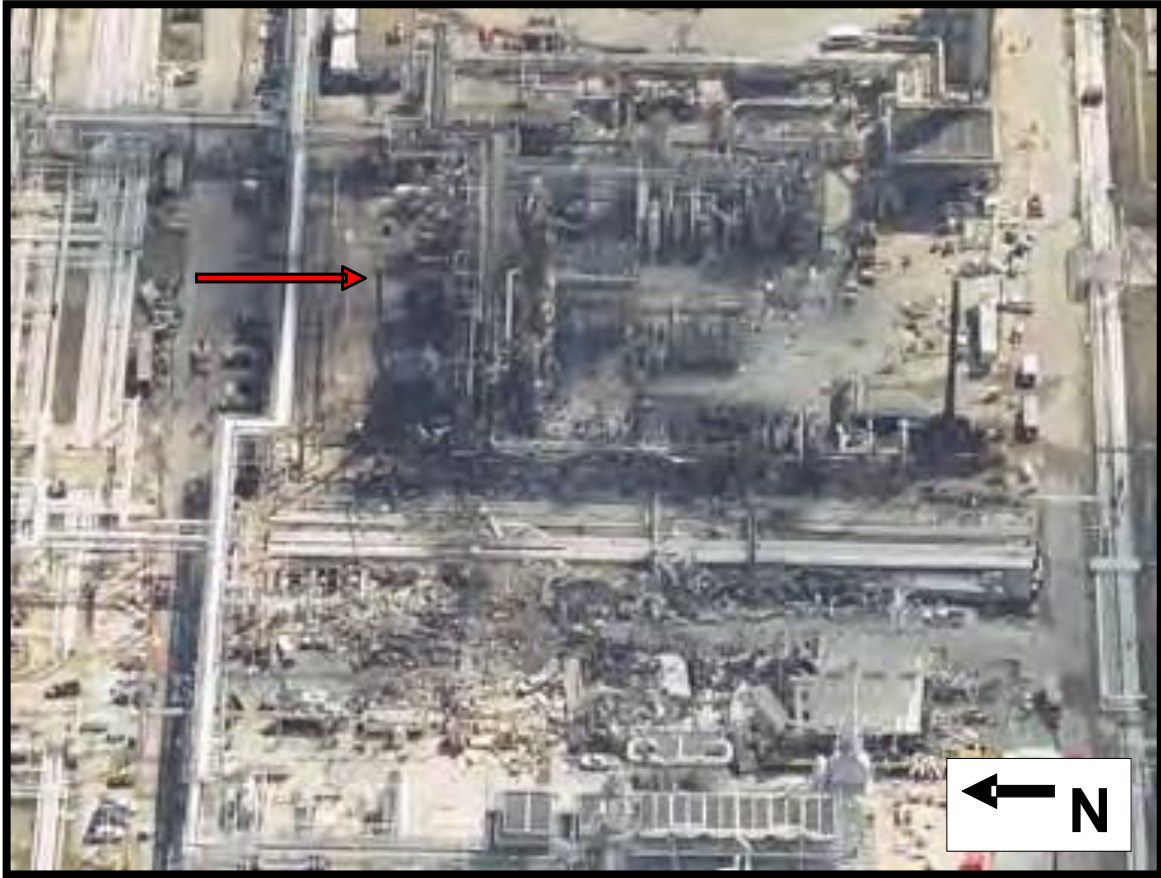
Figure 10. The darkened areas in and around the ISOM unit had the heaviest fire damage; the red arrow points to the top of the blowdown stack

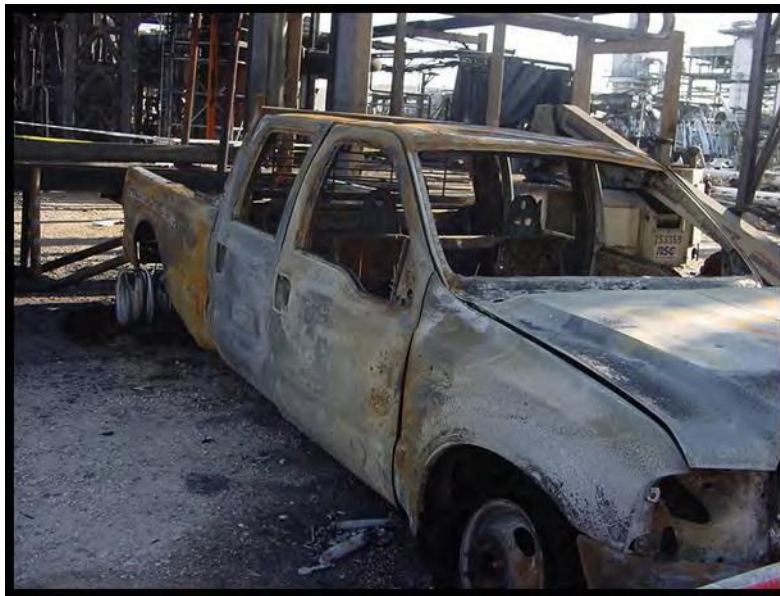
Although several potential ignition sources (Appendix H.16) were identified, the most likely ignition point was an idling diesel pickup truck (Figure 11). This truck was parked about 25 feet (7.6 m) from the blowdown drum, and several eyewitnesses reported seeing or hearing the truck's engine over-revving when the vapor cloud reached it.

Figure 11. Idling diesel pickup truck at north end of ISOM unit

Two eyewitnesses saw the truck catch fire, followed shortly by the vapor cloud explosion. One eyewitness saw sparks leaving the truck after a backfire and igniting the vapor cloud. While the diesel pickup has been positively identified by witnesses as an ignition point, this does not preclude the potential that the cloud was additionally ignited by other sources.

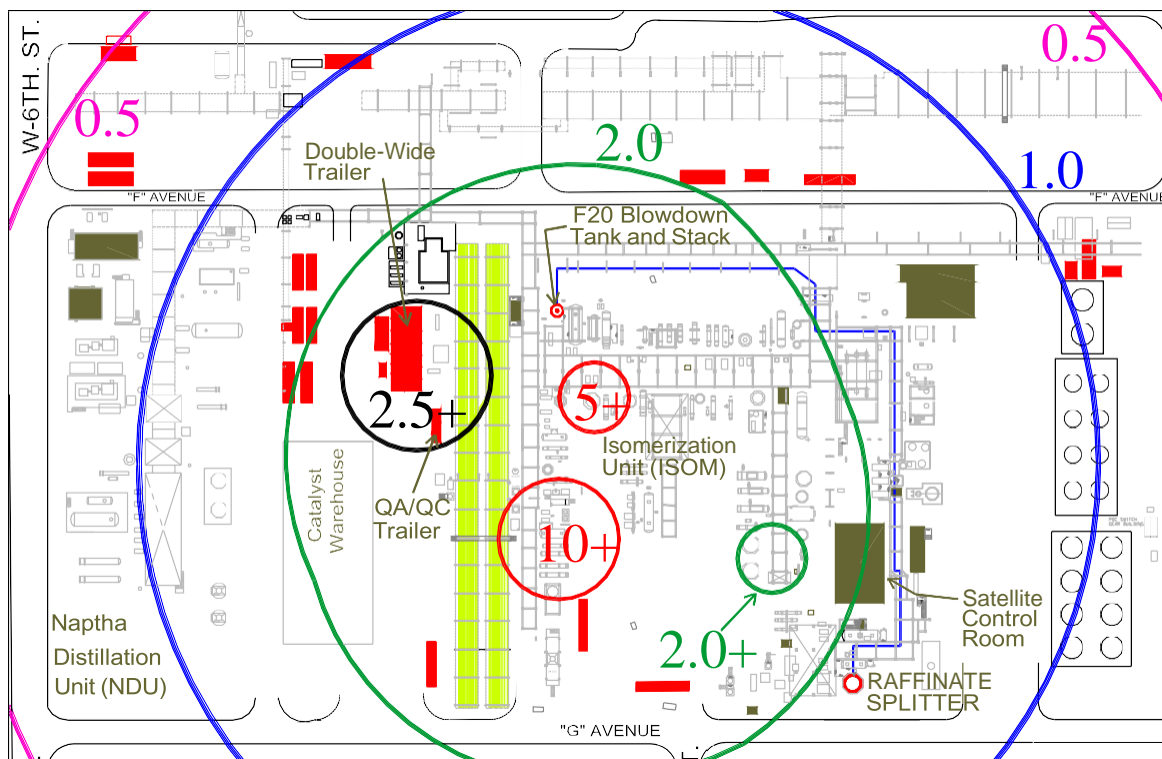
congestion/confinement and flammable mix allowed, greatly intensifying the blast pressure in certain areas. These intense pressure regions, or sub-explosions, produced heavy structural damage locally and left a pattern of structural deformation away from the blast center in all directions. A computer simulation⁴⁹ and a blast overpressure map (Figure 12) were developed based on site observations, structural analysis, and blast modeling (Appendix H).

Figure 12. Blast overpressure map depicting the areas of highest blast pressure (10+, 5+, and 2.5+ psi)

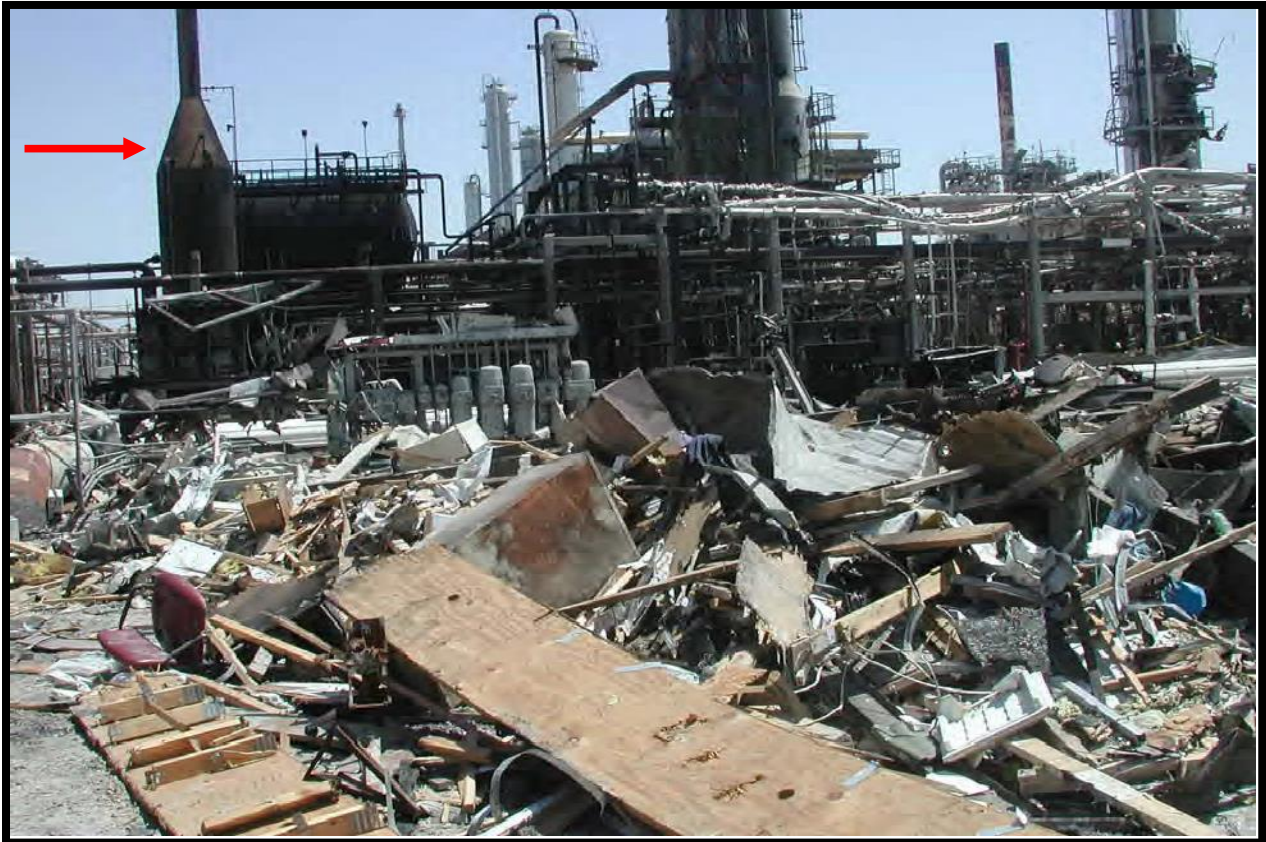
Many of the approximately 70 vehicles in the vicinity of the ISOM unit were damaged and a number were destroyed. More than 40 trailers were damaged; 13 were destroyed. On June 30, 2006, the CSB released a detailed analysis of the trailer damage, which can be viewed or downloaded from the CSB website, www.csb.gov.

Figure 13. Destroyed trailers west of the blowdown drum (red arrow in upper left of the figure)

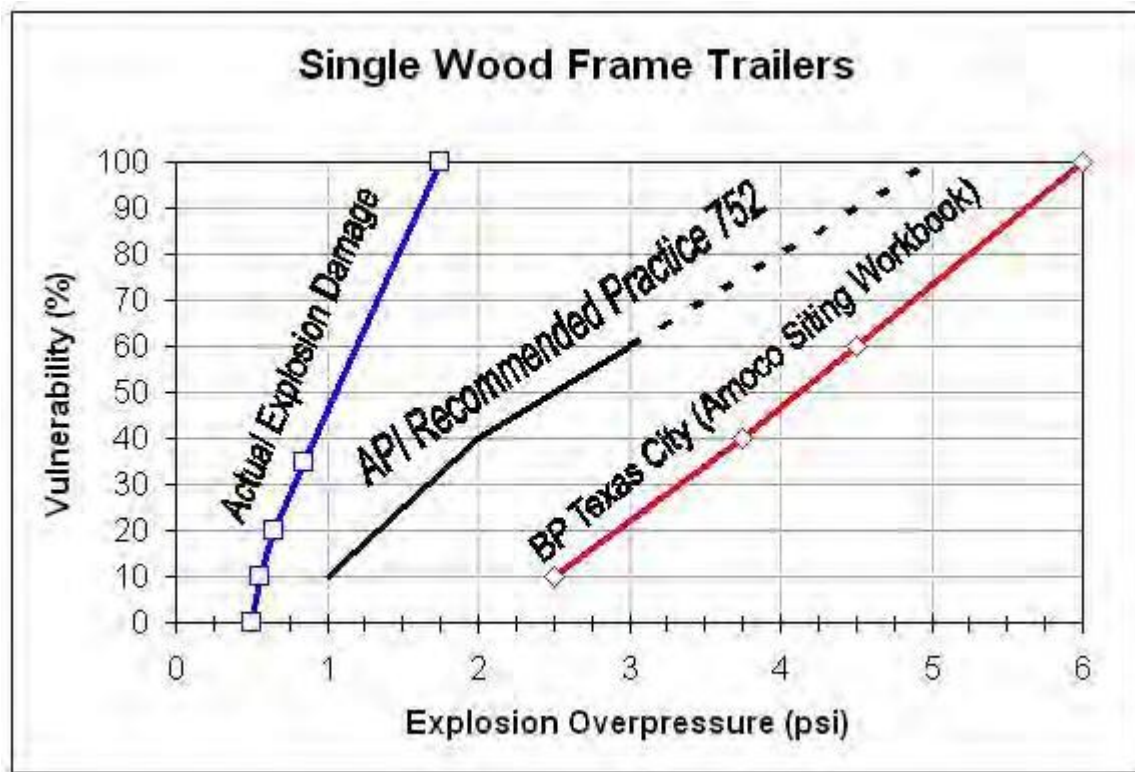
Figure 16. Comparison of explosion damage based on API and BP Texas City criteria

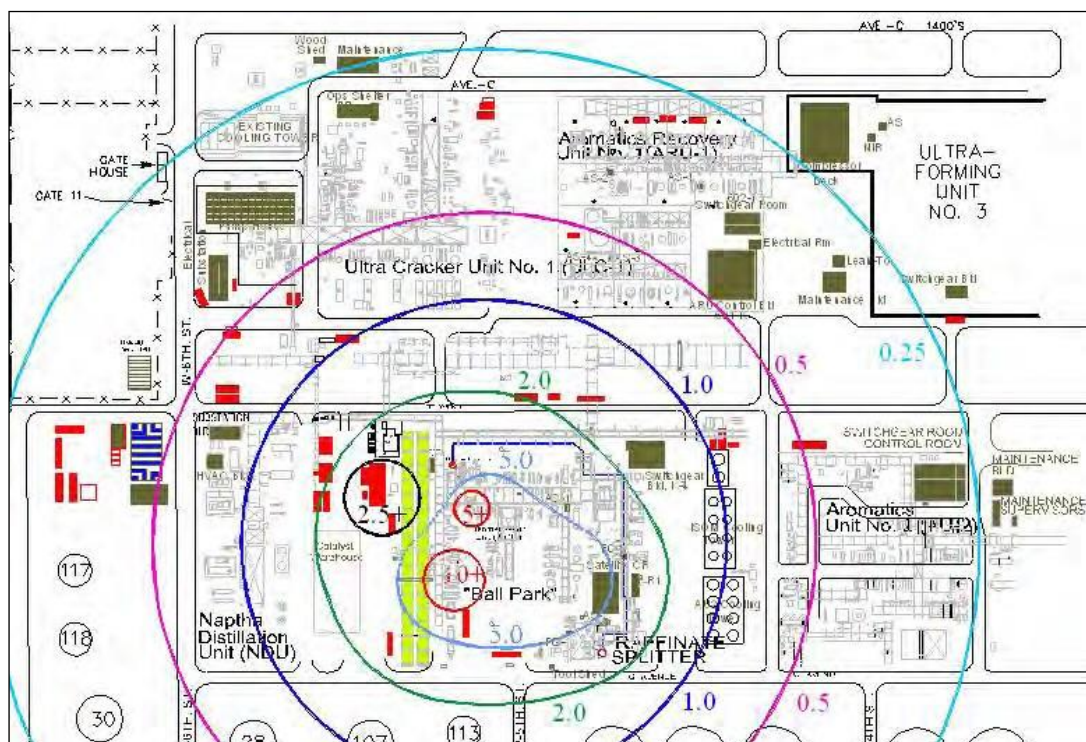
Additional points of interest on the blast overpressure maps (Figure H-2) are

- Areas surrounding the intense pressure regions in the ISOM unit, including the satellite control building, experienced 5 psi and greater overpressures.
- The catalyst warehouse and the six temporary trailers sited directly north of it experienced approximately 2 to 2.5 psi overpressure.
- The east edge of the NDU, first layer of storage tanks south of Ave. G, and the south edge of the ULC unit experienced about 1 psi overpressure.
- The west edge of the NDU, second layer of tanks south of Ave. G, the south portions of ULC and ARU units, and the western edge of the ARU unit experienced 0.5 psi and greater overpressures.
- Five ULC turnaround trailers sited west of Sixth Street; the remainder of ULC and ARU units, and storage tanks farther south experienced 0.25 psi and greater overpressures.

Figure H- 2. Blast overpressure map

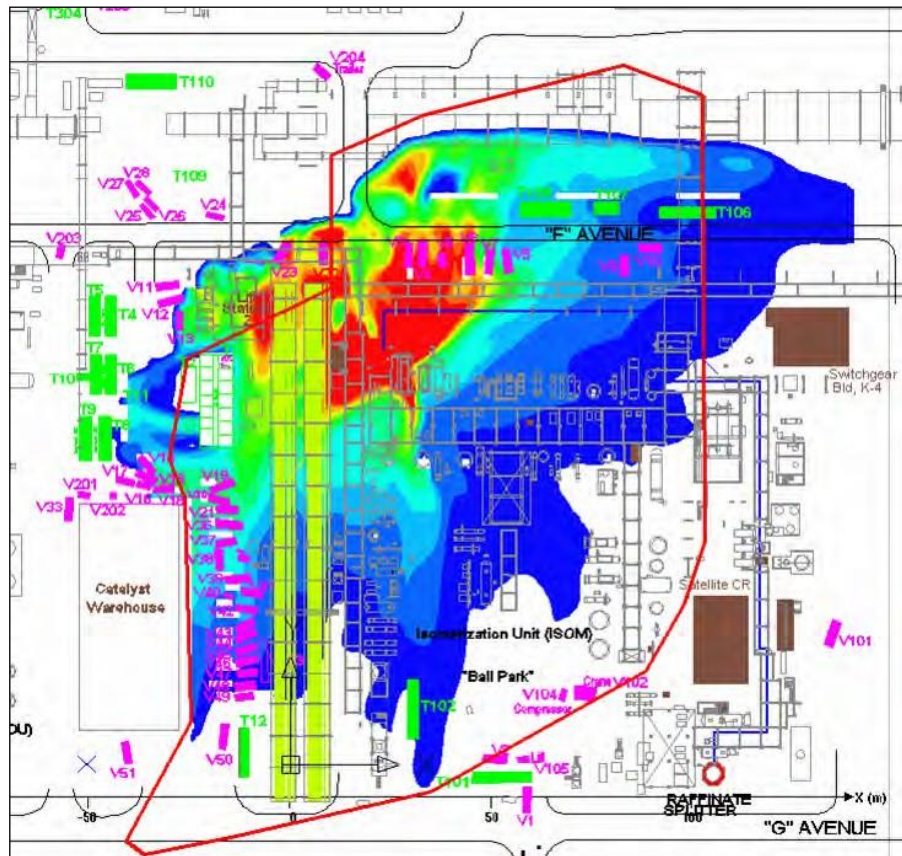
A large domain was chosen that exceeded the expected extent of the flammable dispersion. The domain was also large enough to address sizeable objects around the perimeter of the ISOM unit that would affect wind patterns and ultimately dispersion of flammables. Steady-state wind conditions, as described, were established prior to beginning the dispersion of flammable materials. The dispersion grid was set at 1 meter in the X, Y, and Z directions for the bulk of the model. A tighter grid was chosen at low elevations where the heavy flammable vapor cloud was expected to settle. The CFD modeling attempted to simulate the release conditions and source terms described previously. The CFD model included several vapor source terms that represent vapor generated from evaporation of falling liquid, vapor generated through evaporation when liquid interacted with elevated equipment, and vapor generated by evaporation from liquid pooled on the ground. The numerically discrete nature of CFD allows specifications of definite leak locations; therefore, vapor sources were placed in the model at various locations to represent potential sources. A total of 16 discrete “leak” locations were selected that would be vapor sources in the model, including four sets, placed at various elevations, of four leaks located about the perimeter of blowdown drum. A parameter study that varied the rate of vapor generation for the source terms was then conducted and comparisons made against field data and observations. A comparison (Figure H-3) shows reasonable agreement.

Figure H- 3. Cloud extent comparing field observations (red line) to dispersion modeling

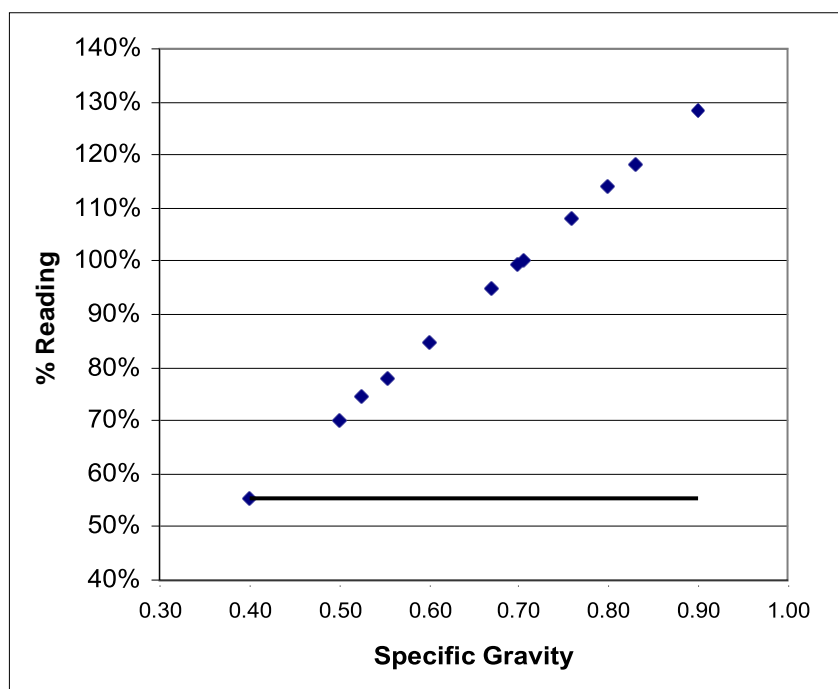
Figure S- 1. Calculated LT-5100 flooded reading versus specific gravity

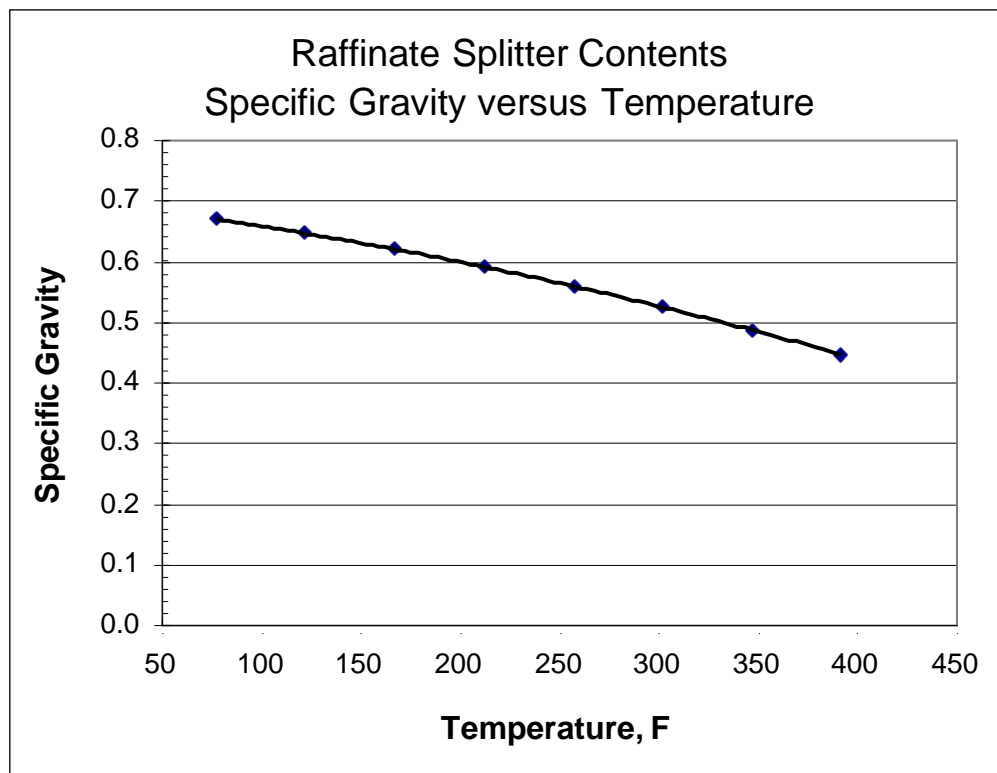
The specific gravity of the hydrocarbon liquid in the raffinate splitter tower is strongly temperature-dependent. At 300°F, the temperature in the base of the raffinate splitter when it overflowed, the specific gravity is about 0.55 (Figure S-2). As Figure S-1 shows, at a specific gravity of 0.55 the transmitter would indicate a level of 78 percent when flooded, which matches the value observed when the raffinate splitter tower over-filled. The CSB concludes that the level transmitter was not calibrated for the specific gravity of fluid at its normal operating temperature.

Figure S- 2. Calculated raffinate splitter feed specific gravity as a function of temperature

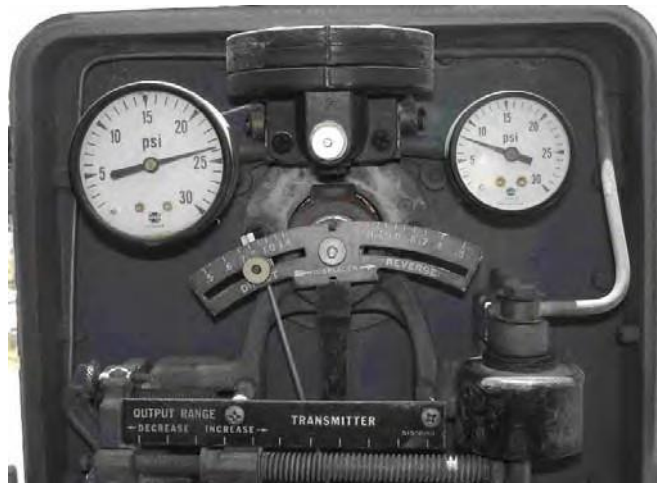
Figure S- 3. LT-5100 cabinet showing calibration set for 0.8 specific gravity

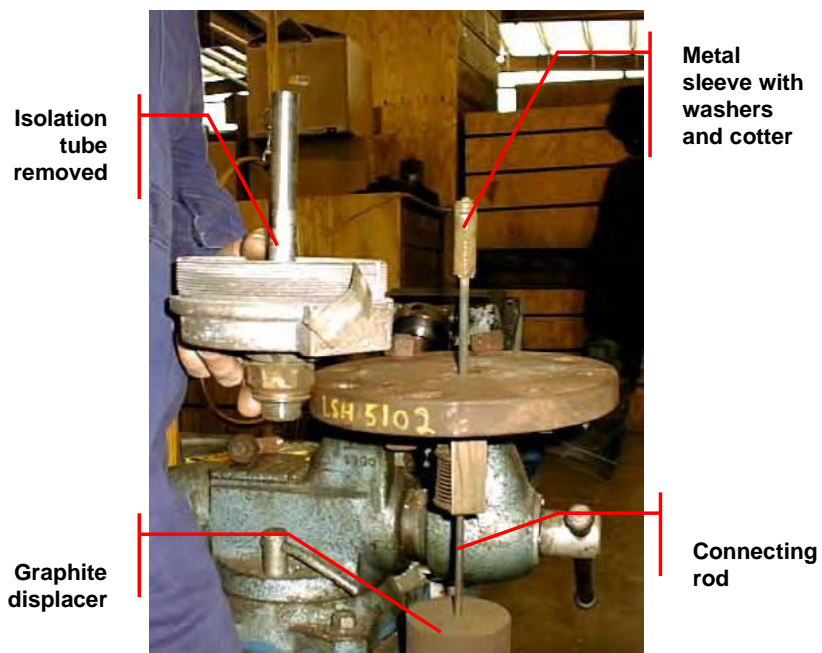
Figure S- 4. LSH-5102 internal components

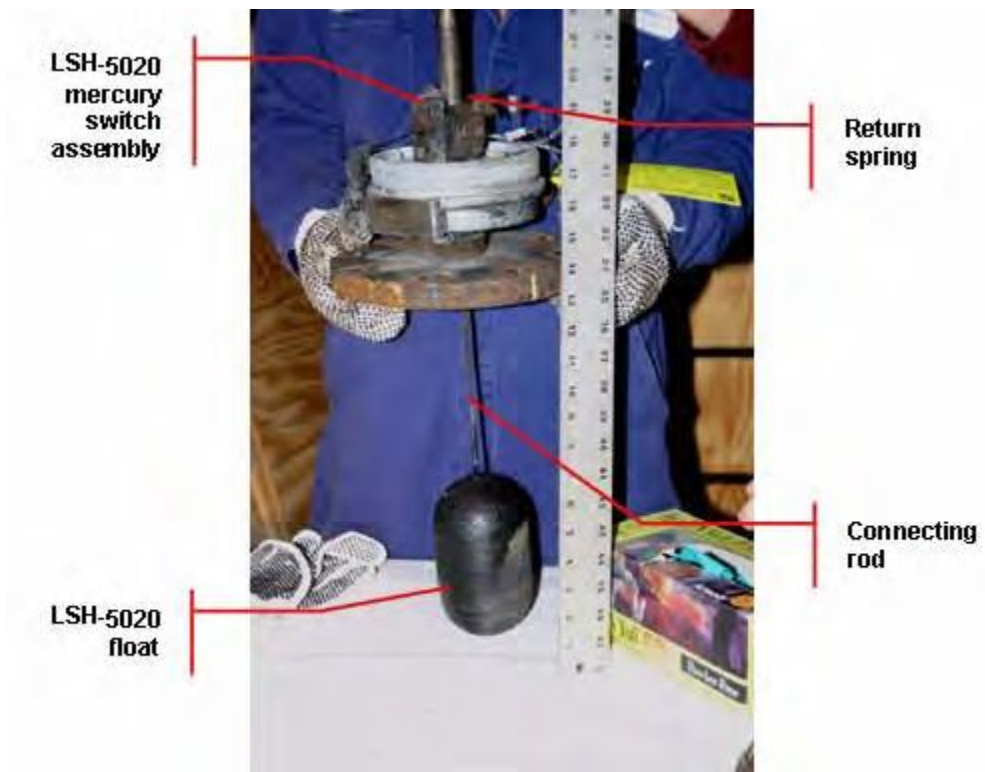
Figure S- 5. Internal components of LSH-5020 blowdown drum high level alarm

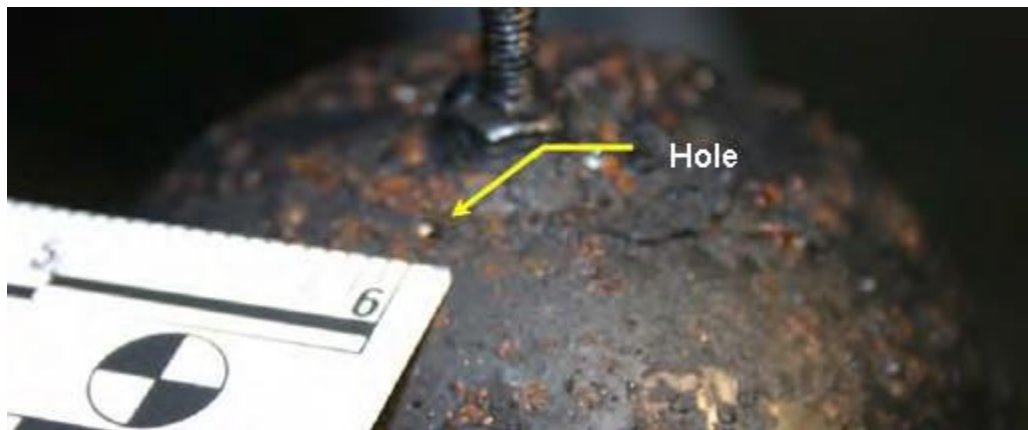
Figure S- 6. Close-up of LSH-5020 float, showing corrosion and hole

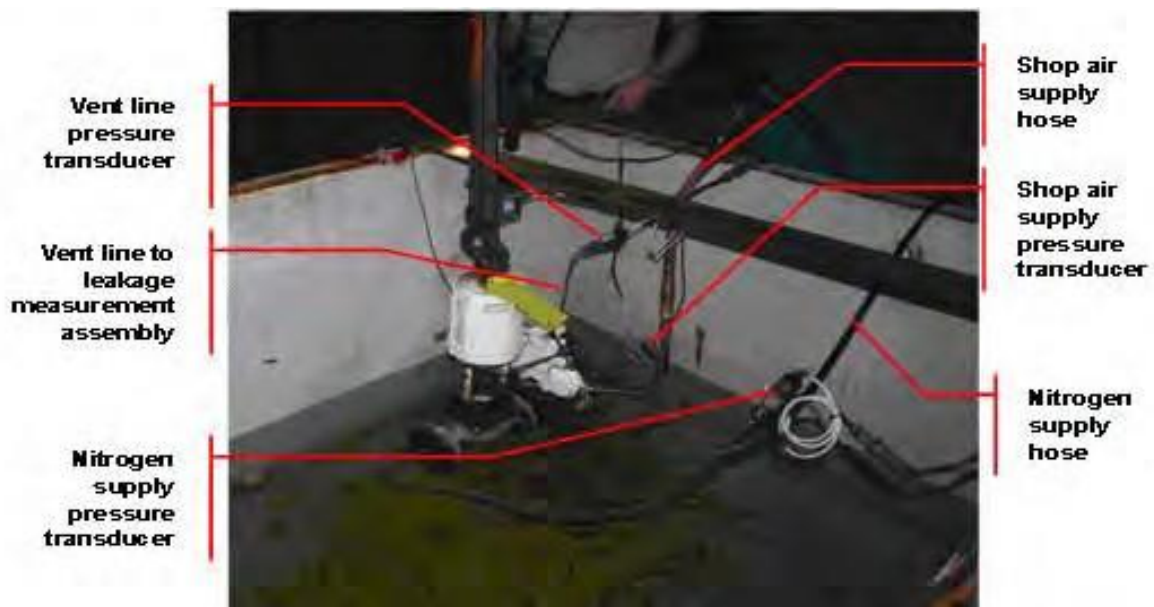
Figure S- 7. PCV-5002 shop testing
