Accident - Bridge collapse in North Carolina

On April 14, 2021, at approximately 5 p.m., the last span of the Herbert C. Bonner Bridge (Bonner Bridge) under demolition collapsed in Dare County, North Carolina. An employee of PCL Civil Constructors, Inc. (PCL), engaged in the steel cutting, was killed. The collapsed span was the navigation span of the Bonner Bridge measuring 180 feet long, 24 feet wide, and approximately 60 feet above sea level, with a total weight of 980 kips.¹

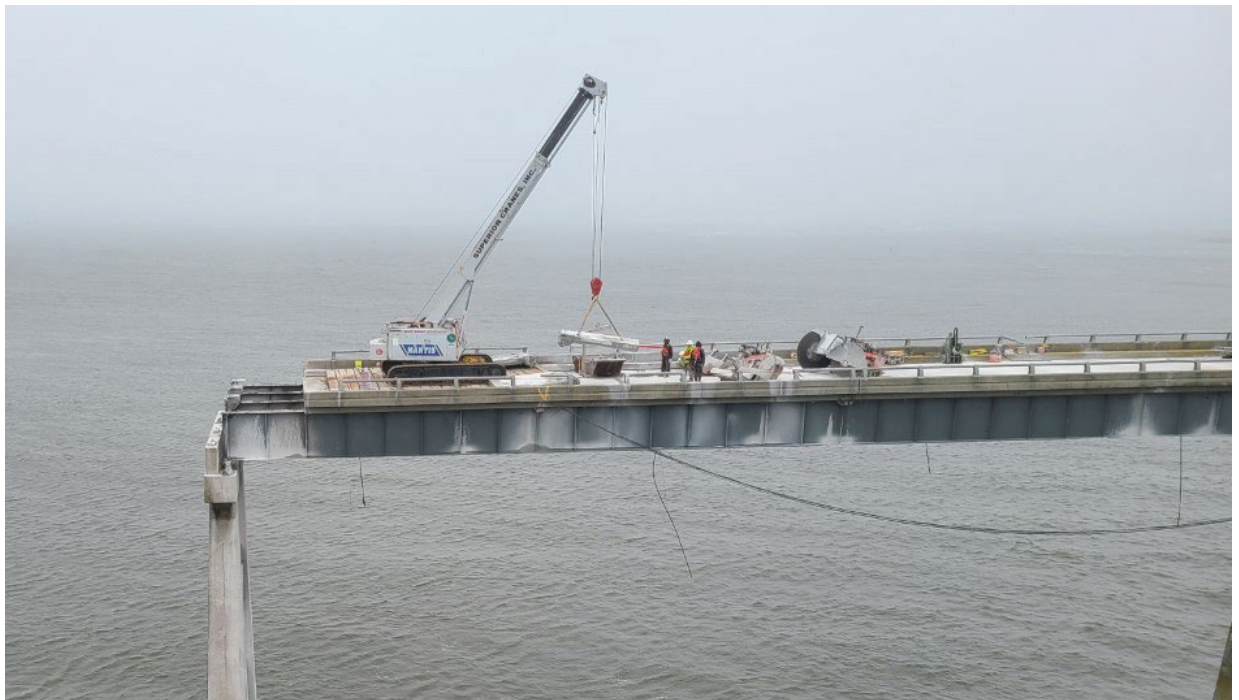
1. PCL removed the center bay of the bridge deck immediately after removing the deck overhang and parapet sections in the same area. In contrast, KCI's demolition plan specified that the center bay of the bridge deck in a span could only be removed after all deck overhang and parapet sections within that span were removed.
2. PCL placed the removed sections of concrete on the deck behind the crane until they were placed on the barge (see Figures 13 and 14)

Figure 13 – Demolition of Span 144
(photographed on 2/15/2021 by NCDOT)

Figure 14 – Demolition of Span 144
(photographed on 2/17/2021 by NCDOT)

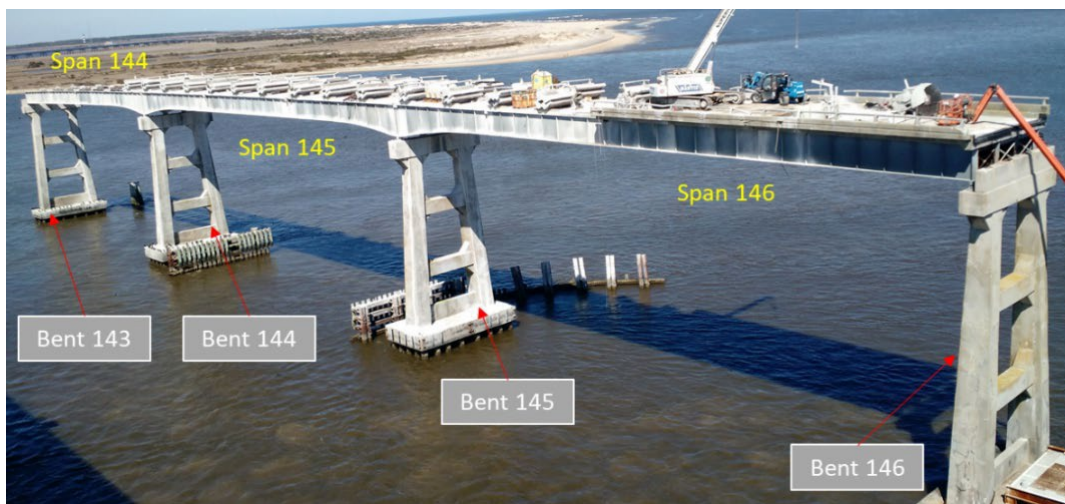
March 10, 2021, PCL developed a plan for stacking deck overhang and parapet segments on Span 146 (see Figure 19). Figure 20 illustrates that PCL placed all overhang and parapet segments on Spans 145 and 146.

Figure 20 – Three steel girder spans under demolition – Looking north (photographed on 3/11/2021 by NCDOT)

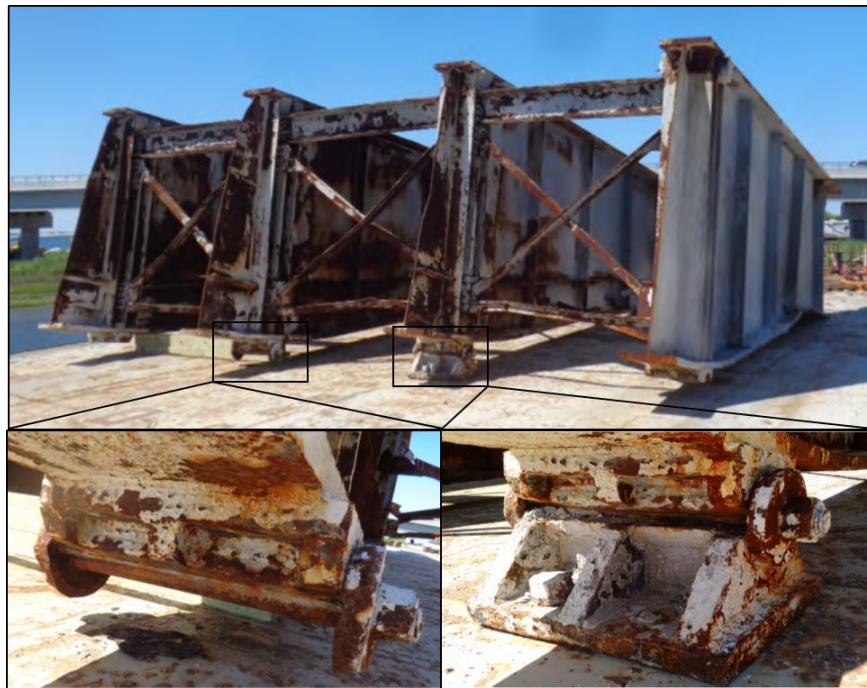
Figure 26 shows the condition and failure pattern of the girders in Span 145 after the collapse. The girders formed a “V” shape at failure, with concrete deck and parapet segments on top at the mid-span region, indicating a significant amount of bending took place in the middle of the span. Bent 145 crumbled completely, leaving the south ends of the girders resting on the footing (see Figure 27). The two columns of Bent 144 fractured at the construction joint approximately 18’ above the waterline and dropped onto the footing (see Figure 28). The north ends of the girders remained attached to the cap of Bent 144 after the collapse occurred. All girder bearings were still attached to the bottom flanges of the four girders after the incident (see Figure 29).

Figure 29 – South girder bearings after the incident

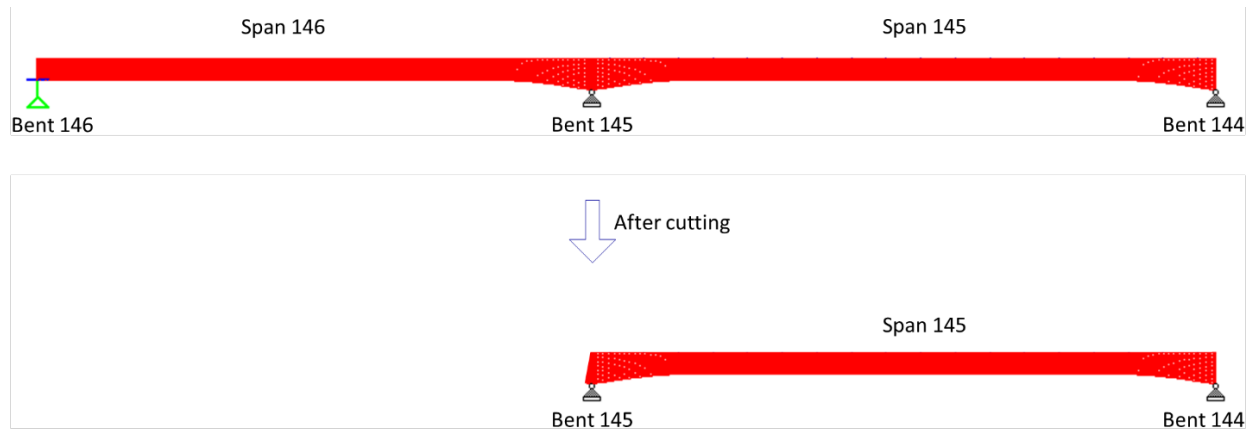
On the day of the incident, before PCL cut the four plate girders in Spans 145 and 146 at Bent 145, these girders were 2-span continuous girders, extending over three supports at Bents 144 to 146 (see Figure 36). Once PCL cut the four girders at Bent 145, the girders remaining in Span 145 became simply supported girders with a much less load-carrying capacity than the 2-span continuous girders before cutting. Our FE analyses confirmed that the maximum Von Mises stress in the girders in Span 145 due to the imposed loads exceeded the yield stress of the A-373 steel, indicating that yielding of steel at some point in these girders occurred when the incident happened.

Figure 36 – Plate girders before and after cutting
