Accident Case - Caribbean Petroleum Tank Explosion and Fire

**Professional Development Hours (PDH) or
Continuing Education Hours (CE)
Online PDH or CE course**

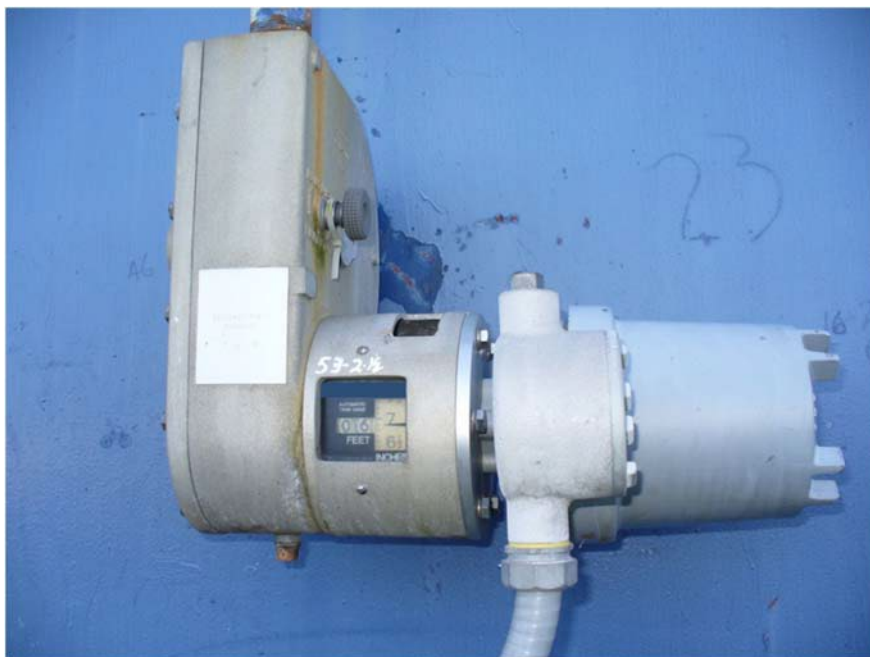
Figure 4: Side gauge: mounted on the side on a tank and displaying the amount of liquid in the tank

- 3) Multiple physical causes likely contributed to Tank 409 overfill:
 - Malfunctioning of the tank side gauge or the float and tape apparatus during filling operations led to recording of inaccurate tank levels;

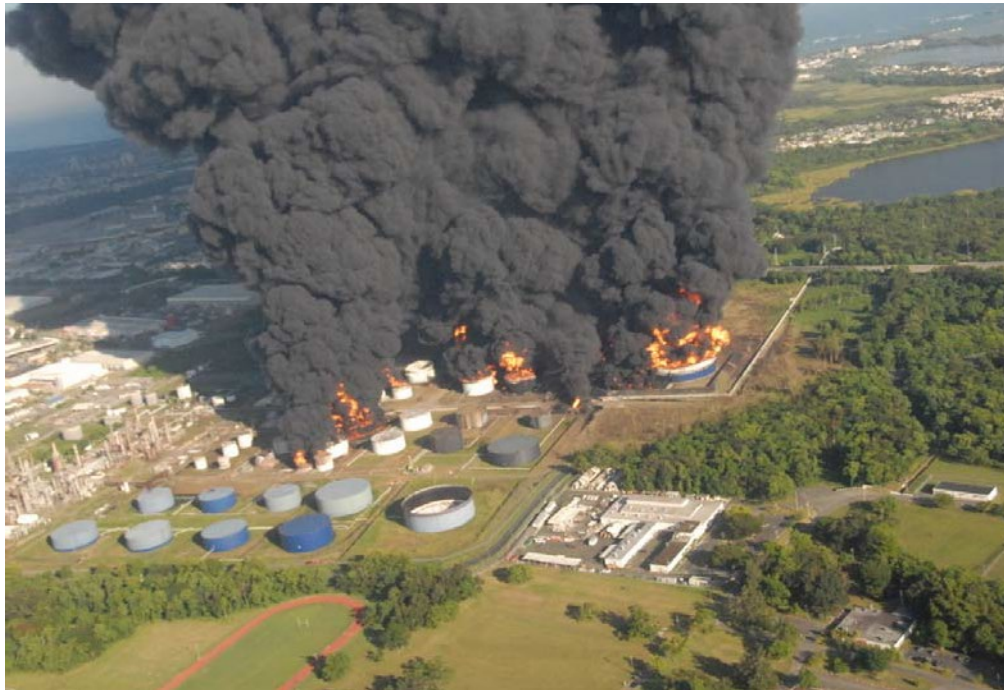
Figure 5: CAPECO multiple tank farm fire, October 23, 2009.

After the explosion, fuel in the damaged tanks burned for over two days while emergency responders fought to control the fire and prevent other tanks from igniting. The large fire demanded emergency personnel and resources from across the Commonwealth of Puerto Rico and the US mainland. Local fire departments with assistance from an industrial firefighting company took 66 hours to extinguish the fire after the explosion. As a result, 17 of the 48 tanks burned. (See Figures 5 and 6.)

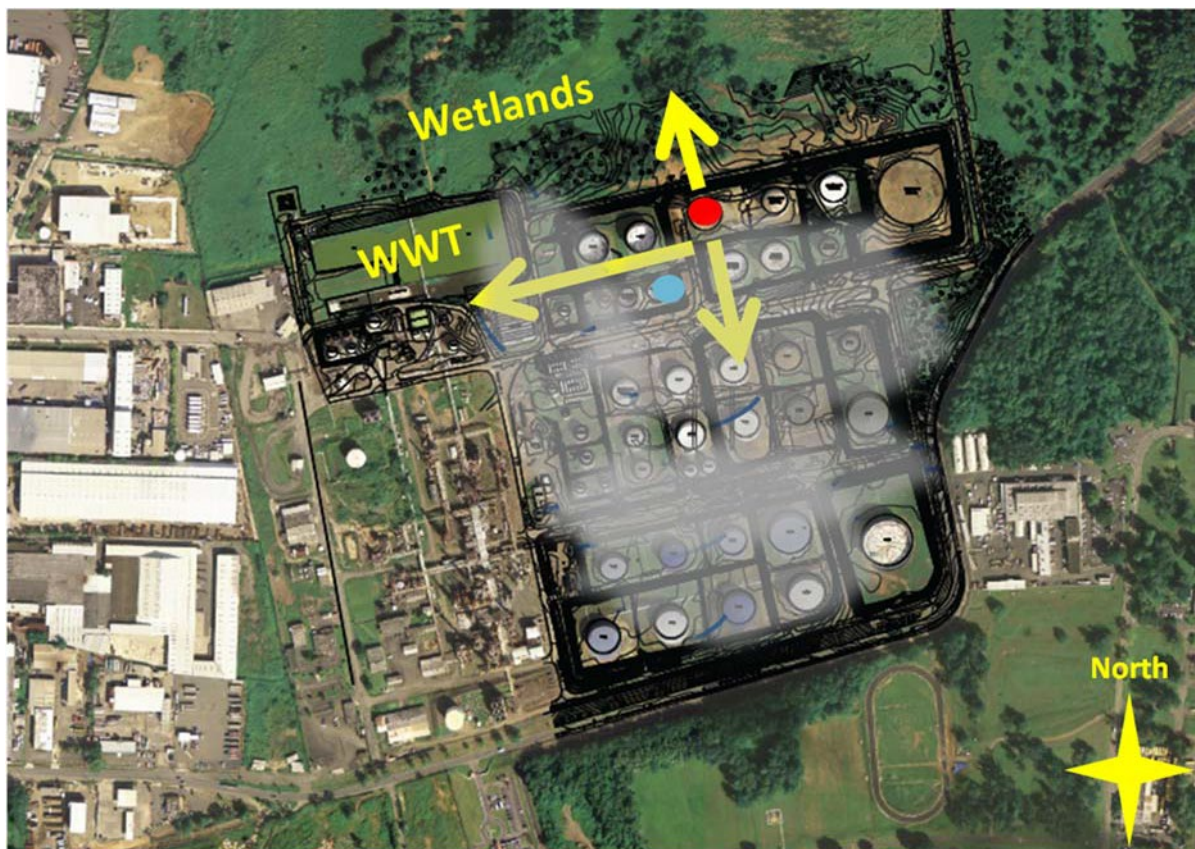
Figure 7. Topographic Survey of CAPECO Tank Farm showing the gasoline vapor cloud migration from higher elevation (Tank 409-Red and Tank 411-Blue) toward low-lying areas by the WWT plant, the south eastern end of the refinery and wetlands to the north. The cloud indicates the approximate area where the vapor cloud migrated based on surveillance footage.

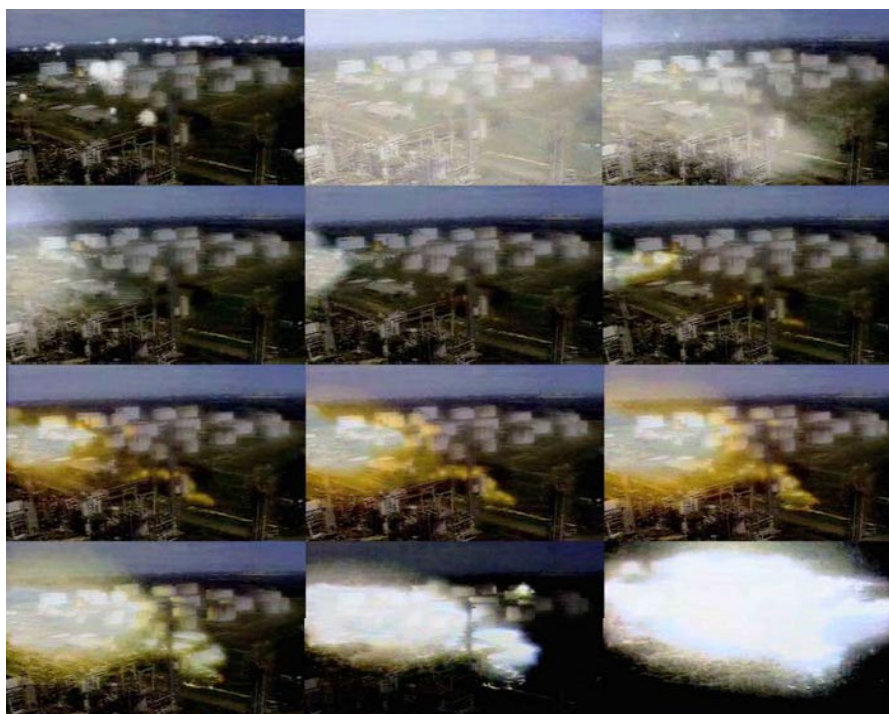
At 12:23 a.m., on October 23, 2009, security cameras at CAPECO and neighboring facilities recorded the ignition of the vapor cloud in the WWT area. About seven seconds after ignition, the vapor cloud exploded, creating a pressure wave that damaged hundreds of homes and businesses up to 1.25 miles from the site. The fire propagated through the vapor cloud and ignited multiple subsequent tank explosions registering 2.9 on the Richter scale.²⁰

Figure 8: CAPECO surveillance footage of flame propagation during October 23, 2009 CAPECO explosion

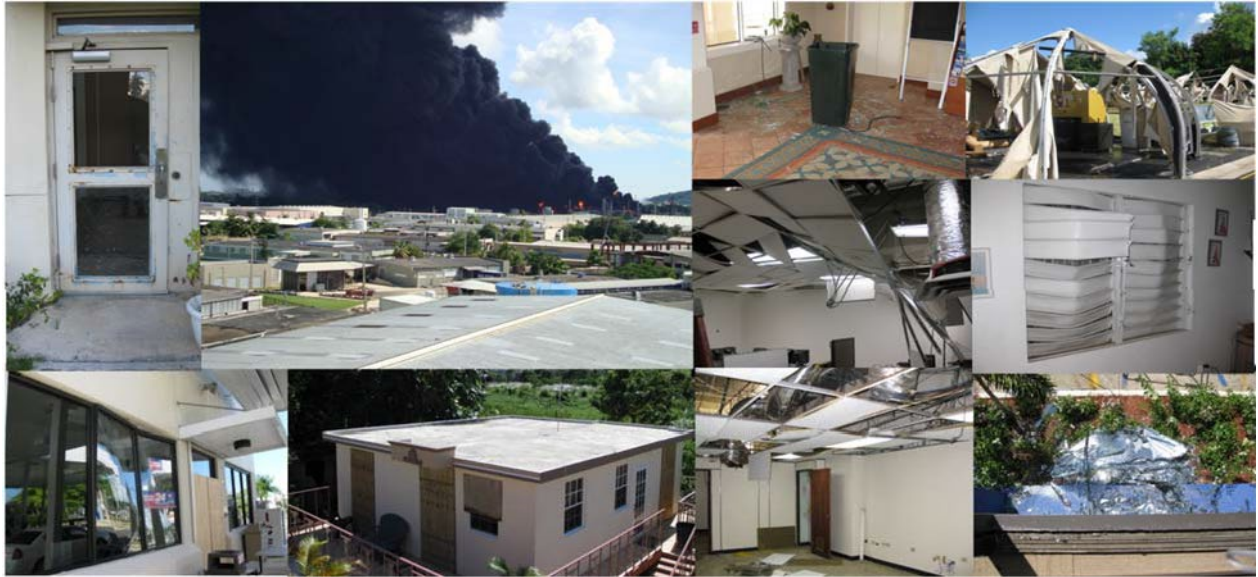
Fort Buchanan experienced the most severe damage—suffering an estimated \$5 million in repair costs. Community impact assessments³⁹ found most of the structural damage occurred in the Puente Blanco neighborhood where PREMA and the Department of Housing (DOH) found damage to 232 of the 266 homes assessed; 139 were repaired and six were demolished by November 2009.⁴⁰ The Puente Blanco community also experienced environmental contamination to several surface water bodies, including federally protected wetlands and streams surrounding the CAPECO site. After assessing 289 homes damaged by the explosion in the Cataño community, the Small Business Administration (SBA)⁴¹ designated 25 single-family homes as destroyed or severely damaged at or beyond 40% of their fair market value. (See Figure 10.)

Figure 10: Community damage surrounding the CAPECO facility

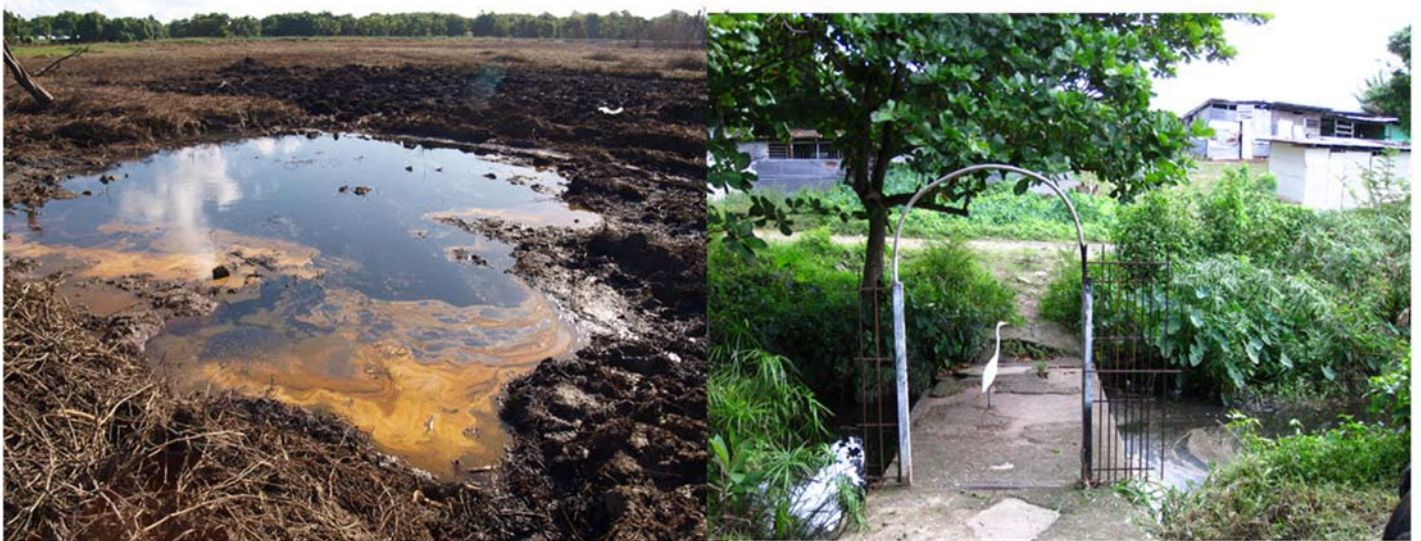
Figure 11: Oil Spill into nearby wetlands (photo from NOAA.gov) and in a local community drain after CAPECO explosion and tank fires

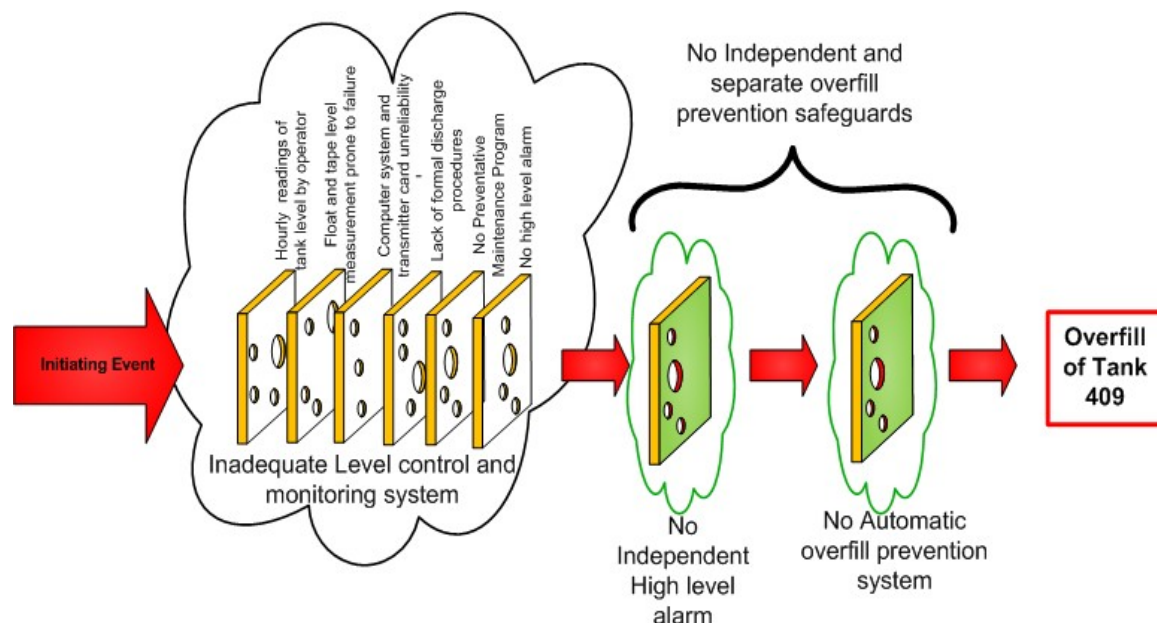
The CSB determined that numerous technical and systemic failures contributed to the explosion and multiple tank fires at the CAPECO tank terminal. The CSB found that multiple layers of protection failed within the level control and monitoring system at the same time. In addition a lack of independent safeguards contributed to the overfill. James Reason's Swiss Cheese Model best demonstrates these systemic failures that led to the accident.⁵⁰ Reason postulates that an accident results from the breakdown of the "interaction between latent failures⁵¹ and a variety of local triggering events (active failures)"⁵² and although rare, the "adverse conjunction of several

Figure 12: Contributing to the October 2009 overfill incident at CAPECO were multiple failures of the level control and monitoring system in addition to a lack of safeguards like a high level alarm, an independent level alarm and an automatic overfill prevention system that allows for automatic shutdown or diversion.

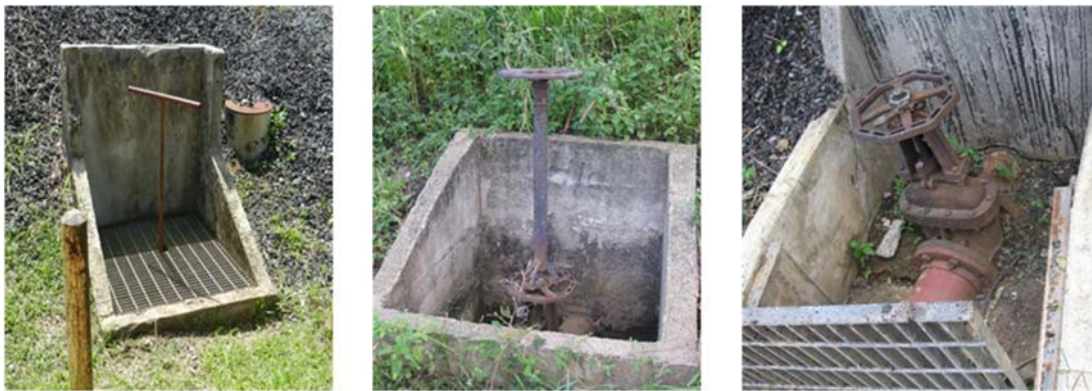
CAPECO's normal practices required operators to open and close valves during the day shifts. Operators customarily inspected whether the dike drain valves were open or closed from their vehicles as they drove by. The tank farm used both rising stem and fixed stem valves on the dike drains leading to the storm water retention pond in the WWT area. Rising stem valves allowed operators to easily observe the open or closed position while fixed stem valves do not provide a visual indication of the position. The fixed stem valve on the dike drain for Tank 409 made it difficult for tank farm operators to observe its position without physically turning it. (See Figure 15.) In some cases, the valve position could not be determined with a visual inspection because the rising stem valve position was hidden in the sump. (See Figure 15, center photo.) Furthermore, none of the dike valves shown in Figure 15 were consistent with RAGAGEP. Regulatory coverage under the EPA Risk Management Plan (RMP) or OSHA's Process Safety Management (PSM) Standard requires that CAPECO use the best available engineering practices to assess valve open/close status.

Figure 15: Various dike drain valves at CAPECO. Tank 409 fixed stem dike drain valve (left): position of the valve is undeterminable without physically turning the valve. Rising stem valves (center, right). In some cases, the valve position is hidden in the sump (center).
