Accident Case - DuPont Methyl Chloride Release

**Professional Development Hours (PDH) or
Continuing Education Hours (CE)
Online PDH or CE course**

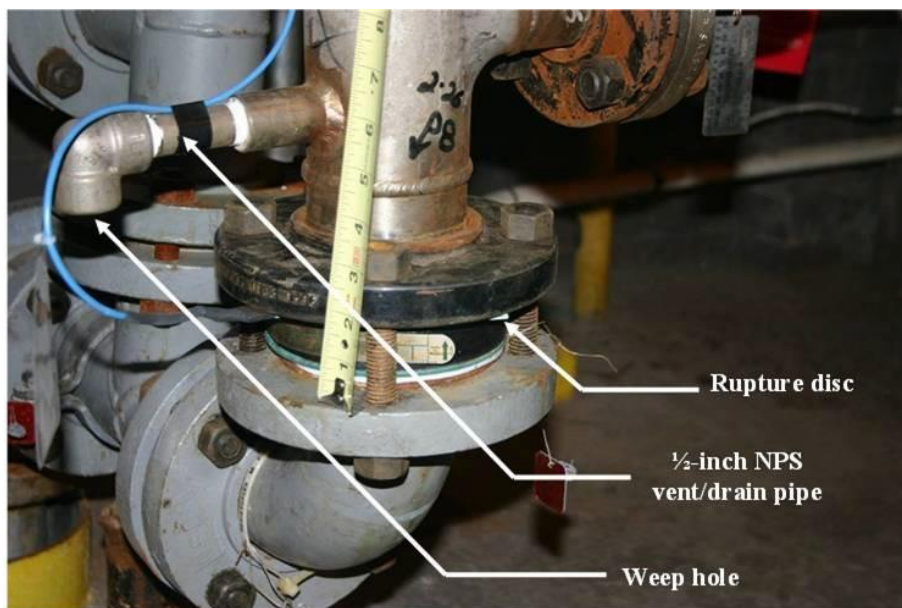
Figure 3. 0.5-inch NPS vent/drain pipe and rupture disc

weep hole (Figure 3). This connection was associated with a thermal oxidizer “vent stack,” that vents to the atmosphere on the roof of the building during a process upset. Operators notified the board operator at 5:19 a.m. when they found the source of the release.

The methyl chloride, DMA, and hydrochloric acid (HCl) mixture is extremely odorous; however, due to the nature of the F3455 process, operating personnel would have had to be in the area of the 0.5-inch weep hole at the time of the release to see or smell the leak.

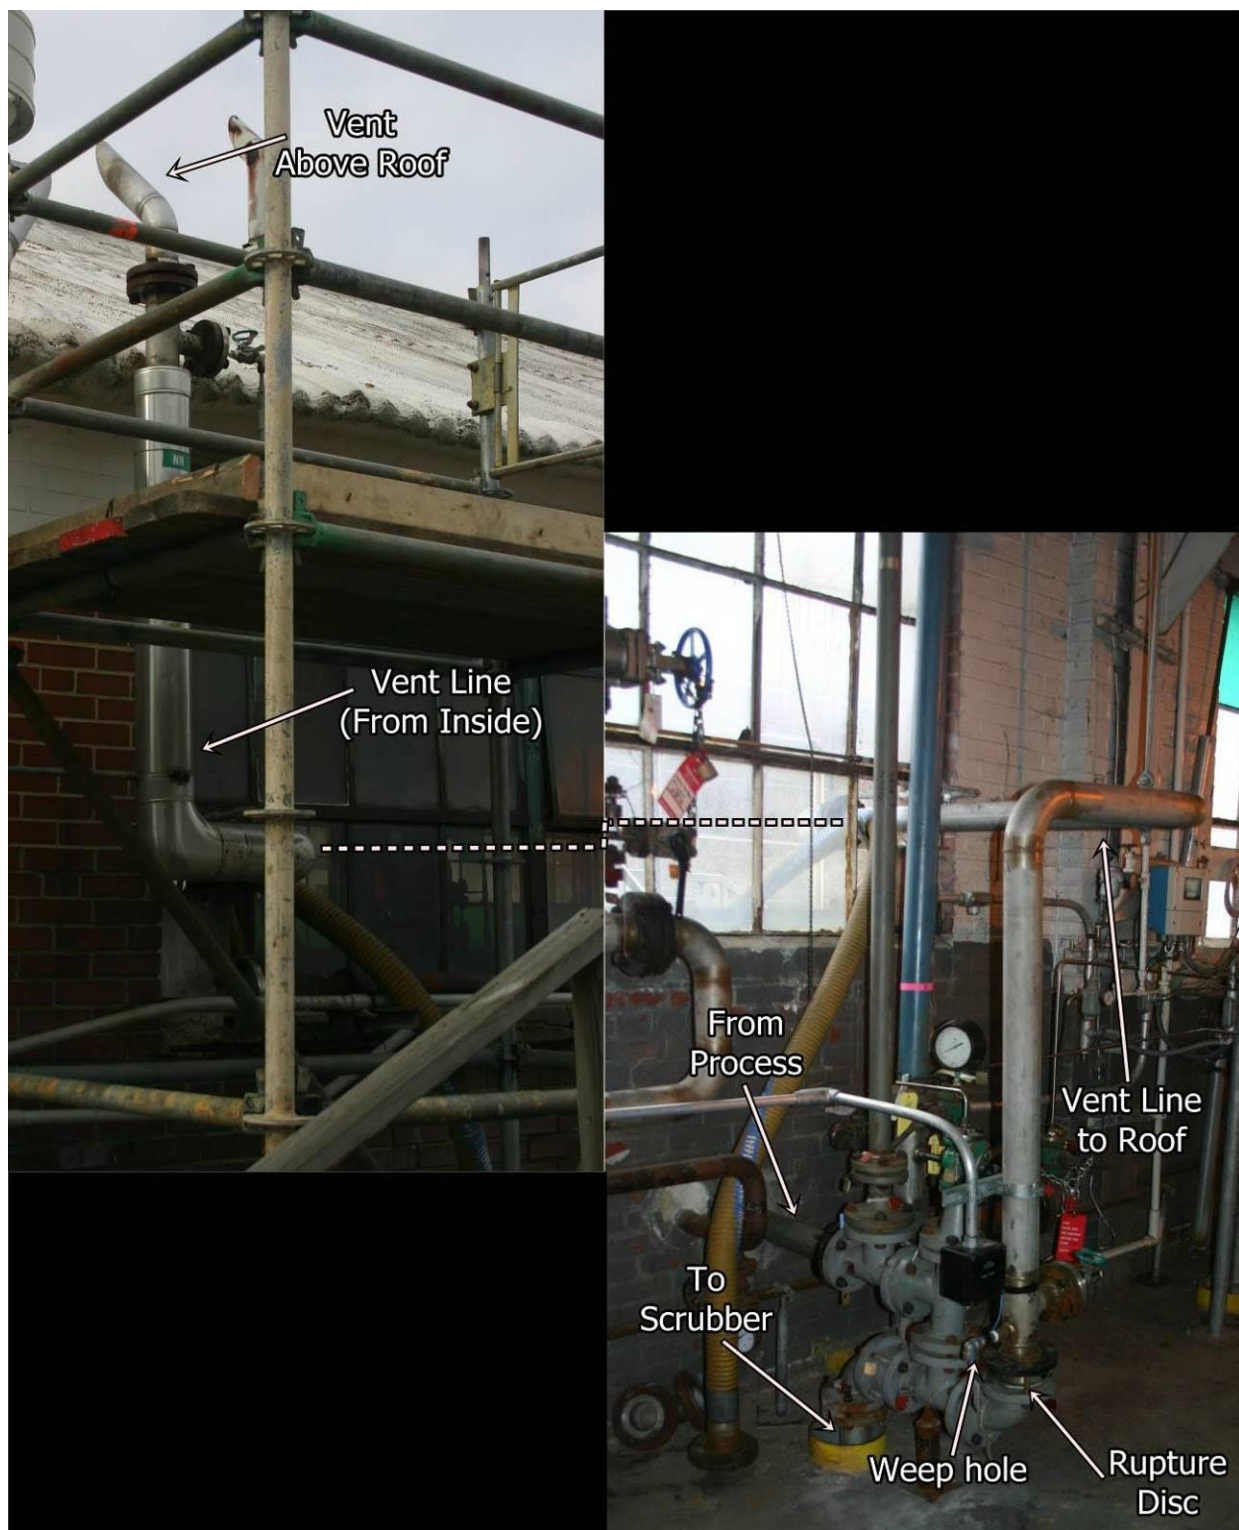
Figure 4. Rupture disc piping and vent pipeline to atmosphere on roof

The rupture disc piping was routed to the atmosphere above the roof of the building, which would have provided an outlet path for the methyl chloride vapor where it would have dissipated and dispersed without notice.

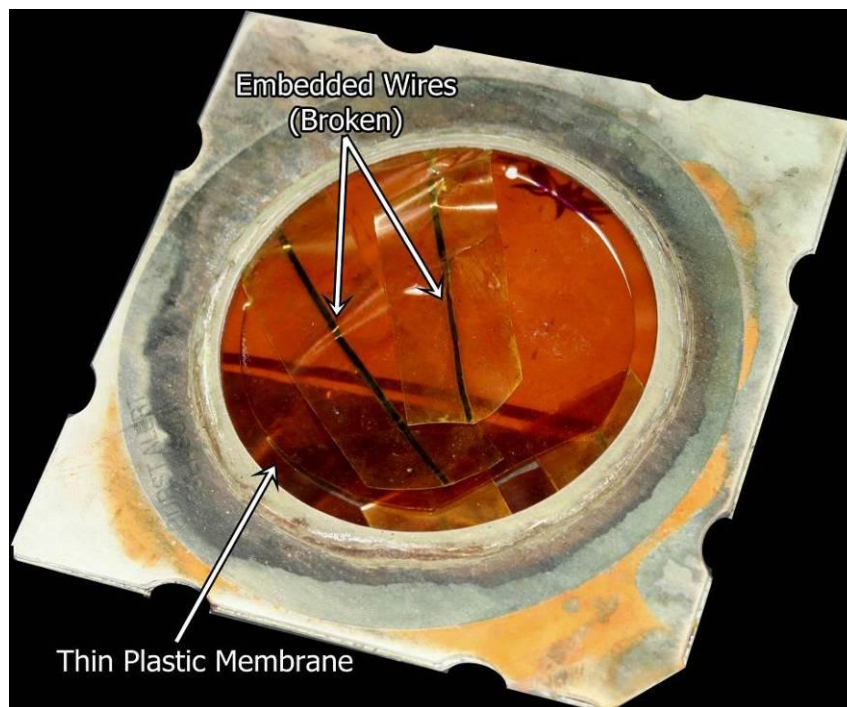
Figure 5. Rupture disc burst sensor post-incident

DuPont Belle used a “burst sensor” intended to notify the board operator that the rupture disk (Figure 5) activated. A burst sensor is a thin plastic membrane with embedded wires installed on top of the rupture disc. Small electrical current passes through the wires. When the rupture disc activates, the membrane and embedded wires break, triggering the alarm.

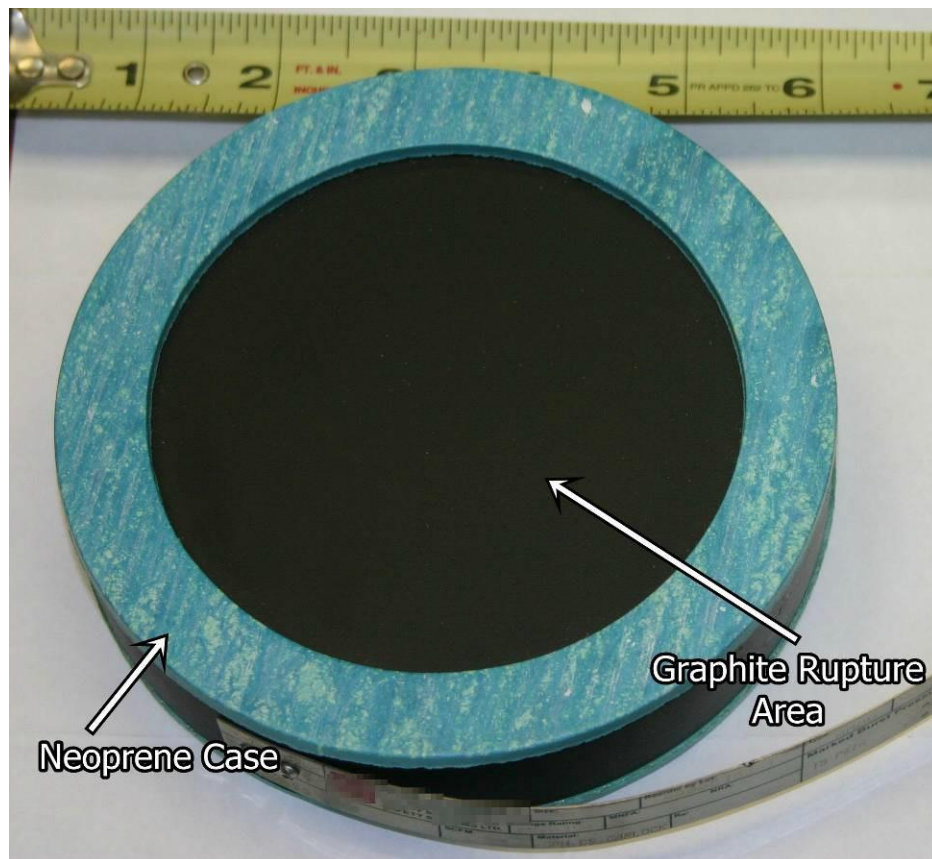
Figure 6. New rupture disc

The rupture disc involved in the incident was a 4-inch diameter graphite rupture disc, designed to rupture at 15 psig, and mounted in neoprene casing (Figure 6). While the rupture disc is on a preventive maintenance (PM) schedule, the annual inspection was so infrequent that the disc is replaced only when it has activated or is removed for certain processes. Operators told the CSB investigators that once removed, the rupture discs, intact or compromised, are discarded and replaced with new ones. Even without a burst

sensor, all overpressure protection devices, including rupture discs, should be routinely checked on an effective PM schedule as a layer of protection.¹⁶

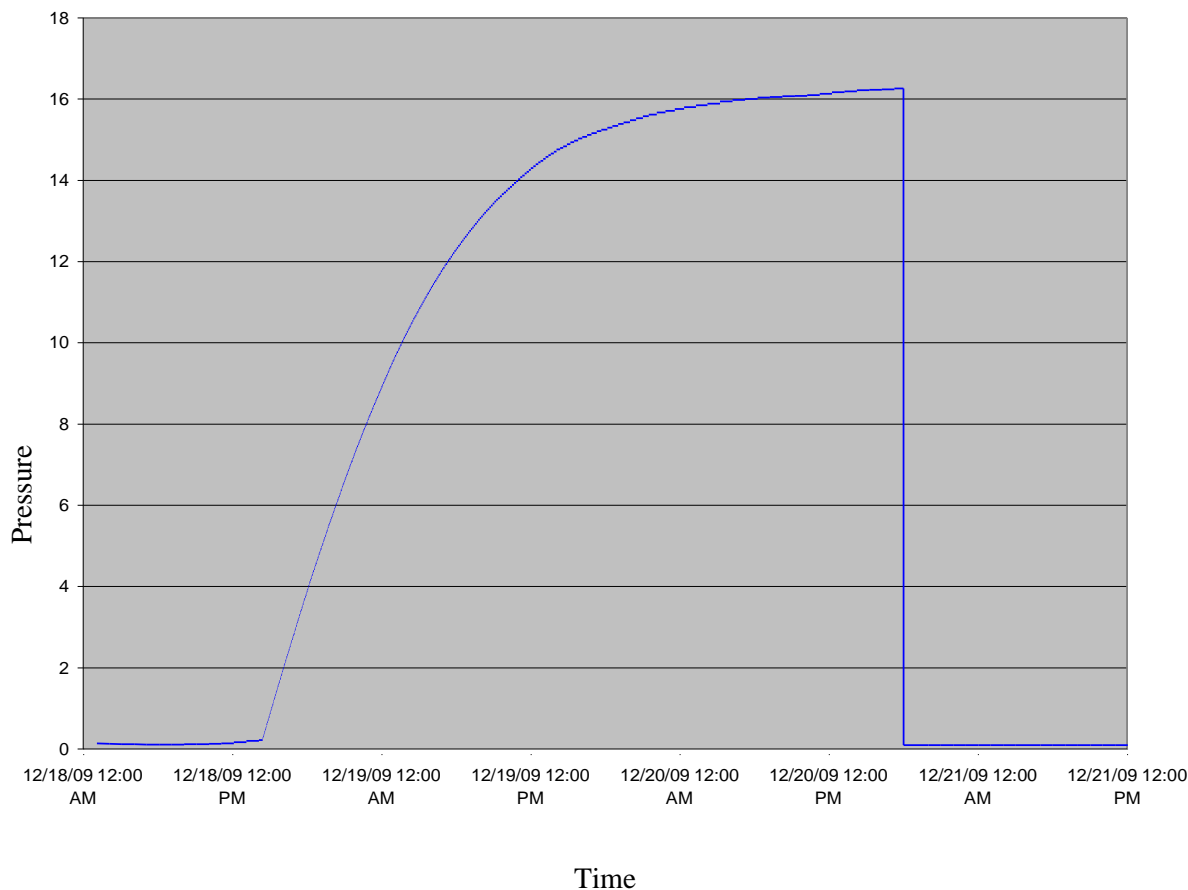
Figure 7. Process data showing sudden pressure decrease when rupture disc burst

DCS data recorded during the shutdown indicated that the pressure in the reactor system increased slowly from December 18, 2009, to December 20, 2009, when it exceeded the rupture disc rating (Figure 7). The source of the pressure was a nitrogen valve on a level indicator that slowly leaked nitrogen into the system.²⁰ The rupture disc burst, triggering an alarm, as it should have. Under normal, live operating conditions, the operators would have investigated to understand, acknowledge, and correct the alarm condition. However, extensive maintenance work was still underway in the unit; thus, the operators did not address the alarm as they would have under normal operation.

The operators did not address the alarm when it triggered in December because they knew that work in the area was causing nuisance alarms; however, when the ECF alarm activated on January 22, 2010, operators responded. The board operator in the F3455 control room investigated and observed that the original alarm from December 21, 2009, was still displayed; the first item on the alarm screen had not been acknowledged because they had become accustomed to nuisance alarm conditions.²¹

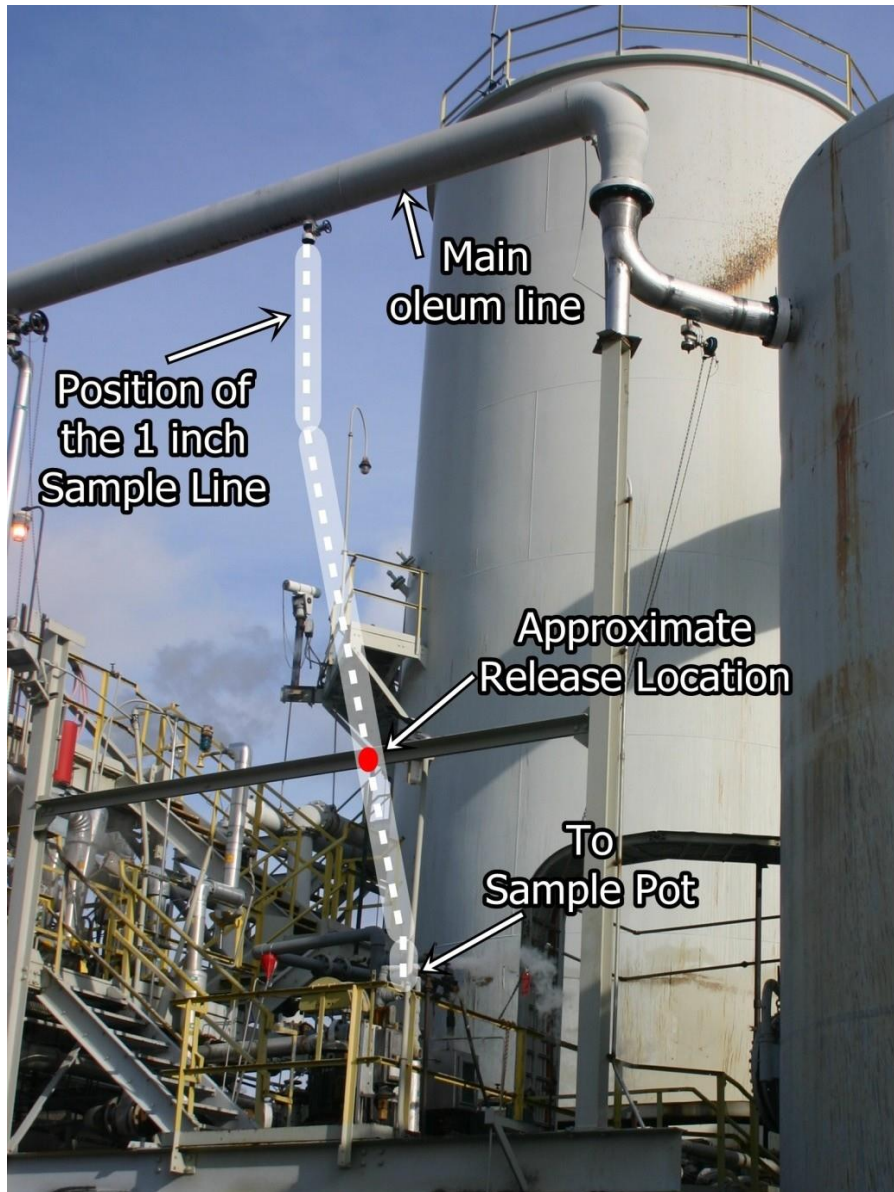
Figure 8. Photo of the position of the 1-inch sample line, which had not yet been replaced

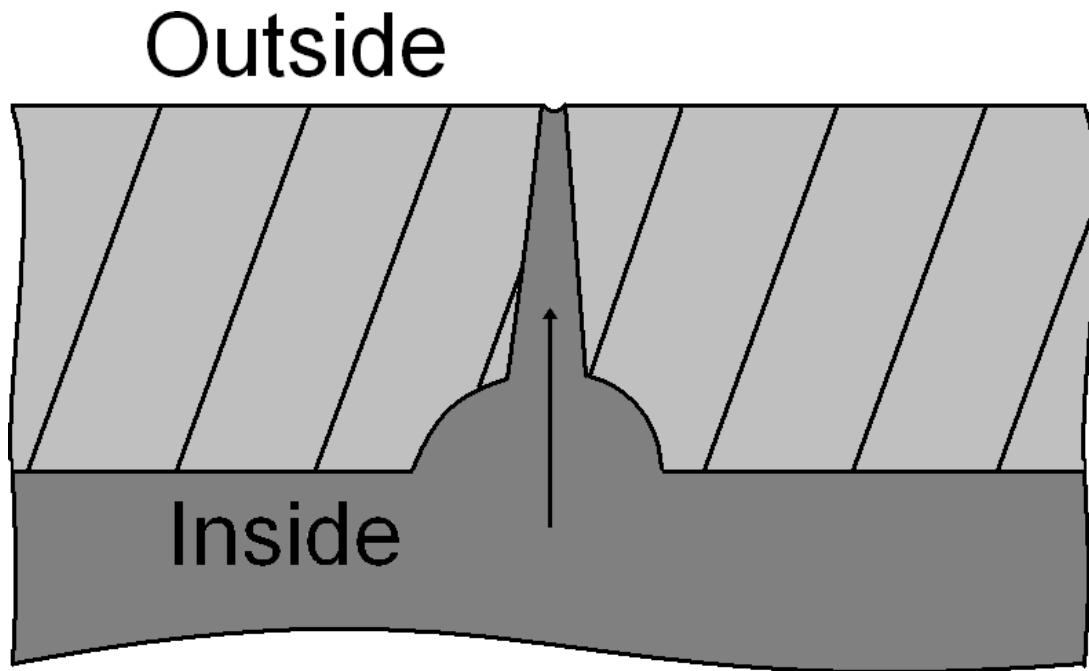
Caused by an unknown defect, oleum corroded through a small section of the pipe involved in the release on January 23, 2010. Starting as a pitting phenomena and finishing slightly larger than a pin hole, the corrosion penetrated the insulated stainless steel sample pipe (Figure 9).

Figure 9. The pitting phenomena in the small initial hole of the oleum sample line wall

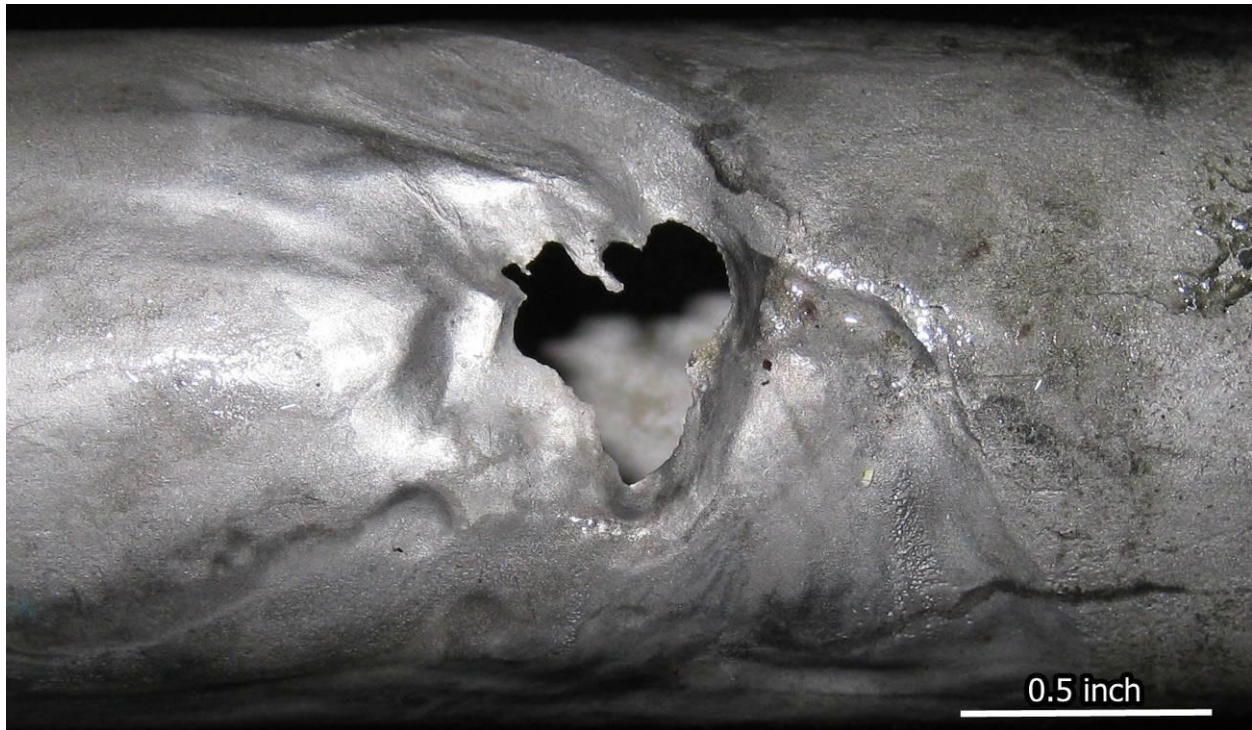
Once oleum was present on the exterior of the oleum pipe, it readily corroded the insulation and steam tracing line and then created a leak in the steam tracing, causing the steam and oleum to mix. This reaction created a strong solution of sulfuric acid that rapidly and effectively corroded the stainless steel sample line exterior, until a second larger hole developed at a location near the original small leak. The second hole clearly shows corrosion occurring from the outside-in (Figure 10).

Figure 10. The larger hole eroded from the outside-in on the oleum sample line²⁶

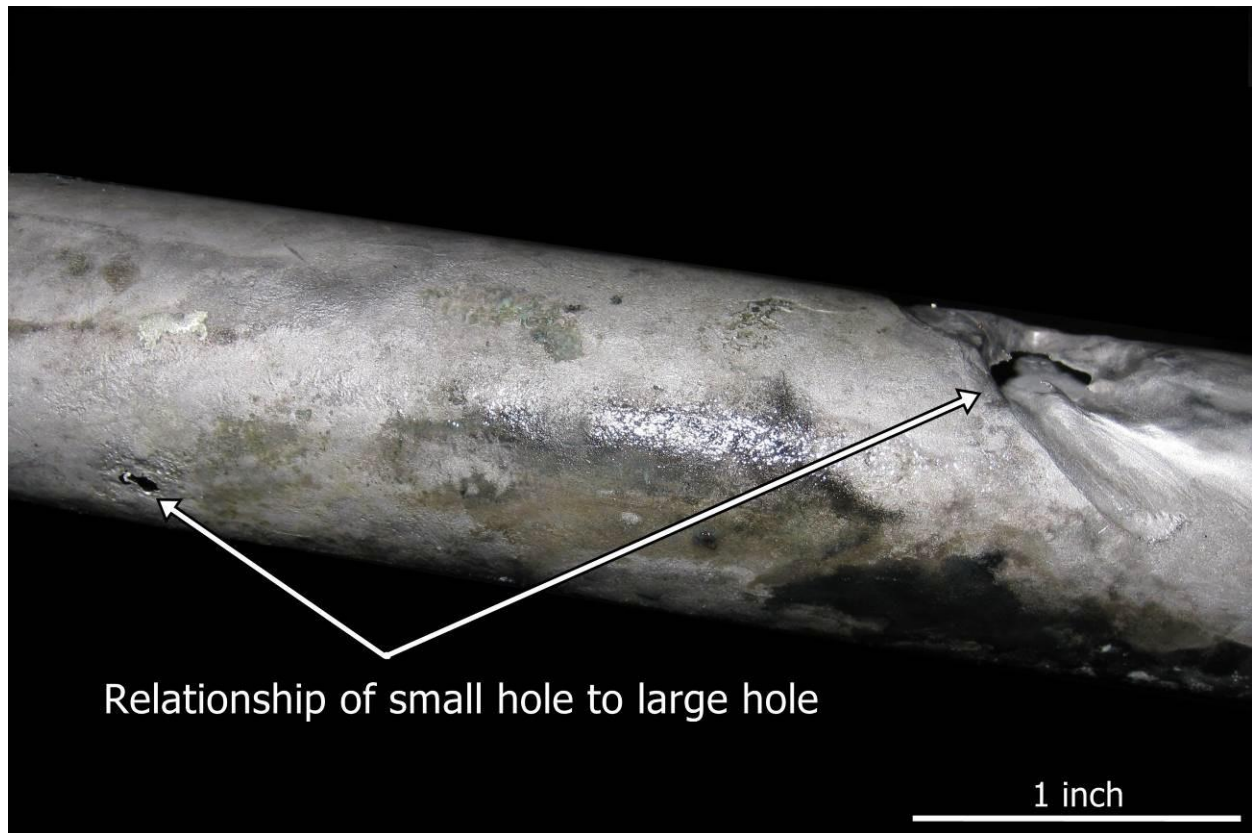
When DuPont removed the oleum-soaked insulation and cover, a larger hole was visible; the acid had also corroded a large amount of the steam tracing. When the sample line was properly cleaned, inspection revealed that the smaller hole was only a few inches away from the larger hole, and after thorough examination, metallurgists concluded that the small hole in the sample line initiated the oleum release (Figure 11).

Figure 11. Photo showing the orientation of the small hole to the main hole

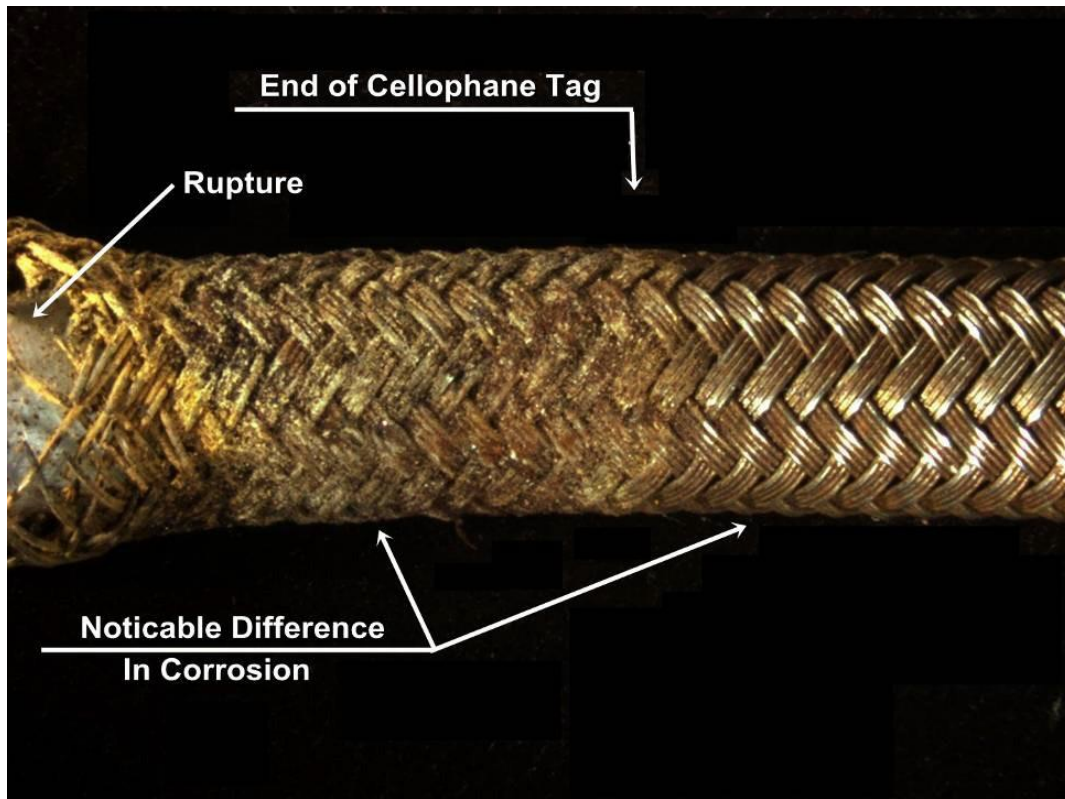
The PTFE, 304 stainless steel, and white plastic adhesive tape contributed to the incident. The PTFE inner core was permeable and susceptible to phosgene vapor diffusing through the hose. The adhesive tape used to secure the tag contributed to the retention of phosgene gas on the exterior of the stainless steel overbraid. The phosgene gas converted to HCl, and 304-stainless steel overbraid is subject to corrosive attack by HCl. Since the white plastic adhesive tag trapped the phosgene permeating through the PTFE inner core, the resulting concentration of HCl was much higher under the tag than elsewhere on the hose (Figure 14).

Figure 14. The distinct effect of the white plastic adhesive tag on the corrosion of the stainless steel overbraid

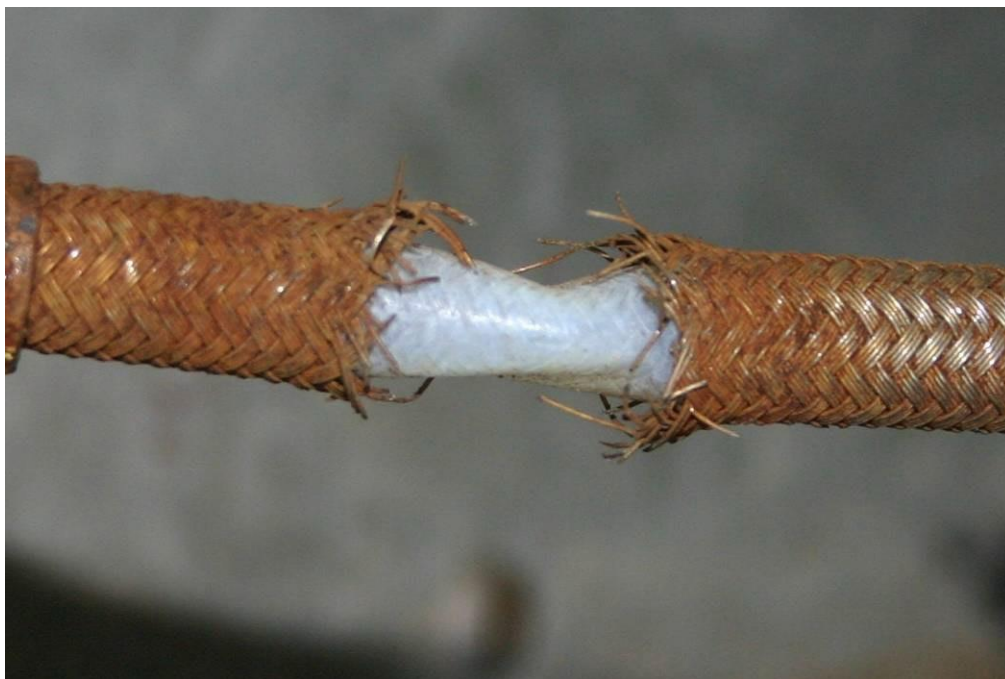
The hillside phosgene supply hose and valve assembly were removed and decontaminated in a water bath. When the hose was removed from the water, the white adhesive ID tag had fallen off, revealing a broken stainless steel braid and collapsed PTFE liner, a possible cause of the flow restriction (Figure 15).

Figure 15. Damaged hillside phosgene hose removed from phosgene cylinder. The plastic adhesive tag that covered the damaged section fell off during the hose decontamination procedure.

An operator stated during an interview that when he saw the physically defective section of the frayed hose, he told his coworkers, stressing that the hose was close to rupturing and that they were lucky to have found it and changed-out the hose in time. Unfortunately, this discovery was not captured as a near-miss, since supervisors were not made aware of the issue.

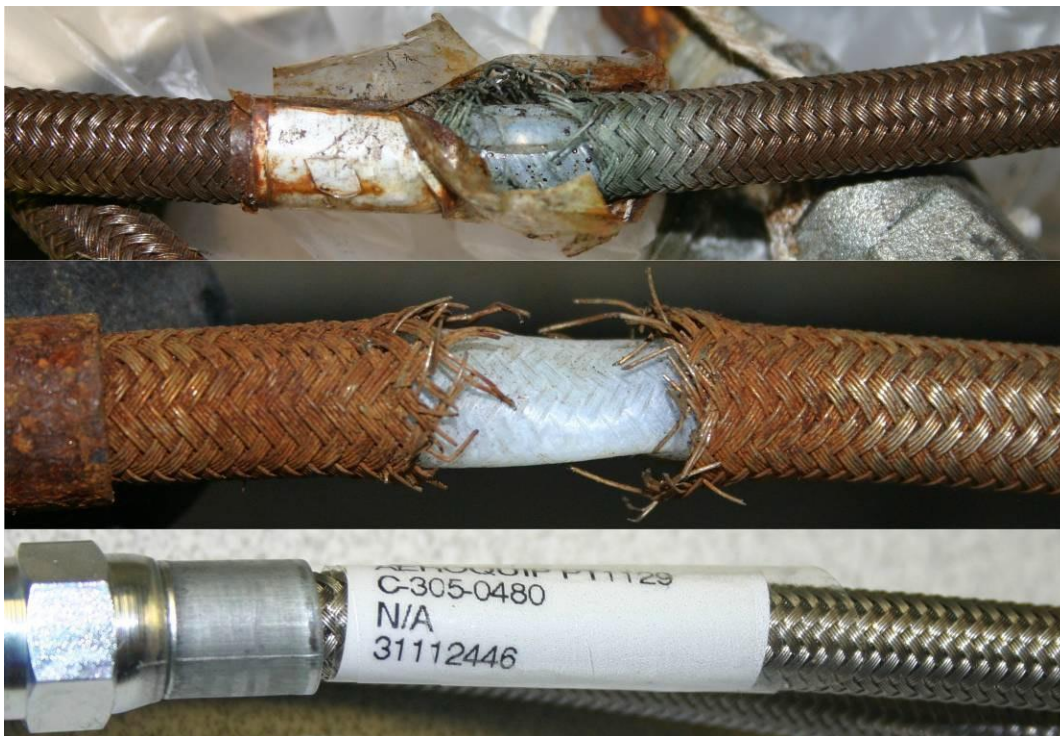
Figure 16. Flex hose comparison photographs: (top to bottom) ruptured riverside hose, flow restricted hillside hose, a new hose with attached ID tag
