US CHEMICAL SAFETY AND HAZARD INVESTIGATION BOARD

INVESTIGATION REPORT VOLUME 1

EXPLOSION AND FIRE AT THE MACONDO WELL (11 Fatalities, 17 Injured, and Serious Environmental Damage)

REPORT NO. 2010-10-I-OS

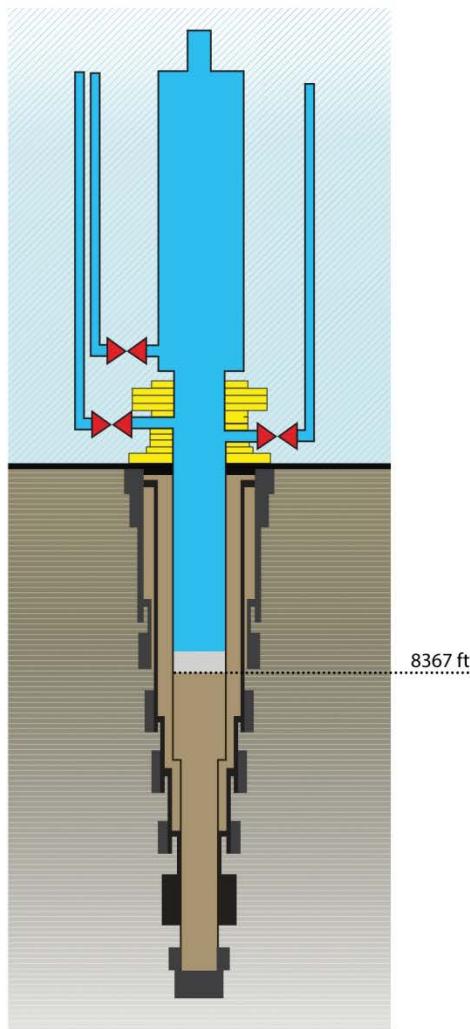
Figure 2-4. The final Temporary Abandonment configuration intended to remove drilling mud down to 8,367 feet to install a cement plug in seawater.

To prepare for the negative pressure test at Macondo, a drillpipe was lowered to the depth identified for the bottom of the cement plug (Figure 2-4). A viscous and dense water-based Loss Circulation Material (LCM) followed by seawater was pumped down the drillpipe to displace the mud by pushing it above the BOP toward the rig.^e After stopping displacement and closing the BOP,^f the crew observed the pressures and/or flow from the well four times over three hours.^g Each time, they observed unexpected results, so

they made adjustments before deeming the well passed the final test. The crew's actions suggest they did not realize that the unexpected readings were indications of a failed negative pressure test and that integrity of the cement had not been secured. (See Appendix 2-A for details.)

After the final negative pressure test was erroneously accepted as a "pass," the Deepwater Horizon crew continued the process of displacement, replacing the drilling mud in the wellbore and riser with seawater in preparation to set the surface plug. Replacing dense drilling mud with seawater had the effect of lowering the hydrostatic pressure on the bottom of the well. With the fluid column removed and no surface plug yet set, the only means left for preventing the hydrocarbons from entering the riser and eventually making their way up the well to the rig was detection of the kick by the crew and manual activation of blowout prevention equipment to seal the well.^a

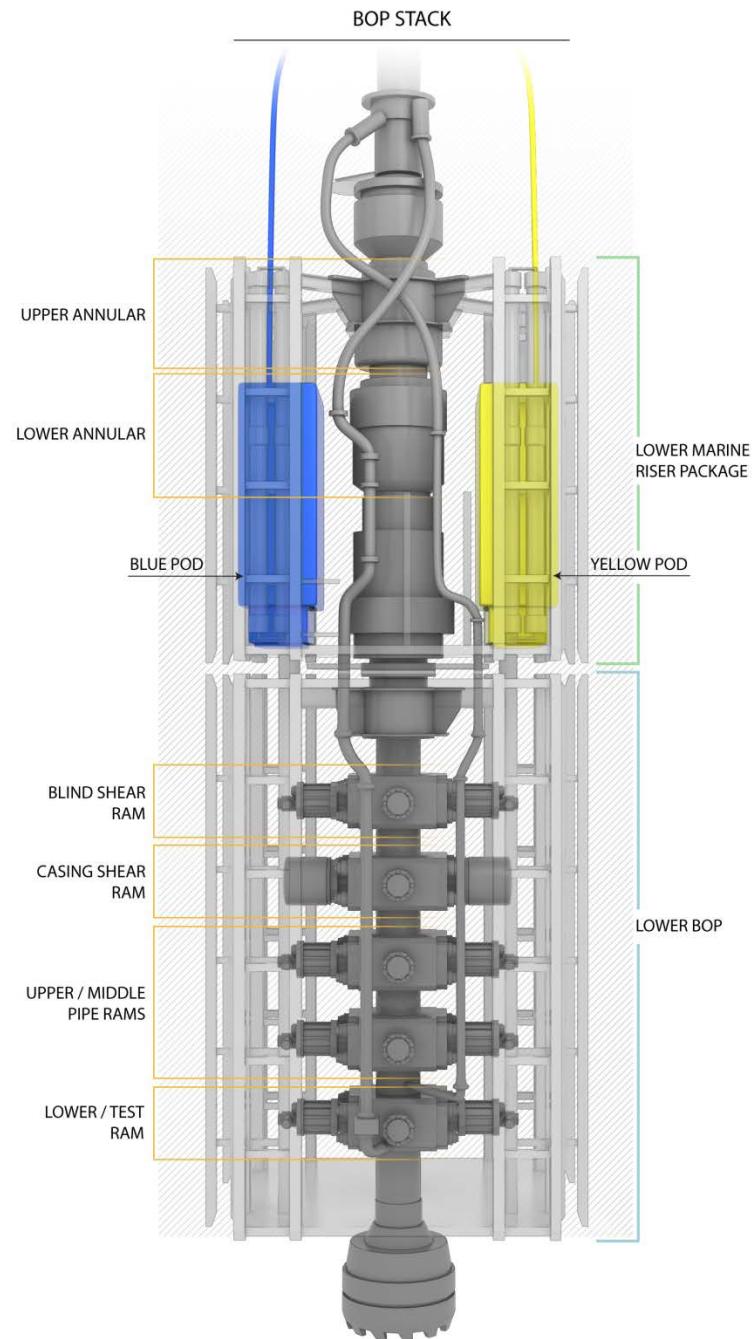
Figure 2-5. The Deepwater Horizon BOP

When drilling mud and hydrocarbons began pouring out of the well and onto the Deepwater Horizon, the drilling crew activated a component called an annular preventer, which should have sealed the space around the drillpipe and prevented further hydrocarbons from rising above the BOP.^a However, well data indicate that this component failed to seal the well.^b Not only did the riser fluids—the hydrocarbons, drilling mud and seawater—that already passed above the BOP continue to travel up the riser and release onto the rig floor, but the riser was also being replenished by the flow of even more hydrocarbons through the leaking component.

Pressure data^c indicate that the crew closed at least one additional sealing component of the BOP called a pipe ram, which successfully shut in the well but caused the pressure in the drillpipe to build substantially as evidenced by the surface drillpipe pressure building. (See Volume 2, Section 2.3 for details.) Riser fluids above the BOP continued to unload onto the rig floor, but their replenishment temporarily ceased. About two minutes later, the first explosions occurred on the rig and data transmission from the rig to shore ceased.

The explosion likely activated the AMF/deadman automatic emergency response system. This system was meant to shear the drillpipe and seal the well, but as evident from the major oil spill that ensued, the well remained unsealed. The likely activation of the AMF/deadman system and the failure of the BOP to seal the well is discussed in detail in Volume 2 (Chapter 3) of the CSB Macondo Investigation Report.
