Accident - Imperial Sugar Dust Explosion and Fire

**Professional Development Hours (PDH) or
Continuing Education Hours (CE)
Online PDH or CE course**

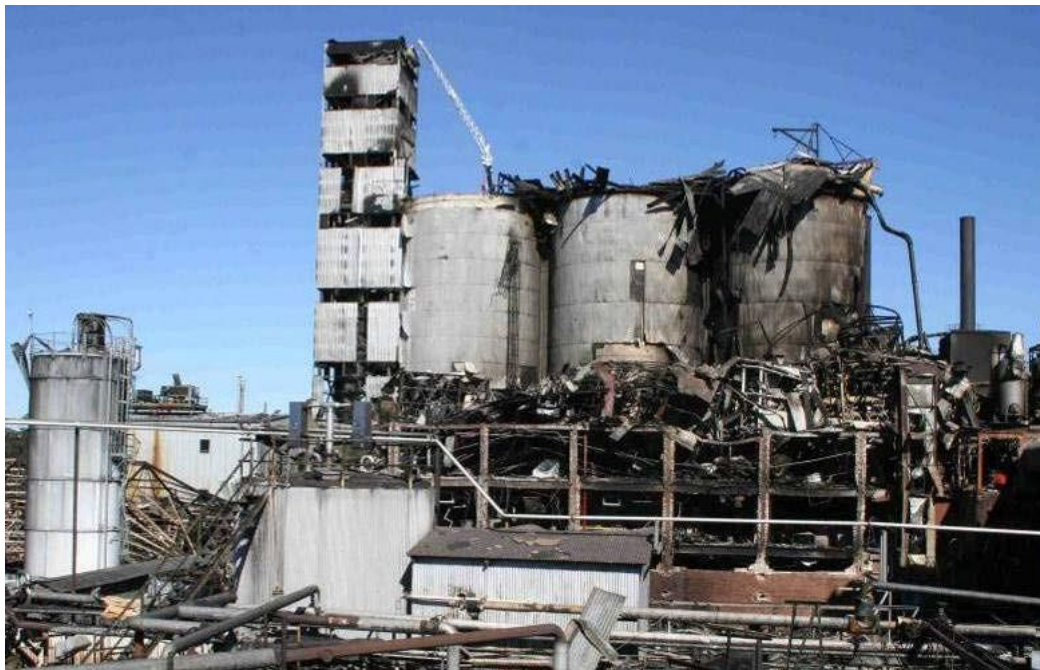
The major fires in the buildings were extinguished the next day, but small fires continued burning for many days. The granulated sugar fires in the 105-foot tall silos continued to smolder for more than 7 days before being extinguished by a commercial industrial firefighting company. The packing buildings, granulated sugar silos, and palletizer room were destroyed. The bulk sugar loading area and parts of the refinery were severely damaged by the explosion and fires (Figure 1).

Figure 1. West bucket elevator tower; silos 3, 2, and 1; and south packing building destroyed by the February 7, 2008, sugar dust explosions and fires

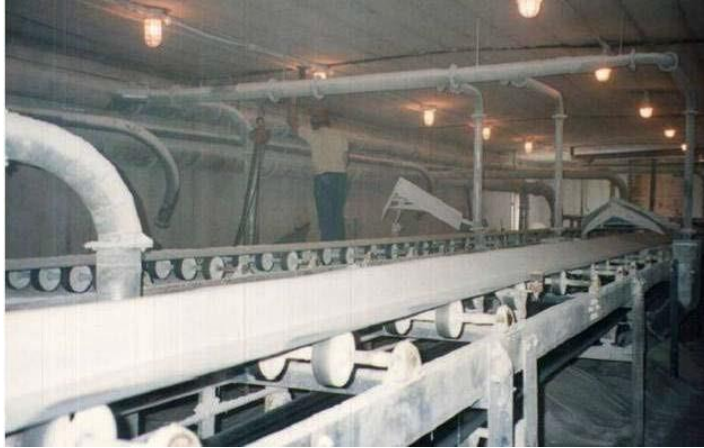
Figure 8. Granulated sugar steel conveyor belts above the silos, circa 1990. Heavy dust accumulation on conduit and spilled sugar on the floor (Imperial Sugar photo)

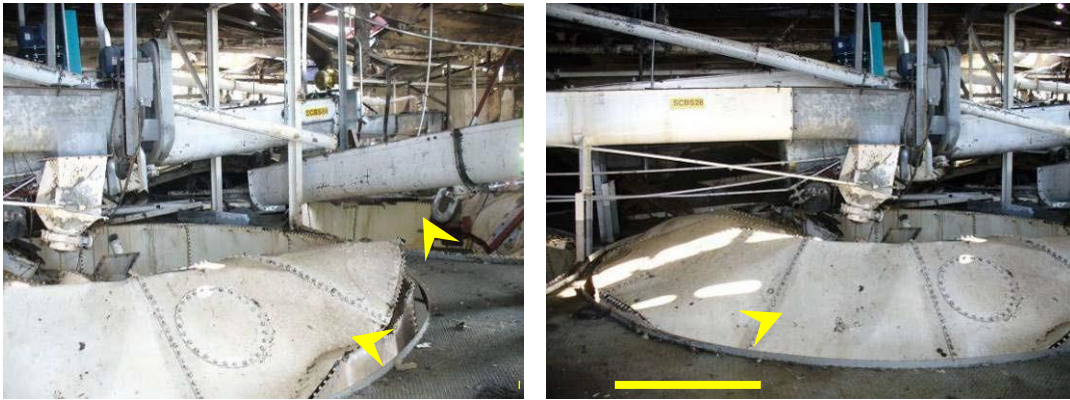
Immediate explosive ignition is not the only means of causing overpressure damage. If sufficient dust has accumulated inside ducts or other equipment and airborne dust inside the equipment ignites, the pressure wave advancing ahead of the rapidly burning dust cloud will loft additional dust into the air and provide additional fuel to the advancing fireball, further increasing the pressure inside the equipment. This so-called “pressure piling” can cause the equipment to explosively rupture. If the equipment does not rupture, it can provide a conduit for the fireball to travel long distances and ignite fires or rupture equipment far from the ignition source. Some dust collection ducts and screw

conveyors in the Port Wentworth facility acted as conduits and ignited fires and ruptured equipment hundreds of feet from the packing building where the incident originated (Figure 12).

Figure 12. Pressure waves traveled through screw conveyors and ruptured steel bulk granulated sugar bins (arrows) hundreds of feet from the sources of the dust explosions

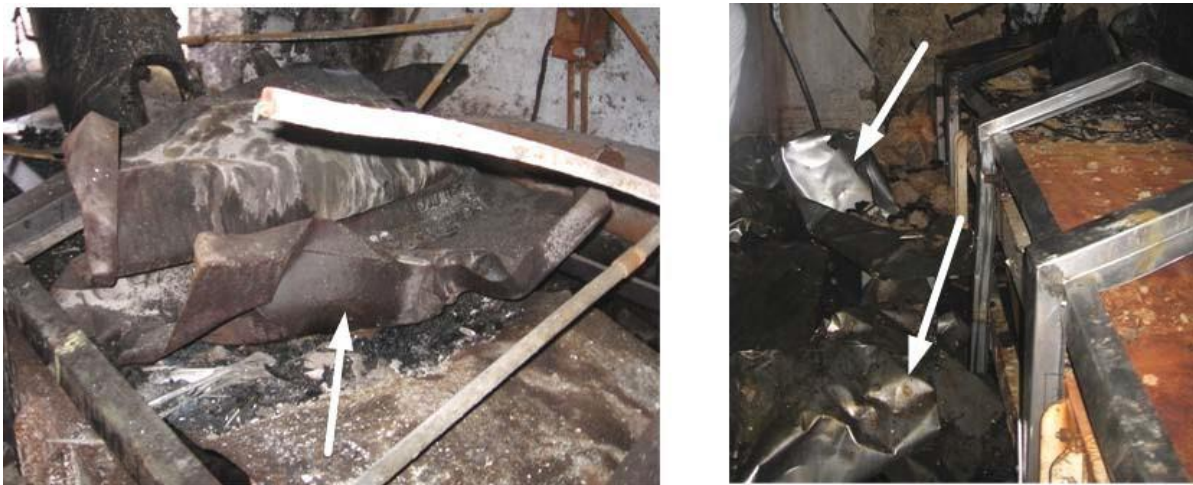
Examination of the equipment in the silo tunnel found that every panel used to enclose the 80-foot long steel belt conveyor had been violently blown off the support frame (Figure 13). Panels east of the approximate midpoint of the conveyor (directly under the silo 1–silo 2 abutment) were deflected eastward, and panels west of the midpoint were deflected westward. Pressure damage inside the pantleg rooms above the tunnel was greatest inside the silo 2 pantleg room and least inside silo 3 pantleg room. Major equipment damage was observed at the east entrance of the silo tunnel with all equipment deflections eastward, away from the tunnel. The equipment under silo 3 and outside the west end of the tunnel had damage patterns clearly indicating that a pressure wave traveled west out of the tunnel.²⁴

Figure 13. Steel belt covers (arrows) crumpled from an initial dust explosion inside the steel belt enclosure (steel frame structure, right photo)

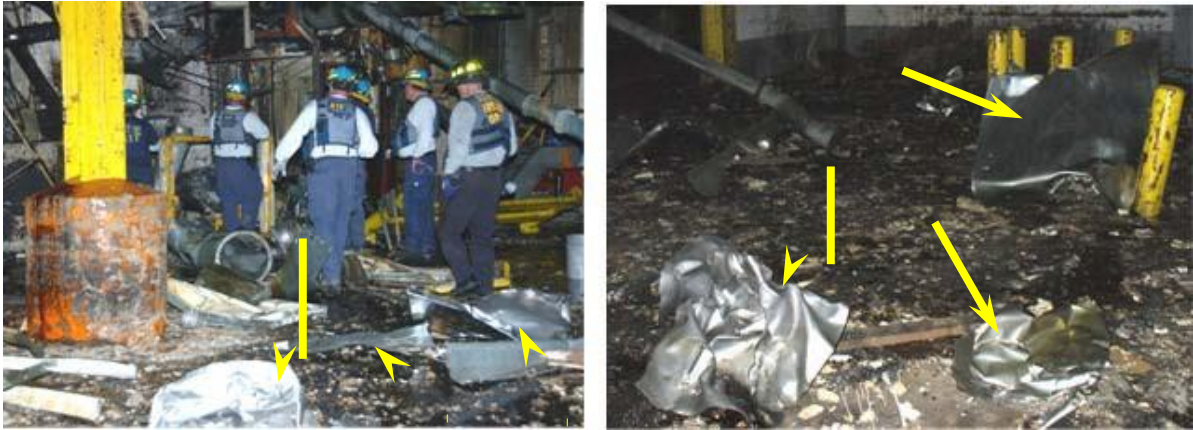
Pressure waves blew the wood walls and doors off the west and east tunnel entrances. Mangled steel belt cover panels were blown out of the east end of the tunnel (Figure 14). The pressure wave also

Figure 14. Stainless steel cover panels (arrows) blown off the steel belt enclosure and out of the tunnel into the packing building

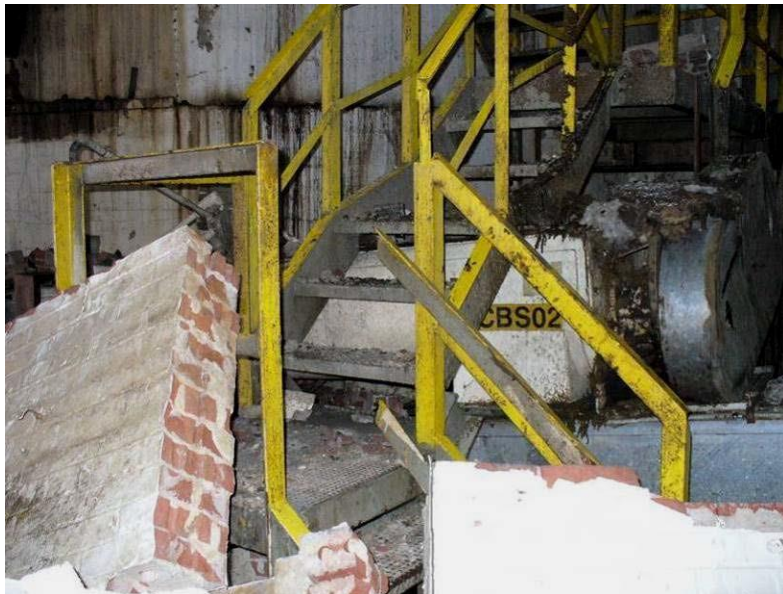
traveled up between silos 1 and 2 and blew the brick walls that enclosed the south stairwell into the work areas on each floor of the south packing building (Figure 15).

Figure 15. South stairwell brick walls blown into the packing building

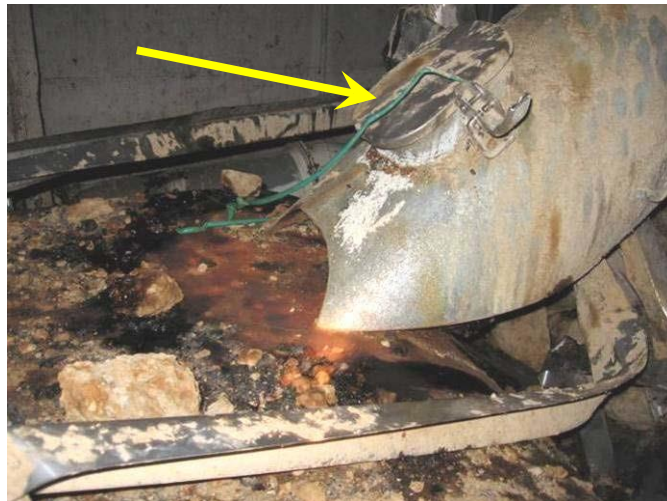
Figure 17. Limited clearance between sugar discharge chute and the steel belt would sometimes be blocked by large sugar lumps; lump-clearing access port (arrow) is on top of the chute

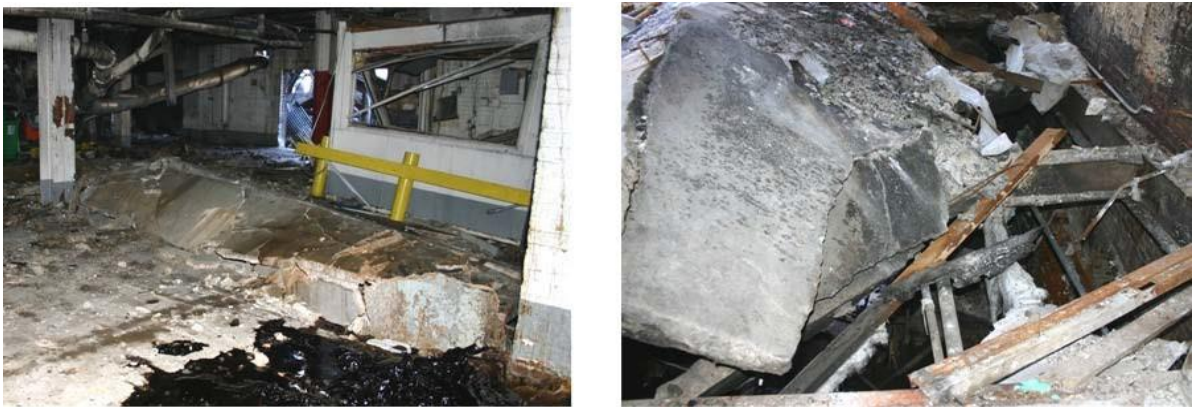
Figure 18. Three-inch thick concrete floor slabs lifted off the steel supports by the explosion pressure waves

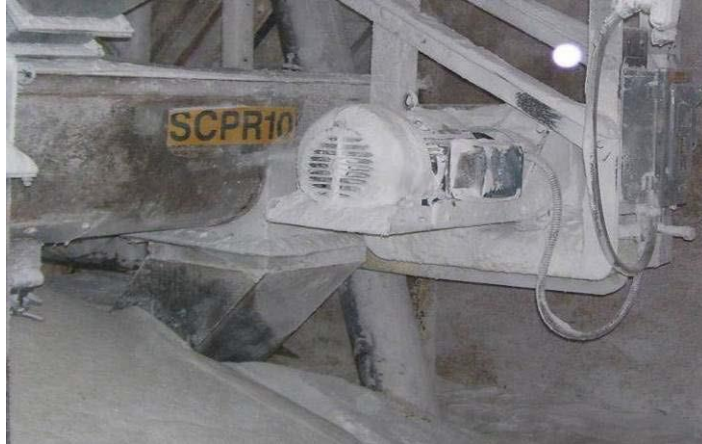
Figure 19. Motor cooling fins and fan guard covered with sugar dust; large piles of sugar cover the floor (Imperial Sugar photo)

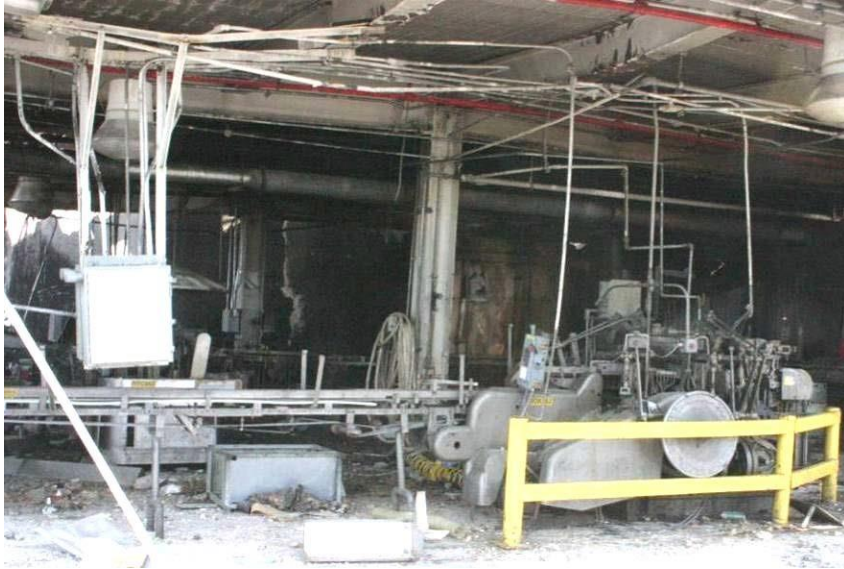
Figure 20. Packaging equipment hindered evacuation in the darkened building

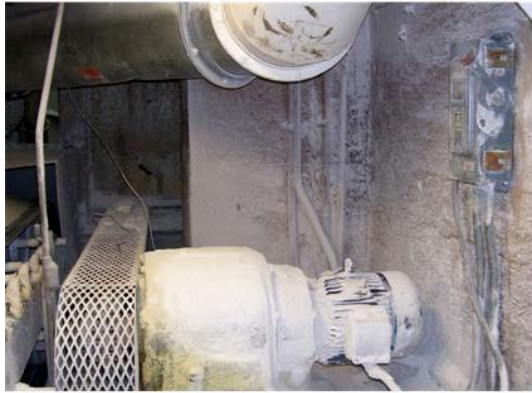
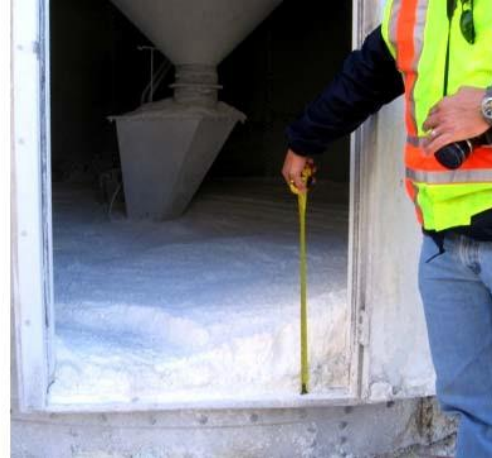
Figure 21. Left: Sugar dust accumulation on steel belt drive motor in silo tunnel (Imperial Sugar Co. photo, Oct. 2006). Right: Cornstarch spilled under cornstarch silo (March 2008).

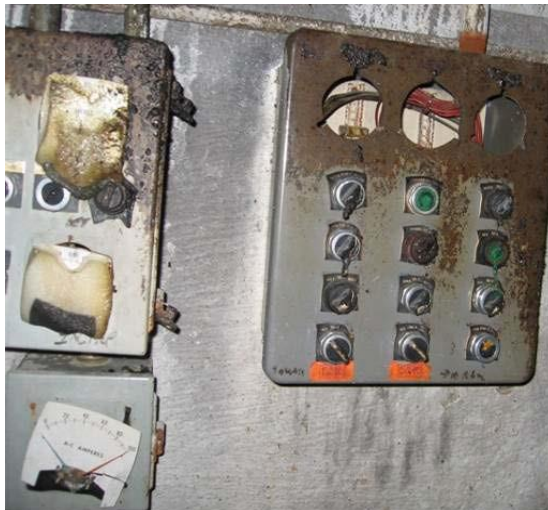
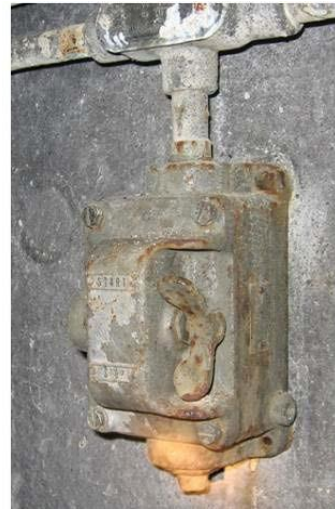
Imperial Sugar had no written policy or procedure to require classifying hazardous areas or require electrical devices rated for such locations at the Port Wentworth facility. Some locations at the facility contained significant accumulations of combustible sugar or cornstarch dust (Figure 21). The CSB investigators noted that some electrical devices were rated for use in hazardous work locations, but non-rated devices were also installed in the same location, frequently near the rated devices (Figure 22). The CSB investigators also observed many non-hazard classified electrical devices installed in dusty work areas and equipment enclosures. Furthermore, some electrical devices in dusty areas were poorly maintained, such as having missing covers or open doors on many breaker panels and other electrical enclosures.

Figure 22. Non-dust rated and rated electrical devices in the silo tunnel

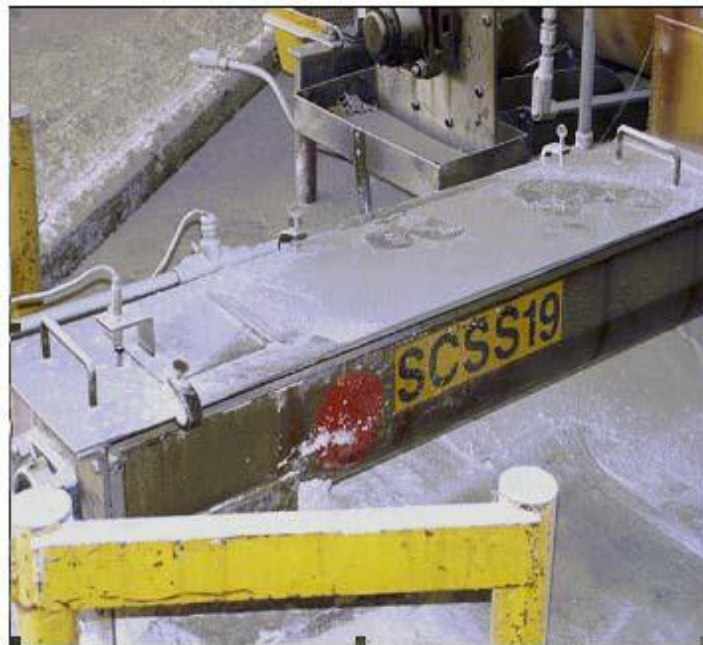
Figure 23. Sugar and dust accumulation on a screw conveyor in the south packing building fourth floor near silo 1 (Imperial Sugar photo)

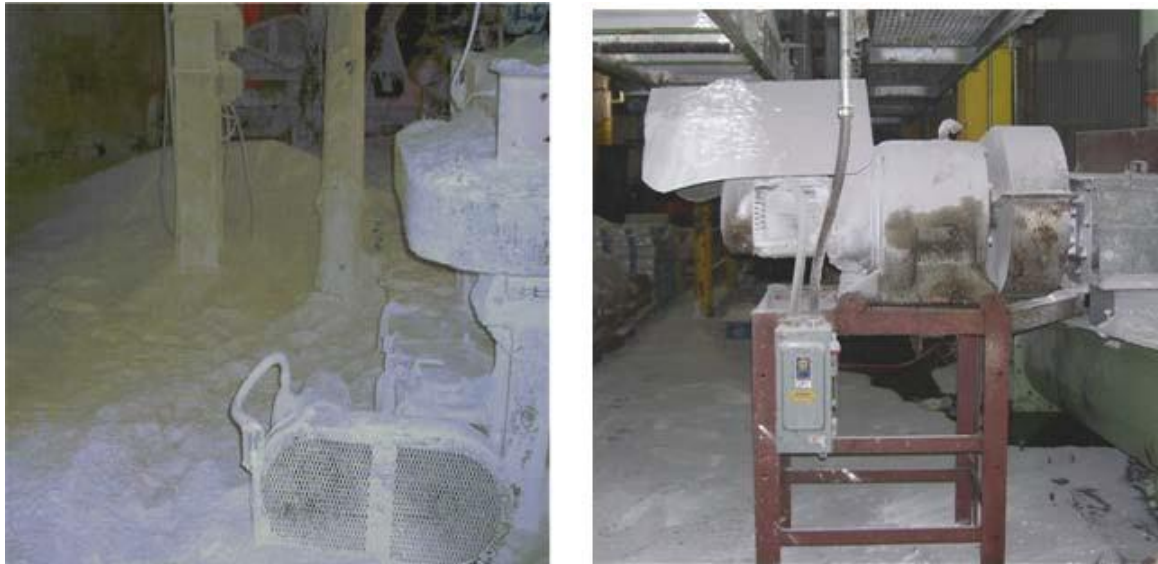
Figure 24. Deep piles of sugar accumulated on floors and equipment. Note shield installed above screw conveyor drive motor to deflect sugar dust (Imperial Sugar photos).
