Gas Well Blowout and Fire at Pryor Trust Well 1H-9

Investigation Report

Published: June 12, 2019

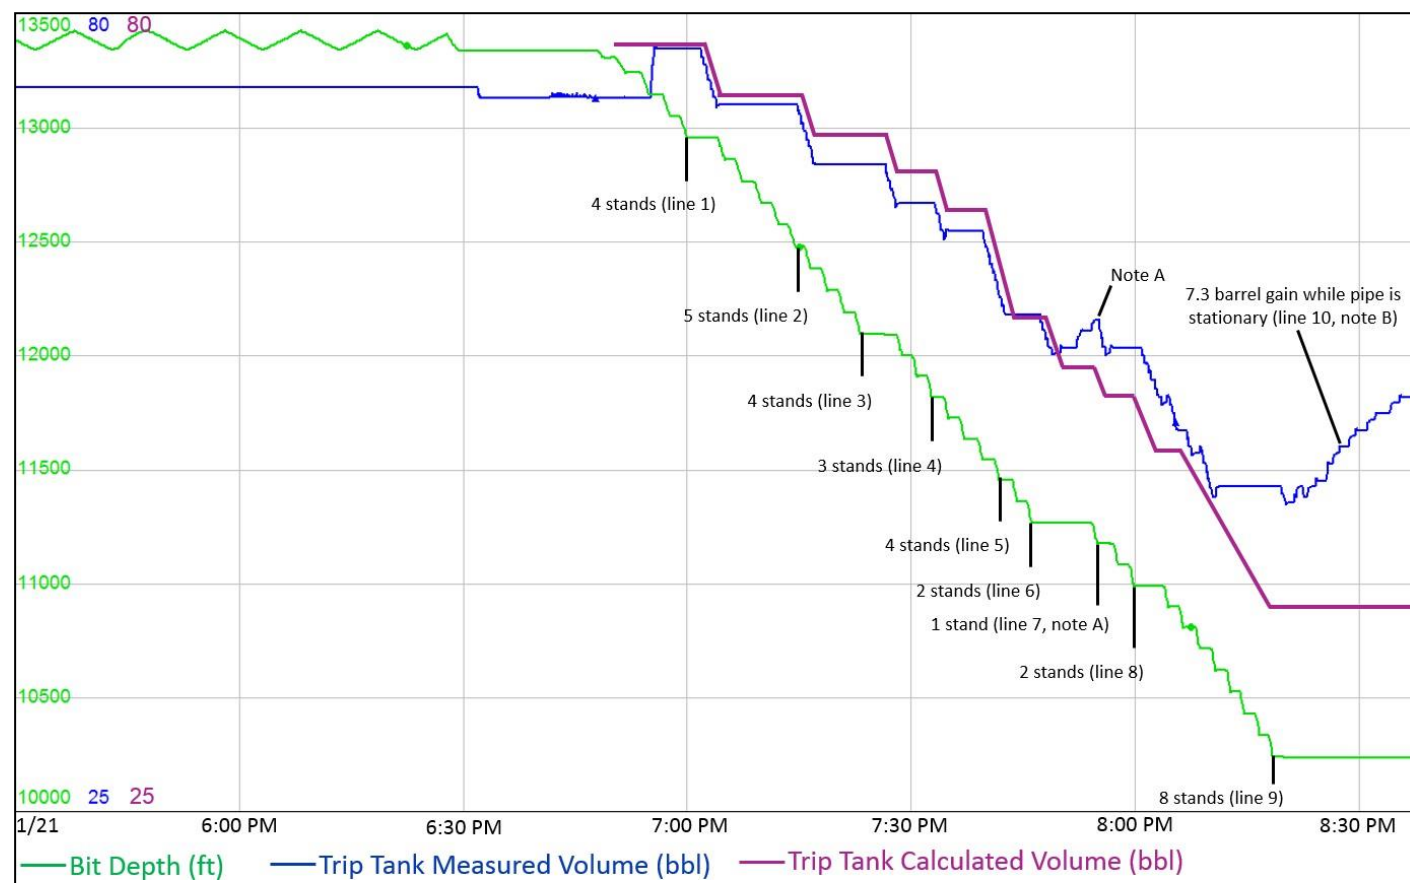
Figure 13. Rig data during the trip out of the wellbore from 13,337 feet to 10,237 feet. The blue line shows the actual, measured trip tank volume, and the purple line shows what the trip tank volume would be had a mud volume equal to the calculated volume of the drill pipe removed been pumped into the well. The line numbers and notes indicated in parentheses correspond to the line numbers and notes in Table 1 below.

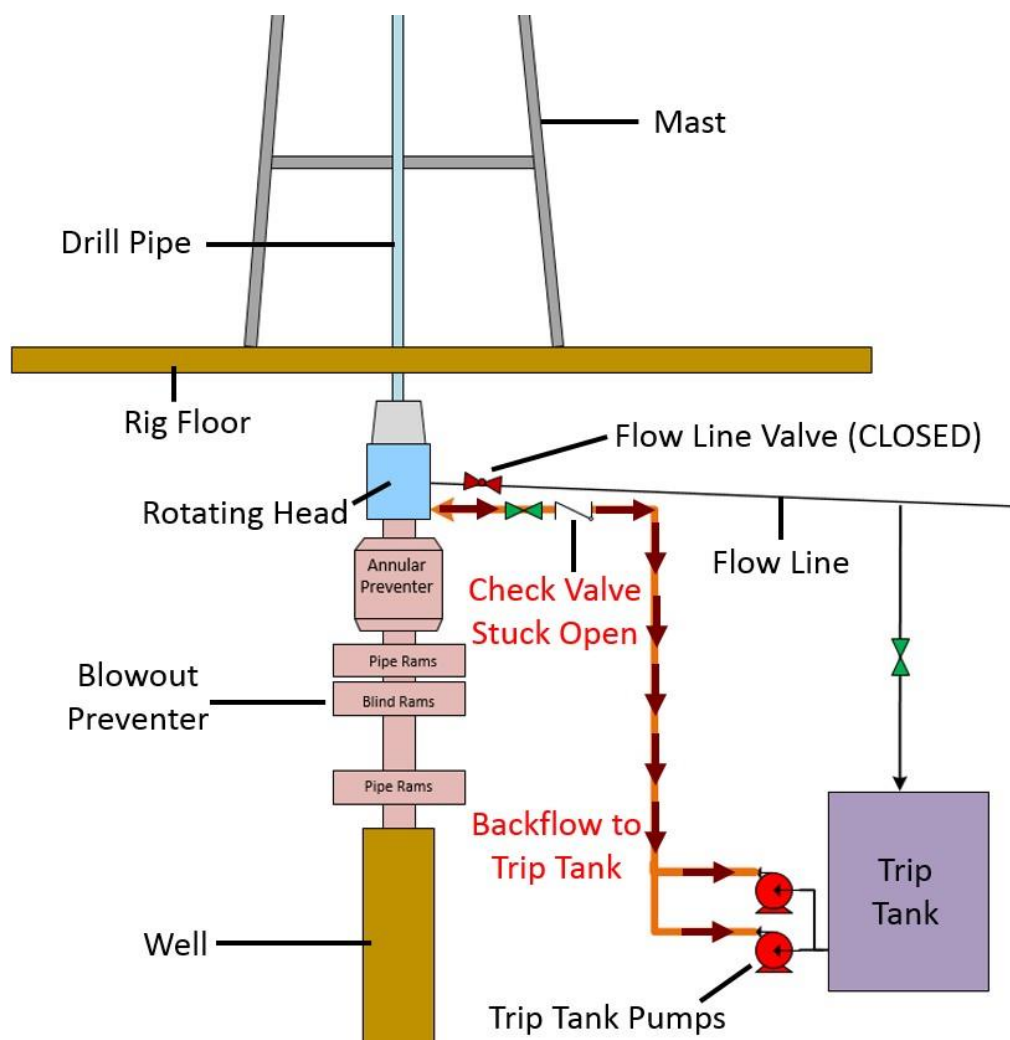
Figure 14. Pressurized mud backflowed through trip tank discharge piping, stuck-open check valve, and centrifugal pumps into trip tank.

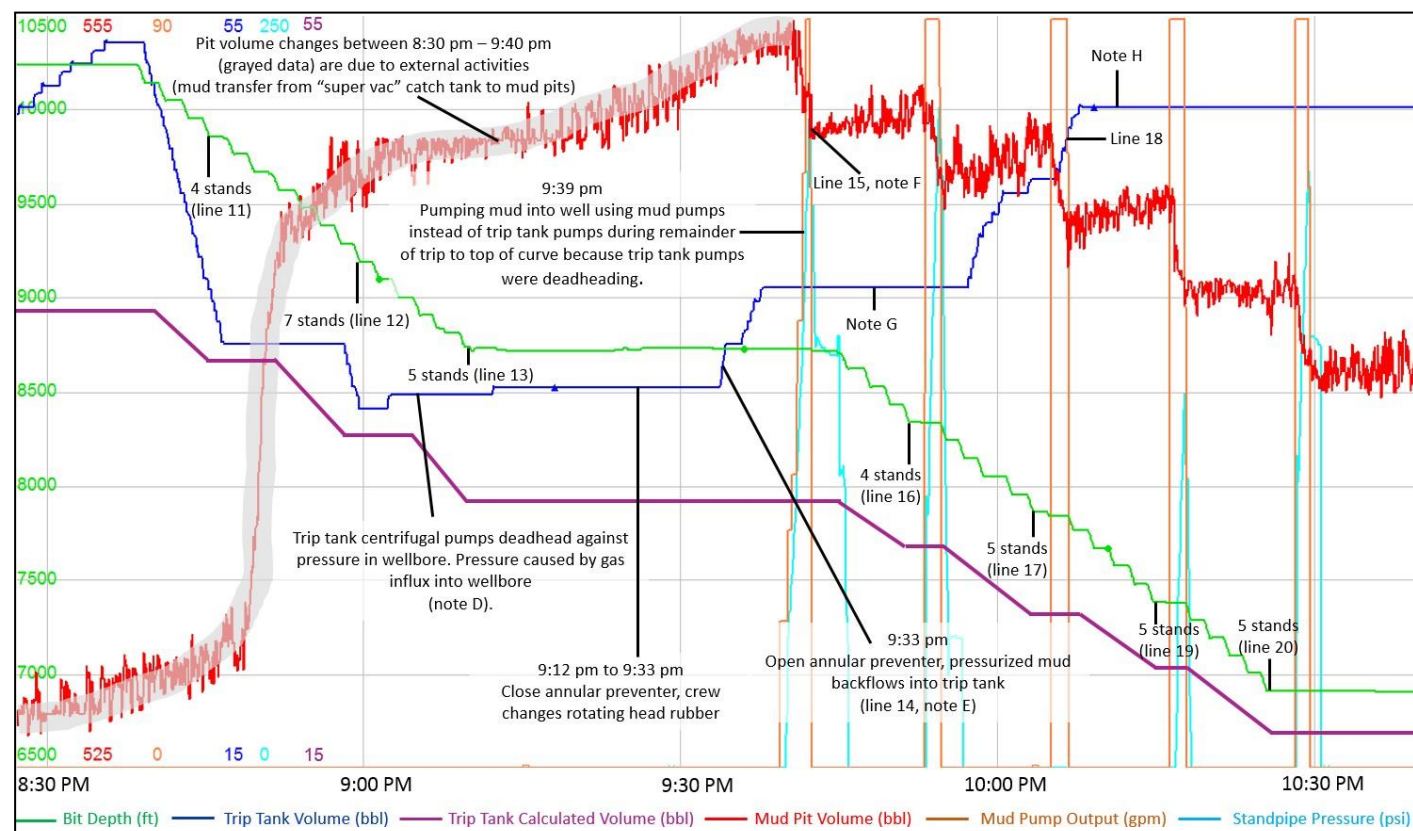
Figure 15. Rig data during the trip out of the wellbore from 10,237 feet to 6,905 feet. The blue line shows the actual, measured trip tank volume, and the purple line shows what the trip tank volume would have been had the calculated drill pipe volume been pumped into the well. The line numbers and notes indicated in parentheses correspond to the line numbers and notes in Table 2 below.

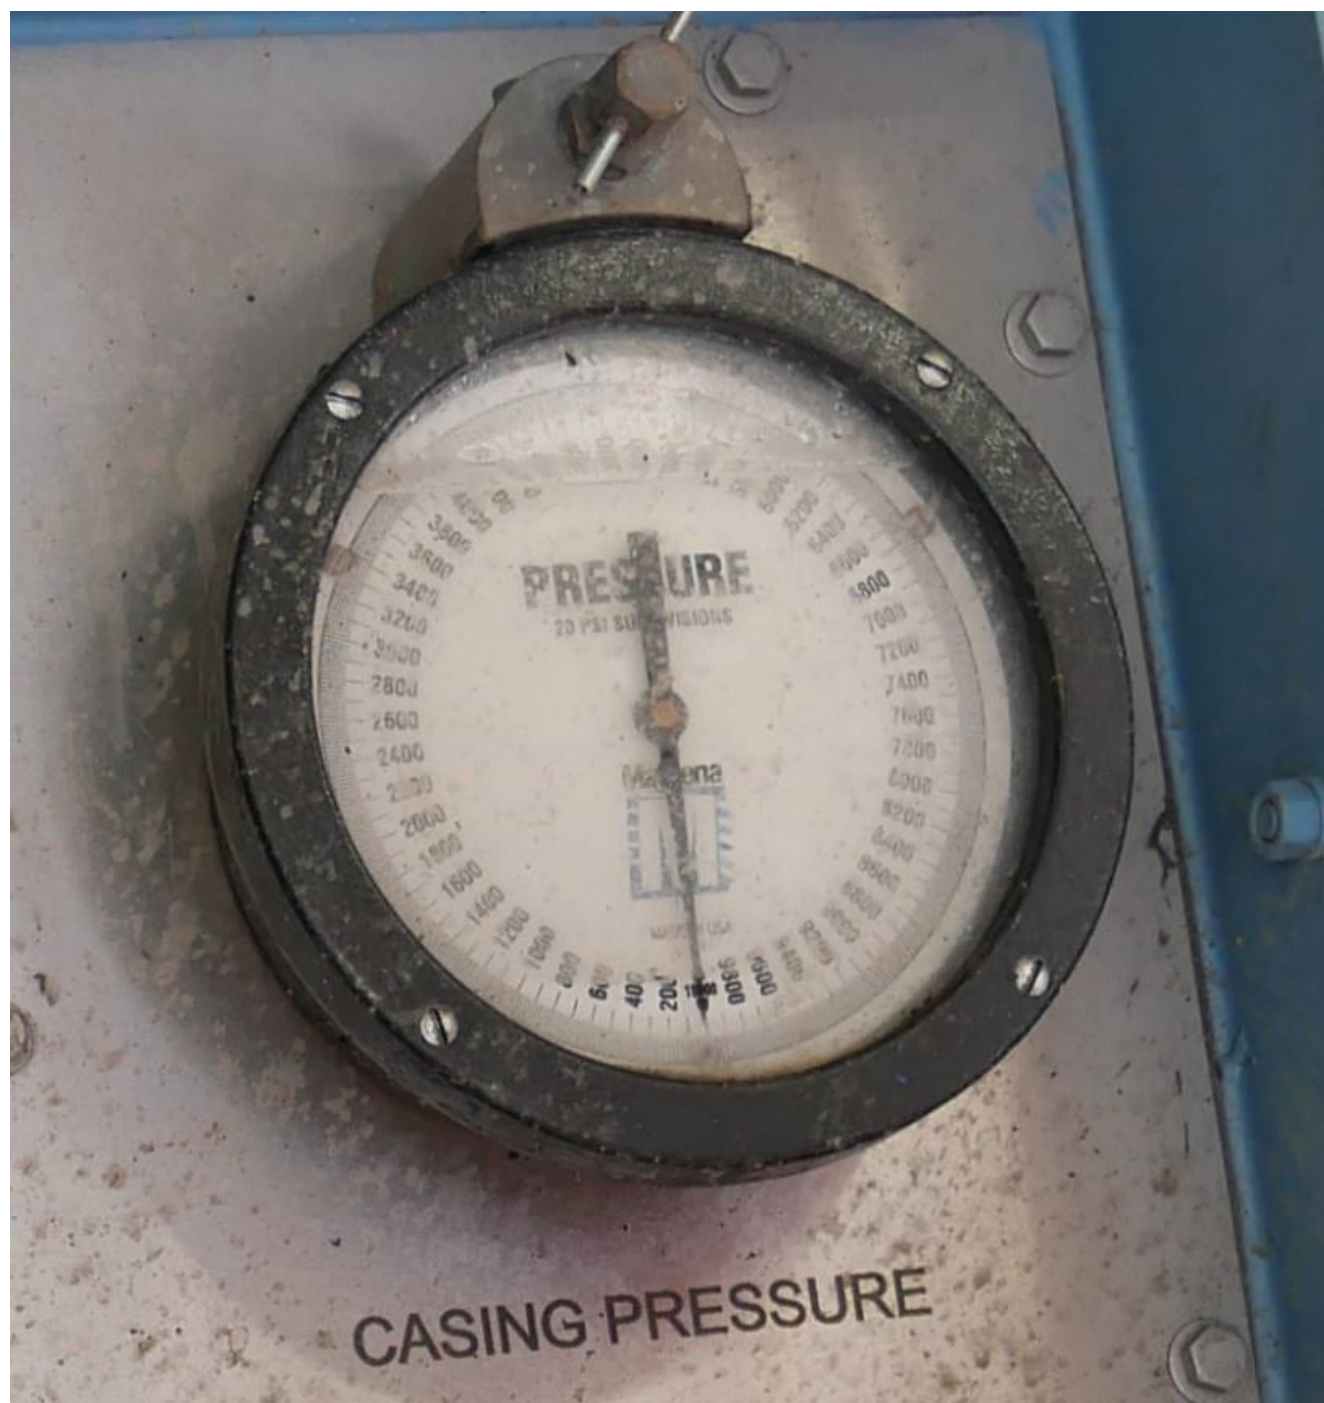
Figure 16. Photo of casing pressure gauge on an exemplar Patterson drilling rig. The pressure gauge could indicate pressures up to 10,000 psi. Low pressures might have been difficult to read on the Rig 219 pressure gauge, or the pressure gauge might not have worked properly at low pressures. The valve on the choke system (“HCR valve”) that needed to be opened to measure annular pressure might have been closed during pressure readings, or the line might have been plugged.

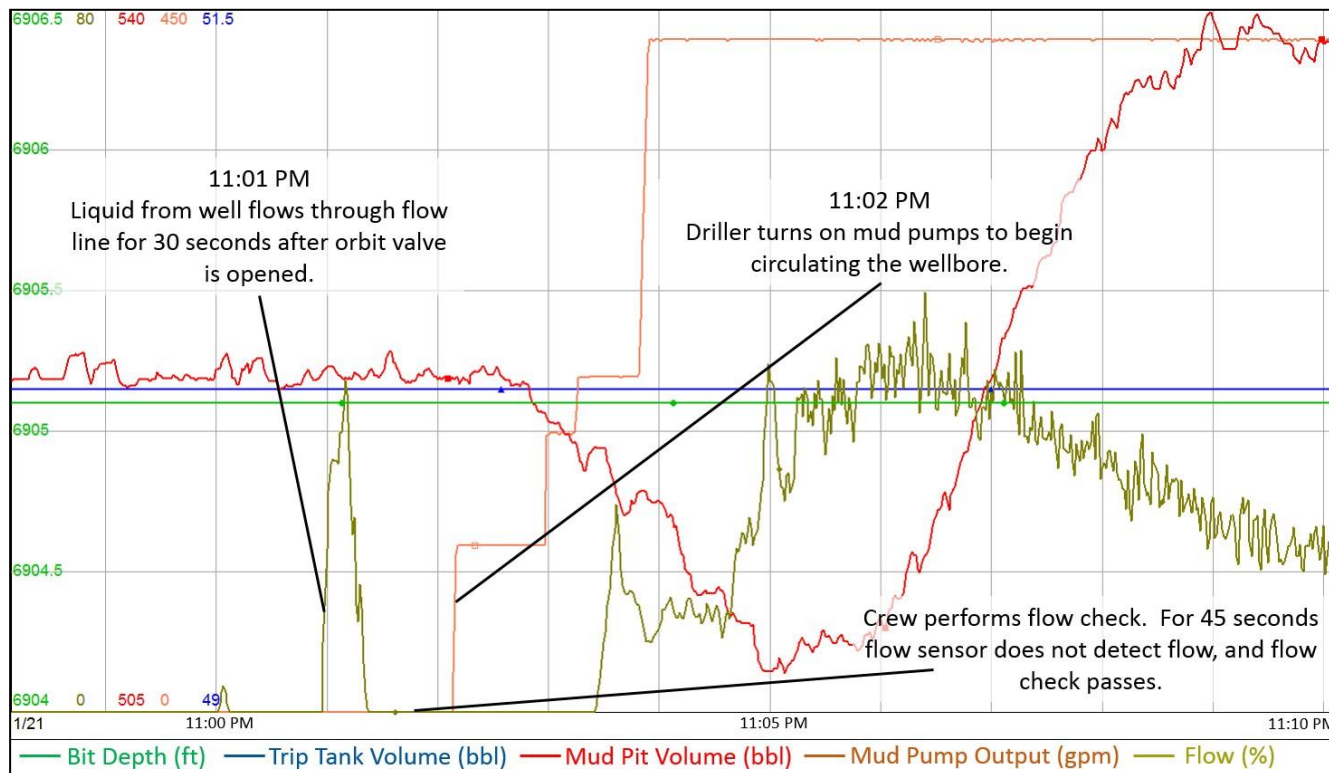
Figure 18. Rig data when the drill bit reached the top of curve. Crew performed a flow check at top of curve. No flow was observed for 45 seconds. Driller turned on pumps to circulate the well.

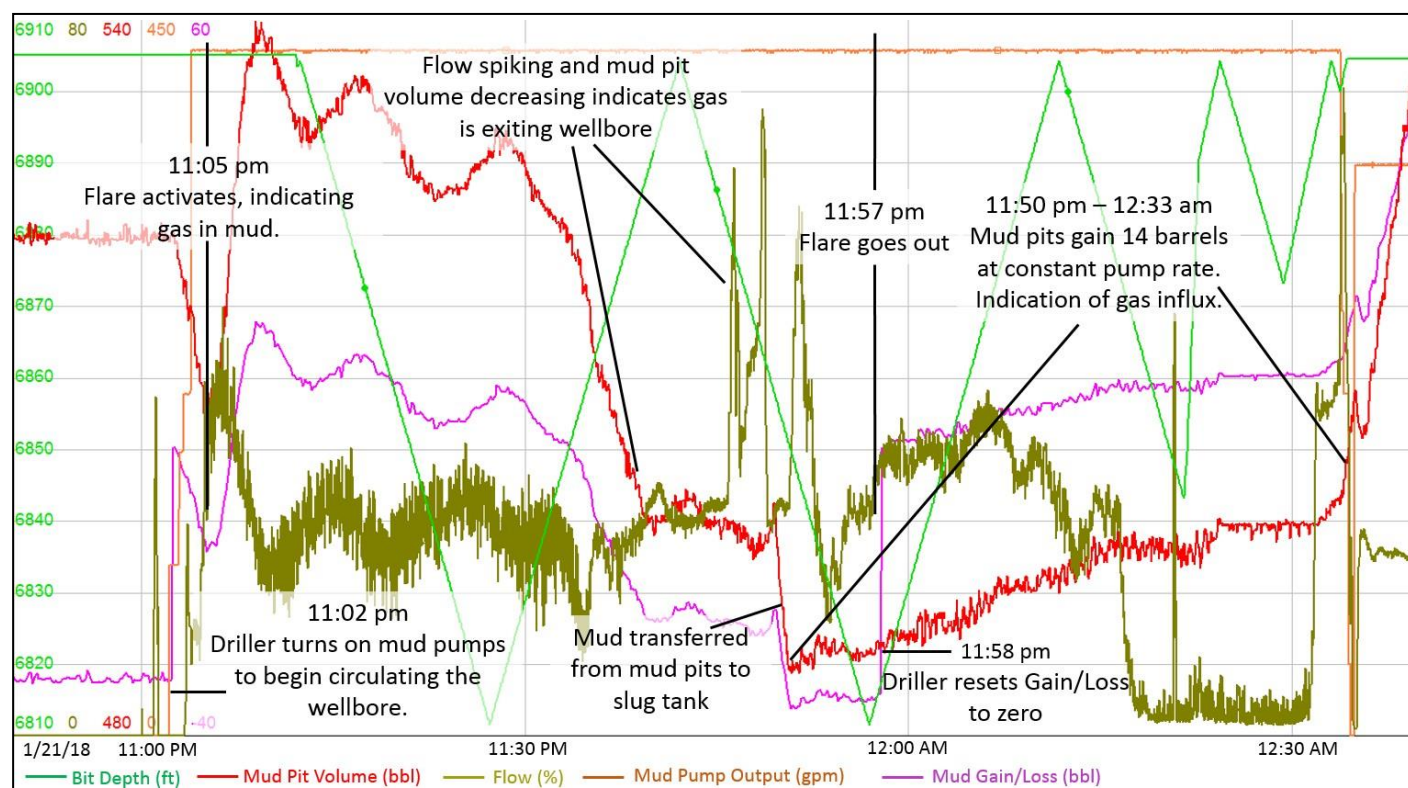
Figure 20. Rig data while circulating the wellbore at the top of the curve. The flare activated while circulating, indicating gas in the mud. Between 11:50 pm and 12:33 am, the mud pits gained 14 barrels while the mud pumps were circulating at a constant pump rate. This pit gain indicates there was gas in the well.

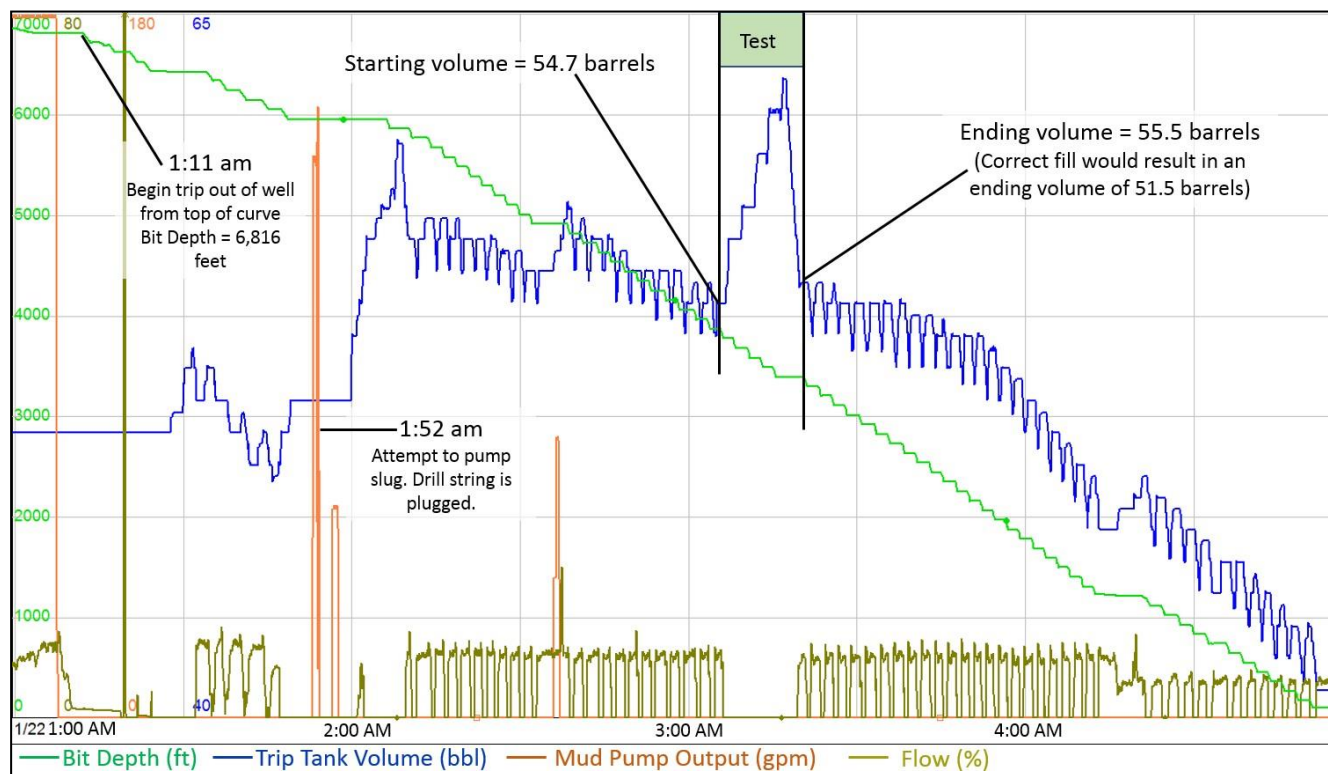
Figure 25. Rig data during trip out of vertical portion of the well on January 22, 2018. The driller and company man were confused by the trip tank volume fluctuations and about what pipe volume to use in trip sheet calculations. The company man and driller incorrectly concluded that the test they performed to determine if the well was taking proper fill had passed.

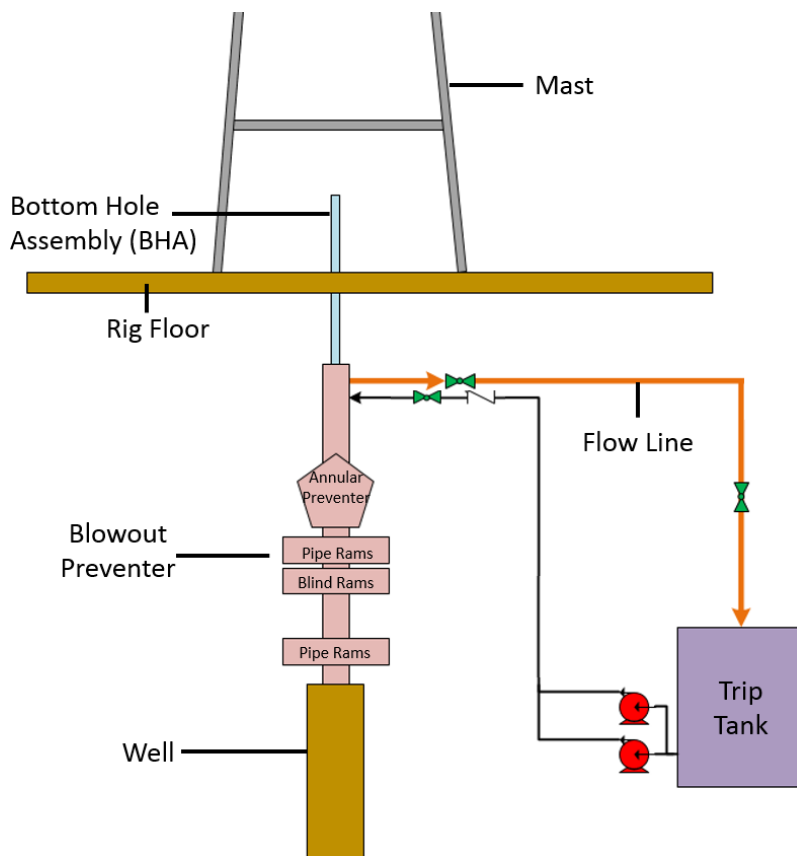
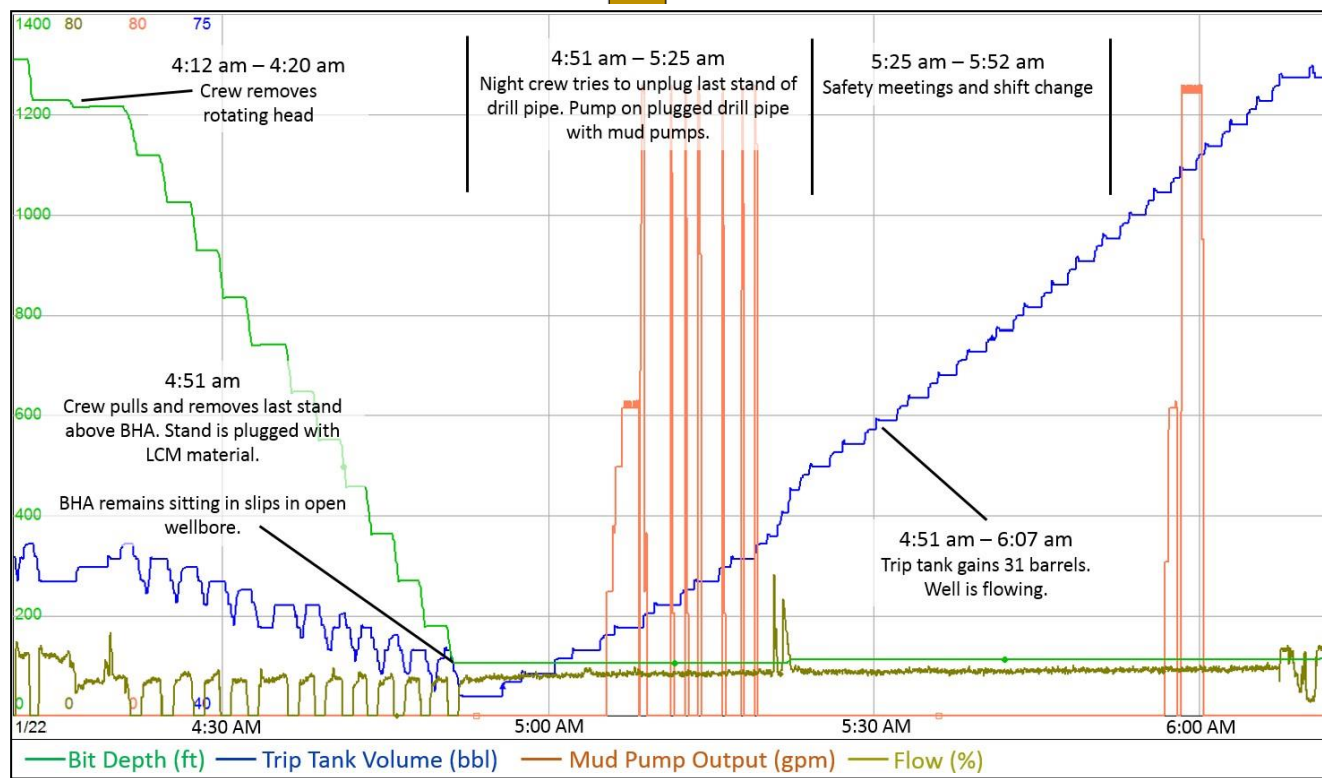
Figure 26. Rig equipment lineup and rig data between 4:10 am and 6:12 am. Between 4:51 am and 6:07 am, the trip tank gained 31 barrels of mud.

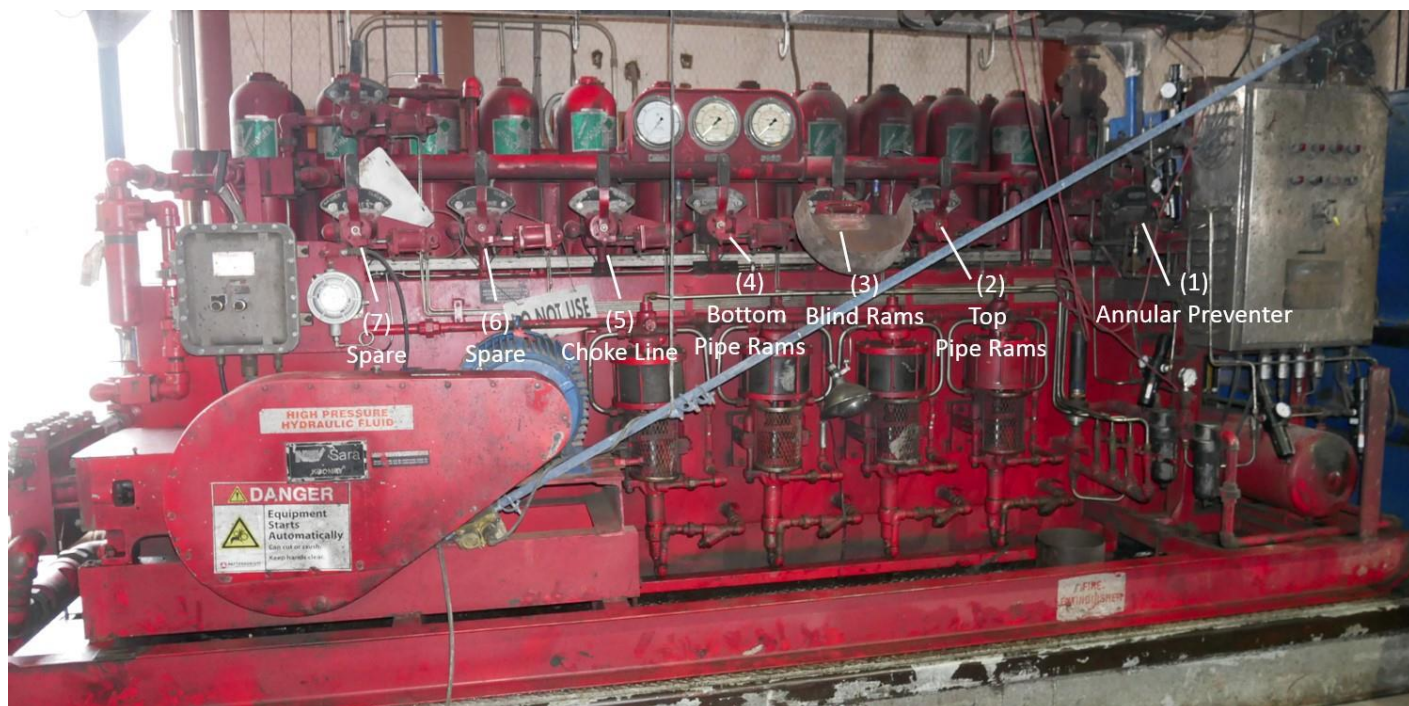
Figure 31. Photo of the BOP accumulator, which is used to function the BOP rams. The rig manager closed the BOP control handles in the following order: (1) annular preventer, (2) top pipe rams, (3) blind rams, and (4) bottom pipe rams. The blowout preventer did not seal the well to stop the blowout when the rig manager functioned the control handles.

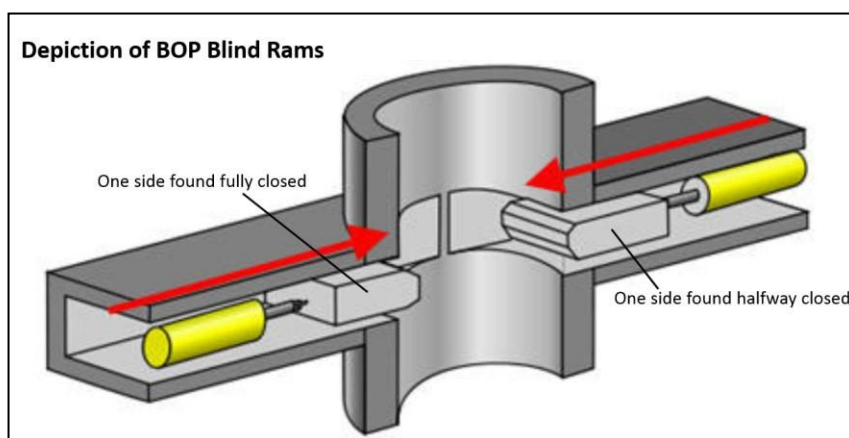
Figure 33. Depiction of BOP blind rams. A Boots & Coots responder found that the south-side blind ram was fully closed, and the north-side blind ram was halfway closed. Source: drillingformulas.com [11] with notations by CSB.

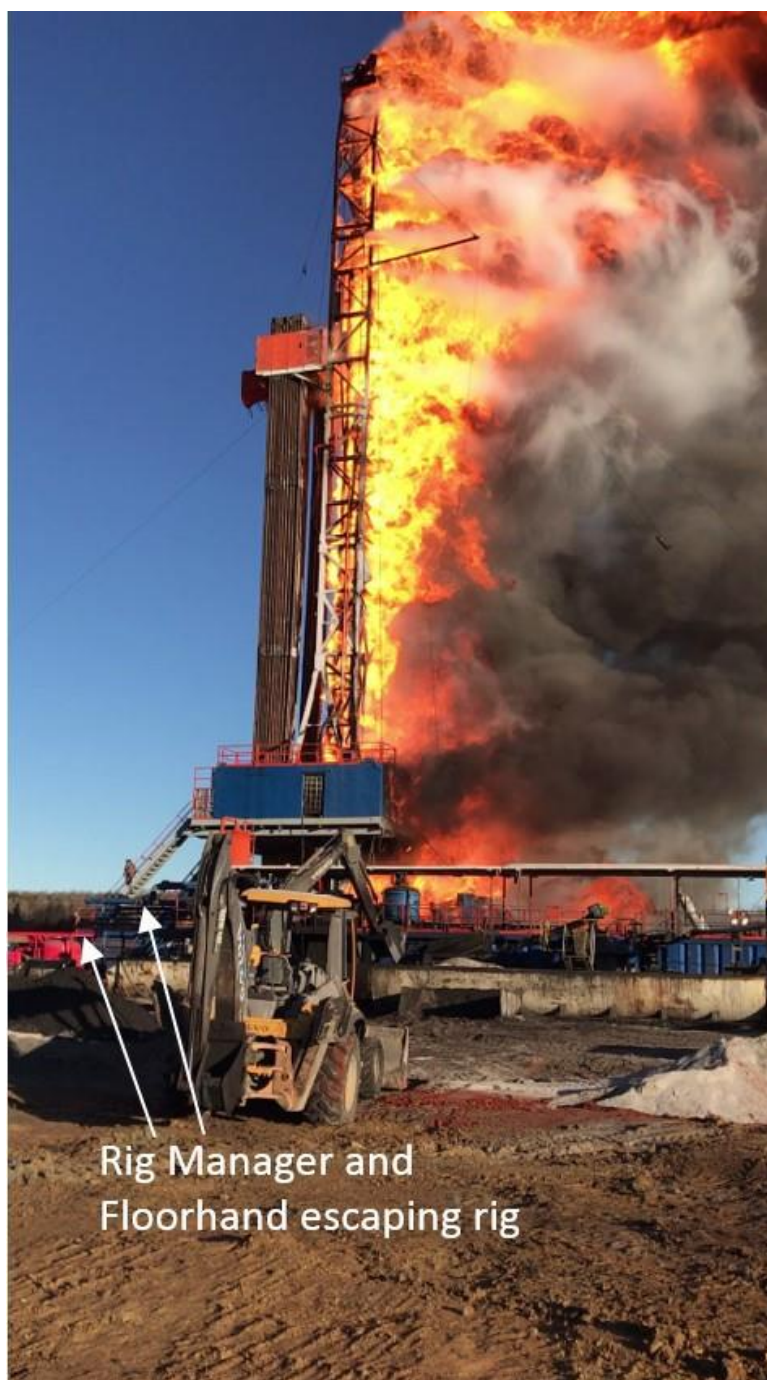
Figure 43. Still from video captured at 8:36 am, shortly after blowout started. The rig manager and floorhand can be seen escaping the rig. At this point, the fire has engulfed the driller's cabin (far side of photo).

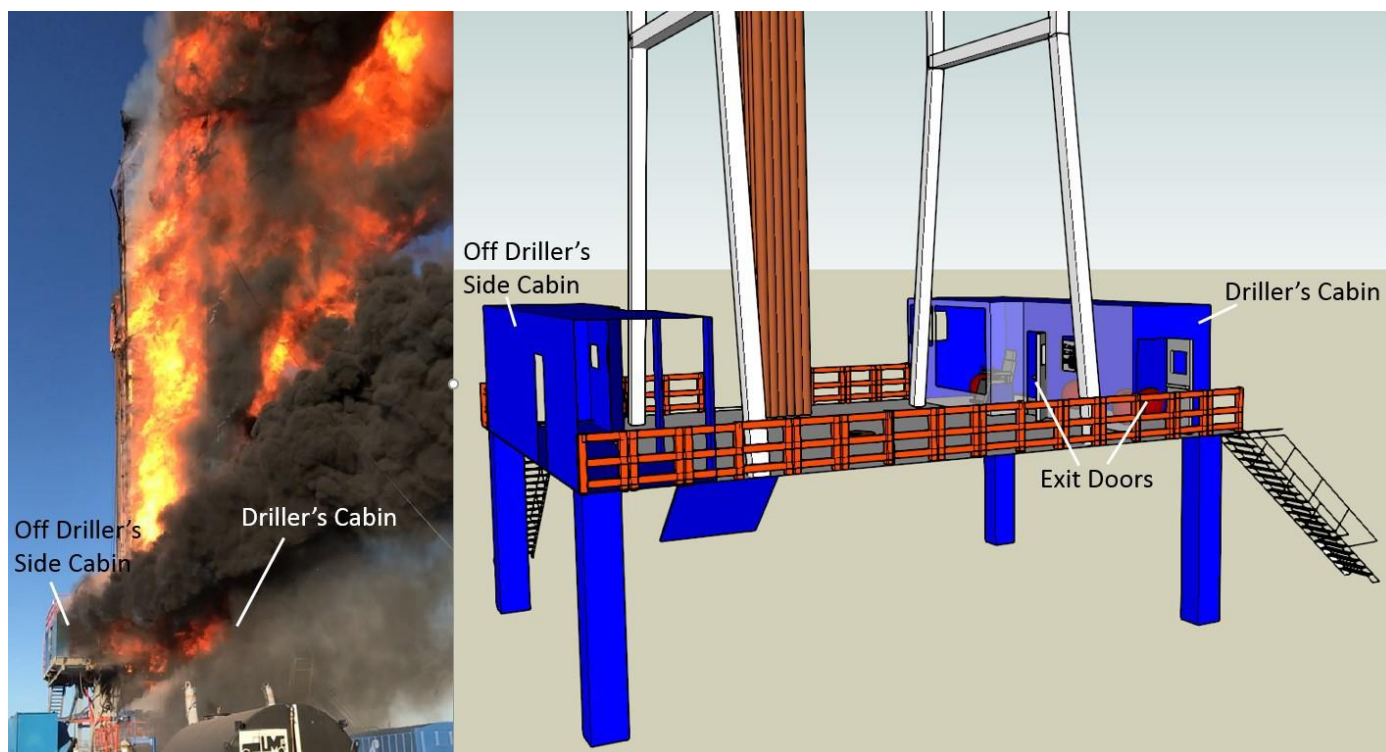
Figure 44. Both exits from the driller's cabin were engulfed by fire.

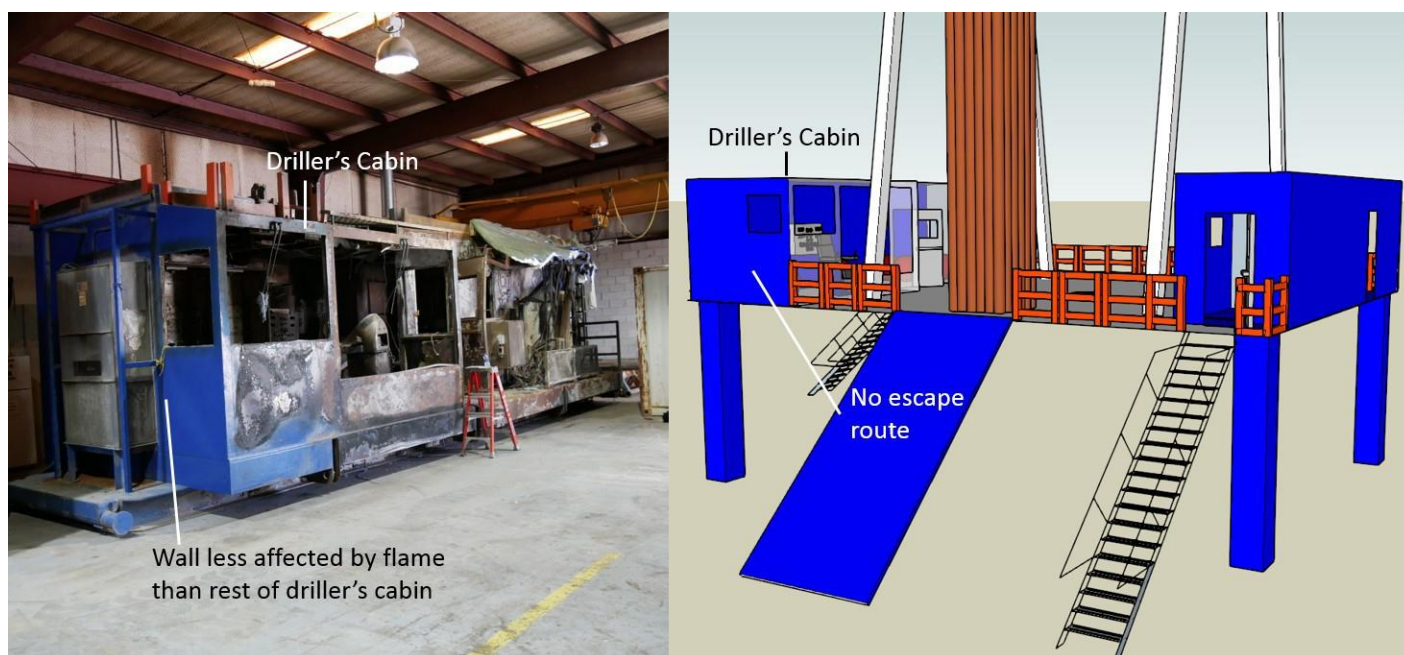
Figure 45. One part of the driller's cabin appeared to be less affected by fire, evident by the paint remaining post-incident. There was no escape route near that location.

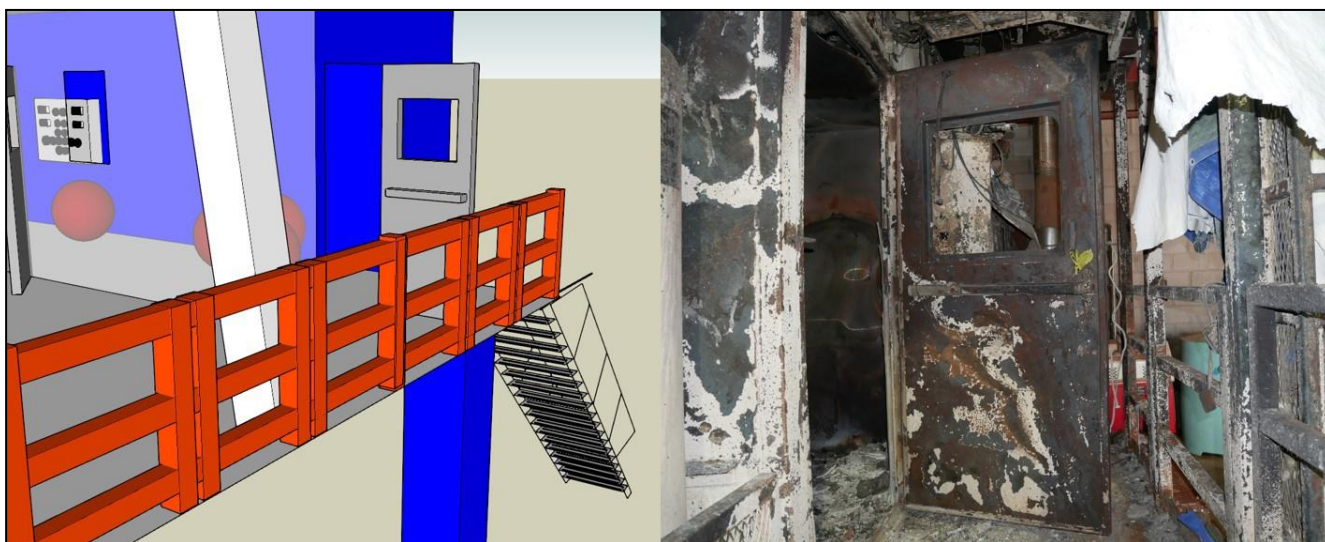
Figure 46. The most viable exit door was hinged such that when the door was opened, the door blocked the escape path to the ground.

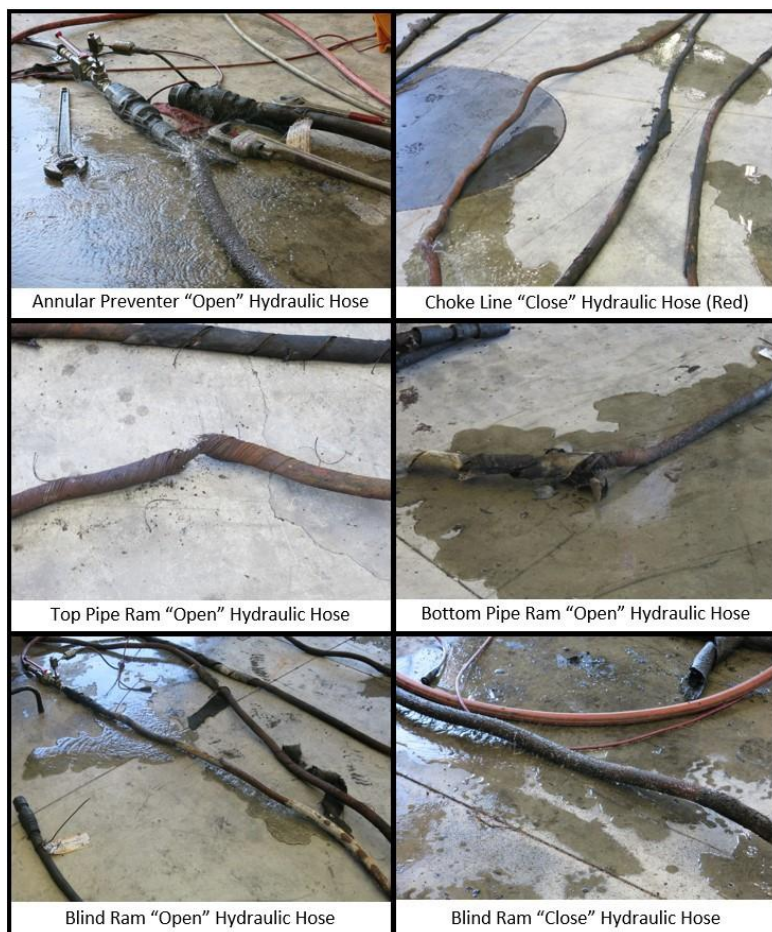
The blowout preventer also failed to close when its activation was attempted after the fire started. The CSB determined the BOP did not function likely because the control hoses that supplied hydraulic fluid to the BOP to function the rams had burned in the fire and leaked the hydraulic control fluid, soon depleting the accumulator stored pressure to the point the blowout preventer could not be closed.

Figure 50. Photos of hydraulic hoses that were installed between the accumulator and BOP, used to send high-pressure hydraulic fluid to the BOP rams to open or close the rams. The hoses were damaged by fire. The hydraulic hoses were leak tested using 40-50 psig water, and all hoses leaked water.

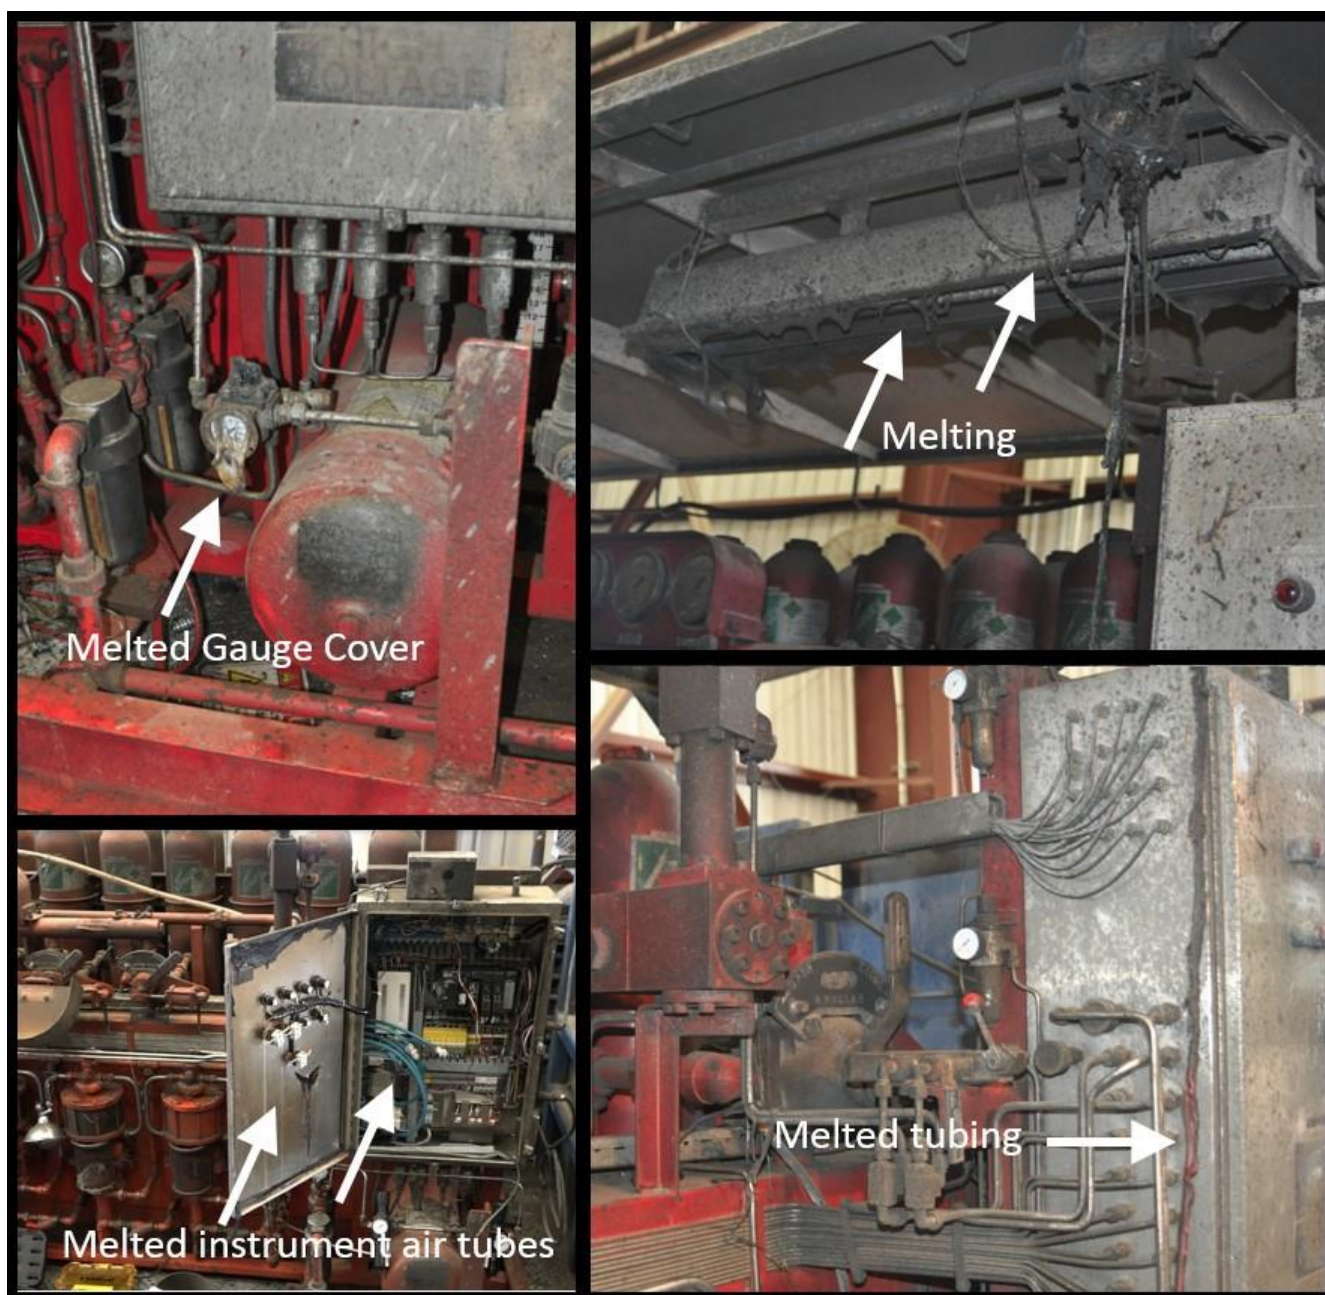
Figure A- 2. Photos of observed heat damage to Patterson Rig 219 accumulator

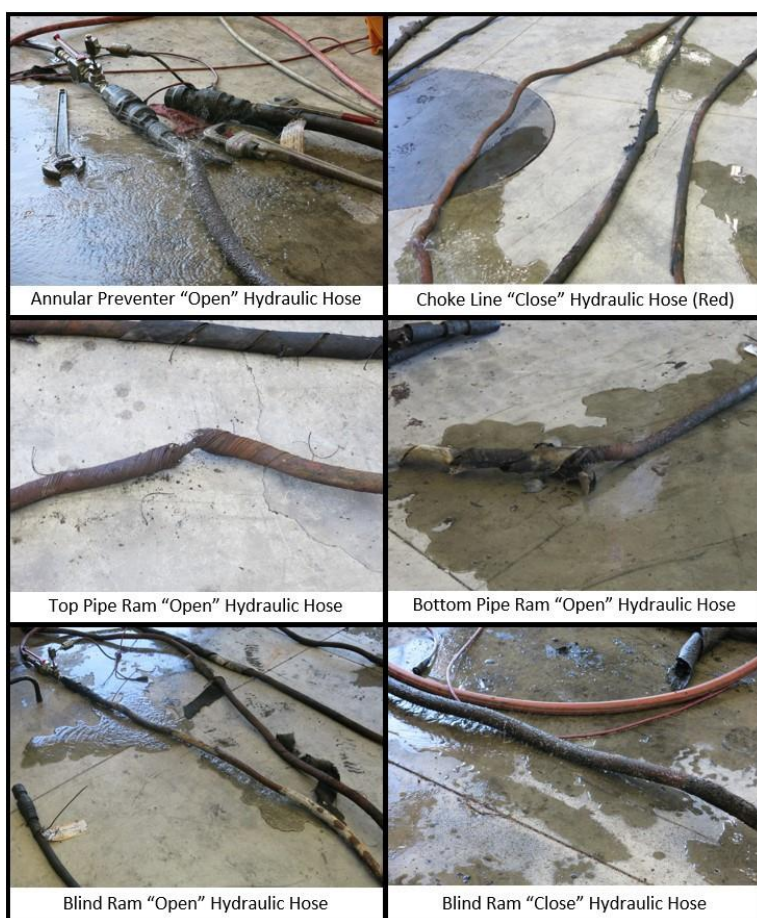
Figure A- 5. Photos of hydraulic hoses that were installed between the accumulator and BOP, used to send high-pressure hydraulic fluid to the BOP rams to open or close the rams. The hoses were damaged by the fire. The hydraulic hoses were leak tested using 40-50 psig water, and all hoses leaked water.
