Mitigation Assessment Team Report Hurricane Charley in Florida

Observations, Recommendations, and Technical Guidance

FEMA 488 / April 2005

On August 19, 2004, the Federal Emergency Management Agency's (FEMA's) Mitigation Division deployed a Mitigation Assessment Team (MAT) to Florida to assess damages caused by Hurricane Charley. This report presents the MAT's observations, conclusions, and recommendations in response to those field investigations.

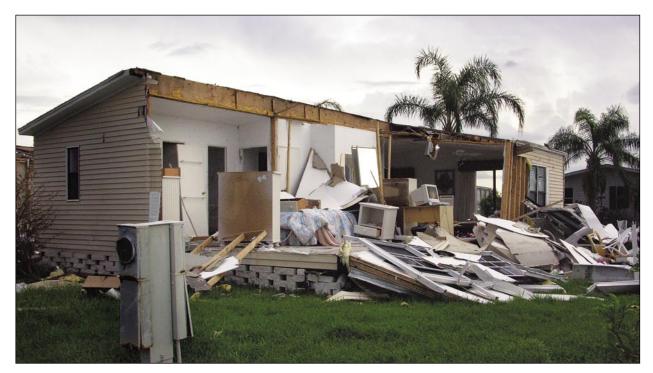
Figure 3-8 experienced extensive structural damage from 3-second peak gust winds in excess of the range of 110 to 130 mph.

Figure 3-8. Post-1994 manufactured home with major roof and wall failure (east of Port Charlotte)

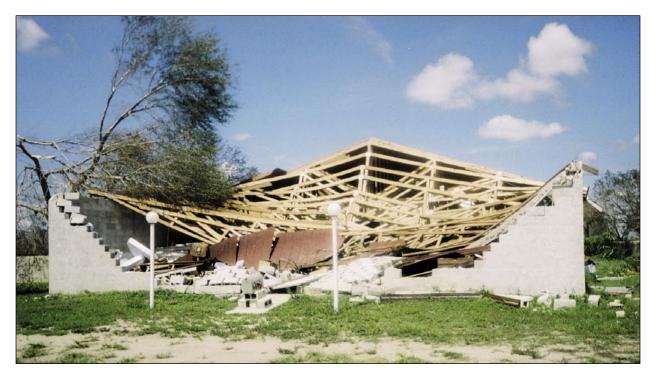
Figure 3-9. Example of wood truss roof failure due to sheathing loss and lack of bracing at gable end on a pre-2001 FBC unreinforced masonry building (north of Arcadia)

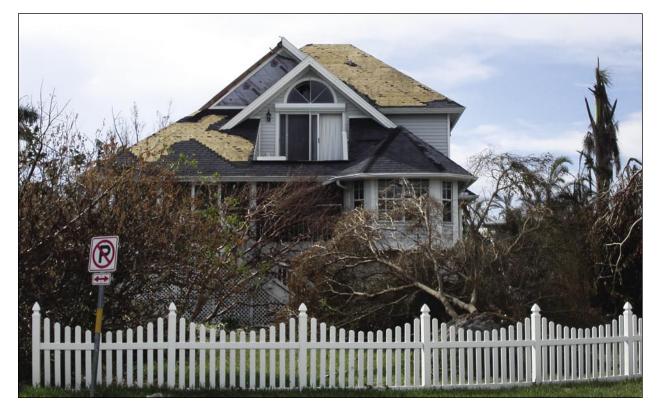
Figure 3-15. Typical asphalt shingle roof covering loss on elevated, two-story house (Captiva Island)

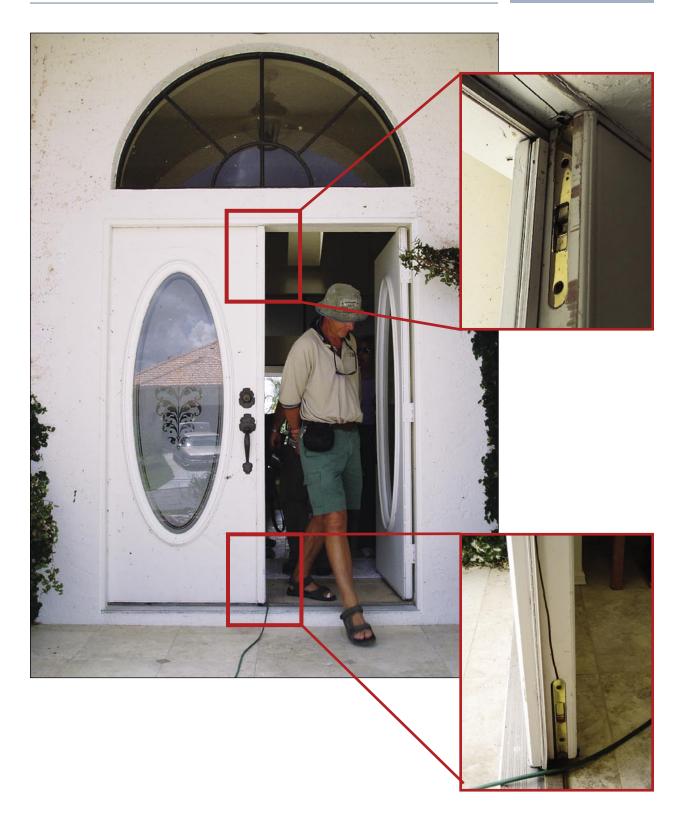
Figure 3-20. Double-entry door that failed under wind pressure. Upper inset shows close-up of crack in door frame at top latch. Lower inset shows crack in door emanating from bottom latch (Punta Gorda).

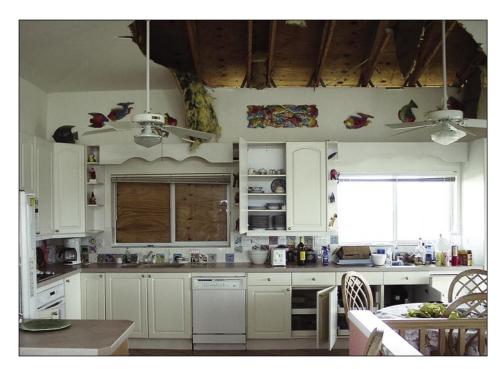
Figure 3-22. The drywall ceiling in the home shown in Figure 3-21 collapsed after becoming waterlogged and weakened by winddriven rain that entered through the exterior soffit space. Plywood covers the opening of a window broken by windborne debris after the plastic shutters blew off (North Captiva Island).

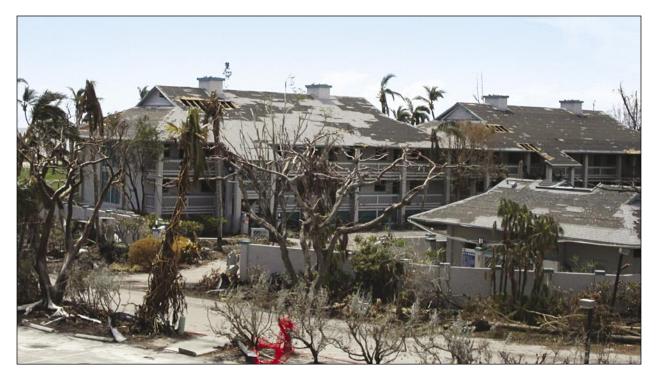
Figure 3-23. Roof covering loss. Note dark areas on roof are exposed underlayment (Captiva Island).

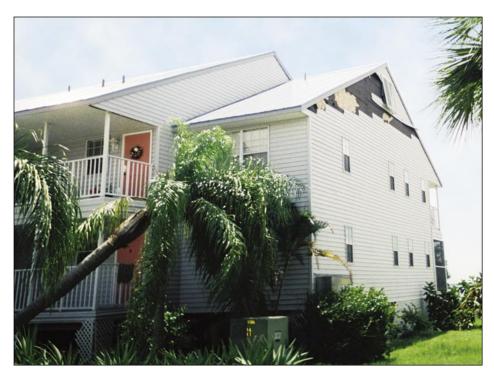
Figure 3-24. Vinyl siding wall covering on multi-family building with damage to gable end wall sheathing (Port Charlotte)

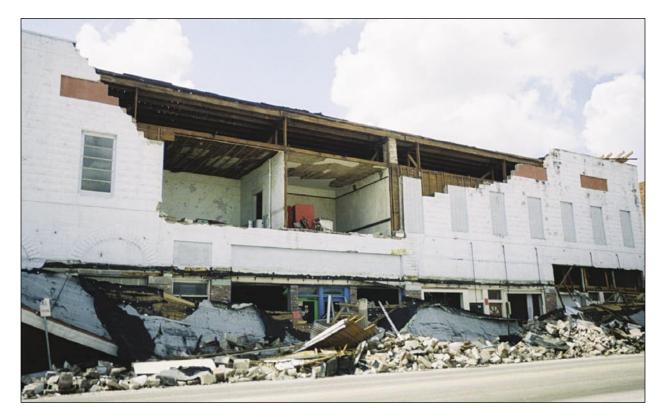
Figure 3-25. Example of unreinforced masonry wall and parapet collapse due to breaching of roof (on opposite side of building) (Wauchula)

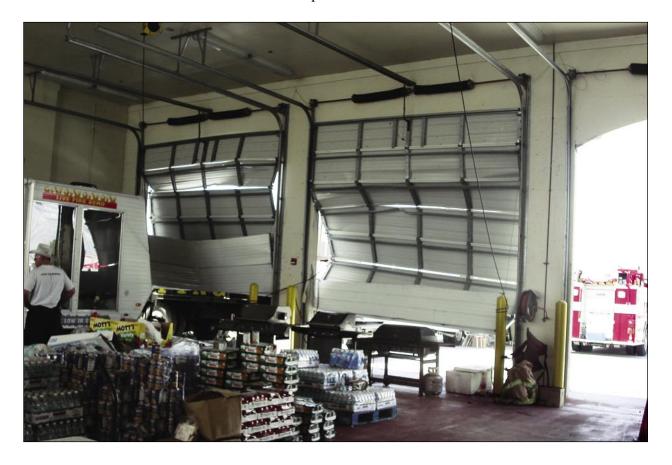
Figure 3-28. Damage to large rolling and sectional doors at Fire Station No. 1 (Punta Gorda)

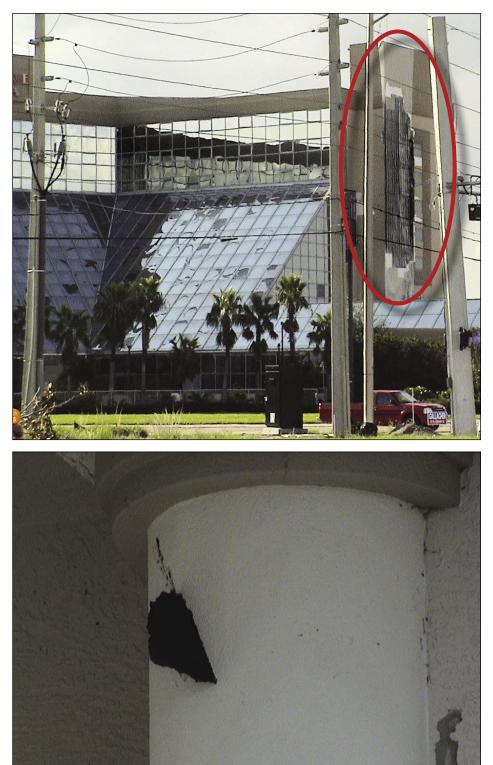
Figure 3-34. Edge impact of an asphalt shingle on decorative column (Punta Gorda)

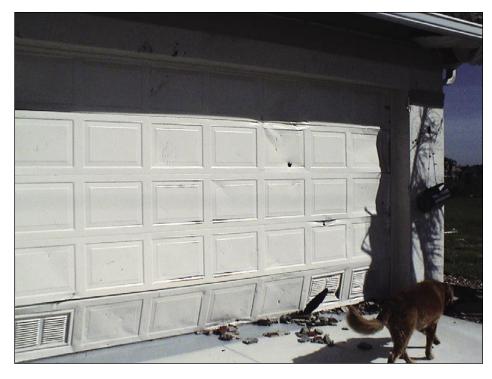
Figure 3-36. Tile damage to a metalpanel garage door (Punta Gorda)

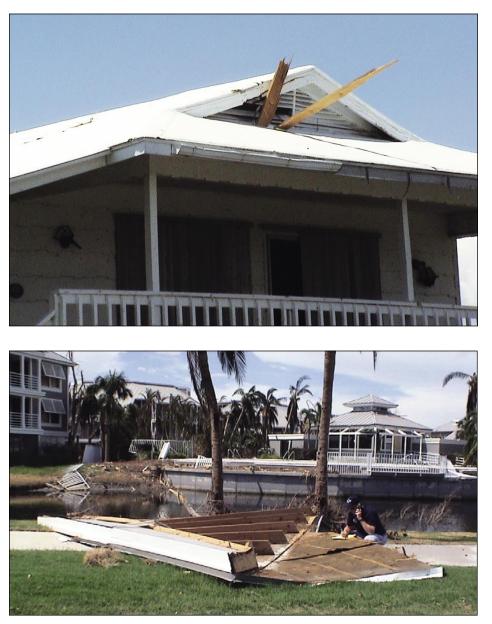
Figure 3-38. Large section of roof structure transported over 200 yards from its source (Captiva Island)

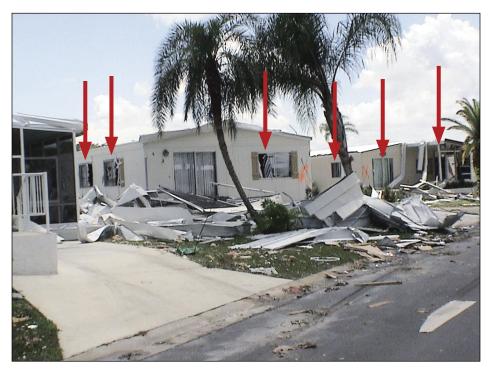
Figure 3-40. Typical metal roof panel and siding debris caused glazing damage to units (Port Charlotte)

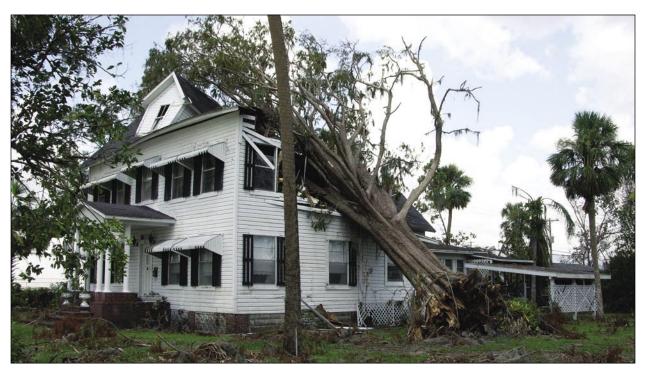
Figure 3-42. Damage to three-story home from tree impact (Wauchula))

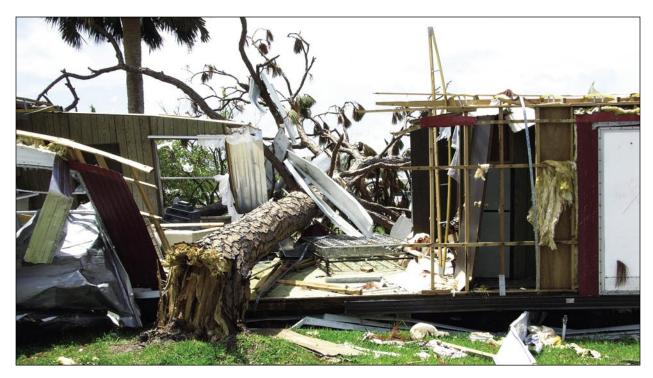
Figure 3-43. Damage to manufactured home from tree impact (Pine Island)

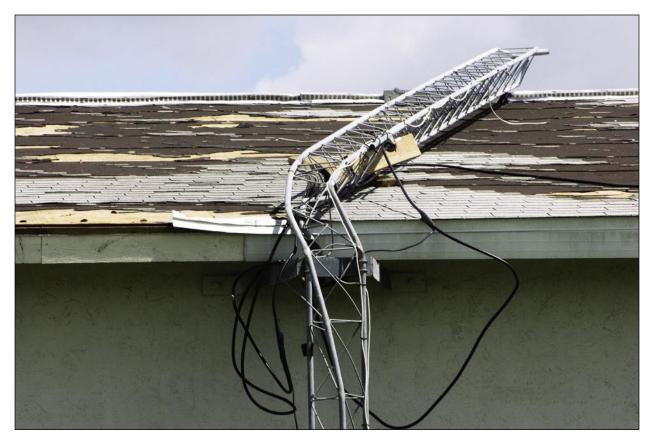
Figure 3-44. Fallen communications tower (Aqui Esta, east of Punta Gorda Isles)

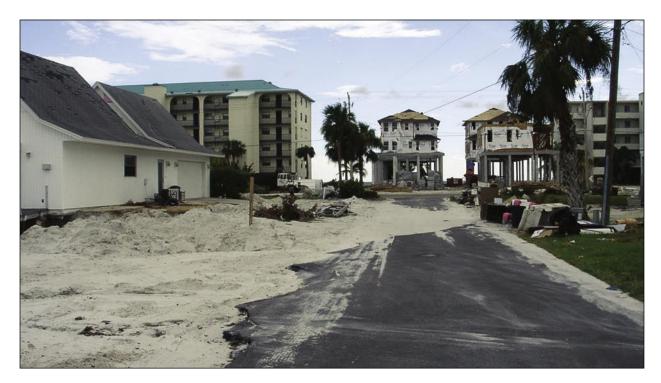
Figure 3-55. Storm surge caused scouring of the road and damage to the infrastructure (i.e., water main) (Fort Myers Beach)

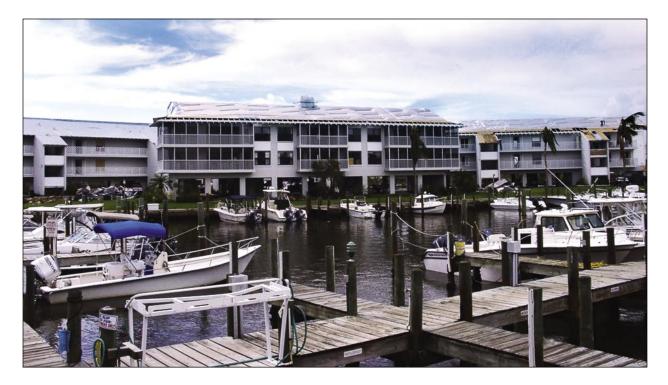
Figure 4-7. Multi-family residential building that performed well structurally, although it had severe roof covering and some sheathing failure at the overhangs, allowing water intrusion (Pine Island)

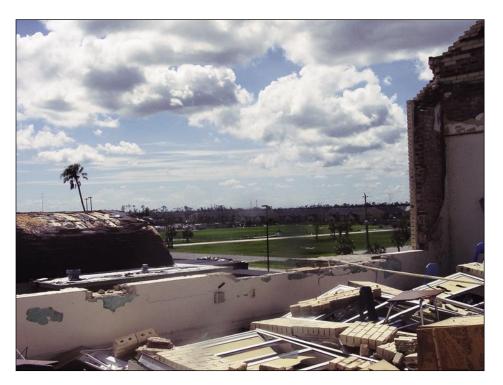
Figure 4-13. Unreinforced brick wall failure of a building built over 50 years ago (photo taken from the inside of a classroom, looking out) (Punta Gorda)

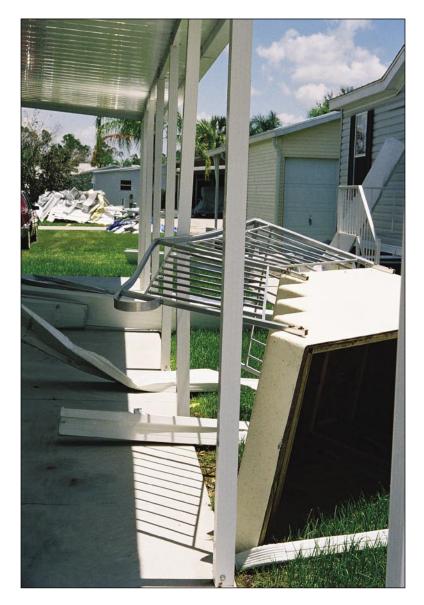
Figure 4-24. Stairway blown into a post of an aluminum carport accessory structure (Zolfo Springs)

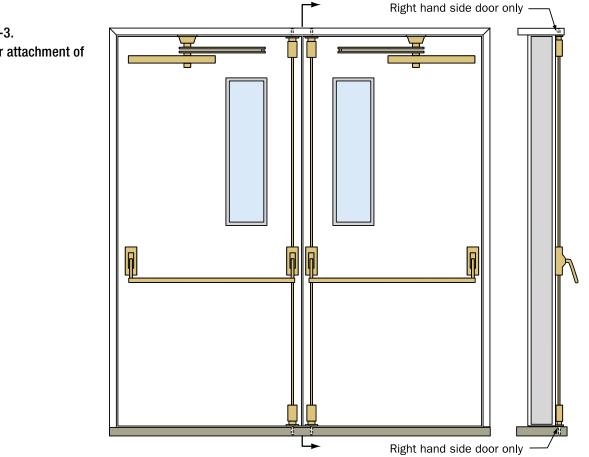
Figure 5-3. Improper attachment of doors

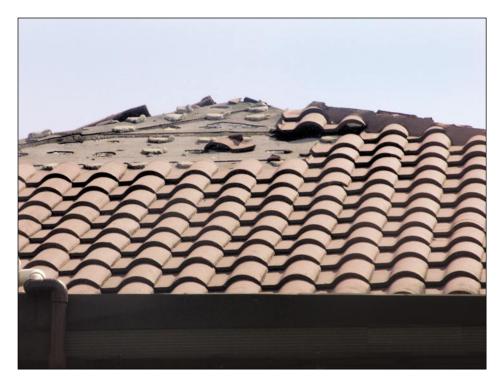
Figure 5-32. Most of the mortar-set hip and ridge tiles blew off this house (Port Charlotte).

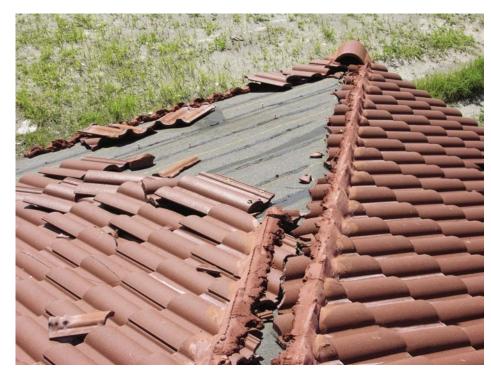
The building shown in Figures 5-35 and 5-36 is located in an area with a basic wind speed of approximately 120 mph. The 2001 FBC, therefore, requires compliance with the calculation method given in Section 1606.3.3. Load and resistance data can be found in the March 1, 2003, Addendum to the 3rd edition of the *Concrete and Clay Tile Installation Manual* (published by the Florida Roofing, Sheet Metal and Air Conditioning Contractors Association [FRSA] and Roof Tile Institute [RTI]). The roof in Figures 5-35 and 5-36 was attached with one 2½-inch long screw per tile directly to the deck. According to Table 12 of the Addendum, the attachment of this roof is suitable for buildings with a mean roof height up to 40 feet in areas with a basic wind speed of 150 mph. The estimated speed at this Exposure B location was in the range of 125 to 140 mph; therefore, the tiles did not perform as predicted by the *Concrete and Clay Tile Installation Manual*.

Figure 5-36. Loss of mortar-set hip tiles and several of the field tiles. Some of the screws remained in the deck, while others had been pulled out (Deep Creek).

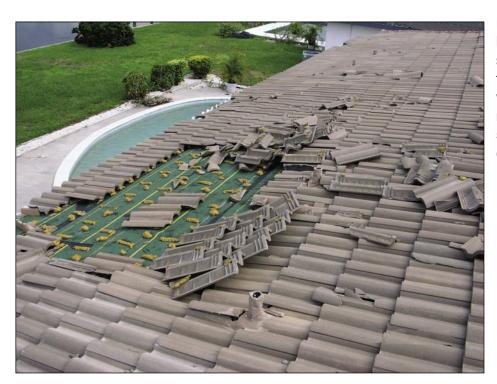
Figure 5-38. In addition to the damage shown in this photo, this one-story roof lost virtually all of the hip and ridge tiles (see Figures 5-22, 5-39, and 5-40) (Punta Gorda Isles).

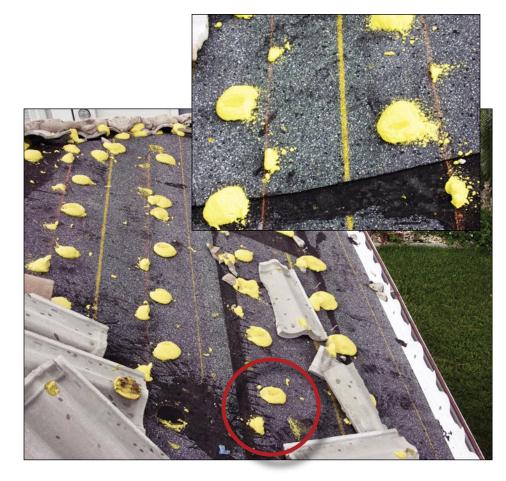
Figure 5-42. The paddy on the tile at the lower left debonded from the asphalt bleedout near a cap sheet lap. Only the center portion of the paddies made contact with the tiles, as shown in the inset (Punta Gorda Isles).

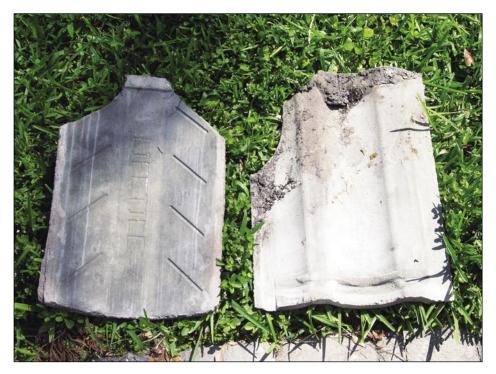
Figure 5-48. Tiles that flew through windows of an occupied residence (Deep Creek)

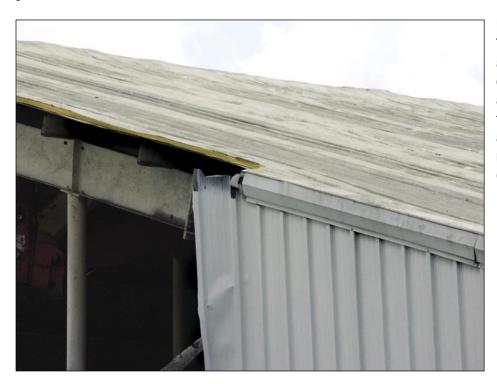
Figure 5-58. The metal wall panels and metal edge flashing on this building blew away, but the exposed fastener R-panels with an SPF covering did not progressively fail (Wauchula).

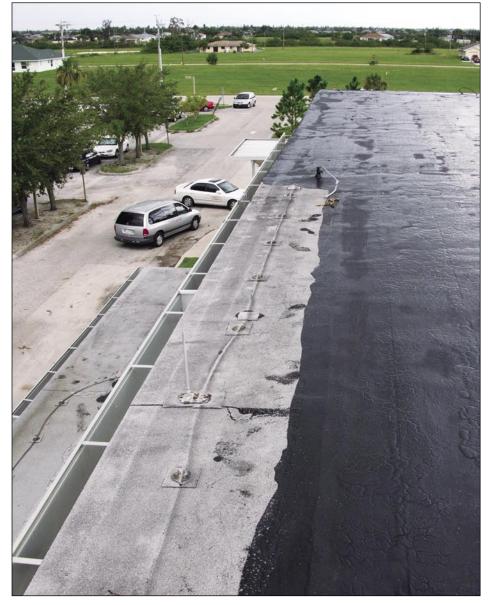
An edge flashing failure also occurred at a middle school in Cape Coral, first occupied in 1998 (Figure 5-63). This metal edge flashing had also been improperly installed underneath the membrane. The flashing should have been installed over the modified bitumen cap sheet and then stripped in to clamp the edge of the membrane. Wind lifted the gutter and metal edge flashing and peeled the modified bitumen membrane. The gutter was not designed for uplift resistance. A portion of a middle school in Port Charlotte also had a mineral surface BUR cap sheet roof, and the metal edge flashing had also been improperly installed underneath the membrane. However, none of the edge flashings lifted. Except for some missile damage, the BUR on this roof performed very well.

Figure 5-63. The edge flashing had a 2-inch vertical flange that extended into the gutter. The flashing was not cleated (Cape Coral). A high school in Arcadia had an aggregate surface BUR over lightweight insulating concrete (LWIC) over steel form deck that had been installed in the mid-1970s. Two areas over the cafeteria blew off, as did a portion over the gym. Repairs had been made by the time the MAT inspected, so it was not possible to definitively determine the cause of the failures. The failures at the cafeteria occurred several feet from the parapet. These failures may have been due to base sheet rupture around the fasteners (which may have been due to spacing problems, fastener corrosion, or deterioration of the base sheet), or deformation or cracking of the LWIC. At the gym roof, the blow-off area extended to the parapet, but it was unclear if the blow-off originated at the parapet. This roof may have failed for the reasons given at the cafeteria, or this failure may have been related to the coping or base flashing attachment. The 13¹/₂-inch-wide coping was attached only at each coping joint with three nails in the horizontal flange and one in the vertical flange. There was significant water infiltration in the cafeteria and gym.

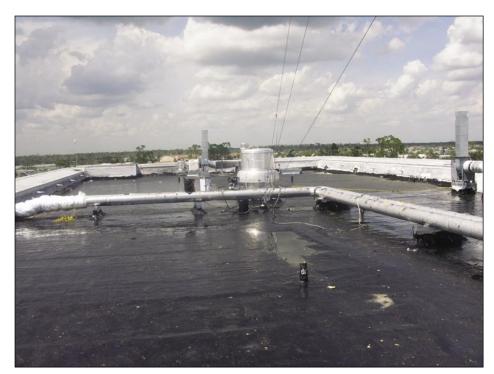
Figure 5-64. View of a portion of the fourth floor roof of a hospital after installation of an emergency roof (the black area). The deck was concrete (Port Charlotte).

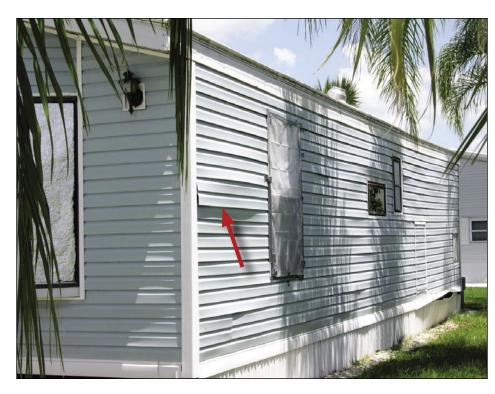
Figure 5-65. The vinyl siding panel with the red arrow is unlatched. The panel above and several others are also unlatched (Zolfo Springs).

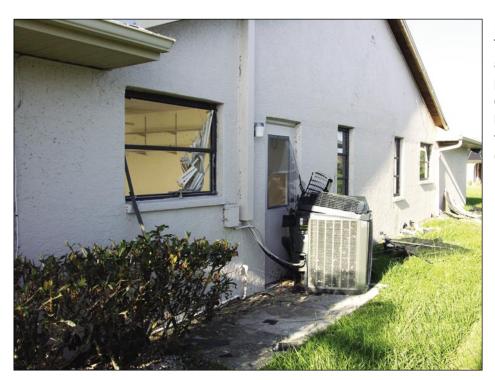
Figure 5-72. This condenser was not anchored to the concrete pad. The electrical and copper tube connections kept it from blowing farther away (Deep Creek).

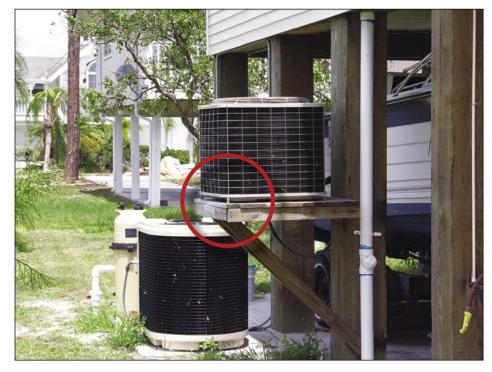
Figure 5-73. Condenser on the elevated platform attached with four angle brackets. The other condenser, located adjacent to it on the ground, should also have been on an elevated platform to account for storm surge (Pine Island).

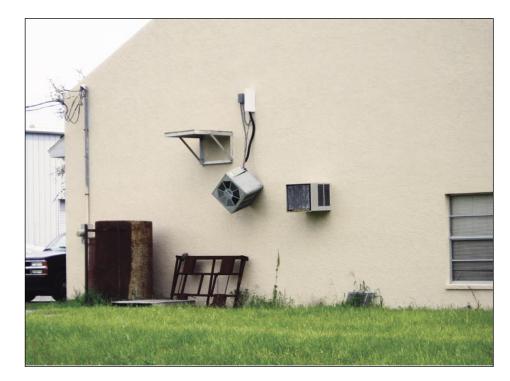
Figure 5-74. Condenser unit displaced from the elevated platform (Port Charlotte)

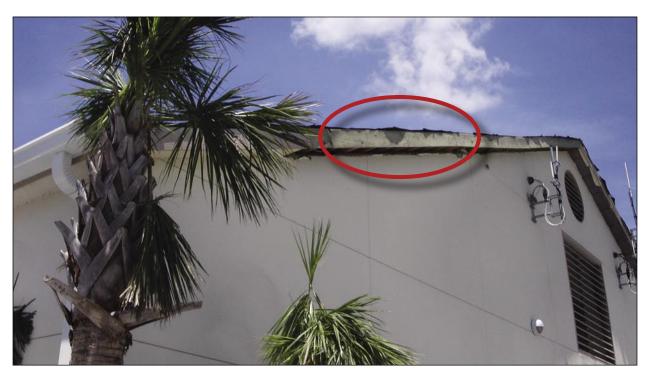
Figure 6-7. Damaged soffit at Punta Gorda Public Safety Complex

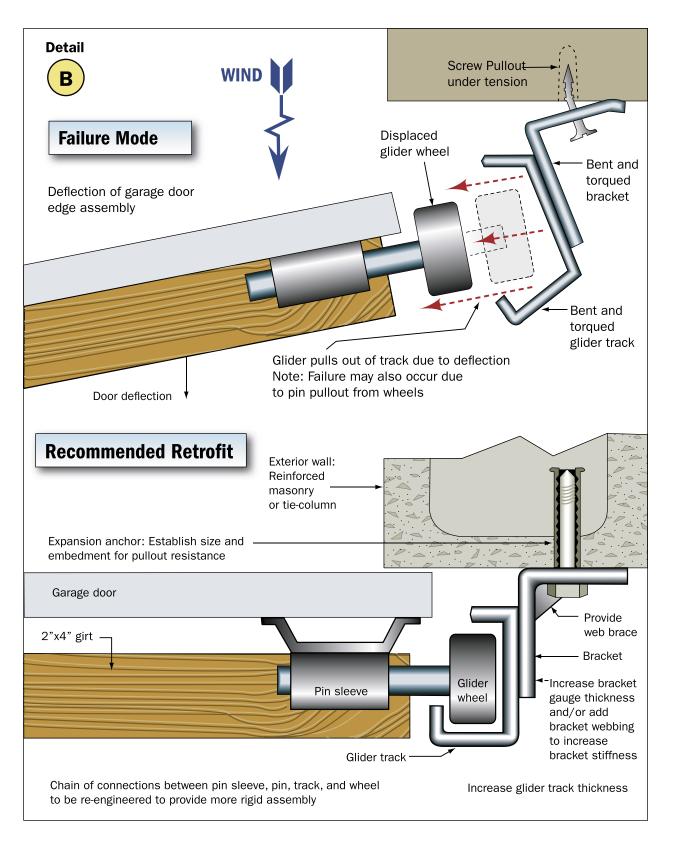
Figure 8-3. Detail B – typical garage door failure at the edge and recommended assembly improvements
