# Collapse of Building Under Construction

**Professional Development Hours (PDH) or  
Continuing Education Hours (CE)  
Online PDH or CE course**

On September 10, 2012 at approximately 9:20 a.m., a portion of the building under construction at Carlton Ave., Brooklyn, NY 11205, collapsed killing one employee, and seriously injuring another. The building under construction consisted of five townhouses, each four stories high, known as Carlton Row Townhouses. The construction of the building was near final completion. The structure essentially consisted of load-bearing masonry walls with cold-formed steel C-joists at each floor.

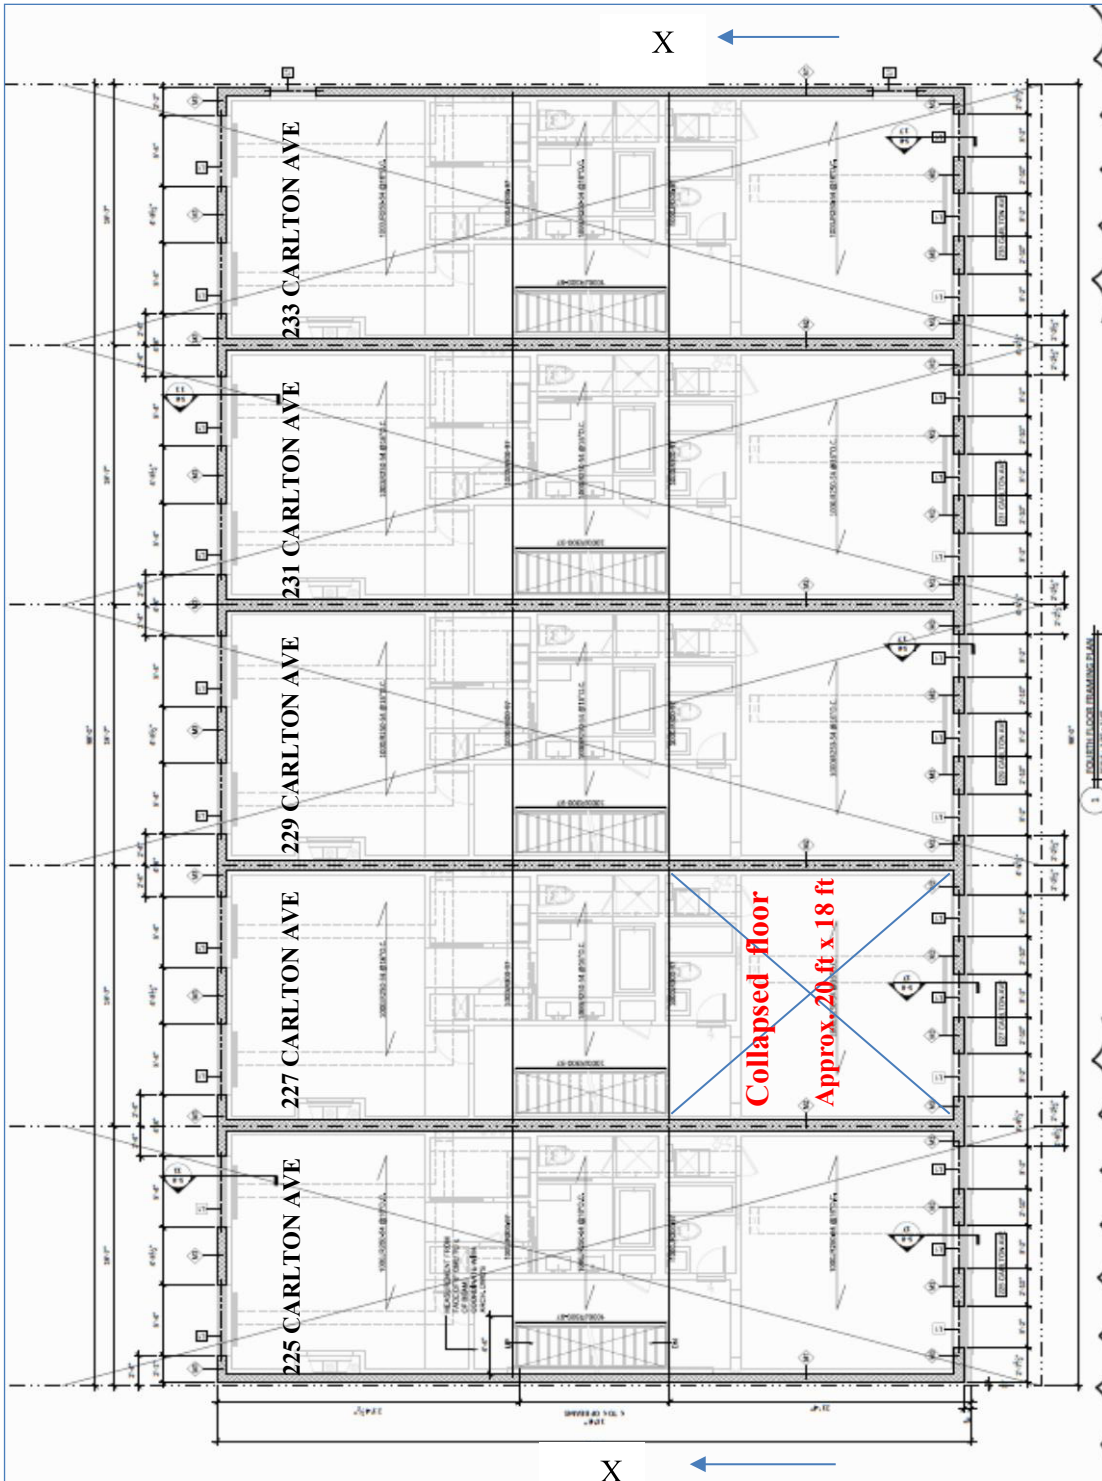
Eyewitnesses reported that soon after the last jumbo bags of sand was placed on the deck near the front of the building, the front 20 feet of the floor collapsed over the third floor which started

a chain of failures of the floors below, and finally the front 20 feet of all the floors were pancaked into the basement, also known as the cellar, see Fig 1 & 2.

Fig. 1 Fourth floor plan - Carlton Row Townhouses - after the floors collapsed

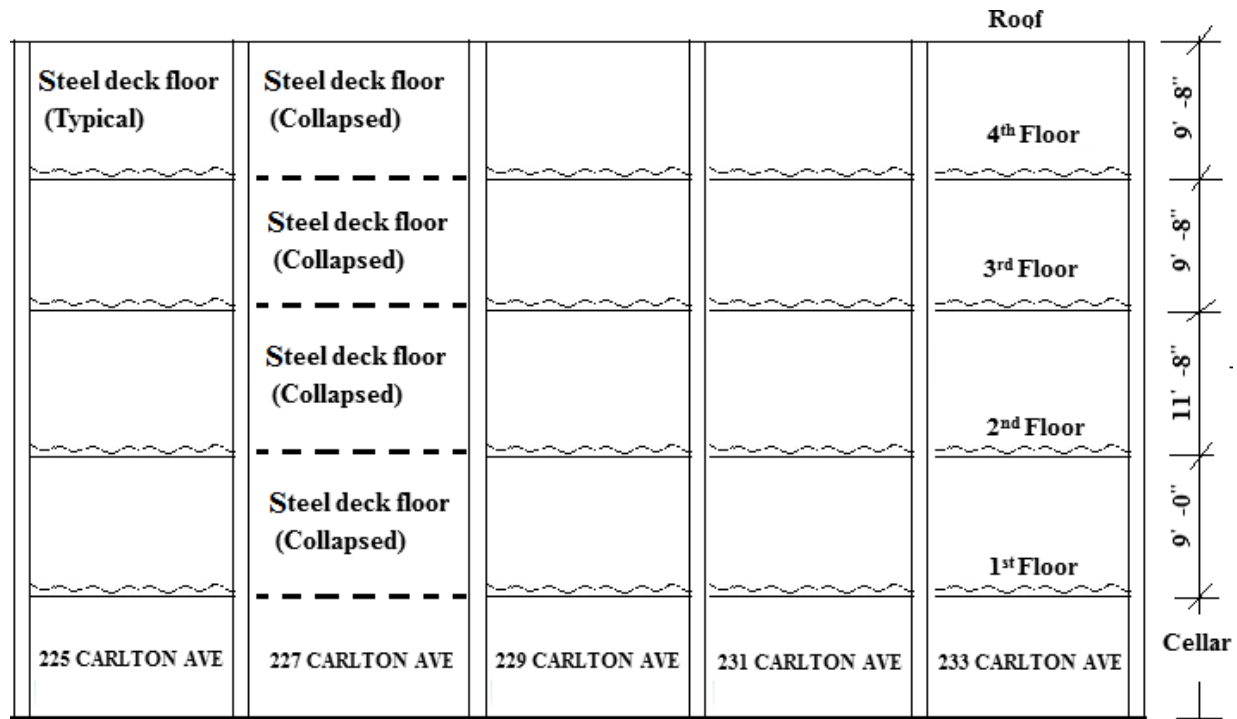
Fig. 2 Vertical section x-x of the building after the floors collapsed.

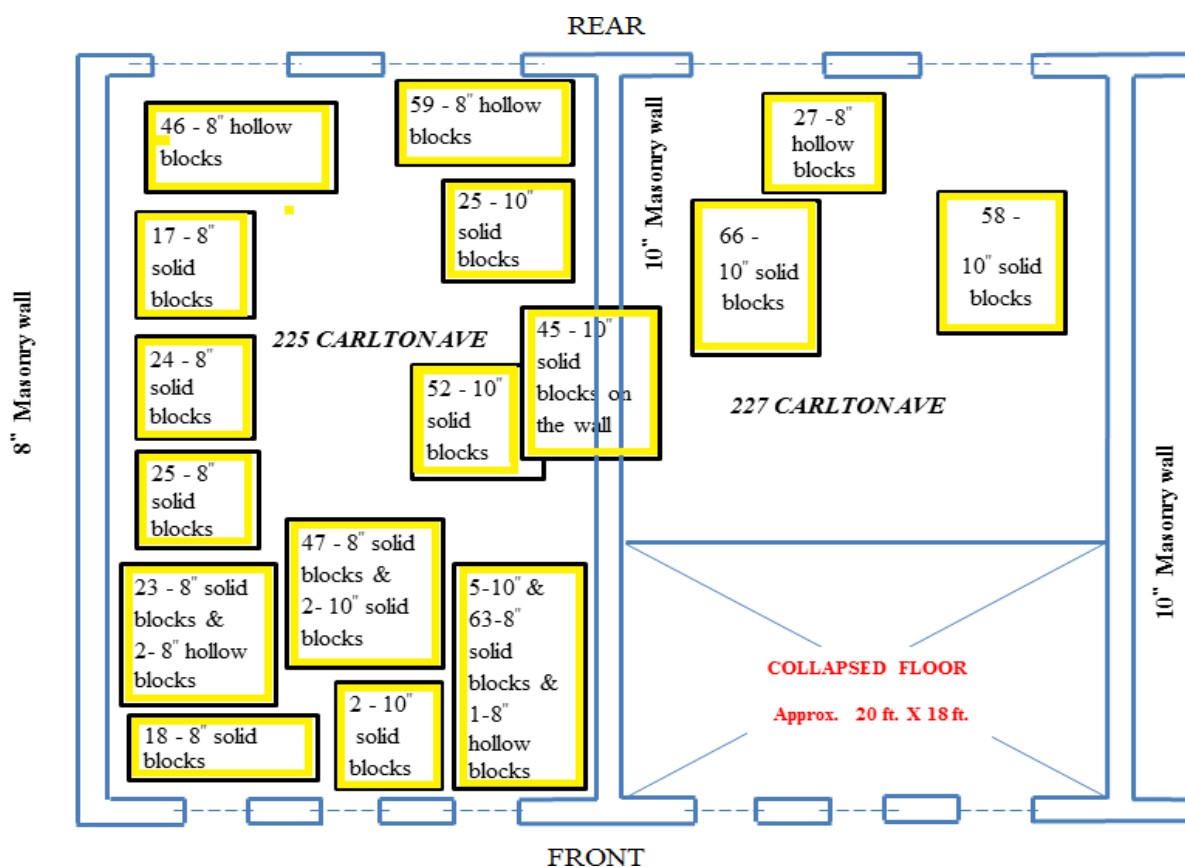
Post-incident observations indicated that the 4<sup>th</sup> floor deck of the adjoining unit # 225 had 10" solid, 8" solid and 8" hollow blocks piled at different locations. Some 10" solid blocks were also piled up on the incomplete party wall between units # 225 and 227. On the unfailed portion of the fourth floor deck of unit # 227, there were also 10" solid and 8" hollow blocks. Below is the tabulation of the blocks observed on the two 4<sup>th</sup> floor decks. Fig. 3 shows the approximate distribution of the masonry blocks on the two 4<sup>th</sup> floors as observed after the incident.

Fig. 3 Masonry blocks observed on the two 4<sup>th</sup> floors after the incident (Not to scale).

No pallets of cement bags or jumbo bags of sand were found on the 4<sup>th</sup> floor, either in unit # 225 or unit # 227. This would indicate that all the jumbo sand bags, three according to the majority of the eyewitnesses, and two pallets of cement bags, 10" solid blocks, 8" hollow blocks which were placed near the front of the 4<sup>th</sup> floor on unit # 227, and a concrete mixer fell with the collapsing floor.

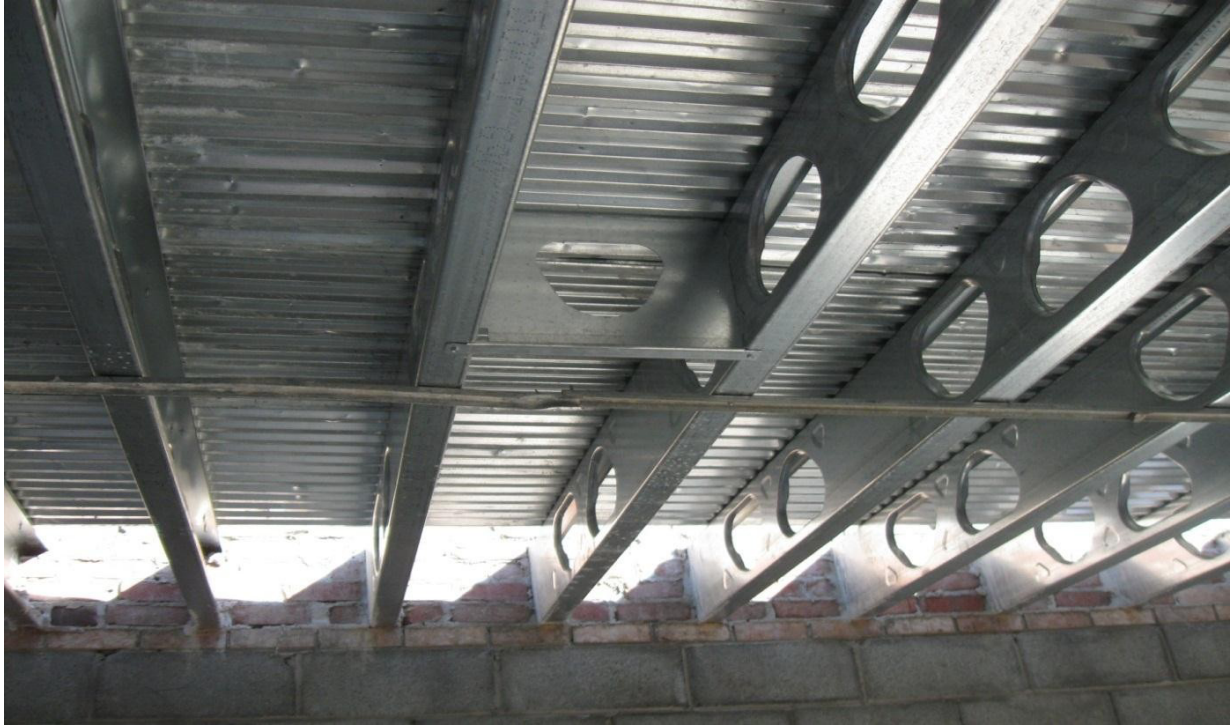
Post-incident observations indicated that there was no uniformity in the providing of lateral bracings to the floor joists. First, the temporary deck which could have provided lateral support to the joists was screwed to the top flange of the joists barely at few locations. Observations on the 4<sup>th</sup> floor and other floors indicated that the deck was screwed very sparingly, and, therefore, could not be relied upon to provide any lateral support to the floor joists. Second, there was a 2" wide steel strap screwed to the bottom flange of the joists at most locations. However, the top strap which was critical in providing lateral stability was not provided at most of the locations, see Fig. 4. Third, the blockings were provided only at the ends, but not at every 10' as required. Fourth, the straps which were provided at the bottom flange (see Fig. 5) were not spaced at 7' intervals, as required.

Fig. 4 Floor joists with no straps at the top flange.

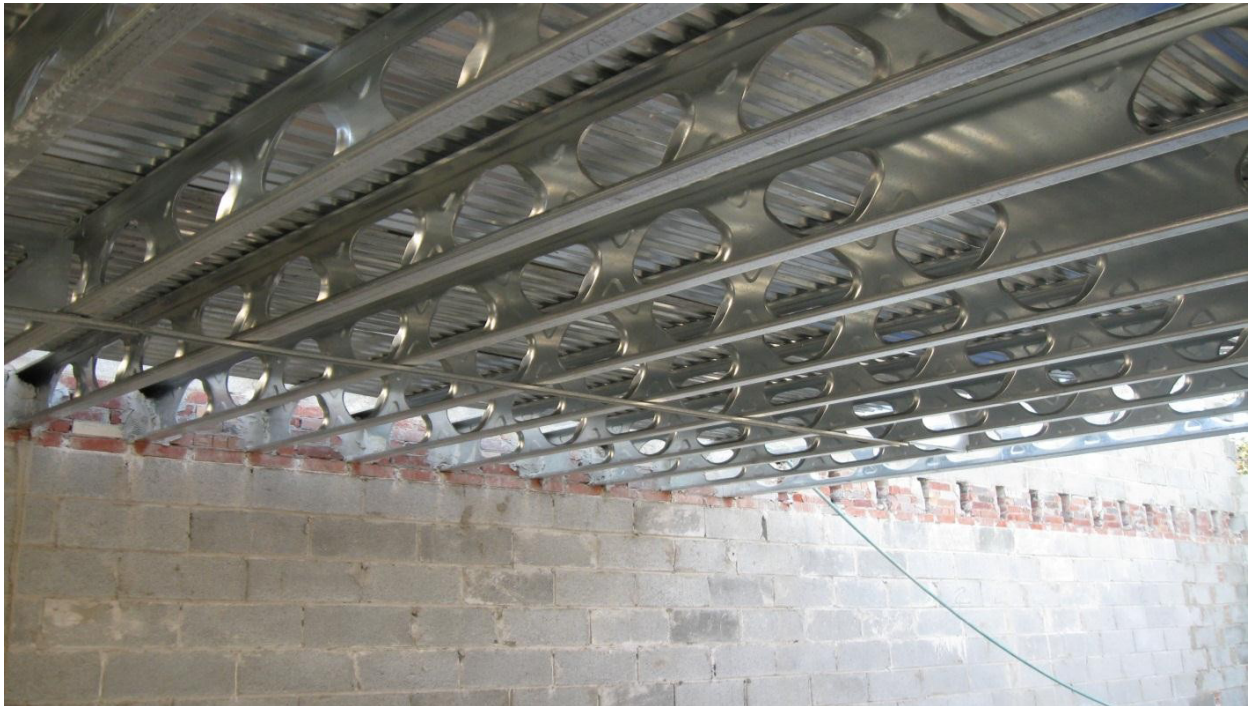
Fig. 5 Floor joists with straps only at the bottom flange.

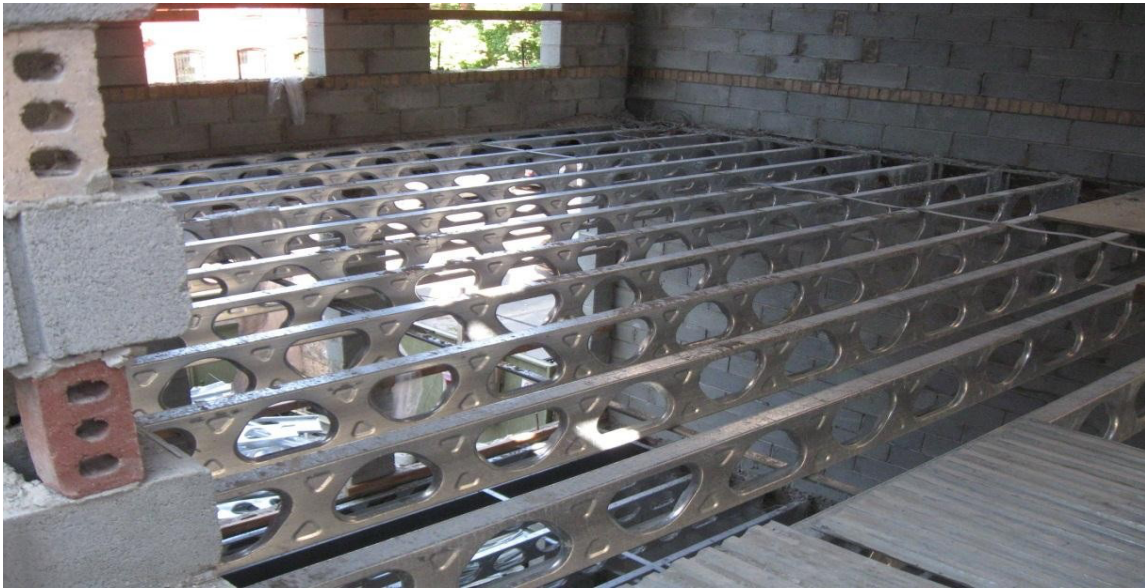
The cold-formed steel joists used to frame the floors of the building were 16-gauge JoistRite sections (Fig. 6 & Appendix) spaced at 16" o.c. (structural drawings S-002.01 to S-006.01 in Ref. 2). JoistRite is a cold-formed steel section manufactured by Marino WARE, see Appendix. The structural drawings called for plywood sheathings to be placed on the floor joists. The contractor, however, decided to place a temporary steel deck (see Fig. 7) on the floor joists during construction to avoid damaging the permanent plywood floor with construction materials.

Fig. 6 Floor joists spaced at 16" o/c.

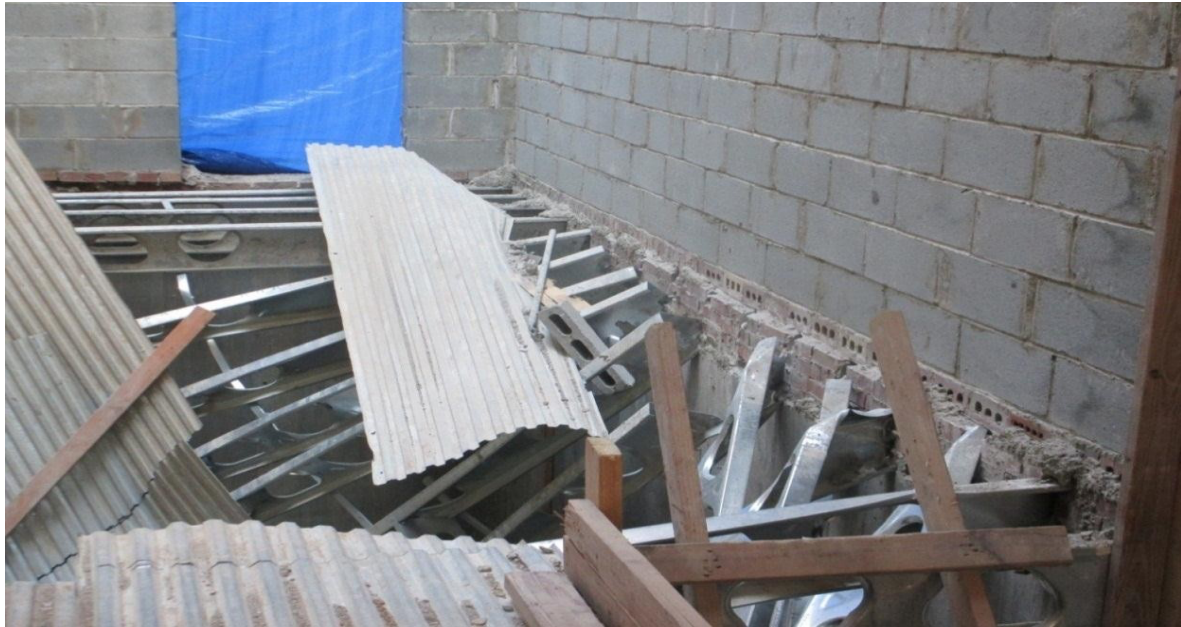
The 4<sup>th</sup> floor of unit #227 partially failed when construction loads (concrete blocks, bags of sand and masonry cement) were stacked up on the floor and collapsed on the 3<sup>rd</sup> floor creating a chain reaction on the floors below. All the floors ended up in the basement (cellar). Fig. 9 shows the area of the of the 4<sup>th</sup> floor unit #227 that collapsed due to construction loads.

Fig. 9 A partially collapsed 4<sup>th</sup> floor due to construction loads.
