Excavation Collapse

**Professional Development Hours (PDH) or
Continuing Education Hours (CE)
Online PDH or CE course**

1. SUMMARY

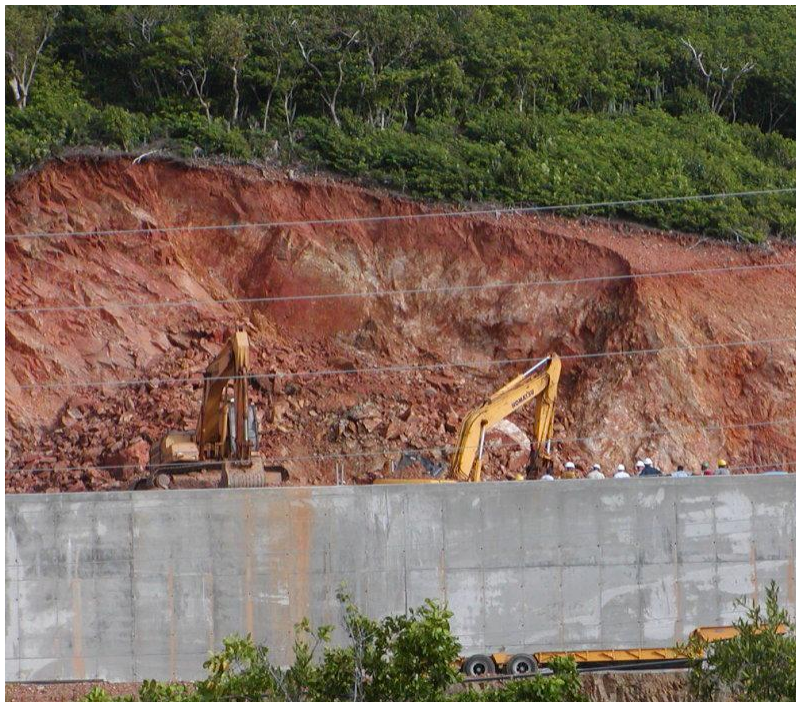
The figure on the cover of this report presents the overall shape of the collapse. As shown, the collapse was in a near circular or spoon shape. Based on references presented in Figures 23 and 24, a collapse of this shape would mostly occur in overburden soil, weathered rock, waste rock or heavily fractured rock. Therefore, the earth deposits in the collapsed area could only be residual soil, weathered rock or heavily fractured rock. They were more soil-like than rock-like deposits.

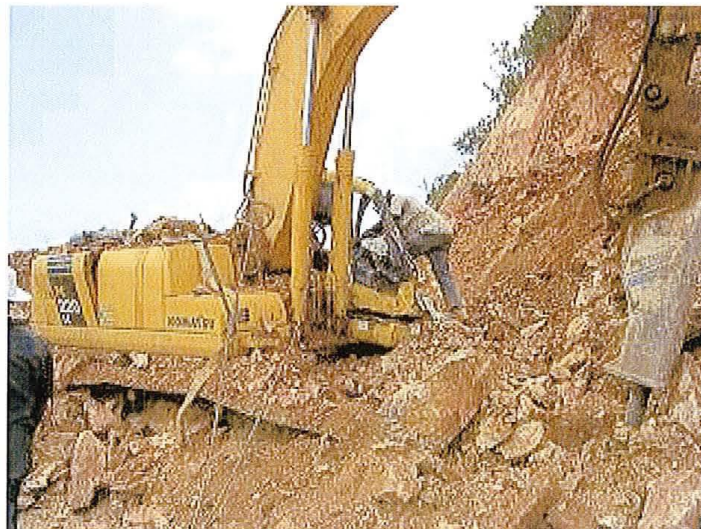
Around 11:00 a.m., the over 40 foot high, steep excavated slope suddenly collapsed. The collapsed earth crushed the cab side of the excavator and then buried it entirely (Figures 5 and 6). As a result of the collapse, the employee inside the cab was killed. At the time of the incident, the excavator was breaking the base of the excavated slope.

Figure 6. Location of the Komatsu PC 220 Excavator during the Rescue Operation, Looking Toward South (Provided by GEC, LLC.).

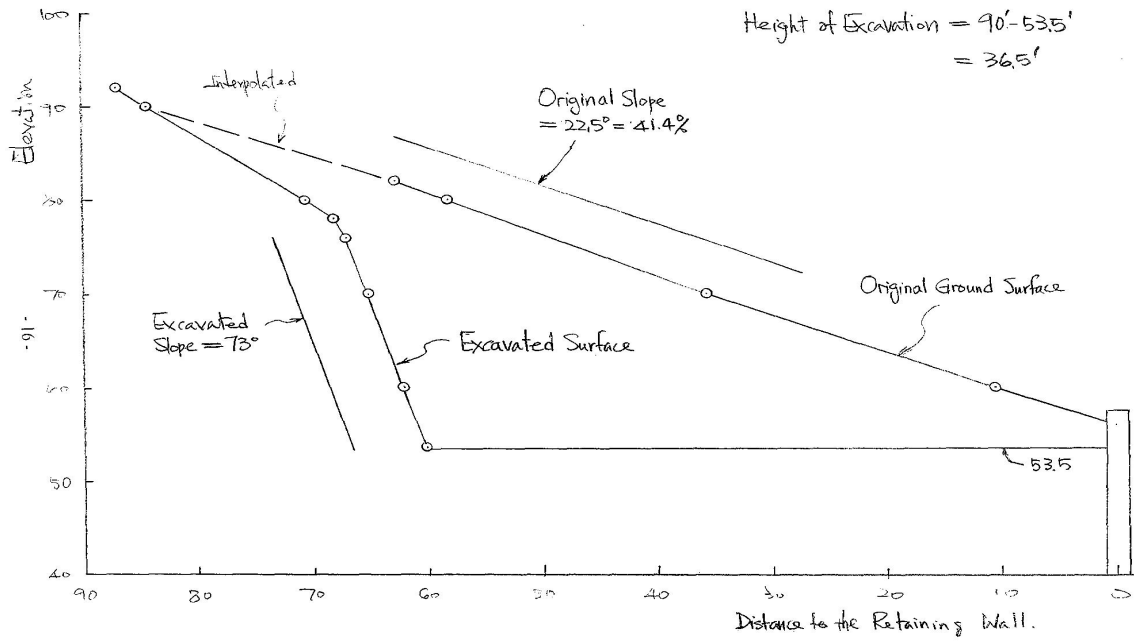
- The original ground slope varied from 41 to 45%.
- The cut slope averaged 76 degrees, approximately . (horizontal) to 1(vertical).
- The excavated elevation of the parking level 2 was about the same as the pavement elevation as indicated in Figures 1 and 2.

Figure 7. Cross Section of the Original Ground Surface and the Excavated Surface, North of the Collapsed Area (73 feet from the North End of the Retaining Wall).

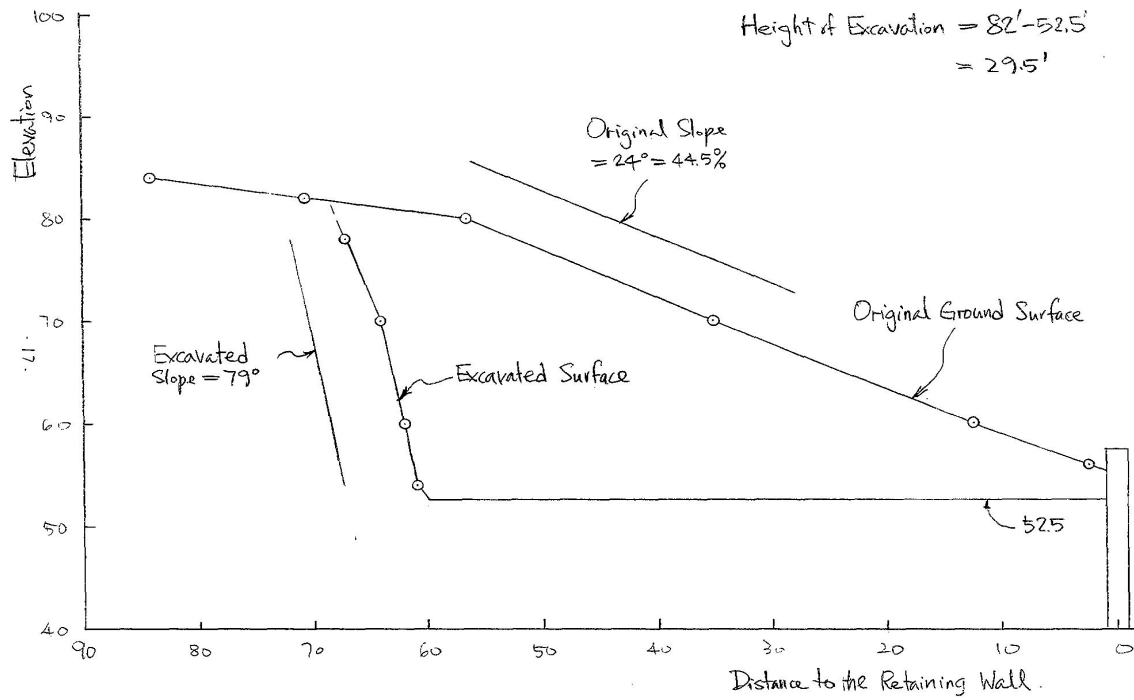
Figure 8. Cross Section of the Original Ground Surface and the Excavated Surface, North of the Collapsed Area (168 feet from the North End of the Retaining Wall).

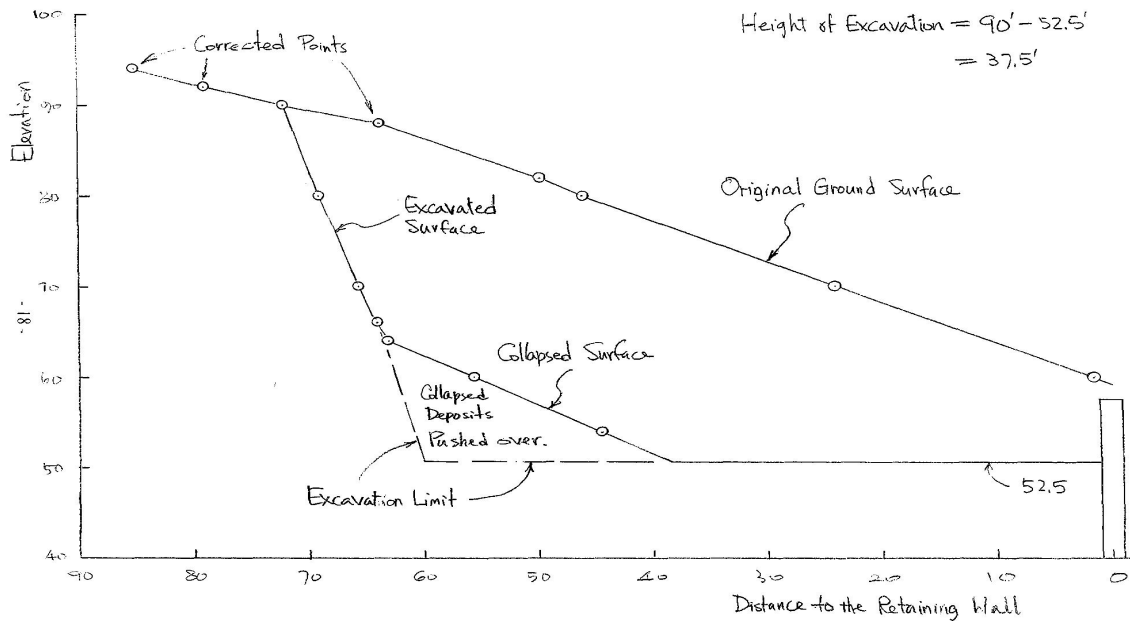
Figures 9 through 12 were developed using the above information. The upper portion of the cut slope in Figure 9 appeared to be intact. The earth deposits on the base of the slope appeared to be pushed over from the south during the rescue operation. This section could represent the north end of the collapse. Figures 10 and 11 were sections in the middle of the collapse. As indicated, the average thickness of the collapsed earth deposits was 8 feet.

Figure 9. Cross Section of the Original Ground Surface, the Excavated Surface and the Failure Surface in the Collapse Area (50 feet from the turning Point of the Retaining Wall).

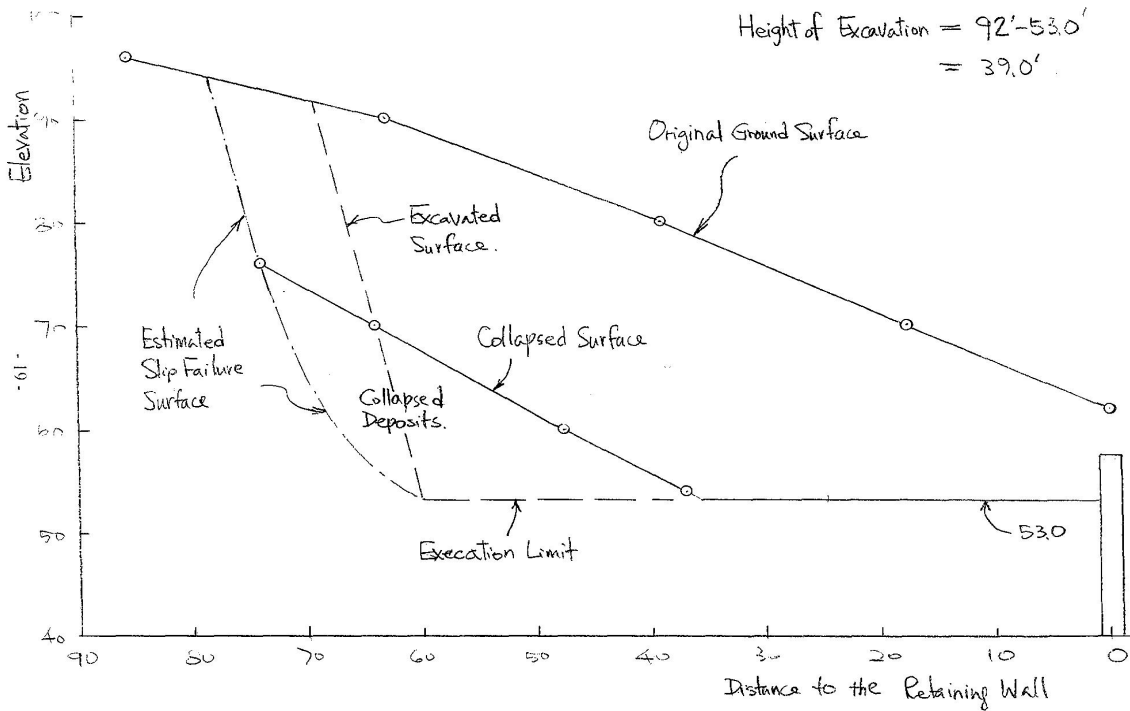
Figure 10. Cross Section of the Original Ground Surface, the Excavated Surface and the Failure Surface in the Collapse Area (70 feet from the turning Point of the Retaining Wall).

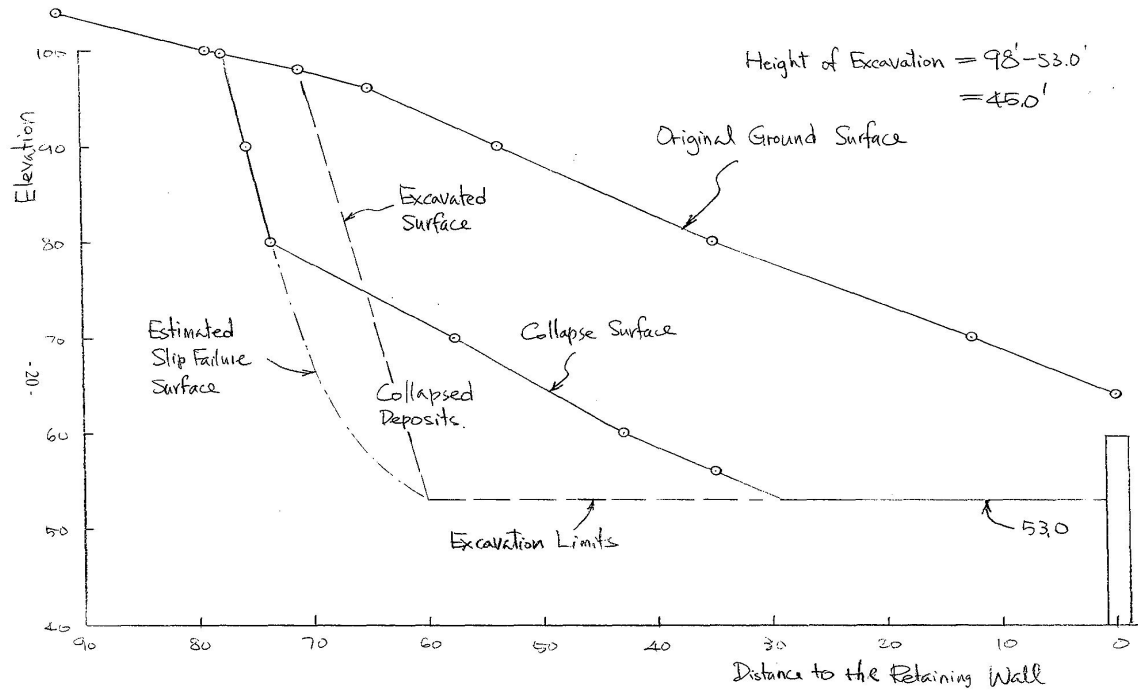
Figure 11. Cross Section of the Original Ground Surface, the Excavated Surface and the Failure Surface in the Collapse Area (90 feet from the turning Point of the Retaining Wall).

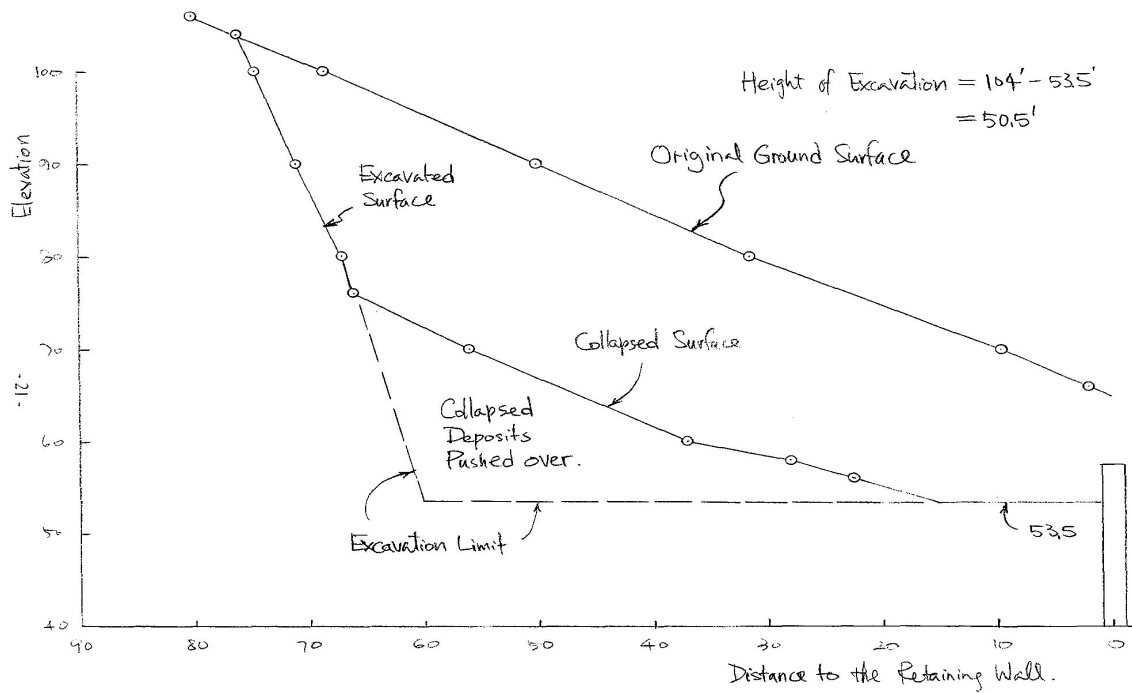
The upper portion of the cut slope in Figure 12 appeared to be intact. The earth deposits at the base of the slope appeared to be pushed over from the north. This section could represent the south end of the collapse. Based on Figures 9 through 12, the average height of the excavation was 43 feet and the width of the collapse was 60 feet. As a result, the volume of collapsed materials is estimated as:

Figure 12. Cross Section of the Original Ground Surface, the Excavated Surface and the Failure Surface in the Collapse Area (110 feet from the turning Point of the Retaining Wall).

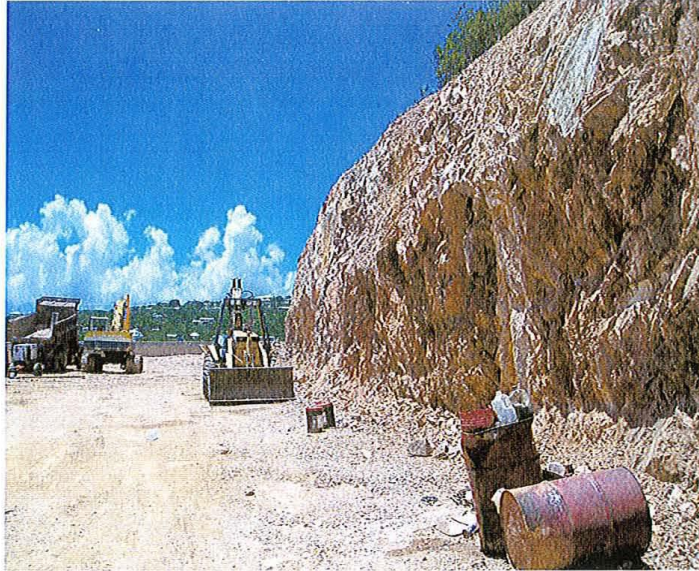
Photographs of the excavated and collapsed surfaces were examined from north to south. Figure 13 represents the excavated surface north of the collapse. As discussed, the exposed surface appeared to be heavily fractured rocks with indentations and over breaks caused by the hydraulic breaker during the excavation. Figures 14 and 15 represent the lower portion of the collapsed surface at its north end. They indicate similar heavily fractured rocks with two large cavities caused either by the excavation over breaks or the collapse.

Figure 13. Excavated Surface North of the Collapsed, Looking Toward South.

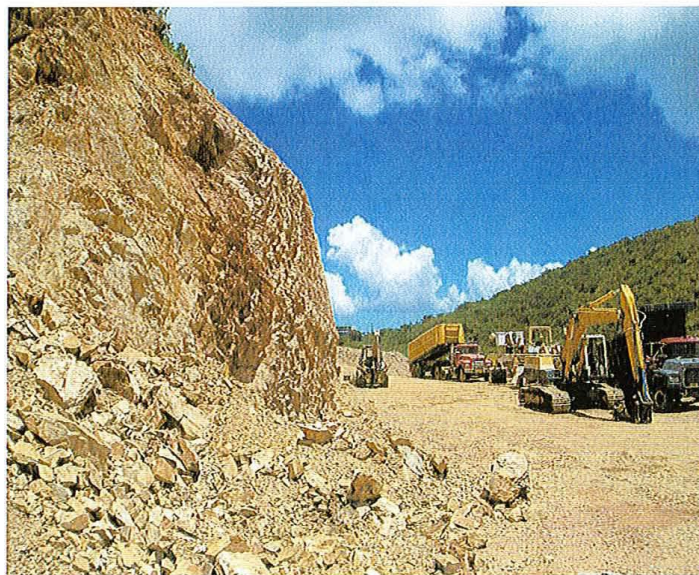
Figure 14. Lower Portion of the Collapse at its North End, Looking Toward North.

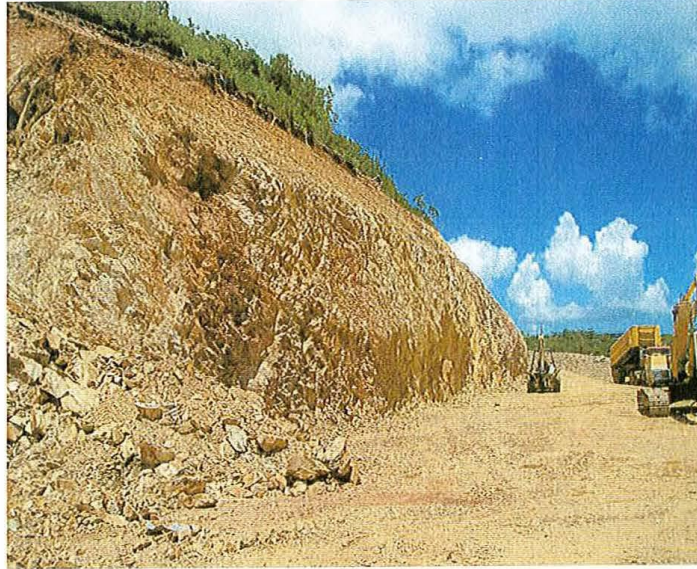
Figure 15. Another View of Figure 15, Looking Toward Northwest.

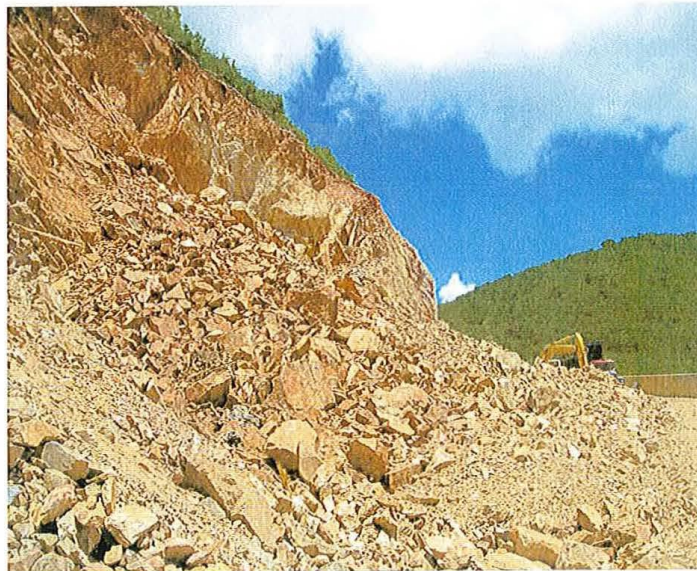
Figures 16 through 18 represent the upper portion of the collapse from north to south. The earth deposits in the upper tension zone varied from residual soil to weathered rock. Weathered rock might appear to be rock but it does not have the strength of rock, as is evident from the weathered rock being crushed to small pieces at the collapsed area.

Figure 16. Upper Portion of the Collapsed Surface (North), Looking Toward North.

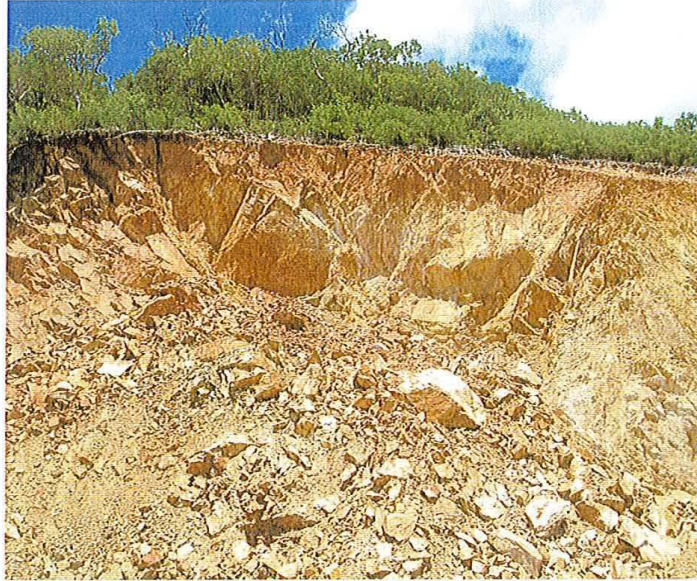
It is interesting to examine Figures 17 and 19. In Figure 17, taken on September 1, 2006, a large weathered rock block could be seen in a seemingly stable position in the upper middle portion of the figure. But Figure 19, taken 25 days later on September 26, 2006, shows that the weathered rock block had fallen, indicating its instability.

Figure 17. Upper Portion of the Collapsed Surface (Center), Looking Toward West.

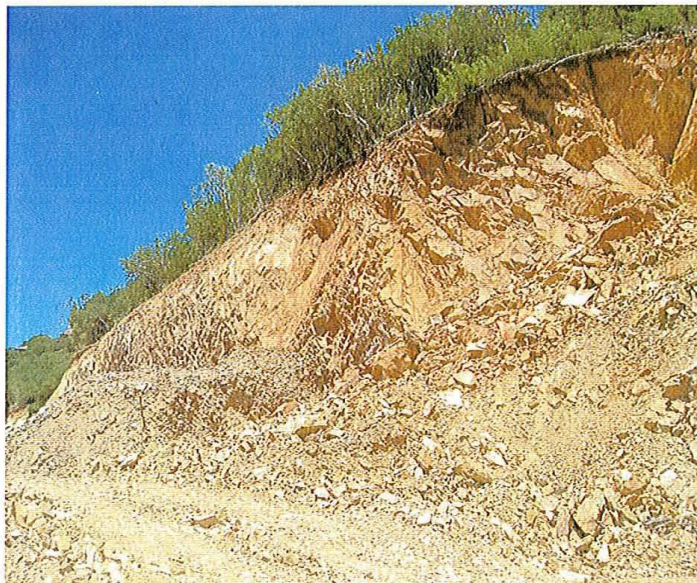
Figure 18. Upper Portion of the Collapsed Surface (South), Looking Toward South.

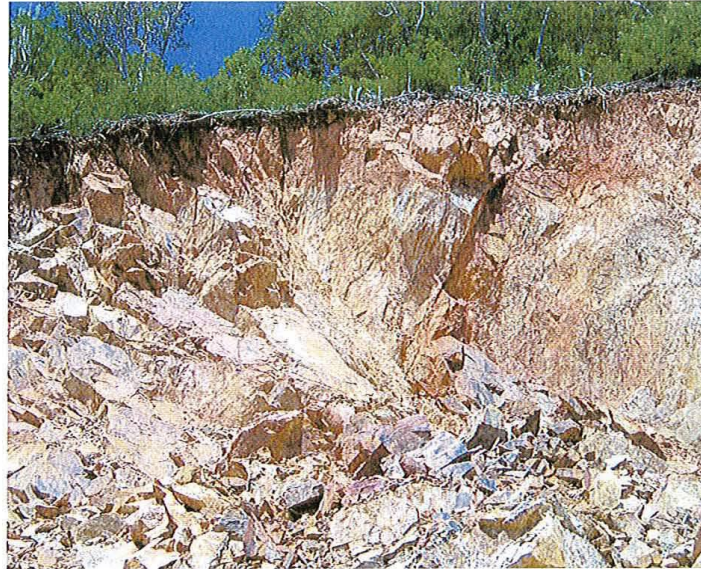
Figures 19 and 20 show numerous brightly colored fractures indicating that the rock mass was heavily weathered. Figure 20 also represents the type of rock pieces at the center of the collapse.

Figure 19. Close-up View of Figure 17 Showing a Rock Block Sled away, Looking Toward West.

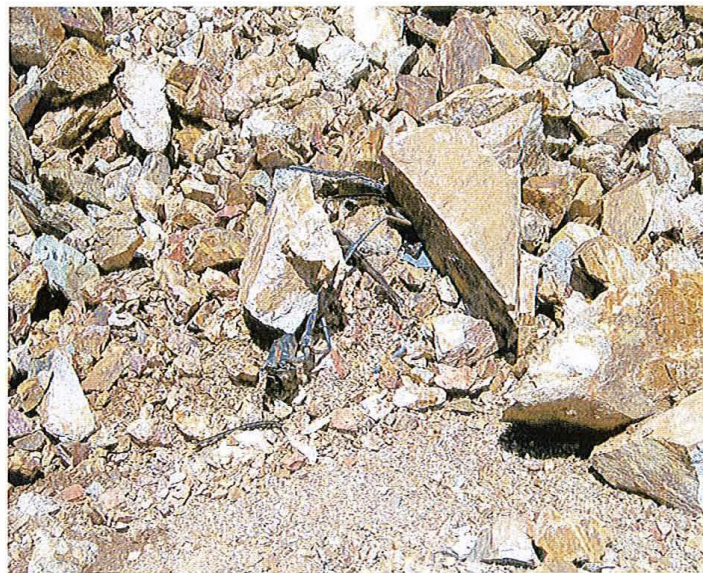
Figure 20 Type and Size of Rock Pieces at the Center of the Collapse.

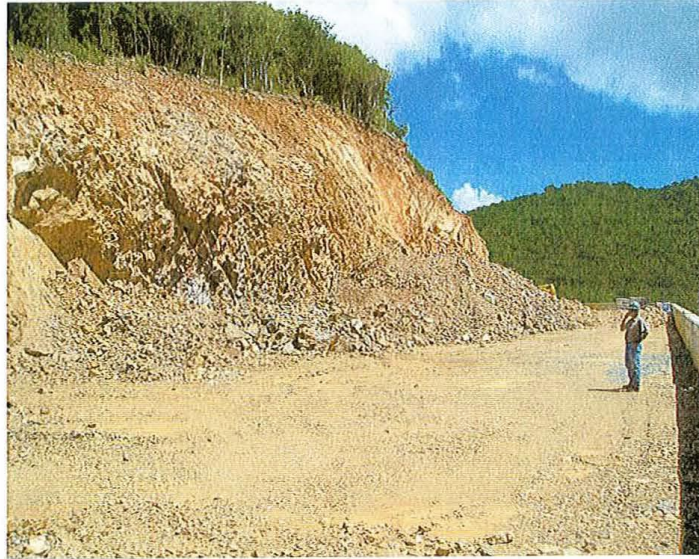
Figures 21 and 22 represent the identifiable rock slabs in the excavated surface south of the collapsed area. However, this rock structure only occurred in less than 10% of the 500 foot long excavation.

Figure 21. Identifiable Rock Slabs in the Excavation Face South of the Collapsed Area, Looking Toward Northwest.

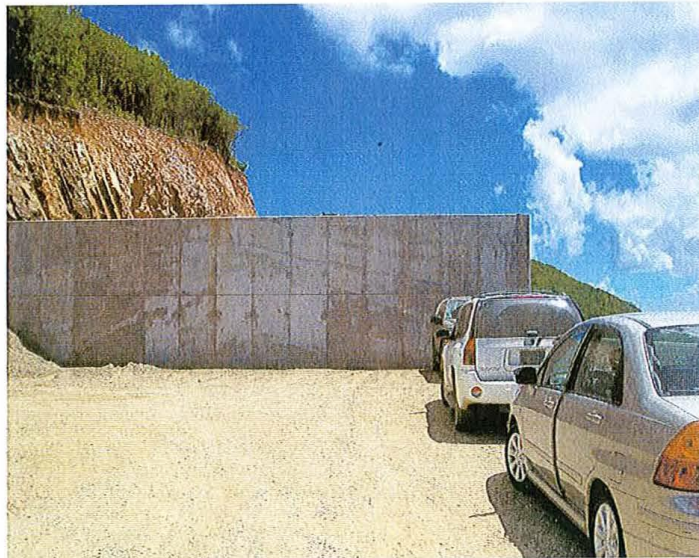
Figure 22. Another Identifiable Rock Slabs in the Excavation Face Further South of the Collapsed Area, Looking Toward North.
