# Investigation of the Failures of Three Hammerhead Cranes on September 10, 2017, in Miami and Fort Lauderdale in the Wake of Hurricane Irma

U.S. Department of Labor  
Occupational Safety and Health Administration  
Directorate of Construction

September 2018

**Report Prepared by  
Mohammad Ayub, P.E., S.E.  
Alan Lu, Ph.D., P.E.  
Office of Engineering Services  
Directorate of Construction**

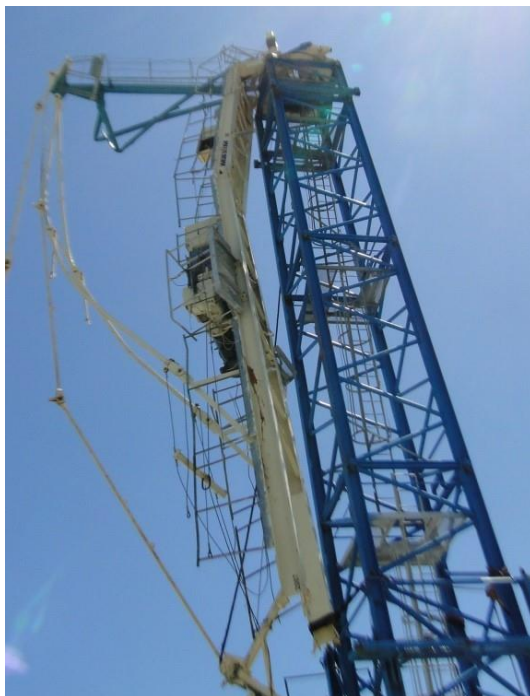
Figure 9 Tower top and counterjib after the incident – the first failure

The failure occurred at approximately 10 a.m. The counterjibs rotated 90 degrees and were hanging upright, though still connected to the turntable. The pendants remained connected to the counterjibs at both locations. The tower top structure also bent 90 degrees toward the counterjib. The two tower-top columns on the counterjib side buckled at approximately mid-height between the top pin and the brace. The jib came off the pinned connection, flipping 270 degrees, and fell over the completed structure with a 90-degree bend where the A-frame (a.k.a. queen post) was located. The last pin of the pendant connecting to the top chord of the jib, and the last pin of the other pendant connecting the A-frame, were opened as the cotter pin loosened. All five pieces of the counterweight fell over the interior of the building, damaging the already-completed floor slab; none fell outside the perimeter of the building. The engineer of record examined the building and

recommended repairs to the slabs. Refer to Figure 9 for the collapsed crane tower top after the failure.

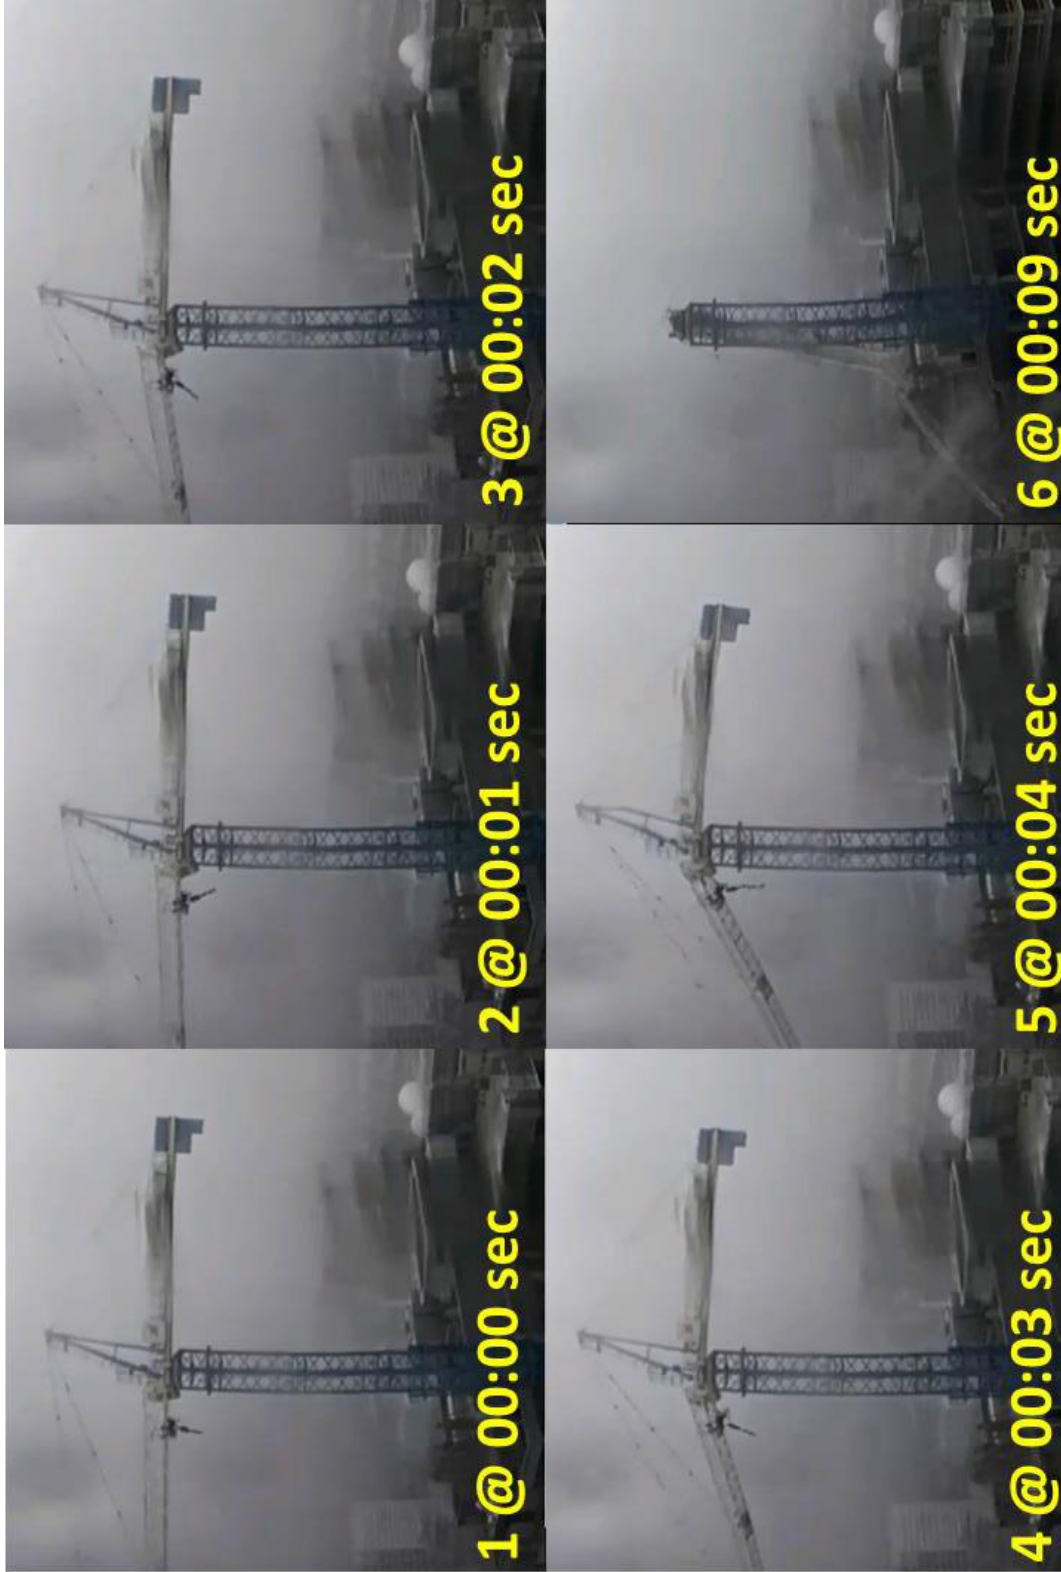
Figure 10 Image sequence showing the crane collapse  
(Courtesy of Nick Tangredi)

A YouTube video was later discovered that showed how the collapse occurred (see Figure 10 for pictures extracted from the video footage). It was discovered that the jib itself swayed toward the right, and the left bottom jib chord detached from the turntable. As the jib continued swaying toward the right, the right bottom jib chord separated suddenly from the turntable and the jib started falling. During the fall of the jib, the two jib pendants were unloaded. The tower top changed in seconds from being loaded from both sides to being loaded only from the counterjib side. Then the two tower top columns, swaying toward the counterjib, failed under the change of the transient load.

1. Jib started to sway to the right, and the left jib bottom chord detached from the turntable;
2. Jib kept swaying to the right, and the jib knocked the cabin;
3. Jib kept swaying to the right, and the counterjib started shaking;
4. Jib kept swaying to the right, and the right jib bottom chord detached from the jib foot. Therefore, the entire jib was no longer mounted to the turntable;
5. Jib fell, and the two jib pendants were not loaded. The tower top was loaded from the counterjib pendants only. The two tower top columns, swaying toward the counterjib side, buckled; and
6. The tower crane collapsed.

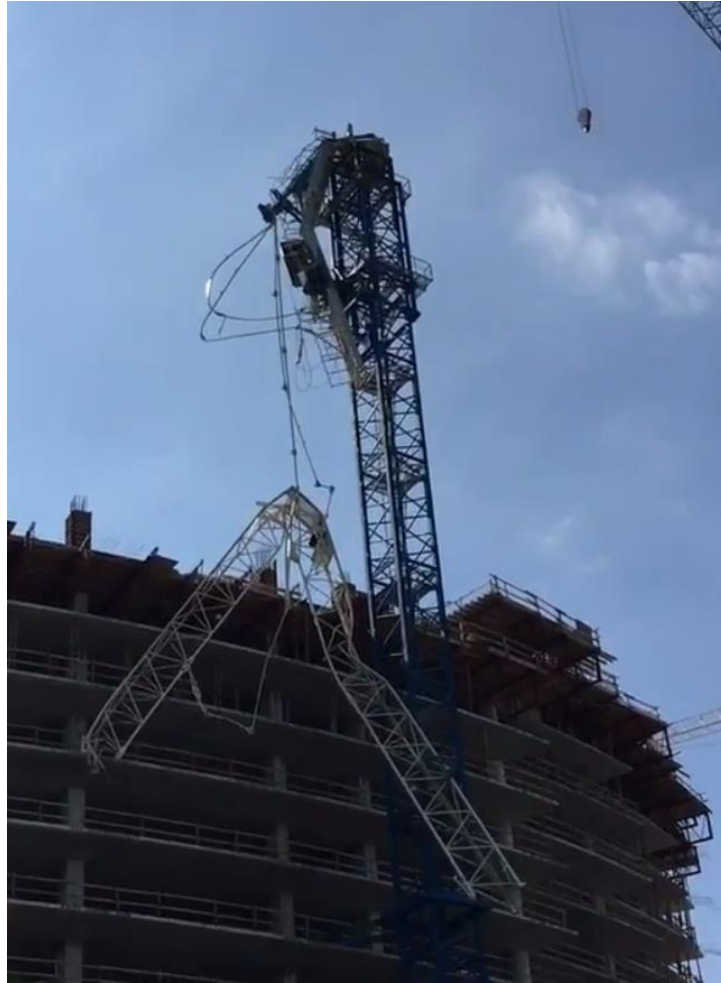
Figure 15 Collapsed crane after the incident – the third failure site

The failure of the tower top occurred in a manner similar to the first two failures. The counterjib beams rotated 90 degrees and were hanging straight down by the side of the crane mast. The tower also rotated approximately 90 degrees. Again the tower top columns toward the counterjib buckled very distinctly between the top pin and the solitary brace about the major axis. All four counterweight pieces fell, but there were no injuries. The jib came off its pinned bearing connections and was bent in a V-shape at the location of the A-frame. During the failure, all pendants remained connected to the jib, and all pins interconnecting the pendants remained intact. A photograph of the crane tower top taken after the crane collapse is shown in Figure 15.

Later, the remnants of the failed crane were examined at the storage yard in Orlando on December 12 and 13, 2017 by the OES structural engineers. Interestingly the inspection indicated similar failure where the tubular frame of the tower on the counterjib side failed at about the same location. All three failures were identical, see Figures 9, 12 and 15.

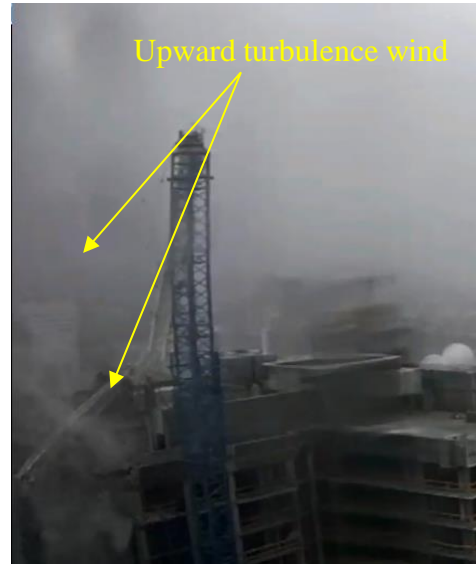
Figure 19 Upward turbulence wind detected when the crane collapsed at the first failure site (Courtesy of Mr. Nick Tangredi)

a) Jib jumped off the left bearing connection

b) Upward turbulence wind detected right after counterweight blocks hit the building

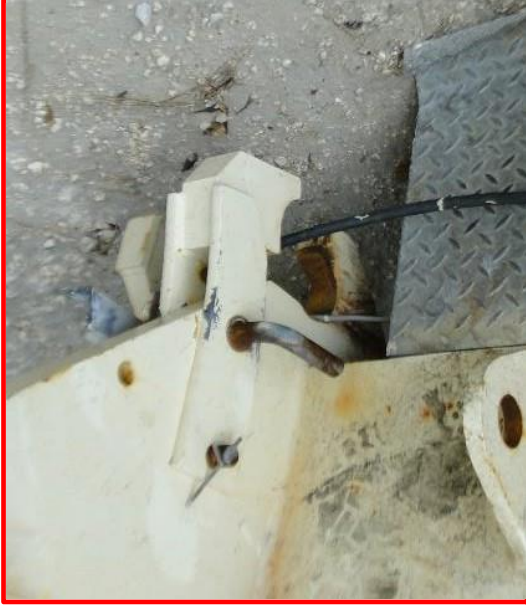
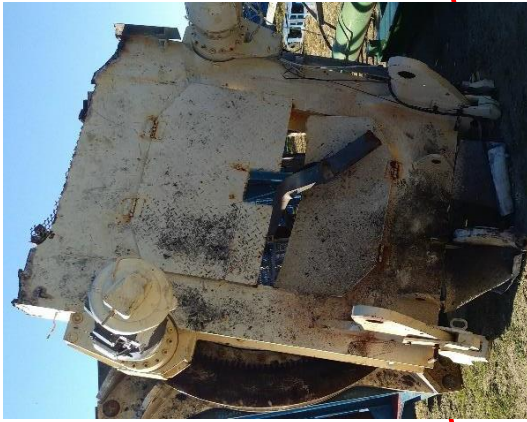
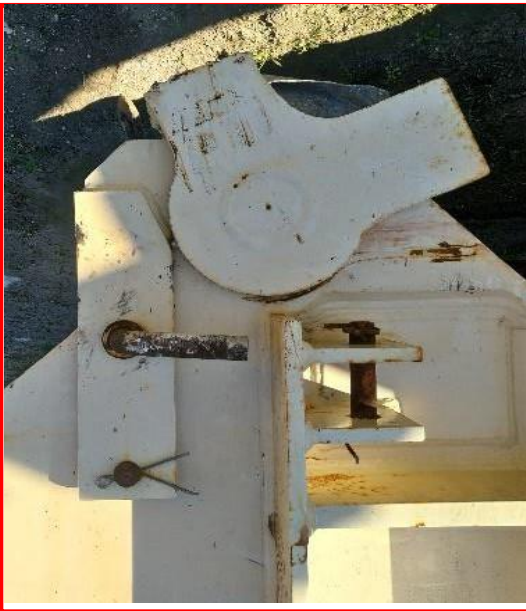
Figure 28 Jib foot bearing connections – turntable side (the first failure)

The right bearing cradle and the right clamp remained intact. However, the right bottom jib chord broke at the weld between the bottom chord tube and the end plate, as shown in Figure 30. The field structural observation is consistent with the collapse of the crane shown in Figure 10. The left jib bottom chord detached from the left turntable cradle because the jib swayed to the right. Once the jib separated from the left turntable cradle, the jib was only supported at the right turntable cradle and the two jib pendants. As the jib continued rotating to the right, the right bottom chord foot broke at the weld between the tube and the end plate, and the jib started falling.

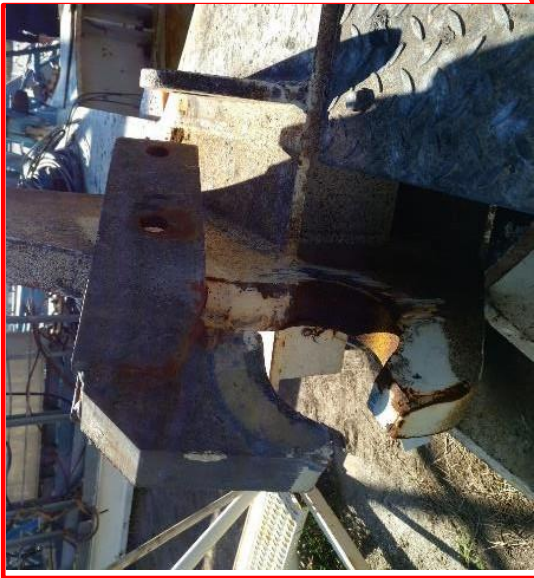
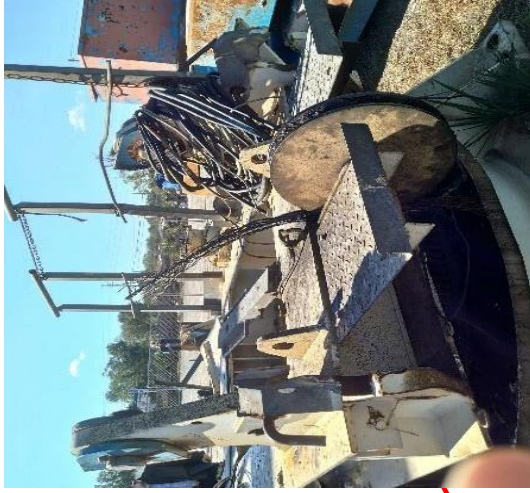
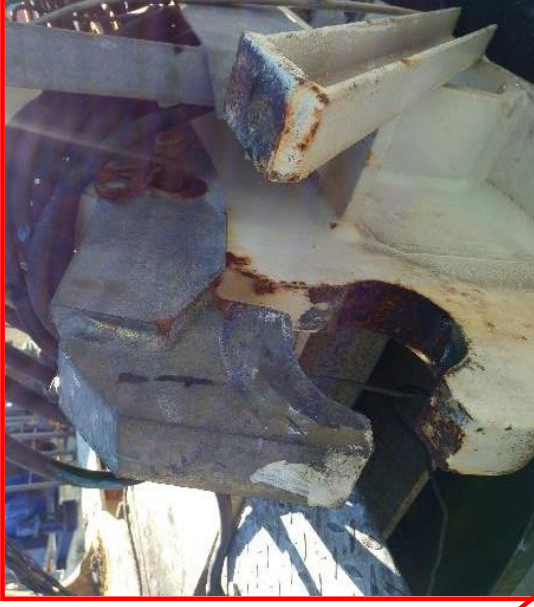
Figure 31 Jib foot bearing connections – turntable side (the second failure)

The front part of the turntable, including the two bracket cradles, is shown in Figure 31. The two jib bottom chord foots after the collapse are shown in Figure 32. It was observed in Figure 32 that the clamp of the left cradle bent vertically and meanwhile, the left bottom jib chord foot remained intact. The clamp of the right cradle bent upward and to the right, while the right bottom jib chord foot, including the end bracket, bent to the right, as shown in Figure 32. The field structural observation indicated that the left jib bottom chord detached from the left turntable cradle because the jib rotated to the right. As the jib continued rotating to the right, the right bracket cradle and the right bottom chord bent to the right till the right bottom chord detached from the right bracket cradle. Per the field observations of the damaged structures the failure modes of the first two cranes' jibs are identical.

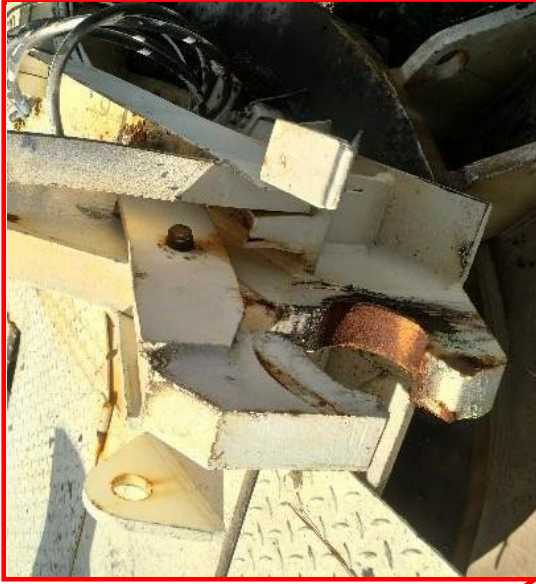
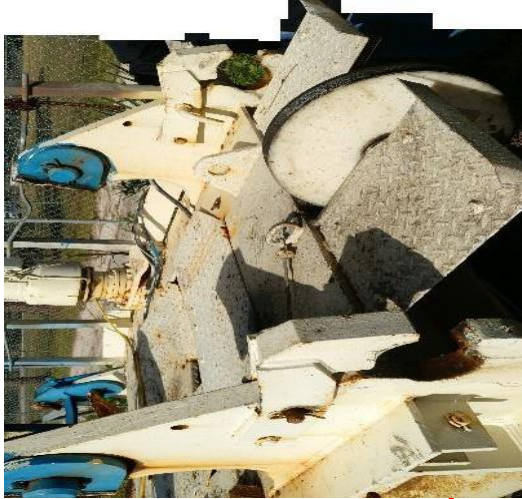
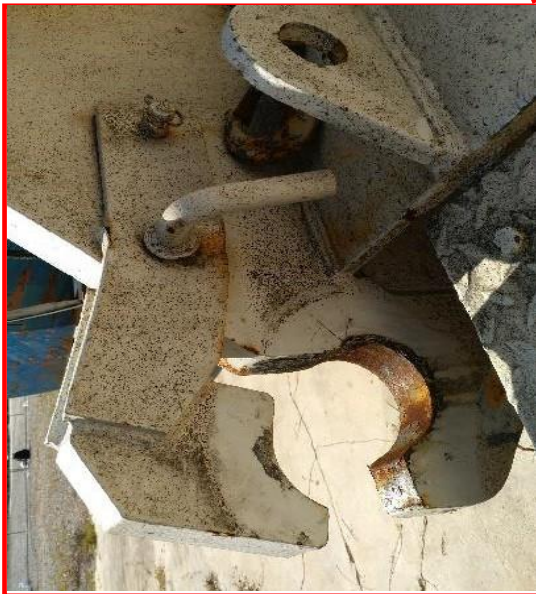
Figure 33 Jib foot bearing connections – turntable side (the third failure)

The front part of the turntable, including the two bracket cradles, is shown in Figures 33, 34, and 35. The two jib bottom chord foots after the collapse are shown in Figure 36. It was observed in Figures 33 to 35 that the clamp of the right cradle bent vertically and, meanwhile, the right bottom jib chord foot remained intact. The clamp of the left cradle bent upward and to the left, while the left bottom jib chord foot remained intact, as shown in Figure 36. The field structural observation indicated that the right jib bottom chord detached from the right turntable cradle first because the jib rotated to the left. As the jib continued rotating to the left, the left bracket cradle bent to the left until the left bottom chord detached from the left bracket cradle. According to field observations of the broken structures, the failure modes of the three cranes' jibs are similar.

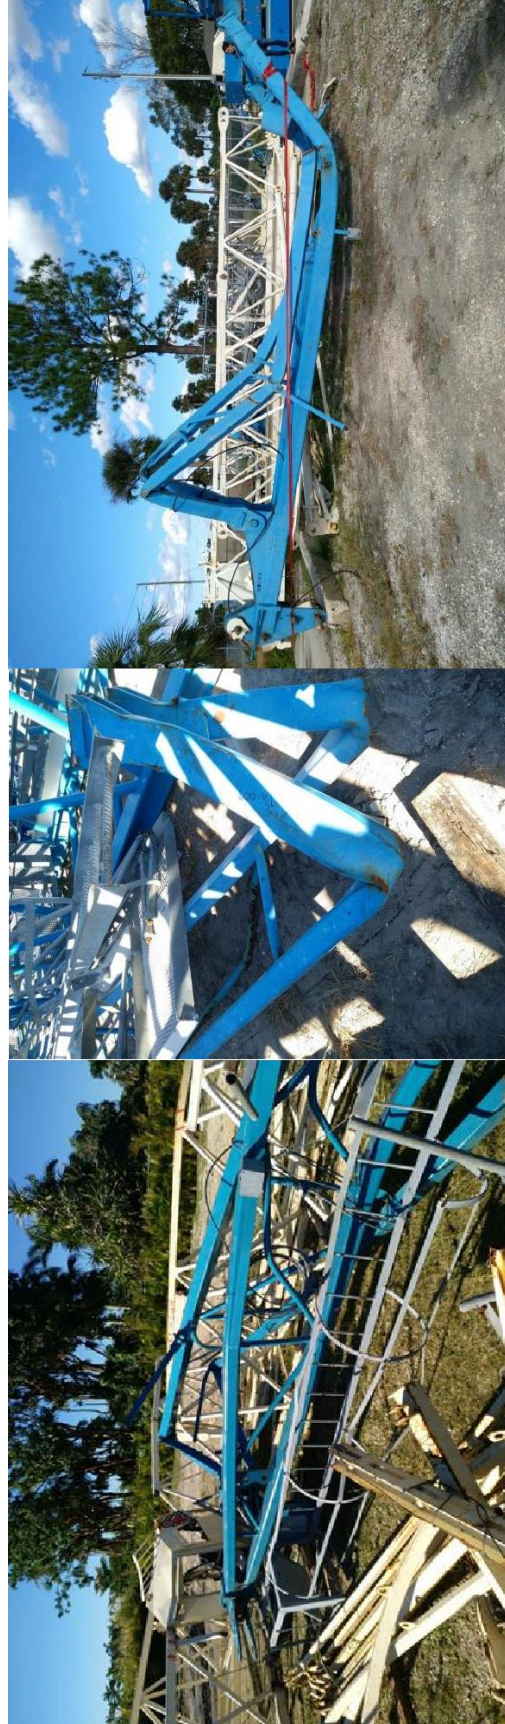
(a) The First Failure

Figure 37 shows the collapsed tower tops from the three failures. All three tower structures bent 90 degrees toward the counterjib. The two tower top columns toward the counterjib bent at approximately mid-height between the top pin and the brace. Considering the crane tower failure of the first incident as shown in Figure 10, it is believed that the tension forces at the tower apex from the two jib pendants disappeared suddenly due to the falling of the jib, and the tower was only loaded from the counterjib pendants. Therefore, compression forces in the two columns on the counterjib side were elevated rapidly, and the two columns failed under the transient forces.

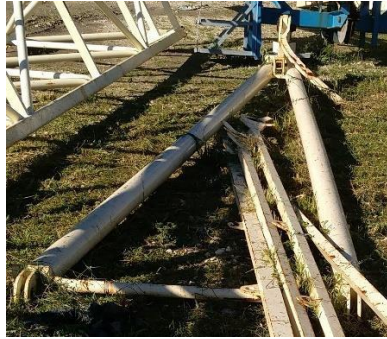
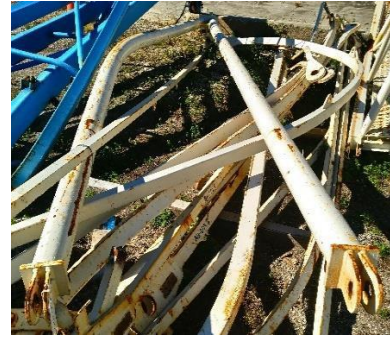
The A-frames of the cranes involved in the first two failures remained intact after the collapses. The two posts of the A-frames remained straight after the collapses, and no bend in the posts could be detected. The A-frame of the crane involved in the third failure was found deformed: the right hand post bent at about the mid-height. It is not clear if the post bent when the jib was falling.
