Fire during Hot Work at Evergreen Packaging Paper Mill

Investigation Report

Published: September 24, 2021

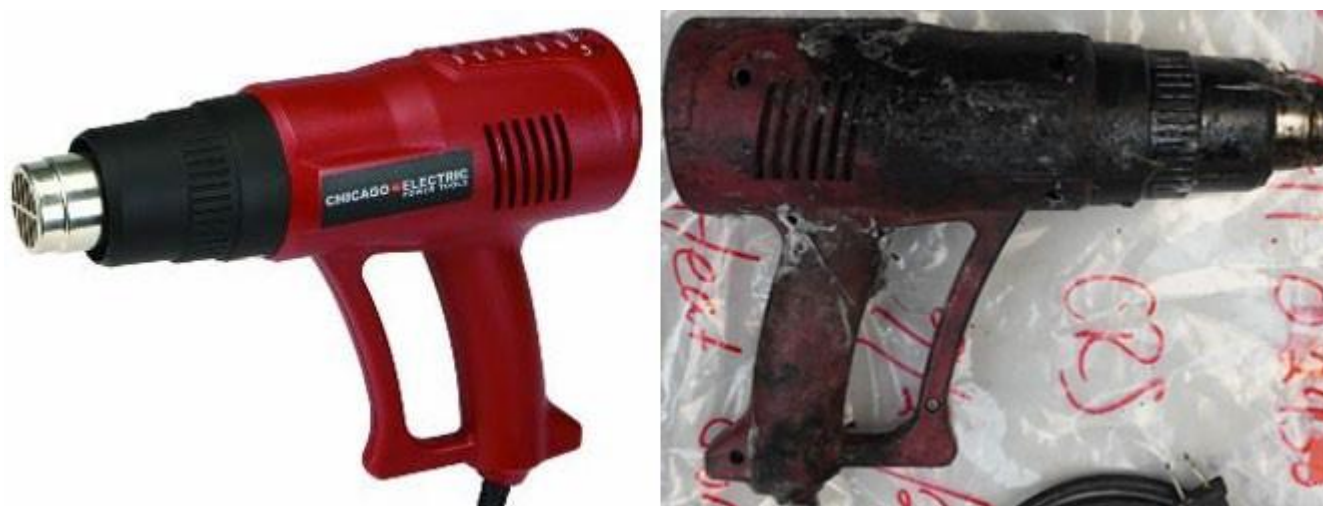
The heat gun Blastco used to warm the resin was a Chicago Electric model heat gun [5]. According to the tool’s manual, it had six different heat settings, each with a low and high sub-setting, for a total of 12 temperature settings. These settings ranged from a minimum of 430°F to a maximum of 1,160°F. One of the Blastco workers who used the heat gun could not recall the exact setting used leading up to the fire but told the CSB that it was set on the third or fourth setting, which corresponds with a temperature of between 650°F (the low temperature of the third setting) and 790°F (the high temperature of the fourth setting).

Figure 4. Exemplar heat gun (left). Heat gun recovered from scene (right). (Credit: Harbor Freight [6], CSB.)

- Blastco did not recognize the ignition hazard posed by the heat gun because it did not recognize its use as a form of hot work, and Blastco did not inform Evergreen or Rimcor of the heat gun's use.
- Worker understanding of ignition sources and forms of hot work is critical to ensure that permitting and effective safety precautions are implemented.
- Blastco's understanding of ignition sources and hot work could be improved by Blastco revising its policies and training methods to specifically identify the use of heat guns as hot work, and by making clear that hot work encompasses any method of work that can ignite a fire and not just spark- or flame-producing work methods.
- Blastco should update its policies and training to include the use of non flame- and spark-producing tools and work methods, such as heat guns and other ignition sources, as hot work.

The CSB recommends to Blastco to update its hot work policy and employee training program to specifically identify the use of heat guns as hot work. The policy and programs should make clear that hot work encompasses any method of work that can ignite a fire and not just spark- or flame-producing work methods.

In addition, there may be FRP applications in which the use of a heat gun is appropriate. The CSB concludes that Blastco should develop a policy, procedure, or guidance document on the correct use of heat guns in FRP operations. The CSB recommends that Blastco develop a policy and standard operating procedures for the proper use of heat guns in FRP operations.

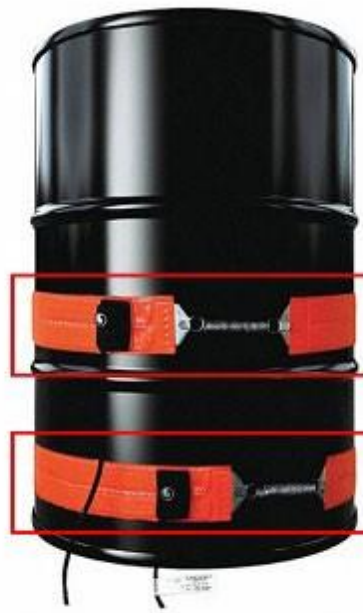
Third, Blastco employees told the CSB that on other jobs, to address the long gel times resulting from cold temperatures, they would apply heating bands to the 55-gallon resin drum to improve the cold weather performance of the resin (**Figure 7**).

Figure 7. Drum heaters. (Credit: Grainger [18].)

Blastco performed a post-incident inventory of its two job trailers and located two drum warmers. According to Blastco, the two drum heaters were located separately, one on each trailer. According to an employee, the company had recently begun renovating and reorganizing one of the trailers but was not yet finished at the time Blastco's work at Evergreen started. The employee stated that when he went to locate the heat bands on the night of the incident, the bands were not in their normal location and he could not locate them on the trailers.
