Masonry Wall Collapse

The Division of Occupational Safety and Health of the State of Tennessee requested the Directorate of Construction, OSHA National Office, to provide assistance in the investigation and causal determination of the April 18, 2013 collapse of a masonry wall during construction of the Goodwill Retail Store in Hendersonville, TN. As a result of the wall collapse, two employees were killed and one was injured. Our investigation and evaluation were based on the information provided by the Division of Occupational Safety and Health of the State of Tennessee. Please note that we did not visit the incident site.

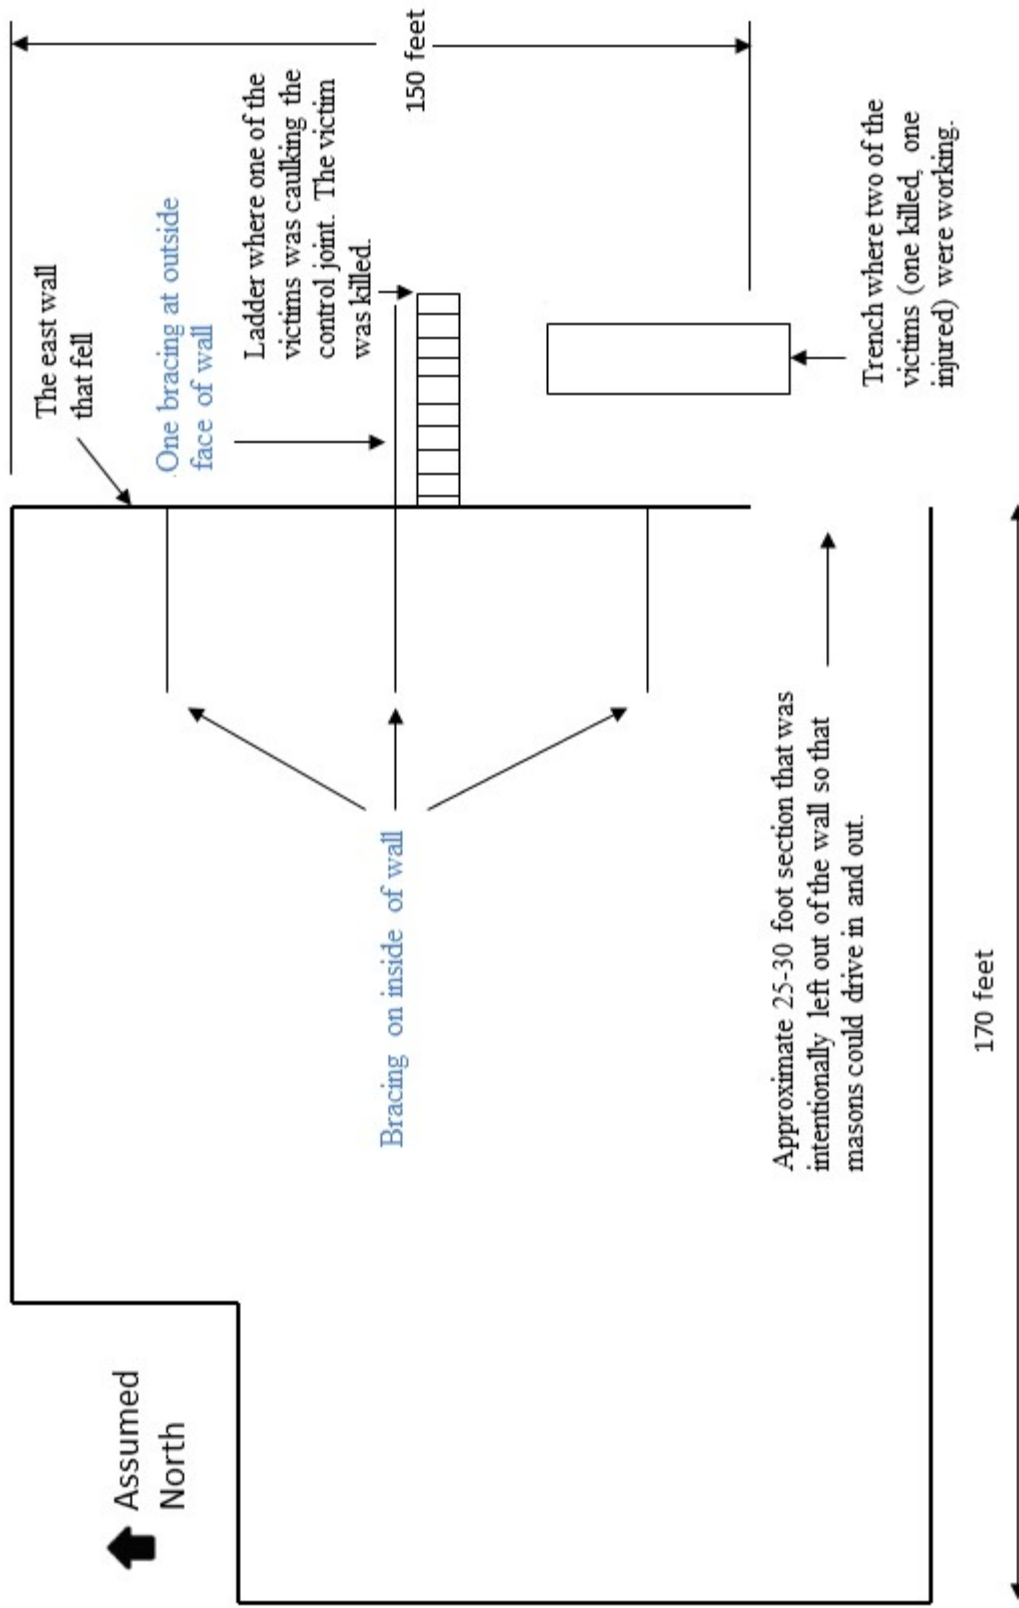
Figure 7 _ Schematic CMU wall plan showing bracing location at east wall

A few days prior to the collapse, all three exterior braces on the north, south and west walls were removed but on the east wall only two exterior braces were removed. The middle exterior brace was left intact on the east wall that fell (see figure 7).

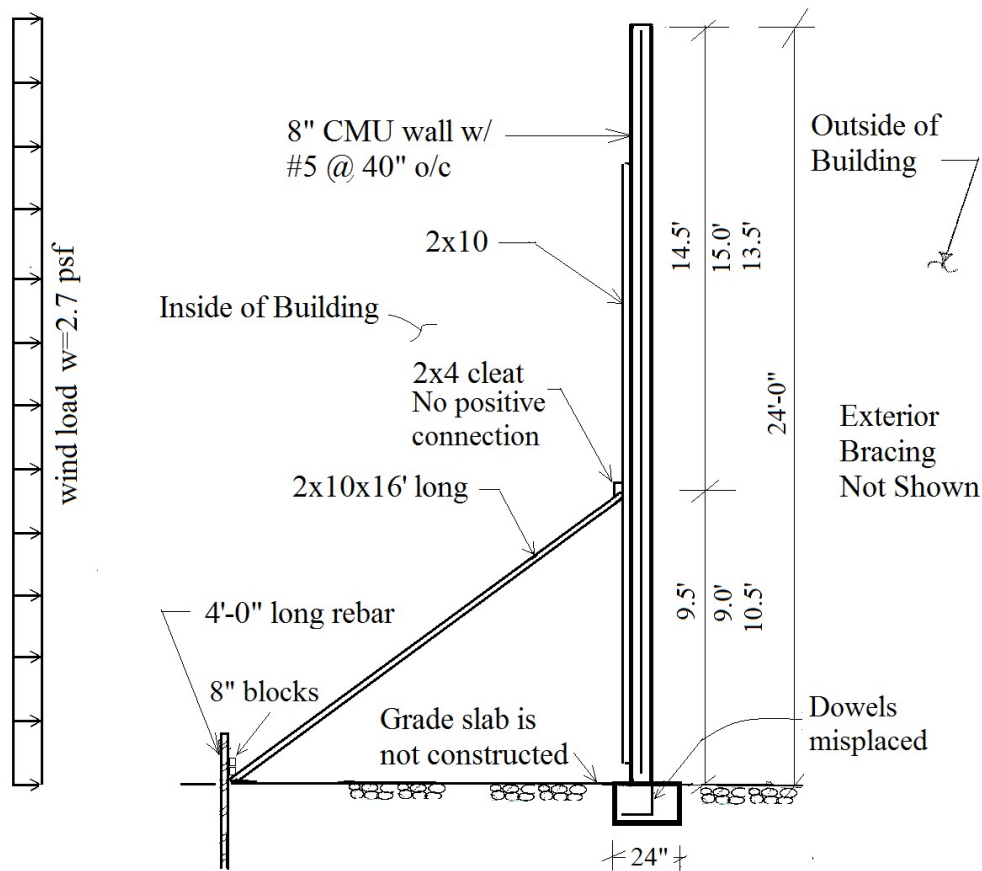
Figure 8 – Section showing interior as-built bracing at east wall

For the installation of the bracing, the contractor installed 2x10 vertical members abutting to the face of the walls (see Figure 8).

Even the few braces that were provided did not meet the industry standards because they were not anchored to the wall either by bolts or screws. They were susceptible to sliding and falling off the walls. The wall could maintain its capability to prevent overturning either by the presence of an adequate number of braces properly fastened to the wall or by the internal strength derived from the flexural capacity due to rebars. In this case, neither was provided.

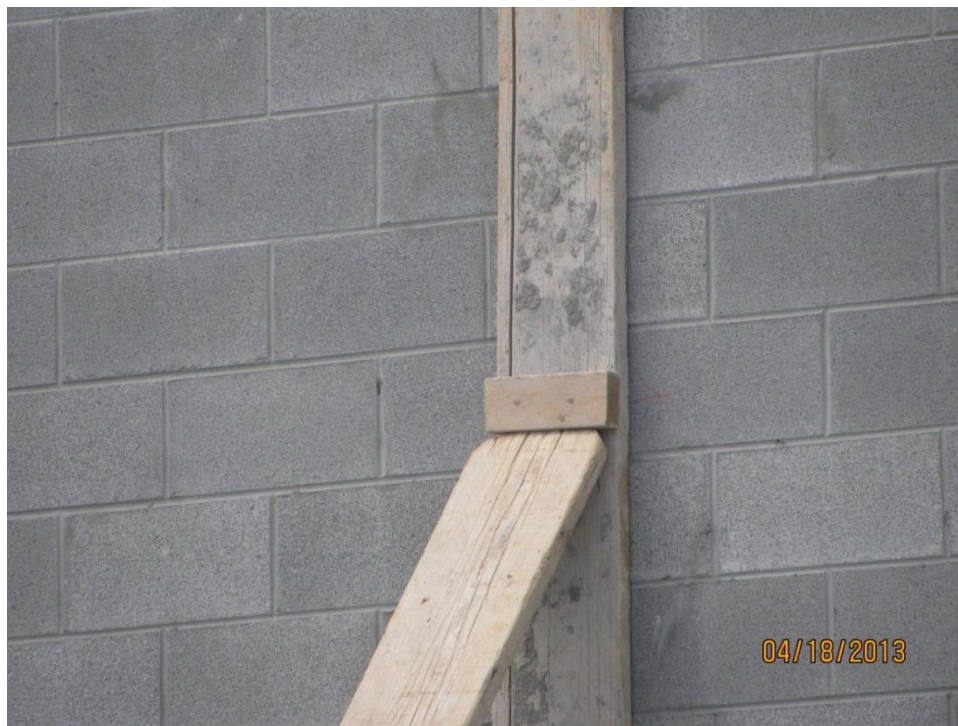
Figure 9 - Top end of brace without positive connection

At mid-height of the vertical member, approximately 10' above, 2x4 horizontal cleats were provided. The 2x4 cleats were nailed to vertical members (see Figure 9). The diagonal bracing member consisted of 2x10 Southern Yellow Pine (SYP) OSHA scaffold plank, the top end of which was held underneath the cleats while the opposite end was held against 4' (\pm) long rebar. The rebar was embedded into the soil for a depth of approximately 2'-6" and projecting out around 1'-6". On top of the plank near the rebar, two CMU blocks were placed (see Figure 10).

7. The length of the brace was considered to be 16'. Bracing member used was 2x10 SYP OSHA plank.
8. The brace was considered to be pinned at both ends. The top of the brace was snugly fitted underneath the cleats (see Figure 9) while the bottom of the brace was held against the rebar embedded into the ground (see Figure 10). There was no positive connection between bracing members.

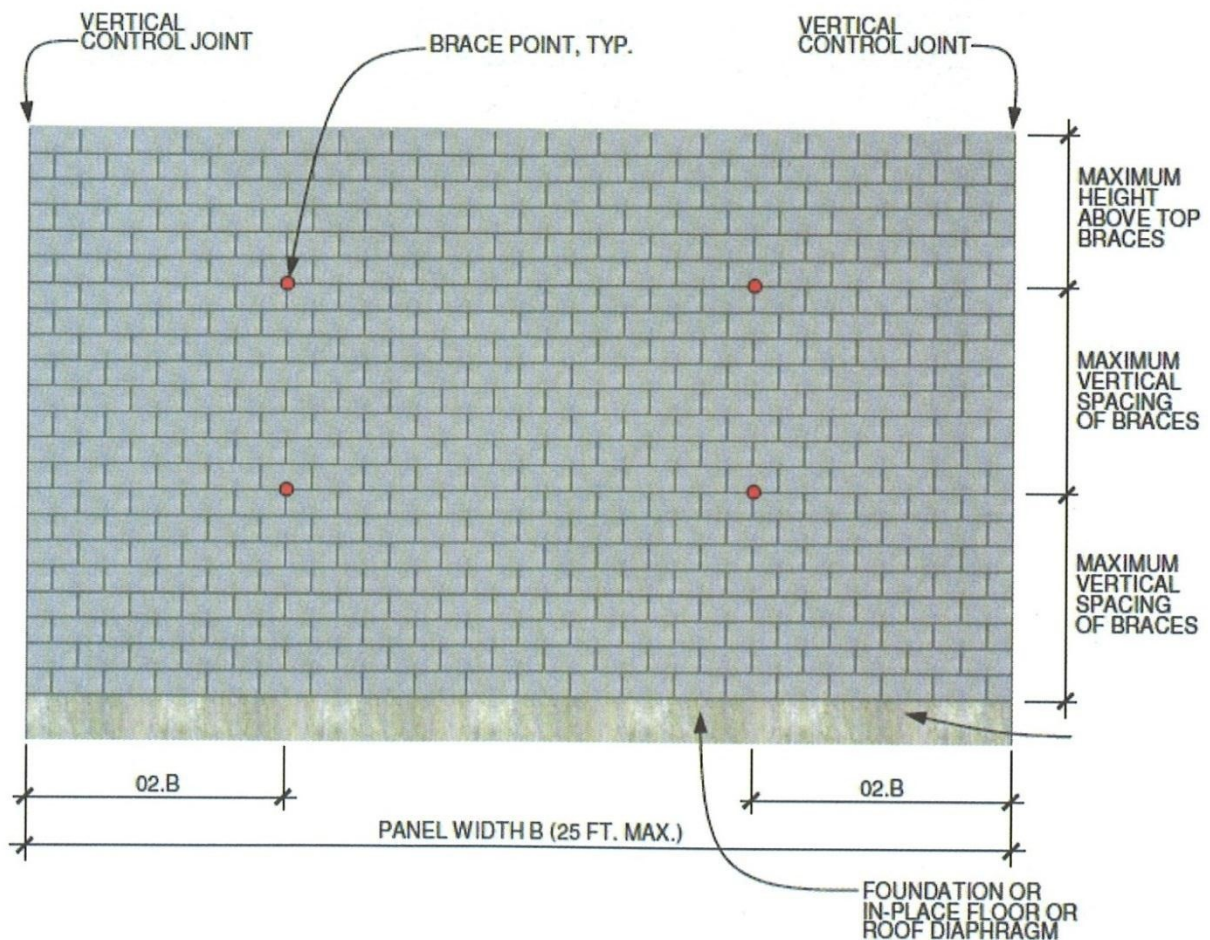
Figure 11 - Brace spacing requirement for masonry wall between control joints

The design of the bracing members was not performed by any contractor or by an engineer. Bracings were installed randomly based on the contractor's judgment. "Standard practice for Bracing Masonry Walls under construction," developed by the Council for Masonry Wall Bracing, was not followed (see Figure 11).

Note: Industry practice required two braces between control joints

The masonry contractor provided too few braces between the control joints of the 150'-long masonry wall that fell. In this project, the control joints in the masonry wall were designed and detailed as a complete separation (see Figure 5) similar to an expansion joint which necessitated a minimum of two braces for the masonry walls between the control joints (see Figure 11). Only three interior and three exterior braces for the entire wall were provided instead of the twelve specified in the industry standard, "Standard practice for Bracing Masonry Walls under construction" developed by the Council for Masonry Wall Bracing. Two exterior braces of the east wall were removed a few days prior to the collapse. All required braces should have been left in place until permanent supporting elements were constructed, e.g., the roof deck and its attachments to the bond beam at the top of the wall. If the masonry contractor had provided an adequate number of braces as per the industry standard, this incident could have been avoided.

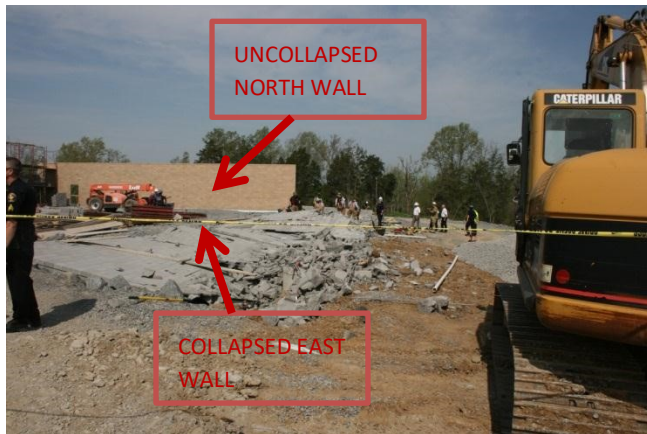
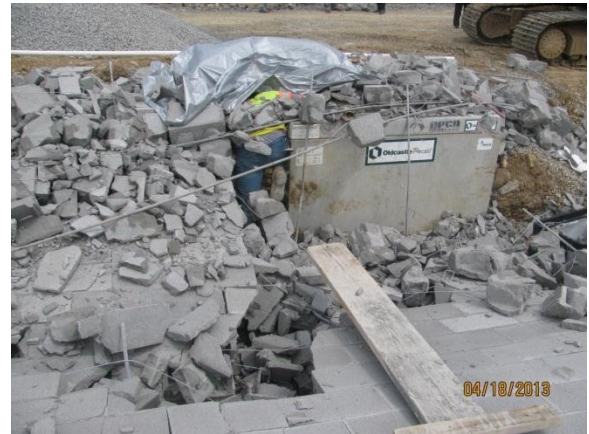
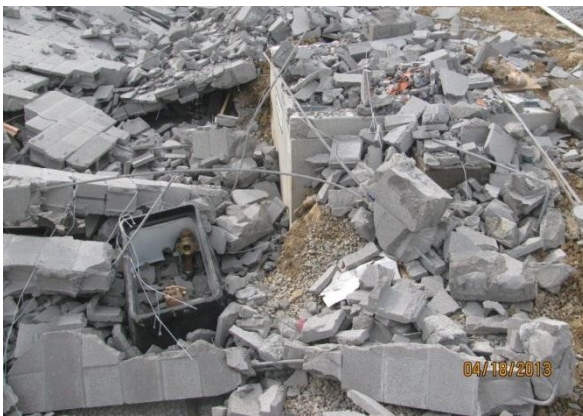
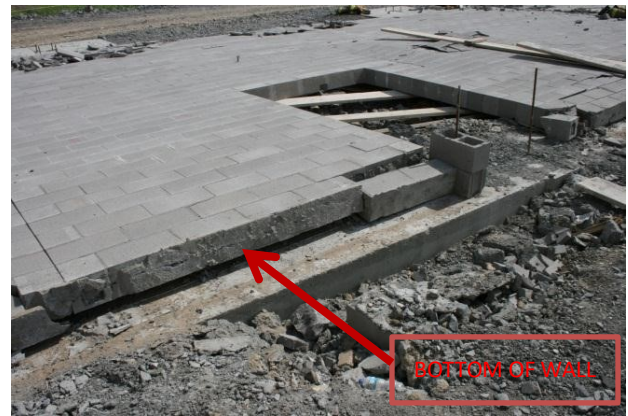
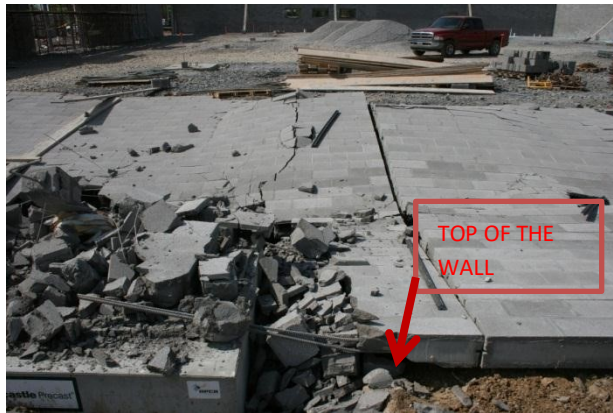
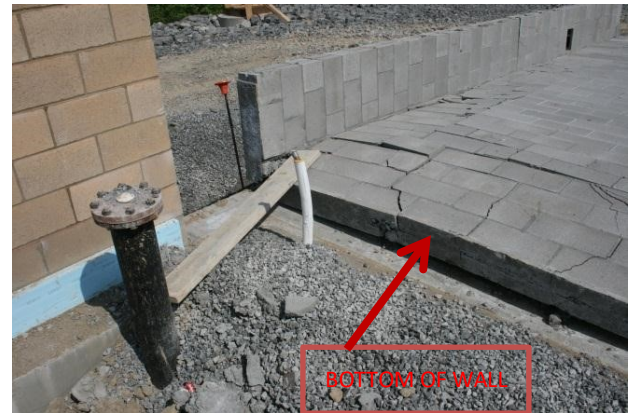
On April 18, 2013 at approximately 9:45 A.M. under a west wind with gusts of 33 mph, the east wall collapsed outwards towards the east. The remaining three walls at the perimeter of the building did not collapse. At the time of the east wall collapse, three employees were installing a backflow preventer in a trench that ran parallel to the east wall (see Figure 6). One of those employees was killed and another employee in the trench was injured when the wall fell outwards. Also, an employee on a ladder caulking the masonry control joints on the east wall (near the middle of the wall at the 2nd control joint, see Figure 6) was killed when the wall fell over him. During the review of the collapsed east wall photos (see Figure 16 to 21), the following items were noticed.

- Three interior braces and one exterior brace on the east wall fell along with the wall.

- The base of the entire east wall overturned outward and was completely separated from the top of the footing with no bent rebar dowels either coming out from the footing or from the wall.
- Some of the wall dowels from the footing to the wall were observed to have fractured at the base of the wall.
- Parts of the masonry blocks were disintegrated and turned into rubble.
- At certain areas of the fallen wall, cracks were visible.
- Parts of the bond beams were completely disintegrated and rebars from the bond beams were exposed, visible and were bent.
- At certain locations, the marks of the fractured rebars were visible either at the center of the CMU wall or at the edge of the CMU wall.

The above statement indicated that the contractor had placed wall dowels at the required locations (i.e., at the center of the CMU wall) but that is not supported by the photographs taken after the incident, and in statements made by the masonry contractor. When the masonry contractor began to build the wall, he noticed that the wall dowels (rebars) of the east wall at many locations (at north and south of the 6'-0" wide door opening) were offset from the correct location. He notified the general contractor of the misplacement of the dowels. Rather than stopping the work and getting guidance from the structural engineer of record, the general contractor advised the masonry contractor to bend the rebars and maneuver them in the block cells. Since the rebars were bent and placed near the inside edge of the CMU wall rather than being at the center of the CMU wall, rebars were not effective in resisting lateral loads arising out of the westerly wind. If the general contractor or inspector had

The analysis indicated that if the contractor had placed the rebar dowels correctly in the footing at the center of the CMU wall, the incident would not have occurred because the masonry had gained adequate strength in 15 days, and the grouted rebar would have provided adequate flexural strength to resist the lateral loads. A significant number of the dowel reinforcements of the east wall that fell

were misplaced to the outside edge of the masonry wall instead of being at the center of the wall. This compromised the flexural capacity of the free-standing wall under the lateral load coming from the west at the time of the incident. In addition, overturning moment due to lateral wind load was much higher than the resisting moment induced by the self-weight of the CMU wall.

promptly reported the misplacement of the rebars to the structural engineer of record, the structural engineer would have recommended corrective measures and the incident could have been prevented. One of the corrective measures was to drill new holes for the rebars in the footing at the center of the masonry wall and epoxy grout to meet the design intent.
