Mast Climbing Platform Collapse in Austin Texas

Investigation of the June 10, 2009 Mast Climbing Platform Collapse in Austin, Texas

U.S. Department of Labor
Occupational Safety and Health Administration
Directorate of Construction

December 2009

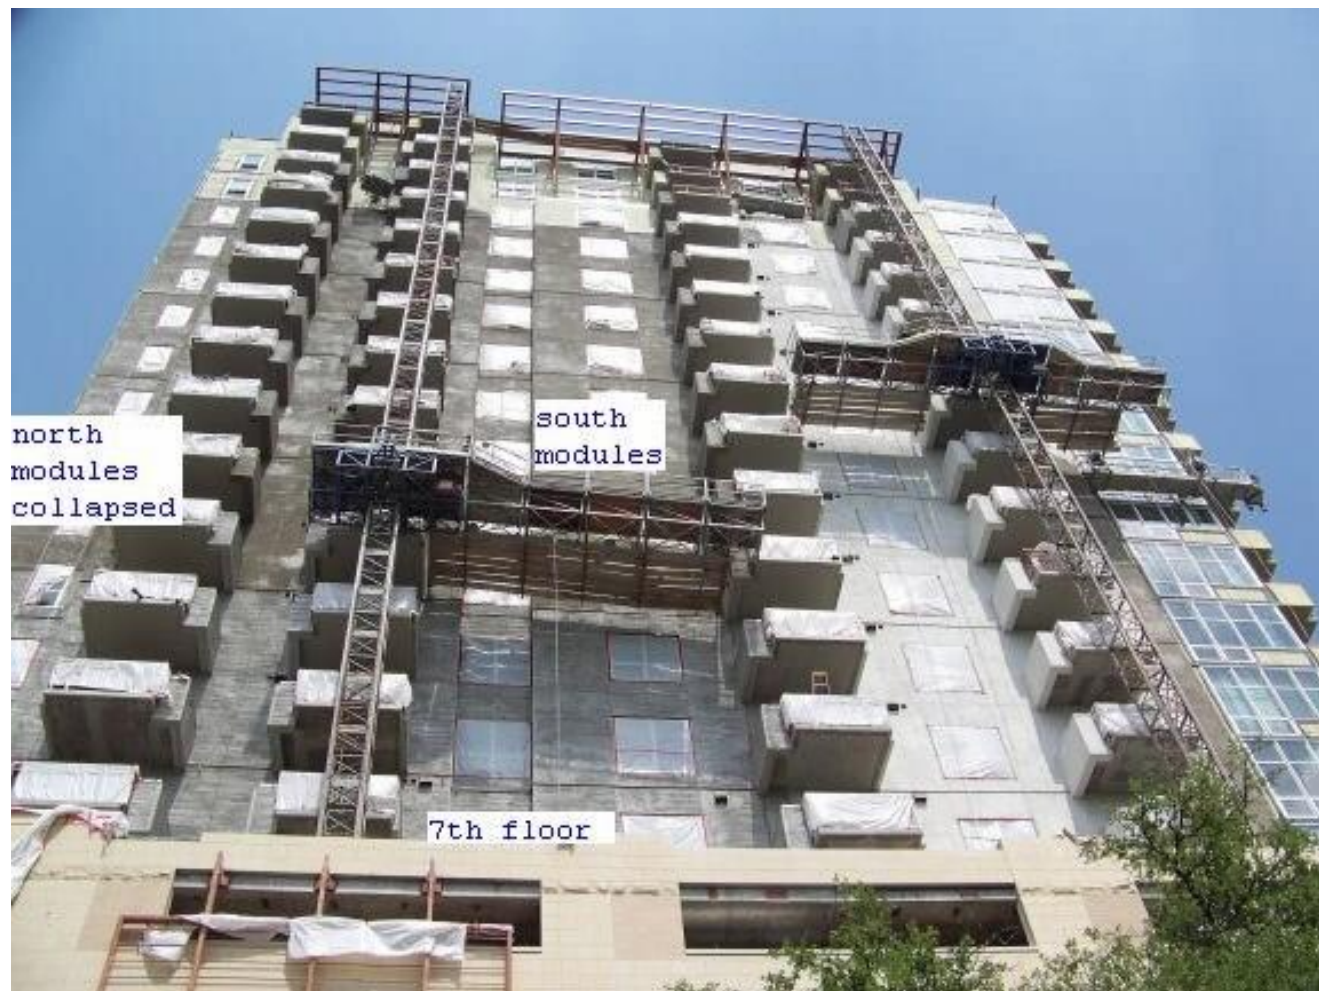
On June 10, 2009, at about 2:20 p.m., three construction employees of Capoera Construction, LLC of Margate, FL were killed when a mast climbing platform north of the mast collapsed at a condominium project under construction in Austin, Texas. The platform south of the mast and the mast itself remained intact and did not collapse. The site where the accident occurred was located at 2101 Rio Grande, Austin, Texas. At the time of the collapse, about eight employees including the operator were located on both sides of the platform. Immediately before the incident, the platform descended from the 13th floor and was stopped at the eleventh floor when the north platform suddenly separated from the main frame (motorized unit) and the mast, and fell to the seventh floor. As a result of the failure, three employees fell with the platform. Two of them fell 11 stories to the ground and the third fell to the seventh floor. The other two employees on the north side were able to hold onto the balcony and were saved.

Figure 1 - Failed scaffold with north side modules separated.

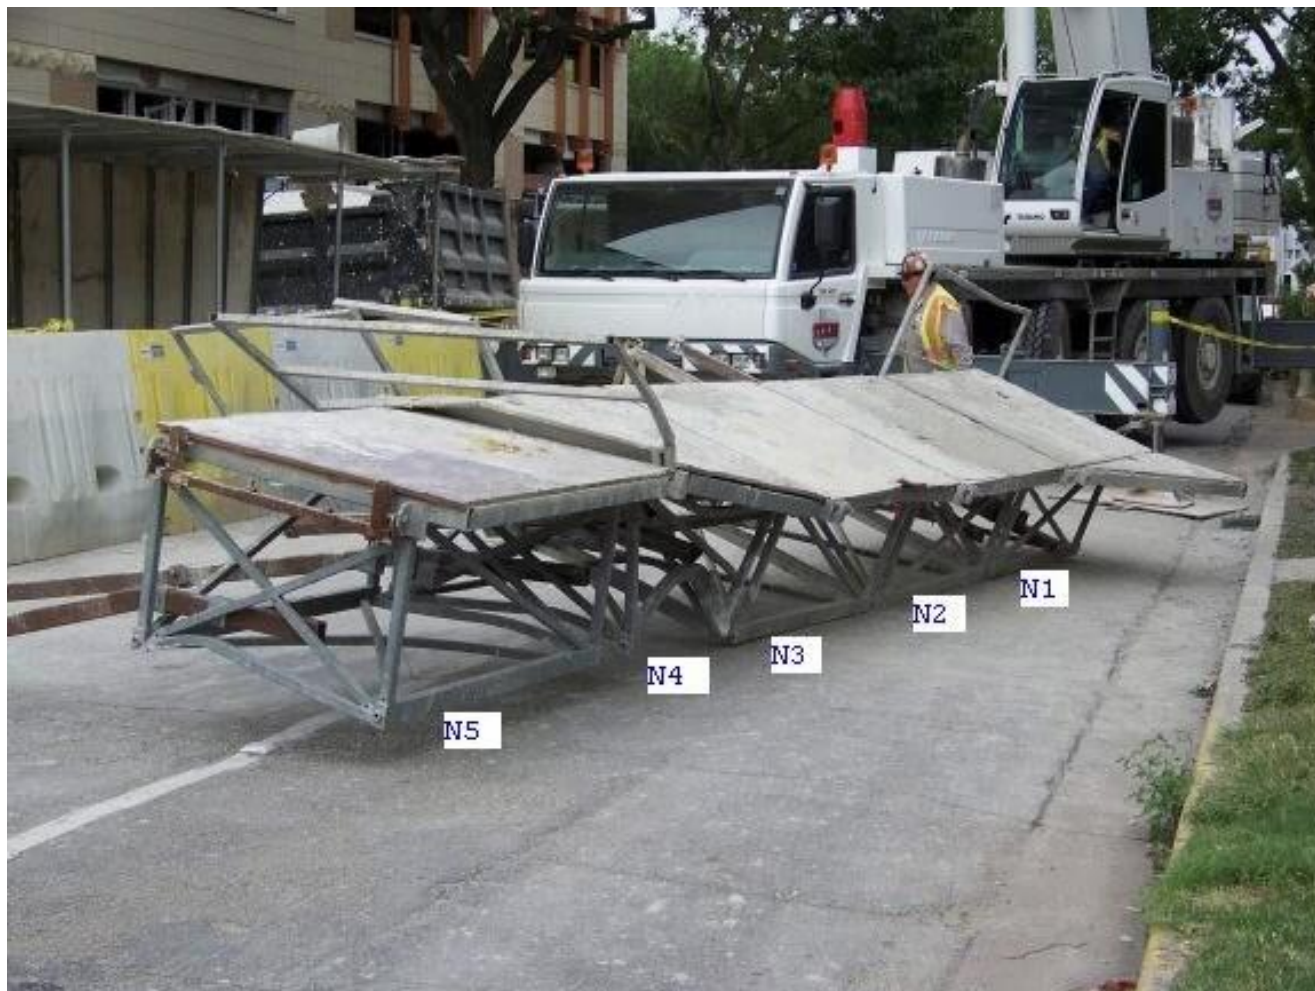
Figure 2 is a photograph of the failed platform on the ground. Five modules are identified as N1 thru N5, N1 being closest to the mast. Loads on the platform were resisted by tensile and frictional forces at the top connection between the modules and the compressive forces by the bottom leveling bolts. The top connection was comprised of high strength bolts in single or double shear. The bottom connection was simply comprised of leveling bolts butting against the

Among the failed deck modules, most damage to the steel members was to module #N4. The bottom HSS steel tubes on the side and the bottom diagonal members were bent upwards. This damage to the deck module #N4 is believed to have happened during the fall when it hit the wall on the 7th floor. The outriggers attached to the modules #N4 and #N5 on the failed platform were bent downward. This is also believed to have happened from the module hitting the wall during the fall.

Figure 2 - Failed Deck Modules (North side)

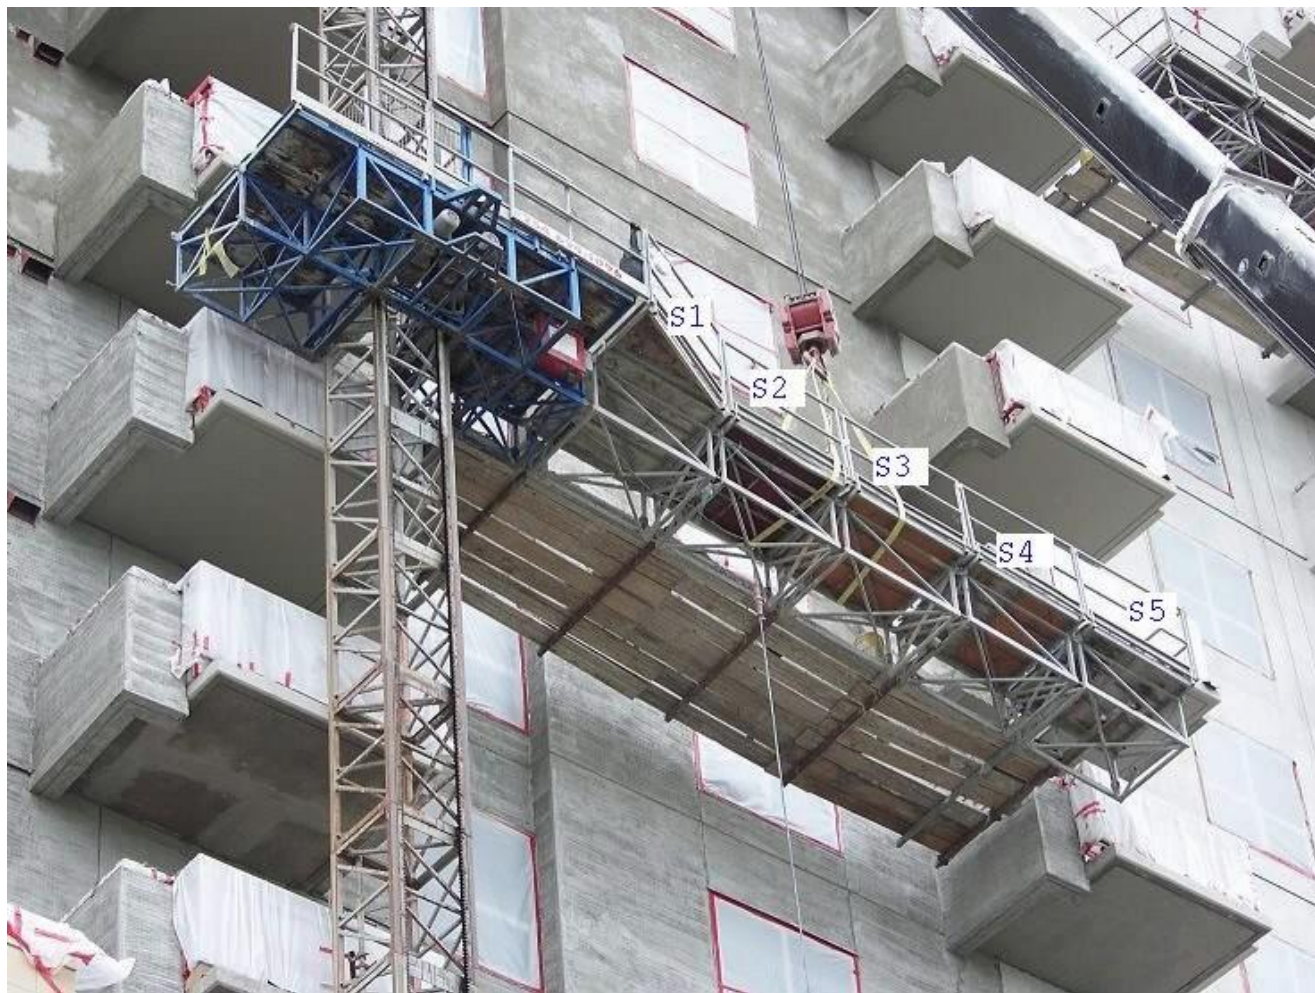
Figure 3 is a photograph of the tower mast, motorized unit and south modules after the incident. Although the mast was standing intact, it was observed that main tubular members on which the motorized unit was moving up and down were not aligned properly. Also, many of the tower mast members had corrosive damage. Some of the sections were crooked and were non-uniform.

The south modules S1 thru S5 can be seen in figure 3. Some of these modules had double ears for the top connection, thereby enabling a three plate double shear bolt connection as shown in the operations manual, see figure 13. The outriggers measured 66” to 69” and there were as many as 7 planks used to create the walk board on this side, see figure 3.

The outriggers were observed to be 69” long. Seven (7) planks were placed to form the walkway platform and five employees were believed to be standing on the collapsed section of the platform. AMC reportedly advised GMI not to use more than 6 planks on the outriggers but seven planks were used nevertheless. Although AMC advised GMI to use six planks, there is no evidence that AMC conducted any analysis to study the impact of six planks on the structural integrity of the platform.

Figure 3 - Outriggers with seven walk board (south side deck modules shown)

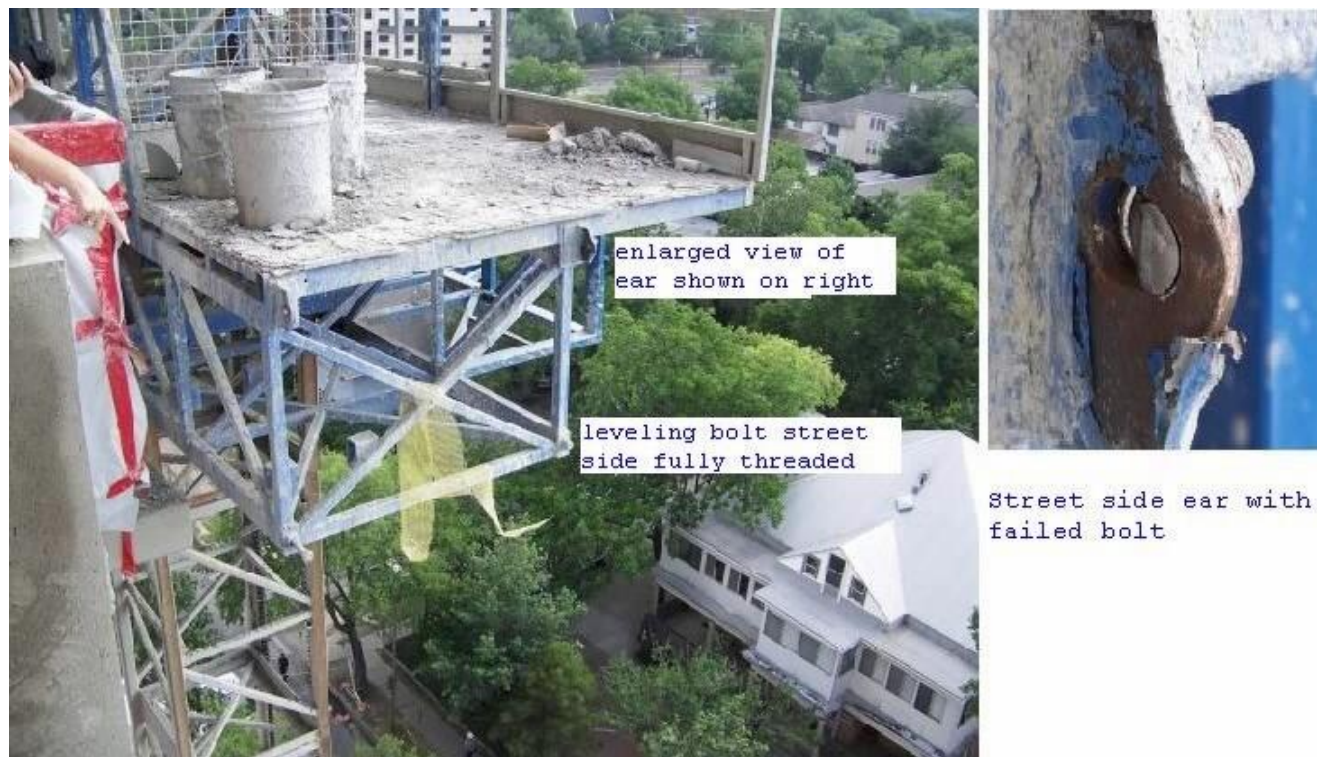
adjoining module. There was no positive connection at the bottom. The modules N1 thru N5 each had a single ear at the top and the bolts were in single shear. Figure 4 shows the single ear used for the top connection between the motorized unit and module #N1. It was observed that the bottom leveling bolt on the street side between the first section N1 and the motorized unit was rendered ineffective as it was completely threaded into the motorized unit, see figure 4. The photo in figure 4 also shows the deformed ear on the street side with a piece of failed bolt trapped. It was also observed that one of the leveling bolts on the street side between deck modules #N4 and #N5 was missing in the failed platform. The outriggers on the north side measured 66” to 69” and there were as many as 7 planks used to create the walk board.

The deck module #N1 was connected to the main platform using single ear placing the bolts in single shear. Most of the other deck modules also were connected using single ear. The operations manual required double ears which would have placed the bolts in double shear. The bolts in double shear carried twice the load.

The most disturbing issue was the absence of a leveling bolt on the street side between the motorized unit and deck module #N1. It created instability of the platform and increased the load

on the bolt on the building side by 100%. This is believed to be the cause of the bolt failure on the building side.

Figure 4 - Leveling Bolts and Ear on the Main Frame to which deck module #N1 was connected.

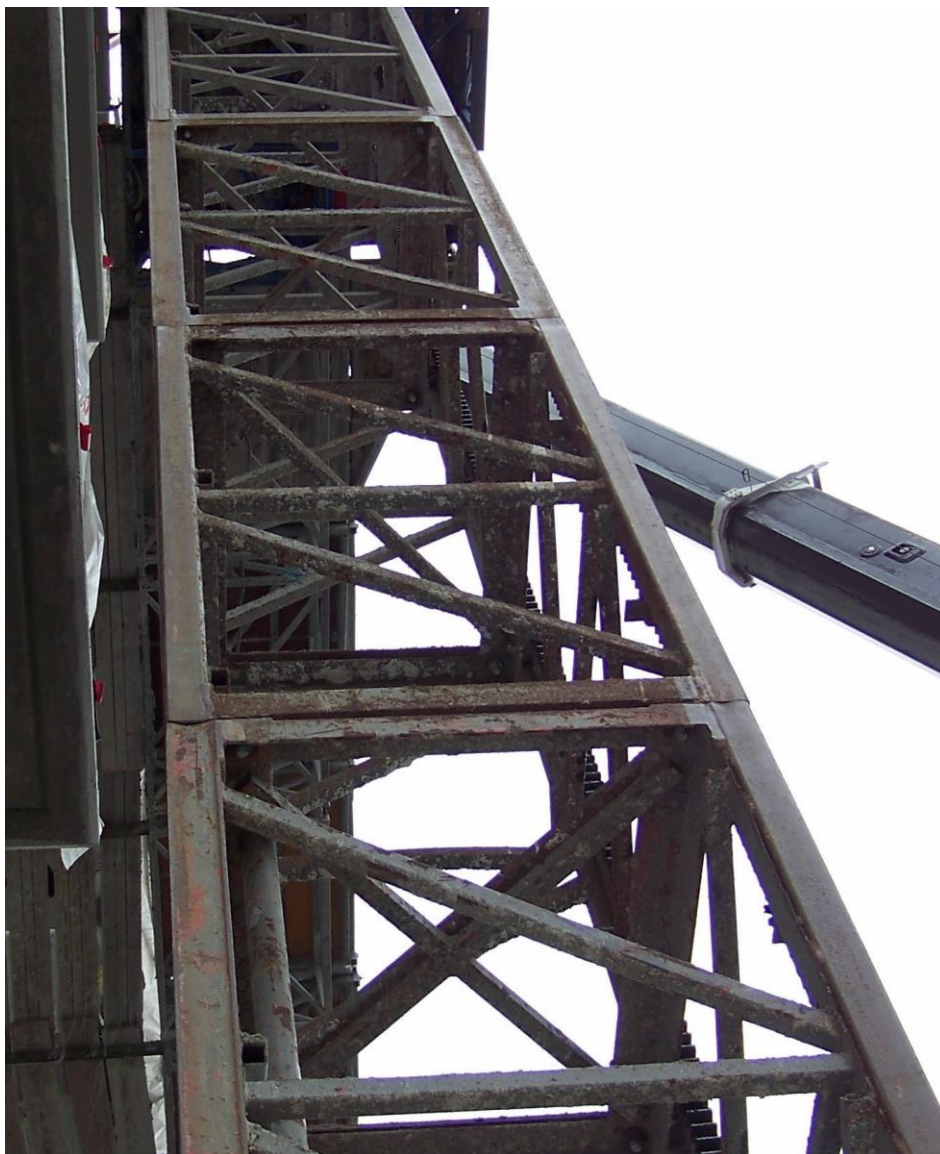
10. The erection of the mast was performed in a manner so that the masts did not align properly. The erectors used hollow structural steel tubing with non-uniform dimensions. In some instances, mast sections were out of alignment by as much as one inch. The maintenance of the mast climbing rollers was extremely poor so that polymeric covers for a majority of the rollers were either completely separated or badly worn out. The combination of misaligned mast sections and worn out rollers could result in erratic movement of the platform.

Figure 5 - Tower Mast showing non-uniform and rusted sections

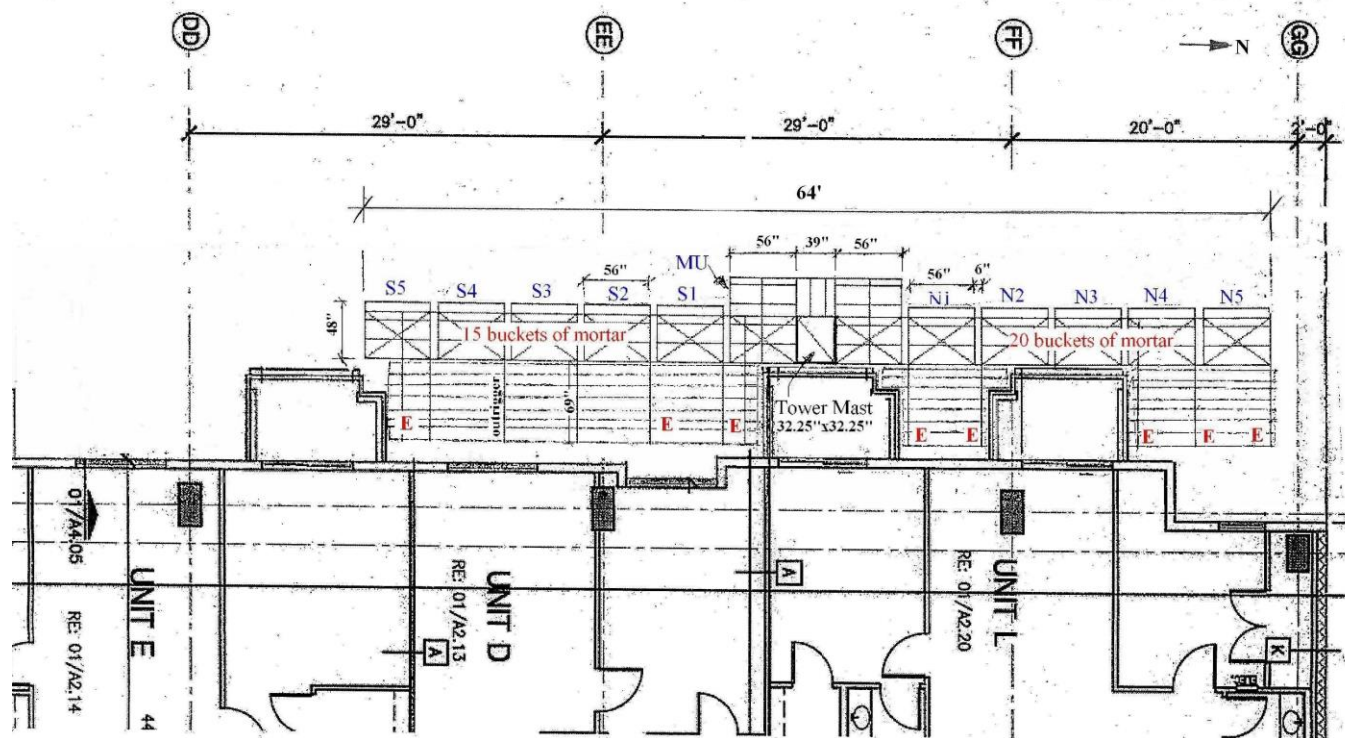
Figure 6 - Location of Platform - Prior to Collapse

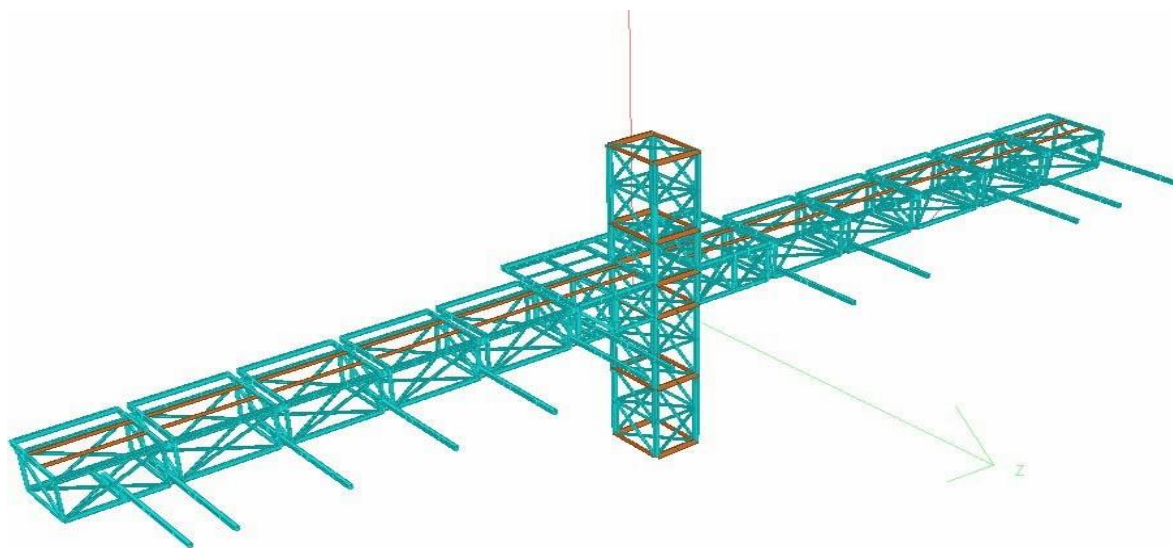
The model did not include the entire height of the tower mast, but a 20' high tower mast was included, supported at the top and bottom. A motorized unit was assumed to be connected to the tower mast directly. The roller mechanism on the mast was also not included in the model. Special consideration was given to the top and bottom connecting links between the deck modules, N1 thru N5 and deck module N1 to the main frame. The top ears on the deck modules (see figure 18) and main frame were modeled as two short members 3" long and the connection between deck modules (see figure 13) using the 3/4" bolt was modeled by creating a hinge connection between the top ears. All deck modules were modeled using single ears and thereby all the bolts were assumed to be in single shear. The reaction at the hinge was calculated to get the shear in the 3/4" grade 8 bolt. The bottom bolt was modeled as a 3/4" grade 8 bolt in compression.

Figure 7 – STAAD Model used for Analysis
