Minor Road Damage Repair

EXECUTIVE SUMMARY

Jointed concrete pavements are designed and constructed to provide long periods of service to the traveling public. In the harsh climate of Minnesota, older generation concrete mix designs, like those specified by MnDOT in the early 1990s, have demonstrated a trend where significant joint distress begins to appear on the surface of the pavement at approximately 17 to 20 years of age. The original concrete pavement test sections at the MnROAD facility, constructed in 1993, utilized older generation concrete mix designs. Following the general trend, by 2011 several of the original concrete pavement test sections that remained in service began to exhibit materials related distress along the joints. To keep the test sections in service and safe for the traveling public, partial-depth joint repairs were performed.

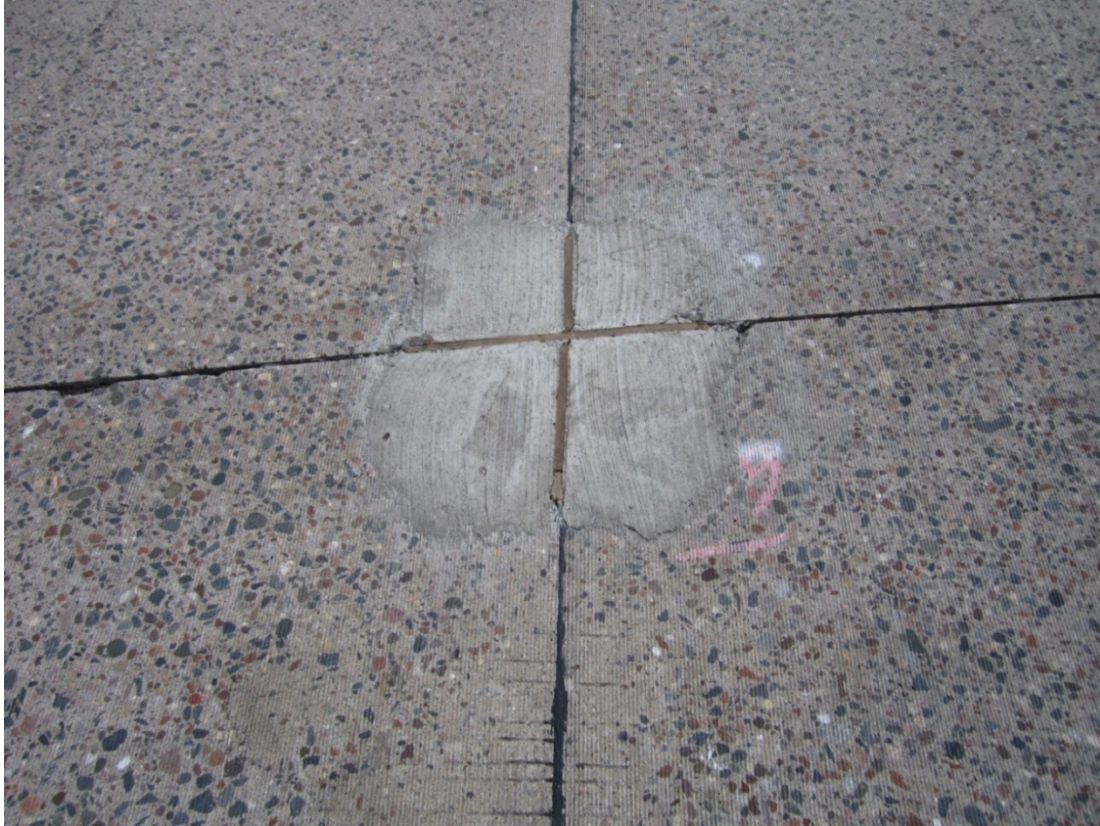
Figure 1.4. Typical MnROAD partial-depth repair with cementitious-based material.
