# Pedestrian Bridge Collapse in Miami, Florida

## 1. Executive Summary

## **6. The cracks**

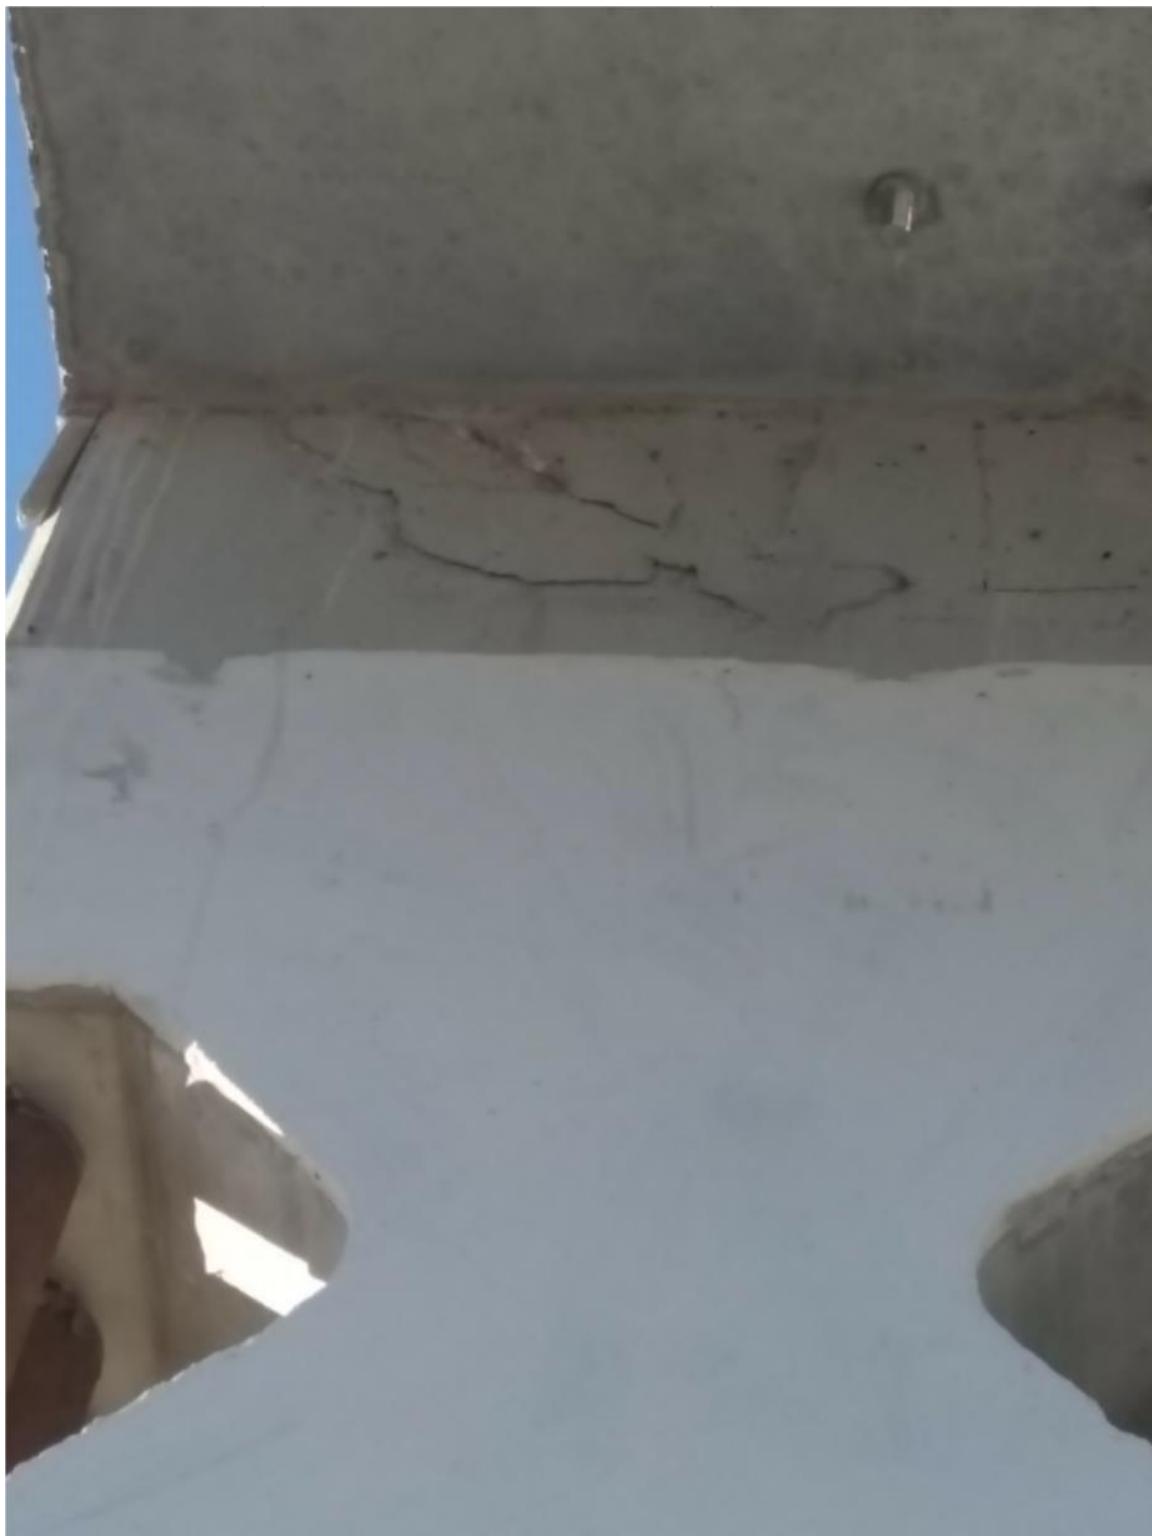
Figure 15 Photo #1 in 2/28/2018 E-mail from MCM to FIGG

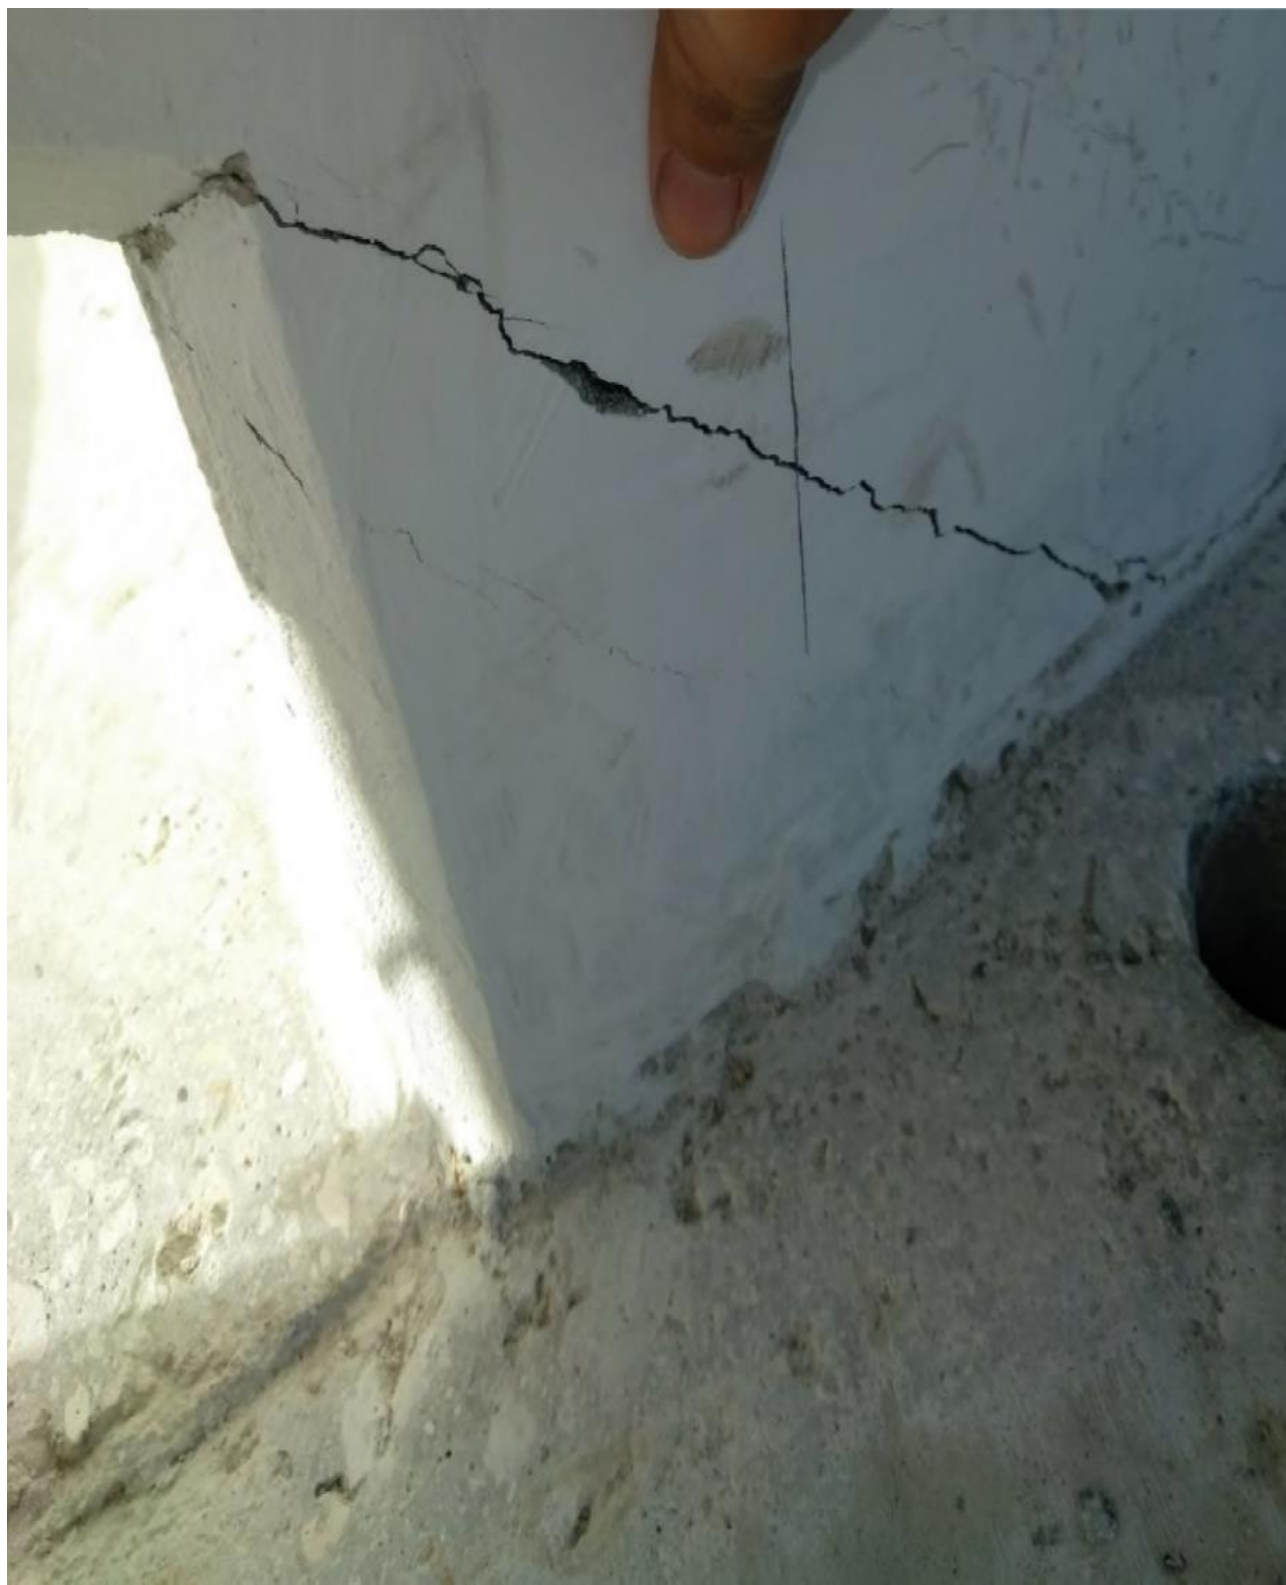
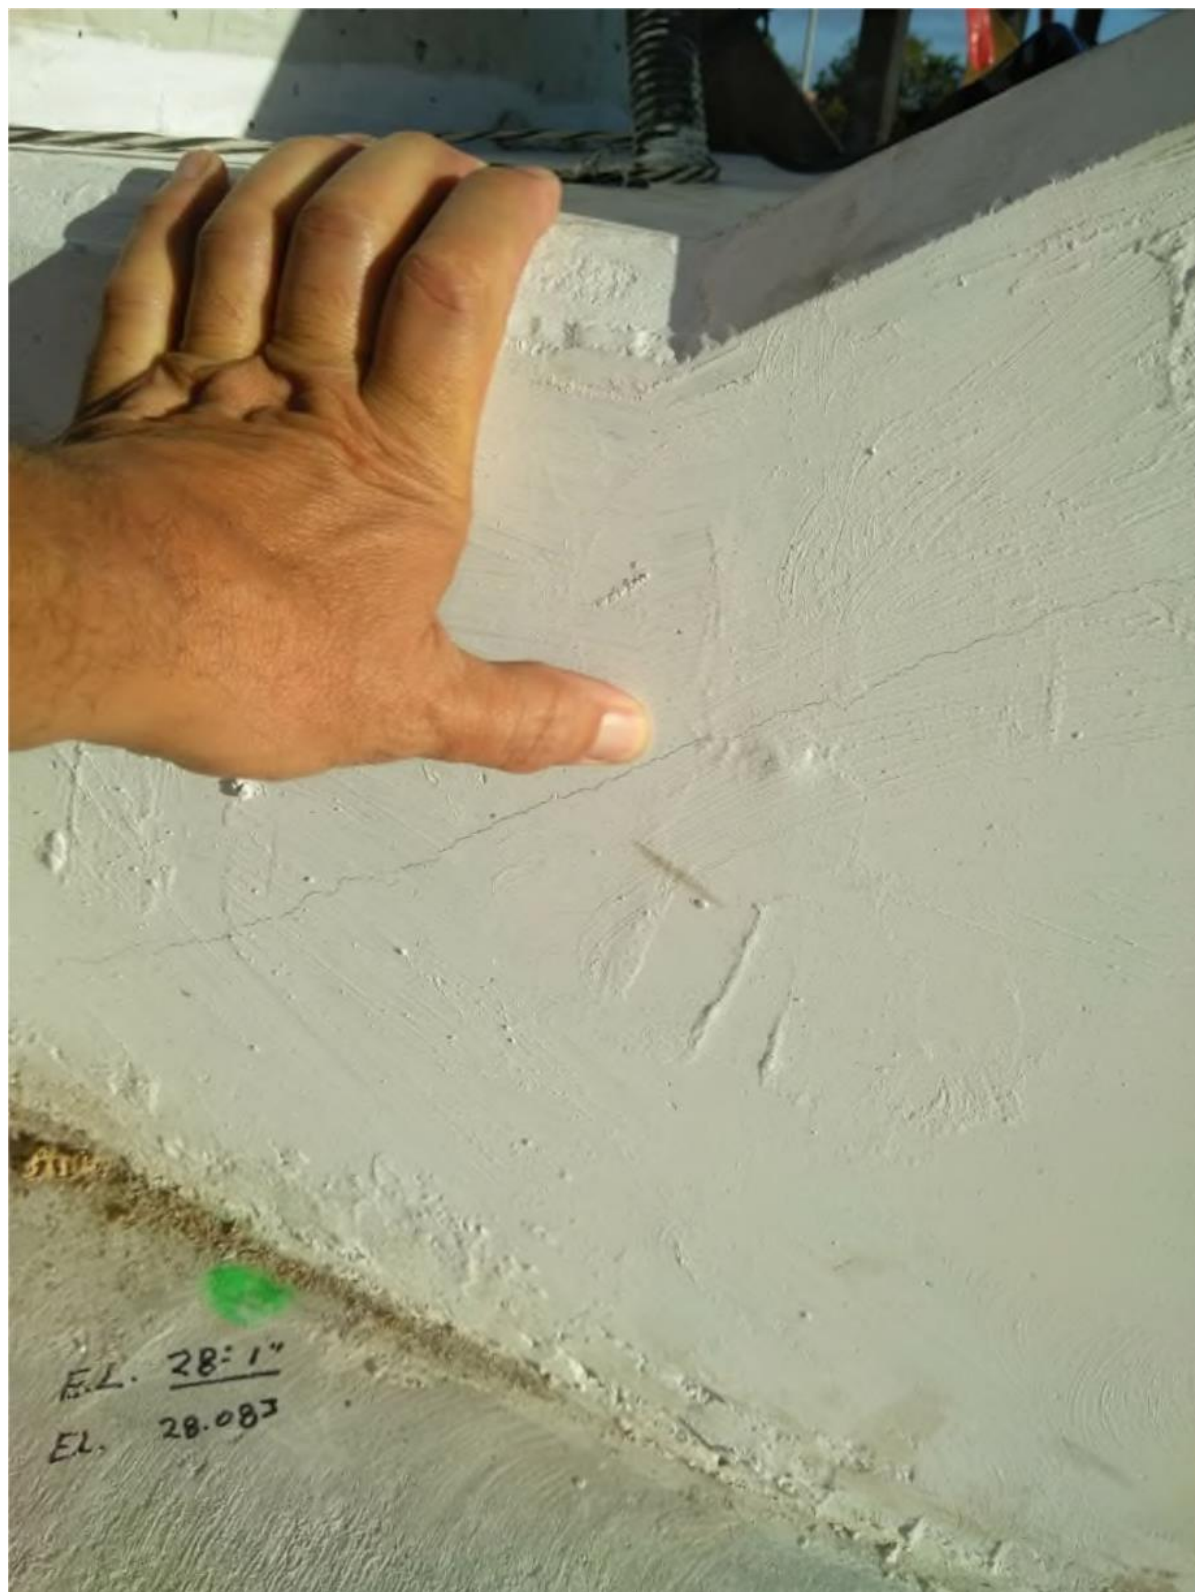
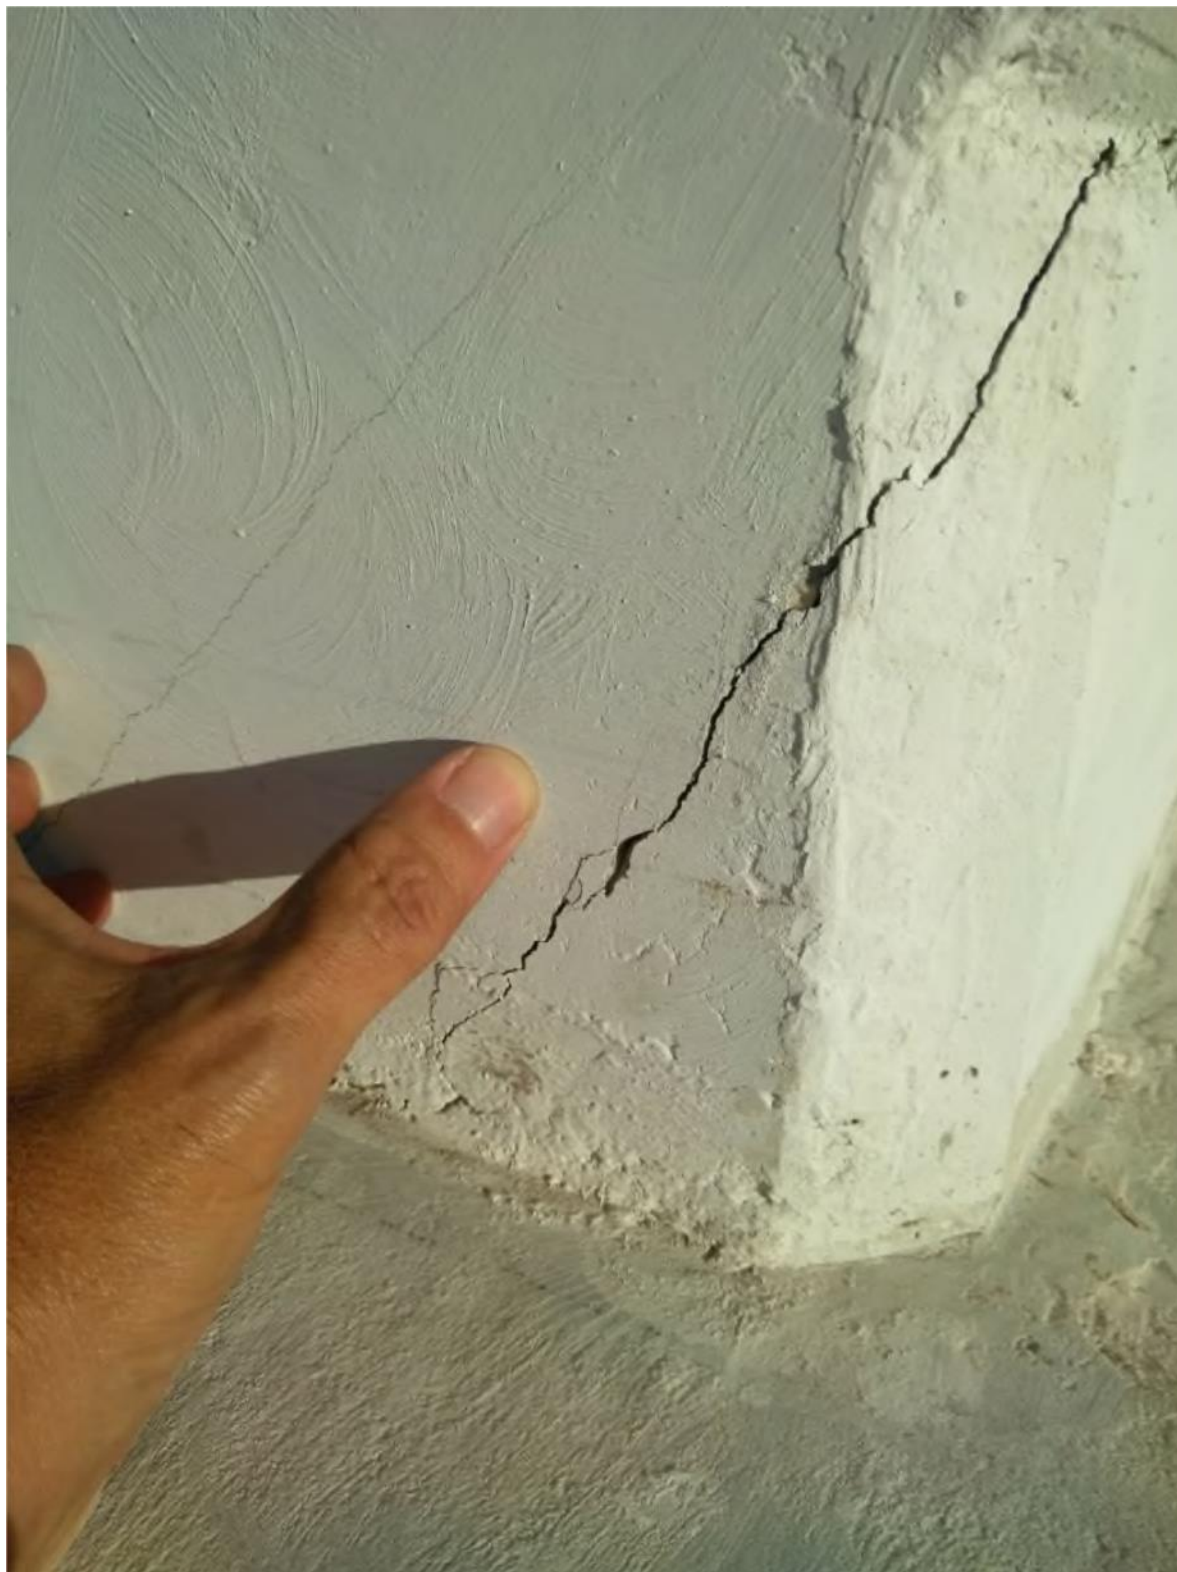
Figure 18 Photo #4 in 2/28/2018 E-mail from MCM to FIGG

Figure 19 Photo #5 in 2/28/2018 E-mail from MCM to FIGG

Figure 20 Photo #6 in 2/28/2018 E-mail from MCM to FIGG

Photos 4, 5 and 6 (Figure 18, Figure 19 and Figure 20): Cracks developed at diagonal 11 and its bottom chamfer. No concern expressed by FIGG. FIGG anticipated that "MCM will seal these cracks in accordance with FDOT Standard Specifications." These cracks were, however, never sealed.

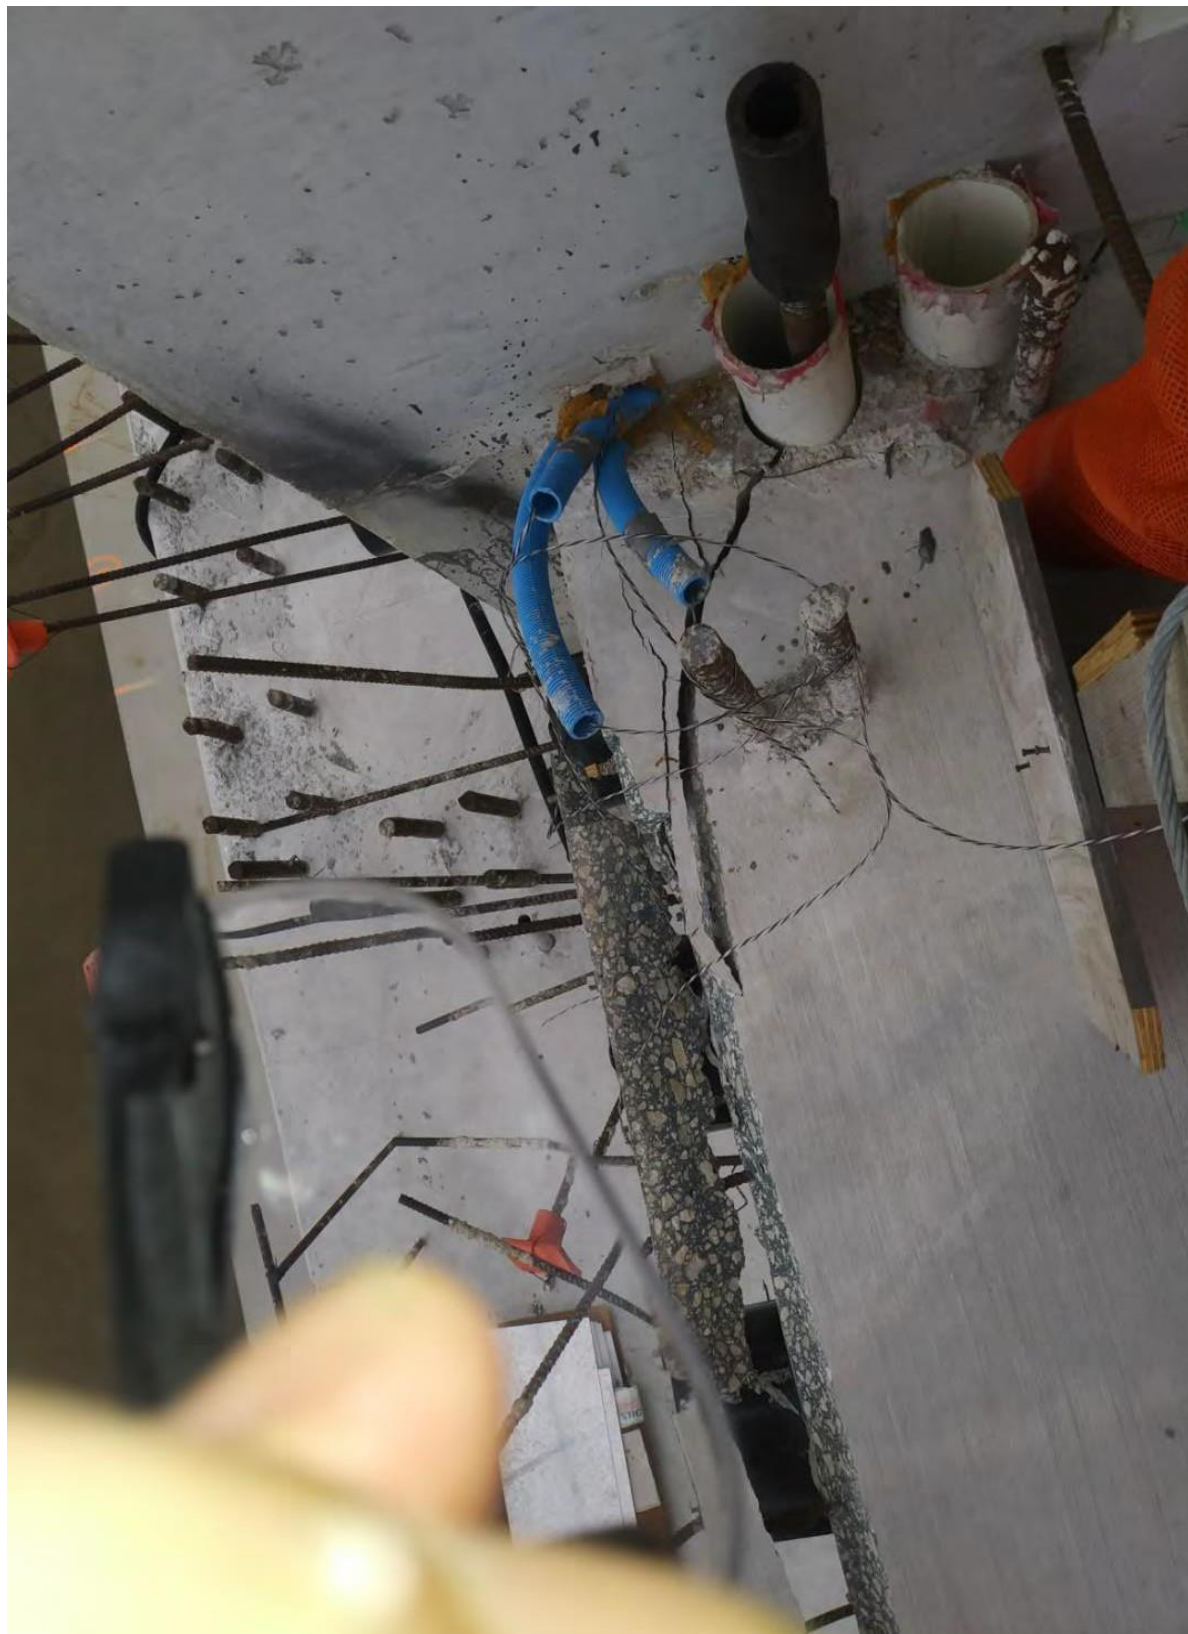
Figure 24 Cracks at the west side diaphragm II MCM email of 3/12/2018 – top face, by BPA.

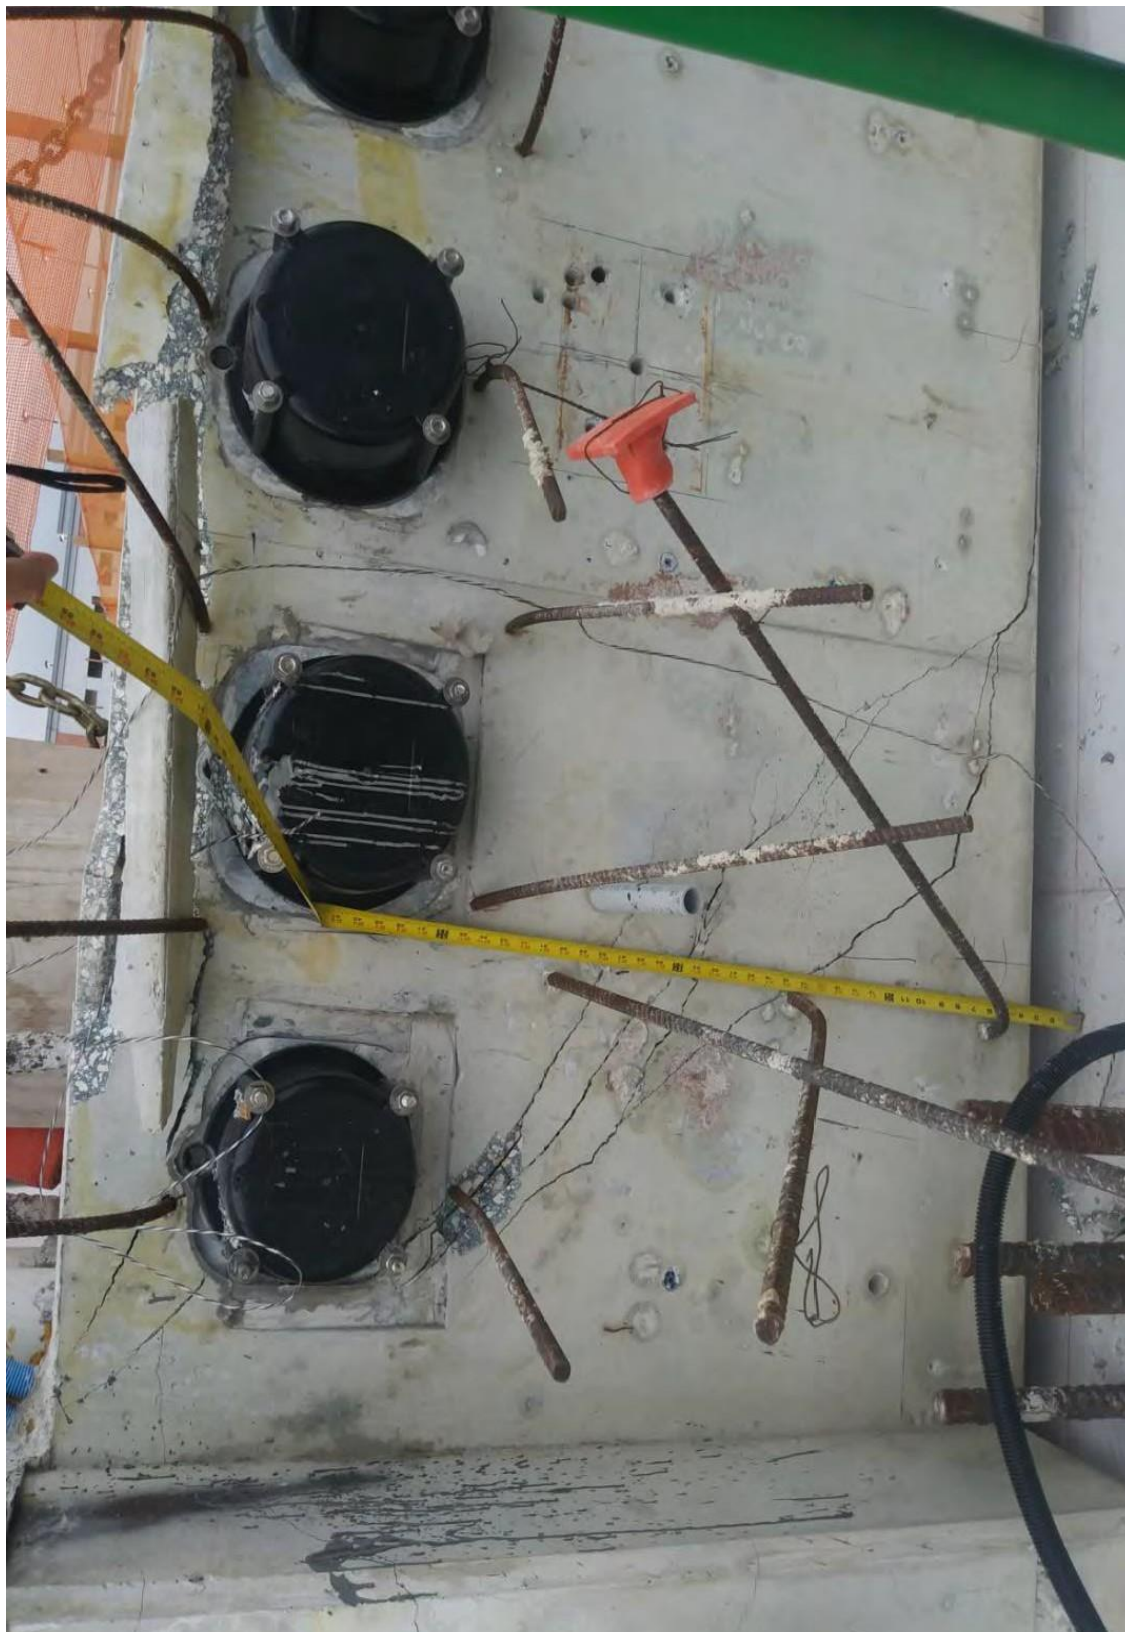
Figure 25 Cracks at the west side diaphragm II MCM email of 3/12/2018, by BPA – side face

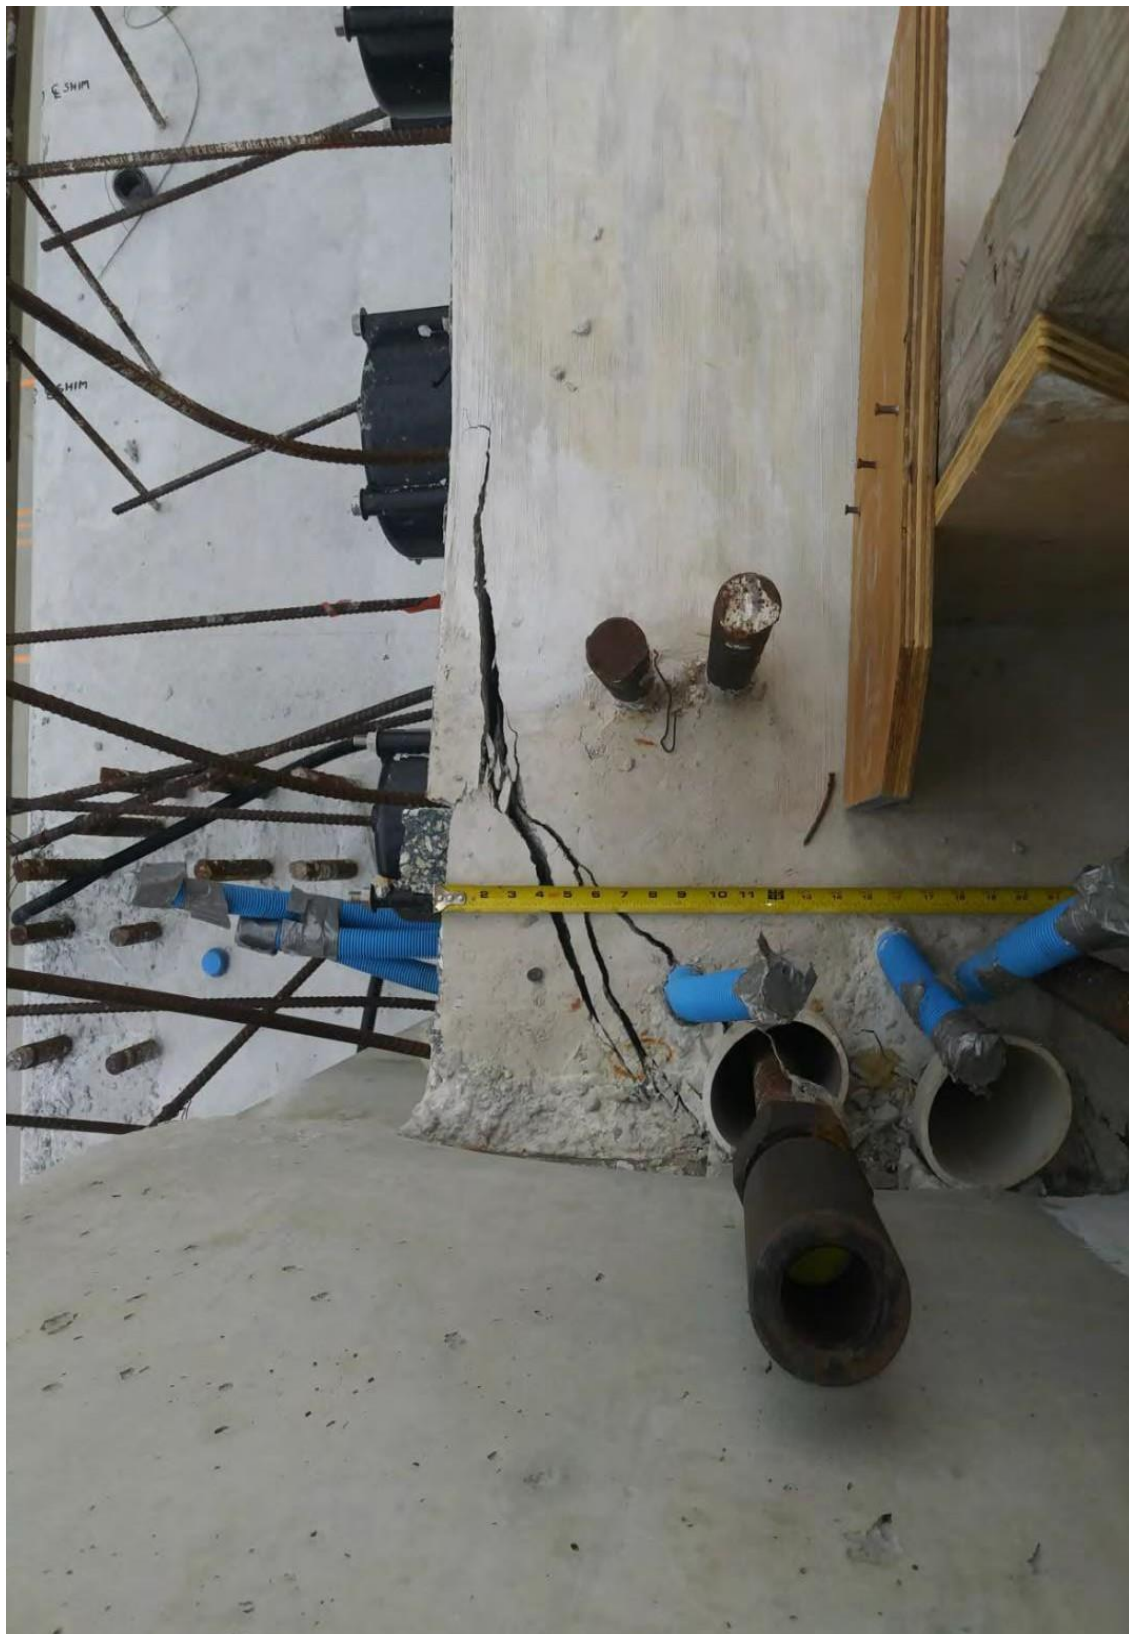
Figure 26 Cracks at the east side diaphragm II MCM email of 3/12/2018, by BPA – top face

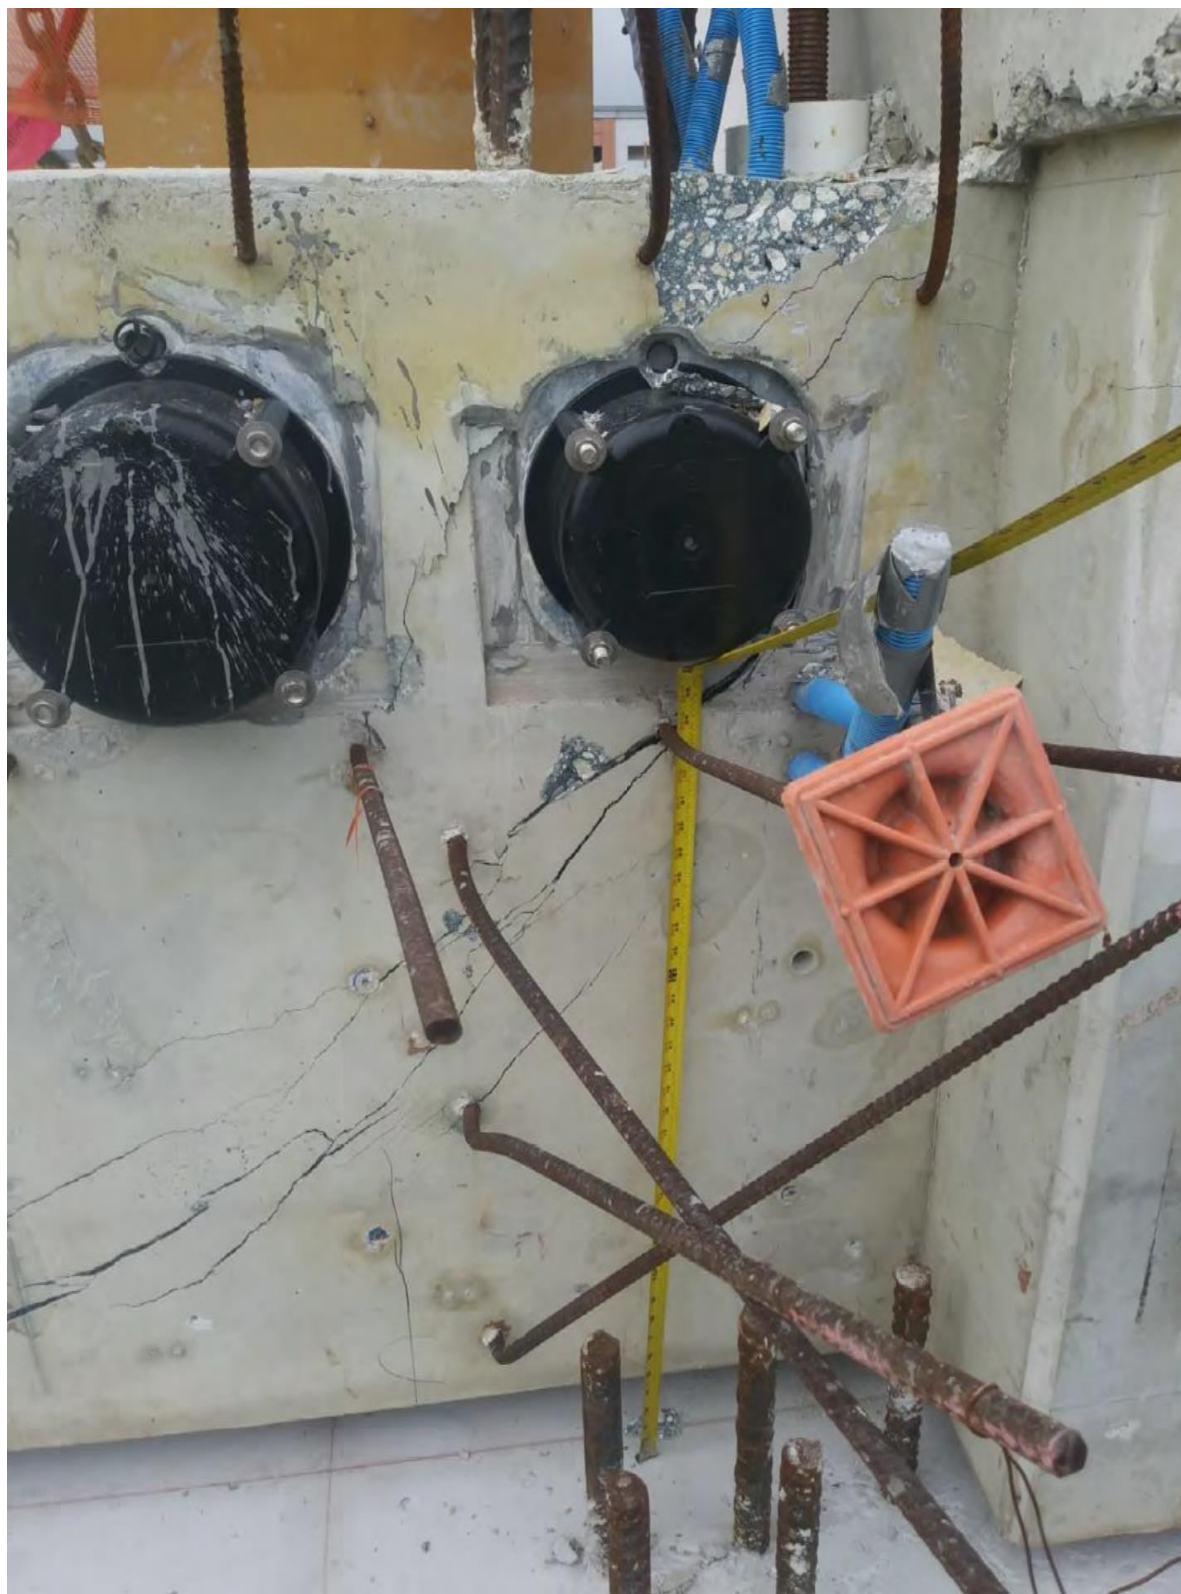
Figure 27 Cracks on the east side diaphragm II MCM email of 3/12/2018, by BPA – side face  
March 13, 2018      As the email was sent by MCM in the evening of March 12, 2018, FIGG did not  
open MCM's email containing the photos of the cracks until the next morning on  
FDA, Inc.

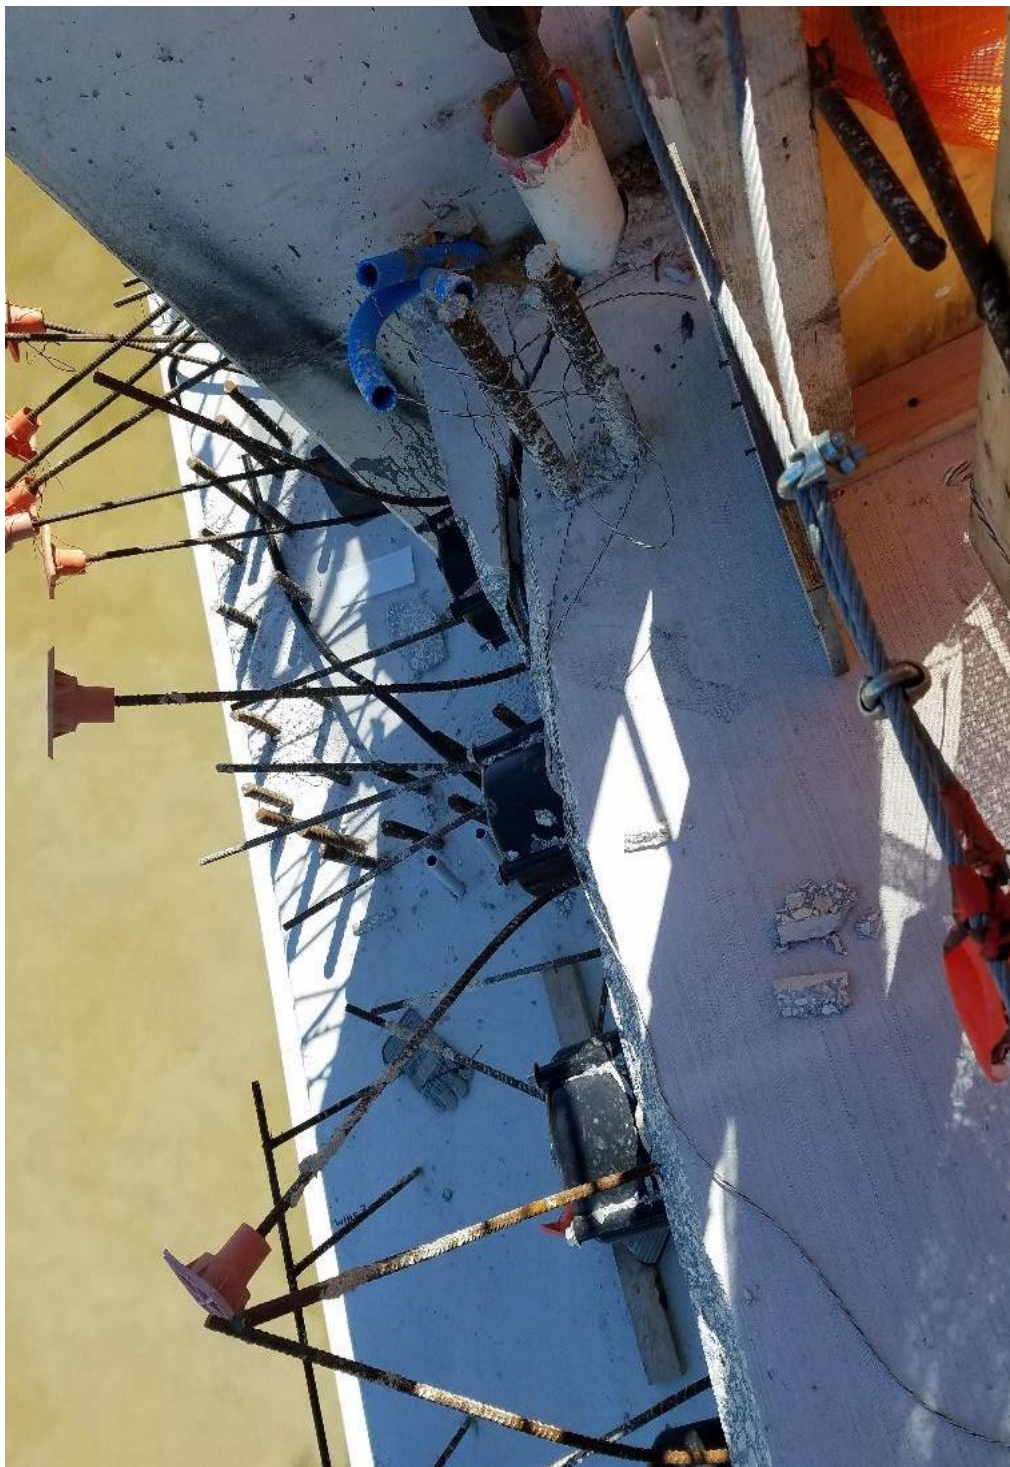
Figure 28 Diagonal cracks on the west side of diaphragm II on 3/13/2018, by BPA – top face

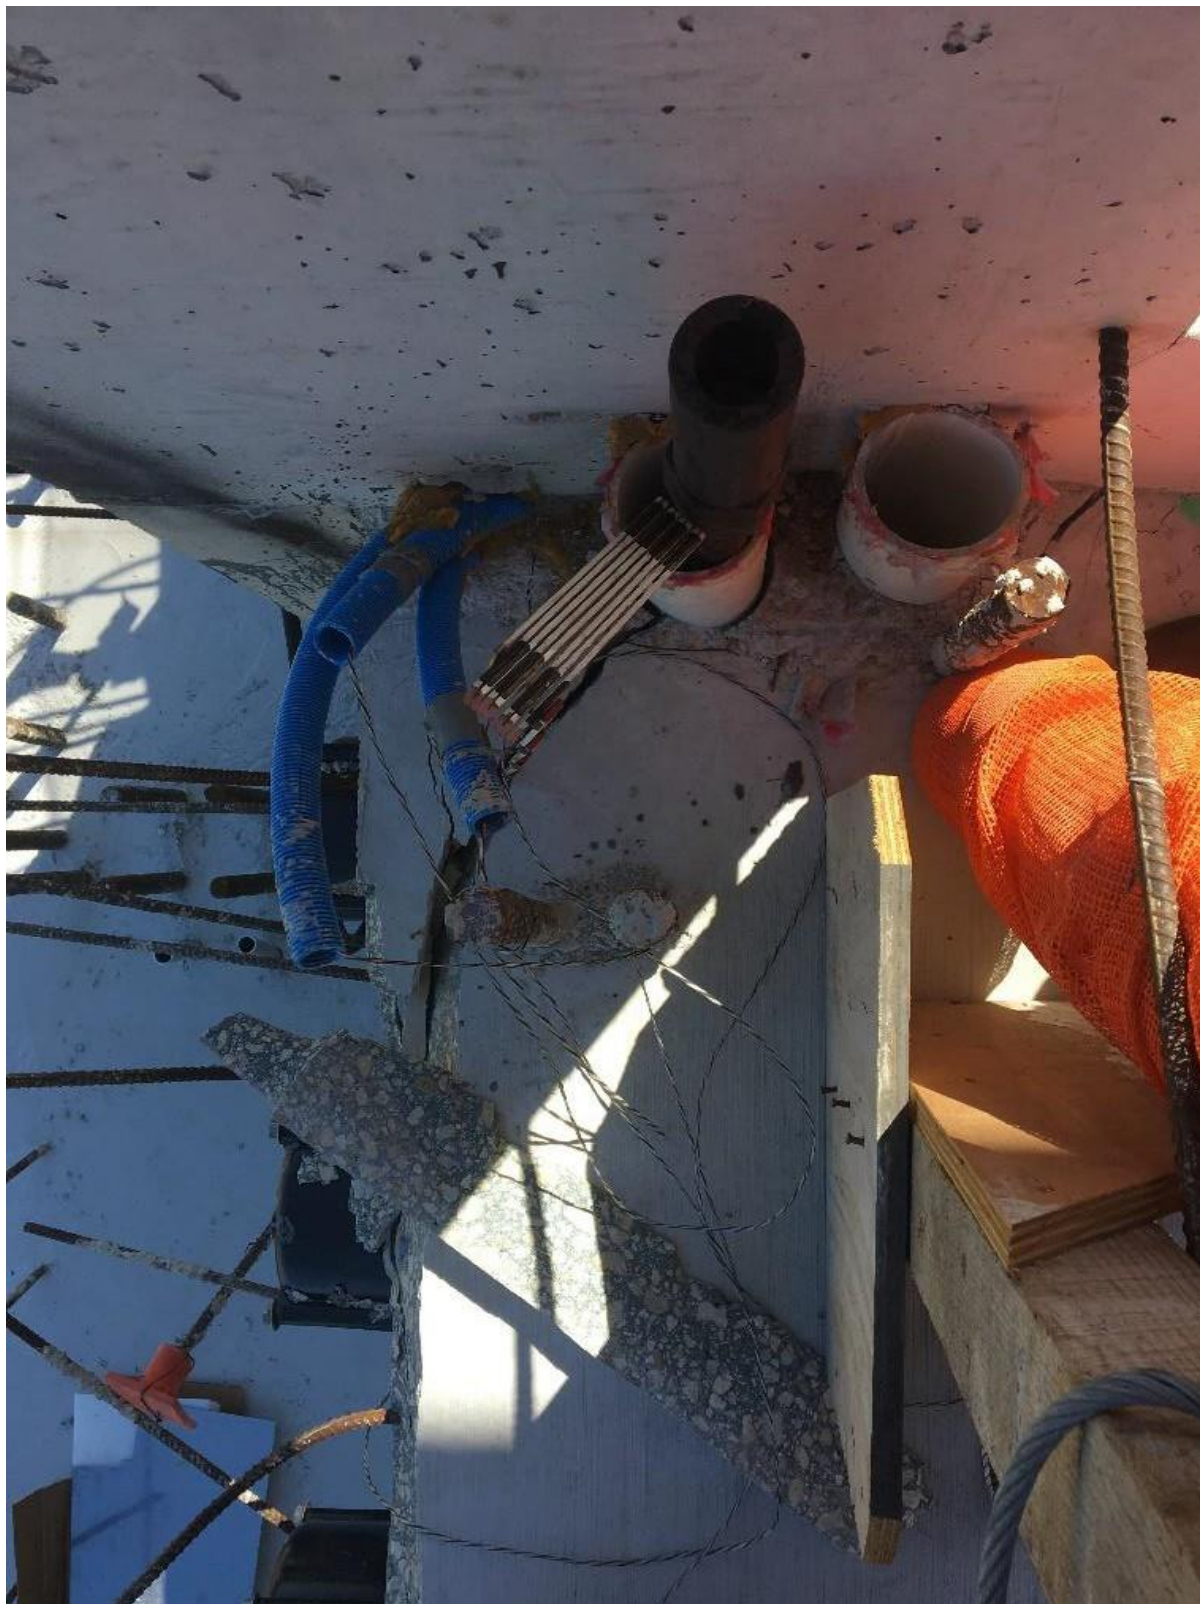
Figure 29 Close-up of cracks at the west side of diaphragm II on 3/13/2018, by BPA

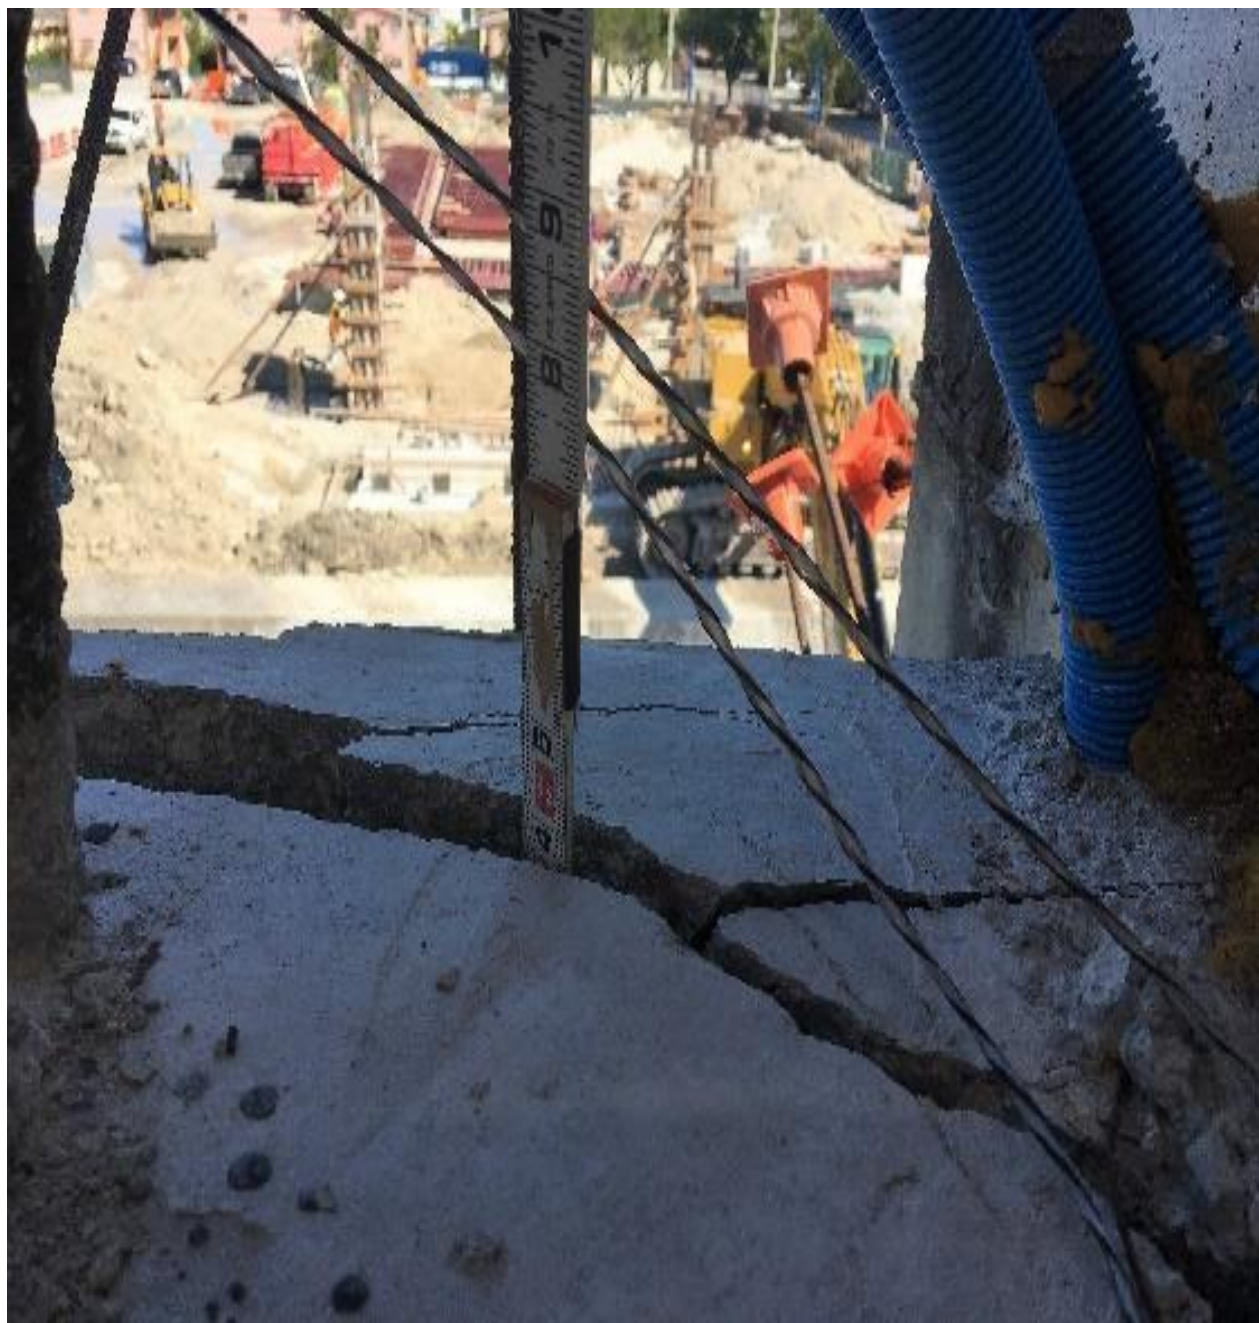
Figure 30 Notice the depth and width of diagonal cracks at the west side of diaphragm II on 3/14/2018  
by BPA

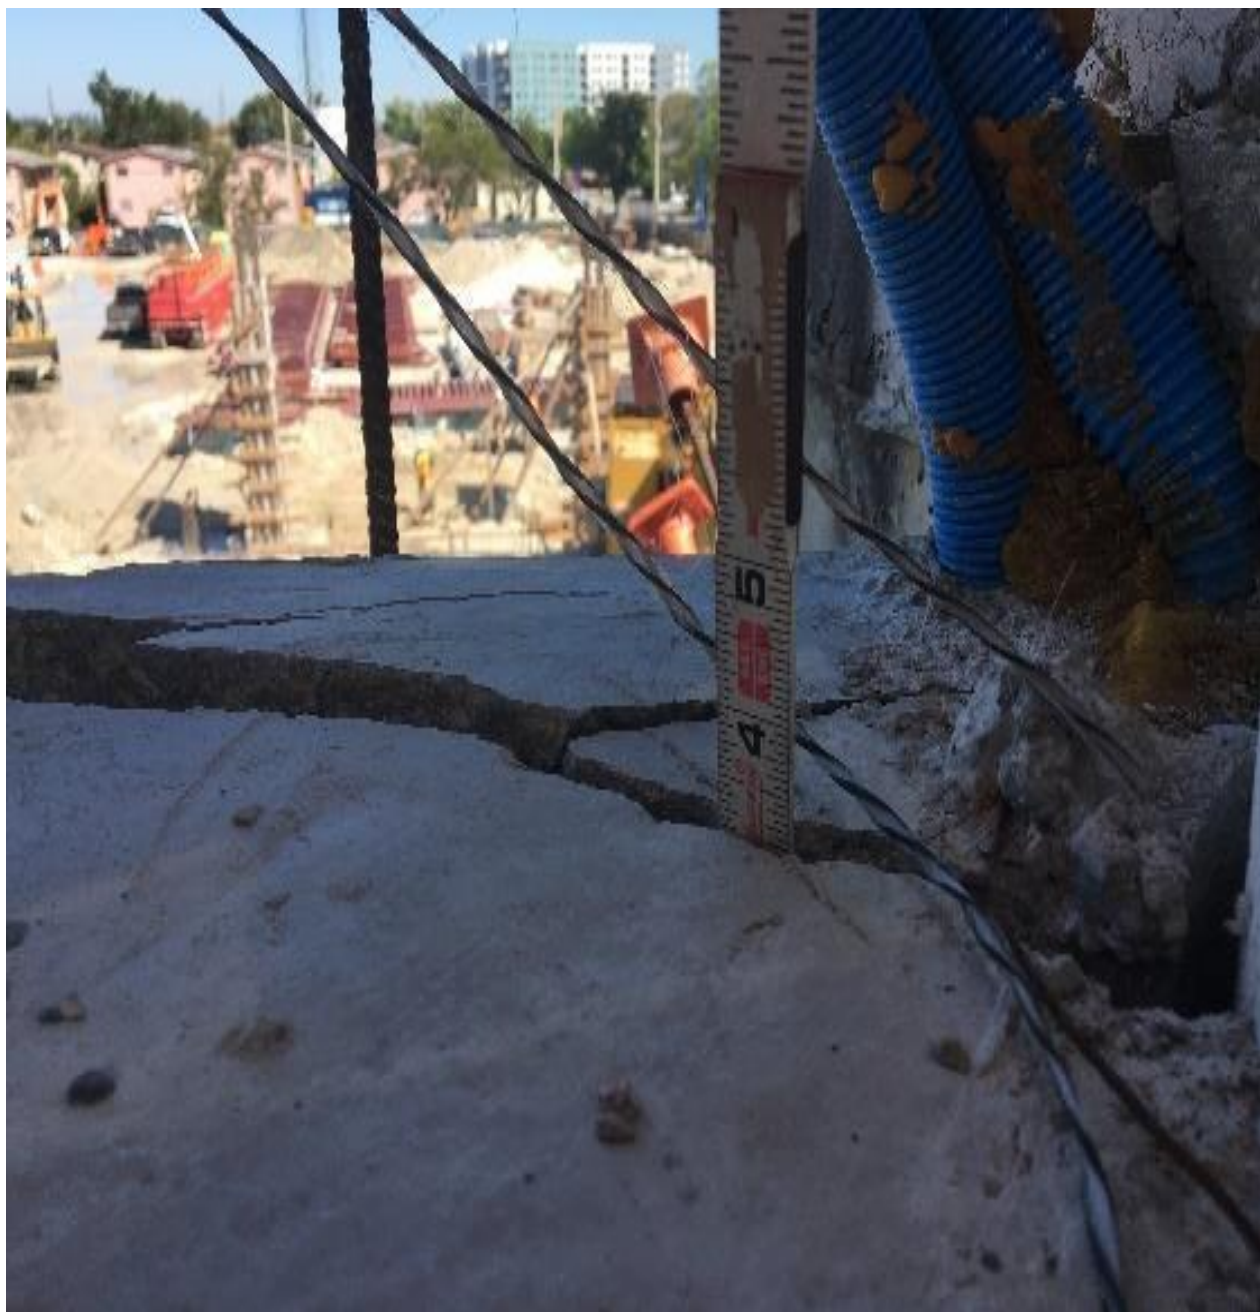
Figure 31 Notice the depth and width of cracks near column 12 at the west side of diaphragm II on  
3/14/2018 by BPA
