# Pedestrian Bridge Collapse in Miami, Florida

## 1. Executive Summary

## **6. The cracks**

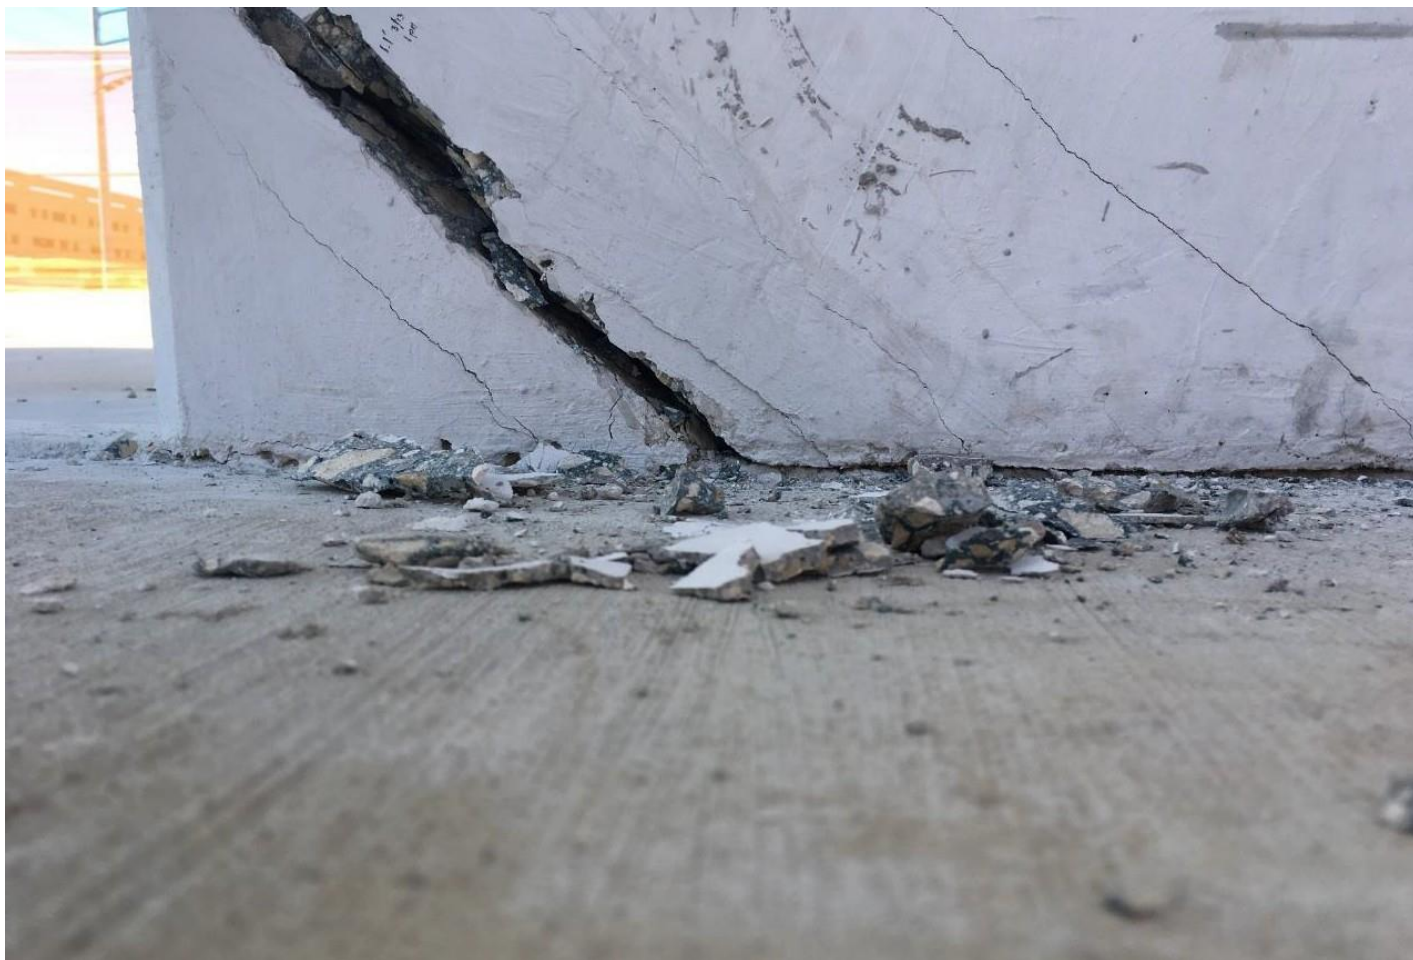
Figure 35 Cracks at the construction joint of the main span deck, diagonal 11 and the chamfer of diagonal 11 on 3/13/2018 by BPA

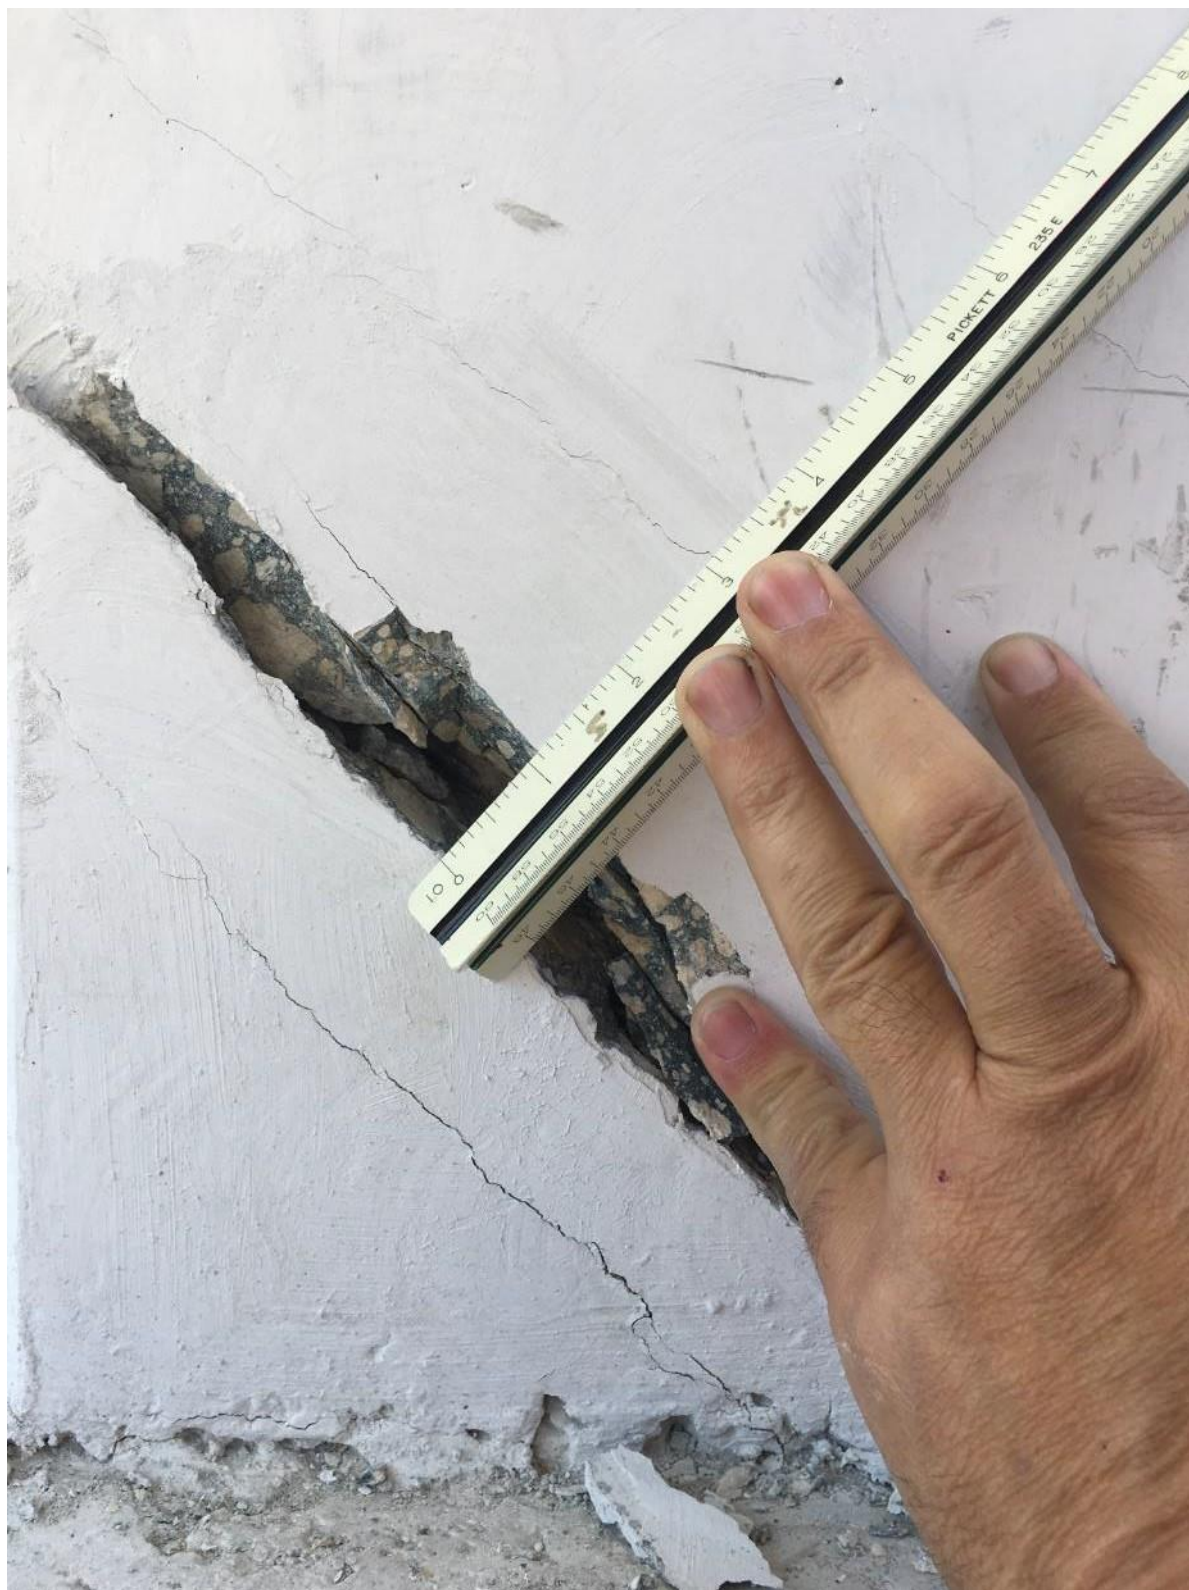
Figure 40 Close-up of longitudinal cracks in diagonal 11 on 3/13/2018 by BPA

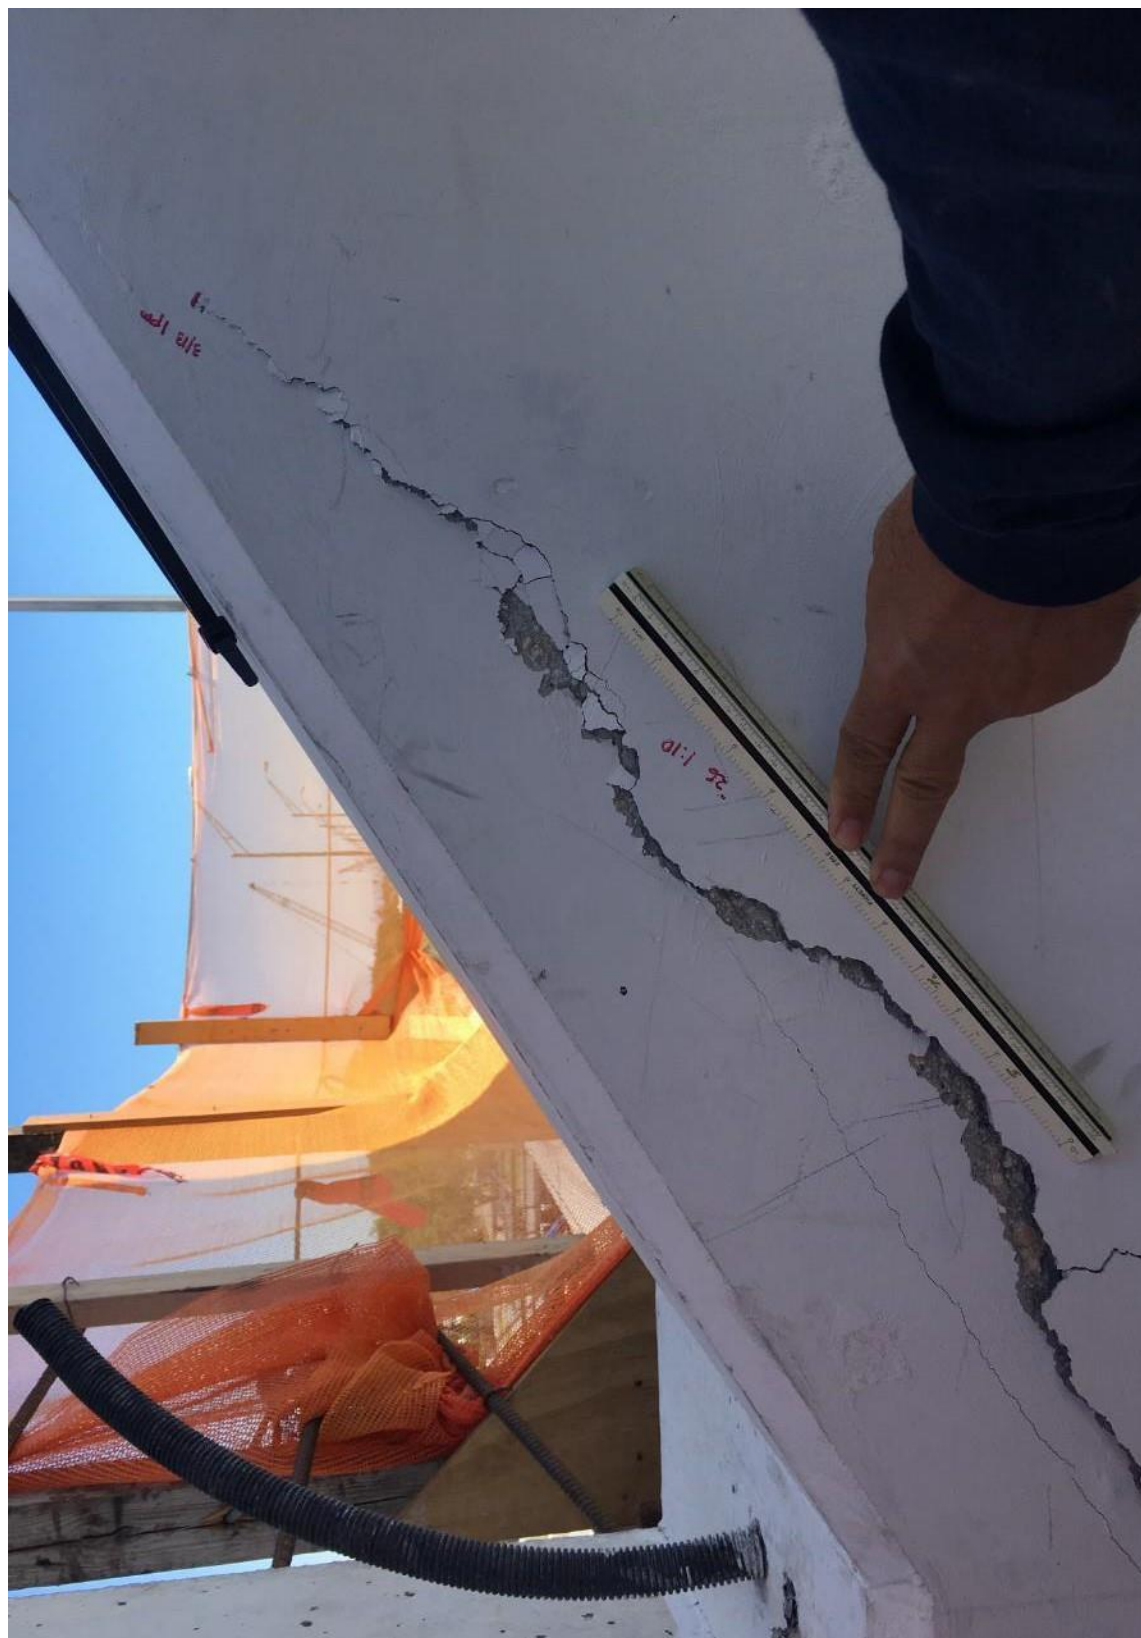
Figure 41 Close-up of longitudinal cracks in diagonal 11 on 3/13/2018 by BPA

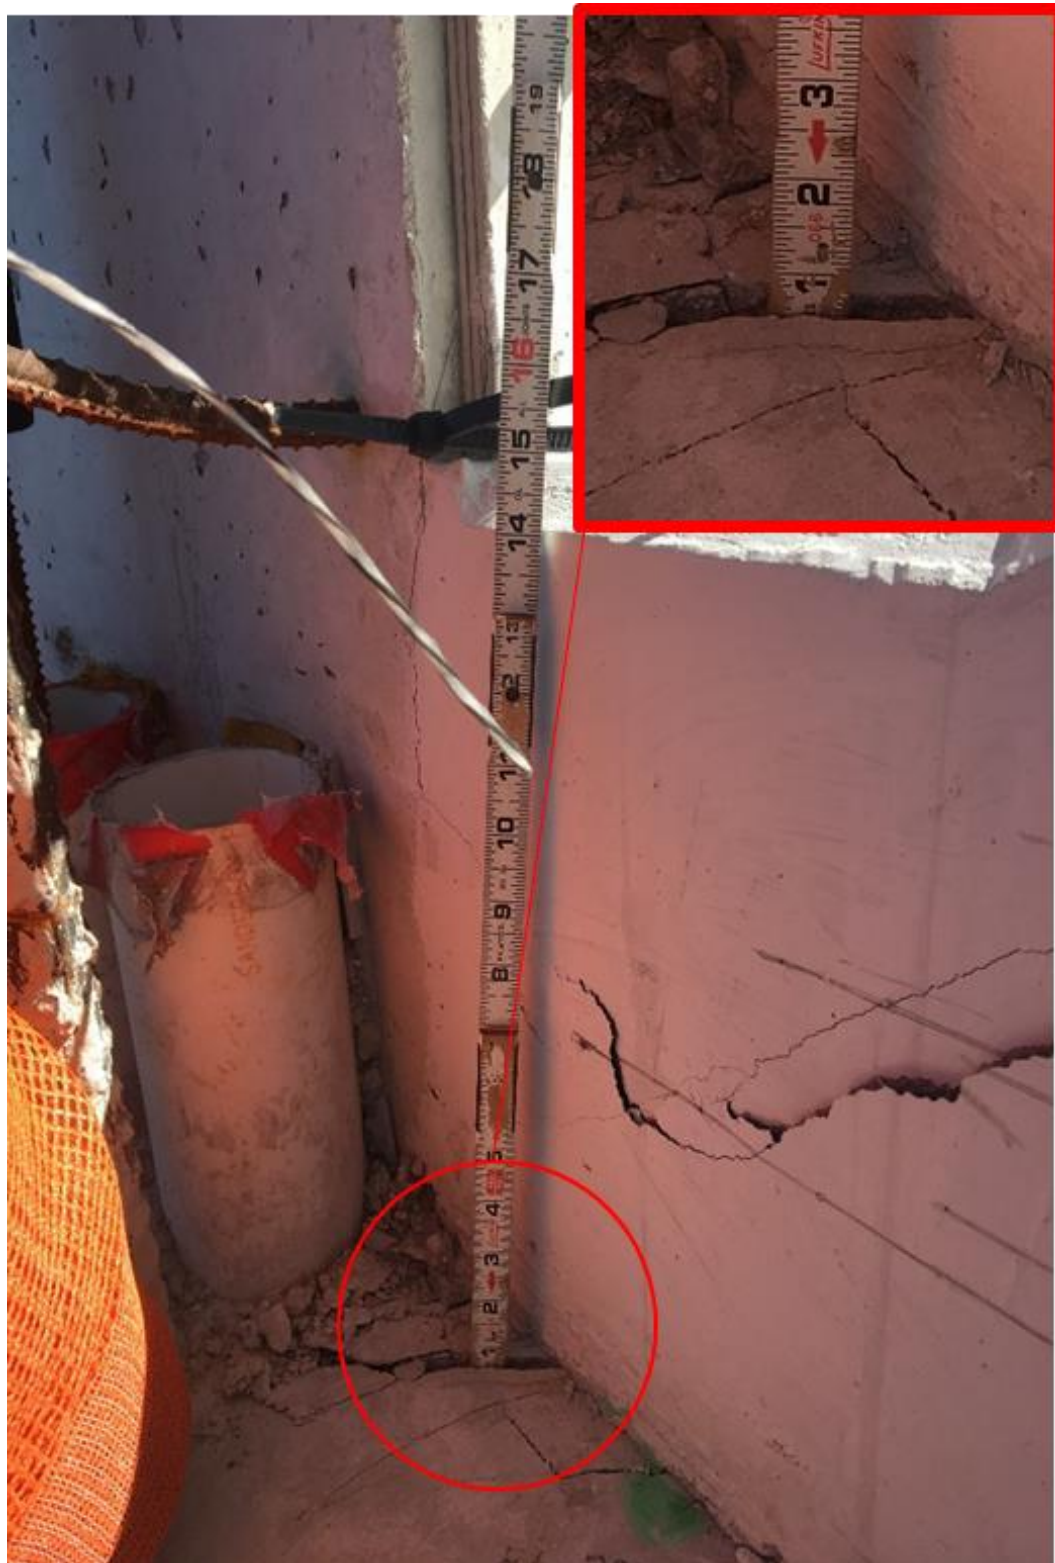
Figure 42 Cracks at the west side of diaphragm II on 3/14/2018 by BPA

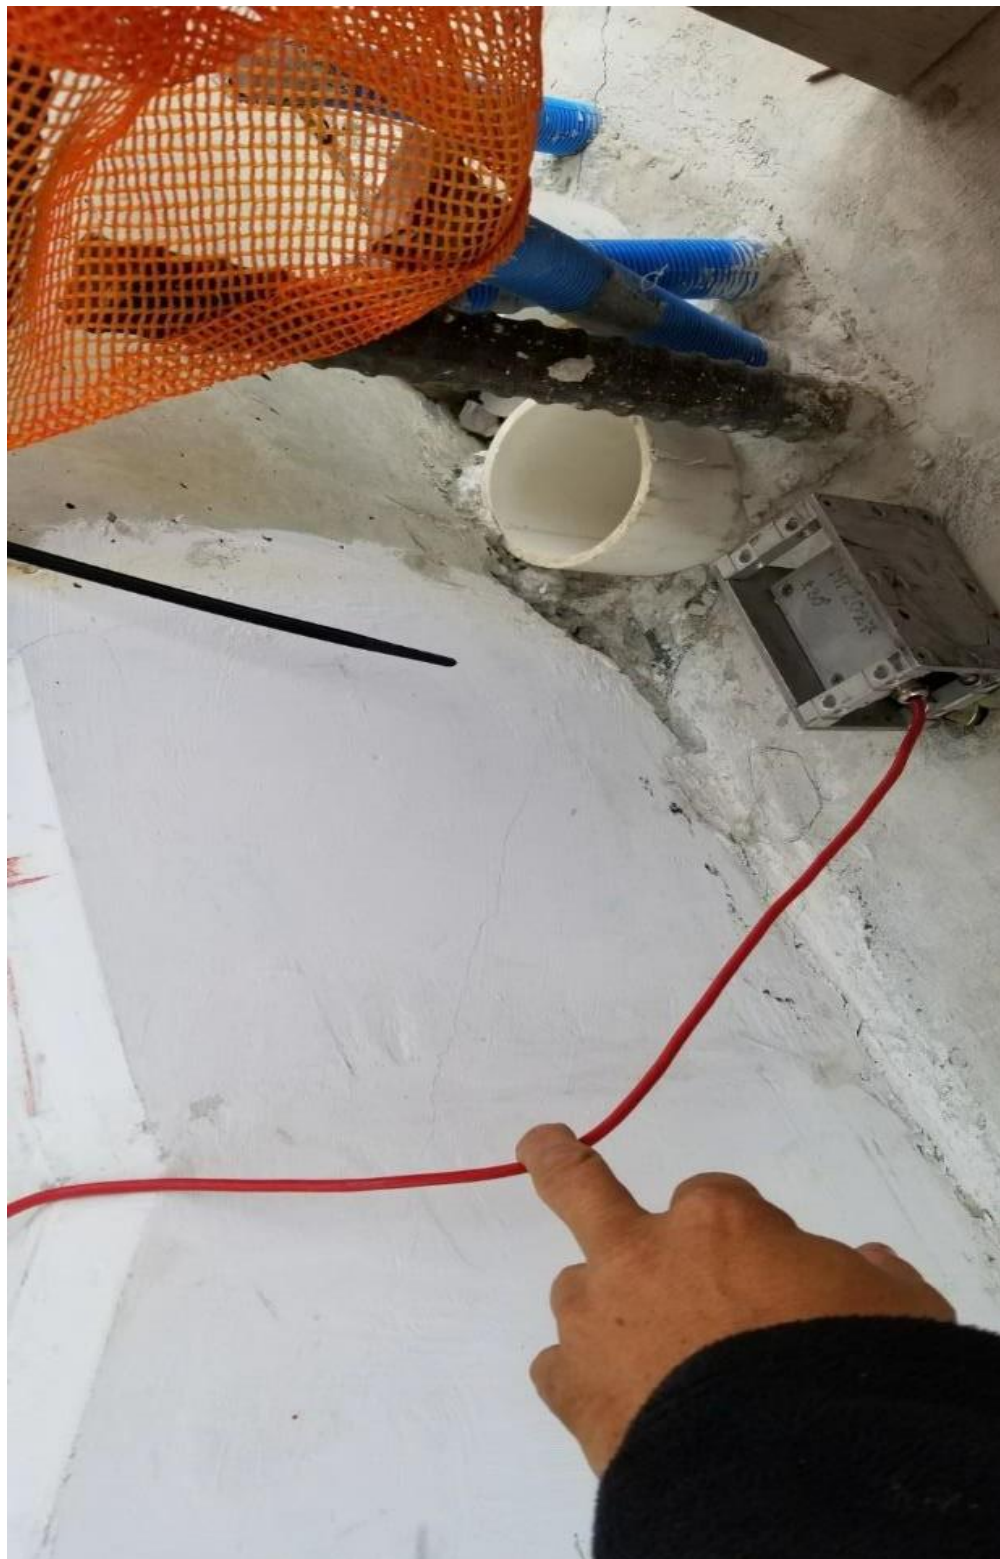
Figure 43 Cracks at the east side diaphragm II on 3/10/2018 – top face, by Corradino

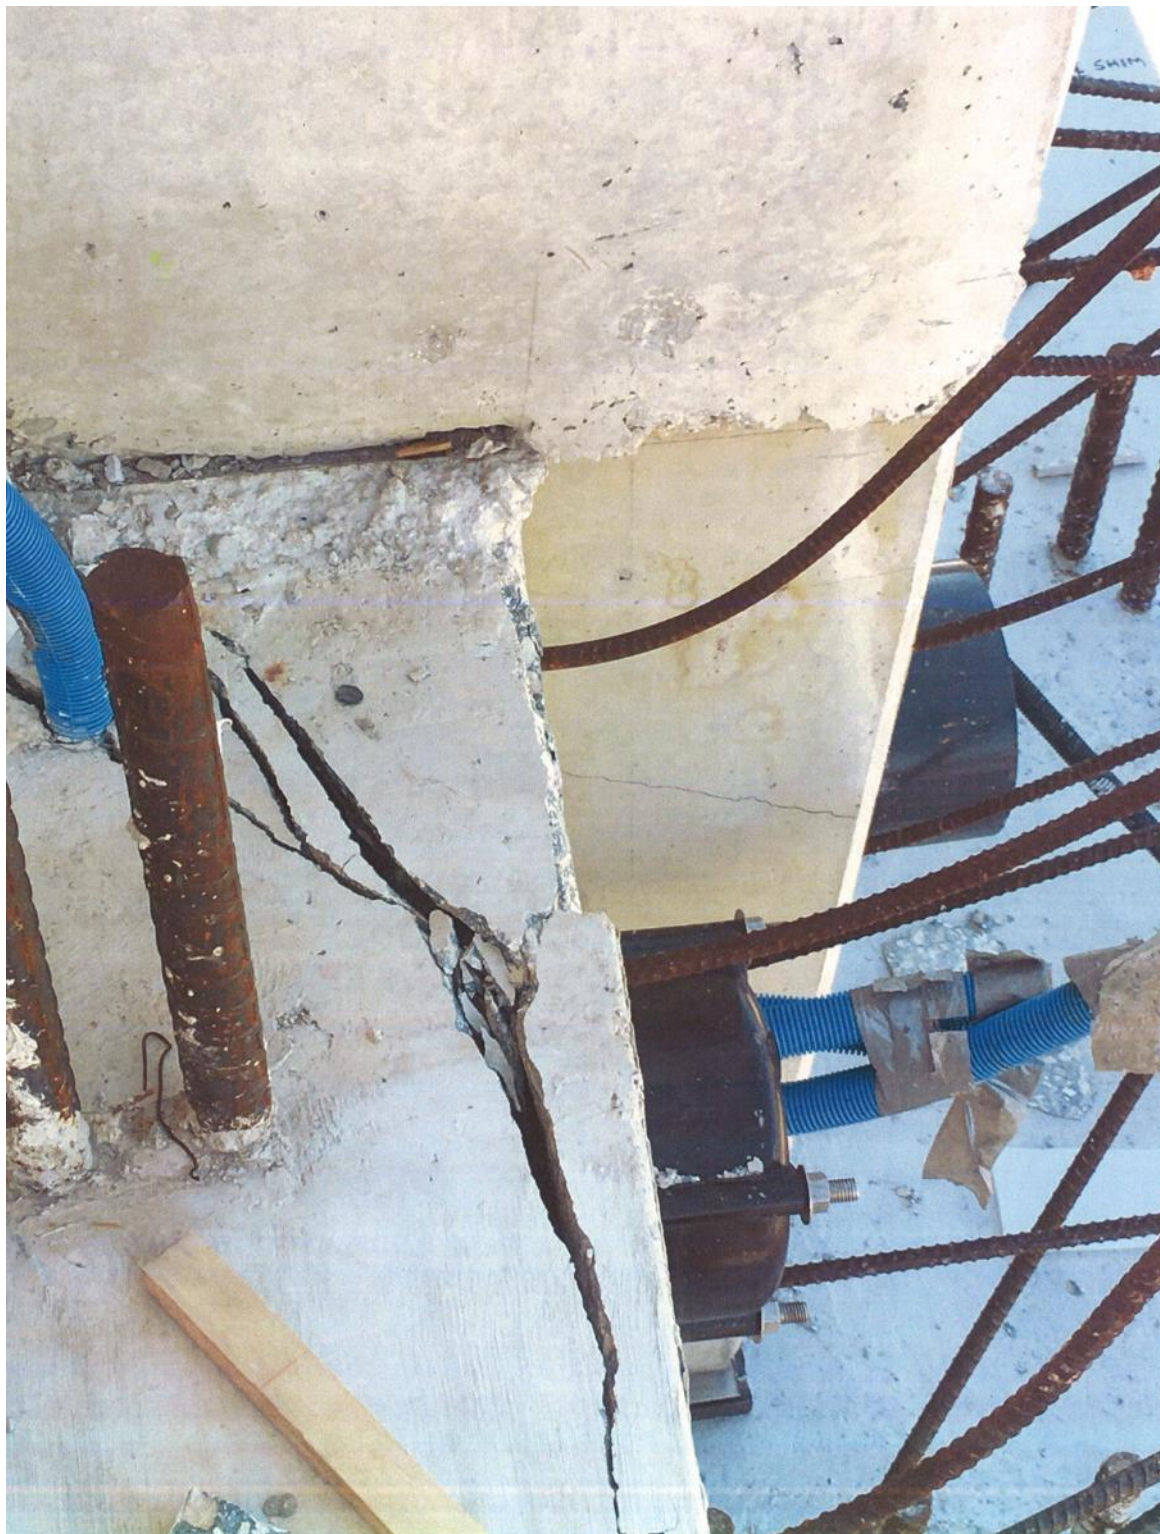
Figure 44 Cracks and movement of the column at the east side of diaphragm II on 3/14/2018 by  
BPA

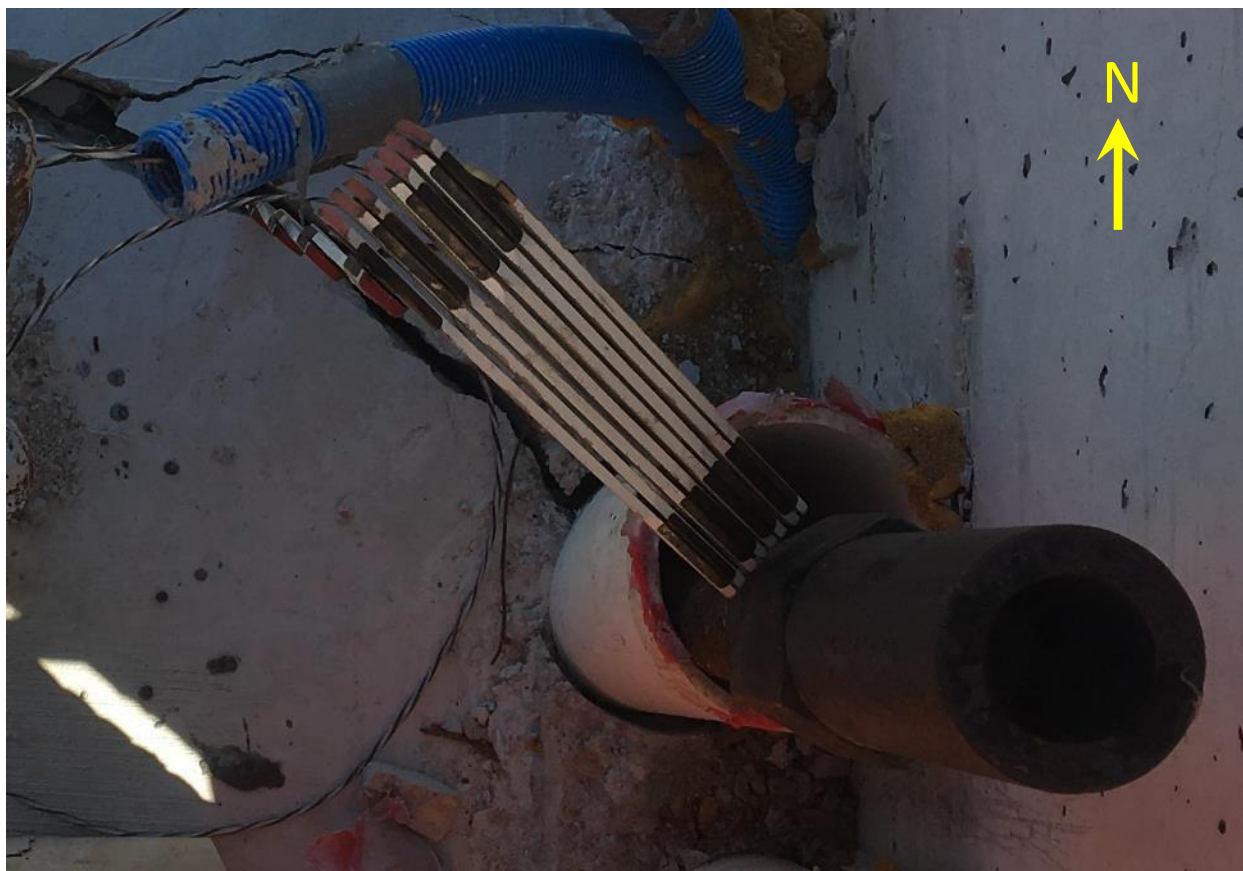
Figure 45 Note the gap indicative of movement between sleeve pipe and concrete, pictured on 3/13/2018 by BPA

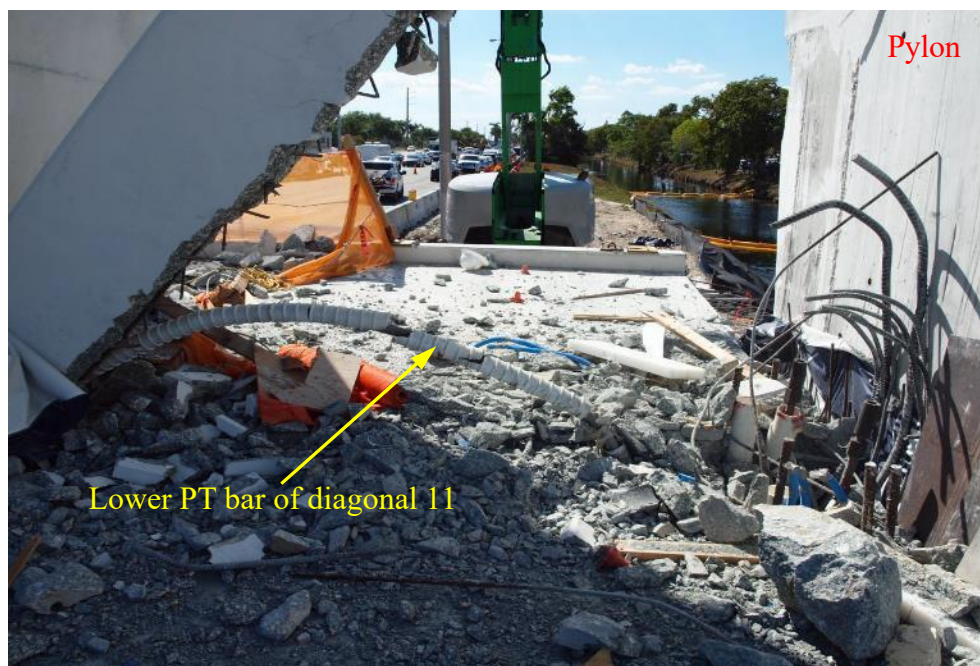
Figure 57 Lower PT separated from the diagonal 11 still embedded in diaphragm after bridge collapse,  
March 17, 2018 by OSHA

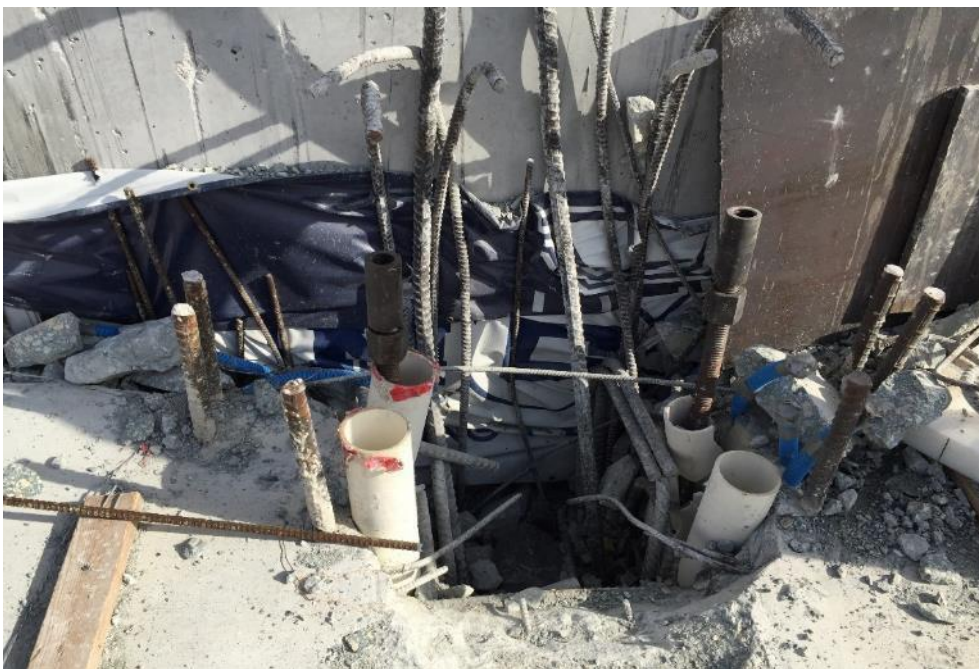
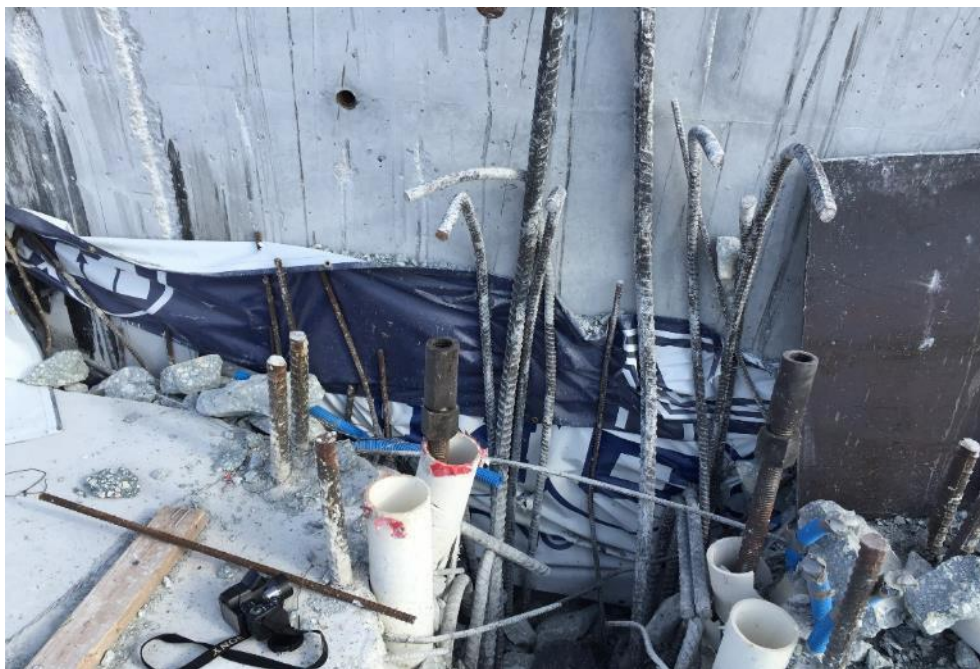
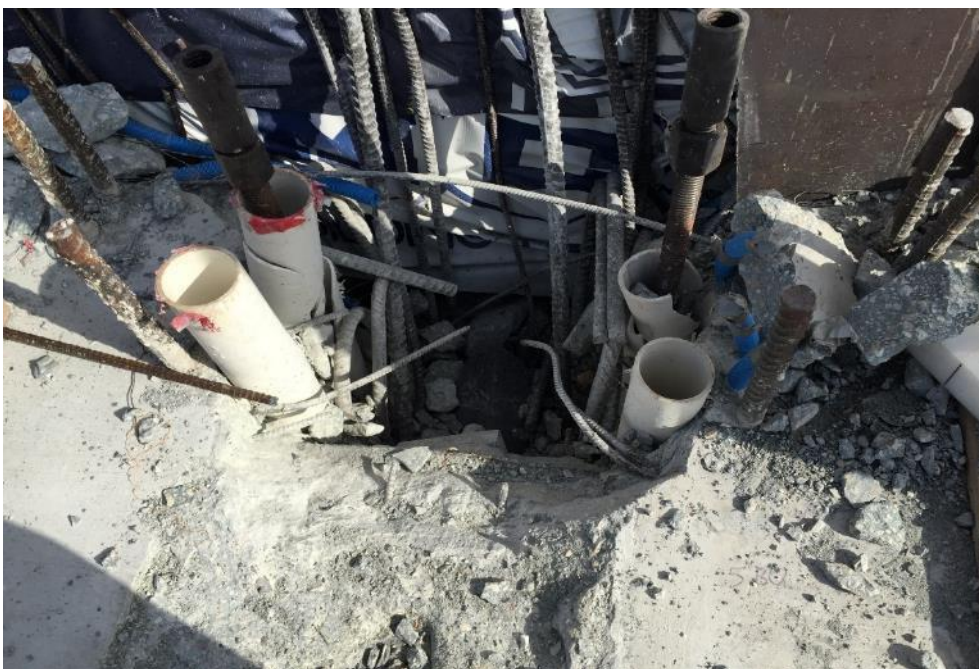
Figure 58 Concrete blow-out failure in Diaphragm II at the time of bridge collapse at the site looking north  
from south, March 21, 2018, by OSHA

Figure 59 Concrete blow-out failure in Diaphragm II at the time of bridge collapse at the site looking north from south, March 21, 2018, by OSHA

Figure 60 Concrete blow-out failure in Diaphragm II at the time of bridge collapse at the site looking north from south, March 21, 2018, by OSHA

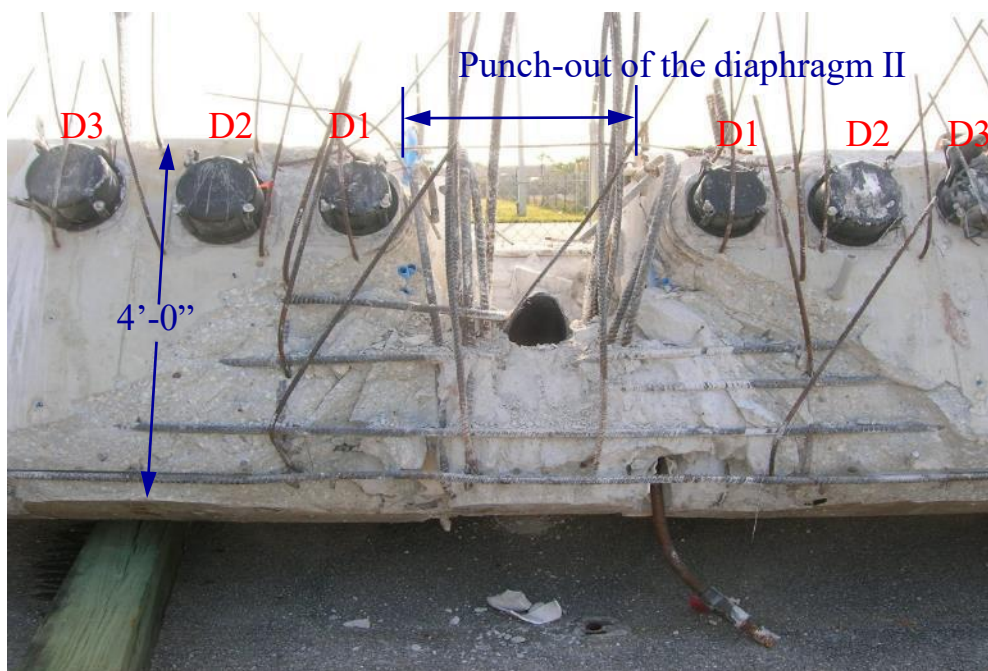
Figure 62 Concrete blow-out failure in Diaphragm II at the time of bridge collapse in the storage yard looking north from south, April 9, 2018, by OSHA

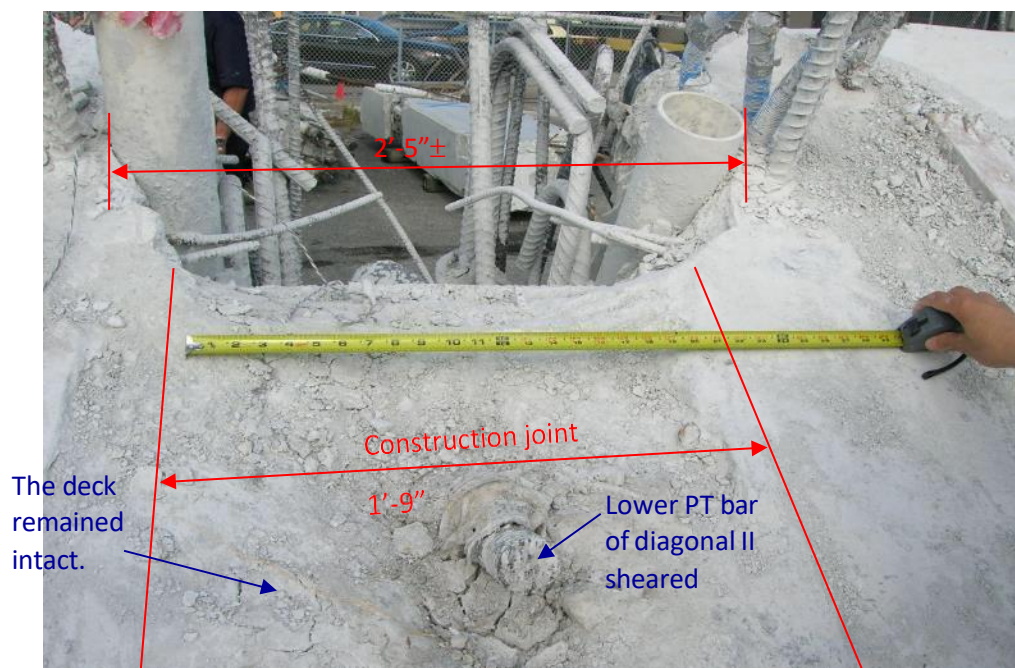
Figure 63 Blow-out hole in Diaphragm II at the time of the bridge collapse in the storage yard looking north from south, April 9, 2018, by OSHA

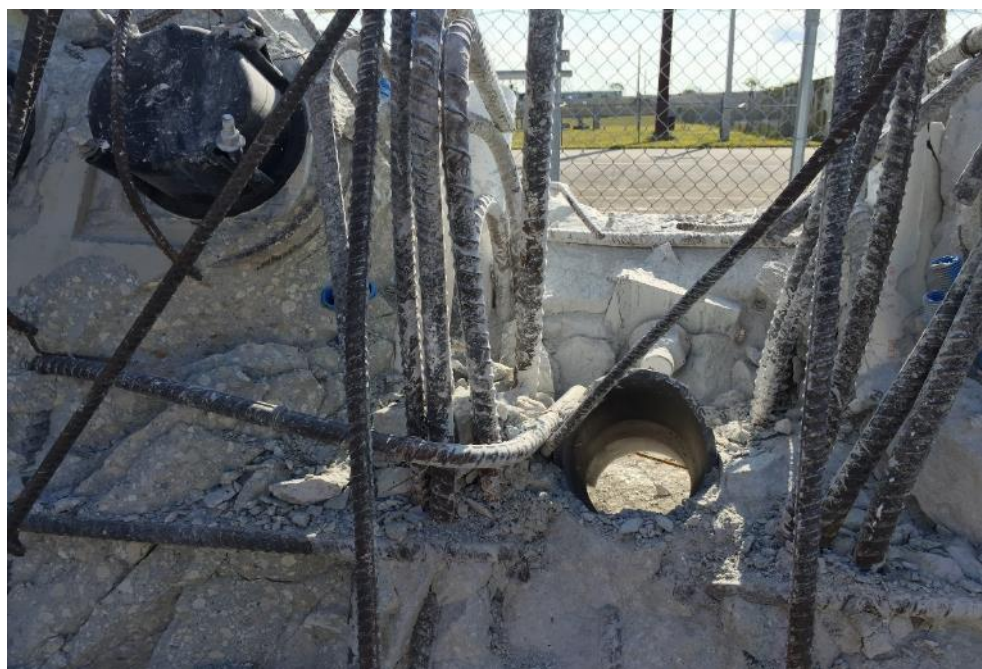
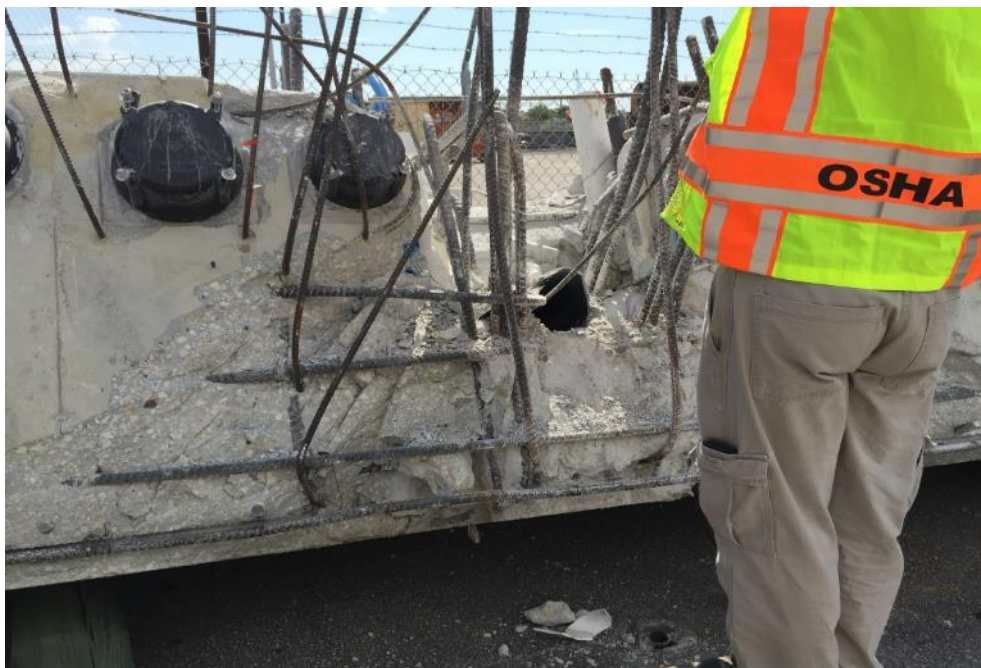
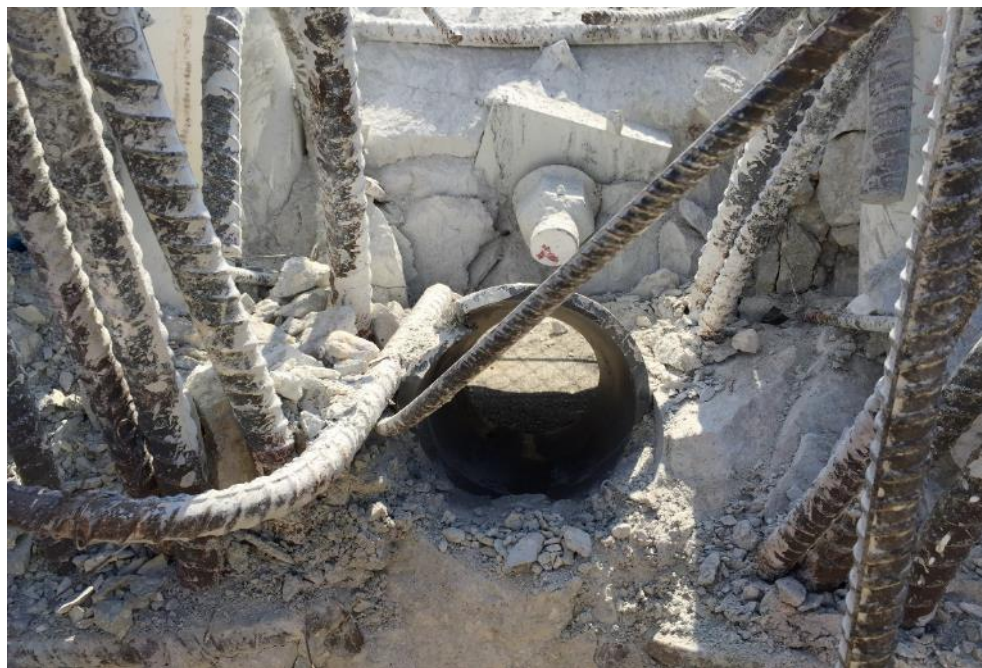
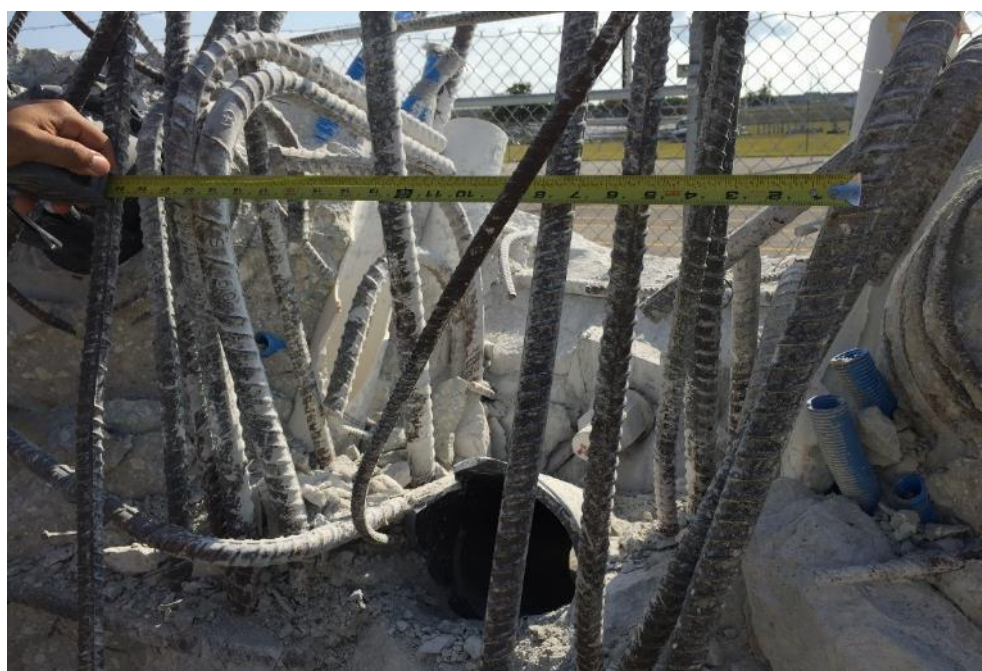
Figure 65 Punched hole in Diaphragm II at the time of the bridge collapse – from south looking towards

Figure 66 Punched hole in Diaphragm II at the time of the bridge collapse – from south looking towards north, April 9, 2018, by OSHA

Figure 67 Punched hole in Diaphragm II at the time of the bridge collapse – from south looking towards north, April 9, 2018, by OSHA

Figure 69 Punched hole in Diaphragm II at the time of the bridge collapse – from south looking towards north, April 9, 2018, by OSHA

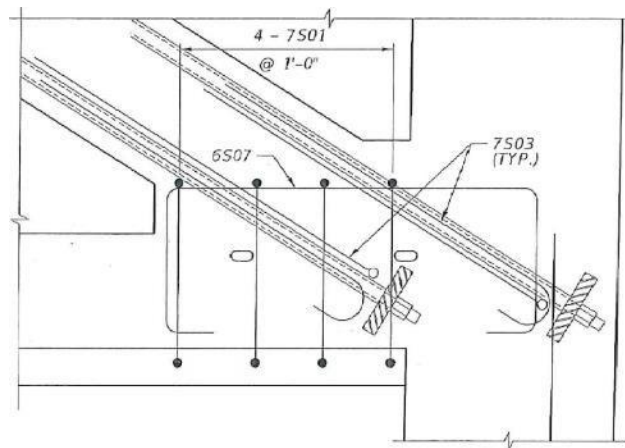
Reproduced below in Figure 77 is the detail entitled “Truss members 11 & 12 connection detail” from drawing B-61 with construction joint identified. Industry standard is to “consider shear transfer across a given plane, such as an existing or potential crack, an interface between dissimilar materials or an interface between two concrete cast at different times.” The construction joint at the bottom of the diagonal 11, therefore, qualifies for evaluation of the shear friction. This bridge is a concrete truss bridge weighing approximately 1,900 kips. Therefore the forces in the truss members are high. We will analyze the construction joint for shear friction by LRFD Bridge Design Specifications by AASHTO, seventh edition.

Figure 77 Construction joint detail at diagonal 11 and deck.

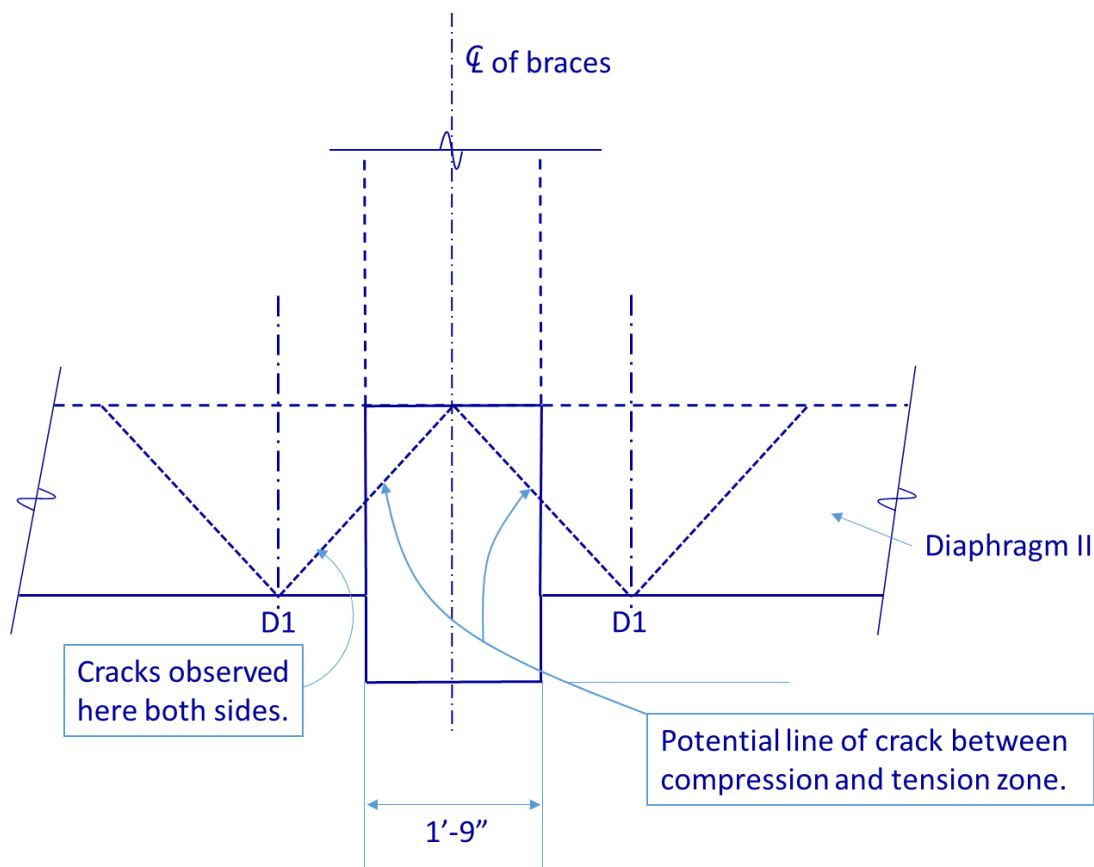
A 12" dia. semicircular cut was made in the center of the deck to accommodate an 8" round drain pipe. This not only reduced the cross sectional area of the deck at the key location but prevented the placement of any PT tendons or heavy mild reinforcement to capture the horizontal force from the deck. There was a 4" and 4½" diameter plastic pipe placed right against the columns in diaphragm II. Such locations often act as a crack initiator.

Figure 78 Potential line of crack – plan view

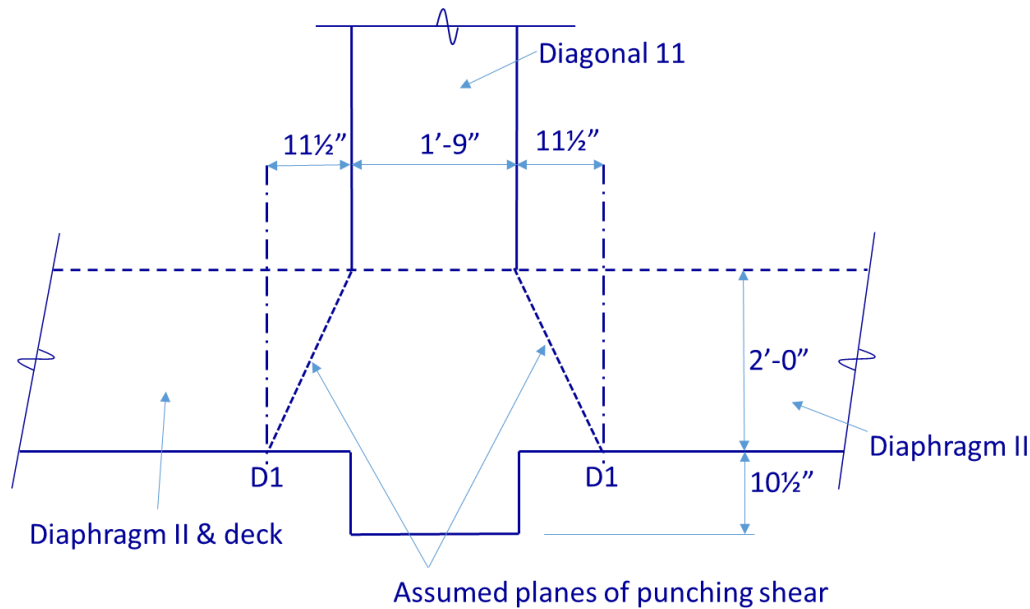
Figure 79 Potential Punching shear failure at north end – plan view
