# Structural Investigation of the January 20, 2014 Plant Collapse at International Nutrition Facility in Omaha, NE

U.S. Department of Labor  
Occupational Safety and Health Administration  
Directorate of Construction

July 2014

Report Prepared by  
Mohammad Ayub, P.E., S.E.  
Office of Engineering Services  
Directorate of Construction

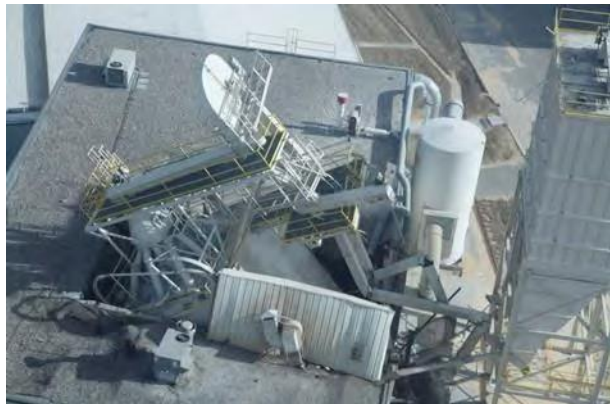
**Fig.1** Aerial view of collapse

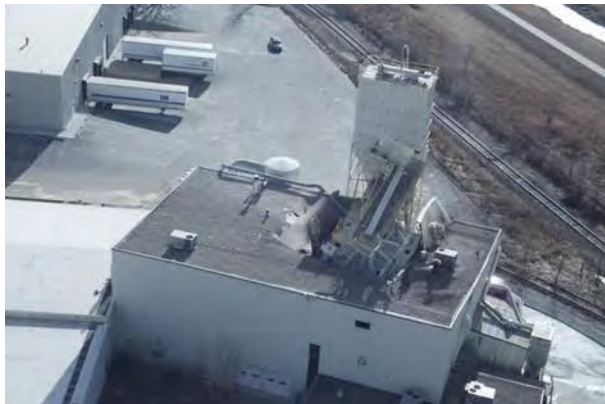
**Fig. 2** Aerial view of collapse

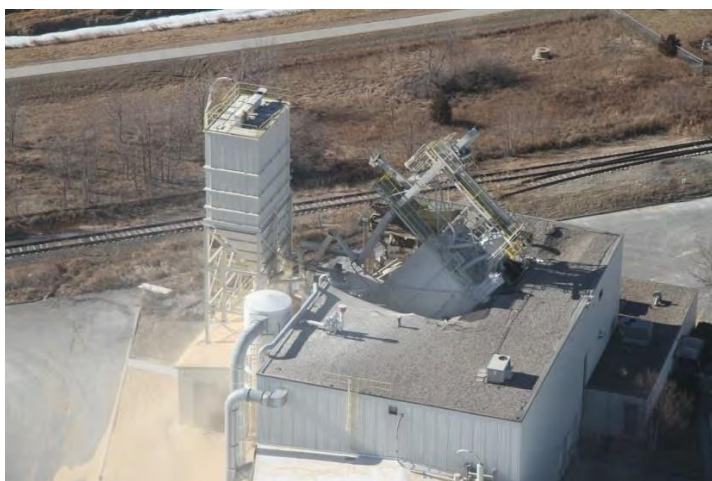
**Fig. 3** Aerial view of collapse

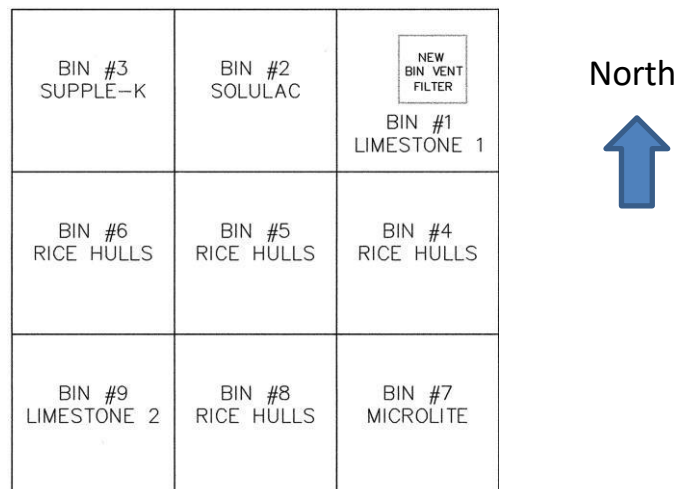
It is interesting to note that on one of the KBC drawings, F1.8 dated July 2, 1996, there is a sketch showing nine bins with limestone in two diagonally opposite bins, Microlite in one corner bin, supple-K in the fourth corner bin, with the rest of the bins having rice hulls (see Fig. 8, below).

**Fig. 8** Bin layout (Taken from drawing F1.8 by Ken Bratney Company, 1996)

We understand as per KBC that the drawing merely indicated what KBC believed to be the current practice at that time. Microlite and Supple-K generally weighs 75 and 85 pounds per cubic foot (pcf), respectively. Limestone weighs approximately 90-95 pcf, and Rice Hull is approximately 20 pcf.

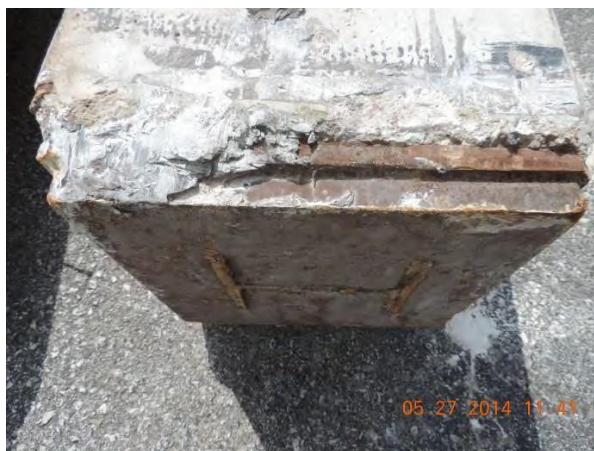
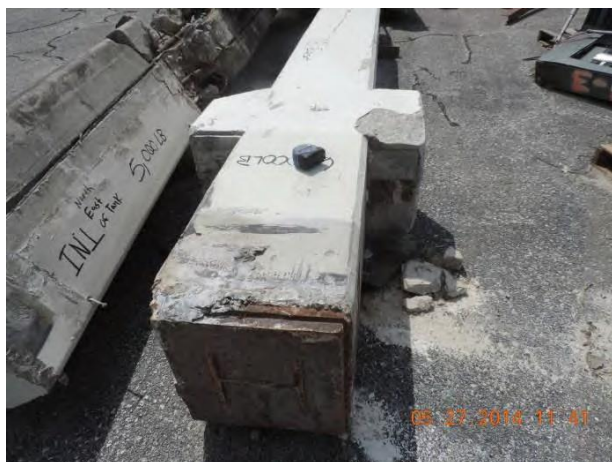
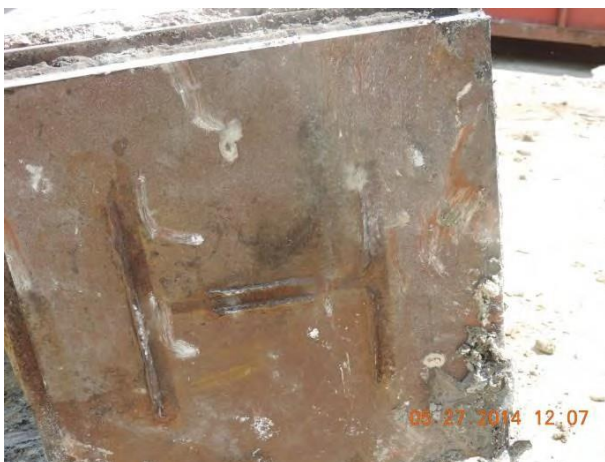
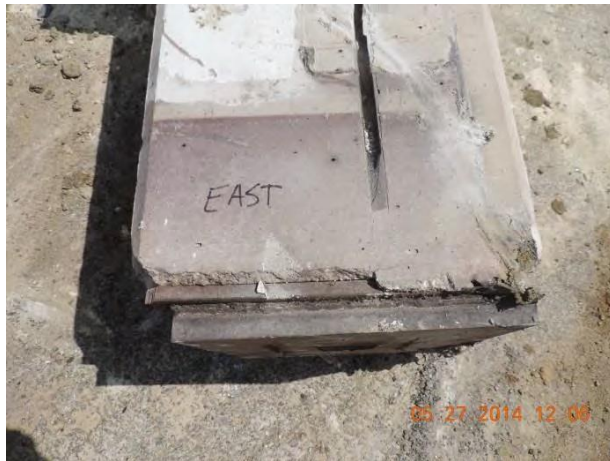
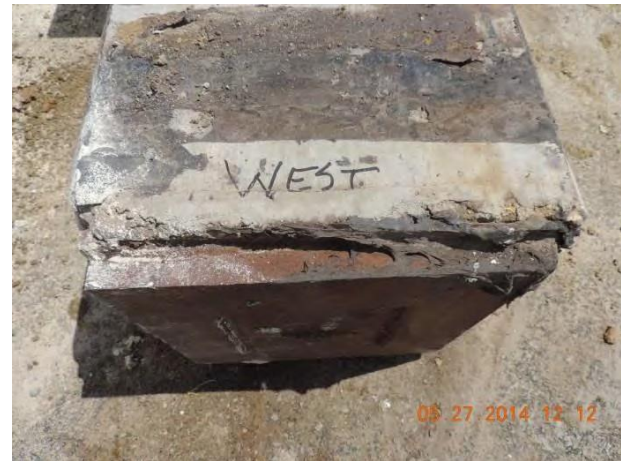
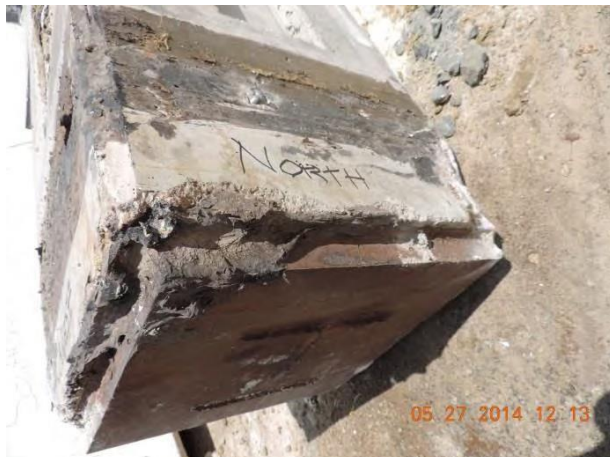
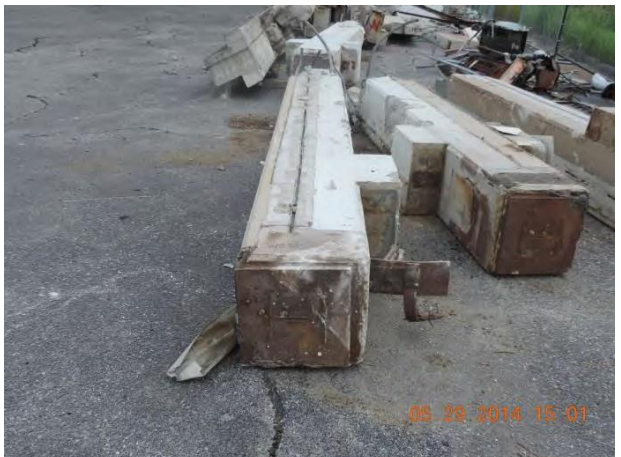
The four corner columns, W8x40, remained intact and did not exhibit any signs of distress. The failure occurred at the bottom of the columns where the welds to the column base plate failed, see Figs. 78 thru 85. The column base plate remained connected to the embed plates of the concrete columns; see Figs. 78 thru 85 and 95. For typical hoppers pictures after they have been retrieved from the debris, see Figs. 96 thru 98.

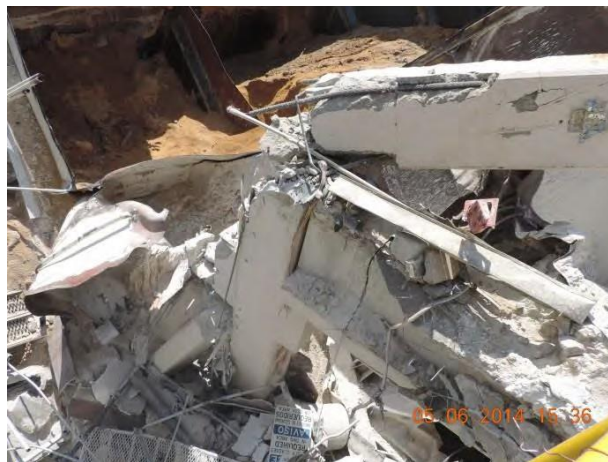
During the collapse, all four concrete columns remained intact except the NE column which was sheared at approximately the level of the inverted tee beam at the third floor, and was found inside bin No.1 during the demolition and recovery. The reason of the shear at that location was the lack of adequate lap splice of the longitudinal bars on one face of the column, see Figs. 99-103.

**Fig. 101** Another view of fracture of NE column at 3<sup>rd</sup> floor

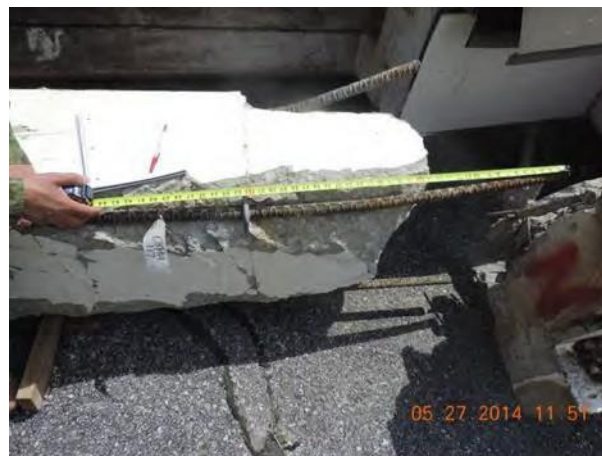
**Fig. 103** NE corner column showing inadequate lap splice

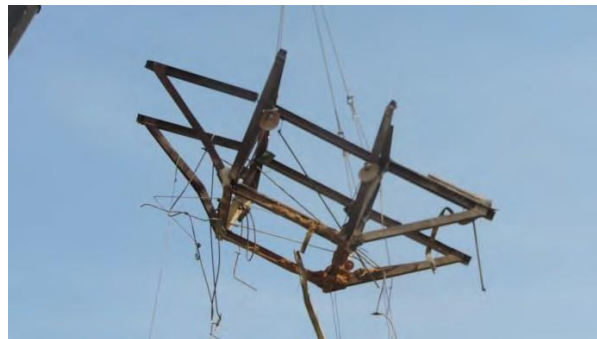
The four interior trusses escaped serious damage and emerged relatively intact from the debris see Figs. 104 and 105. The top chords of the north and south interior trusses were continuous

**Fig. 105** Interior trusses being retrieved
