# Tank Explosion in West Virginia

# Investigation Report

Published: December 2019

On May 24, 2017, an explosion occurred at the Midland Resource Recovery (MRR) facility in Philippi, West Virginia, killing two workers<sup>a</sup> and severely injuring another worker. The founder and president of MRR was one of the victims. The CSB initiated an investigation of the incident and deployed an investigative team on May 28, 2017. While the CSB was investigating this incident, the MRR facility experienced a second explosion, on June 20, 2017. This explosion fatally injured a contractor<sup>b</sup> employed by Specialized Professional Services, Inc. (SPSI). MRR had hired SPSI to perform investigation and mitigation work at its Philippi facility following the May 24, 2017, explosion.

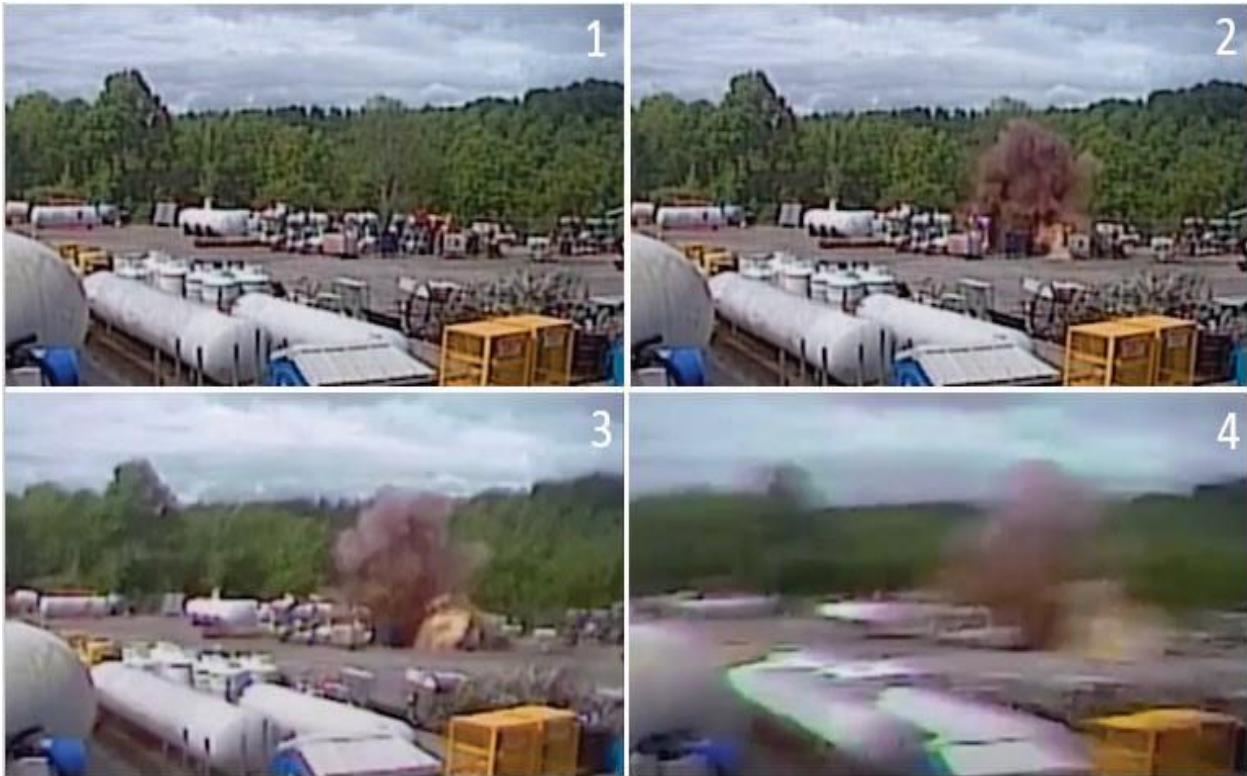
Figure 9. Surveillance Video Capturing May 24, 2017, Explosion. These still frames from an MRR surveillance camera capture the May 24, 2017, explosion. (Credit: MRR).

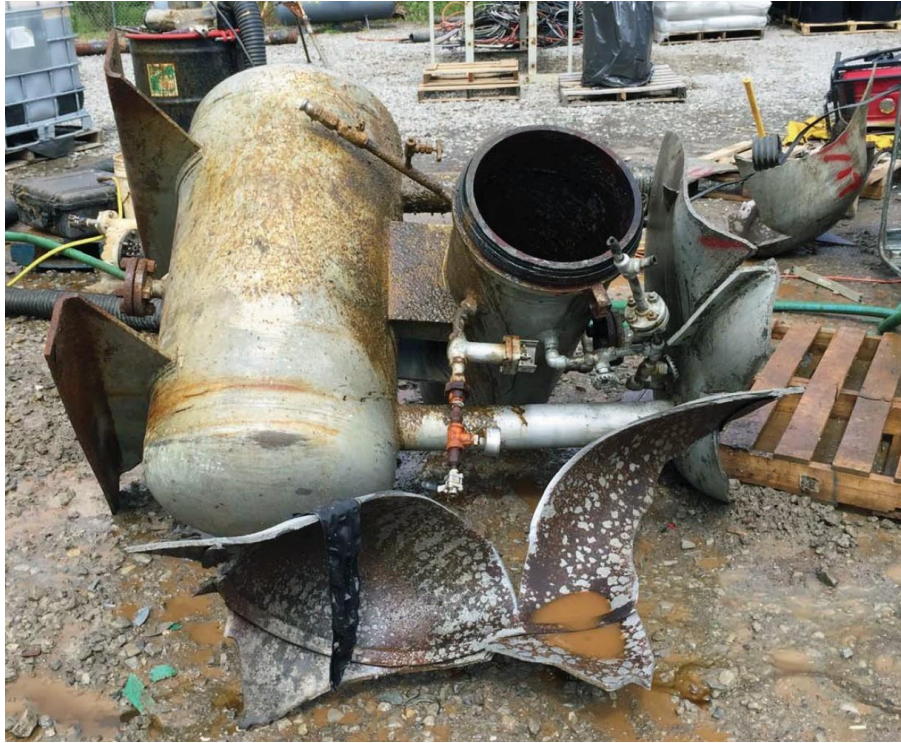
The CSB could not determine the exact actions of the three personnel leading up to the explosion because there were no immediate witnesses, and surveillance footage could not be used to determine their actions definitively. Figure 9 shows still frames of the explosion from the surveillance footage. Figure 10 and Figure 11 show the MP odorizer after the incident. Figure 12 shows the variation in appearance of process water within MRR’s chemical treatment process. Figure 13 shows aluminum components that were likely inside the middle chamber of the MP odorizer. MRR

Figure 10. MP Odorizer That Exploded on May 24, 2017. This photo shows the failed MP odorizer from the May 24, 2017, explosion. (Credit: MRR).

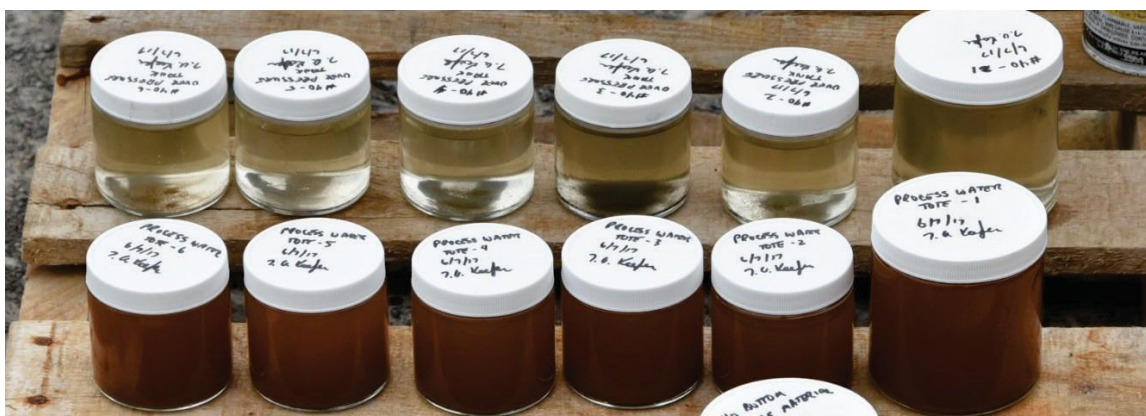
Figure 12. Process Water. The light-yellow samples (top row) were taken from the bottom chamber of the MP odorizer that exploded on May 24, 2017. The brown samples (bottom row) were taken from a “process water” tote not involved in the May 24, 2017, incident. Note the color differences showing the drastic color variation of the process water, indicating that different vessels likely had different types and quantities of materials in them before chemical treatment. (Credit: CSB).

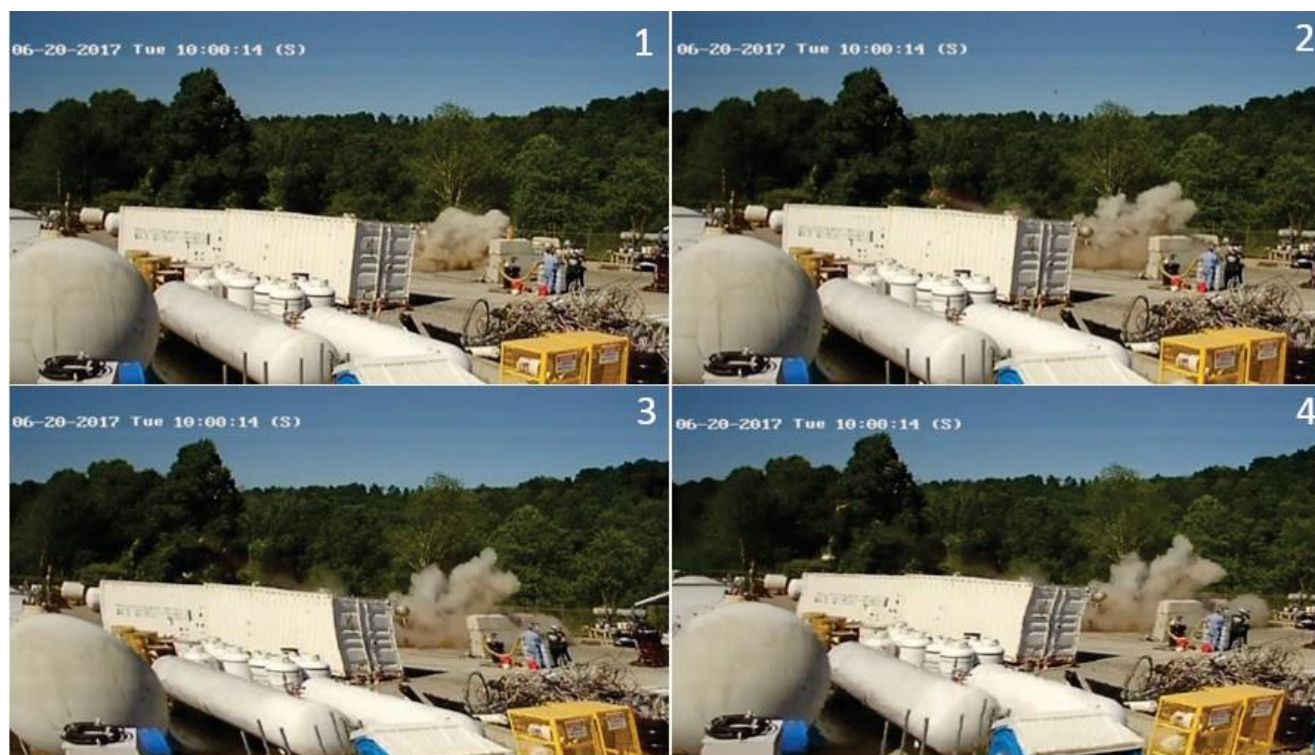
Figure 15. Surveillance Video Capturing June 20, 2017, Explosion. These still frames from an MRR surveillance camera capture the June 20, 2017, explosion. The MP odorizer involved in the explosion is partially obstructed from view, behind the white shipping container. No flames were visible in the surveillance footage. (Credit: MRR).

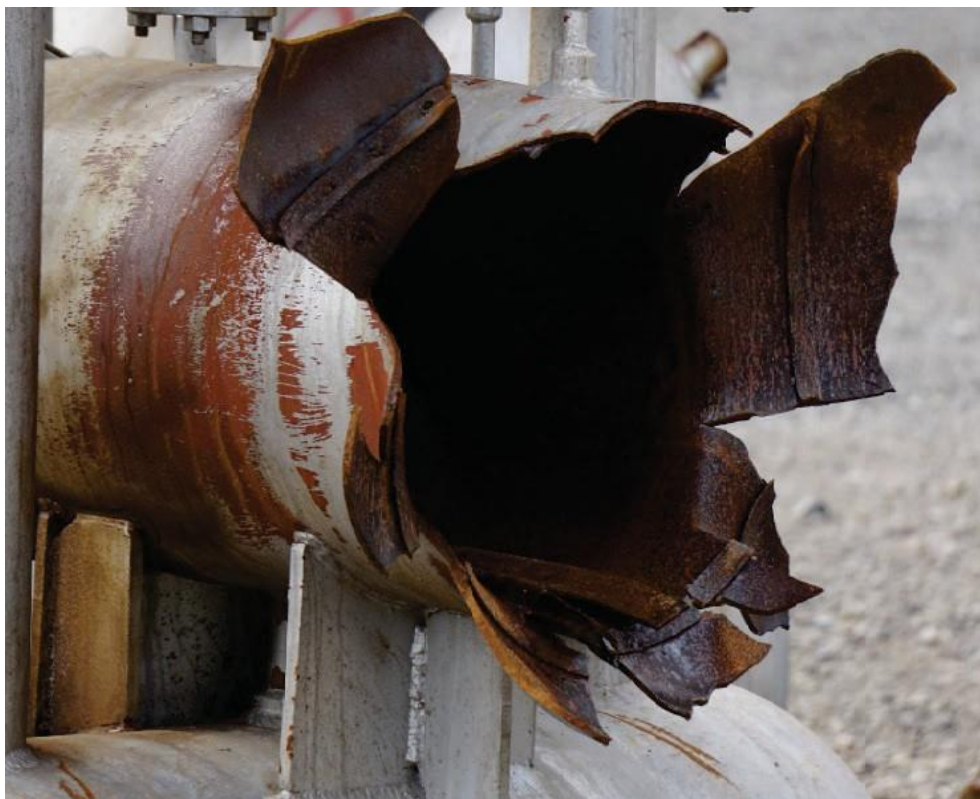
Figure 17. Ruptured MP Odorizer Middle Chamber from June 20, 2017, Incident. This photo shows the post-incident condition of the rounded end of the middle chamber that ruptured in the June 20, 2017, explosion. (Credit: SPSI).

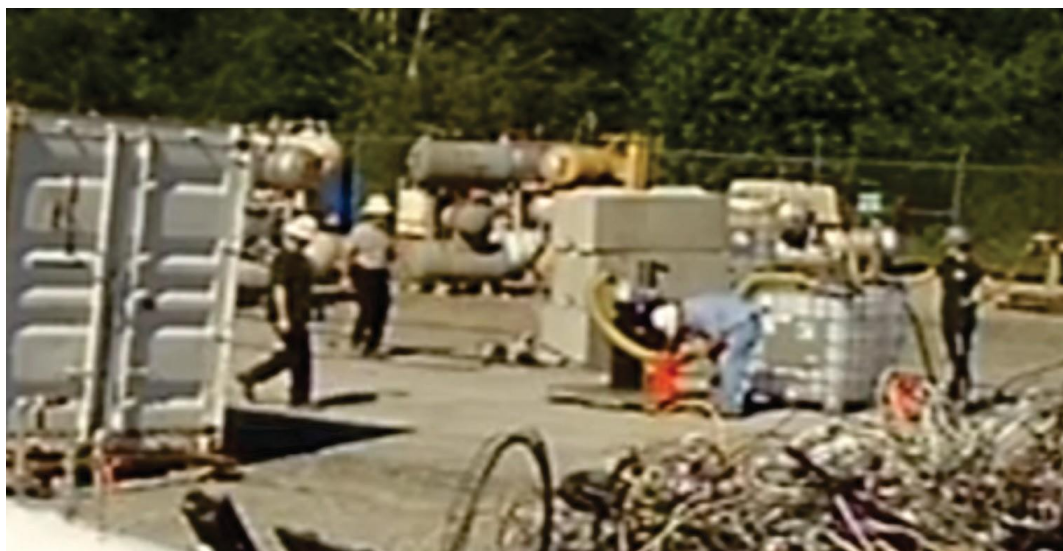
The SPSI manager’s statement about the concrete barriers is consistent with the protocol SPSI developed to drain the process water from the MP odorizers. The protocol does not mention the concrete barriers, establish any type of exclusion zone near the MP odorizer, or suggest that SPSI workers would use the concrete barriers as a safeguard while performing the work. The SPSI manager’s statement is also consistent with the worker actions that took place on June 20, 2017. During the nearly five minutes from when SPSI started their activities to drain the process water from the MP odorizer up to the time of the explosion, only one of the four SPSI employees consistently remained behind the concrete barrier wall (Figure 18).

Figure 18. Concrete Barriers. This surveillance video image from June 20, 2017 at 9:56 a.m., shows only one of four SPSI workers positioned behind the concrete barrier. Two other concrete barriers were placed, but they are outside the view of this surveillance camera (Credit: MRR).

Based on SPSI worker actions captured by the surveillance video leading up to the explosion, MRR and SPSI needed to provide more barriers and strengthen their work plan for these concrete barriers to properly serve as a worker protection safeguard. Had MRR and SPSI established a more robust barrier system, such barriers may have helped to protect the SPSI field supervisor from being struck and fatally injured by the projectile when the MP chamber

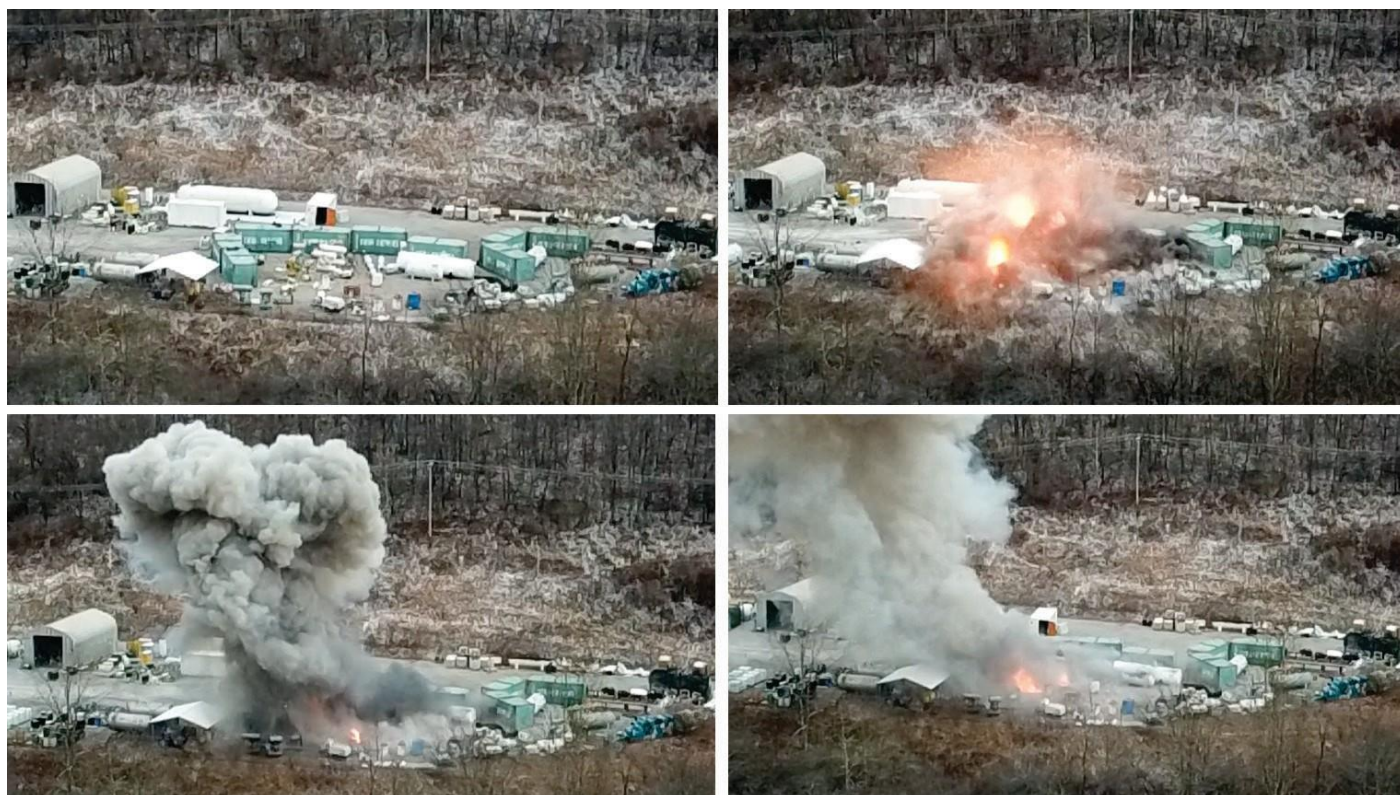
Figure 19. Explosive Venting. These drone video images show the explosive venting used to cut holes in a group of MP vessels to drain the vessels while minimizing risk to people. The bottom right image shows a fire that erupted from flammable liquids that drained from some of the MP vessels. (Credit: MRR).

The use of explosive venting of the vessels at MRR provides the safest means to reduce the risk of another incident. Both incidents have resulted after manual manipulation, of some kind, of valves or fittings on the vessels. The use of explosive venting of large and small compressed gas vessels, is and has been used for at least 35 years and is the industry standard for reducing risk of catastrophic pressure vessel failure [Figure 19].

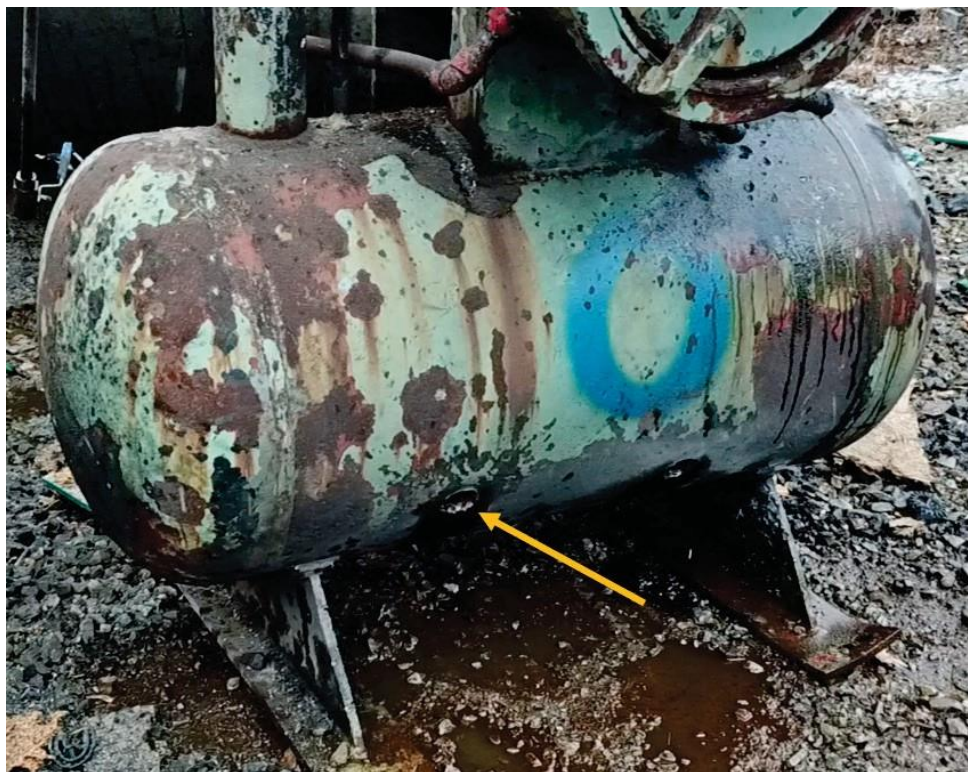
Figure 20. Drain Hole. This drone image shows one of the holes cut by the explosion venting process used to drain the bottom chamber of an MP vessel. (Credit: MRR).

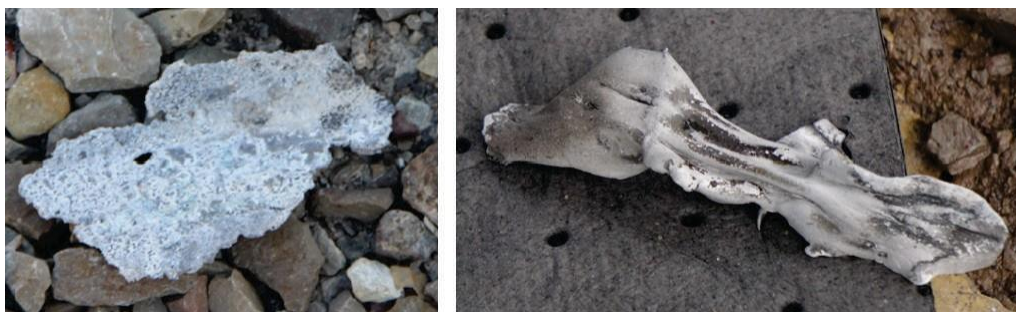
Physical evidence from the May 24, 2017, and June 20, 2017, incidents show differences in the aluminum MP odorizer components. For example, aluminum components from the May 24, 2017, incident have a general corrosion appearance while aluminum parts from the June 20, 2017, incident show signs of melting from heat (Figure 21). These differences could be related to how much exposure the aluminum parts had with the sodium hypochlorite and whether or not liquid was present in chamber two, affecting how much these parts were heated by the explosion. It is also possible that the physical difference in the aluminum parts may indicate that the reactive chemical mechanism involved was not the same.

Figure 21. Aluminum Parts. The picture on the left shows an aluminum part from the MP odorizer involved in the May 24, 2017, incident that appears to have general corrosion. The photo on the right shows an aluminum part from the MP odorizer involved in the June 20, 2017, incident that appears to show signs of melting from heat. (Credit: MRR (left), SPSI (right)).

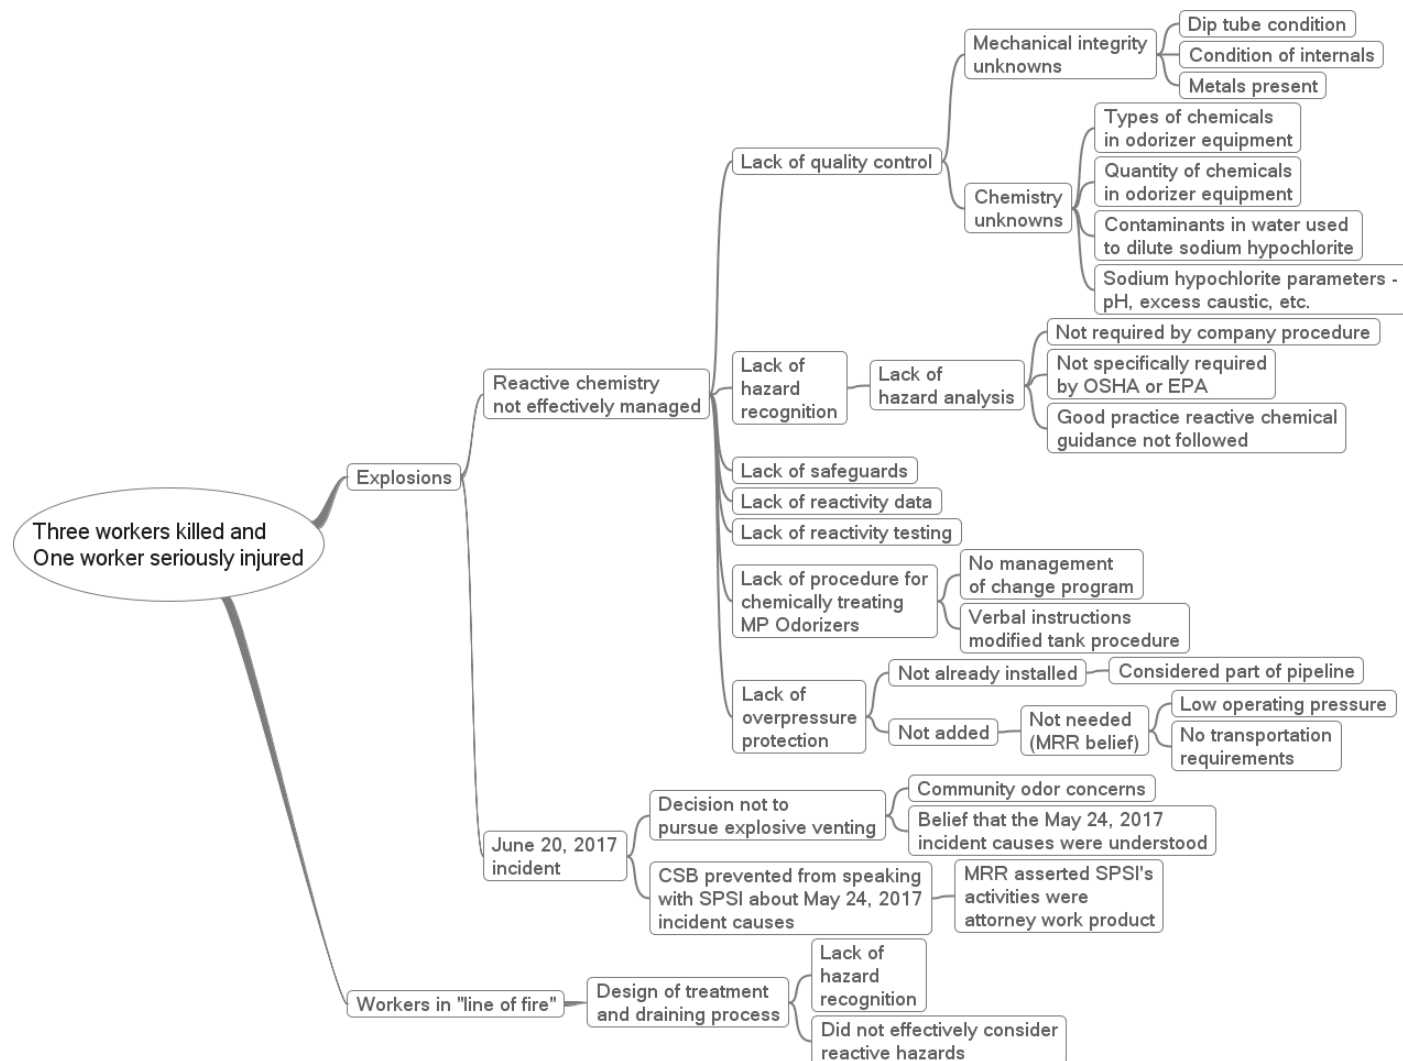
Figure 22. Causal Analysis. This image shows a simplified version of the CSB causal analysis. (Credit: CSB).
