# EPA/OSHA JOINT CHEMICAL ACCIDENT INVESTIGATION REPORT

Napp Technologies, Inc.  
Lodi, New Jersey

## **Executive Summary/Overview**

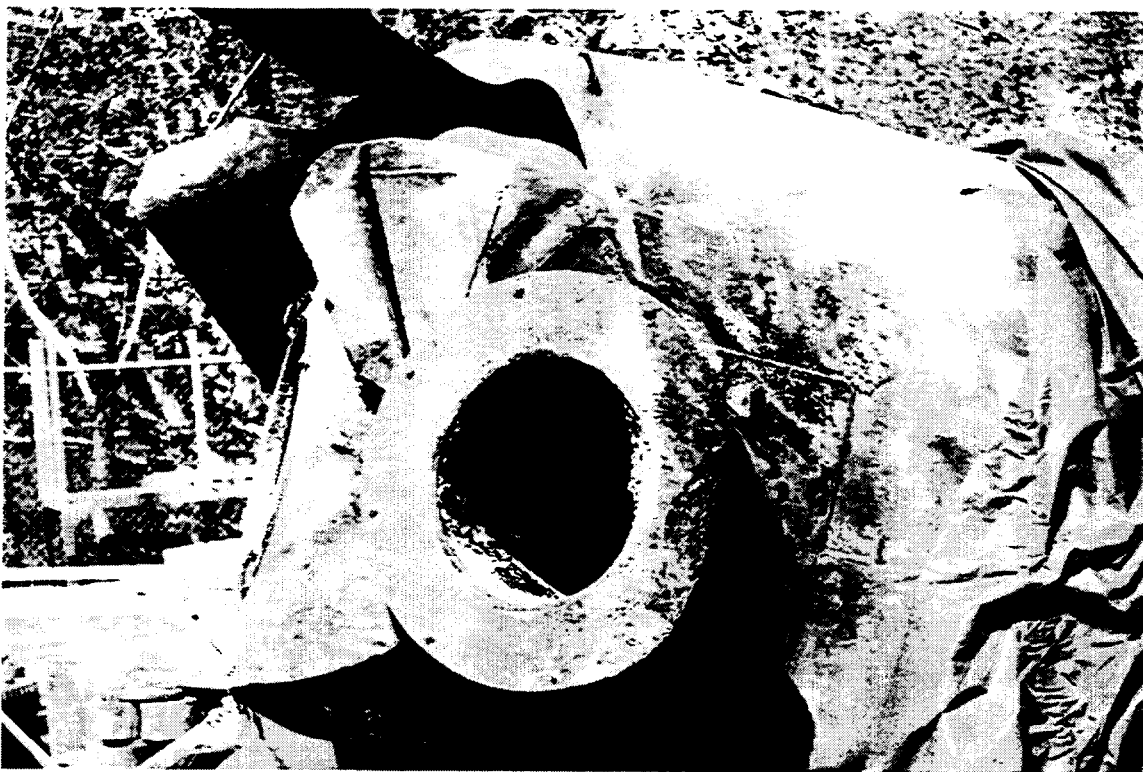
Figure 9: The general condition of the 125 cubic foot blender: a) the top access ports and damaged insulation jacket, and b) the flange to which the belt drive attaches.

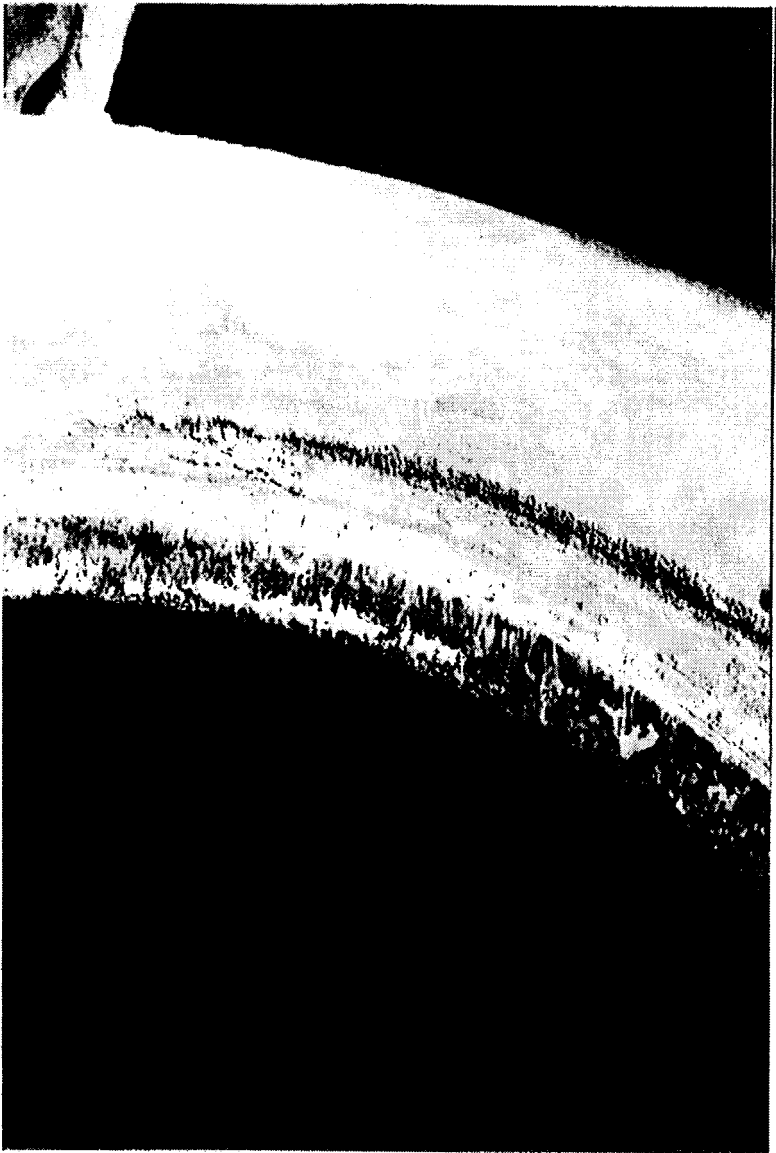
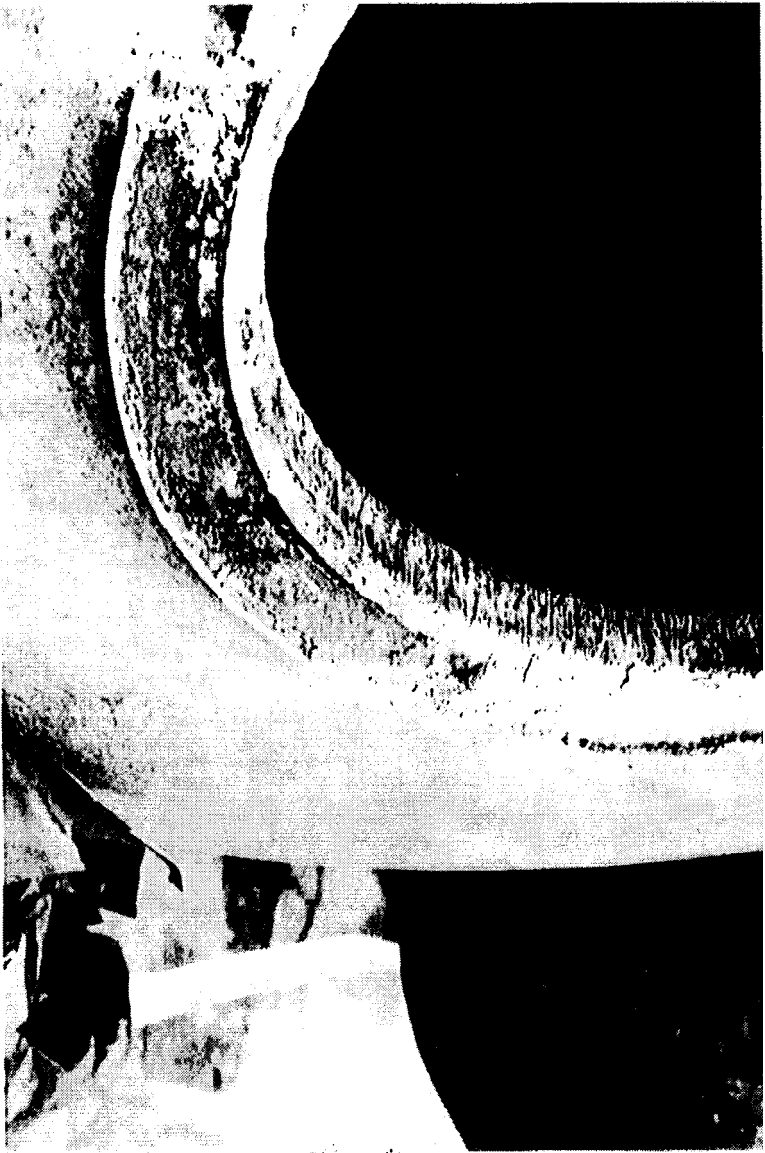
The analysis of the remains of the blender showed extensive erosion damage in parts of the interior and around several openings. Ejection of heated material from the inside of the blender is the likely cause of the erosion. The blender also showed extensive damage attributed to impact when the blender was propelled about 40 feet due to the explosion. The investigators looked in particular for possible damaged areas where water could have entered the blender. Metallurgical examination of the water-cooled graphite seal for the vacuum tube showed grooves that could have allowed water to leak into the blender.

Figure 12: The striation markings on the top access ports.

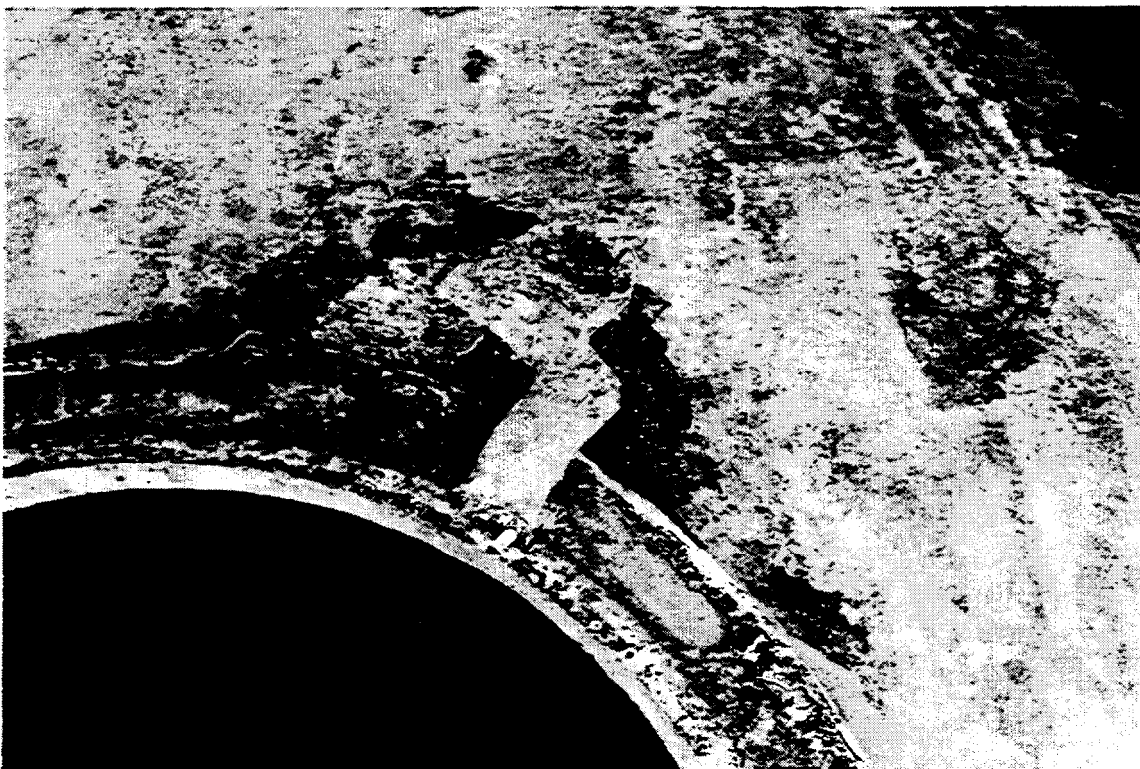
Figure 13: The tabs that held the to access port door are bent down against the stainless steel shell.

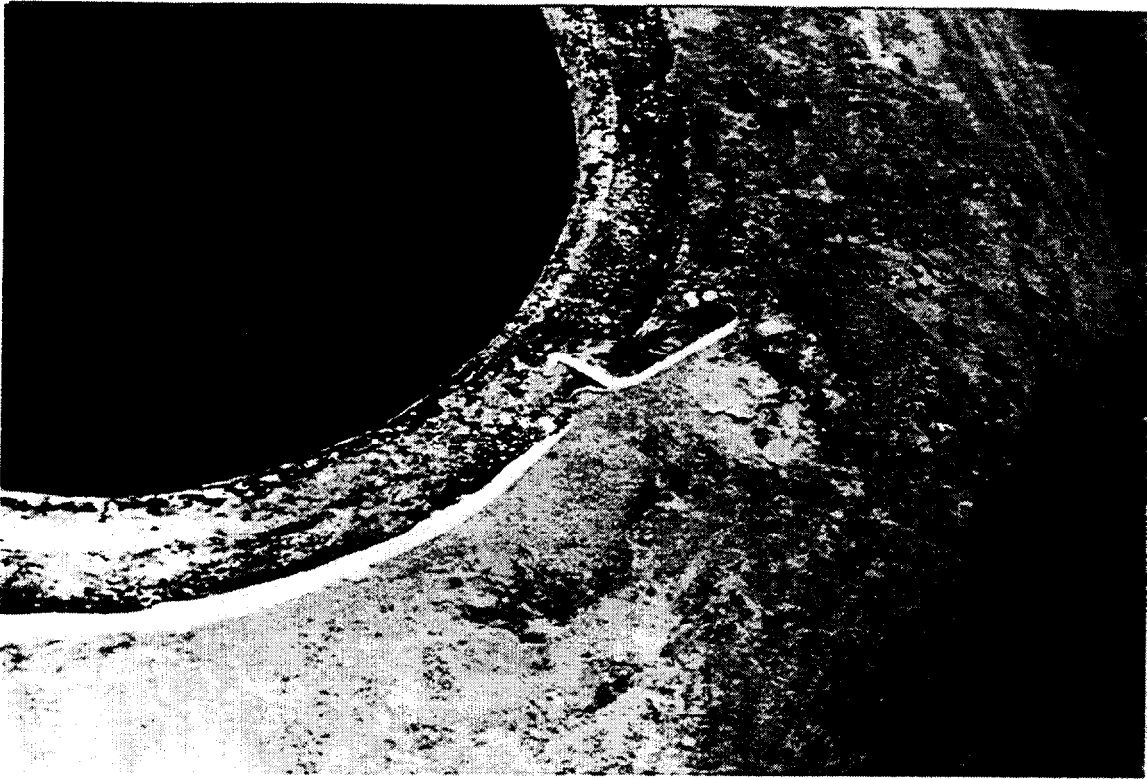
Figure 14: The insulation jacket has torn away from where it was attached to the stainless steel shell and the access door tabs are bent over against the shell.

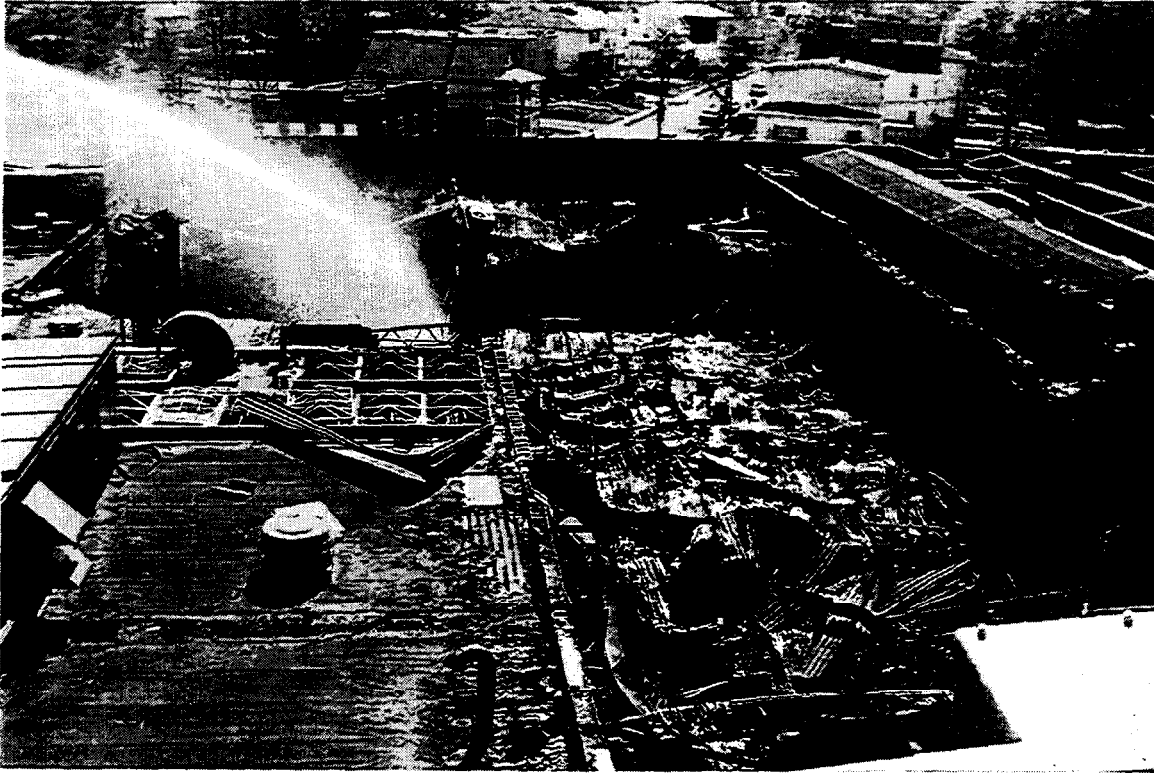
Figure 24: The Napp facility after the explosion and fire showing location in the plant where the processing took place and the location of the facility with respect to residential area in background.
