EPA/OSHA JOINT CHEMICAL ACCIDENT INVESTIGATION REPORT

**Shell Chemical Company
Deer Park, Texas**

Accident Investigation Report

Shell Chemical Company, Deer Park, TX, June 22, 1997

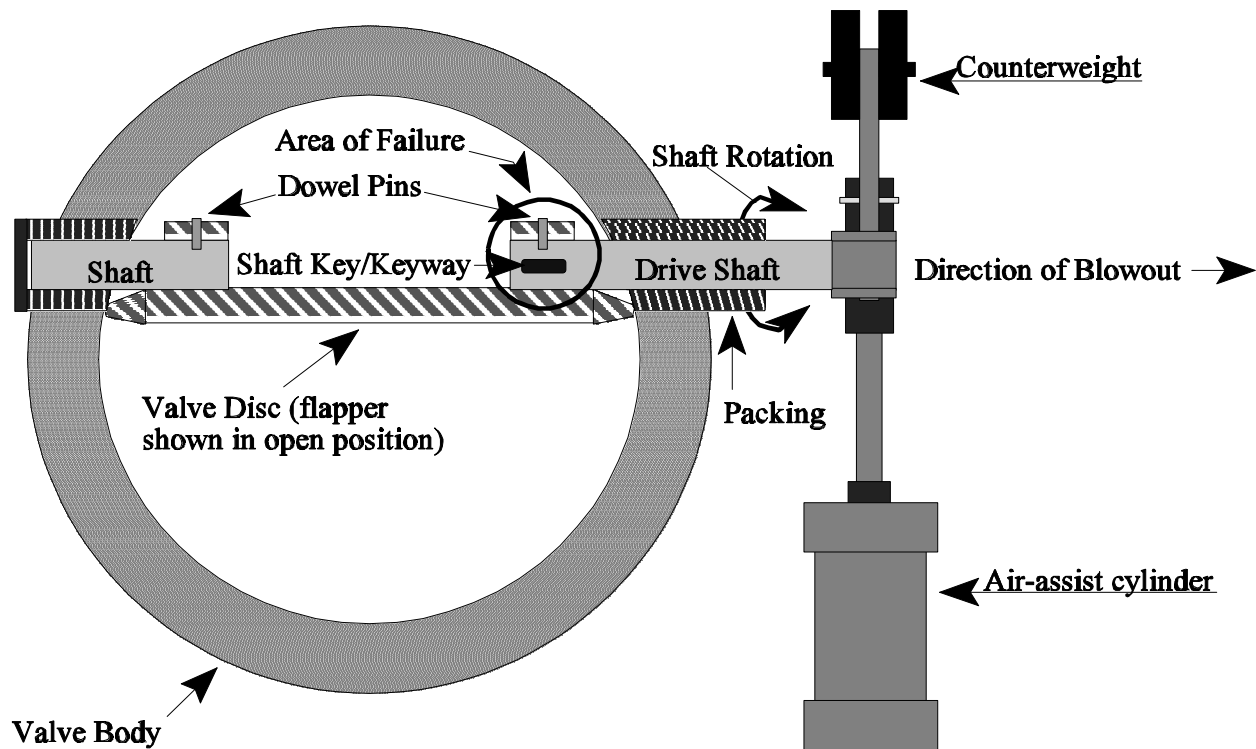
Figure 2: Clow Model GMZ Pneumatically-Assisted Check Valve

The Clow Model GMZ check valve installed as the PGC fifth stage suction check valve had an internal diameter of 36 inches and weighed 3.2 tons. The valve had a design limit pressure of 480 psig, and a design limit temperature of 115 degrees Fahrenheit. The JCAIT found no evidence that these limits were exceeded at any time prior to or during the accident.

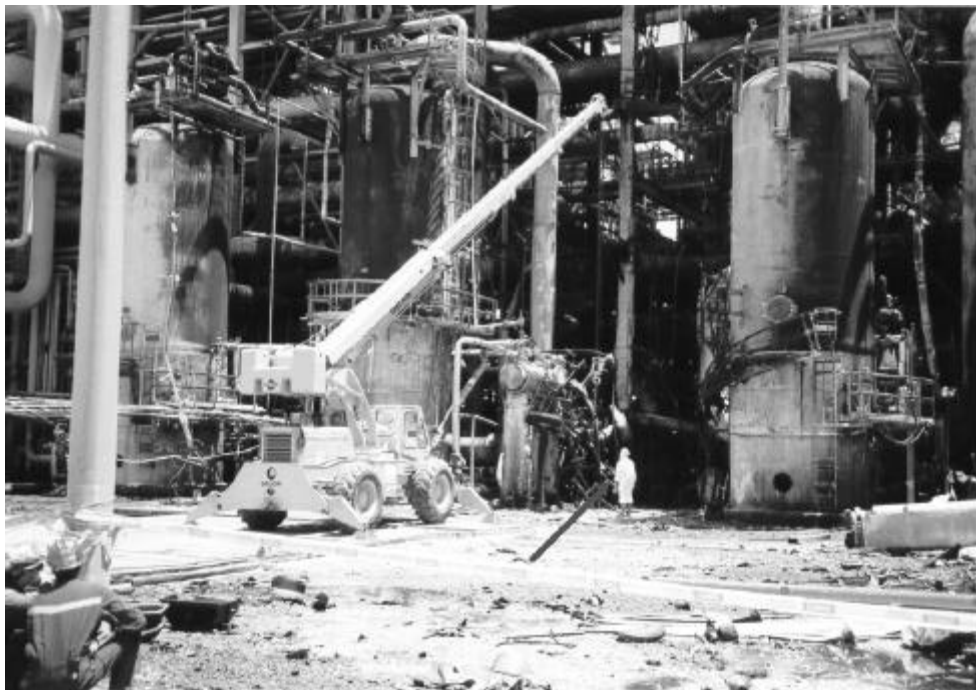
Figure E-6: Photograph of explosion and fire damage in the area of the PGC fifth stage suction and discharge drums (viewed from the north). The man in the lower center provides a reference to the scale of the surrounding structures. The failed check valve was located behind the drum to the man's right.

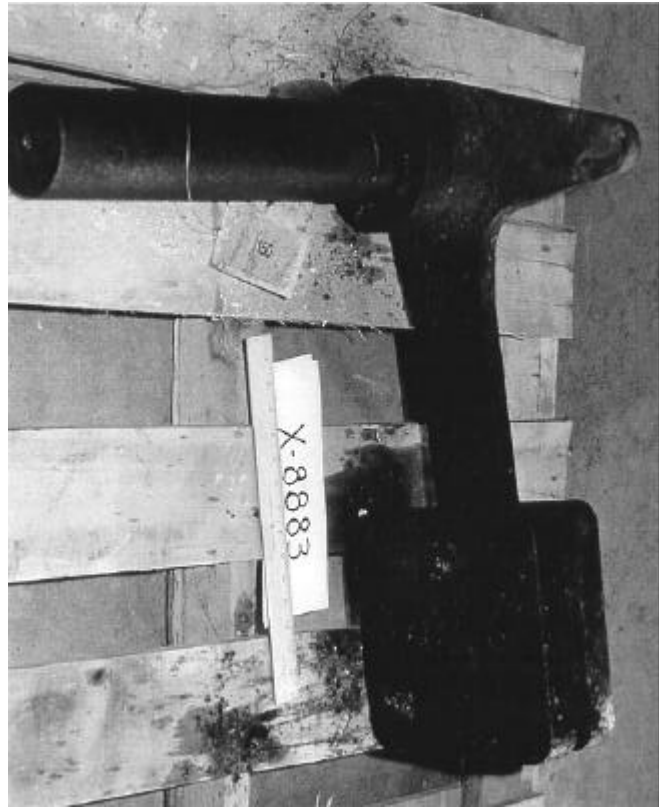
Figure E-11: Photograph shows the drive shaft and counterweight that were ejected from the 36" Clow check valve.

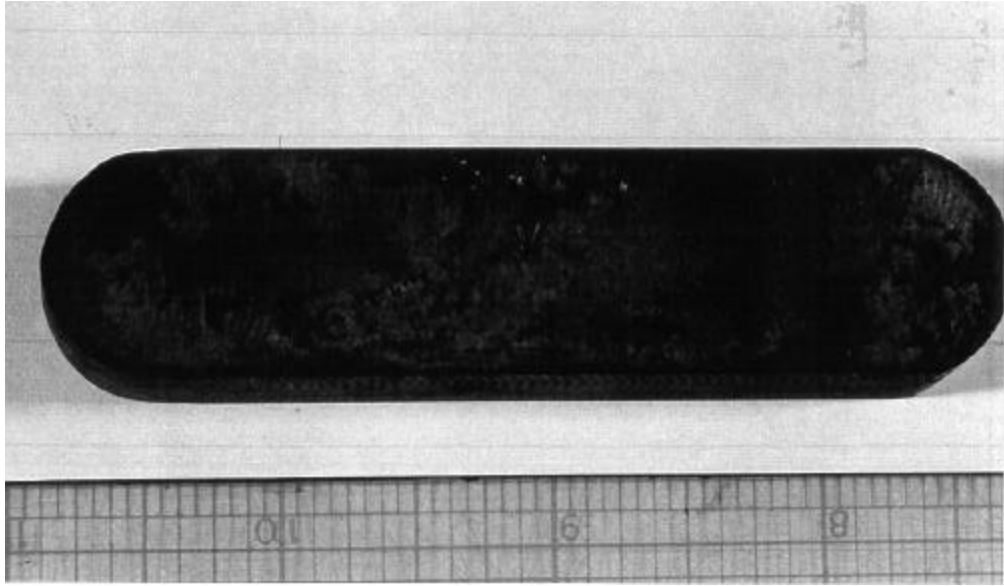
Figure E-13: Photograph shows the metal key intended to help mechanically connect the drive shaft to the valve disk.

Figure E-14: Photograph depicts the measured looseness of the key within its machined slot, or keyway. The key was intended to transfer torque between the shaft and the valve disk, but the key's loose fit forced the much smaller dowel pin to transfer virtually all drive shaft torque. The key eventually fell out of its slot as the drive shaft moved outward after the dowel pin fractured.

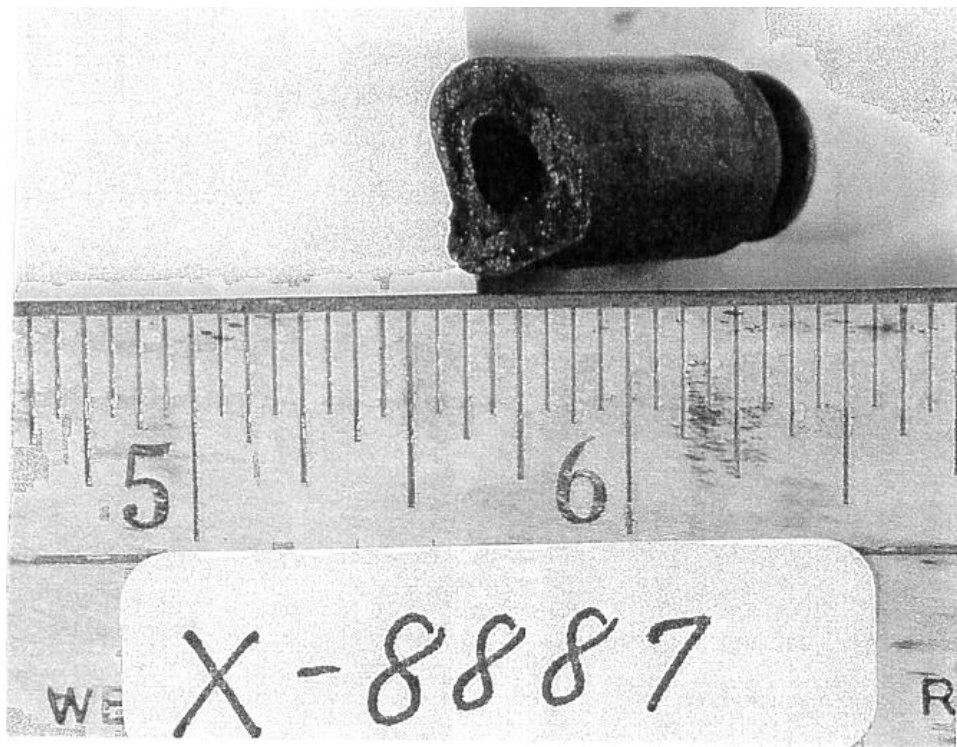
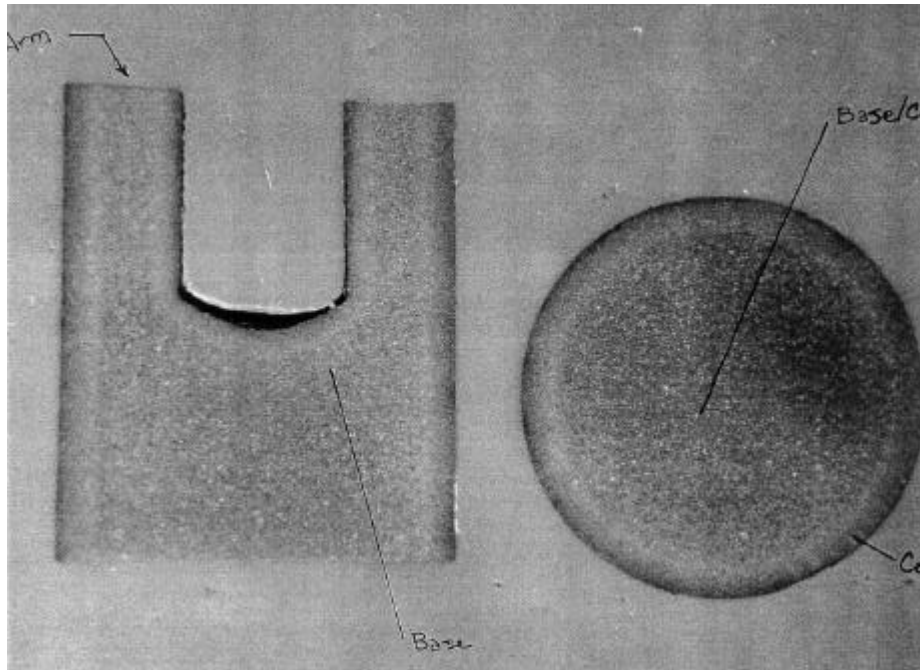
Figure E-17: Views of the longitudinal and transverse cross-sections taken through the intact dowel pin showing the carburized case at both the outside diameter of the pin and within the drilled hole.

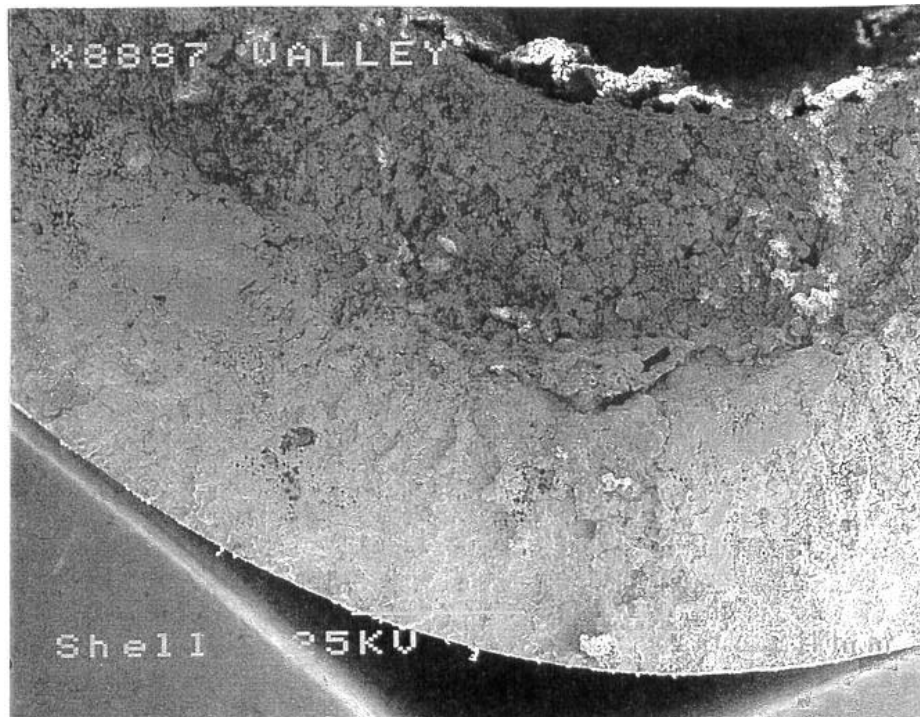
Figure E-18: 25X magnification fractograph displaying a portion of the fracture face of the dowel pin which broke in the service of the 36" Clow check valve.

Figure E-19: 100X magnification scanning electron microscope (SEM) fractograph depicting the intergranular fracture at the carburized surface of the dowel pin.

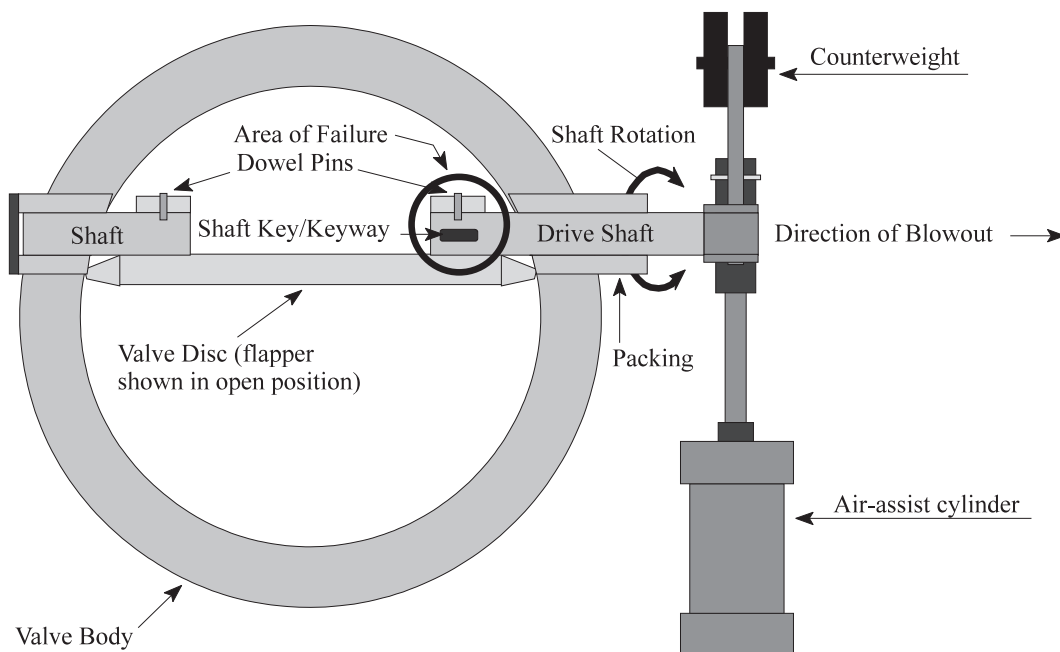
Simplified cross-sectional view of check valve (flow direction is into page)

Valves subject to this hazard may be designed with a two-piece valve stem (sometimes referred to as a "stub-shaft" design). In each of the cases described above, the malfunctioning component was a Clow stub-shaft Model GMZ pneumatically assisted swing check valve (see diagram below). In these check valves, one stem piece functions as a drive shaft that connects the internal valve disk to an external air-assist cylinder and counterweight assembly. The drive shaft penetrates the pressure boundary through a stuffing box. The exterior portion of the drive

shaft is connected to a pneumatic piston and counterweight, and the interior portion of the shaft is coupled directly to the valve disk using a cylindrical hardened steel dowel pin and a rectangular bar key. This arrangement provides a power-assist to close the valve during compressor shut down, preventing reverse flow of compressed gases. These particular valves have probably not been produced since 1985, but still exist in some process facilities constructed before that date. Similar valves currently or previously produced and sold by other valve manufacturers may also be subject to this hazard.
