# Pressure Vessel Explosion at Loy-Lange Box Company

St. Louis, MO | Incident Date: April 3, 2017 | No. 2017-04-I-MO

# **Investigation Report**

### Published: July 29, 2022

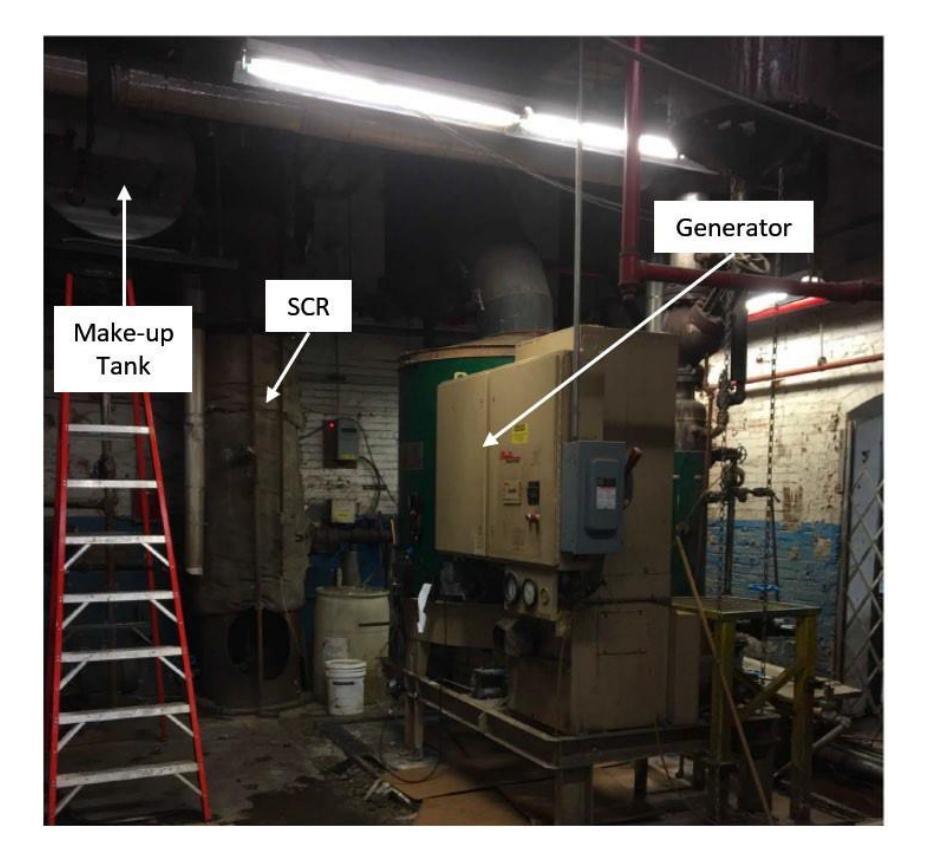
**Figure 3.** Pre-incident photo of the Loy-Lange steam generation equipment. (Credit: Clayton. Annotated by CSB.)

A pre-incident picture of the Loy-Lange steam generation room is shown below in **Figure 3**, which also shows the close proximity of the SCR to one of the steam generators.

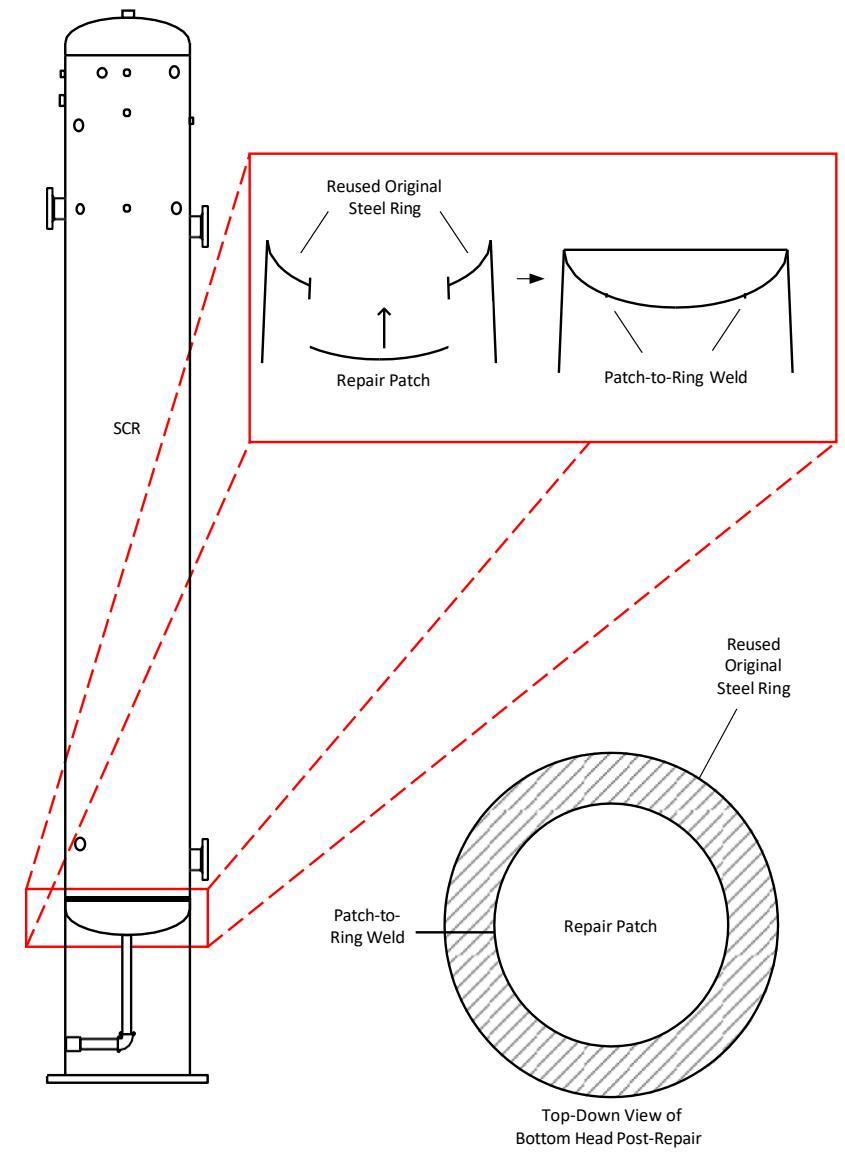
**Figure 7**. Conceptual diagram showing repair made to SCR bottom head in 2012. (Credit: CSB)

As illustrated in **Figure 7**, Kickham cut the SCR shell from the bottom head, leaving the bottom head attached to the skirt. With the bottom head and skirt removed from the SCR shell, Kickham inspected the inside surface of the SCR. A Kickham employee who oversaw the repair said Kickham observed pitting corrosion damage in the bottom head. The employee said that the corrosion pits were isolated in the center of the head. With access to the inside surface of the

bottom head, Kickham cut out a circular portion of the center of the bottom head. According to a Kickham employee, the size of the circular portion was chosen to remove all the pitting and corrosion damage. The Kickham employee also told CSB investigators that the repair removed all corrosion damage in the SCR bottom head. In interviews, CSB investigators asked whether Kickham did any ultrasonic thickness (UT) measurement during the course of its repair. CSB investigators also asked whether Kickham inspected visually or used a micrometer.

When Kickham cut out a circular portion of the bottom head, it left a ring of the original head material still connected to the shell. This report calls this material the "reused original steel ring." Kickham welded the new patch plate (termed the "repair patch" in the remainder of this report) to the reused original steel ring of the bottom head.<sup>a</sup> Kickham then rewelded the bottom head and skirt assembly to the SCR shell. Kickham told the CSB that when workers welded the patch in, the metal to which they were welding (the reused original steel ring) was of nominal thickness (0.250 inches). Kickham and Loy-Lange conducted a post-repair hydrostatic pressure test on the SCR prior to returning it to service. The test was conducted using water at 110 psig.

After the incident that is the subject of this report, Kickham told the CSB that Kickham did not fabricate ellipsoidal heads, such as the SCR bottom head. Kickham also told the CSB that Loy-Lange requested an "emergency repair," and Kickham interpreted this request to mean that Loy-Lange desired the repair to be completed immediately, presumably so that Loy-Lange could start the system up again the following Monday. To perform the repair, Kickham bent a steel plate so that it would fit the SCR, in lieu of fabricating or purchasing an ellipsoidal head.

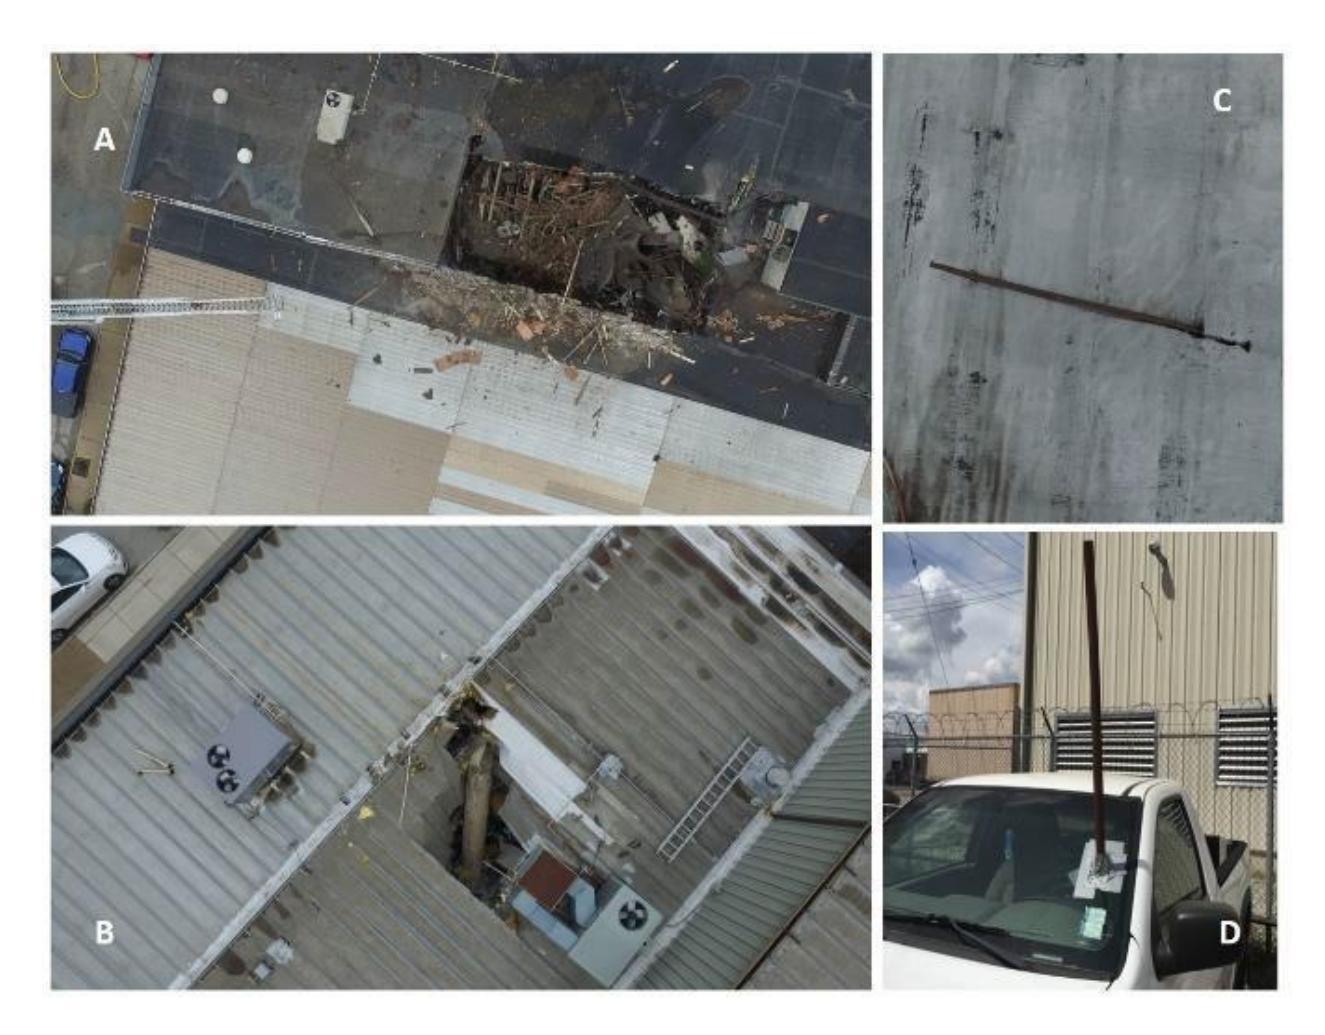
Figure 11. Damage from the incident. (Credit A-C: St. Louis Fire Department, D: CSB)

(Figure 11C). A section of 1.5-inch pipe approximately seven feet in length pierced the windshield and embedded in the dashboard and through the floorboard of an unoccupied pickup truck parked in the area (Figure 11D). A map of the debris field is shown in Figure 12. As a result of the incident, one stationary engineer at Loy-Lange was fatally injured. At Faultless Healthcare Linen, three employees were fatally injured when the SCR fell through the roof.

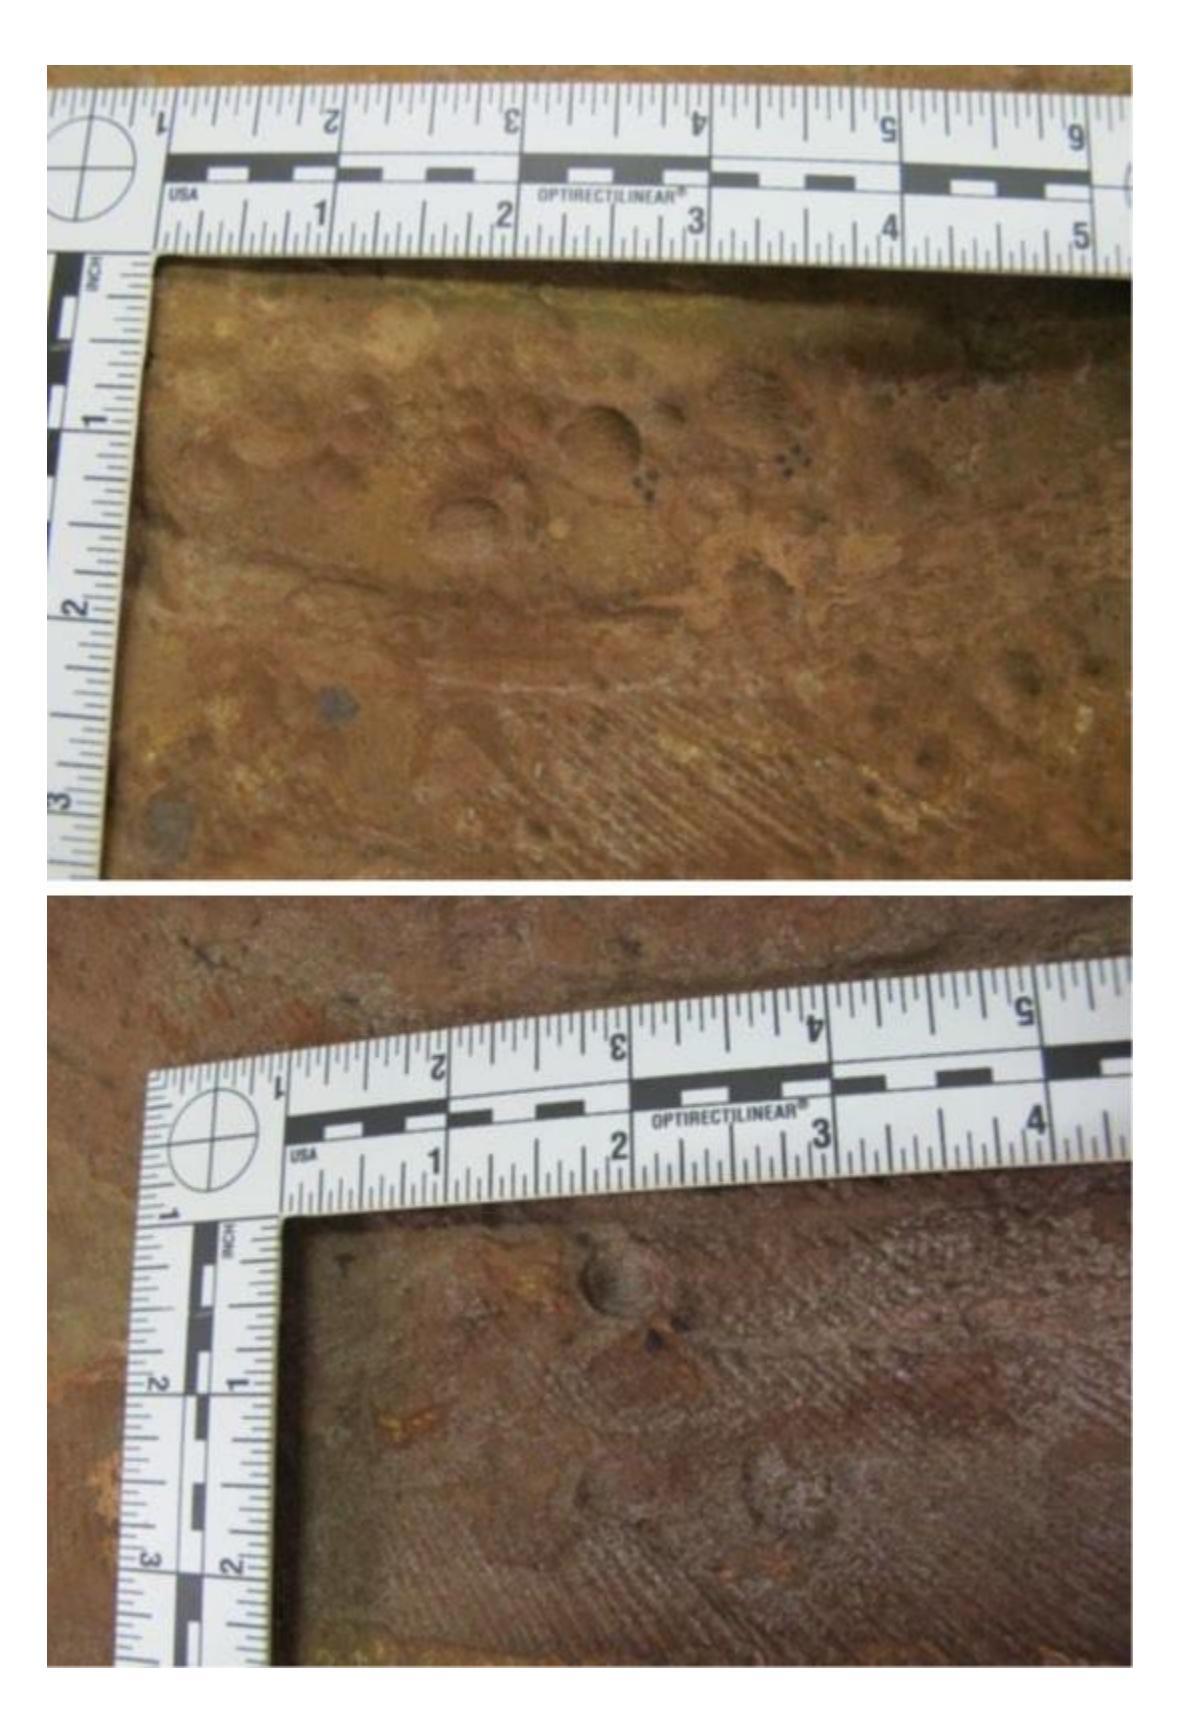
Extensive pitting and generalized corrosion damage (**Figure 16**) was found in both the separated portion of the bottom head and in the portion of the bottom head that remained attached to the SCR shell. This pitting and generalized corrosion damage is consistent with the appearance of oxygen pitting and corrosion damage. The shell and upper head were found to be relatively unaffected by corrosion damage, as pictured in **Figure 17**.

Figure 16. Pitting corrosion damage in SCR bottom head. (Credit: CSB)

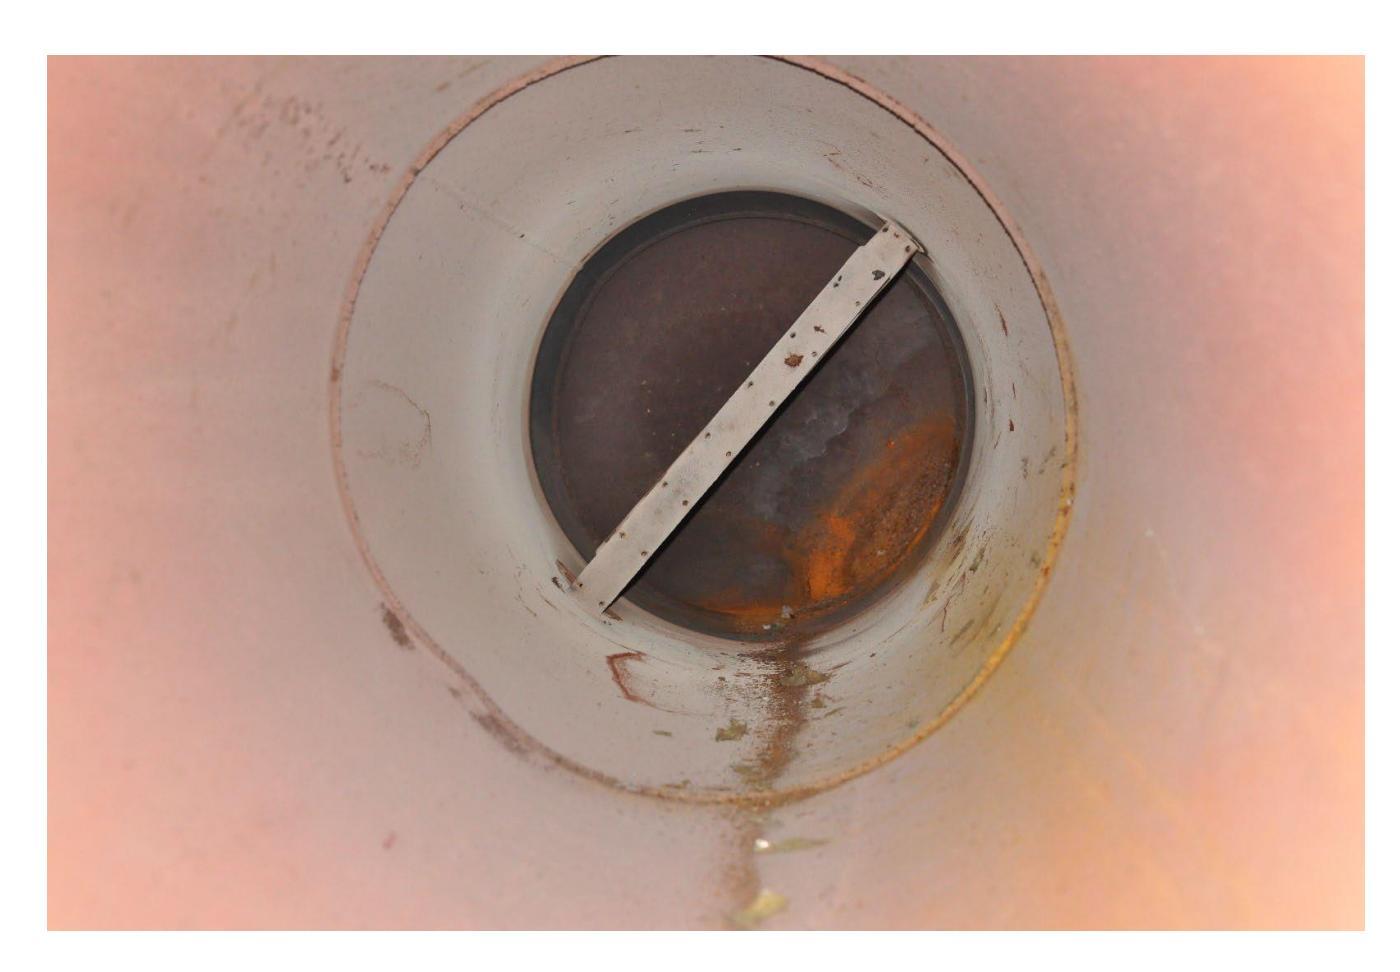
Figure 17. Photo of the inside surface of the SCR shell and upper head. (Credit: CSB)

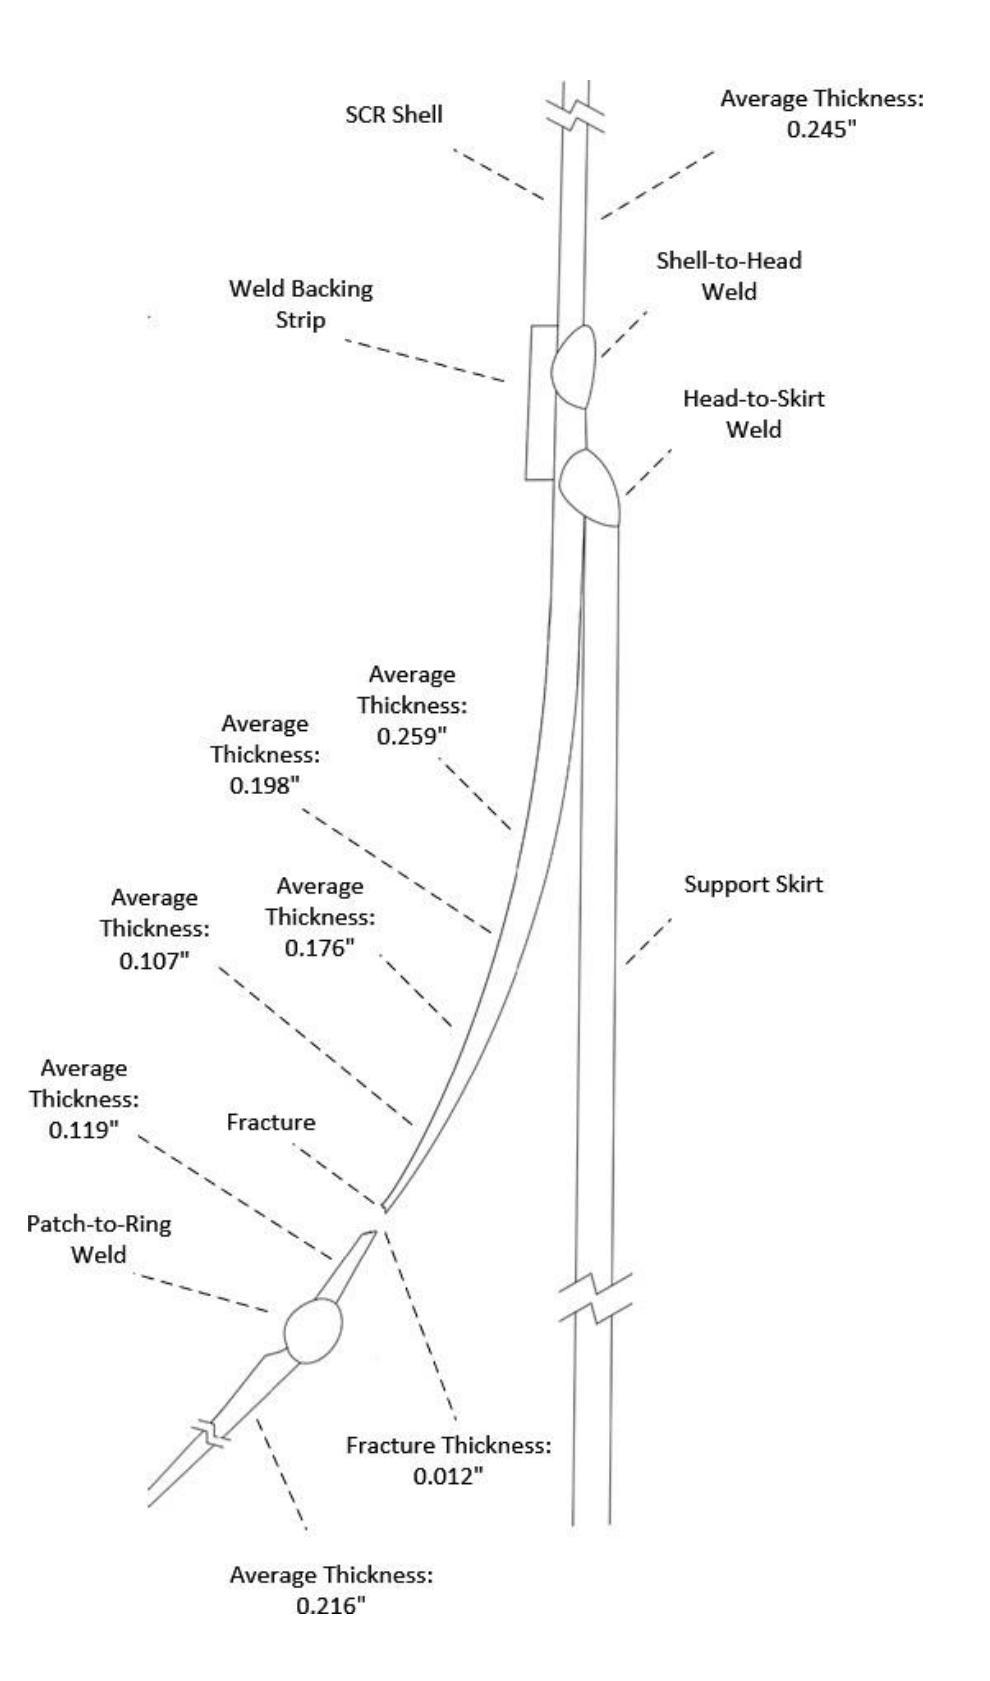
The CSB commissioned comprehensive non-destructive thickness examination of the SCR after the incident. Some of the examination findings are illustrated in **Figure 18**. The thickness of adjacent spots on either side of the patch-to-ring weld were measured and compared (**Figure 19**). On average, the repair patch was almost twice as thick as the re-used original steel ring.

**Figure 18**. Conceptual cross-sectional diagram of the SCR bottom head, showing examination findings. (Credit: CSB)

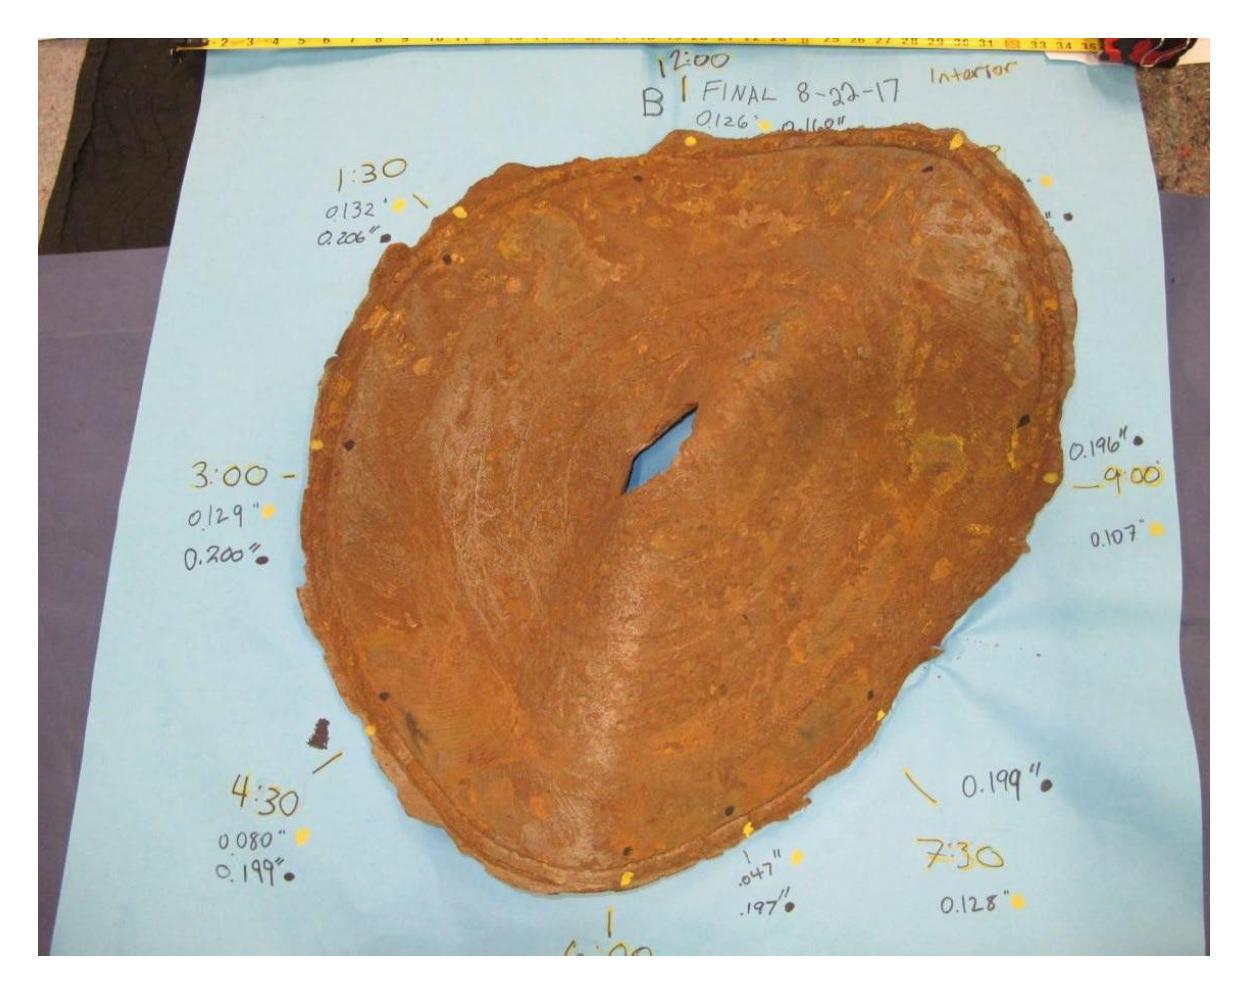
Figure 19. Thickness comparison on either side of patch-to-ring weld. (Credit: CSB)

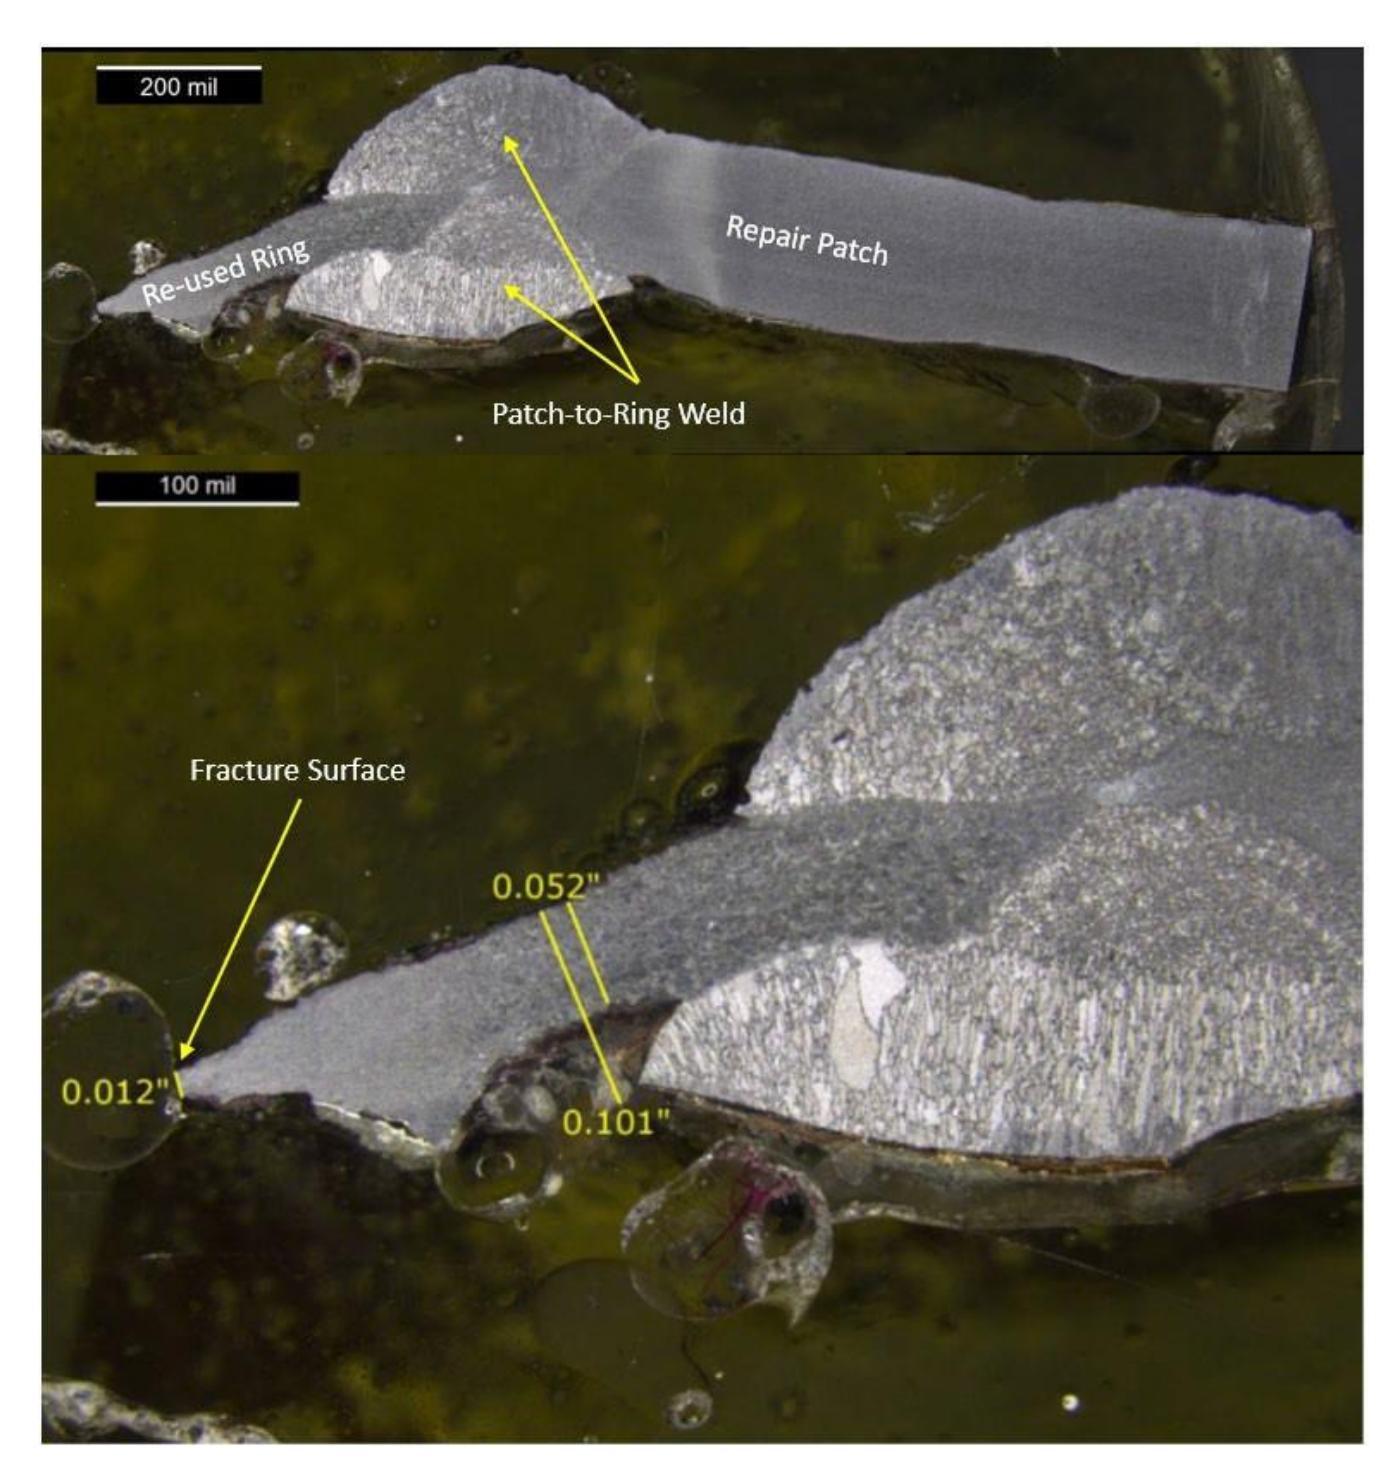
Destructive thickness examination found that corrosive attack reduced the nominally 0.250-inch steel to 0.012 inches at the thinnest spot measured, a thickness loss of 95 percent (**Figure 20**). The spot that measured 0.012 inches was at the fracture edge, in the re-used ring. The average post-incident thickness of the re-used ring around the periphery of the fracture, as measured by calipers, was 0.107 inches. The examination also discovered four weld repairs in the portion of the re-used ring that remained attached to the shell. These welds were cross-sectioned and examined. Three of the four welds were weld overlays, used to fill in thin spots from the inside of the vessel. The fourth was a plug weld, used to plug a full penetration through the thickness of the head. All four of these welds were made to the ring of bottom head material that remained attached to the SCR shell. A photo documenting one of the weld overlays is shown in **Figure 21**, and photos documenting the plug weld are shown in **Figure 22**.

Figure 20. Post-Incident metallurgical examination of patch-to-ring weld and fracture. (Credit: CSB)

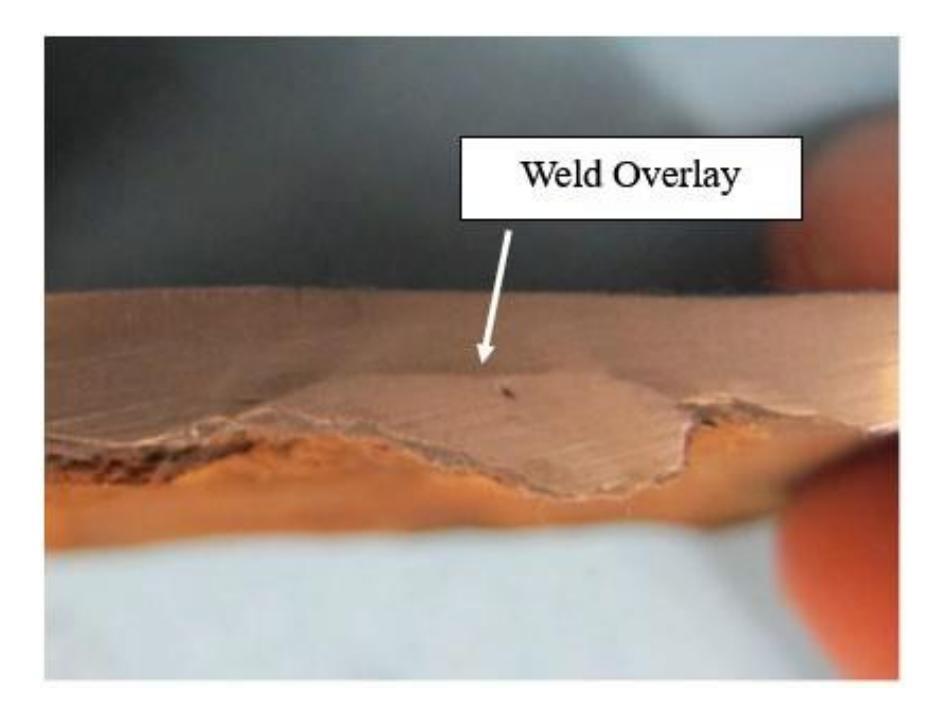
**Figure 21.** Weld overlay found in the ring of steel still attached to the shell, cross-sectioned. (Credit: CSB)

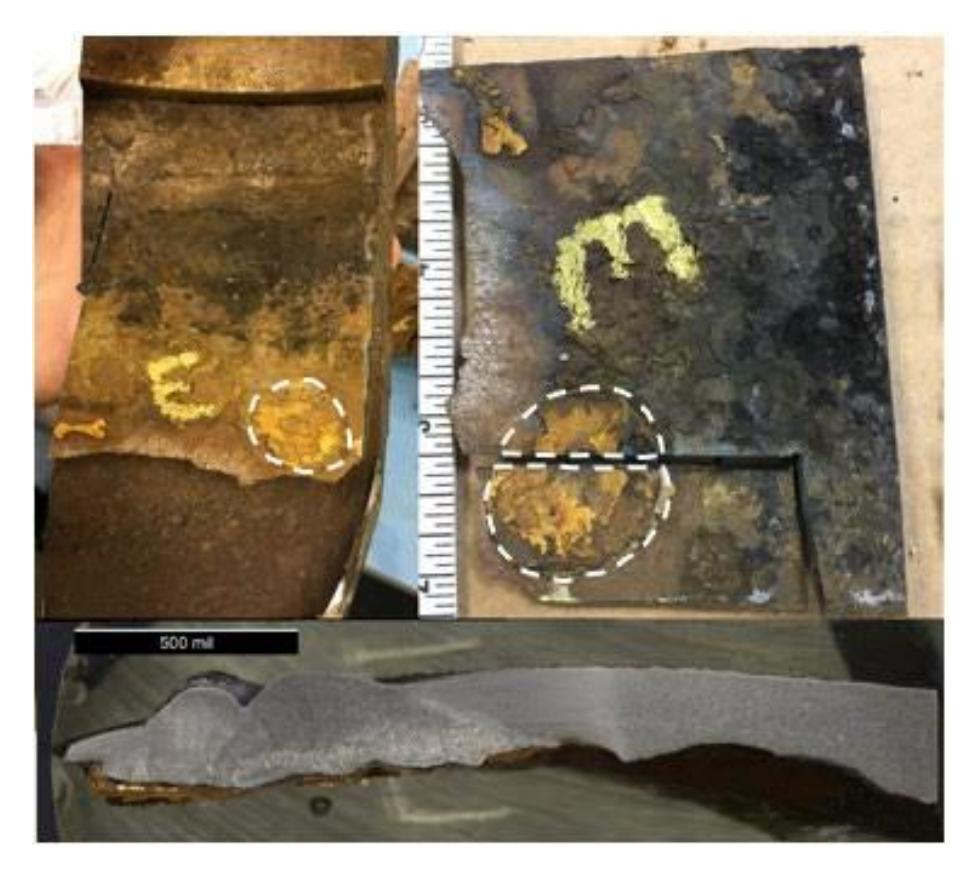
**Figure 22.** Plug weld found in the ring of steel still attached to the shell, cross-sectioned. (Credit: CSB)

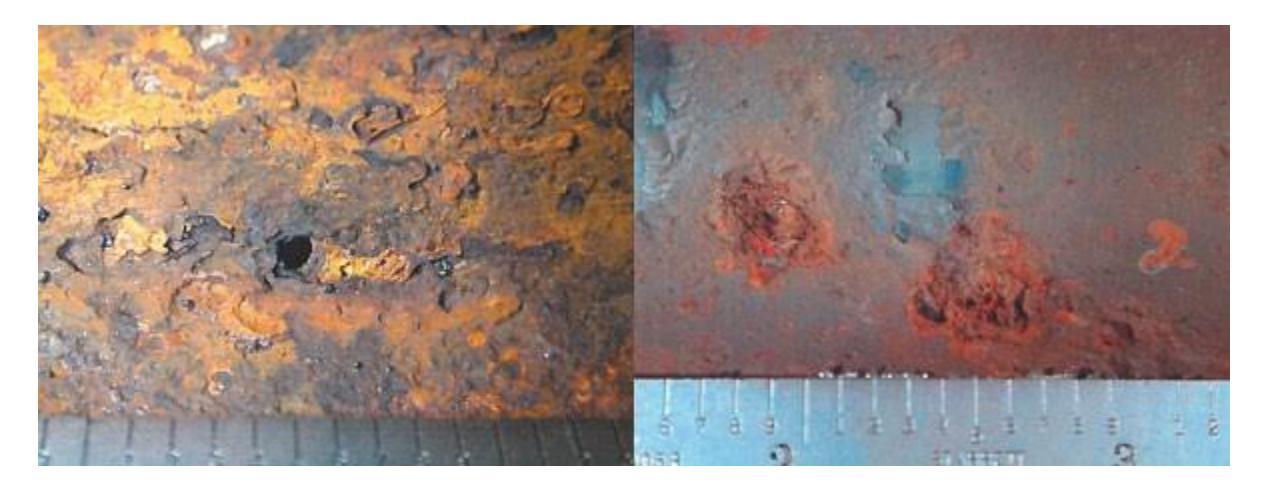
In addition to these leaks in the SCR, Loy-Lange experienced corrosion in other parts of the steam system. The CSB found documentation of one known steam separator leak and four generator coil failures.<sup>a</sup> **Figure 28** shows the oxygen pitting corrosion found in two of the four generator coil failures. The images were taken by Clayton after Loy-Lange submitted the failed coils to Clayton for warranty replacement consideration. The left image is of a 2002 coil failure and the right image is of a 2004 coil failure.

Figure 28. Pitting damage in two of Loy-Lange's steam coils. (Credit: Clayton)

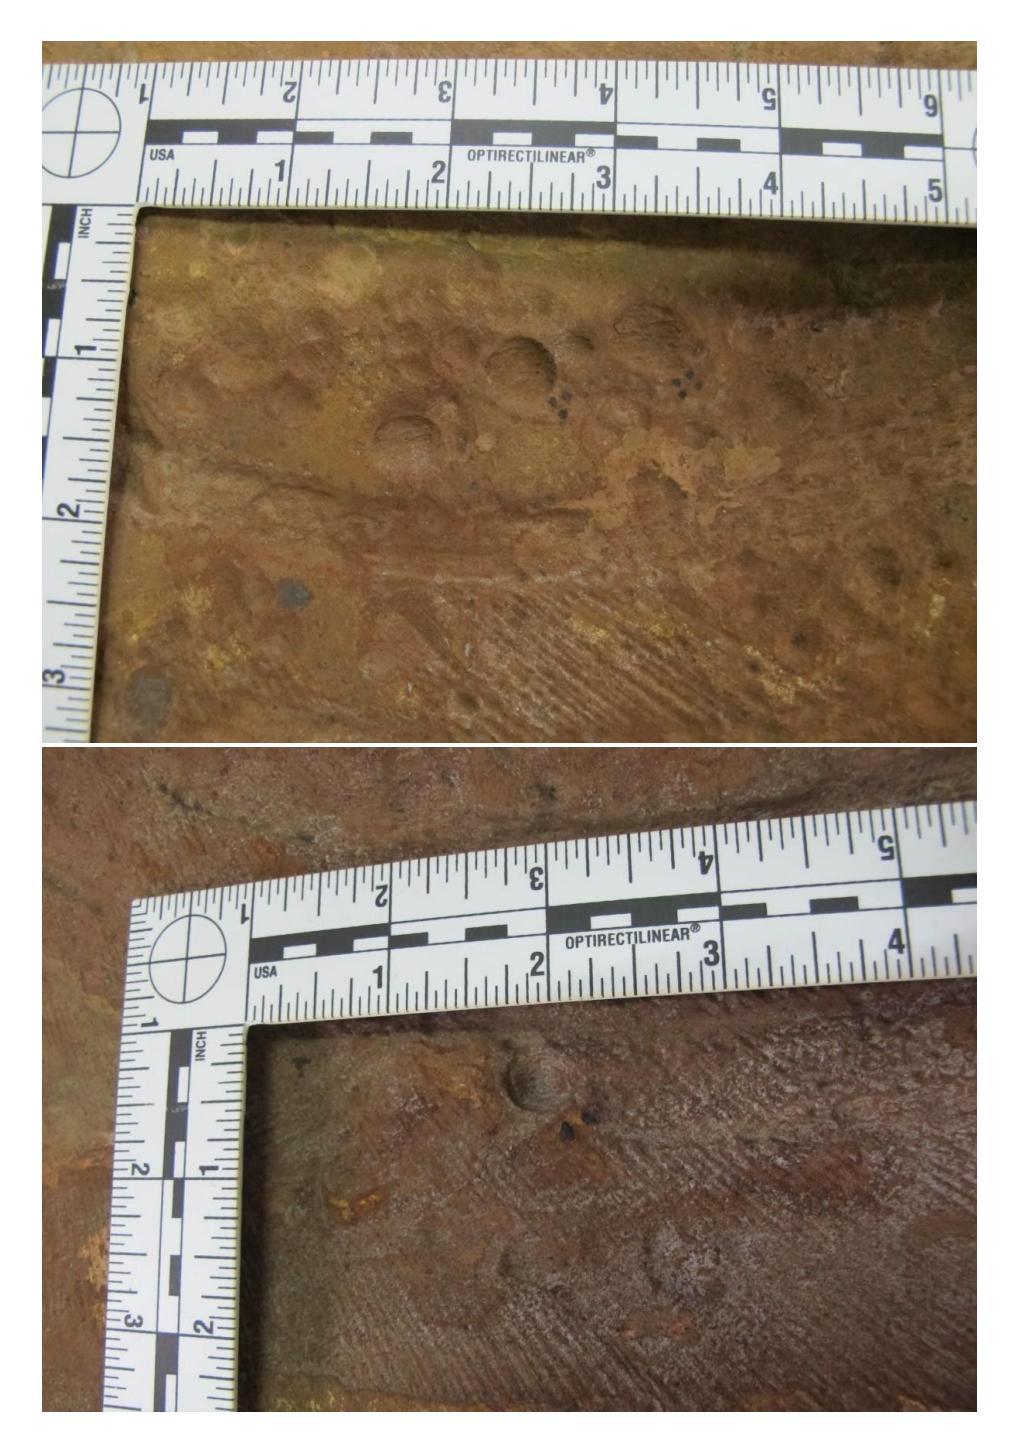
Figure 30. Pitting corrosion damage in SCR bottom head. (Credit: CSB)

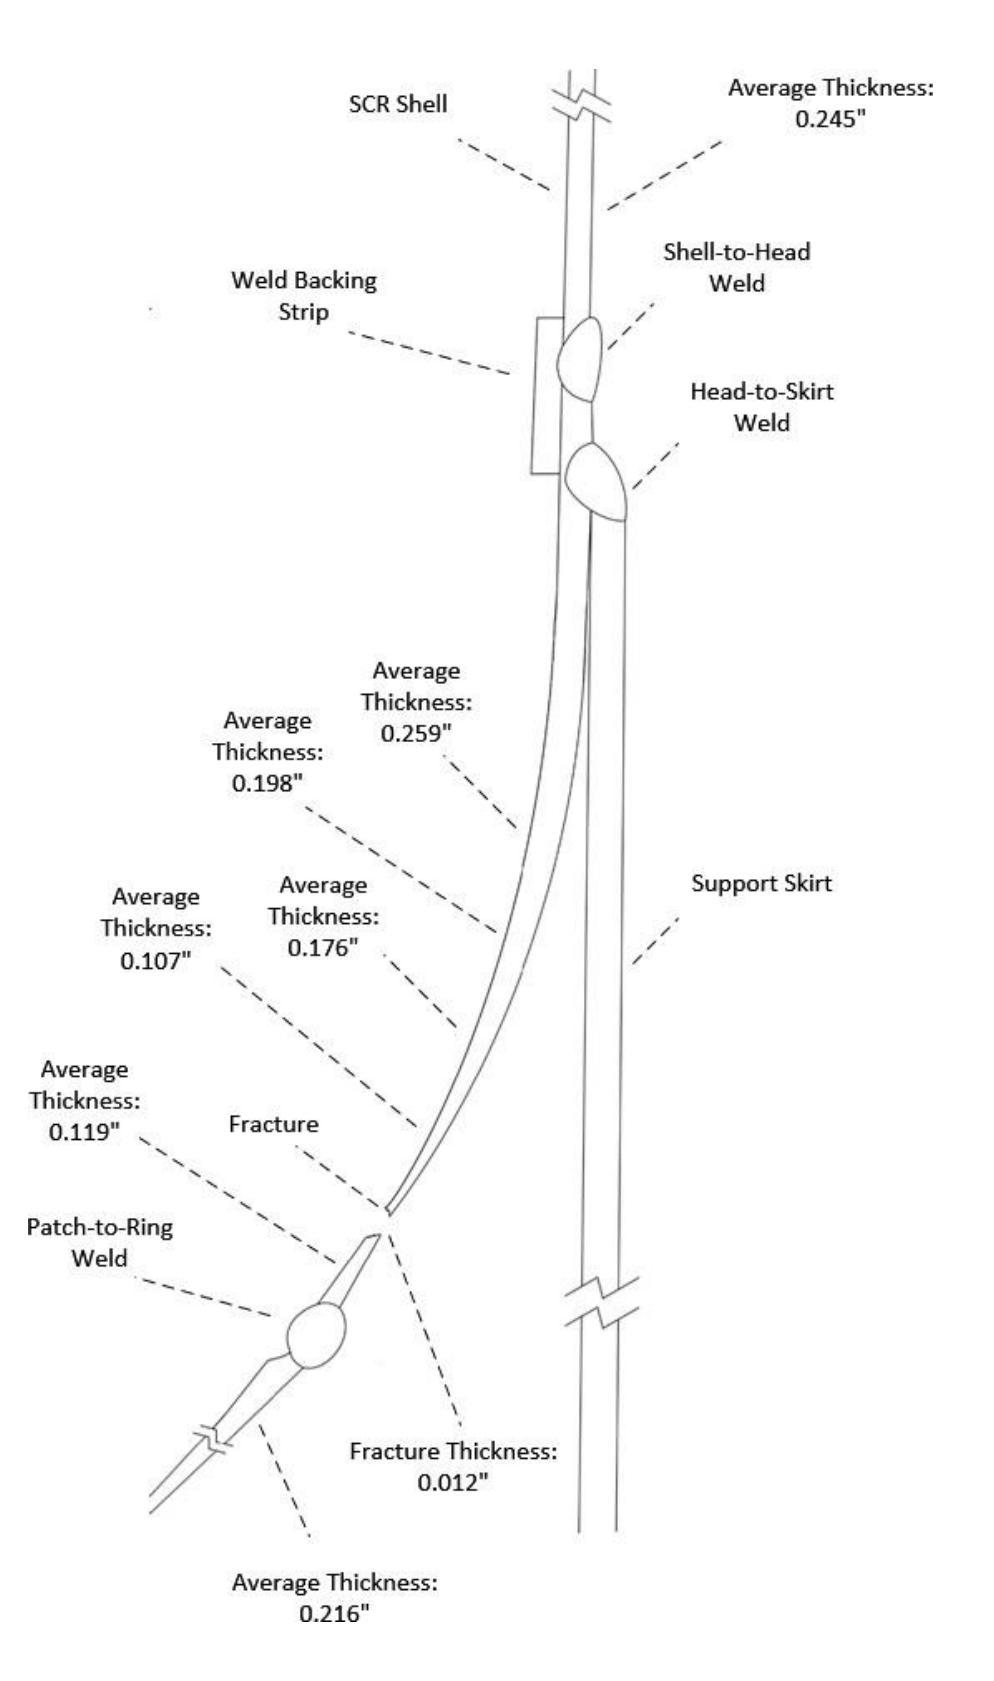
**Figure 31**. Conceptual cross-sectional diagram of the SCR bottom head, showing examination findings. (Credit: CSB)

The minimum thickness of the SCR bottom head, specified on the vessel's U1A form, was 0.2204 inches. As shown above in **Figure 31**, the average thickness of nearly the entire SCR bottom head was thinner than the required thickness after the incident. The thinnest spot measured on the fracture surface, likely the fracture initiation point, was measured at 0.012 inches, and the average thickness near the patch to ring weld was roughly half the minimum required thickness.

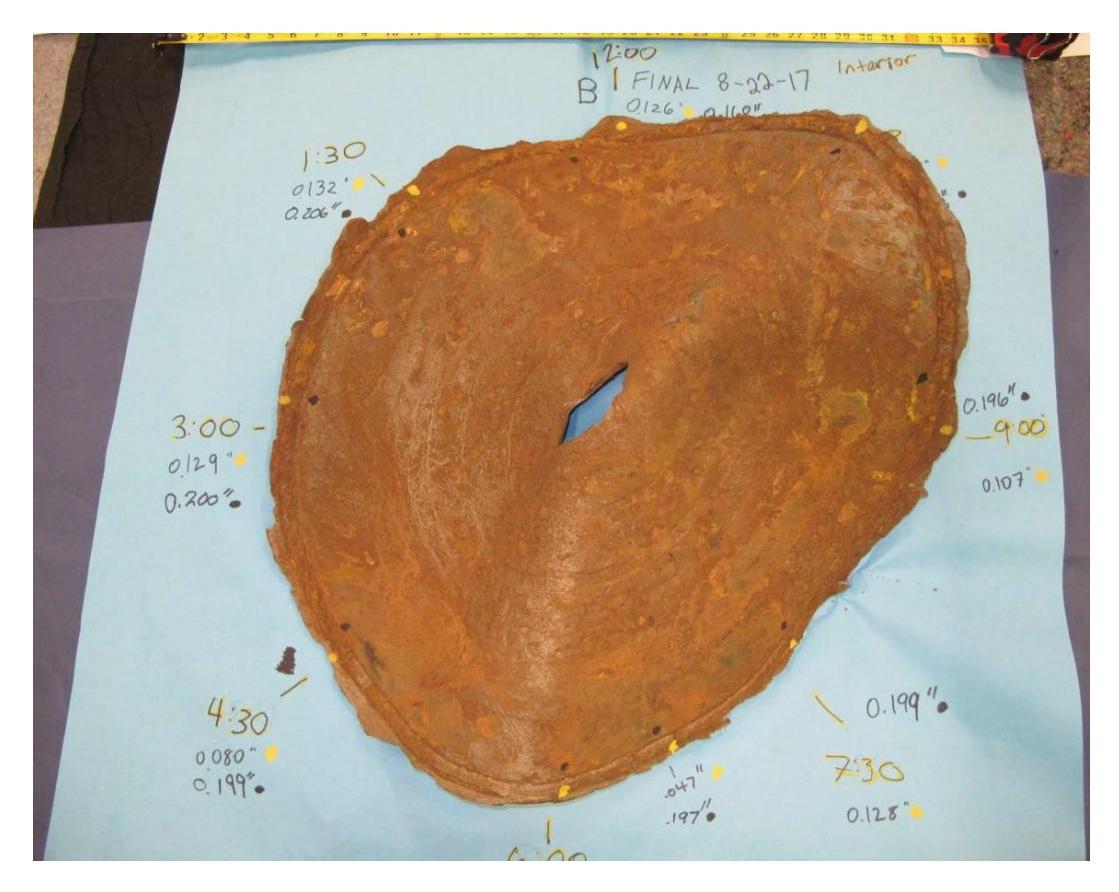
According to Kickham, it used visual examination and a measuring tape to verify the thickness of the plate (Section 1.3). These methods, however, failed to detect the presence of the remaining corroded material. A more accurate quantitative measurement of the thickness of the re-used steel, such as the use of calipers or ultrasonic thickness measurement, may have prevented this incident by enabling Kickham to measure more precisely the thickness of the material it planned to leave in place and remove any material that did not meet the vessel's minimum thickness requirements.

Figure 34. Thickness comparison on either side of patch-to-ring weld. (Credit: CSB).

Based on the metallurgical examination and corrosion calculations, there is evidence that the 2012 repair did not remove all existing corrosion damage. It is important to remove all corroded material that is too thin to meet the vessel's minimum thickness requirements because a decrease in thickness could impact the pressure retaining ability of the vessel. The CSB concludes that Kickham likely left thinned material in place when it repaired the SCR bottom head in 2012, and in so doing did not adhere to the requirements of *NBIC Part 3 Repair and Alterations*.
