Accident - 7 Key Lessons to Prevent Worker Death During Hot Work in and Around Tanks

INTRODUCTION

This bulletin summarizes 11 accidents – nine of which the agency has investigated – to highlight seven key lessons that were found to be applicable to all or most of the incidents, especially the need for effective hazard assessment and proper monitoring of potentially flammable air concentrations in work areas.

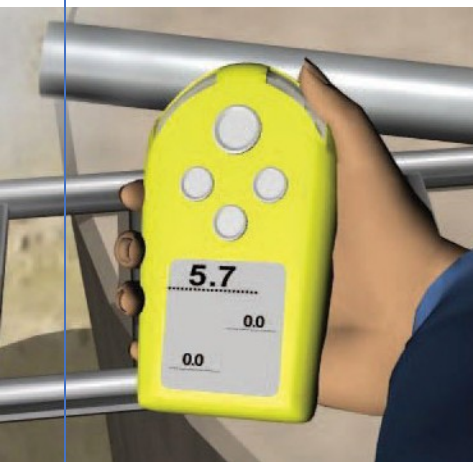
Example of a combustible gas detector used to test for the presence of flammable gas or vapor.

Flammable gas and vapor concentrations are generally determined using a portable combustible gas detector, also called an LEL³ meter. Combustible gas detectors are relatively inexpensive and widely available. Training in LEL instrument use is a key component to effective gas testing and is a critical aspect of an effective hot work safety program.

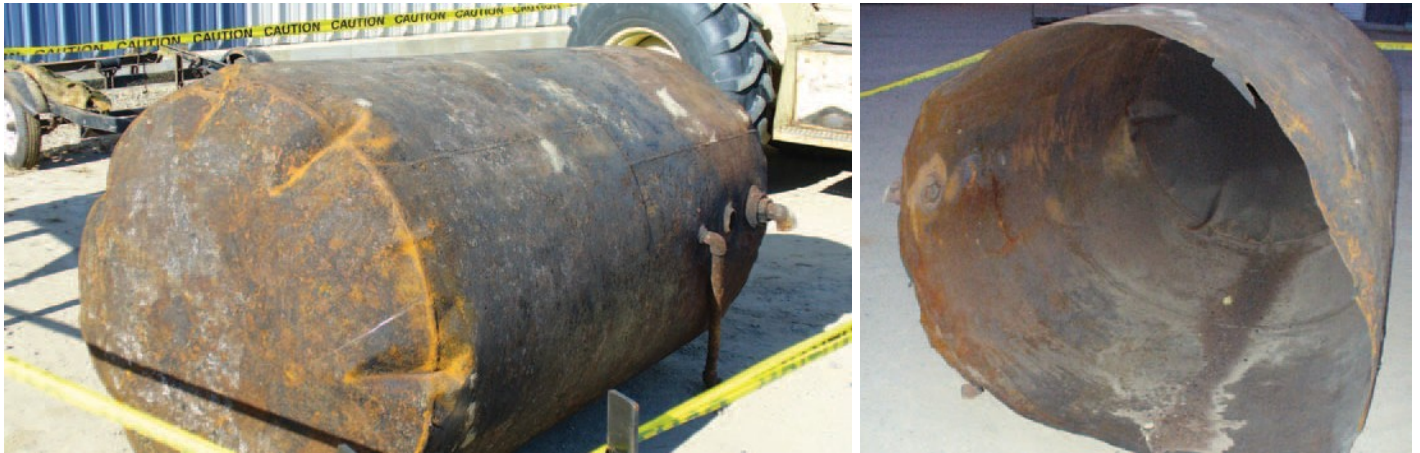
Exterior and interior views of the fuel tank involved in the hot work accident at A.V. Thomas Produce.

Two employees at A.V. Thomas Produce were using an oxygen-acetylene torch to loosen a fitting on an old fuel tank, which the company hoped to refurbish for field storage of diesel fuel. The workers, however, were unaware that the tank contained residual hydrocarbon liquid and vapor from an unknown prior use. The tank was not cleaned or purged before work began. Shortly after applying heat to the tank, an explosion occurred, blowing the end of the vessel off. Both employees were airlifted to a regional burn center, where they were treated for burns covering 30 to 50% of their bodies.

The facility had no formal hot work program, and no permit was issued for the hot work being performed. No combustible gas testing was performed prior to commencement of the hot work; the company did not have a policy that required it. In addition, many workers were mono-lingual Spanish speakers and had not been trained on safe hot work procedures or on the proper use of gas detectors in their native language.

Analyze the Hazards, Monitor the Atmosphere,
Test the Area, Use Written Permits, Train Thoroughly

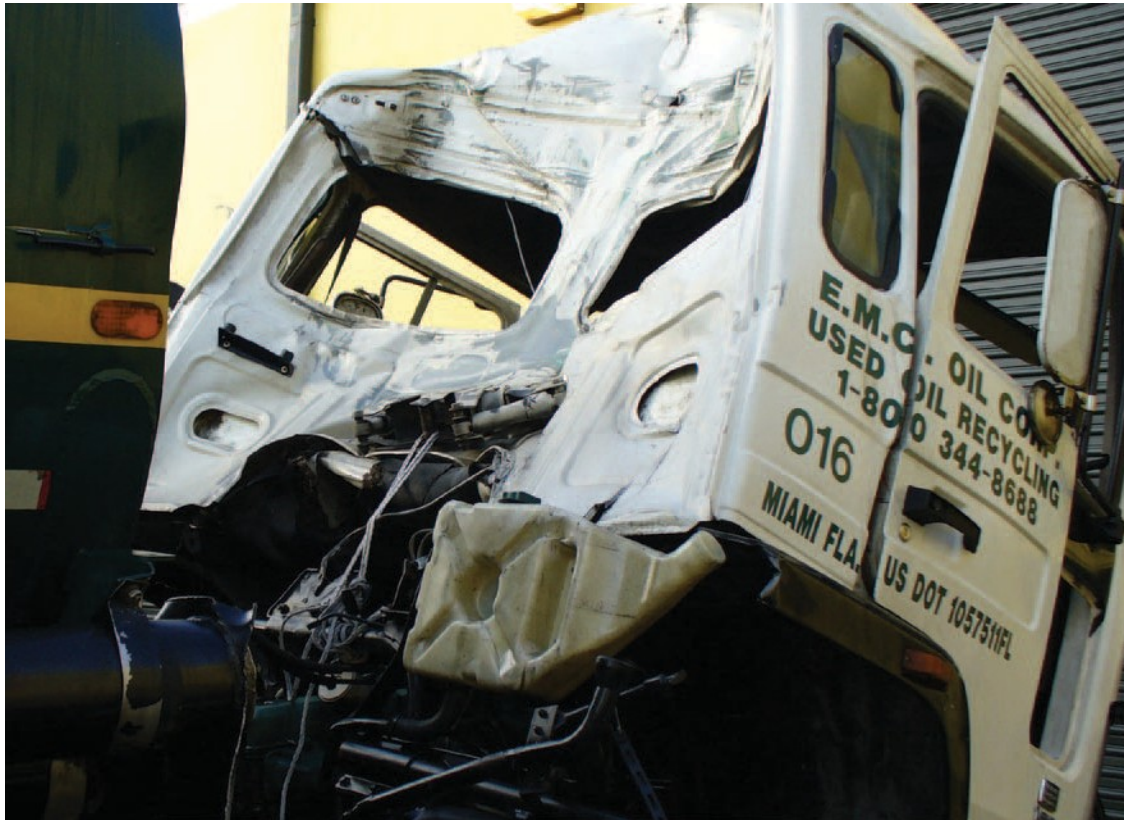
EMC Used Oil Corporation
Miami, Florida, December 2, 2008
1 Worker Killed, 1 Injured

Damage to an oil tanker sustained from the December 2, 2008, explosion at EMC Used Oil Corporation.

An explosion killed a contract welder who was repairing a two-compartment oil tanker and injured another worker at the EMC Used Oil facility. The welder was in the process of welding transfer piping onto the tanker when residual hydrocarbon vapor from the 2,500-gallon rear compartment ignited, causing a powerful explosion.

The surviving worker stated that the contractors did not perform combustible gas monitoring and relied upon the host company to assure that tanks were safe for hot work. However, EMC indicated that it relied on contractors to monitor for gas; although the company owned a multiple gas detector, it was used only for confined space entry. EMC did not have a formal hot work permitting or authorization system.

Use Alternatives, Analyze the Hazards, Monitor the Atmosphere, Test the Area, Use Written Permits, Supervise Contractors

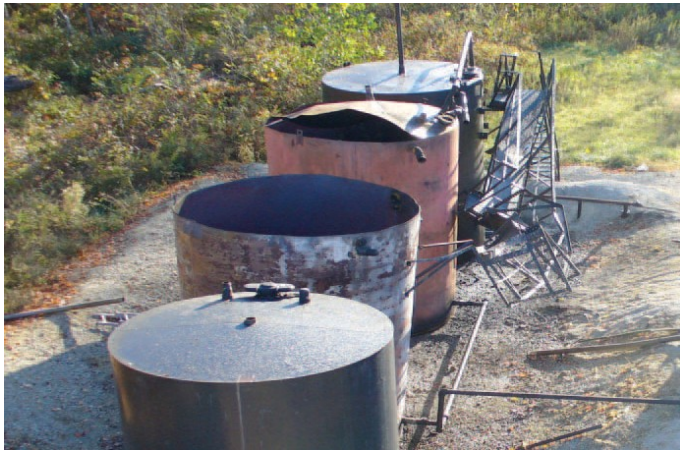
Oil storage tanks involved in fire and explosion at MAR Oil.

An explosion killed two contract workers while they were welding above a series of three interconnected crude oil storage tanks at a MAR Oil site. The explosion occurred when the workers attempted to weld a bracket on top of one of the tanks, near an atmospheric vent. Because the tanks were interconnected, oil flowing into an adjacent tank likely displaced flammable vapor into the tank being welded. The vapor escaped through the vent and was ignited by welding sparks.

The CSB investigators found that combustible gas monitoring was not performed prior to or during the welding. There is conflicting evidence as to whether or not the welding job was authorized by the host company. MAR Oil lacked a formal hot work program that required the hot work be identified in a written permit and be authorized by a person responsible for hot work management. The company had no formal program to select or oversee contractors, and the two contractors lacked documented training on safe hot work practices.

Use Alternatives, Analyze the Hazards, Monitor the Atmosphere, Test the Area, Use Written Permits, Train Thoroughly, Supervise Contractors

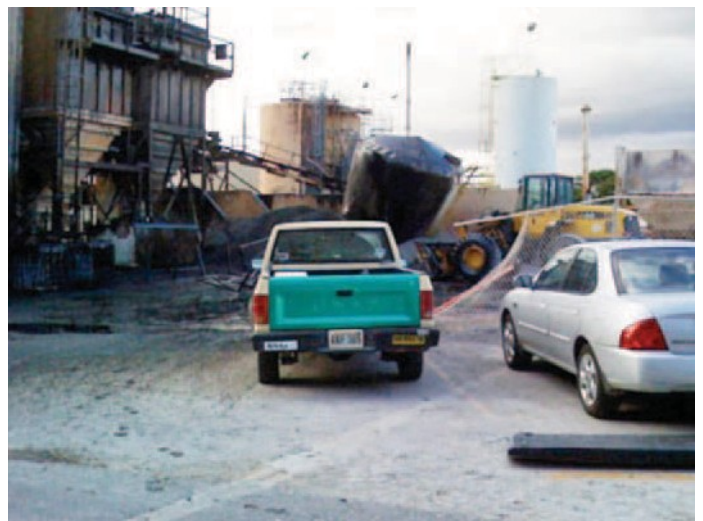
Philip Services Corporation¹⁴

A contract welder was killed while welding on a catwalk located over a 9,300-gallon waste oil storage tank at the Philip Services Corporation (PSC). Following an investigation, the Honolulu Fire Department (HFD) concluded that, during the welding, sparks dropped in and around the vent area of the tank. The contents of the tank ignited, resulting in an explosion and fire. The force of the explosion hurled the contract welder about 120 feet, fatally injuring him. Three others were injured, and the tank was thrown about 30 feet.

According to the HFD investigation, a PSC official asserted that the contractors were not authorized to weld within the dike area surrounding the tank, a hot work permit had not been issued for the welding, and combustible gas monitoring was not conducted. Conversely, the contracting company's personnel asserted that they believed that the work was authorized and that PSC had conducted combustible gas monitoring prior to the welding activity.

View of Philip Services Corporation following a October 7, 2008, waste oil storage tank explosion.

Use Alternatives, Analyze the Hazards, Monitor the Atmosphere, Test the Area, Use Written Permits, Supervise Contractors

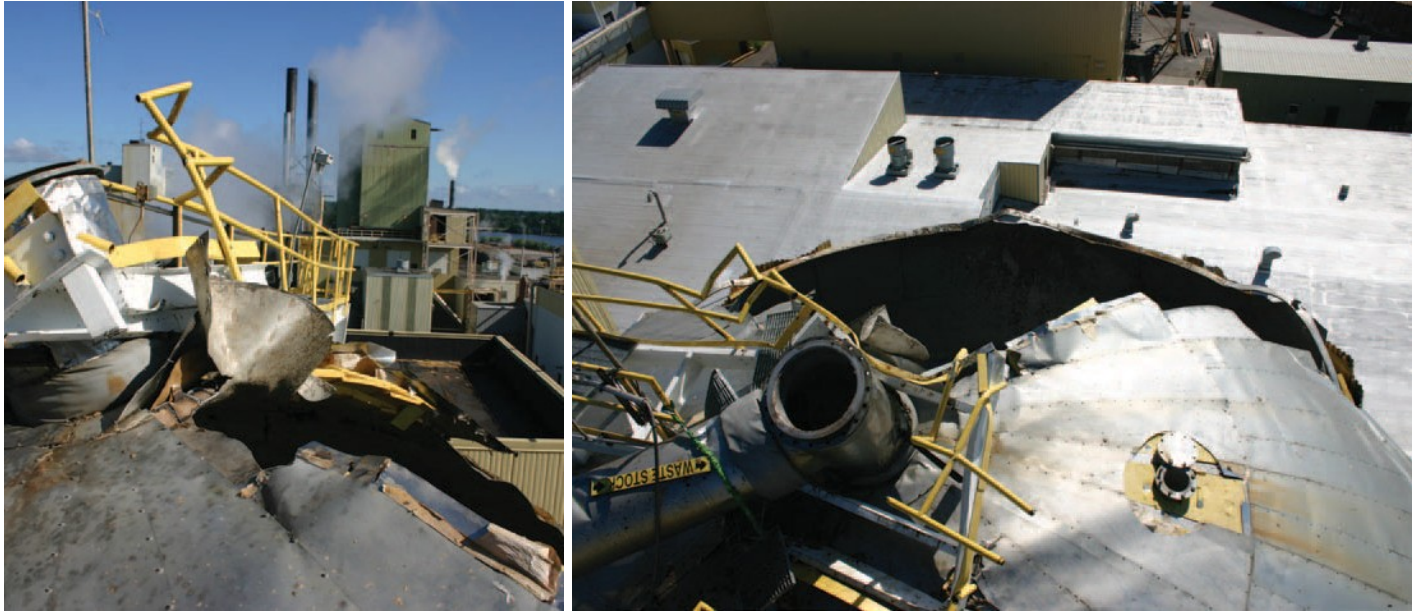
Packaging Corporation of America
Tomahawk, Wisconsin, July 29, 2008
3 Workers Killed, 1 Injured

Views of the storage tank involved in the 2008 explosion at Packaging Corporation of America.

Three workers were killed in an explosion at the Packaging Corporation of America (PCA) fiberboard manufacturing facility while they were welding on a temporary metal clamp to stabilize a damaged flange connection. The flange was located on top of an 80-foot tall storage tank that contained recycled water and fiber waste.

Facility personnel were unaware of the potential presence of flammable gas from the decomposition of the organic material in the tank, and combustible gas monitoring was not typically required or performed prior to starting work. At the time of the accident, three workers were on a catwalk above the tank; one began welding the flange into place when sparks from the welding ignited flammable vapors inside the tank. The resulting explosion ripped open the tank lid, knocking two of the workers to the ground 80 feet below. All three workers died of traumatic injuries. A fourth worker, who had been observing the work from a distance, survived with minor injuries.

The CSB analysis of the tank contents determined that anaerobic bacteria had multiplied inside the tank and water recycle system over time, feeding on organic waste material. The bacteria likely produced hydrogen, a highly flammable gas, which ignited during the welding work. The CSB found that at the time of the incident, PCA supervisors and workers were unaware of the risks of flammable gas production from anaerobic bacteria growth. PCA did not perform a hazard analysis or recognize fiber waste tanks as potentially hazardous. Combustible gas monitoring was not required for the work.

Analyze the Hazards, Monitor the Atmosphere,
Test the Area

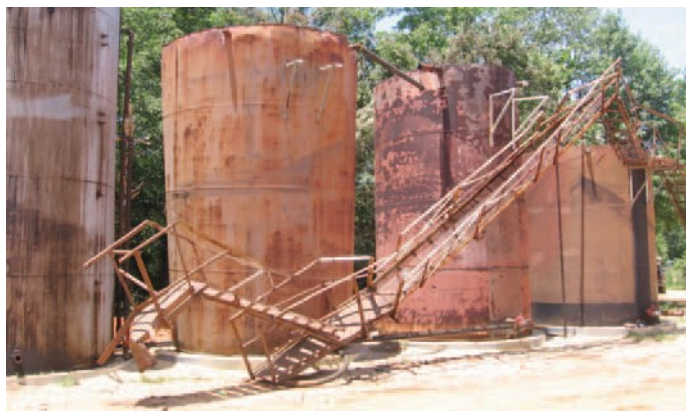
**Partridge-Raleigh Oilfield Raleigh,
Mississippi, June 5, 2006
3 Killed, 1 Seriously Injured**

On June 5, 2006, contract workers were installing a new pipe between two oil tanks at a rural oilfield when sparks from a welding torch ignited flammable hydrocarbon vapor venting from one of the tanks. That tank and another nearby tank exploded, killing three workers who were standing above the tanks and seriously injuring a fourth. As in the MAR Oil accident, all of the tanks were interconnected by piping and one of the tanks contained crude oil, the source of the vapor that fueled the explosions.

The workers had not performed combustible gas monitoring prior to or during the hot work, instead relying on the unsafe and unreliable practice of using a lit torch to check one of the tanks for flammable vapor. Workers did not empty or isolate the tank that contained crude oil prior to initiating hot work activities.

Neither the contract company nor Partridge-Raleigh required written hot work permits. The contractor company did not provide hot work safety training to employees. Furthermore, Partridge-Raleigh did not have safety requirements for its oilfield contractors.

Tanks involved in the 2006 accident that killed three workers at the Partridge-Raleigh Oilfield.

Use Alternatives, Analyze the Hazards, Monitor the Atmosphere, Test the Area, Use Written Permits, Train Thoroughly, Supervise Contractors

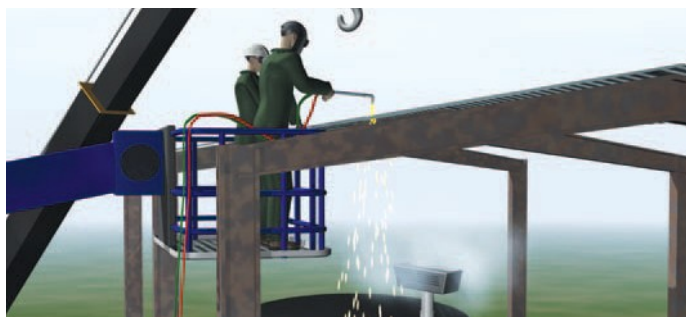
**Bethune Point Wastewater Plant
Daytona Beach, Florida, January 11, 2006
2 Workers Killed, 1 Critically Injured**

Two workers were killed and another critically injured in an explosion involving a methanol storage tank at a municipal wastewater treatment facility in Daytona Beach, Florida. The explosion occurred while the three workers were cutting a metal roof located directly above the tank vent. Sparks showered from the cutting torch and ignited methanol vapor escaping from the vent, creating a fireball on top of the tank. A corroded and ineffective flame arrester¹⁵ on the vent allowed the fire to propagate through the device, igniting methanol vapors and air inside the tank, resulting in an explosion.

Depiction of hot work from the CSB's 2007 "Public Worker Safety" video illustrating the accident at Bethune Point.

Combustible gas monitoring was not performed or required.

Use Alternatives, Analyze the Hazards, Monitor the Atmosphere, Test the Area, Use Written Permits, Train Thoroughly

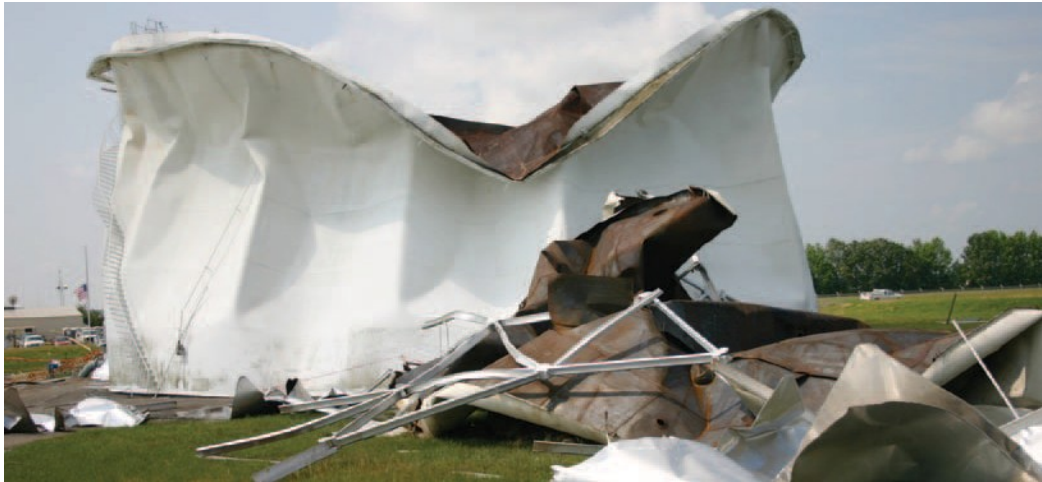
TEPPCO Partners, LP **Garner, Arkansas, May 12, 2009** **3 Workers Killed**

The gasoline storage tank at the TEPPCO McRae Terminal following the 2009 hot work accident that killed three workers.

Three contractors were using a cutting torch on top of the internal floating roof of a 67,000-barrel capacity gasoline storage tank at the TEPPCO Partners McRae Terminal when an internal explosion blew both the top of the floating roof and the secondary dome-shaped lid off the tank. All three were killed. The contractors were preparing to install a gauge pole. The gauge floats within the pole and measures the quantity of product within the tank. Part of the installation process involved cutting an opening into the floating roof for the pole to be inserted. The torch-cutting activity most likely ignited flammable vapor within the tank.

Prior to commencing work, the contractors had been issued both a confined space permit to enter the tank and a hot

work permit to torch-cut the roof. The hot work permit indicated that gas testing occurred at 7:00 am, the start of the work shift. However, no documentation exists indicating that gas testing was conducted after the workers returned from lunch or when they started the hot work activities just prior to the explosion at approximately 2:30 pm. Work atmospheres can change rapidly; gas monitoring needs to be conducted immediately prior to and during hot work activities to ensure that workers are constantly aware of the potential development of an explosive atmosphere.

Analyze the Hazards, Monitor the Atmosphere,
Test the Area, Supervise Contractors

To effectively use a combustible gas detector, consider the characteristics of the gas (lighter or heavier than air) as well as the appropriate locations and frequency of test. Training of personnel and proper maintenance, adjustment and calibration of the device are also crucial for effective gas detector use. (API Recommended Practice 2009, 2002, p.12)

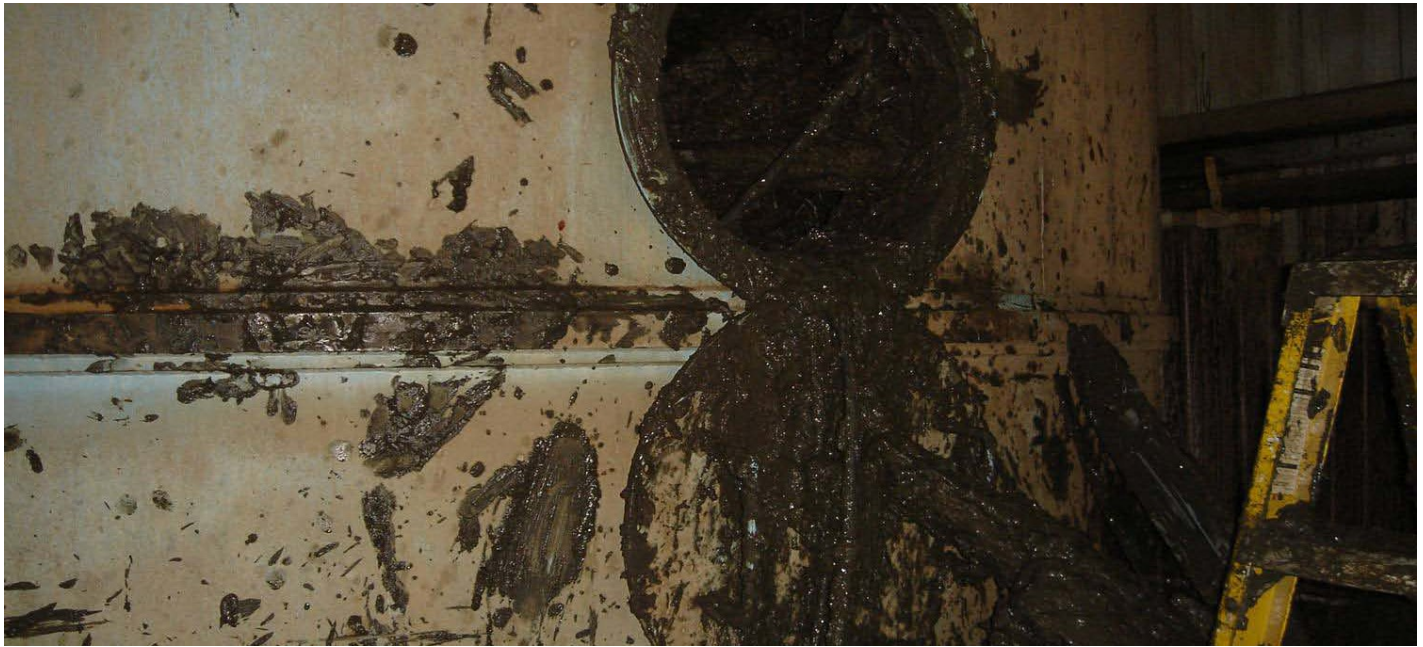
Potato-washing tank involved in the February 2009 accident at ConAgra Foods.

A welding contractor was killed while repairing a 1¼ by ½ inch crack on the bottom of a water clarifier tank at a ConAgra Foods facility. The 23-foot-tall tank was used to separate dirt and debris from wastewater in a potato-washing process area. The tank was open at the top and had a metal skirt around its cone-shaped base. While the welder was working inside the tank, an explosion occurred; the internal tank structures collapsed, resulting in his death.

The CSB determined that approximately 14 inches of debris-laden water had leaked through the crack in the tank and accumulated in the hidden space under the tank skirting. Examination of a sample of the liquid indicated that bacterial decomposition of the organic matter likely produced flammable gas, which was then ignited by the welding activity.

In this case, ConAgra personnel had tested for combustible gas inside the tank prior to the hot work, but only from the entrance of the tank and no flammable gas was detected. Monitoring for combustible gases was not conducted in the immediate area of the crack just prior to the initiation of the welding or in the adjacent space where flammable gas was present. Personnel were inadequately trained on the use of the specific combustible gas detector that was used and no hot work permit had been issued prior to commencing the welding.

Analyze the Hazards, Monitor the Atmosphere,
Test the Area, Use Written Permits, Train Thoroughly

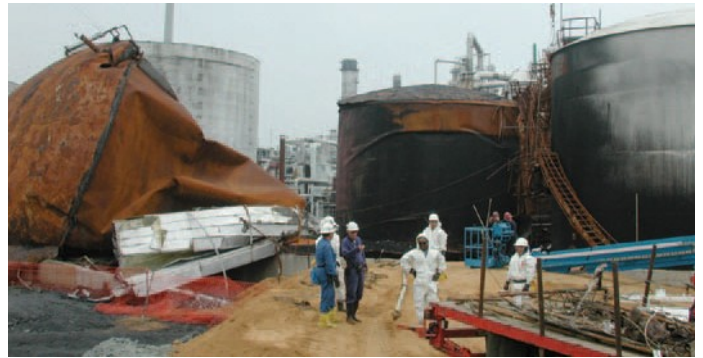
Motiva Enterprises Refinery

A massive explosion destroyed a large storage tank containing a mixture of sulfuric acid and flammable hydrocarbons at the Motiva Enterprises Delaware City Refinery. One contract worker was killed, eight others were injured, and sulfuric acid from collapsed and damaged tanks polluted the Delaware River. The explosion occurred during welding operations to repair a catwalk above the sulfuric acid tank, when flammable hydrocarbon vapor was ignited by welding sparks. This resulted in a powerful explosion inside the tank, which had holes in its roof and shell and a deficient inerting system.

On the day of the accident, combustible gas testing was performed only at the start of the hot work, but monitoring was not conducted for the duration of the hot work activities. Throughout the five hours between the last gas test and the explosion, the ambient temperature warmed by 14 degrees. This warming increased the evaporation of hydrocarbons inside the tank, and the resulting flammable vapor leaked out the tank's holes into the work area.

Motiva had a hot work program that included written permits, but the program was inadequate. Hot work was allowed near tanks that contained flammables including

A view of the flammable storage tank involved in the accident at the Motiva Refinery.

those that had known holes due to corrosion. Continuous atmospheric monitoring and the control of welding sparks were not required.

Use Alternatives, Analyze the Hazards, Monitor the Atmosphere, Test the Area, Supervise Contractors
