# Summary Report on Building Performance

Hurricane Katrina 2005

FEMA 548 / April 2006

*This is a summary of the information that can be found in the full MAT report Hurricane Katrina in the Gulf Coast: Building Performance Observations, Recommendations, and Technical Guidance (FEMA 549, 2006).*

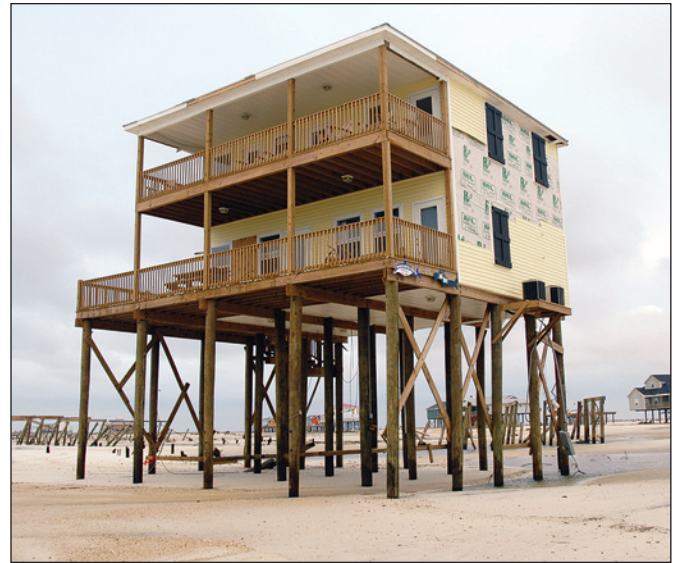
To perform successfully, piles must be adequately embedded. Where piles were not adequately embedded, pile foundation failure occurred and resulted in destroyed or missing houses or racked piles and leaning buildings (see Figures 2-1 and 2-2).

**Figure 2-1.** Successful example of well-elevated and embedded pile foundation following Katrina. Note adjacent building failures where foundations were not high enough or where pile embedment was insufficient (Dauphin Island, Alabama).

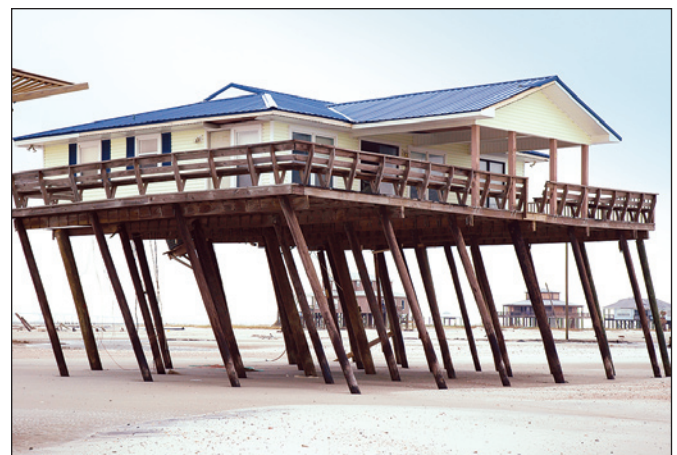
**Figure 2-2.** House that nearly failed due to insufficient pile embedment (Dauphin Island, Alabama)

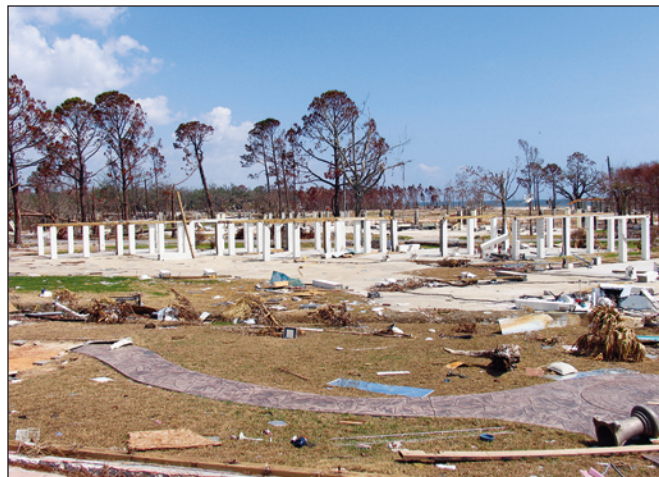
**Figure 2-3.**  
Typical building failures when surge and waves exceeded pier foundation height (Long Beach, Mississippi)

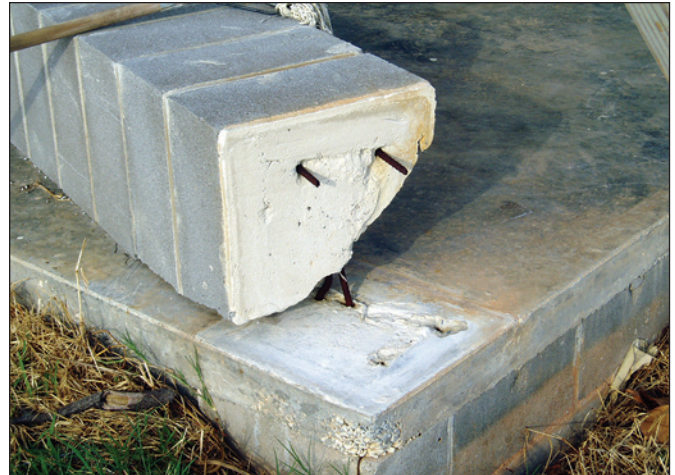
**Figure 2-4.**  
Pier connection failure (Belle Fontaine Point, Jackson County, Mississippi)

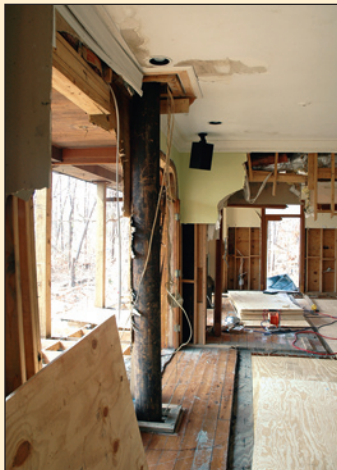
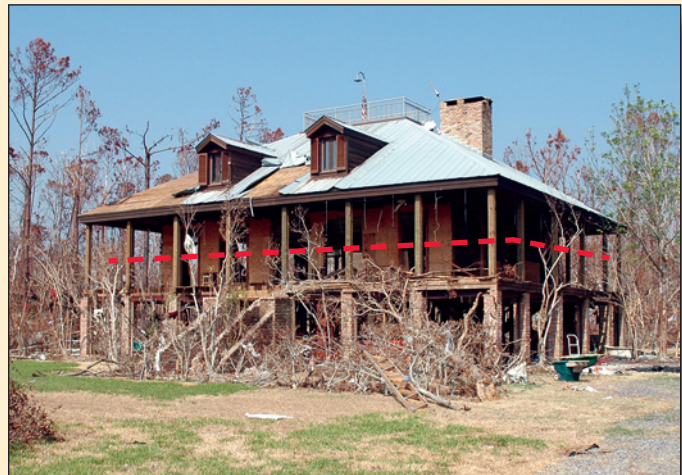
Storm surge and waves reached at least 4 feet (red line) above the elevated floor (Waveland, Mississippi).

Wave damage to floors and walls, but pole construction left a repairable, surviving building.

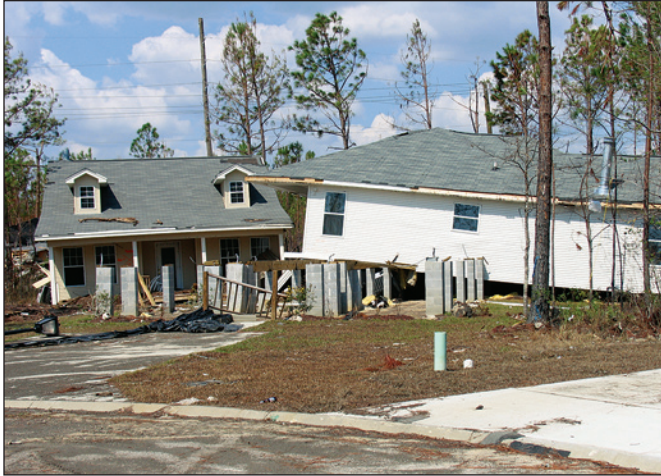
For example, 19 of 32 new houses in a Pass Christian subdivision (approximately 1 mile from the Gulf shoreline) floated off of their pier foundations due to flood heights of approximately 8 feet above the BFE and poor connections between the building and the floor beams or the floor beams and the piers (see Figure 2-5). Buildings that remained attached were flooded to approximately 8 feet above the floor elevations, but received minimal structural damage and appeared repairable.

**Figure 2-5.**  
Buildings floated off of pier foundations (Pass Christian, Mississippi)

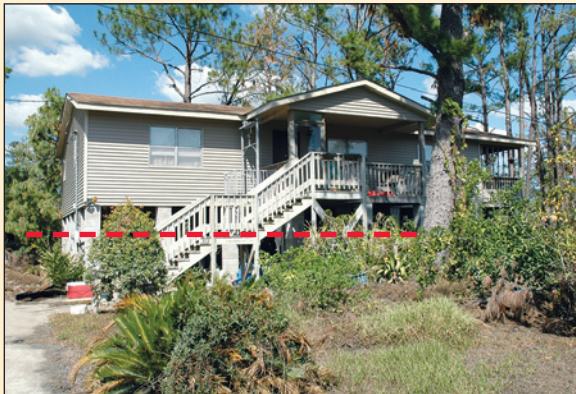
This house in Lacombe, Louisiana, was elevated above the flood depths associated with Katrina using FEMA mitigation grant funding. Note the estimated water line associated with Hurricane Katrina (red line).

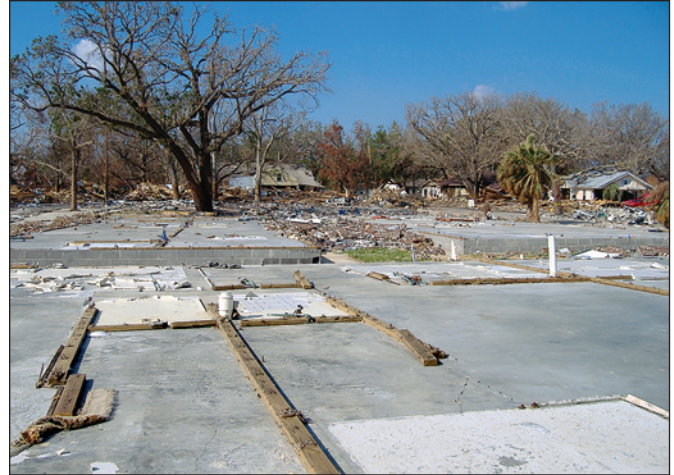
storm surge exceeded the slab elevation by more than about 3 feet and where breaking wave heights are believed to have exceeded 1.5 feet, wave damage to load-bearing walls resulted in severe building damage or total loss. As an example, in Biloxi, Mississippi, high surge elevations and floodborne debris impacts caused total destruction of buildings supported on slab-on-grade foundations (see Figure 2-6).

**Figure 2-6.**  
Waves, surge, and floating debris destroyed many single-family homes on slab foundations. Note the debris from houses that washed landward into other buildings (Biloxi, Mississippi).

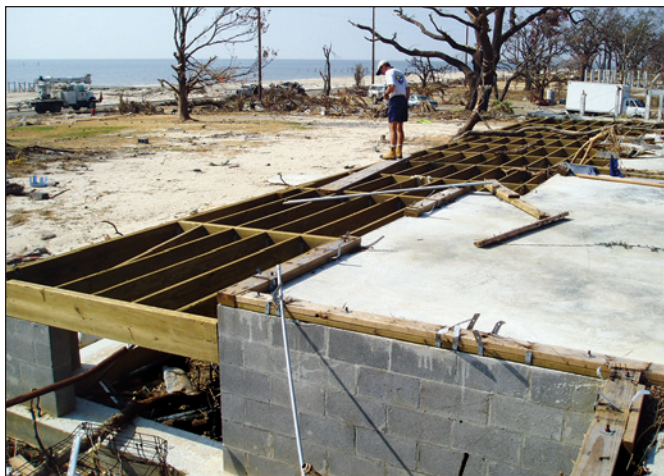
Figure 2-7.

**Stem Wall Foundations:** Stem walls typically use a masonry wall to contain and elevate compacted fill, which, in turn, supports a slab. The higher elevation above surrounding grade makes the foundation preferable to a slab-on-grade, and adds a safety factor against local stormwater flooding. Stem wall foundations are frequently used to meet the elevation requirements when the BFE is several feet above grade. Similar to buildings with slab-on-grade foundations, buildings with stem wall foundations experienced severe damage when flood levels and wave heights exceeded the top of the slab (see Figure 2-7). As with other shallow foundations, stem wall foundations are susceptible to undermining due to erosion or localized scour.

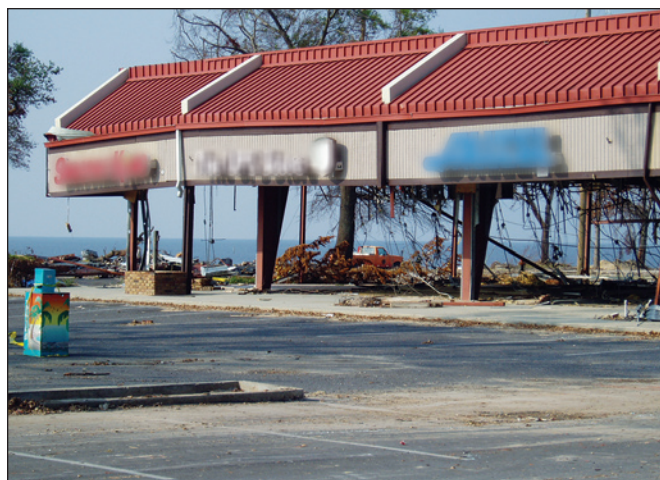
Figure 2-8.

A wide variety of commercial buildings experienced flooding and severe damage from the storm. These buildings included downtown storefronts in the older business districts, stand-alone food service/resort retail businesses, motels, churches, seafood handling/processing facilities near the harbors, strip malls, and larger retailers. No type of commercial building constructed on slab foundations near the coastline escaped damage when the storm surge or wave elevations exceeded the first floor levels (see Figure 2-8).

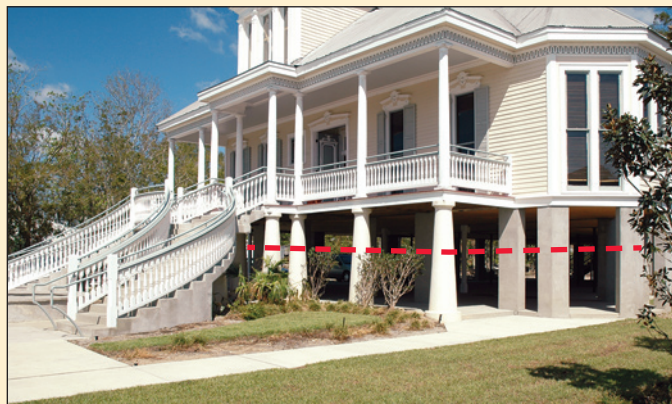
This building in Mandeville, Louisiana, was relocated from New Orleans for use as a restaurant. The local building inspector recommended the elevation seen here, which protected this building from flood damage. Note the estimated flood depth in relation to the first floor (red line).

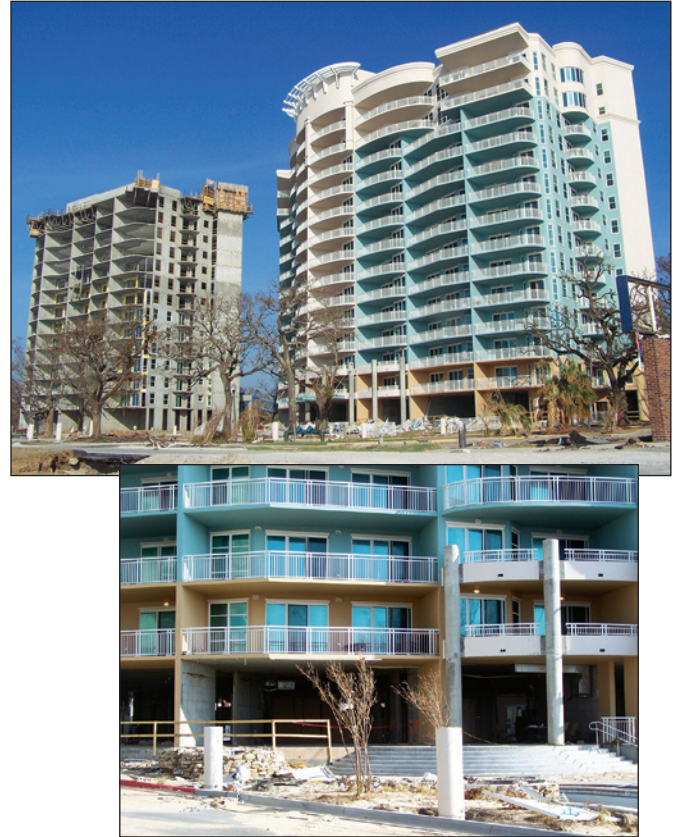
**Figure 2-9.** High-rise buildings along Beach Boulevard received non-structural flood damage to the lower floor, and no apparent flood or wind damage to higher residential floors (Gulfport, Mississippi)

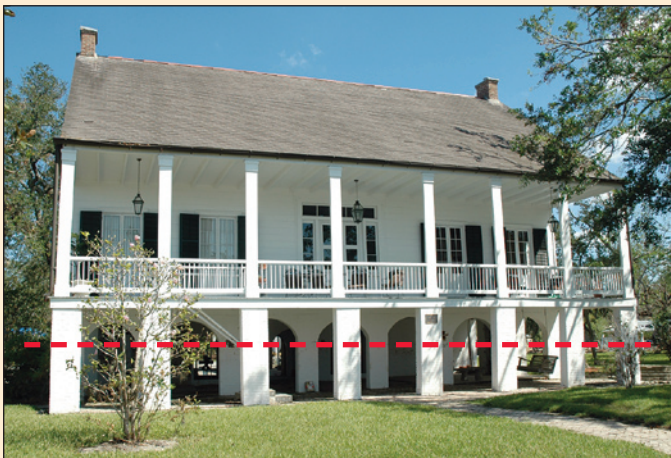
This 100-year-old building on the National Register of Historic Places sustained minimal flood damage due to elevation on taller piers (an architectural choice, not a requirement when the building was constructed in 1905). Note the estimated flood depth in relation to the first floor (red line) (Mandeville, Louisiana).

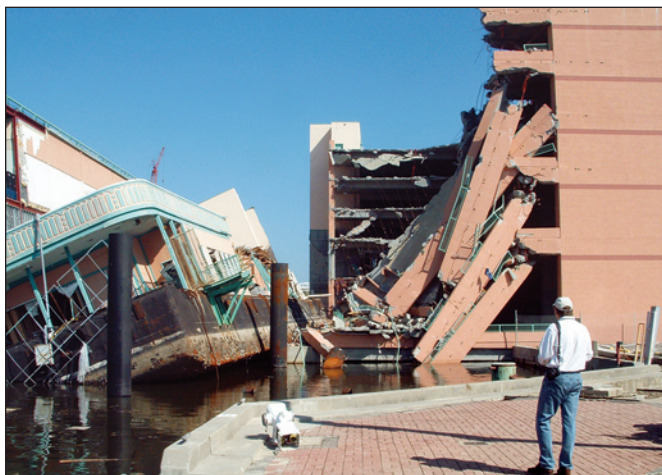
Some of the high-rise casino hotels and condominiums close to the shoreline experienced some of the worst storm surge depths and wave heights. The foundation stability of the large buildings was not affected; most were cast-in-place, reinforced concrete. Although sited near the shoreline and experiencing the worst flood conditions, the high-rises were some of the better examples of successes. However, some of the high-rise casino hotels were damaged when adjacent casino barges were pushed into them by storm surge (see Figure 2-10).

Figure 2-10.  
Parking deck collapse due to impact by casino barge, on  
left (Biloxi, Mississippi)

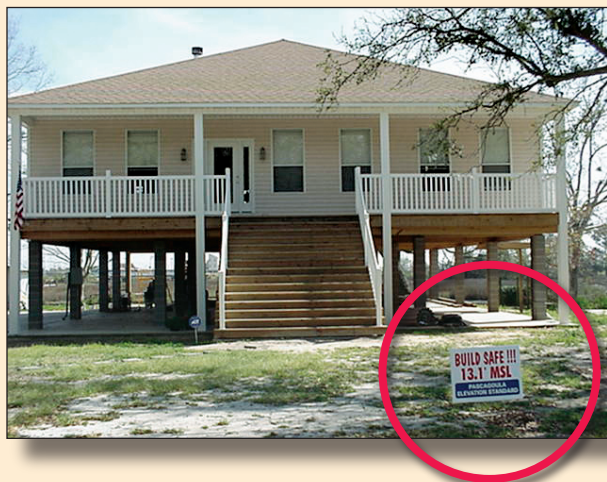
Following Hurricane Georges in 1998, the City of Pascagoula, Mississippi, established an elevation standard higher than the BFEs stated on the community's FIRMs. In some cases, this represented up to a 5-foot increase above mapped BFEs. As a result, buildings impacted by Hurricane Katrina that were built to this standard suffered less flood damage than older housing built to lower elevation requirements. According to the effective FIRM at the time of Hurricane Katrina, the building is located in Zone V with a BFE of 12 feet.

This photo was taken pre-Katrina c.1999/2000.  
Note the "Build Safe!" sign in front yard (circle),  
(Pascagoula, Mississippi).

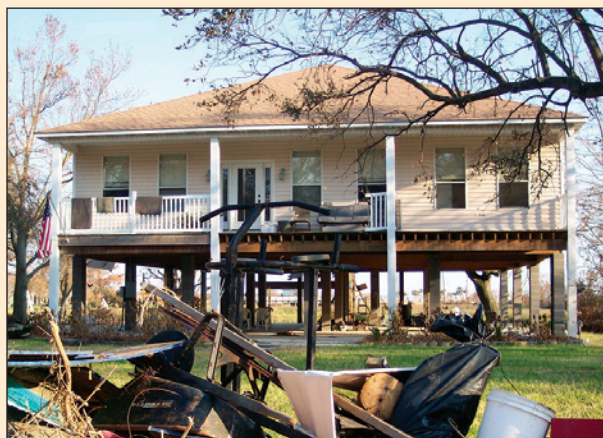
This photo was taken post-Katrina, illustrating  
the survival of this elevated building.

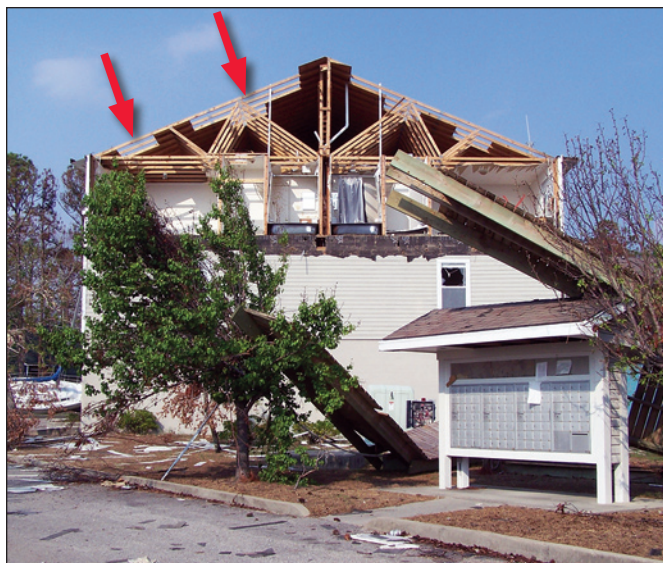
**Figure 2-12.** Failure of the gable end wall of this apartment building led to pressurization of the attic and the release of sheets of plywood sheathing. Note the plywood roof sheathing “unzipped” by wind pressures (arrows), (Ocean Springs, Mississippi).

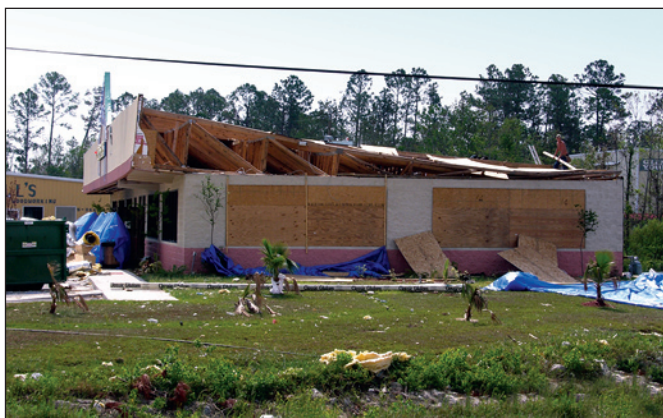
**Figure 2-13.** Failure in a wood frame commercial building. Trusses lost roof sheathing, allowing trusses to tip over (Ocean Springs, Mississippi).

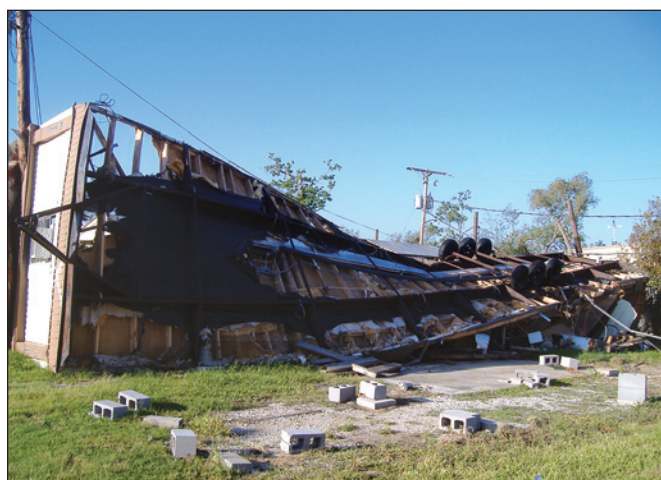
While most of the damage to manufactured housing was from flooding, wind damage was noted in both older and newer manufactured homes. The styles of manufactured home installations impacted performance during Hurricane Katrina. When properly anchored, manufactured home damage under wind loads was less significant. Unanchored or improperly anchored homes or homes with damaged anchors were prone to wind-related damage (see Figure 2-14).

**Figure 2-14.** Manufactured home rolled over by Hurricane Katrina’s winds (Chalmette, Louisiana)

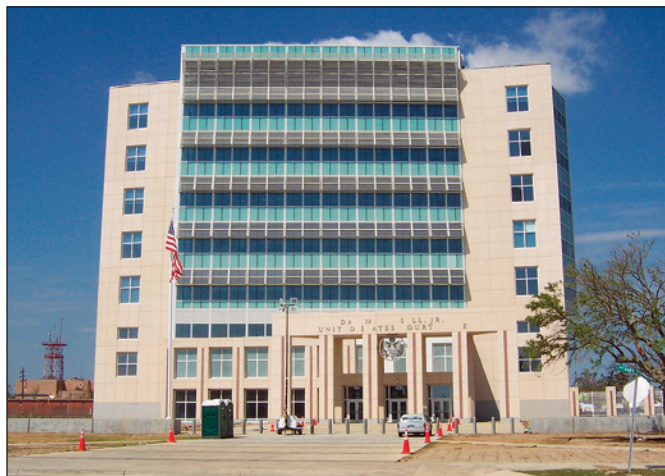
In general, reinforced concrete and heavy steel buildings observed by the MAT performed well structurally (see Figure 2-15). While the MAT noted little structural damage to most buildings constructed with reinforced concrete frames, extensive damage to unreinforced masonry buildings was observed.

**Figure 2-15.**  
Reinforced concrete/steel frame building that performed well structurally, but did have some building envelope damage and roof mounted HVAC equipment damage (Gulfport, Mississippi)

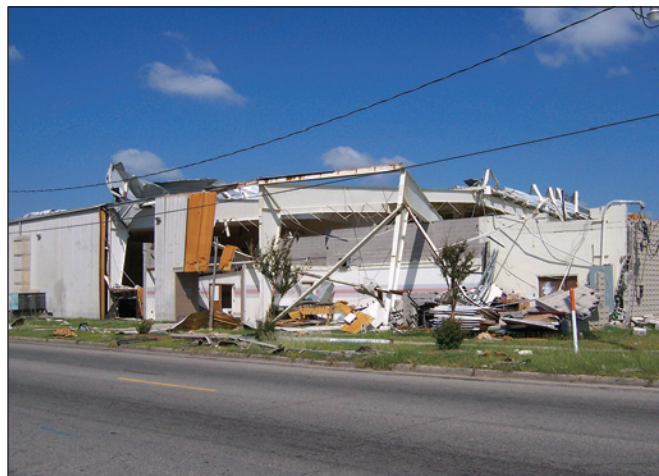
**Figure 2-16.**  
Pre-engineered metal building failure (Gulfport, Mississippi)

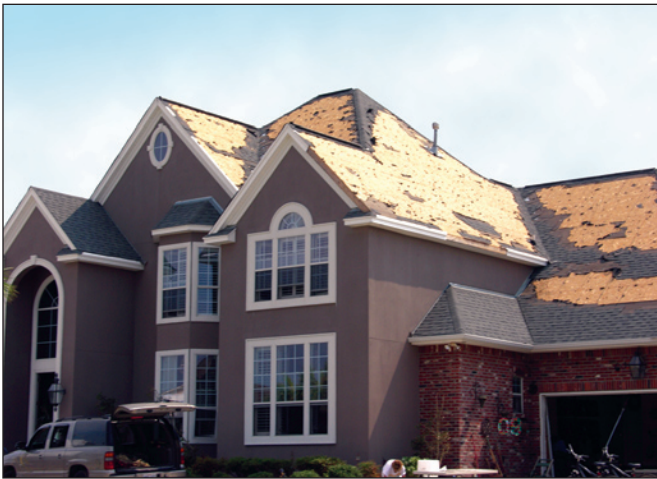
Damage to roof coverings can cause major building performance problems during hurricanes. Rainwater entering a building through damaged roofs causes significant damage to the building contents and interior. Throughout the areas observed by the MAT, many of the residential buildings had asphalt shingle roof coverings. The vast majority of the observed roofs experienced damage, ranging from loss of a few hip trim shingles or tabs to loss of a large number of shingles and underlayment (see Figure 2-17). Failures of hip/ridge trim shingles and failures along the eaves and rakes were common.

**Figure 2-17.**  
Extensive loss of roof covering and underlayment (Slidell, Mississippi)

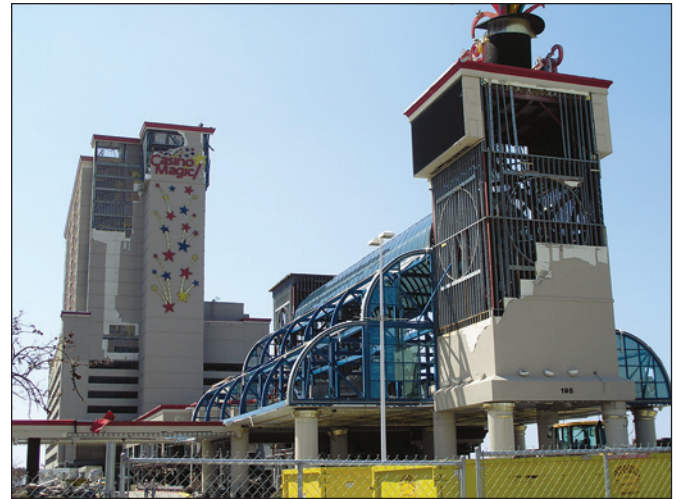
**Figure 2-18.**  
Multi-story building showing severe EIFS damage. In some areas, the gypsum board on the interior side of the studs was also blown away (Biloxi, Mississippi).

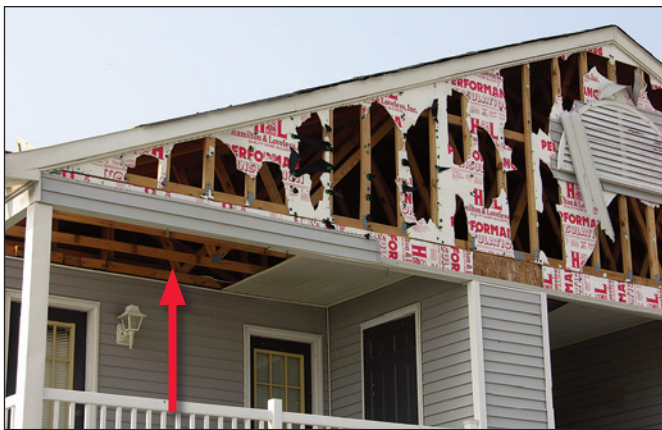
**Figure 2-19.**  
Loss of vinyl siding and foam insulation at a gable end wall. Note the missing vinyl soffit (red arrow). Not visible was the loss of roof sheathing caused by progressive failure that was initiated by soffit loss (Long Beach, Mississippi).

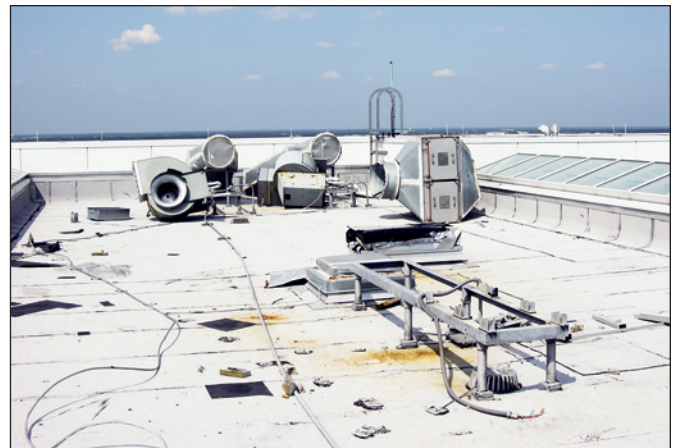
The MAT observed many damages to mechanical and electrical devices mounted on the exterior of buildings. Lost equipment included fan units and HVAC units, electrical and communications equipment, and lightning protection systems. There are several effects due to loss of this equipment. In many instances, the displaced equipment left large openings through the roof and/or punctured the roof membrane. Equipment loss often affected the operational functions of the facilities. Blown-off equipment became high-momentum windborne debris in some cases. The equipment observed on critical and essential facilities was not anchored more effectively than the equipment on common commercial buildings (see Figure 2-21).

**Figure 2-21.**  
The equipment on this new Federal courthouse blew away because it was resting on vibration isolators that provided lateral resistance, but no uplift resistance. Two large openings through the roof were left after the ductwork blew away (temporary covers had been placed over the openings).

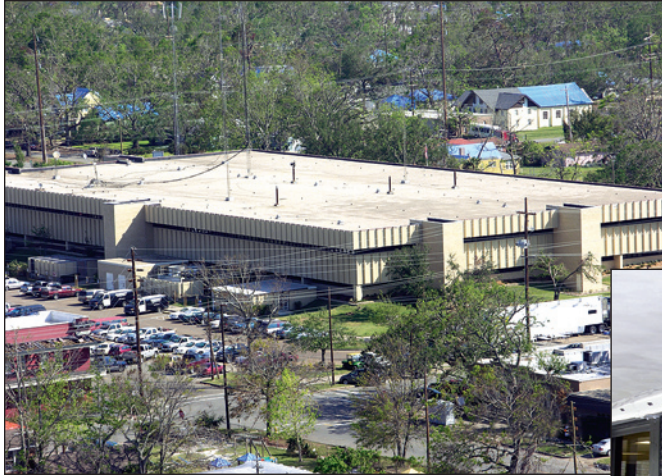
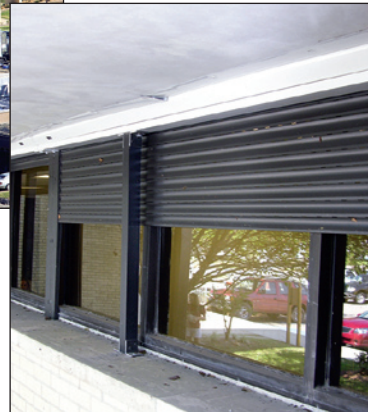
**Figure 3-1.**

The EOC is located near the center of the first floor of the First Judicial District Courthouse in Gulfport. The windows and glazed doors were retrofitted with roll-down shutters, but communications tower damage and vehicle damage from roof aggregate still occurred (Gulfport, Mississippi).

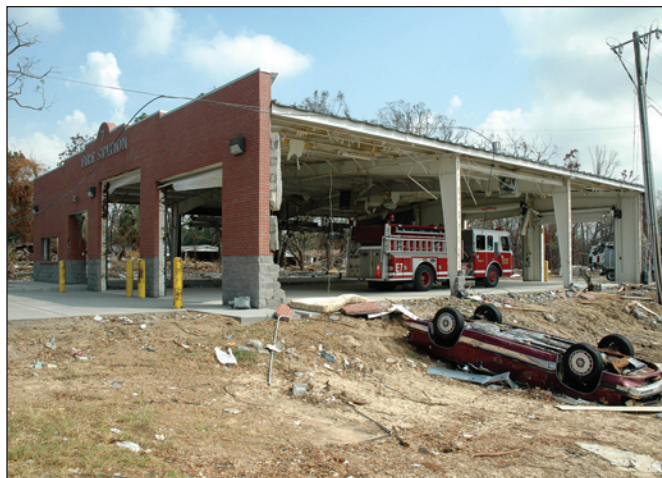
**Figure 3-2.**

Newly constructed Gulfport Fire Station 7 destroyed by waves and storm surge (Gulfport, Mississippi)

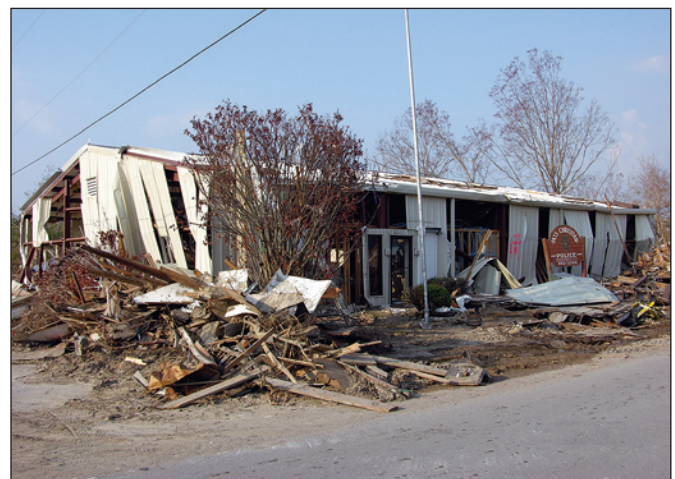
**Figure 3-3.**  
Police department destroyed by storm surge  
(Pass Christian, Mississippi)

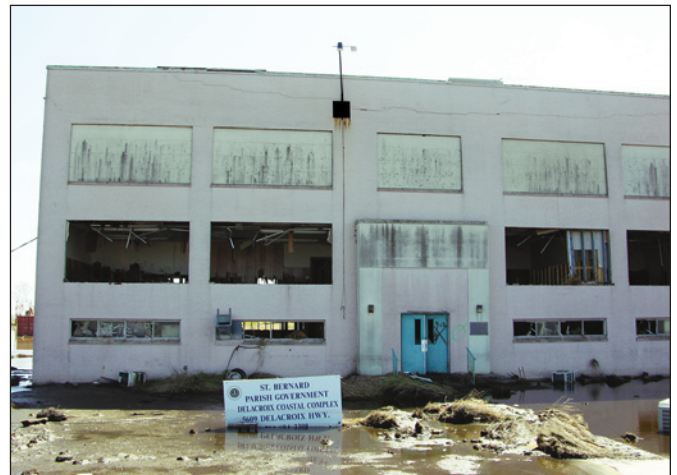
**Figure 3-6.**  
Storm surge damage to the St. Bernard Parish Coastal  
Government Complex (Delacroix, Louisiana)
