The Effects of Traffic Calming Measures on Pedestrian and Motorist Behavior

REPORT NO. FHWA-RD-00-104

August 2001

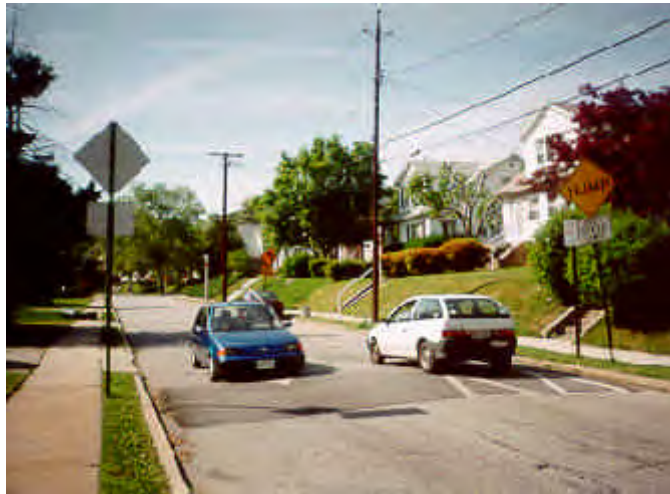
Figure 1. Two vehicles slow down as they pass over a speed hump.

Also known as road humps, undulations, or "sleeping policemen," the purpose of speed humps is to promote the smooth flow of traffic at slow speeds of about 32 to 40 km/h (20 to 25 mi/h). The speed hump is an elongated hump with a circular-arc cross-section (round-top) or flat-top, rising to a height of 76 mm (3 in) above the normal pavement surface and having a length of 3.7 m to 6.7 m (12 ft to 22 ft) in the direction of vehicular travel (Figure 1). Speed humps usually extend the full width of the road, excluding the gutter to allow for drainage (1).

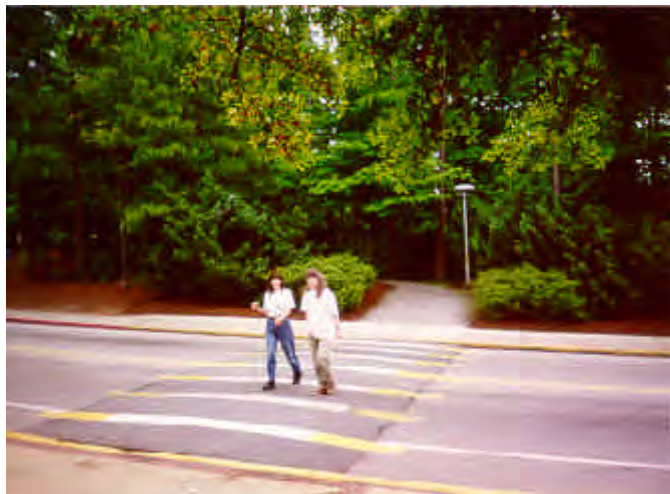
Figure 2. Pedestrians using a raised crosswalk.

Raised crosswalks are flat-top speed humps with crosswalk markings painted on the top (Figure 2). Raised crosswalks elevate pedestrians above the surface of the roadway and can make them more visible to motorists. Raised crosswalks cause motorists to slow at the most critical location, where pedestrians cross. They are generally designed to keep pedestrians at one level so that there is no need for curb ramps. Drainage is accommodated by pipes along the gutter or other design features.

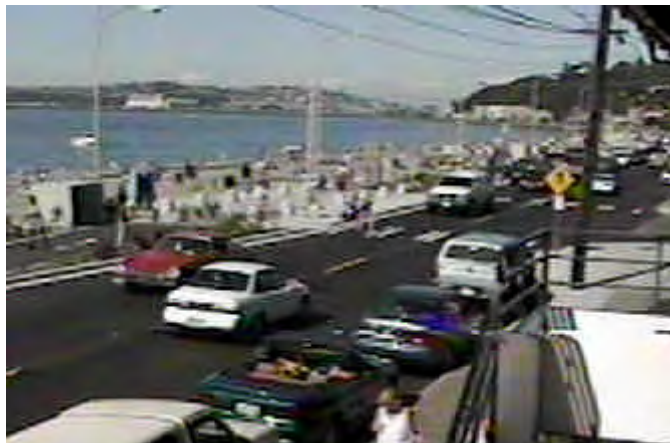
Figure 4. A motorist yielding to pedestrians, Alki at 59th, Seattle.

By constricting the roadway, bulbouts are intended to slow vehicles down and increase the likelihood that motorists will see pedestrians sooner than they would otherwise. Therefore, it was hypothesized that bulbouts would increase the number of pedestrians for whom motorists yielded. In other words, more pedestrians would have the benefit of motorists yielding to them (Figure 4).

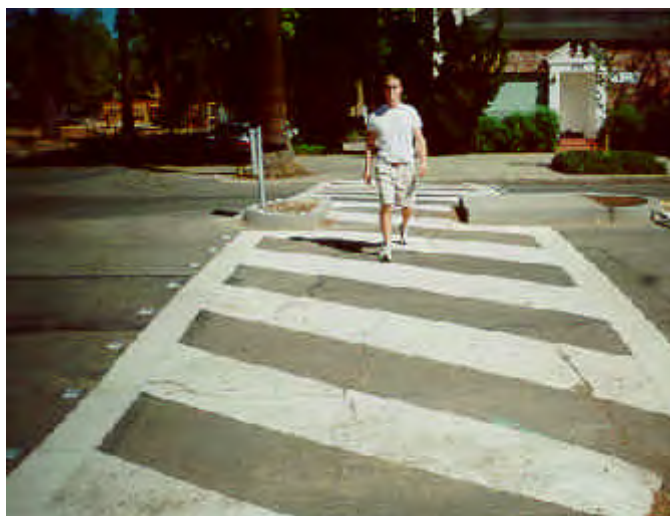
Figure 10. Pedestrian in crosswalk with refuge island, Sacramento, California.
