Trench Collapse

Professional Development Hours (PDH) or Continuing Education Hours (CE) Online PDH or CE course

The Project

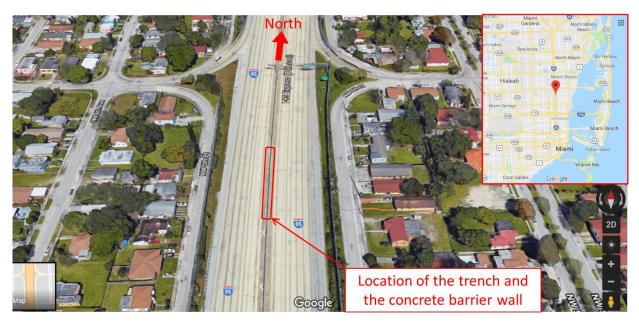
Figure 1 Project site (courtesy of Google.com)

The project was the I-95 Miami rehabilitation project in Miami, Florida. Archer Western Contractors, Ltd. (Archer Western) was the contractor of the project. The project included the removal and replacement of concrete pavement within the established project limits, such as replacement of all asphalt shoulder pavement with full depth concrete shoulder pavement. The project also included drainage modifications and new concrete barrier walls in the center median of the I-95, see Figures 1 and 2.

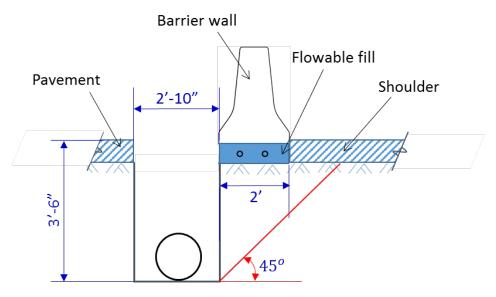
Figure 3 Typical section of the excavation prior to the collapse – looking north

After Archer Western installed the buried drainage pipe involved in the incident, video evidence from the pipeline video inspection indicated that the pipe was either damaged during construction or mis-installed. Therefore, Archer Western decided to open a trench to repair/replace the pipe, see Figure 3, and had its employees to hand-dig the trench along the concrete barrier wall. The trench was approximately three and one-half feet deep, approximately 2 feet 10 inches wide and more than one hundred and thirty feet long. The concrete barrier wall involved in the incident was approximately 121 feet long, see Figure 4.

The trench cross section, shown in Figure 3, is based on the observations and measurements obtained from our field visit on February 6, 2018. The concrete barrier wall sat directly on the utility trench, which was backfilled with flowable fill. Other than the subgrade soil underneath, the concrete barrier wall was not supported by or secured to any other structures, such as an inlet or pavement shoulder, see Figures 4 to 6.

The loads imposed on the subgrade soil from the concrete barrier wall was not limited to the immediate area of the wall, but also extended some distance away from the wall. This distance can be estimated as being equal to the depth of the excavation. Thus, a critical plane is formed sloping up from the bottom of the excavation toward the wall at an angle of 45 degrees, see Figure 3. Since the footing of the concrete barrier wall remained completely above the critical plane, according to the discussions in the preamble to OSHA's excavation standards (at 54 Federal Register 45924, October 31, 1989), the stability of the concrete barrier wall was endangered by the excavation operations. Therefore, per OSHA standard CFR 1926.651(i)(1) support systems should have been provided to ensure stability of the concrete barrier wall to protect employees working the trench.

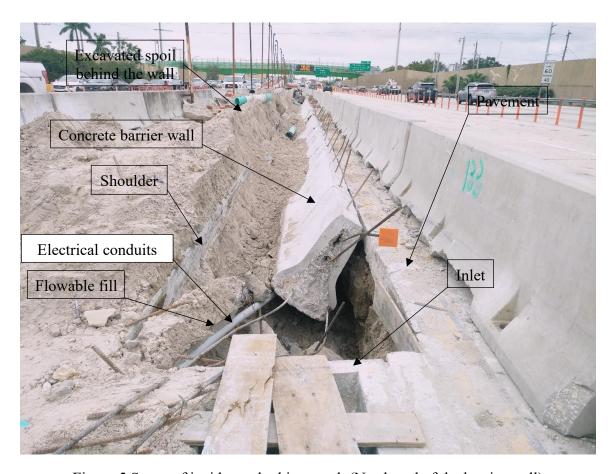
Figure 5 Scene of incident – looking south (North end of the barrier wall)

During our site visit, the excavated soil was classified as OSHA Type C soil according to the site conditions and natural characteristics of the earth deposits, see Figures 5 and 6. Based on the OSHA laboratory test (see Appendix A), the sample of earth deposits collected at the incident site was further classified as granular sand with no cohesion, corresponding to OSHA Type C soil.

The soil sample contained 91.7% sand and gravel. At the incident site, it was also observed that large clumps of excavated spoil broke into small pieces without difficulty. Besides, approximately 0.1 inches of rain fell within 24 hours of the incident (see Appendix B for national climatic data). These facts confirmed that the subgrade soil at the incident site was not able to sustain the concrete barrier wall when the collapse occurred.

- 1) The cause of the failure was the instability of the concrete barrier wall. The instability of the concrete barrier wall was caused by the trench excavation operations.
- 2) No support systems such as shoring, bracing, or underpinning were provided by Archer Western to ensure the safety of employees and the stability of the concrete barrier wall, prior to, during and after the trench was opened.
- 3) Archer Western violated the OSHA standard CFR 1926.651(i)(1) by not providing a support system, such as shoring, bracing, or underpinning to ensure stability of the concrete barrier wall for the protection of the employees.
- 4) Archer Western violated the OSHA standard CFR 1926.651(k)(1) by not conducting any inspection of the excavation and the adjacent areas by a competent person prior to the start of the work or as needed throughout the shift, on or prior to 02/04/2018.
