Accident - BP-Texas City Refinery Explosion and Fire

**Professional Development Hours (PDH) or
Continuing Education Hours (CE)
Online PDH or CE course**

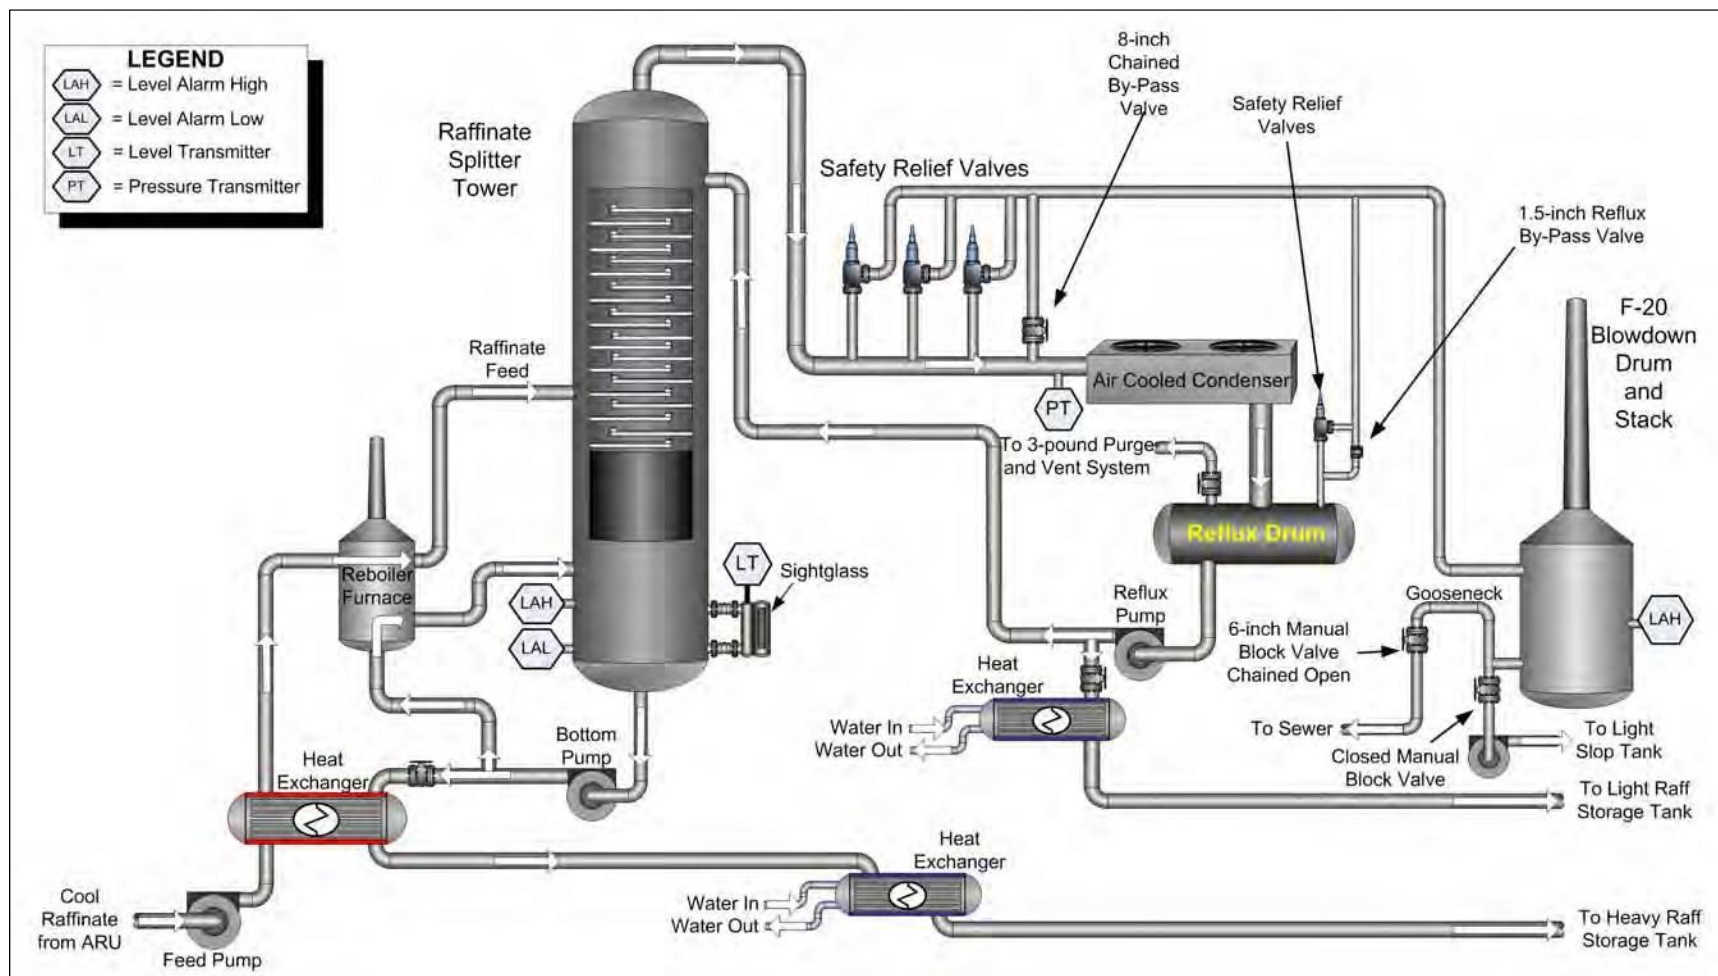
Figure 1. Raffinate section of the ISOM

The tower was a vertical distillation column with an inside diameter of 12.5 feet (3.8 m) and height of 170 feet (52 m) with an approximate liquid-full volume of 154,800 gallons (586,100 liters). The tower was fitted with 70 distillation trays¹⁷ that separated the light from the heavy raffinate (Figure 1).

Liquid raffinate feed was pumped into the raffinate splitter tower near the tower's midpoint. An automatic flow control valve adjusted the feed rate. The feed was pre-heated by a heat exchanger using heavy raffinate product and again in the preheat section of the reboiler furnace, which used refinery fuel gas. Heavy raffinate was pumped from the bottom of the raffinate splitter tower and circulated through the reboiler furnace, where it was heated and then returned below the bottom tray. Heavy raffinate product was also taken off as a side stream at the discharge of the circulation pump and sent to storage. The flow of this side stream was controlled by a level control valve that, when placed in "automatic," adjusted to maintain a constant level in the tower. The splitter tower was equipped with a level transmitter, which provided a reading of liquid level in the tower to the control room board operator.¹⁸ The transmitter measured the tower's liquid level in a 5-foot (1.5-m) span within the bottom 9 feet (2.7 m) of the 170-foot (52-m) tall tower. The splitter tower also had two separate alarms that indicated high liquid level; one was programmed to sound when the transmitter reading reached 72 percent (a height of 7.6 feet or 2.3 meters in the tower). The second, a redundant hardwired high level switch,¹⁹ was designed to sound when the liquid level reached 7.9 feet (2.4 m) in the tower (which corresponded to a reading of approximately 78 percent on the transmitter). The raffinate splitter was also fitted with a redundant low level alarm.

Light raffinate vapors flowed overhead and down a 148-foot (45-m) long section of pipe before they were condensed by the air-cooled fin fan condensers and then deposited into a reflux drum. Liquid from the reflux drum, called “reflux,” was then pumped back up into the raffinate splitter tower above tray 1 (the top tray). The reflux drum was operated as a “flooded” drum, which means that during normal steady-state operation, it was kept completely full. The reflux drum also had high and low level alarms and a safety relief valve set at 70 psig (483 kPa). A bypass line, which discharged into the raffinate splitter disposal header collection system, allowed release of non-condensable gas (e.g. nitrogen) and purge the system. During startup, uncondensed vapors that built up in the drum were normally vented through a control valve to the refinery’s 3-pound purge and vent gas system (Figure 1). This control valve malfunctioned and was not used during the March 23, 2005, startup.

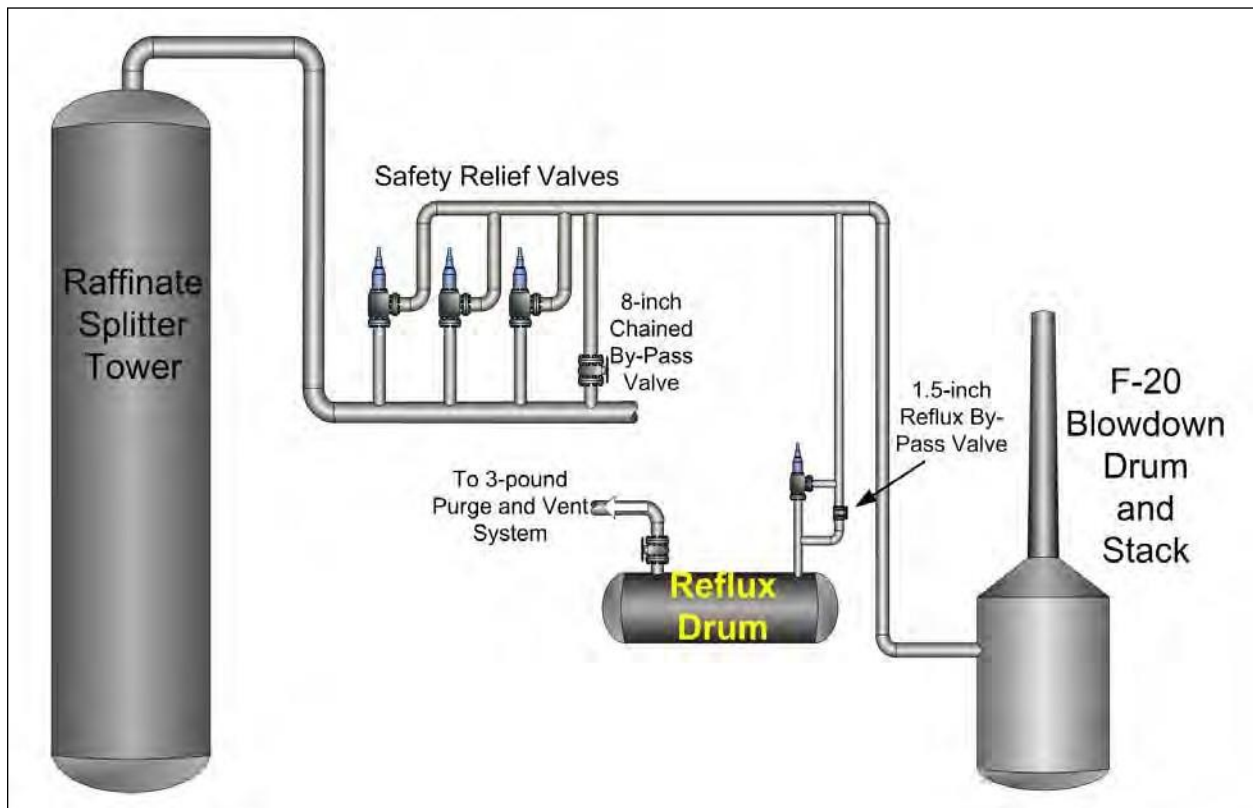
Figure 2. Disposal collection header system

To protect the raffinate splitter tower from overpressure, three parallel safety relief valves (Figure 2) were located in the overhead vapor line 148 feet (45 m) below the top of the tower. The outlet of the relief valves was piped to a disposal header collection system that discharged into a blowdown drum fitted with a vent stack.

The disposal header collection system received liquid and/or vapor hydrocarbons from venting relief and blowdown valves from equipment in the ISOM unit and discharged them to the blowdown drum. The header collection system included a 14-inch NPS (35.6 cm outer diameter) elevated pipe about 885 feet (270 m) long from the raffinate splitter tower (Figure 2). Other sections of the ISOM unit also discharged from two additional collection headers into the blowdown drum.

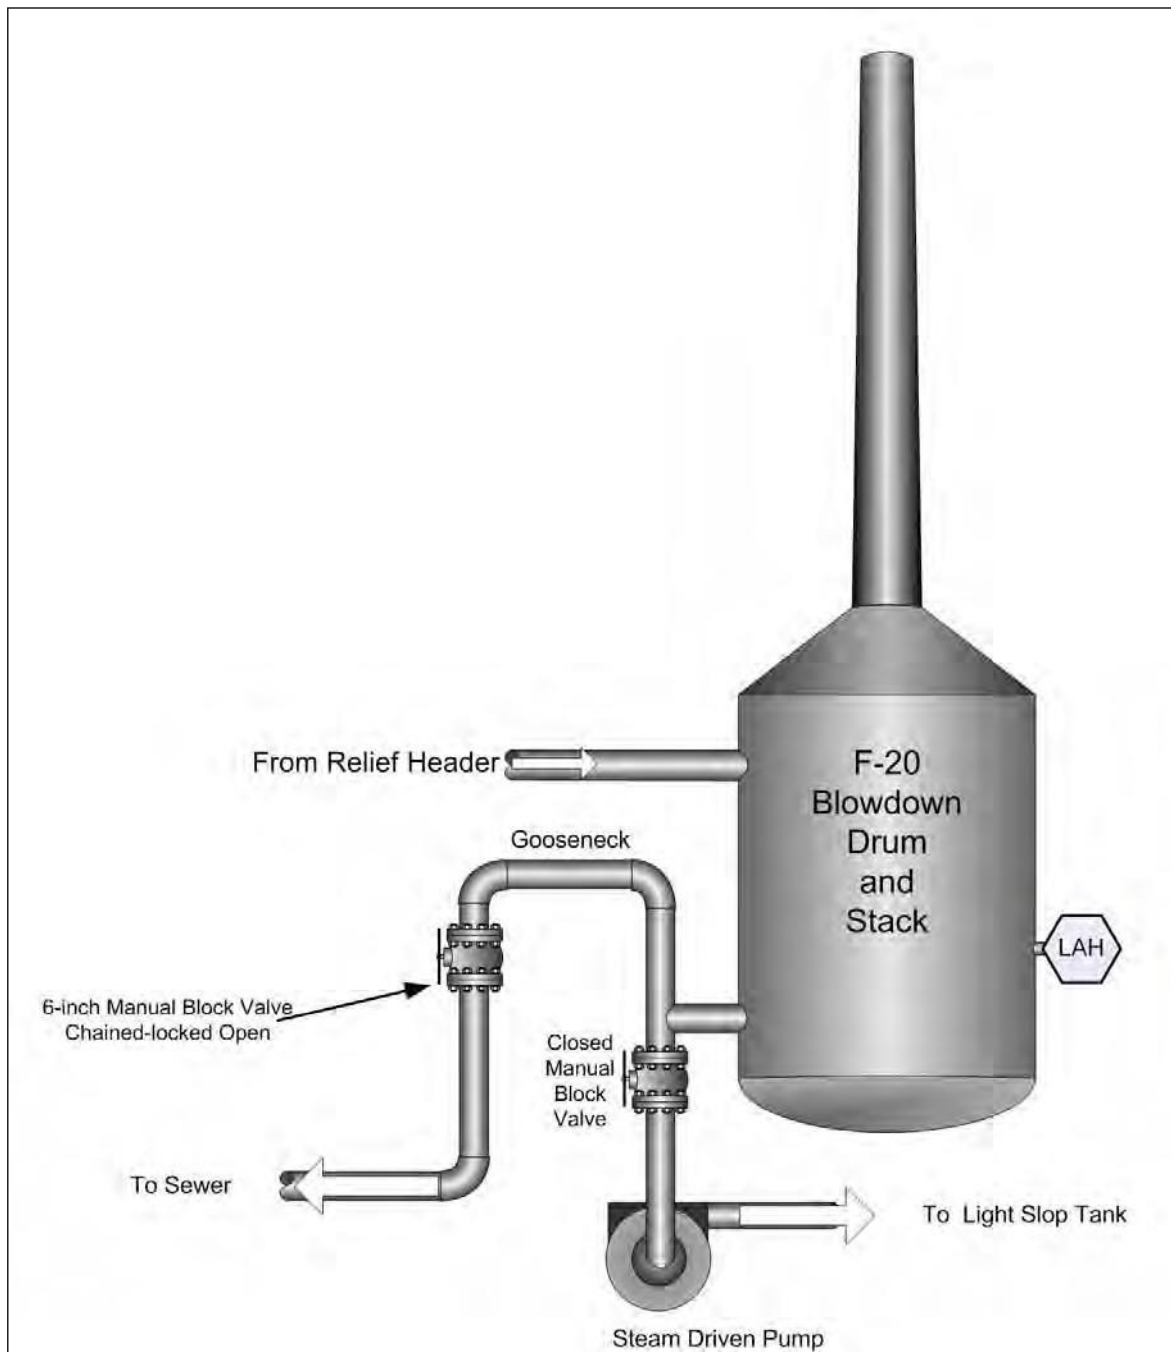
Figure 3. Blowdown drum and gooseneck

A liquid level, normally water, was maintained in the bottom of the blowdown drum. The height of this level was controlled by a "gooseneck" seal leg piped to a closed drain (Figure 3 and 4).

As the blowdown drum and stack filled, some of the flammable liquid flowed into the ISOM unit process sewer system through the chained-open 6-inch NPS manual block valve (Figures 3 and 4) and the other safety relief valve discharge pipe headers. As explained in section 2.2.5, this practice of discharging to the sewer was unsafe.

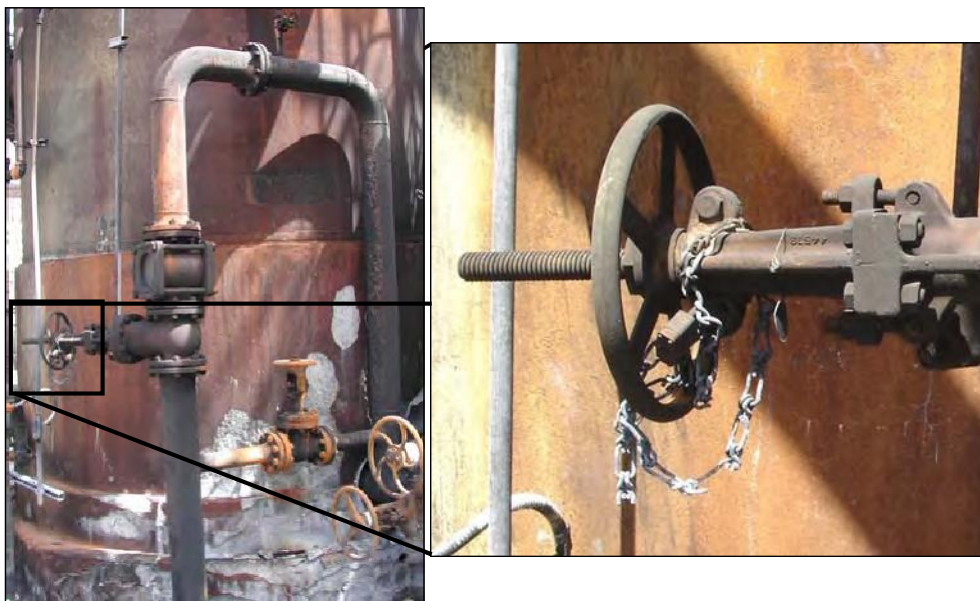
Figure 4. Left: Gooseneck piping and manual block valve (chained-locked open) Right: Close-up of manual block valve

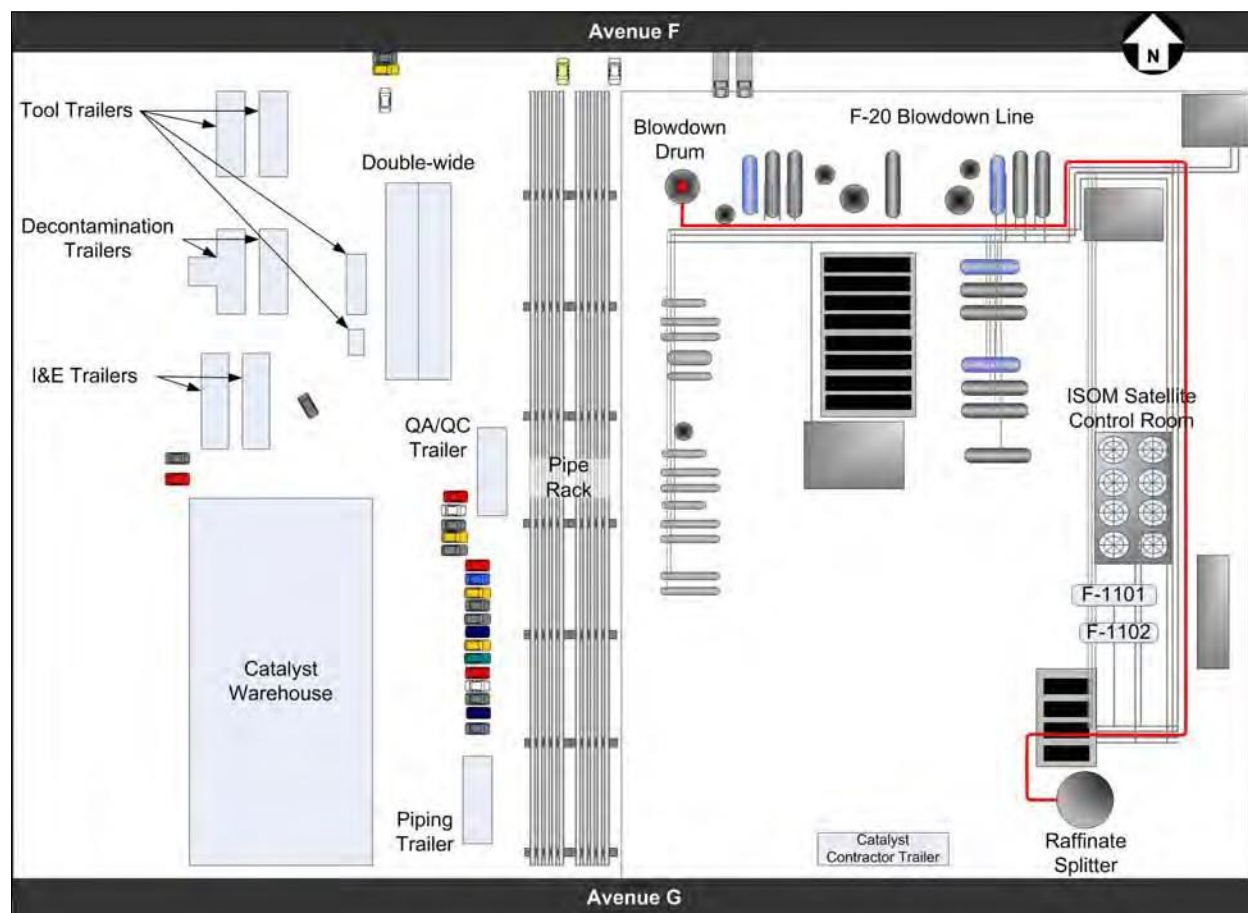
Figure 15. Trailer area and adjacent ISOM unit

BP's placement of occupied trailers close to the ISOM unit was a key factor leading to the fatalities from this disaster. All 15 who died during the March 23, 2005, incident were in or around trailers. The trailers were sited in this area primarily for convenience: the unoccupied area between the ISOM and NDU units was selected because it was across the road from the Ultracracker, (ULC) and would be a convenient staging area for the contractors in their turnaround work (Figure 15). The CCPS noted that this practice is an increasing trend:

While planning for the 2005 ULC unit turnaround, in September 2004 BP sited a double-wide trailer between the NDU and ISOM to house employees for the Motorization Project. Nine others were located in the same area to support the ULC turnaround, but a MOC was not conducted for any of them despite being required by BP policy (Figure 15). (Appendix F provides further information on the location, construction, and use of all the trailers sited in this area.)

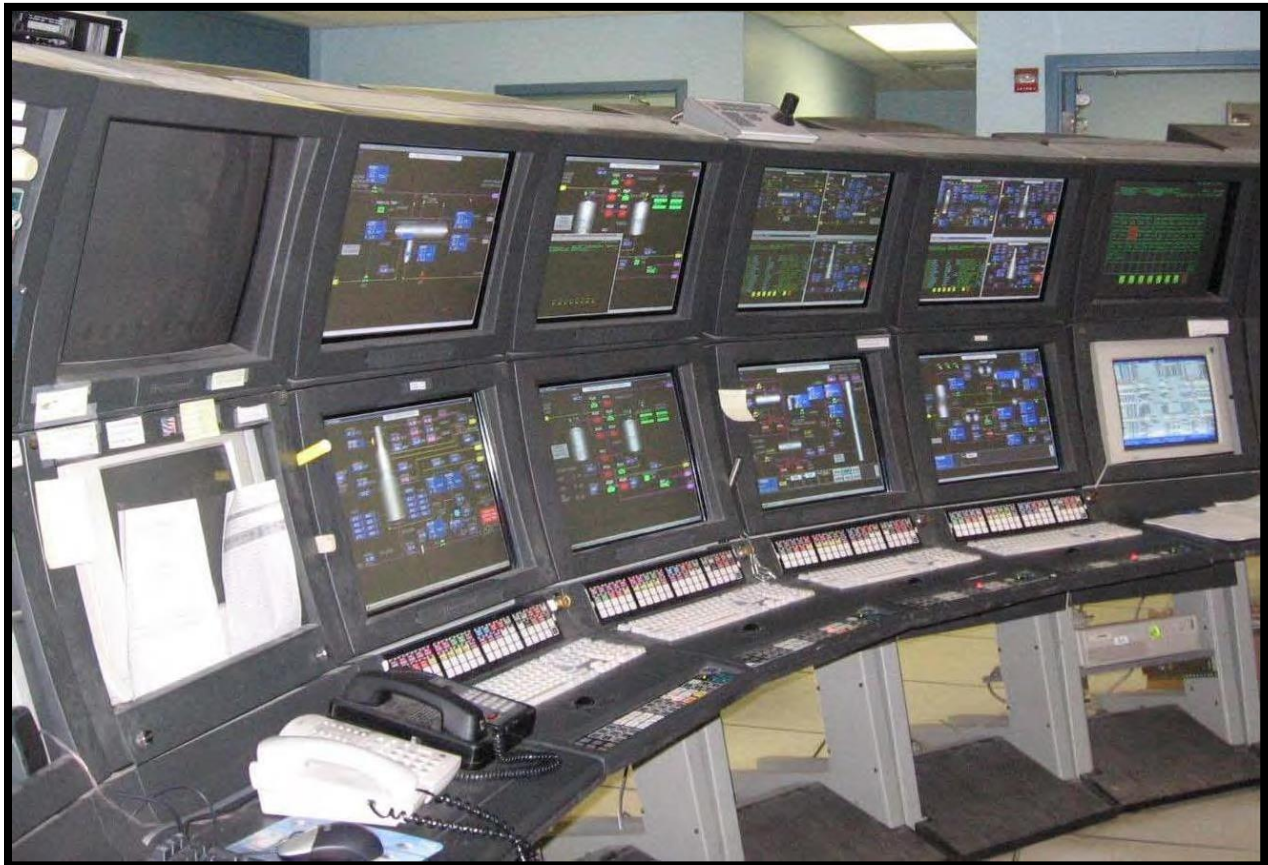
4.0 INCIDENT INVESTIGATION SYSTEM DEFICIENCIES

The control board for the ISOM/NDU/AU2 complex (Figure K-1) consisted of eight computerized control board monitor screens, four of which could be subdivided into four smaller display windows, for a total of 20 screen windows. Additionally, four additional monitors (two on either side of the eight monitor screens) displayed the critical unit alarms.

Three of the smaller screen windows were reserved strictly for alarm data (one for each unit). Each was a historical (chronological) record of the alarms; the alarm data displayed on these three screens could also be sorted by alarm priority type (low, high, emergency/critical). Additionally, the board operator was
