Accident - Bridge collapse in North Carolina

On April 14, 2021, at approximately 5 p.m., the last span of the Herbert C. Bonner Bridge (Bonner Bridge) under demolition collapsed in Dare County, North Carolina. An employee of PCL Civil Constructors, Inc. (PCL), engaged in the steel cutting, was killed. The collapsed span was the navigation span of the Bonner Bridge measuring 180 feet long, 24 feet wide, and approximately 60 feet above sea level, with a total weight of 980 kips.¹

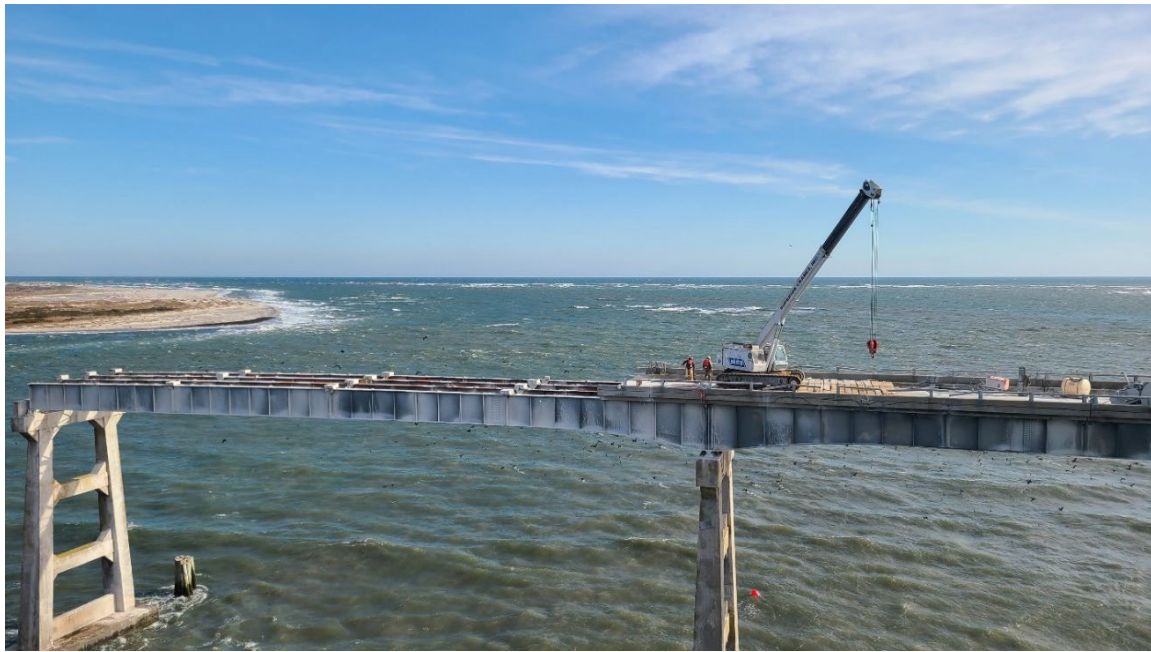
Figure 16 – Demolition of Spans 144 and 145
(photographed on 3/2/2021 by NCDOT)

March 2, 2021, PCL began cutting the concrete deck in Span 145 (see Figure 16). PCL stockpiled deck overhang and parapet segments on Span 145 (see Figures 17 and 18). PCL did not follow KCI’s demolition plan, nor the supplemental memorandum dated February 25, 2021.

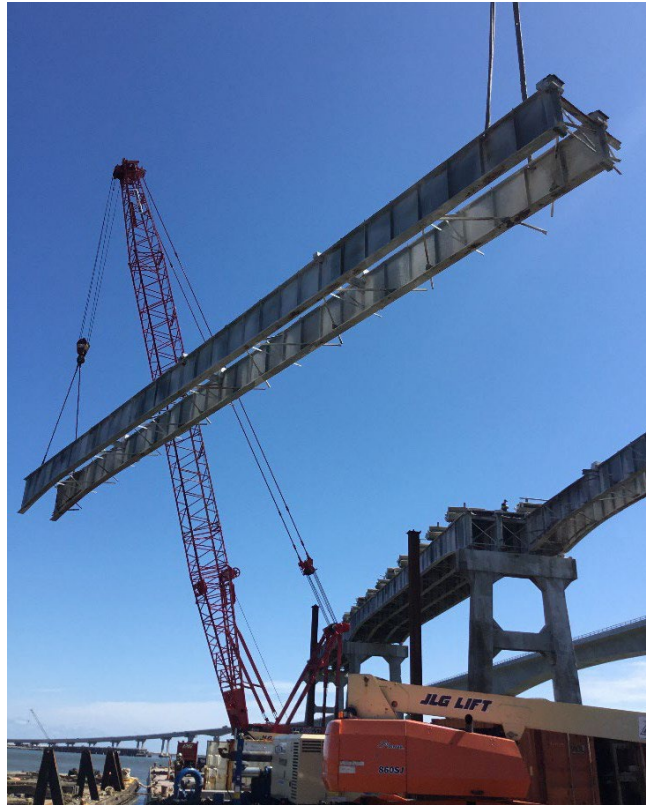
Figure 22 – Removal of Span 144 girders
(photographed on 3/30/2021)

March 30, 2021, PCL removed all steel girders in Span 144 (see Figure 22).

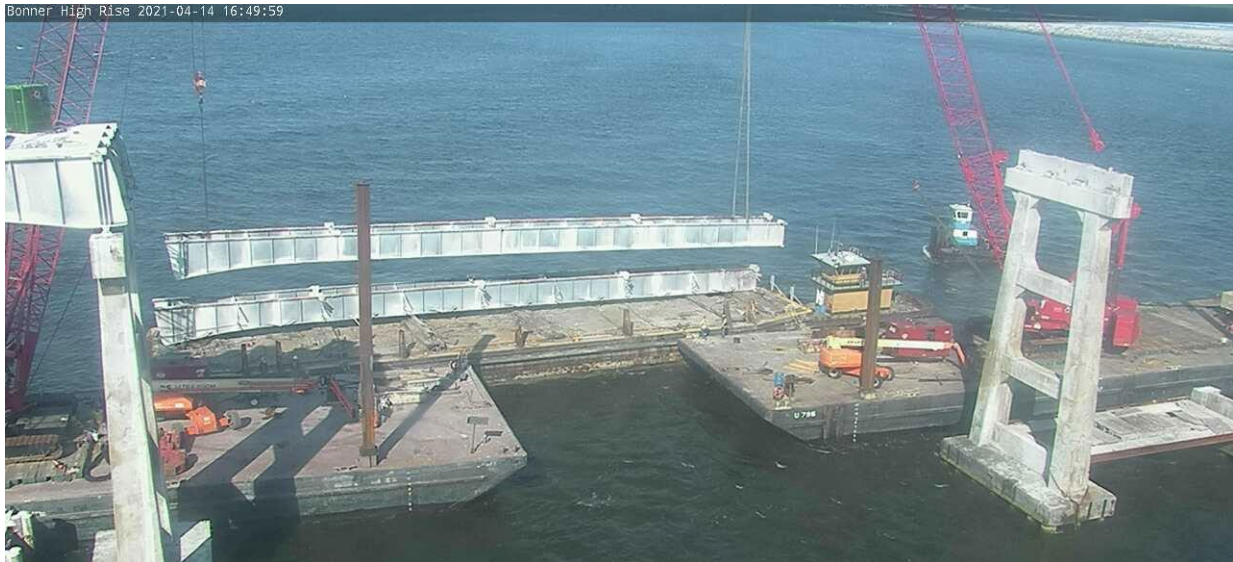
Figure 25 – Steel girders in Span 146 had been removed
(photographed on 4/14/2021 by NCDOT)

April 14, 2021, PCL cut the four steel girders in Spans 145 and 146 at Bent 145 and removed the four girder segments in Span 146 utilizing two marine cranes (see Figure 25). Shortly after Span 146 was removed, Span 145 collapsed (see Figure 26).
