Accident Case - Caribbean Petroleum Tank Explosion and Fire

**Professional Development Hours (PDH) or
Continuing Education Hours (CE)
Online PDH or CE course**

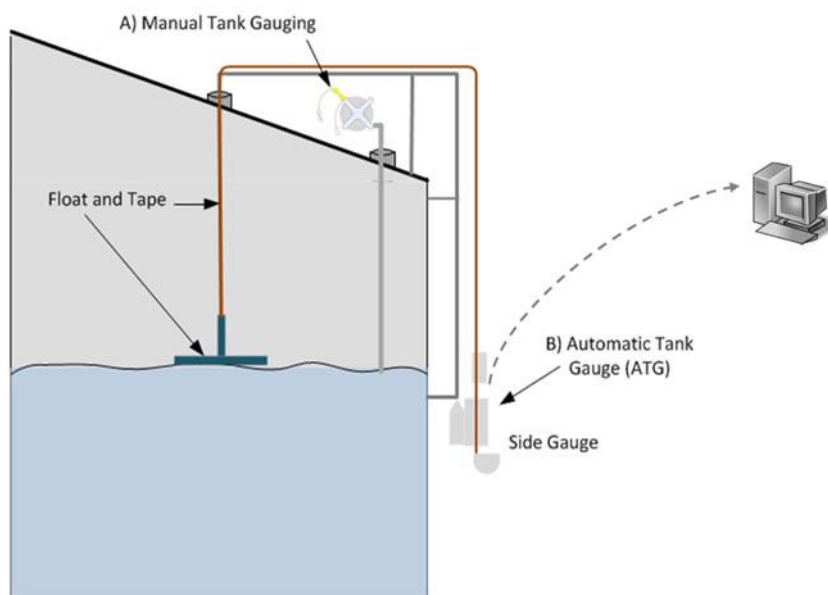
Figure 3: Manual and Automatic Tank Gauging. (A) Manual Gauging requires an operator to use a tape and measure to determine the liquid levels inside the tank. (B) Automatic Tank Gauging (ATG) requires an operator to read a level measurement from a tank gauge mounted to the side of the tank.

Prior to the start and end of filling operations, the independent inspector manually measured the fuel tank levels by lowering a gauging tape¹² into the tank. (Figure 3.) A CAPECO operator

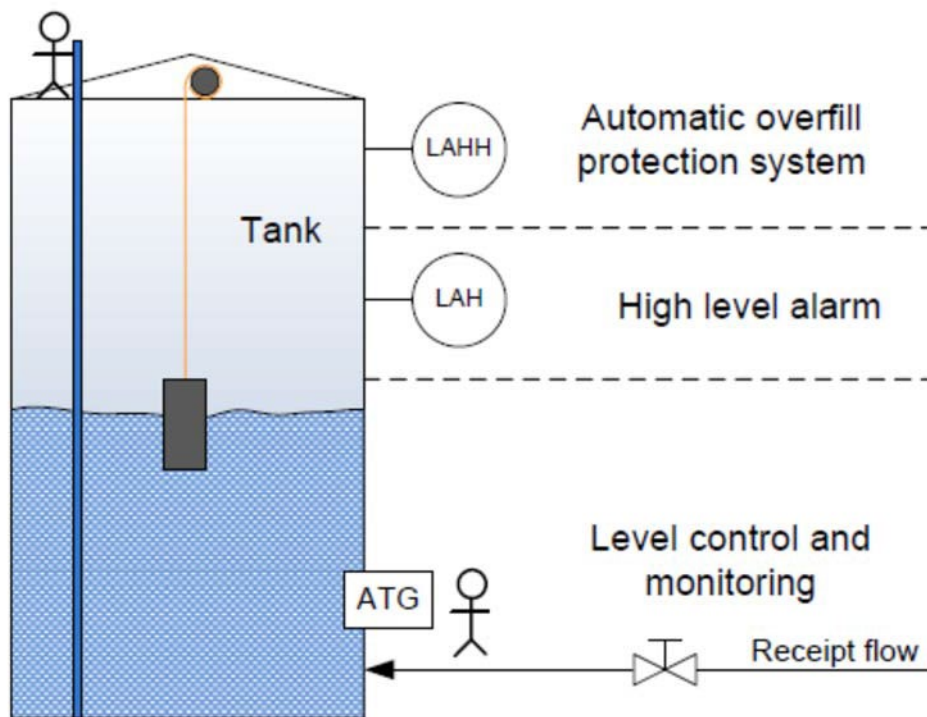
Figure 13: A comprehensive overfill prevention system includes the ATG, high-level alarm (LAH), and automatic overfill protection system (LAHH), in addition to the operator and facility procedures that govern, monitor, and control the flow of fuel into a tank.

CAPECO lacked a reliable automatic level control and monitoring system for measuring tank levels. (See Figure 13.) The automatic gauging system at CAPECO, described in Section 3.6.3, had a history of repeated failures and prolonged out-of-service periods. On the night of the incident, the float and tape device inside Tank 504 became stuck and the transmitters for Tanks 107 and 409 were not receiving data from the side gauge on Tank 409; therefore, data on the tank liquid level and a calculated fill rate into 409 were not available in real time on the computer. The computer monitoring system was often compromised by outages from lightning strikes and accidental breakage of the computer cables after maintenance activities in the tank farm area. In addition, the transmitters⁵⁶ that sent the data to the computer were also susceptible to electromagnetic interference and frequently needed replacing after lightning storms.

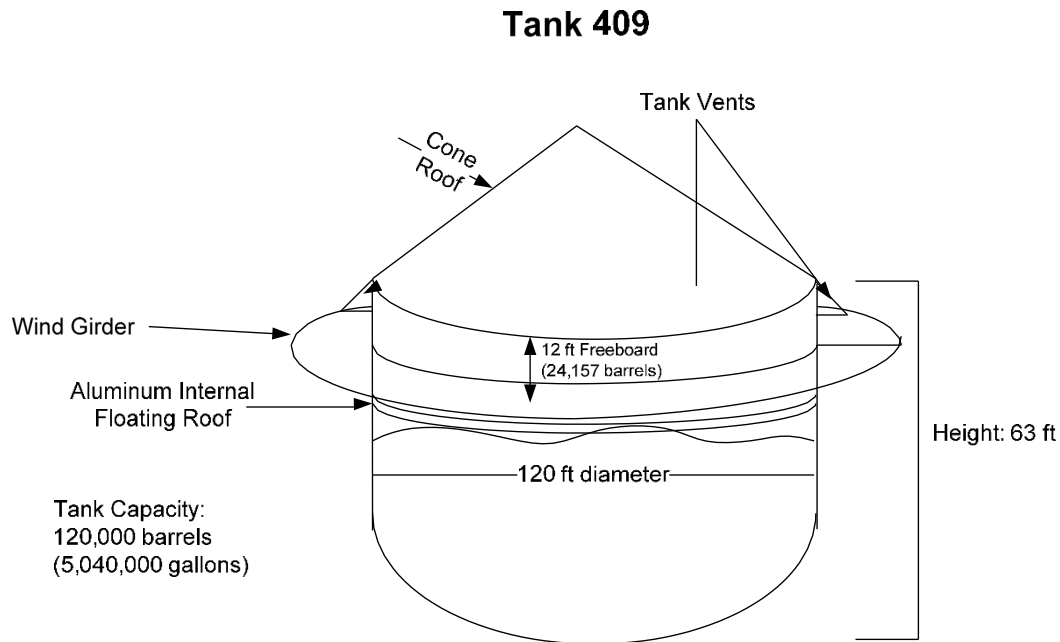
Figure 14: Tank 409 Specifications

Tanks 409 and 410 were located within the same secondary containment dike.²³ Similar to the Buncefield incident,²⁴ during the overflow, gasoline sprayed from the tank vents, hitting the Tank 409 wind girder and aerosolized,²⁵ forming a vapor cloud.²⁶ A CSB topographic survey of the site shows that Tanks 409 and 411 were located at the highest point within the tank farm area, allowing the vapor cloud to spread to lower lying areas in the direction of the WWT (Figure 7). See Figure 14, Tank 409 Specifications.

The destruction of the Tank 409 internal floating roof in the explosion prevented the CSB from determining if it failed during filling operations. Therefore, internal floating roof failure might have contributed to the overfilling of Tank 409. The roof construction of Tank 409 was subject to numerous operational limitations. Tank 409 had a fixed cone roof with an aluminum internal floating roof (IFR), and a freeboard⁷¹ of 12 feet (24,157 bbls). (See Figure 14 for Tank 409 specifications.) Aluminum IFRs are prone to corrosion when exposed to caustic liquids but sufficient for petroleum and organic materials. An internal floating roof can fail by means of turbulence,⁷² roof submersion,⁷³ seal issues, and fatigue.⁷⁴
