Accident Case - DuPont Methyl Chloride Release

**Professional Development Hours (PDH) or
Continuing Education Hours (CE)
Online PDH or CE course**

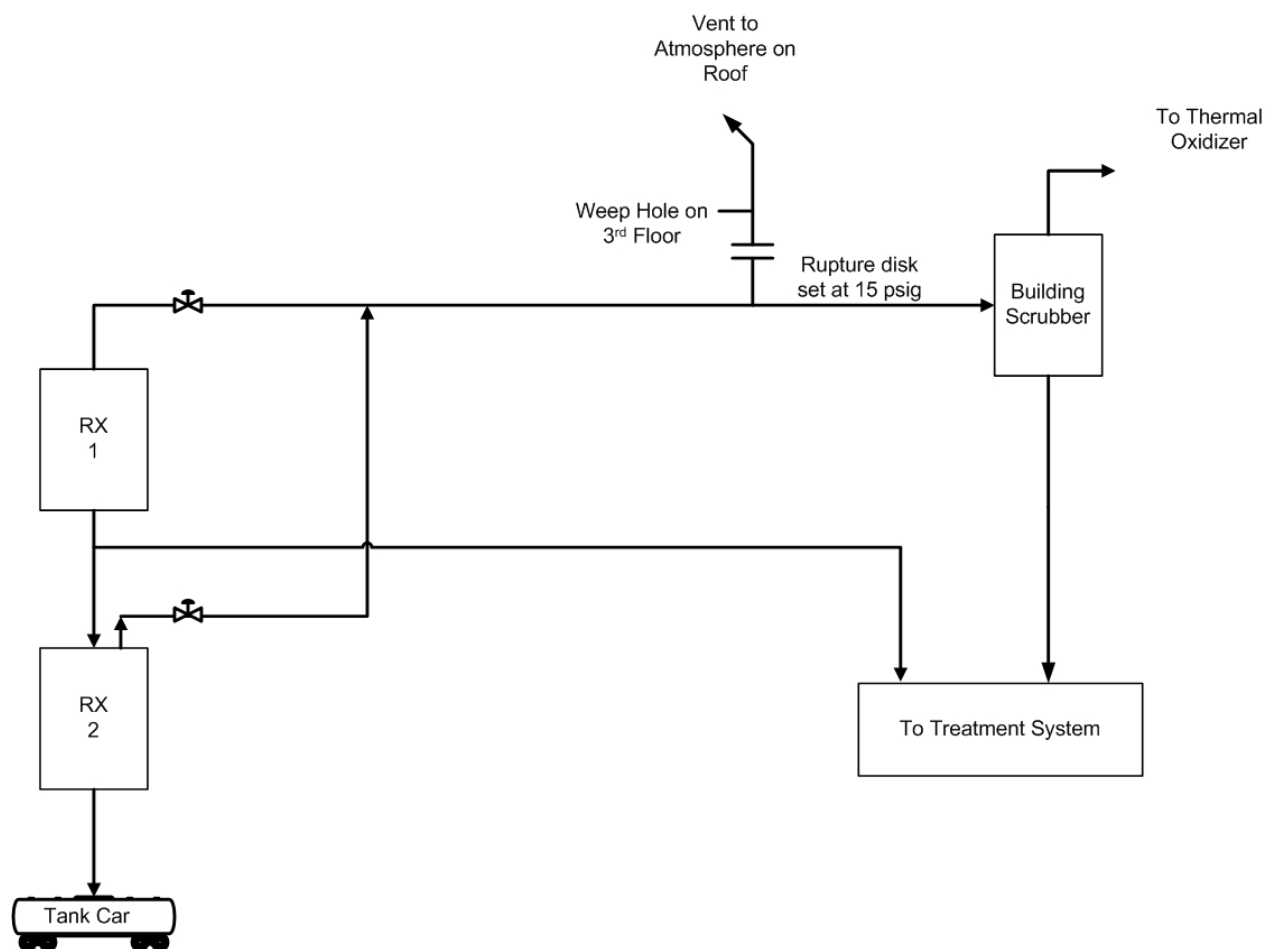
Figure 2. Simplified thermal oxidizer and rupture disc block flow diagram

The Belle plant's F3455 unit manufactures the intermediate F3455, a chemical that is shipped to another DuPont facility to make the herbicide Velpar®. Due to the exothermic reaction in the first reactor, dissolved methyl chloride vaporizes and normally exits through the reactor vent line along with carbon dioxide, nitrogen, and trace amounts of dimethylamine (DMA) vapor through a process scrubber and then to a thermal oxidizer for emission control. To avoid damage to the scrubber⁶ if excessive pressures occur, a piping connection upstream of the vent line is routed to a rupture disc that will burst and allow venting outside on the roof of the building which contains two reactors (Figure 2). However, due to a lack of safety considerations during installation, a 0.5-inch weep hole⁷ was placed on the vent line inside the building; consequently, dangerous chemicals vent inside the building if the rupture disc bursts.

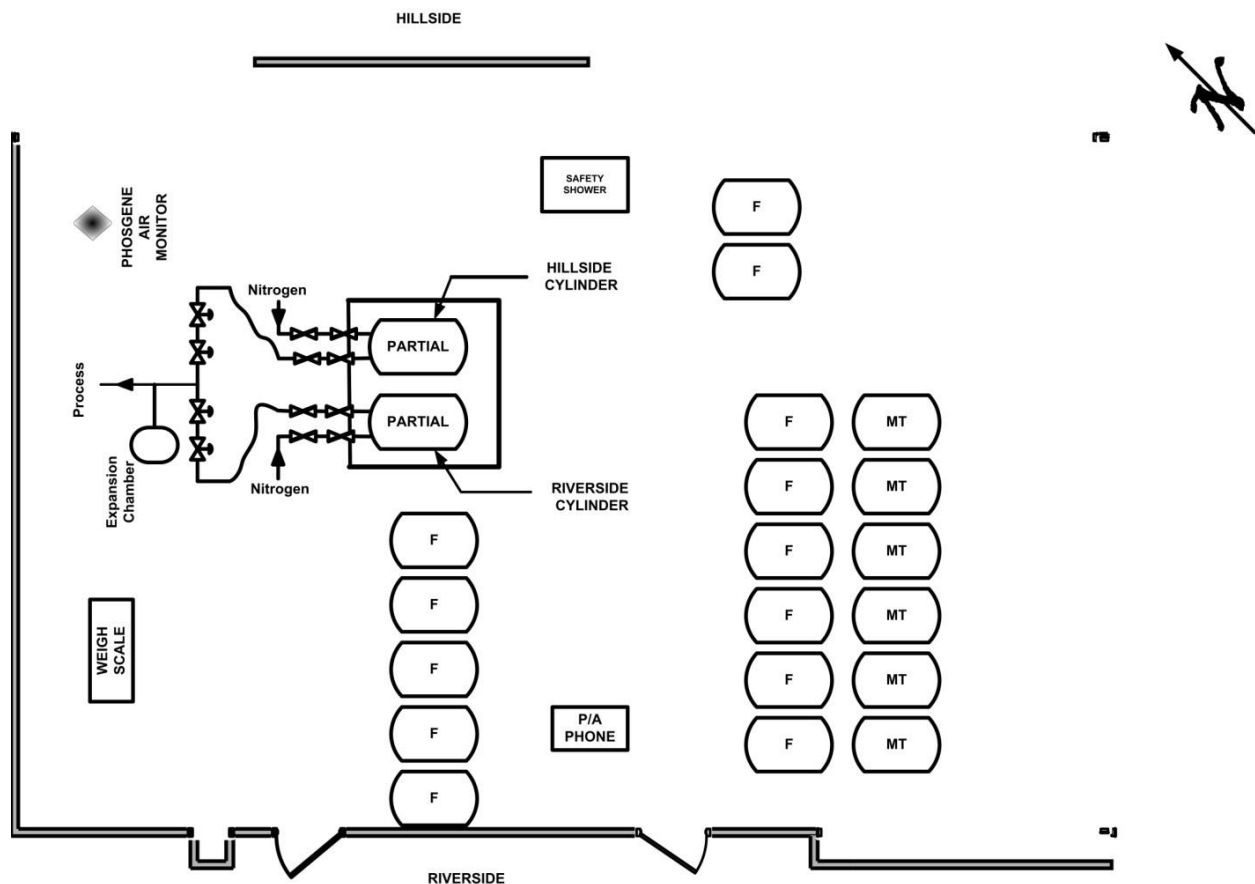
Figure 12. Phosgene shed and full (F) and empty (MT) cylinder locations on day of incident (not to scale)

During normal operation, two cylinders are staged on weigh scales and each is connected to the process with two 0.25-inch diameter by 48-inch long PTFE-lined, 304 stainless steel overbraid hoses. One hose transfers liquid phosgene to a steam vaporizer and one provides 70-psig nitrogen to the cylinder. The scales record the weight of the in-service cylinder and when the container is nearly empty, an alarm notifies the board operator, who then directs operators to switch to a full cylinder. This switch is completed by opening valves to the full cylinder and closing valves to the empty cylinder. The hoses remain coupled in this operation, and plant SOPs do not require enhanced PPE such as a fully encapsulated suit and breathing air. Under normal operating conditions, the process consumes two to three cylinders of phosgene per day.

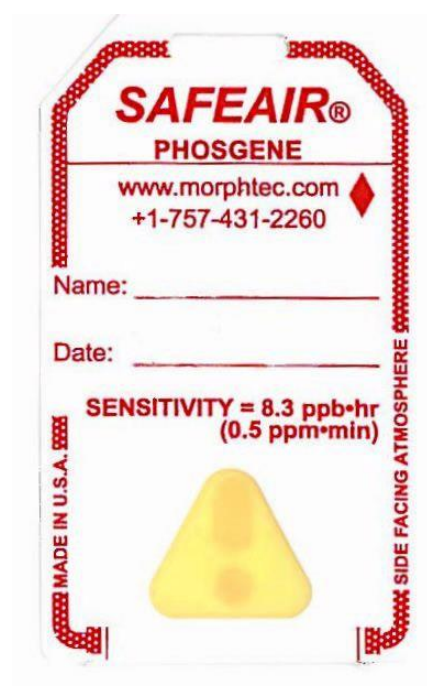
Figure 13. SafeAir Phosgene Dosimeter Badge³⁷

³⁷ The badge in Figure12 has a range of 0.5 to 450 ppm-min. The SafeAir badge worn by the exposed employee had a range of 0.9 to 100 ppm-min.

Immediately after the operator was sprayed, he called for assistance on the SLM unit public address phone in the phosgene shed. A coworker who responded to the call noticed that the victim's phosgene dosimeter badge (Figure 13) was discolored, indicating an exposure. The coworker directed the exposed worker to a plant truck to transport him to the plant's medical center for assessment and treatment. As they drove to the medical center, the two workers were met by the Shift Supervisor and the exposed worker was transferred to the shift supervisor's vehicle to complete the trip. While en route to the plant's medical center, the front gate guard was radioed and advised to call Metro 9-1-1 and request that an ambulance respond for a medical emergency. The exposed worker, while at the medical center waiting for the ambulance, chose to wash his face and hands, but there is no evidence or record that he was placed in a safety shower to wash off, as instructed by the emergency procedures, or that any decontamination activity took place beyond the hand and face washing. He was given a change of coveralls to put on in exchange for the work clothes he was wearing. The gate guard called Metro 9-1-1 at 1:59 p.m., requesting transport for a medical emergency patient to the hospital. The 9-1-1 dispatcher asked if there was a chemical release; however, the gate guard, who was unaware of the situation, responded that there was no release and that the response was for a medical emergency. As part of the Metro 9-1-1 emergency response protocol, the dispatcher asks for specific information to ensure that responders are as informed as possible prior to arrival at the scene. At 2:03 p.m., an ambulance was dispatched from the KCEAA. At 2:08 p.m., responding EMTs asked Metro dispatchers if more information was available about the victim. When Metro called DuPont to get more information, the line was busy. EMTs also wanted to know if there was a chemical exposure, but Metro 9-1-1 could not get that information from DuPont. Six minutes later, the EMTs arrived at the DuPont gates.

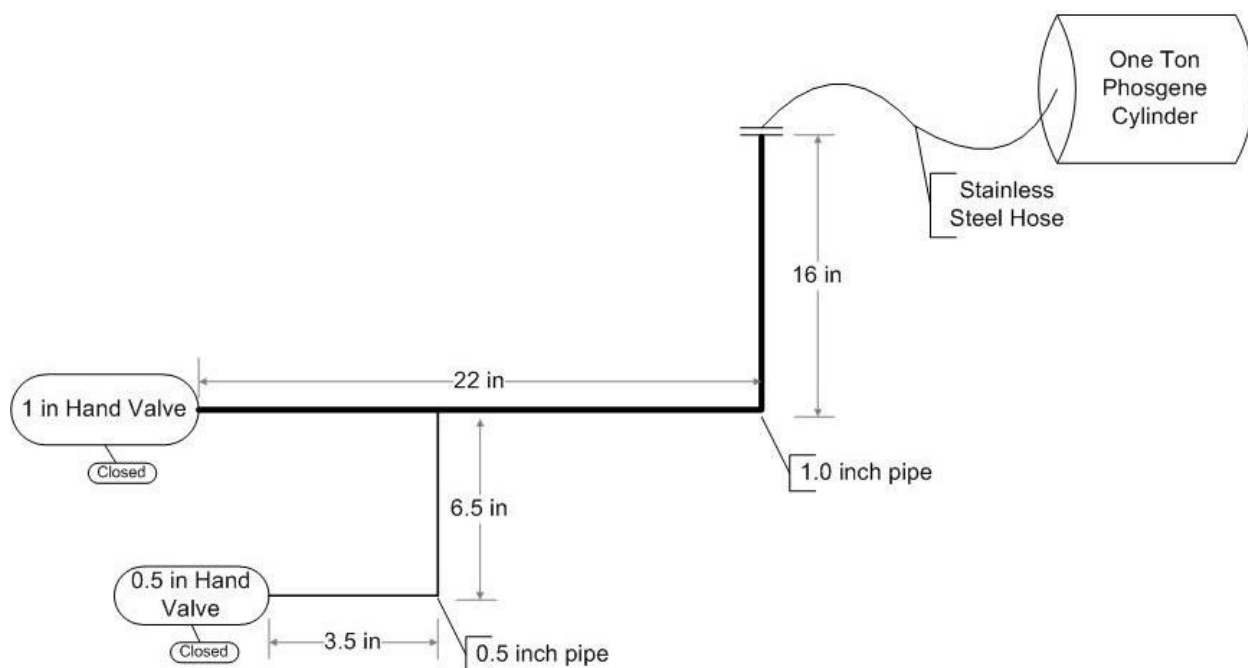
Figure 18. The hose and piping system that supplied phosgene for the release

Figure 18 shows the hose and piping dimensions and the maximum amount of phosgene present in the piping system associated with the hose failure.

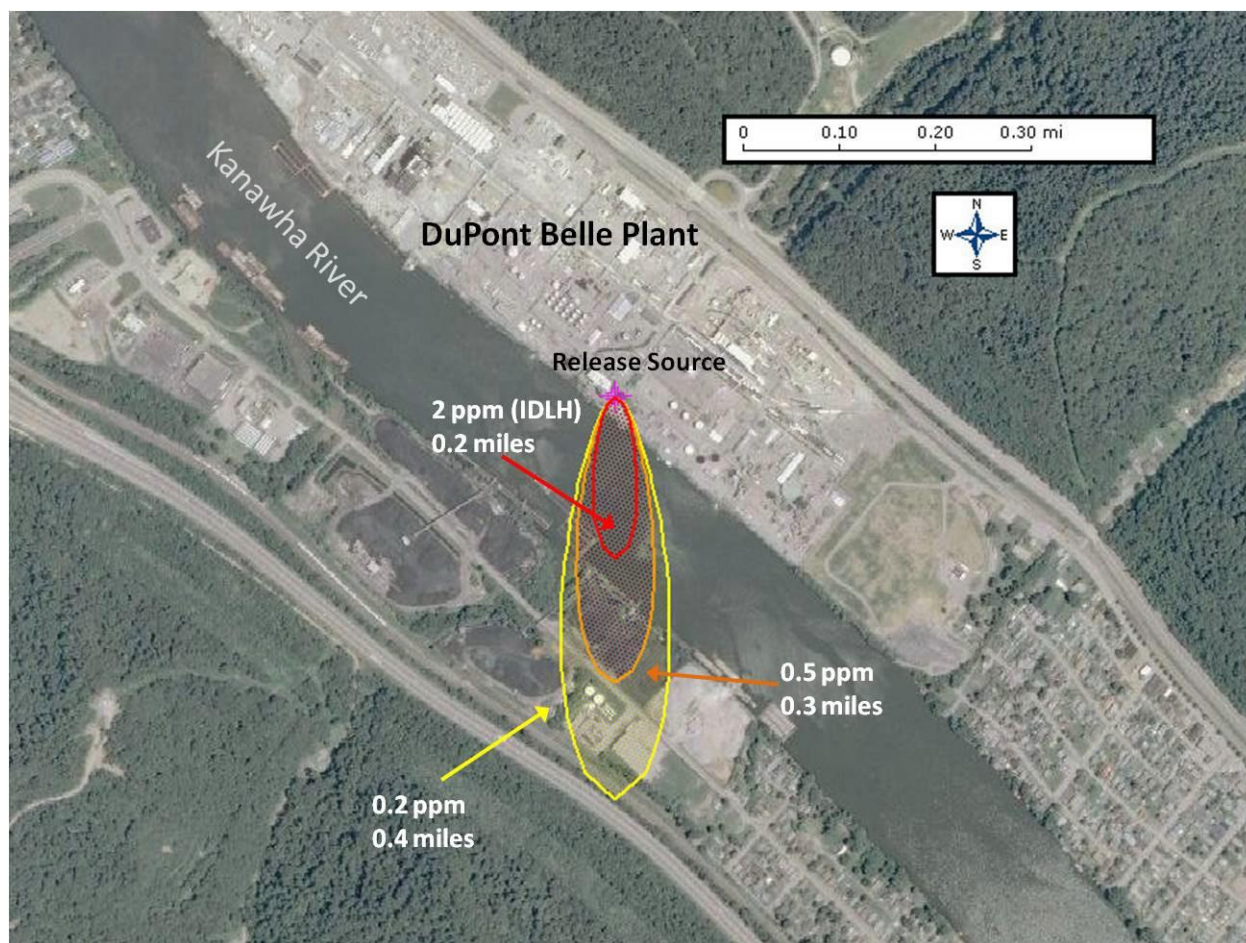
Figure 19. ALOHA estimate of phosgene concentrations with MARPLOT GIS overlay

The ALOHA program generated a display of concentration “threat zones” over a distance downwind from the source of the release. Using the EPA MARPLOT program, threat zones are displayed over a satellite map of the area using a GIS interface (Figure 19).

The release estimates from the ALOHA program are based on the weather conditions recorded at the Charleston Yeager Airport around the time of the January 23, 2010, phosgene release, but may not accurately represent atmospheric conditions at the plant. The ALOHA program also does not consider the topography or terrain surrounding the plant. The fence line monitors south and southwest of the phosgene shed recorded phosgene concentrations between 0 and 0.27 ppm, suggesting phosgene vapor may have traveled south of the DuPont Belle plant fence line toward the river. The ALOHA threat zone overlay in Figure 19 displays a model of the worst case release conditions indicating that IDLH concentrations of phosgene could have been present on the Kanawha River shortly after the release and lower concentrations could have traveled across the river. The community reported no odors or exposure symptoms the afternoon of the phosgene release incident.
