Accident - Imperial Sugar Dust Explosion and Fire

**Professional Development Hours (PDH) or
Continuing Education Hours (CE)
Online PDH or CE course**

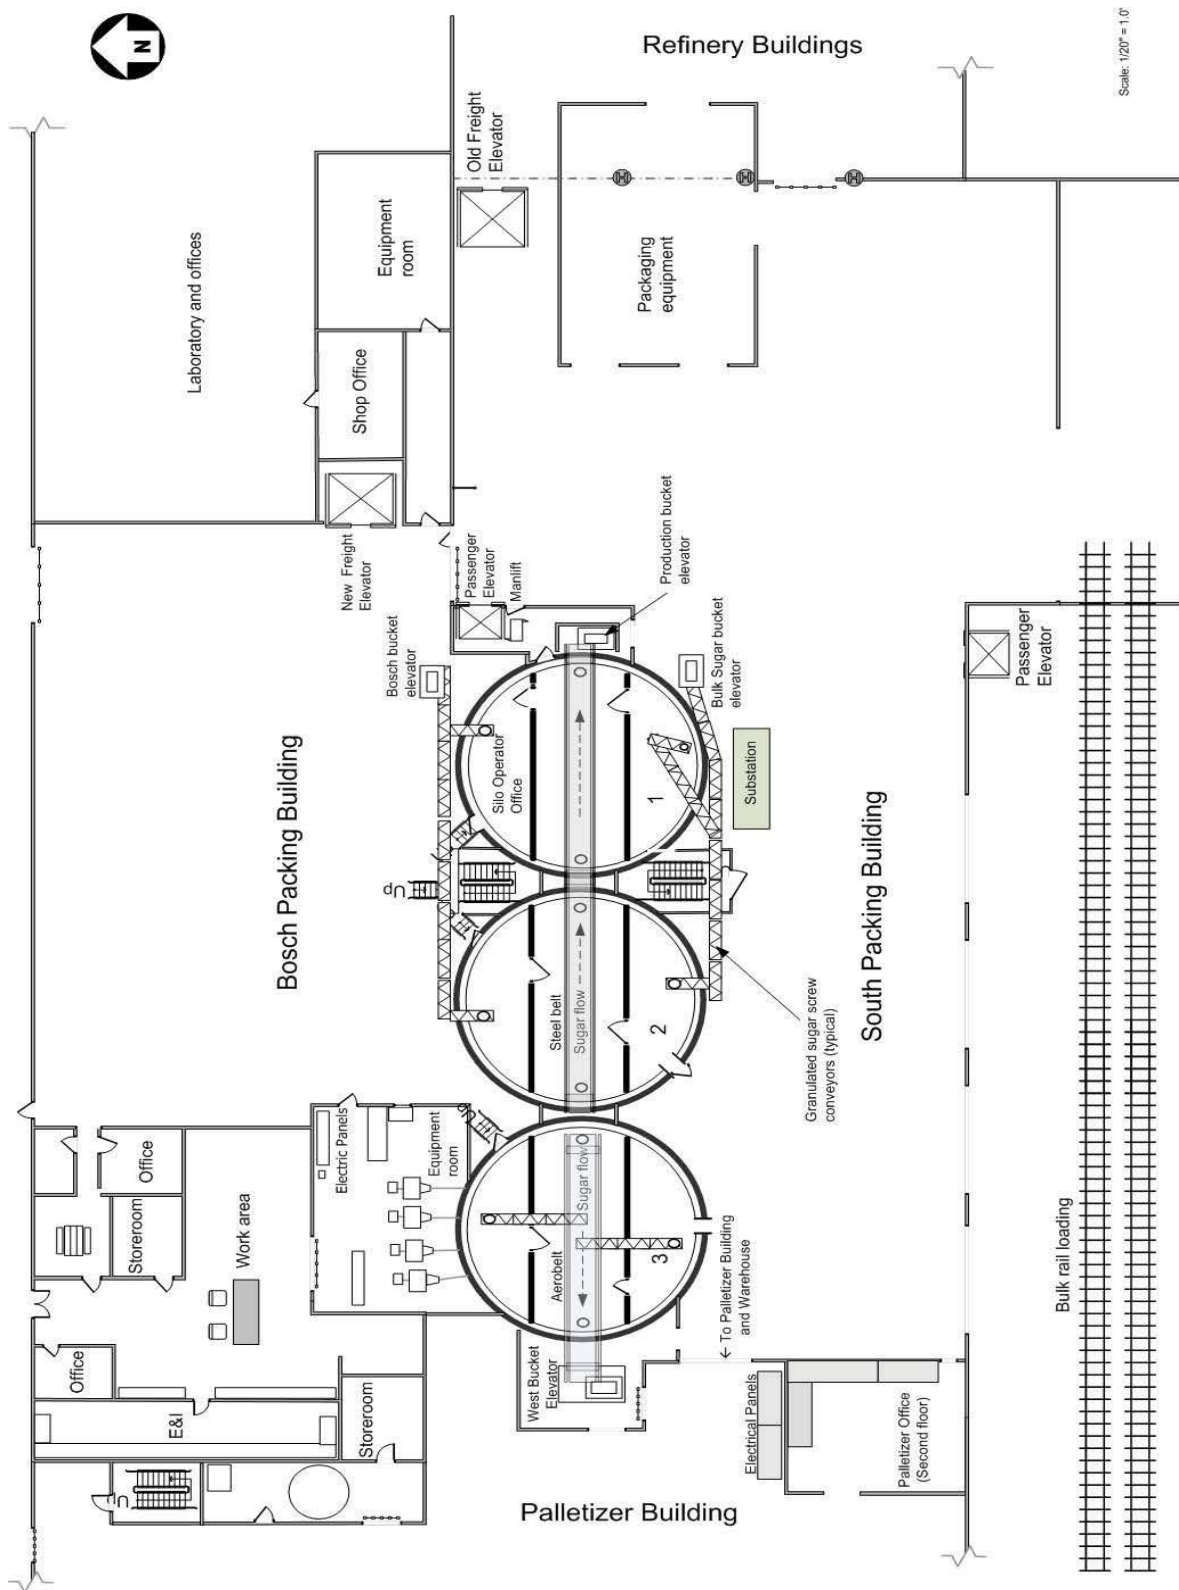
Dozens of screw conveyors,⁶ bucket elevators,⁷ and horizontal conveyor belts transported granulated sugar throughout the packing buildings (Figure 5). Although bucket elevators were enclosed and screw conveyors were covered, they were not adequately sealed to prevent releasing sugar dust and sugar into the work areas. Because the large open work areas were not equipped with airborne dust removal equipment, sugar dust accumulated on overhead conduit, piping, ceiling beams, lights, and equipment. The closed granulated sugar screw conveyors located throughout the facility were not

Figure 5. Packing buildings first floor plan

²³ Although the enclosure on the belt conveyors in the penthouse could have been designed to safely vent an explosive overpressure outside the building, designing a deflagration vent system for the belt conveyor in the silo tunnel was impractical. That conveyor was located on the ground floor in the center of the building (Figure 5) far from any building exterior wall or roof.

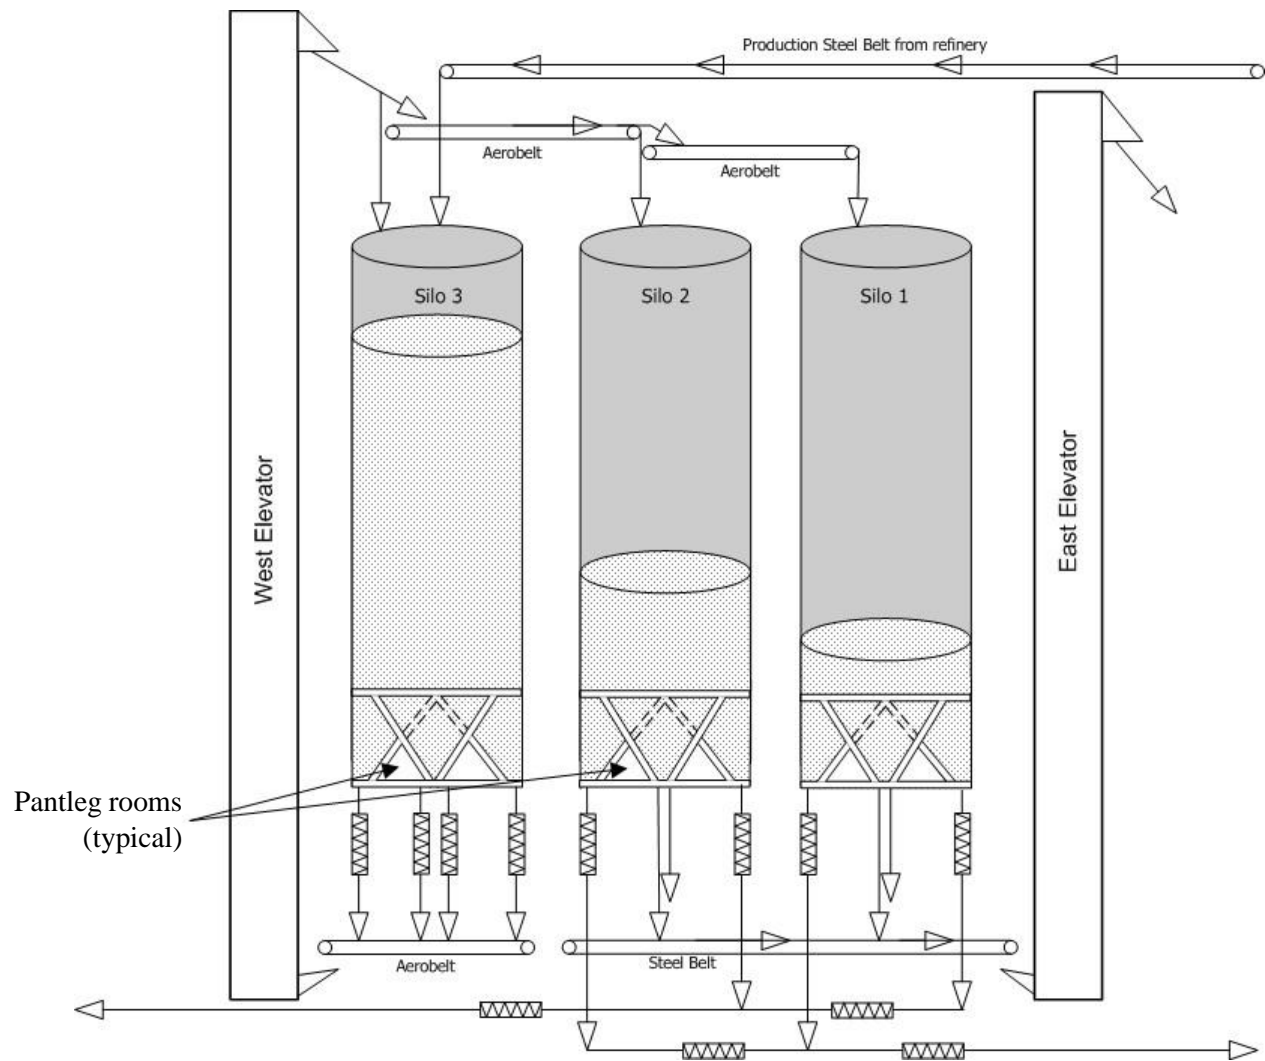
Figure 7. Granulated sugar supply and discharge through the silos

above the silo tunnel (pantleg rooms, see Figure 7) and concluded that the primary dust explosion most likely occurred in the silo tunnel, approximately midway along the length of the steel belt.

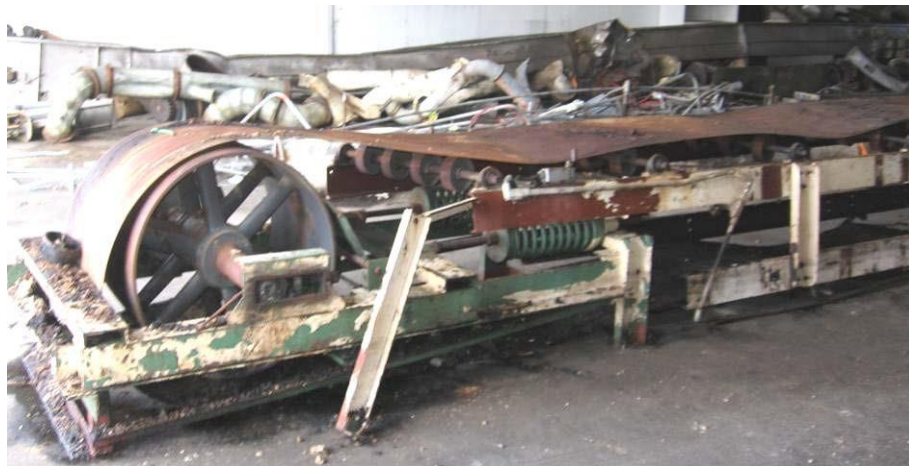
A 32-inch wide, 80-foot long steel conveyor belt (Figure 9) in the silo tunnel transported granulated sugar from silos 1 and 2 into the packaging production bucket elevator pit at the east side of silo 1. Similar steel belt conveyors were located in the penthouse above the silos.

Figure 9. Silo tunnel steel conveyor belt (removed after incident)

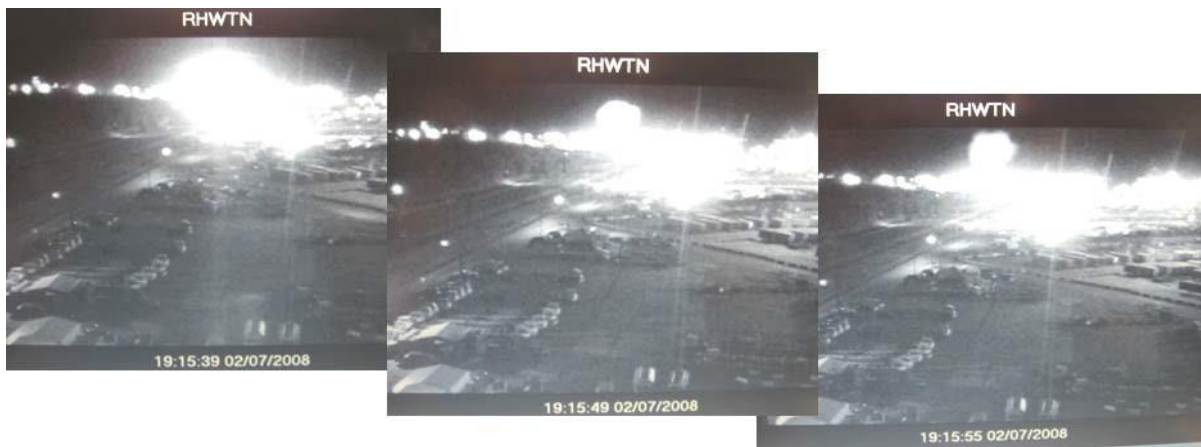
Figure 10. Violent fireball erupting from the facility (elapsed time - 16 seconds)
(Georgia Ports Authority security video).

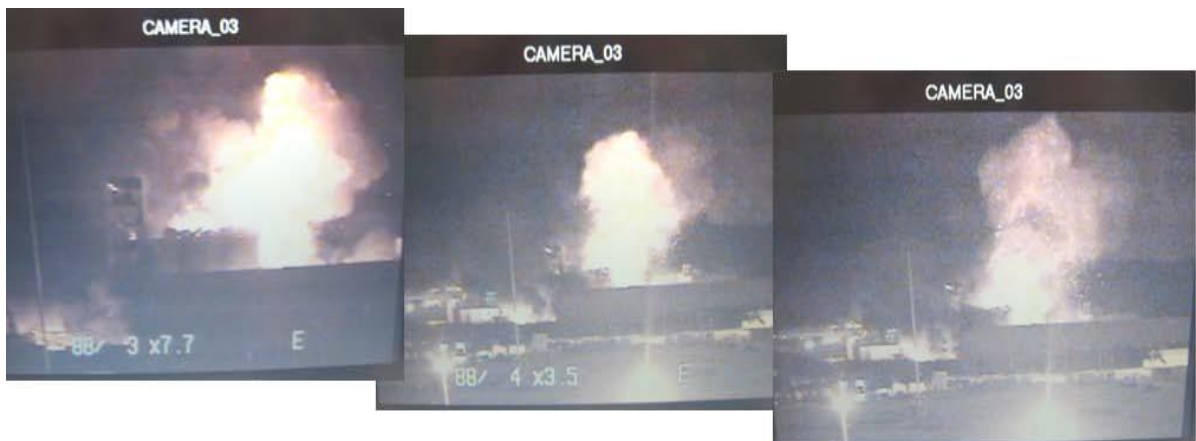
Intense fireballs advanced through the entire north and south packing and palletizer buildings as sugar dust, shaken loose from overhead surfaces, ignited. Heaving and buckling floors opened large crevasses. The piles of granulated and powdered sugar that had accumulated around equipment rained down and intensified the fires burning below. Fireballs advanced through enclosed screw conveyors and ignited fires in the refinery and bulk sugar building hundreds of feet from the packing buildings where the incident had begun. Violent fireballs erupted from the facility for more than 15 minutes as spilled sugar and accumulated sugar dust continued fueling the fires (Figure 11).

Figure 11. Large fireball and burning debris erupt from the packing buildings 15 minutes after first explosion (elapsed time - 10 seconds) (PCS Phosphate security video).

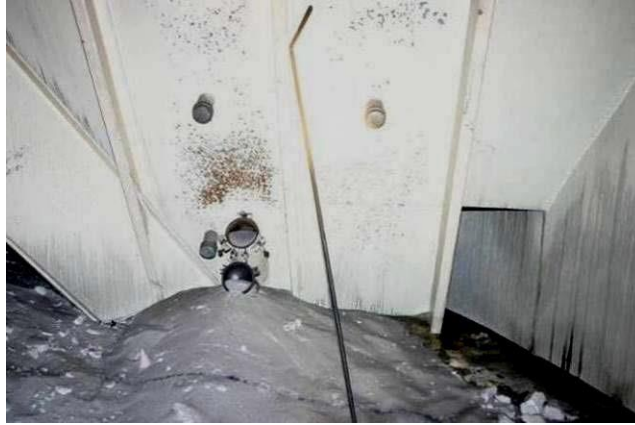
The CSB learned that, during the 3 to 4 days preceding the incident, workers were clearing sugar lumps lodged in the silo 1 sugar discharge holes above the steel belt. Through access ports in the pantleg room (Figure 16), they used steel rods to break and dislodge sugar lumps found above and inside the sugar discharge holes. Workers also used access ports located on the discharge chutes to break lumps that lodged on the steel belt, blocking sugar flow from the upstream discharge chutes (Figure 17).

During the silo 1 “rodding” activities, sugar continued to flow from silo 2 onto the steel belt upstream of the silo 1 discharge chutes. Based on the statements from the workers who were clearing the sugar lumps from the silo outlets, it is highly likely that sugar lumps lodged between the moving steel belt and one or both silo 1 discharge chutes. Sugar lumps small enough to enter the discharge chute, but too large to pass between the end of the chute and the steel belt would create a “dam” that would cause sugar traveling from silo 2 to spill off the steel belt upstream of the silo 1 discharge chute. Spilled sugar would then accumulate inside the covered conveyor, likely covering parts of the steel belt.²⁵ Sugar dust released into the air from the sugar spilling off the conveyor, and sugar dust generated as the steel belt traveled through the sugar pile, below, could accumulate in the unventilated enclosure.

Figure 16. Access port inside the pantleg room and steel rod used to break sugar lumps in the sugar outlet on silo floor
