Gas Well Blowout and Fire at Pryor Trust Well 1H-9

Investigation Report

Published: June 12, 2019

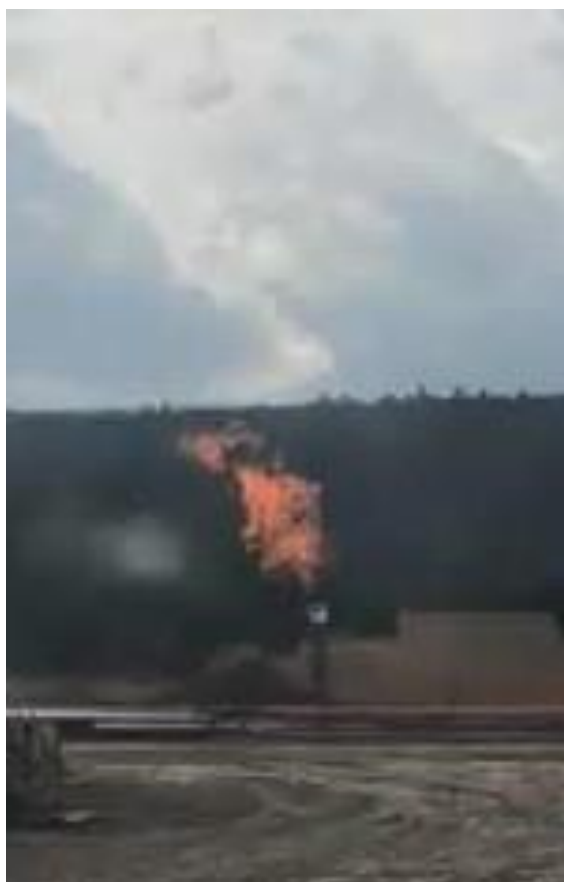
At 7:30 am, gas started to reach the surface of the well, showing as elevated *gas units* in the mud.^c The gas in the mud caused mud to spit out of the possum belly, covering with mud a portion of the rig, the mud pits, and other equipment. After 11:00 am, the crew aligned the mud piping so that the mud was routed to the *Mud Gas Separator*, and by 11:11 am the flare activated (Figure 9). Witnesses reported the flame from the flare at times was 20-30 feet high and at one time may have been 40-50 feet high.

Figure 9. Video still of flare at 11:10 am on January 21, 2018.

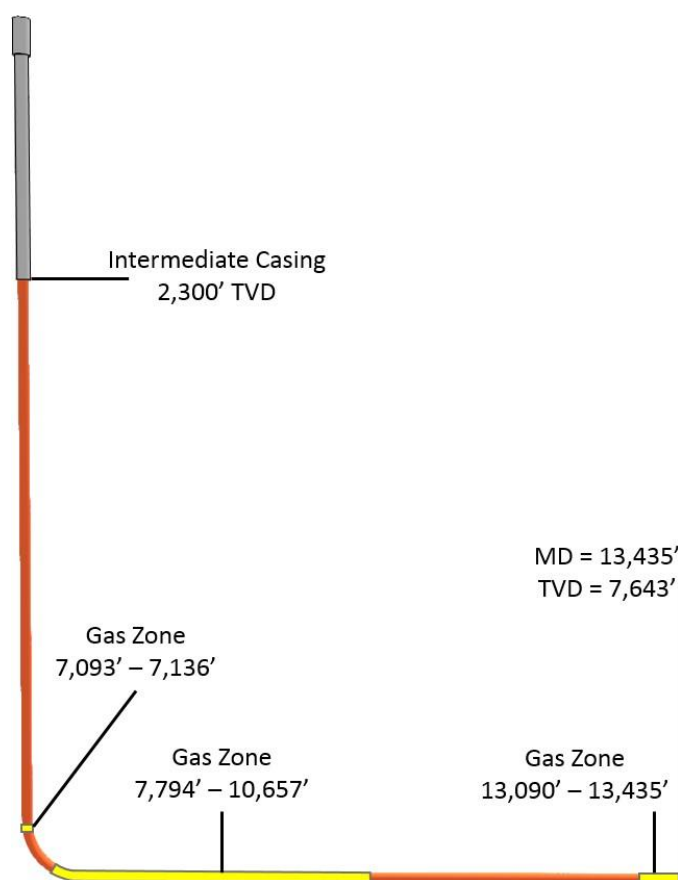
The well profile at this point is shown in Figure 10. Post-incident analysis of the well data shows that the 11,000 feet of uncased, open wellbore included three areas where some amount of gas had entered the well while drilling, as interpreted from measured gas units during the drilling operation and the flaring at the surface that occurred on January 21.

Figure 10. Areas where gas entered the wellbore while drilling.

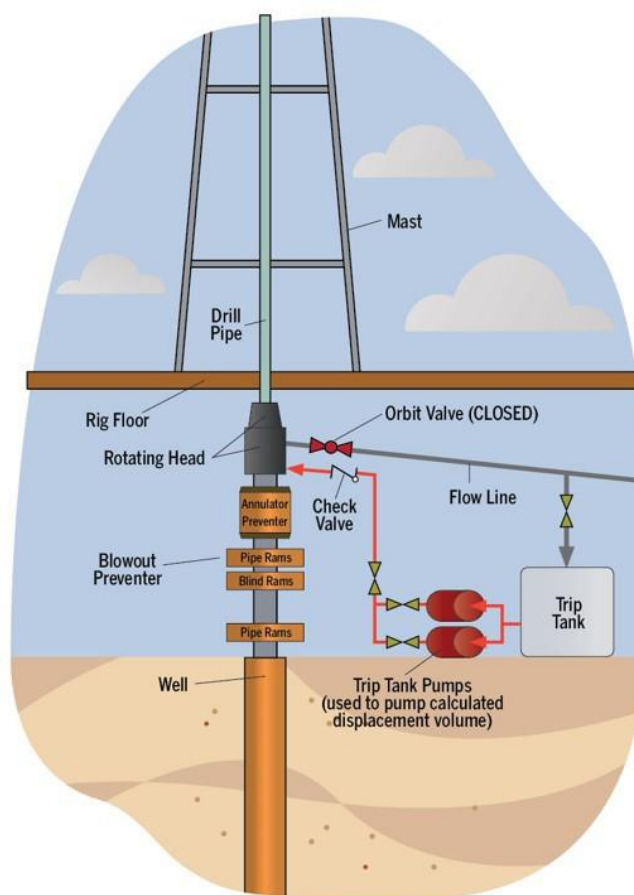
Discussed below, by the time the drill bit reached the top of the curve, 20 barrels of mud less than the calculated drill pipe displacement volume had been pumped into the well. While the well appeared to be filled to the surface, the volume discrepancy is an indication that gas had entered the well, occupying this 20-barrel portion of the drill pipe displacement volume (Sections 5.1.2.1 and 5.1.2.2). The company man and drilling engineer were aware the well did not take proper fill, but the full extent of the discrepancy might not have been known because the driller had difficulties with the electronic trip sheet used to track the calculated drill pipe displacement against measured fill volumes during the tripping operation (Section 6.3).

In summary, during the tripping operation out of the horizontal section of the well (1) not enough mud was pumped into the well to replace the drill pipe displacement volume, (2) there were gains in the trip tank volume likely caused by pressurized mud backflow through the trip tank pump discharge line, and (3) at one point, the trip tank pumps started deadheading against the surface pressure in the well. Post-incident, these clearly are indications that gas was in the well, but these indications were not effectively acted upon to stop operations and restore the primary well control barrier, hydrostatic pressure produced by mud.

Figure 12. Equipment configuration during Calculated Fill tripping method

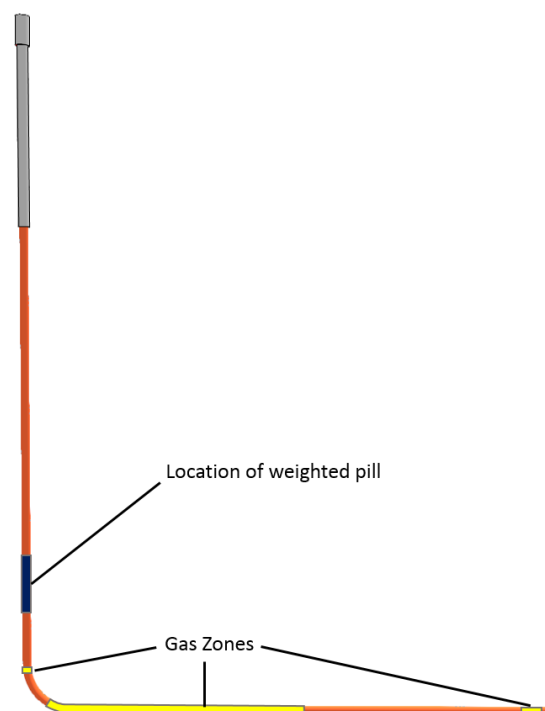
At 12:35 am, the drilling crew pumped 46 barrels of the pill into the drill pipe. Following the pill with mud, they pumped the pill out of the bottom of the drill pipe and into the annulus with the bottom of the pill at a depth of about 6,500 feet, and with the top of the pill at about 5,800 feet (Figure 21). Some of the pill material remained in the bottom of the drill pipe.

Figure 21. Depiction of well with gas zones and location of weighted pill.

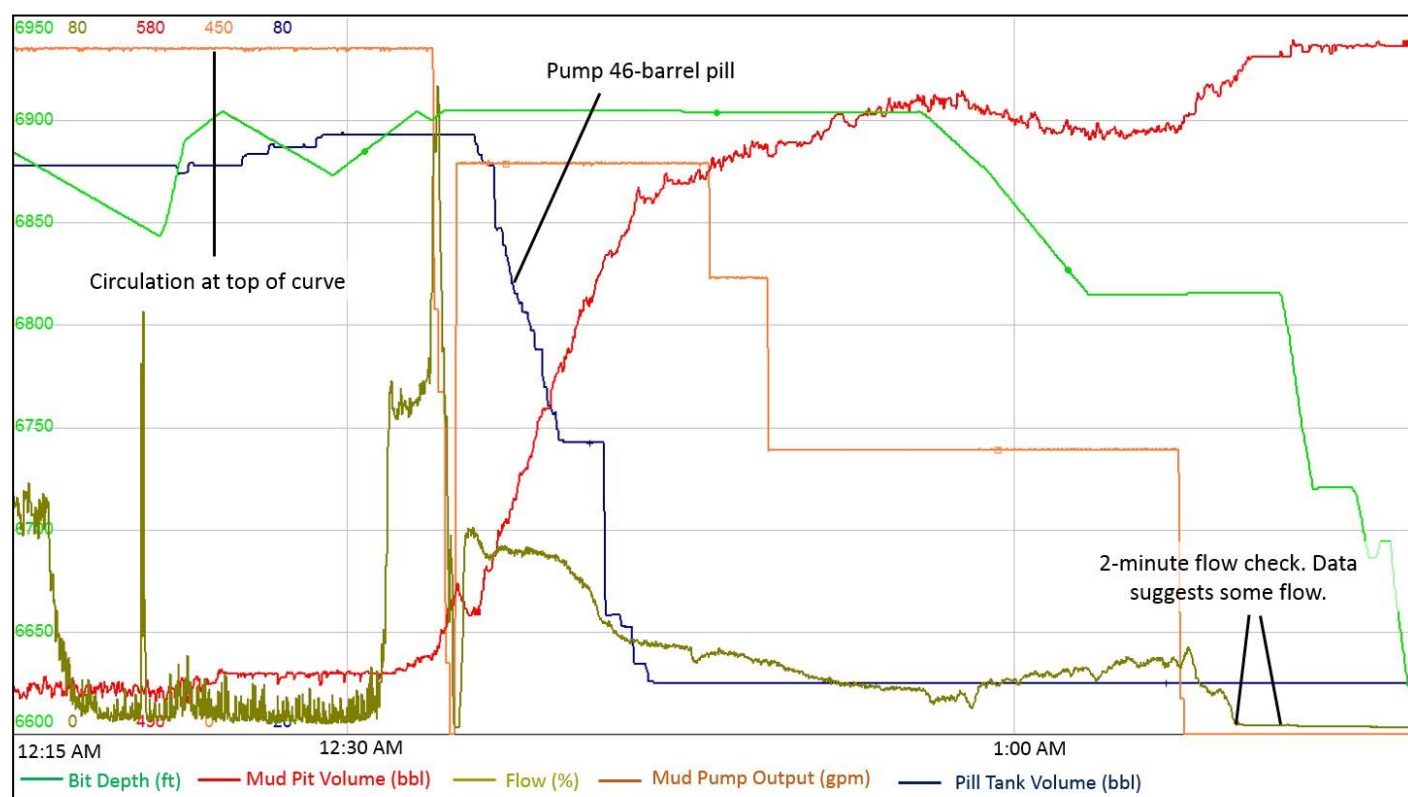
After spotting the pill, at about 1:10 am the crew performed a visual, 2-minute flow check. The flow check passed. However, the CSB could not verify that the crew observed no flow during this flow check. The return flow meter data indicates some very small flow (1% of the flowmeter scale) during this flow check (Figure 22). Despite the flow check result, gas was still entering or expanding in the well. The 50-barrel volume and 10-pound-per-gallon weighted pill did not produce the hydrostatic pressure necessary to prevent gas from entering the vertical portion of the well. After pumping the weighted pill, the well was still underbalanced and the primary well control barrier was still not in place (Section 6.5).

Figure 22. Data during pumping of pill and subsequent flow check.

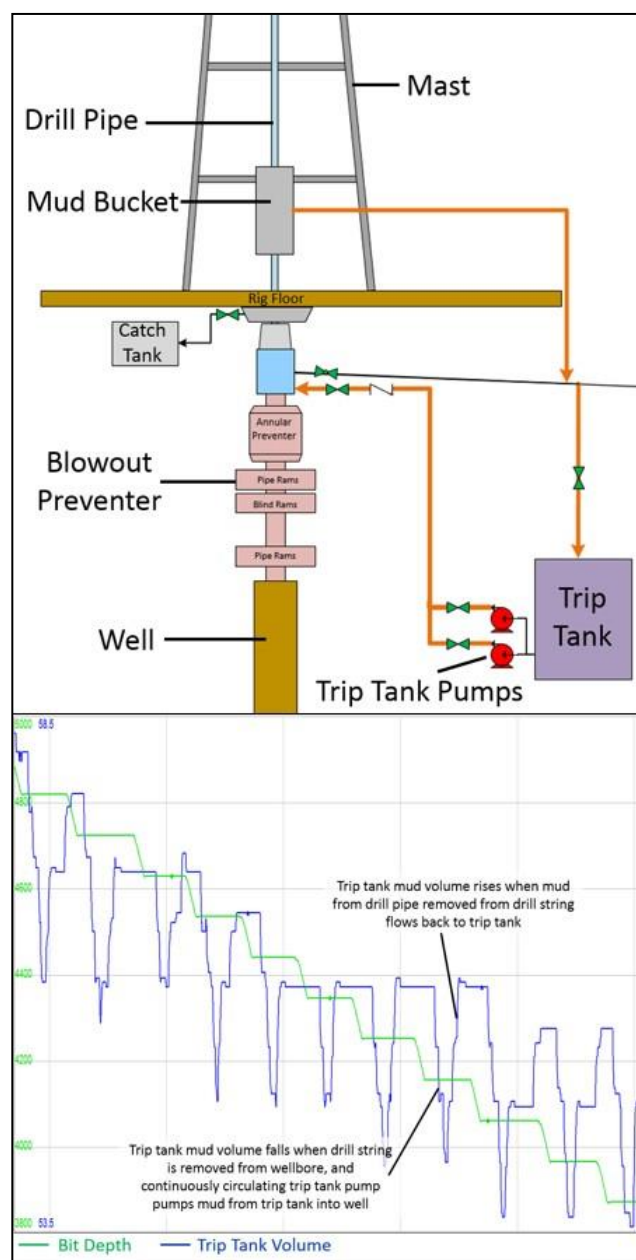
On Rig 219, the mud bucket discharge was routed to the trip tank. Level changes in the trip tank are a key indicator of mud gains or losses while tripping, and adding the mud into the trip tank from the mud bucket during the tripping operation confounded that information for the driller and company man. As the crew tripped out pipe, the trip tank volume fluctuated up and down from mud draining into the trip tank and from mud being pumped out of the trip tank (Figure 24). The driller communicated that he had never before tripped wet pipe out of the well with this lineup, and all of the volume fluctuations in the data made monitoring for the correct volume reduction in the trip tank difficult.

During the tripping operation, the driller and company man performed a test to determine if the well was taking proper fill. The company man wanted to double check that dry pipe volume was the correct displacement volume for their trip sheet calculations (Figure 25). They turned off the trip tank centrifugal pumps and removed five stands of drill pipe from the wellbore. They then turned on the trip tank centrifugal pumps to see if a corresponding five drill-pipe-stand volume of mud pumped into the well. The driller and company man believed they saw the proper volume of mud enter the well, and they resumed tripping normally. A review of the data, however, shows that the full calculated volume for five stands of drill pipe did not enter the well. From start to end of test, the trip tank volume should have reduced by 3.2 barrels, the volume required to replace the five stands of pipe. By the end of the test, however, the trip tank volume had actually increased by 0.8 barrels, indicating that the well did not take any fill, and in fact had gained four barrels of influx or expanded gas. It is unclear why the driller and the company man believed this test passed. The result was that, unknown to Patterson and RMO, gas continued to enter or expand inside the well during the tripping operation. By the end of the trip, less than half of the drill pipe volume removed from the well had been replaced with mud.^a The other half of the drill pipe volume was likely replaced with hydrocarbon gas from the formation(s).

Figure 24. Rig equipment alignment and data during tripping operation out of vertical portion of well. The crew was tripping wet pipe, and the mud from the pipe stands removed drained back to the trip tank, causing the trip tank volume to fluctuate.

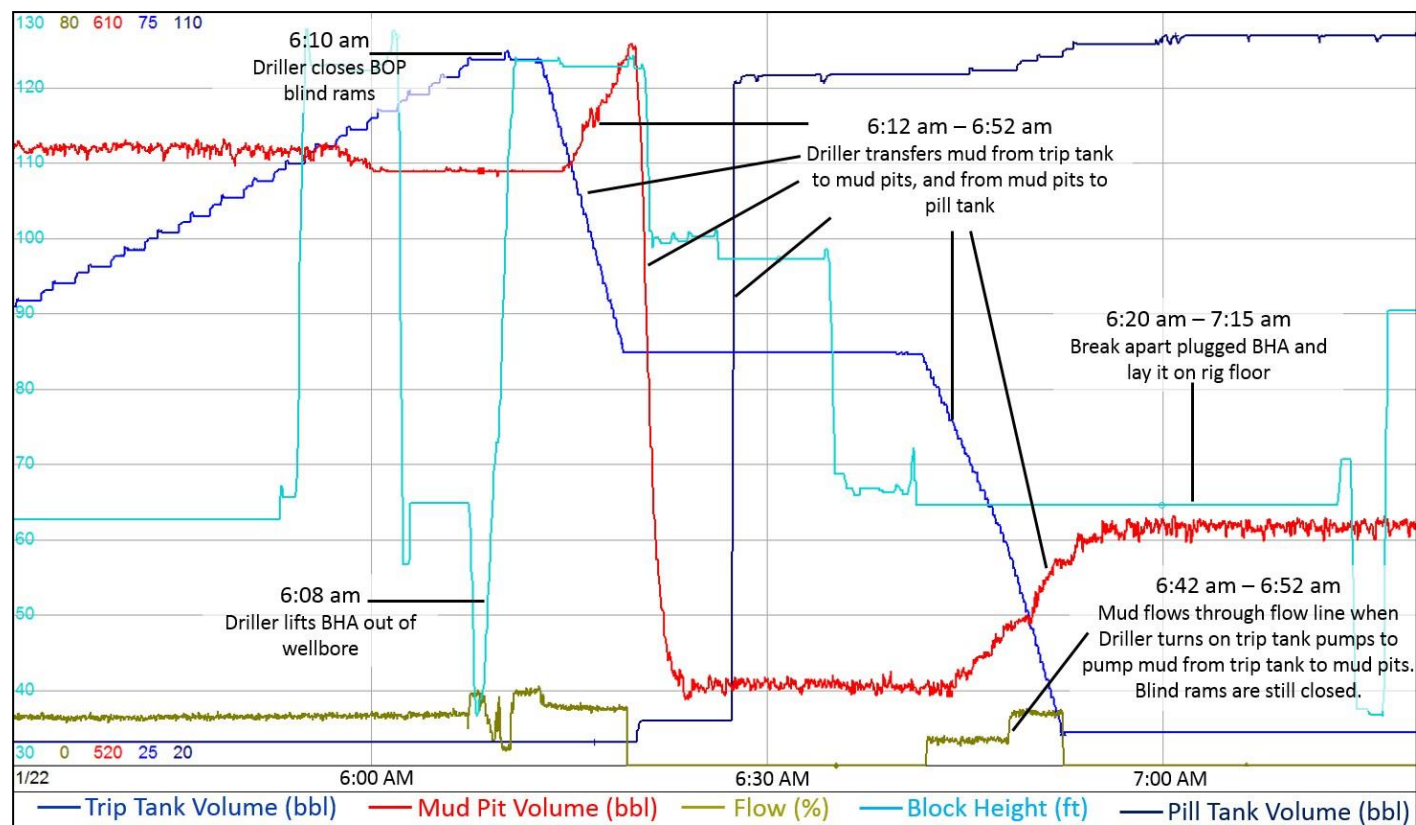
Figure 27. Rig Data between 5:32 am and 7:20 am on Monday, January 22, 2018 (day of incident).

By 7:15 am, the day crew had broken apart the plugged BHA and laid it on the rig floor (Figure 27).

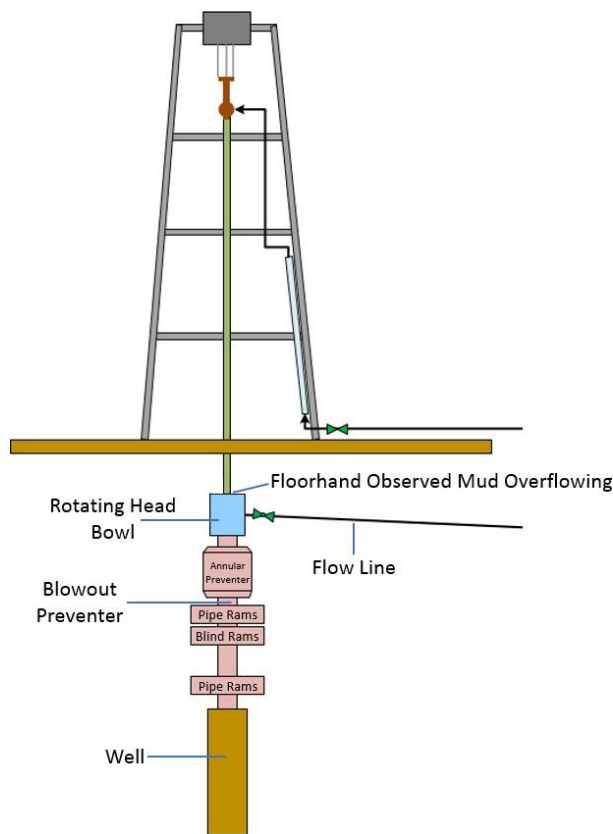
Figure 28. Depiction of where floorhand observed mud coming out of BOP stack while BHA was being tested.

The driller lowered the BHA into the well, until only about 2-3 feet of it remained above the rig floor. At 8:09 am, with the piping now aligned so that flow from the well was routed to the mud pits, the driller reset the mud Gain/Loss indicator on his rig data monitor to zero. He then turned on the pumps to test the BHA tool. A floorhand observed—and told the driller—that when the pumps turned on, mud was coming up out of the top of the rotating head bowl (Figure 28).^b A crewmember told the CSB that this was expected because the rotating head rubber was not installed. At some point during the testing, the same floorhand observed that mud had stopped coming over the rotating head bowl. He communicated his observation to the driller.

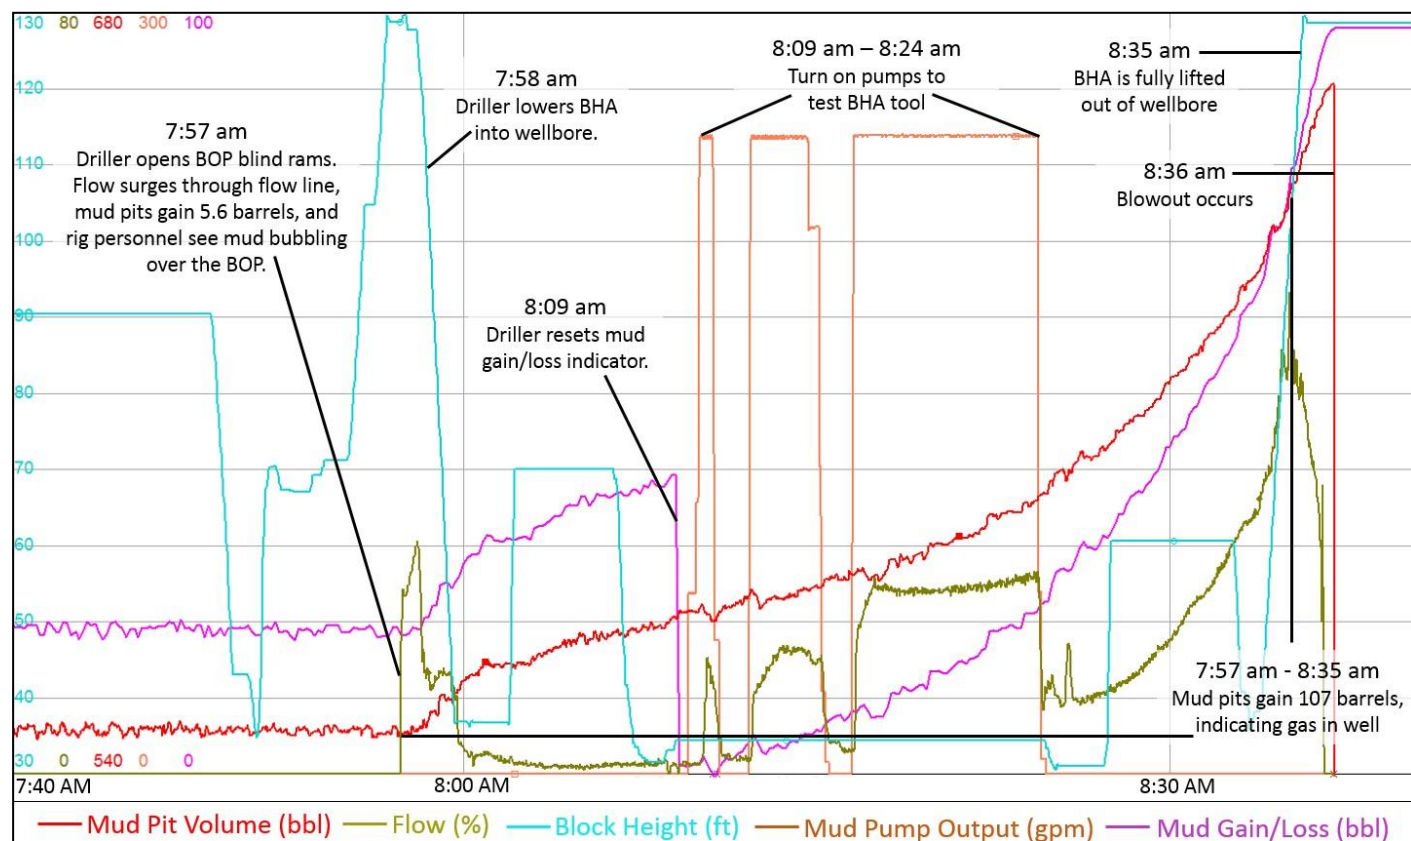
Figure 29. Rig Data between 7:40 am and 8:41 am on Monday January 22, 2018 (day of incident).

From the time the BOP blind rams were opened at 7:57 am through the completion of BHA testing and removal from well at 8:35 am, the mud pits gained 107 barrels of mud due to gas influx/gas expansion within the well (Figure 29), a

significantly large volume. It is unknown if the driller saw this gain, which would have displayed as a number on a monitor in front of him (Figure 37). No action was taken to shut in the well.

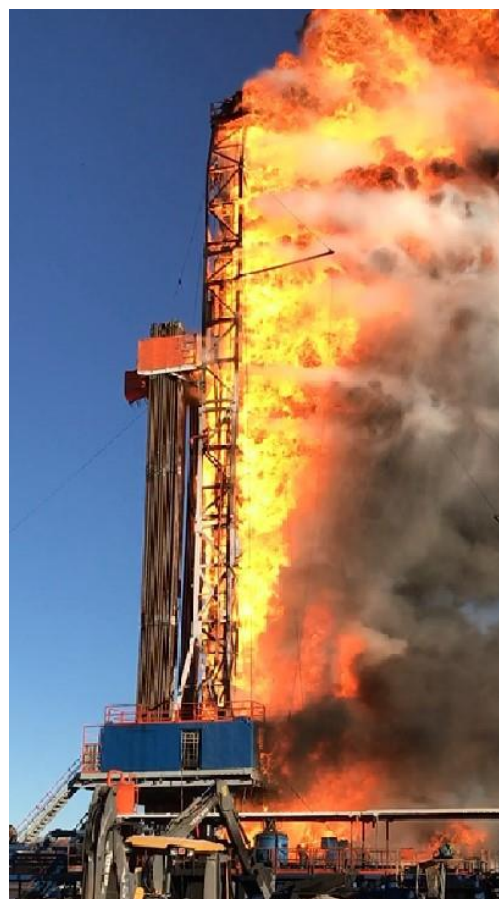
Figure 30. Video still of the blowout and fire taken shortly after it started.

At 8:36 am,^a shortly after the driller communicated that he was going to close the blind rams, mud started spraying out of the well. The floorhand saw the motorhand and the second floorhand open the door to the driller's cabin so they could run into it from the rig floor. The mud continued to spray out of the well and covered the windows of the driller's cabin. The floorhand moved behind the drill pipe rack on the rig floor with the rig manager. Very quickly after the mud started spraying out of the well, the diesel oil-based mud and gas escaping the well caught on fire (Figure 30).^b Between the removal of the BHA from the well at 8:35 am and the blowout at 8:36 am, the mud pits gained an additional 12 barrels of mud, totaling to a 119-barrel gain since the blind rams had been opened at 7:57 am.

The floorhand observed fire reaching 20-30 feet above the rig crown. The rig manager called his superintendent to alert him to the blowout. The rig manager then told the floorhand to wake everyone in the crew house up. The floorhand then ran to the crew house and woke up the other crew so they could move to a safe location.

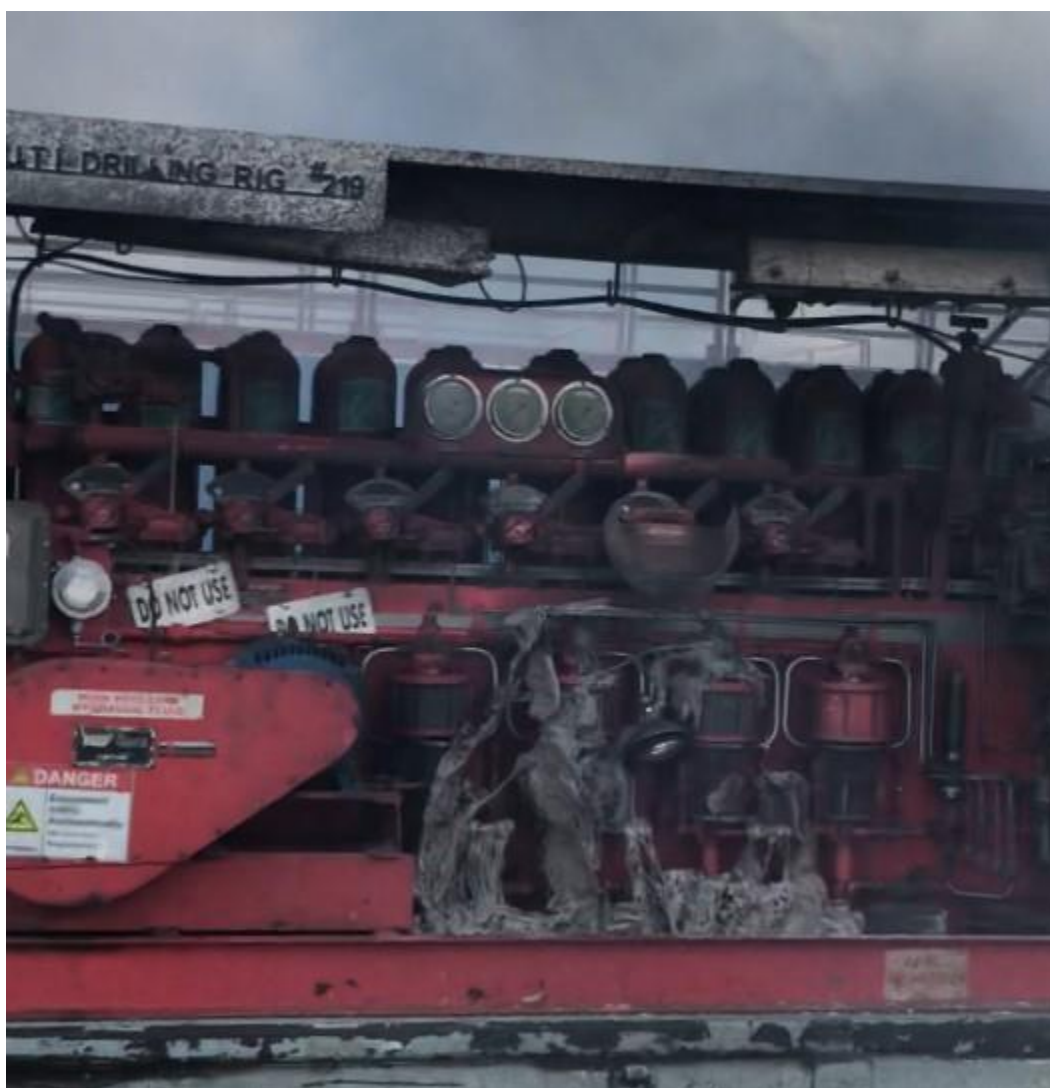
Figure 32. Video captured at 11:51 am on January 22, 2018 shows all BOP handles in the closed position.

bottom pipe rams (Figure 31 and Figure 32). The BOP did not seal the well to stop the blowout. The company man from the previous shift later also tried to function the blind rams, the pipe rams, and the annular preventer, but the BOP did not seal the well. The CSB determined the BOP did not seal the well likely because the control hoses that supplied hydraulic fluid to the BOP to function the rams had burned and leaked the hydraulic control fluid, soon depleting the accumulator stored pressure to the point the BOP could not be functioned (Section 6.13).

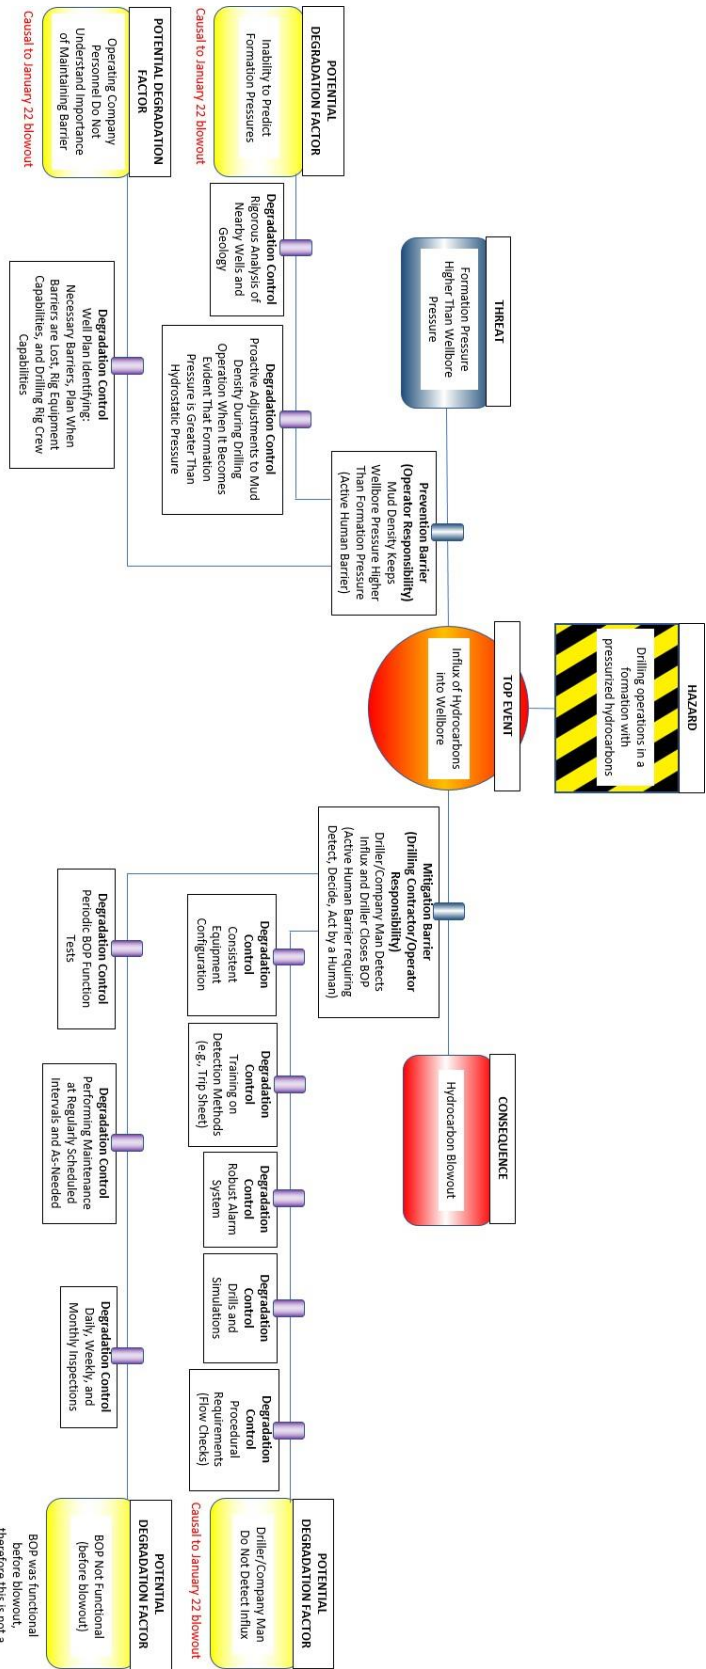
Figure 34. Bowtie diagram of Pryor Trust Well 1H-9 barriers

The CSB created a bowtie diagram (Figure 34) to illustrate the two planned barriers to prevent a blowout. Both barriers had associated degradation factors that could, and ultimately did, reduce the reliability and availability of the barriers.

Like any barrier, the mud barrier was subject to failure. Figure 34 shows two main degradation factors that contributed to the failure of the mud from preventing a gas influx, and no sufficient degradation controls were in place to prevent those degradation factors from leading to failure of the barrier.

Shown in Figure 34, a number of "degradation controls" could have been in place to reduce the likelihood that rig workers would miss the signs of gas influx. These controls include:

An effective alarm system is one of the “degradation controls” shown in Figure 34 to help ensure that the mitigation barrier, the detection of an influx by rig workers and closure of the BOP, would function as expected. In this case, however, shutting down the alarm system nullified it as a degradation control, thereby increasing the likelihood that the detect-influx-and-activate-BOP mitigation barrier would fail, which is what ultimately happened. Had the alarm system been on, the existing alarm system likely also would have nullified the system as a degradation control, since most of the alarms would not have been warning of the ongoing well control event (Appendix E). The alarm system would not have been effective in alerting the driller to the imminent blowout.

Shown in Figure 34, drills are an important control to increase the likelihood that the driller will detect a gas influx. Without drills, the degradation factor that “driller does not detect influx” is a greater risk, increasing the likelihood of failure of the secondary “Driller Detects Influx and Closes BOP” barrier.

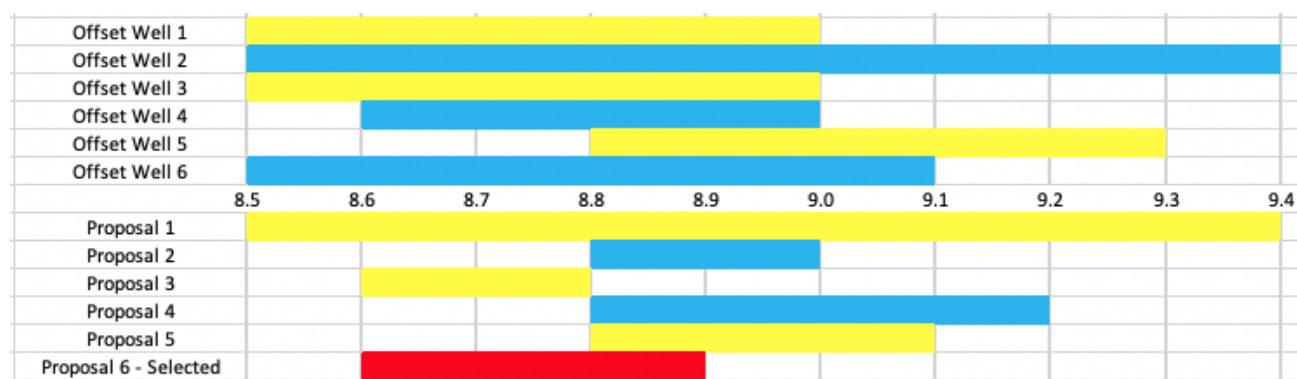
Figure 35. Comparison of the offset well mud weights, and the proposed mud weights provided in the various mud program proposals for the 2H-16 well.

RMO received six different proposals from mud companies for the mud program for Pryor Trust well 2H-16, which were based on the following mud weights for the “production zone” (2,340 ft - 15,929 ft)—the portion of the well where gas was anticipated (Figure 35):

During the drilling of 2H-16, the well experienced lost returns at 1,950 ft MD at a mud weight of 8.8 ppg, losing about 200 barrels of mud to a formation. After this loss event, the mud weight was reduced. The goal was “to keep [mud weight] as low as possible,” and the crew used a mud weight as low as 8.15 ppg while drilling the production zone. They drilled the remainder of the well without incident.

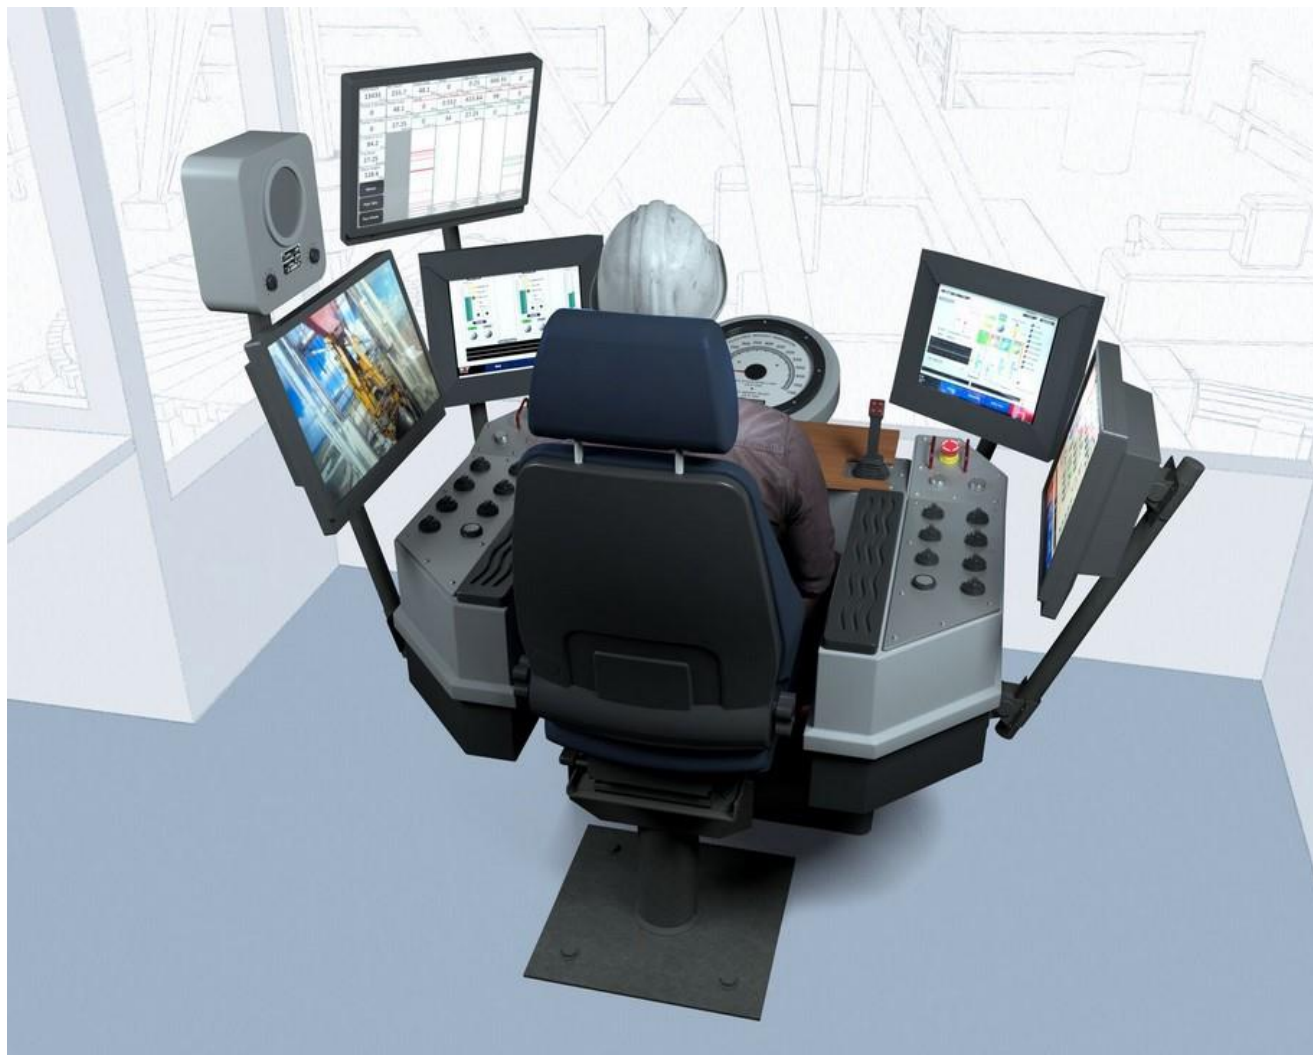
Figure 37. Depiction of driller console on Rig 219. The upper screen to the left of the driller displayed the aggregate of the drilling data.

On the drilling data monitor (upper left monitor), the driller could adjust alarm set points, silence individual alarms, silence all alarms for all parameters by turning the alarm horn off, or completely deactivating the alarm system so that both the horn and visual indications of alarms would be disabled. The data system installed was provided by Pason,

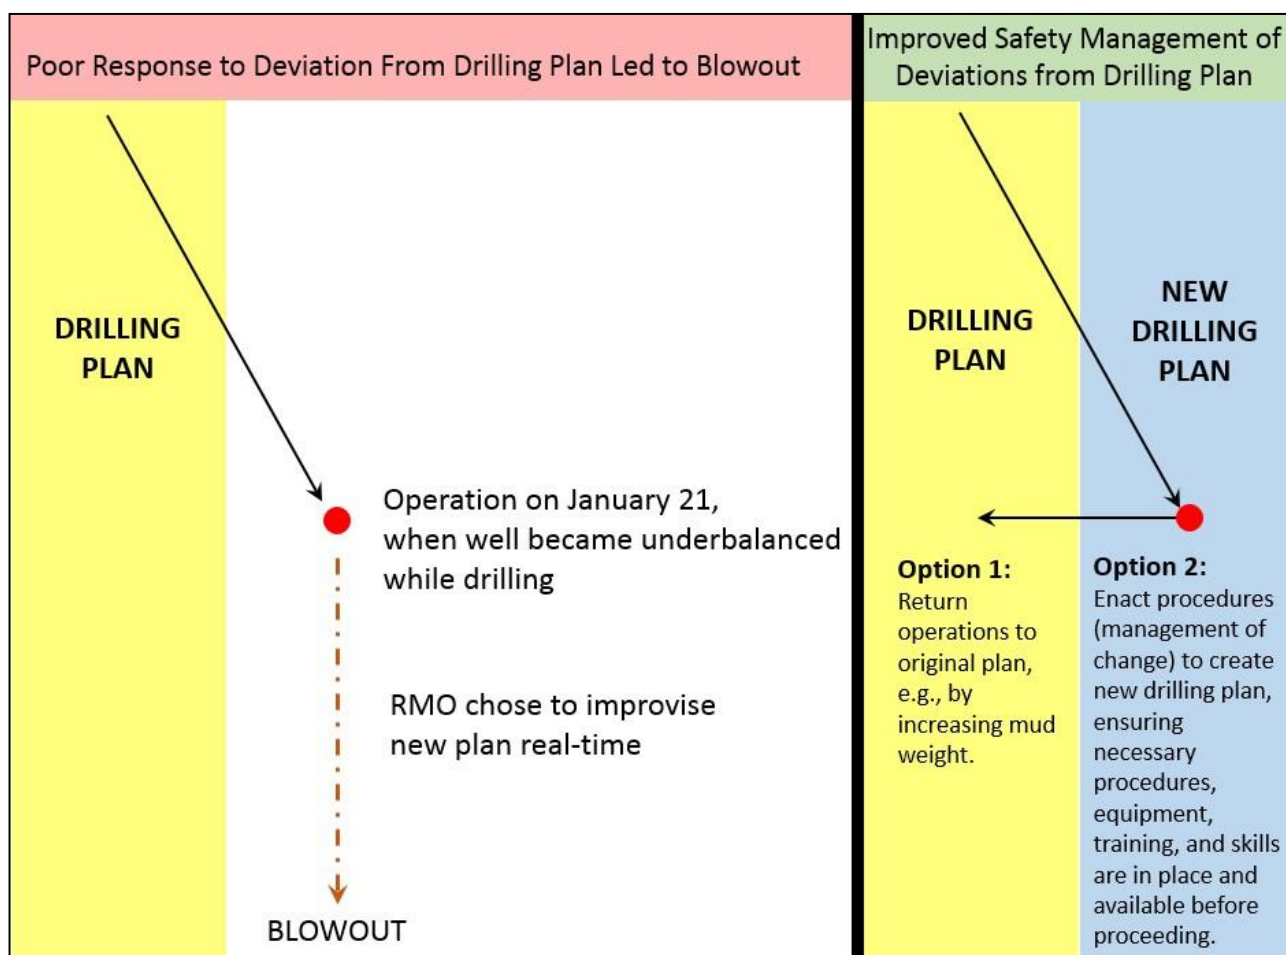
Figure 39. Depiction of RMO's and its representatives' response to deviation from drilling plan (left), and improved safety management of deviations from drilling plan (right)

Sometimes operational excursions from original drilling plans are possible due to the inability to accurately predict geological behavior and formation pressures. Figure 39 below shows how RMO and its representatives responded to the deviation from the original drilling plan, which did not include underbalanced drilling. On January 21, when the well suddenly was underbalanced, RMO and its representatives chose to improvise a new plan as they proceeded real-time. This decision led to RMO and its representatives not fully considering the hazards of the operation or considering the need for specialized equipment and procedures.

In operations with a healthy safety management system, when deviations from the original drilling plan occur, one of two options should be enacted, as shown in Figure 39. One option is to adjust parameters to return to the original drilling plan, which in this case would have required increasing the mud weight to return to overbalanced drilling. The second option is to stop operations and create a new drilling plan—using a management of change process—ensuring that necessary procedures, equipment, training, and skills are available so that the new plan can be performed safely before proceeding.

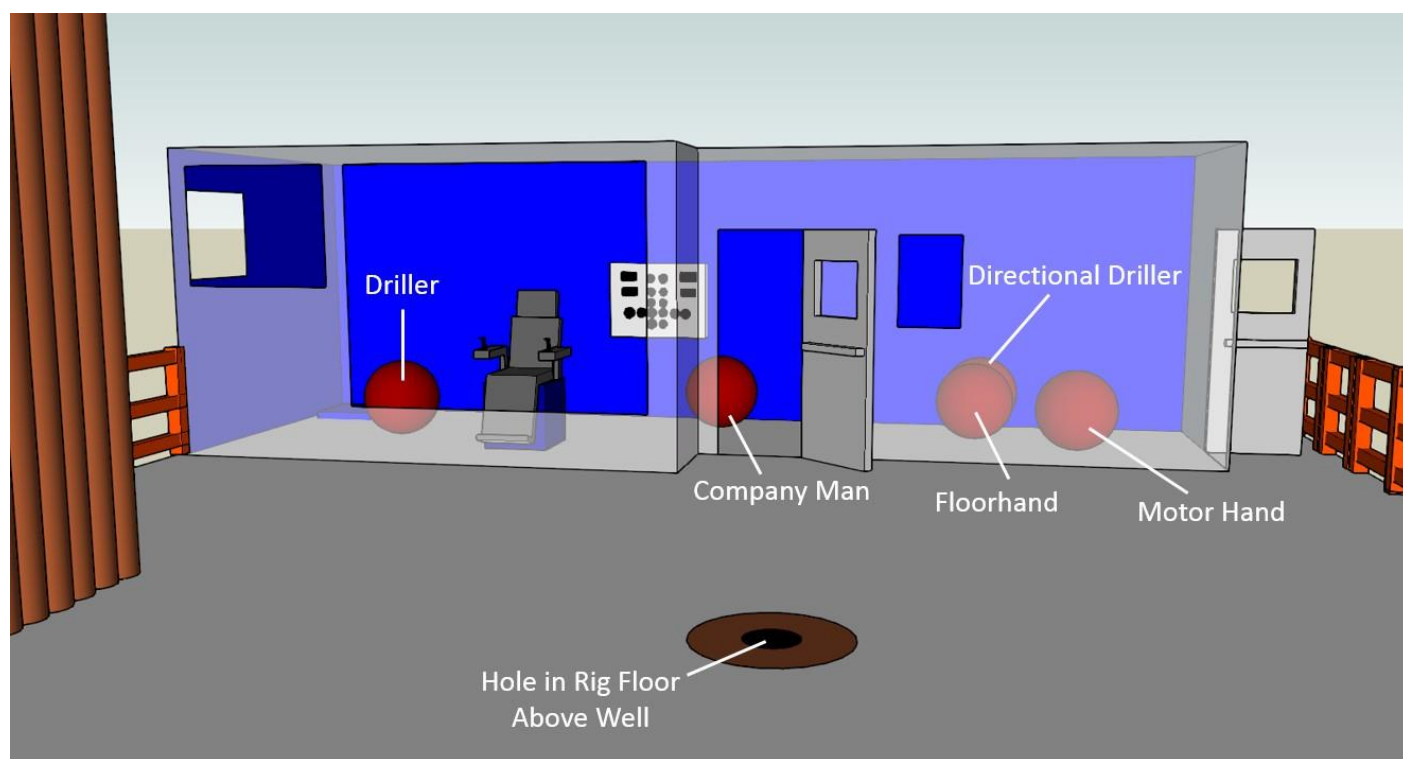
Figure 42. Locations where victims were found in the driller's cabin

At the time of the blowout when mud started erupting from the well, the motorhand and second floorhand entered the driller's cabin. The driller, company man, and directional driller were already inside the driller's cabin when the blowout started. All five personnel were victims of the blowout and post-incident were found deceased in the driller's cabin. The locations where the victims were found is shown in Figure 42. Autopsies determined that all victims died from thermal burn injuries with found or probable smoke and soot inhalation.

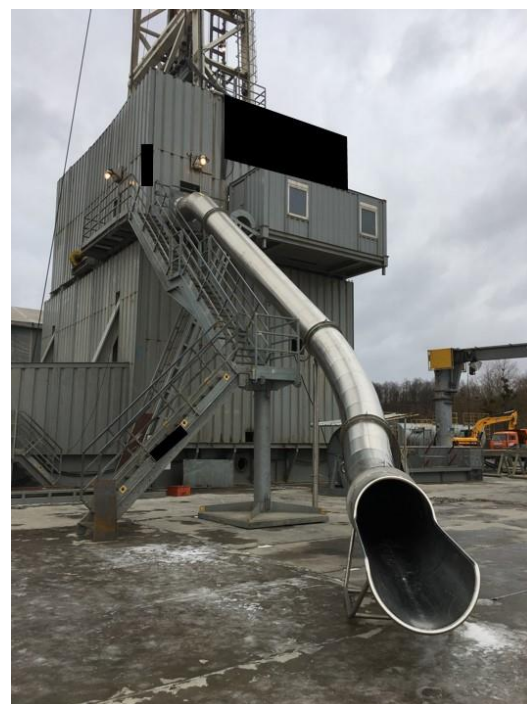
Figure 47. Example design strategy to provide quick egress from drilling rig during a blowout.

The design and location of the driller's cabin on Rig 219 appears to be typical across the industry. Drilling rig design changes are needed to help protect workers on the rig floor and in the driller's cabin from blowout and fire hazards, and to allow quick escape from the rig. Had the fire rating of the driller's cabin been ensured for a minimum time (e.g., 10 minutes), with emergency escape options from the driller's cabin floor (e.g., an escape hatch) or from the back wall, there could have been a better chance for the workers in the driller's cabin to survive this incident. As an example of a quick evacuation design, the CSB was informed that escape slides are required in Ukraine for the safety of drilling rig workers (Figure 47). This and other escape options would need to be evaluated by the U.S. drilling industry.

- (a) Protect drilling cabin occupants from blowout hazards including heat, blast overpressure, and projectiles; and
- (b) Establish the minimum required evacuation methods from the drilling cabin, rig floor, and mast in the event of a blowout so personnel can quickly escape in variable hazard location conditions.

The drilling industry should also consider alternative design methods, such as locating the driller's cabin at a safe distance from the well, for example at ground level. Such a design could incorporate the use of cameras to allow the driller to view and direct rig floor activities, keeping workers in the driller's cabin out of range of fire and explosion hazards. [**Recommendation 2018-01-I-OK-R5**]

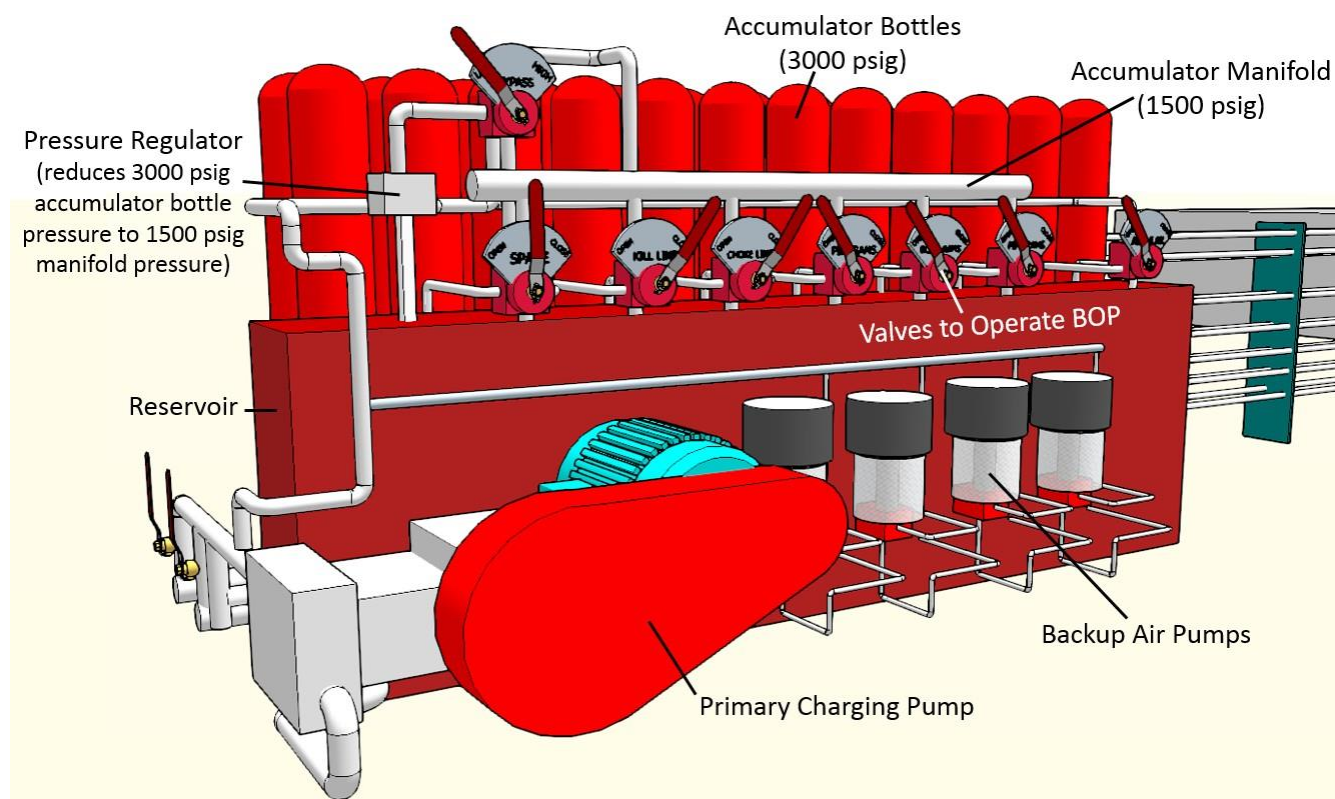
Figure 48. Depiction of the Patterson Rig 219 accumulator. The top valve on the accumulator is the Bypass valve. From left to right, the bottom valves are Spare, Kill Line, Choke Line, Bottom Pipe Rams, Blind Rams, Top Pipe Rams, and Annular Preventer.

Blowout preventers are hydraulically operated equipment, using high-pressure hydraulic fluid stored in an accumulator.^a A depiction of the Rig 219 accumulator is shown in Figure 48.^b Hydraulic fluid at 3,000 psig is stored in the accumulator bottles. That pressure is reduced to 1,500 psig through a pressure regulator for the manifold. Hydraulic fluid in the accumulator manifold is used to function the blowout preventer.

^c Discussed in Appendix A, post-incident testing found that the charging pump activated at an accumulator pressure of about 2,000 – 2,100 psig and automatically switched off when the accumulator pressure reached 2,800 psig. Based upon information from Patterson rig crew members that the accumulator pressurized normally to 3,000 psig pre-incident, this change to the accumulator pump set points may have been a result of the fire and post-incident activities.

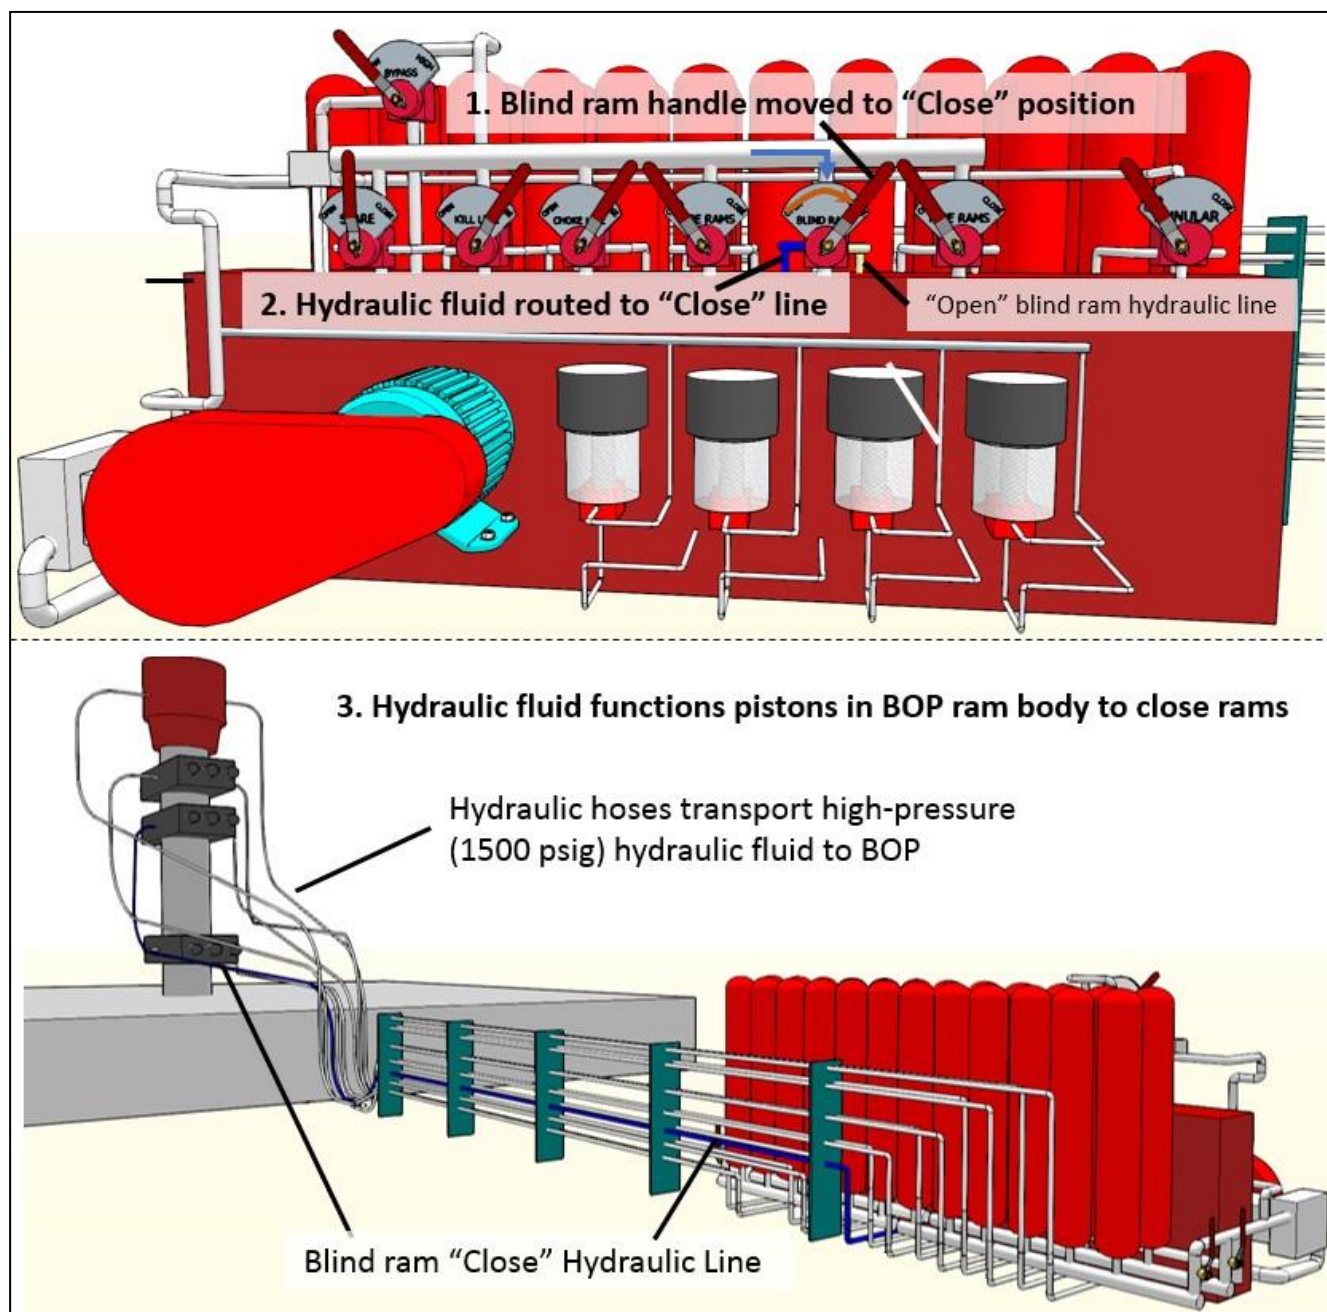
Figure 49 illustrates how the accumulator is used to function the blowout preventer. When a person moves an accumulator handle to its “close” position for, for example, the blind rams, 1500 psig hydraulic fluid from the accumulator manifold is routed to the blind ram “close” hydraulic line, which then moves two pistons inside the ram body to close the rams. The pressurized hydraulic fluid that was in the “open” piston chambers and hydraulic line drains into the accumulator reservoir. When a person then moves the handle to the “open” position, high-pressure hydraulic fluid is routed to the blind ram “open” hydraulic line, which then moves the pistons in the ram body in the opposite direction to then open the rams. The pressurized hydraulic fluid that was in the “close” piston chambers and hydraulic line drains into the accumulator reservoir.
