Gas Well Blowout and Fire at Pryor Trust Well 1H-9

Investigation Report

Published: June 12, 2019

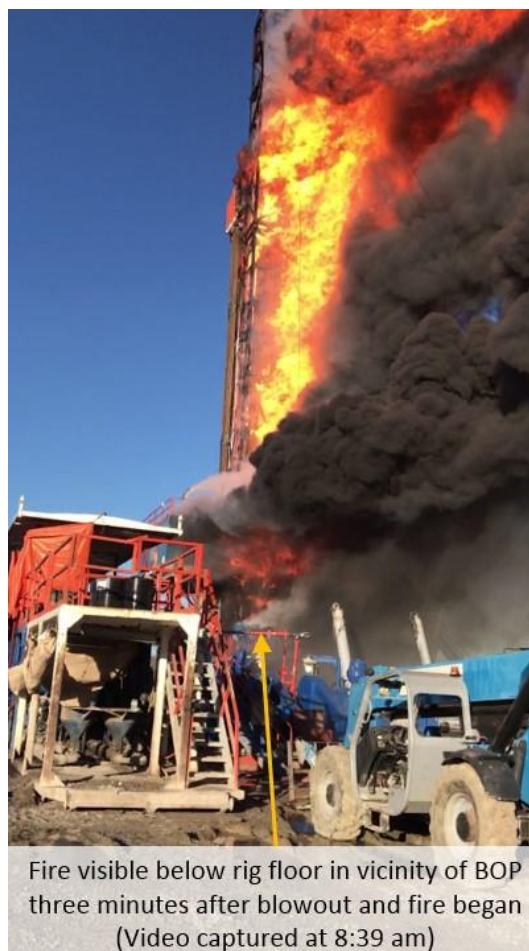
Figure 51. Video still of Patterson Rig 219 fire, taken 3 minutes after blowout began.

Prior to and during the blowout, the two BOP pipe rams, blind rams, and annular preventer were open. The valve to the choke line (HCR valve) was closed. By design, the “open” hydraulic hoses and the “opening” chambers of each BOP piston are kept under pressure by the accumulator when the accumulator valve is in the open position, and the reverse is true when a valve is in the closed position. Post-incident testing found that the hydraulic hoses that would have been pressurized by hydraulic fluid with these valves in these positions were severely damaged by the fire to the point they could not hold liquid (Figure 50). The hydraulic hoses were made of synthetic rubber, fiberglass, and steel wire spiral layers, and were designed to hold the rated working pressure of the lines at a flame temperature of 1300 °F for a 5-minute period, meeting API requirements.^a The hydraulic hoses were exposed to fire within three minutes after the blowout began (Figure 51). One video obtained by the CSB suggests the exposure to fire occurred within one minute, but due to the angle of the video it is difficult to be certain. Hydraulic fluid likely escaped from these pressurized hydraulic lines from fire damage, possibly due to flame temperatures exceeding 1300 °F,^b exposure to flames for longer than five minutes before the BOP was attempted to be operated, or both.

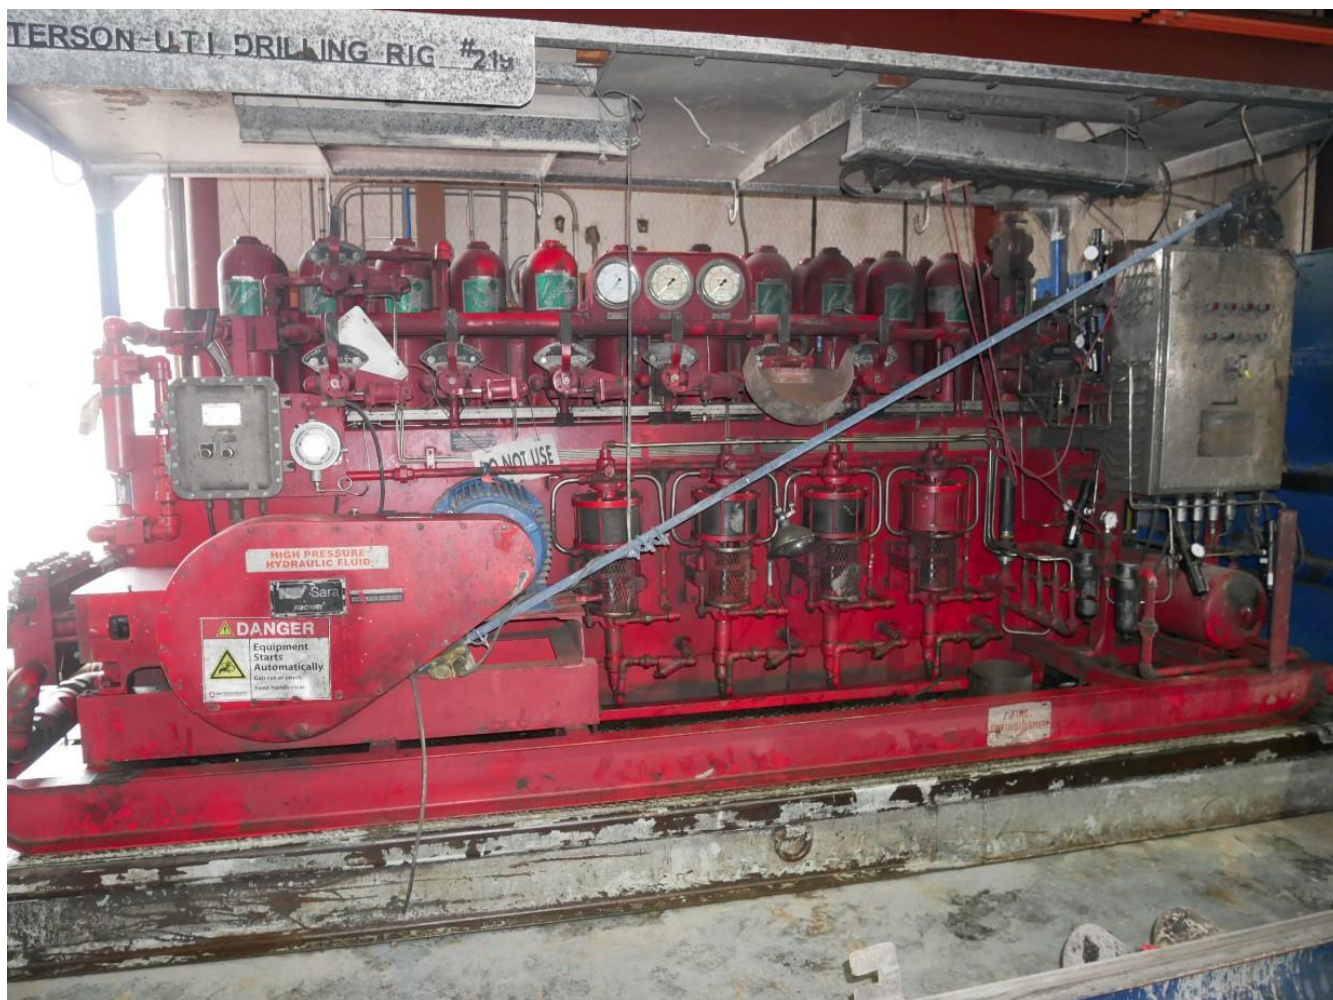
Figure A- 1. Photo of Patterson Rig 219 accumulator

- The accumulator was manufactured by NOV SARA INDIA (P), LTD. It was manufactured in 2008 (Figure A-1).

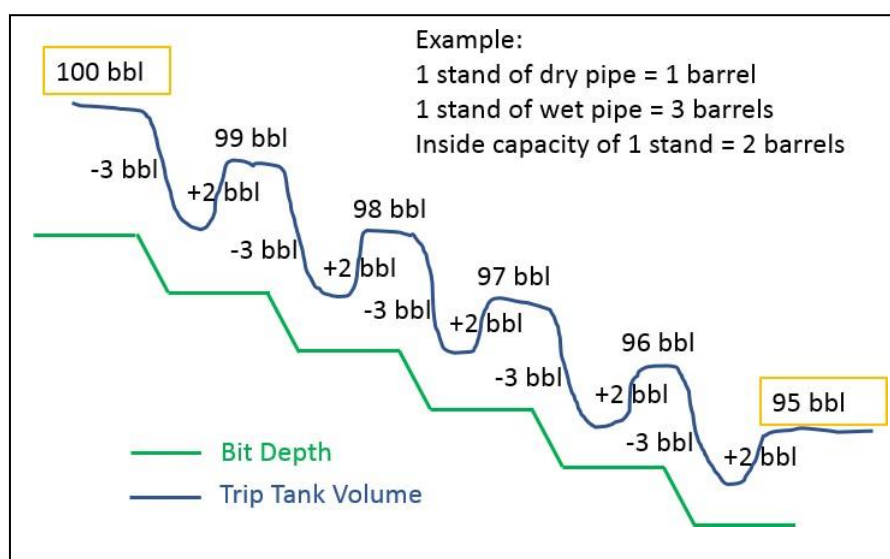
Figure C- 1. Example trip tank fluctuation pattern when tripping wet pipe when mud bucket drains to trip tank.

- Figure C- 1 illustrates how a trip tank volume could behave when tripping wet pipe, when the drill pipe contents drain back into the trip tank as shown in Figure C- 2.

- In this example, tripping five stands of drill pipe containing mud (each stand has dry volume of 1 barrel) with the mud bucket draining to the trip tank results in a five-barrel decrease in the trip tank volume. This is a volume reduction of the *dry volume* of the drill pipe stand even though the drill pipe was being pulled “wet.”
- This calculation assumes there is no mud leakage or mud spilled on the drill floor during the tripping operation.
- The *Guide to Blowout Prevention*, created by the company Well Control School (WCS) states:

- Routing drill pipe/mud bucket drainage elsewhere (e.g., a catch tank) requires usage of wet volume for trip sheet calculations. This will also reduce trip tank volume fluctuations and can reduce crewmember confusion. The CSB was informed, however, that the general standard in the North Sea for wet tripping is that the fluid from the mud bucket is routed to the trip tank so that if the float (a type of check valve preventing back flow) fails in the drill string and the well starts to kick up the drill string, then the kick can be identified.

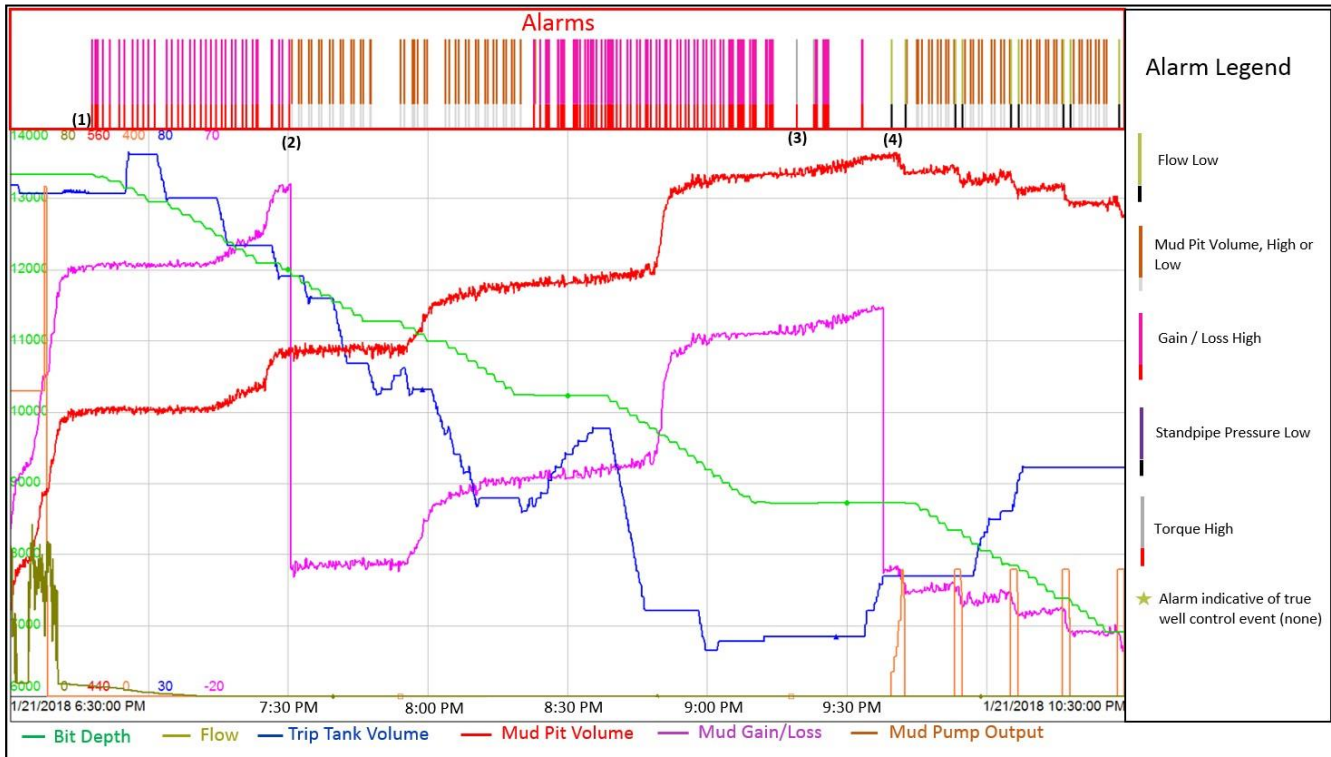
Figure E- 1. Information from alarm system data, indicating what alarms would have activated between 6:45 pm and 10:30 pm during the trip out of the lateral section, had the alarm system been turned on. Information about the specific alarms is in Table E- 1 below. The numbers in parentheses correspond with the note numbers in Table E- 1.

- (1) During the trip out of the lateral part of the well, the orbit valve in the flow line was closed. This valve alignment prevented any mud to flow from the well into the mud pits. The Gain/Loss alarm activates when a significant change occurs in the mud pit volume (the alarm was set to activate at a change of minus 40 or plus 15 barrels. Because the orbit valve was closed, the changes in mud pit volume during this tripping operation were caused by other operations, such as mud transfers, unrelated to the tripping operation. The Gain/Loss alarm would not have been indicative of the gas influx in the well and would therefore have been a nuisance or non-critical alarm.

- (4) The flow alarm was set to alert low flow when the mud pumps were running and the flow value was less than 5%. When the driller turned on the mud pumps during the tripping operation, the closed orbit valve prevented mud flow through the flow line. The low flow alarm would not have been indicative of a well control event. (Note: this alarm could still indicate a hazardous equipment lineup if the driller did not intend to close the orbit valve, which was not the case here.)

- (5) Gains in the trip tank volume were a result of pressure at the surface of the well caused by a gas influx pushing mud to the trip tank through the trip tank discharge line. There were no alarms on the trip tank to alert the driller to the trip tank volume gain. The trip tank was equipped only with a high- and low-volume alarm to alert the driller when the trip tank was almost full or almost empty. The driller is expected to identify indications of gas influx by completing a trip sheet, comparing the calculated volume of mud expected to be pumped to the actual amount of mud pumped into the well from the trip tank. The CSB was told that the general standard in the North Sea is the driller can set a gain/loss alarm for trip tank level.

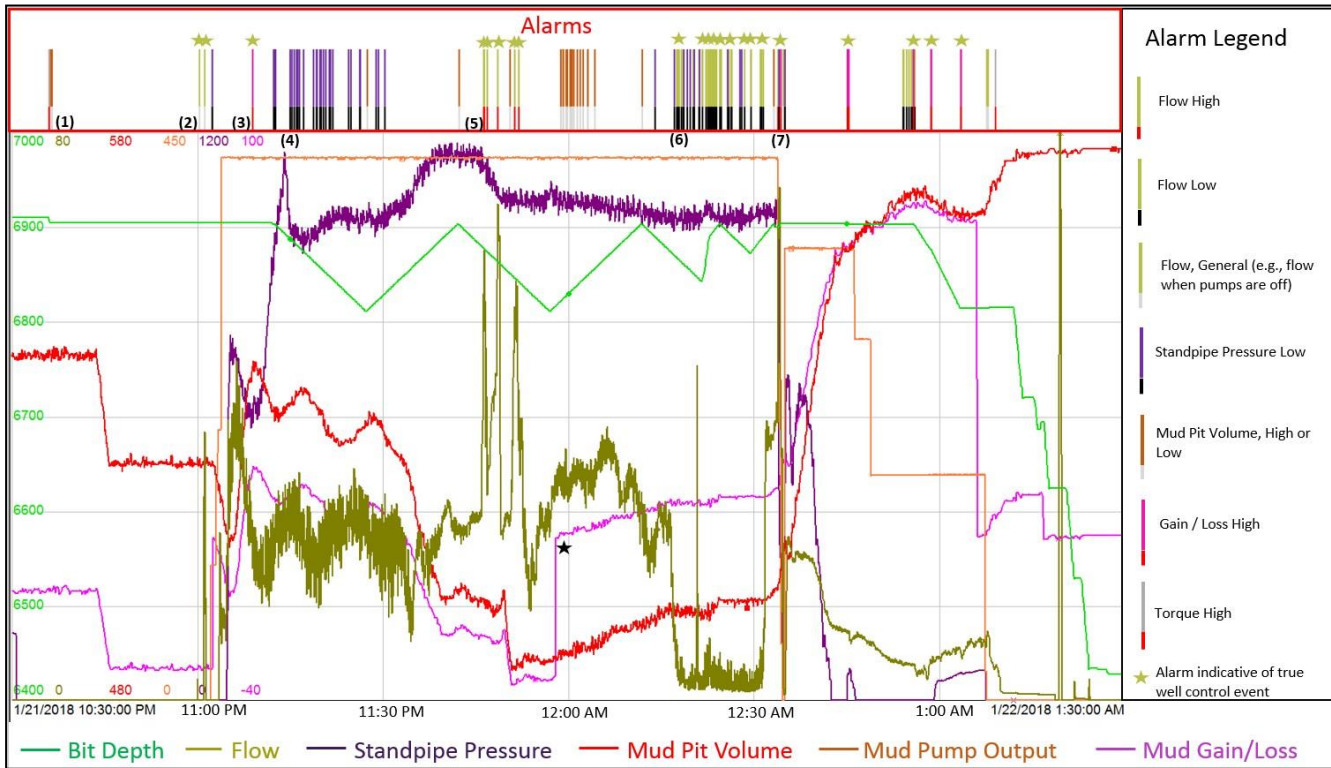
Figure E- 2. Information from alarm system data, indicating what alarms would have activated between 10:30 pm and 1:10 am while circulating at the top of the curve, had the alarm system been turned on. Some of these alarms could have alerted to the well control event. Information about the specific alarms is in Table E- 2 below. The numbers in parentheses correspond with the note numbers in Table E- 2.

- (4) The Standpipe Pressure Low alarm would have been triggered early during the circulation operation. The standpipe pressure increased again between 11:30 pm and 12:00 am during the well circulation, corresponding to a gas release from the well (Section 5.2), which would have caused the low pressure alarm to stop activating. Had the alarm system been active, the standpipe pressure alarm could have been used as a well control event indication if the setpoints been adjusted to make the information significant. At the current set points, however, this alarm would not have been warning of the well control event.

- (6) The flow suddenly dropped during circulation, and would have triggered the Flow Low alarm. The Flow Low alarm would have been a correct indicator of the decrease in mud flow from the well. While it is unclear what caused this drop in flow, this alarm would need driller attention.

- (7) The Gain/Loss High alarm activation would have been a true indicator of a gain in the mud pit volume due to increased flow from the wellbore, signifying a well control event. The alarm set point, however, was set outside of the Patterson recommended limits. Patterson required that this alarm be set at +/- 5 barrels, but it was set to alarm at plus 15 barrels and minus 40 barrels. The driller reset the Gain/Loss measurement to zero at 11:58 pm (black star). The Gain/Loss High alarm would have activated when the Gain/Loss reached 15 barrels, at 12:34 am.

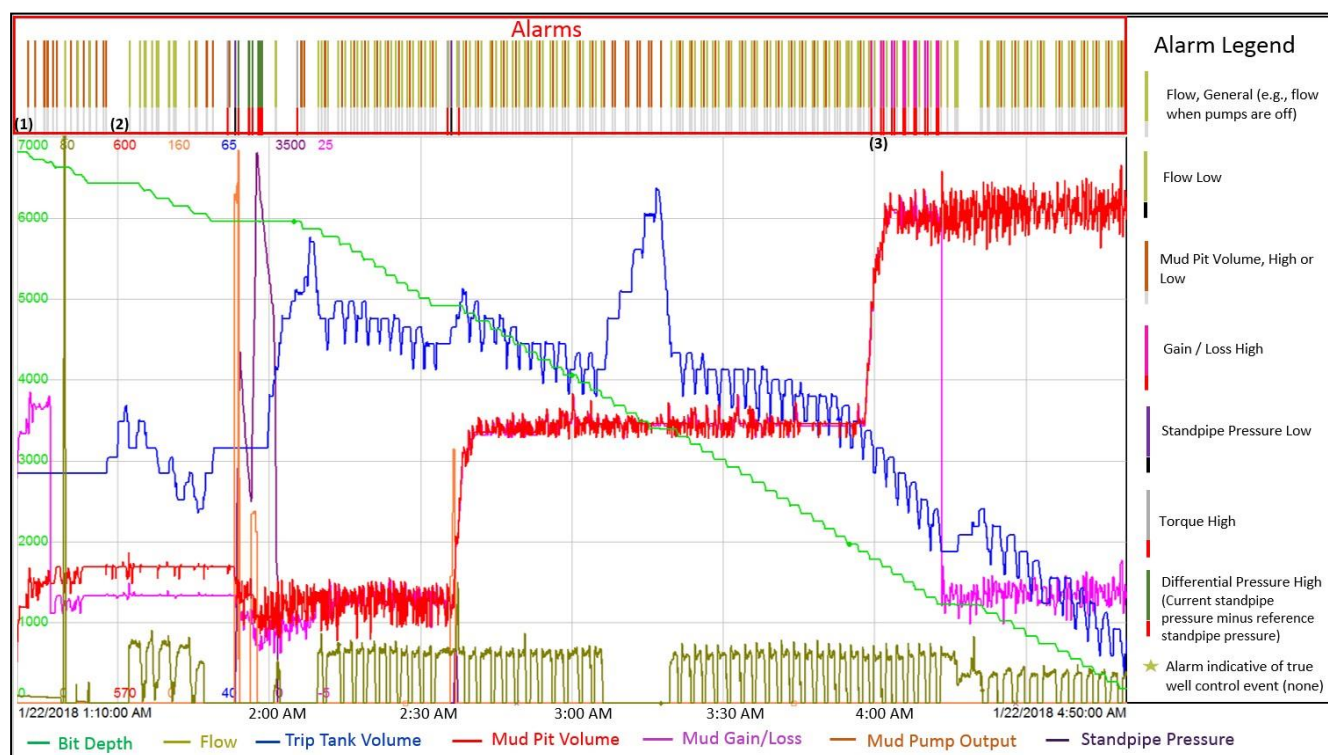
The tripping operation out of the vertical portion of the well occurred between 1:10 am and 4:50 am. During this period, alarms would have activated had the alarm system been on for parameters including mud pit volume, flow, Gain/Loss high, differential pressure, standpipe pressure, and torque. These alarms would have been activated by other rig operations (e.g., transferring mud) or parameters that would be pertinent to the drilling operation but were irrelevant to the tripping operation. As such, all alarming would have been non-critical alarms not indicative of the well control event. No alarms would have activated that warned of a potential well control event during the tripping operation.

Figure E- 3. Information from alarm system data, indicating what alarms would have activated between 1:10 am and 4:50 am while tripping out of the vertical section of the well, had the alarm system been turned on. None of the alarms would have alerted to the well control event. Information about the specific alarms is in Table E- 3 below. The numbers in parentheses correspond with the note numbers in Table E- 3.

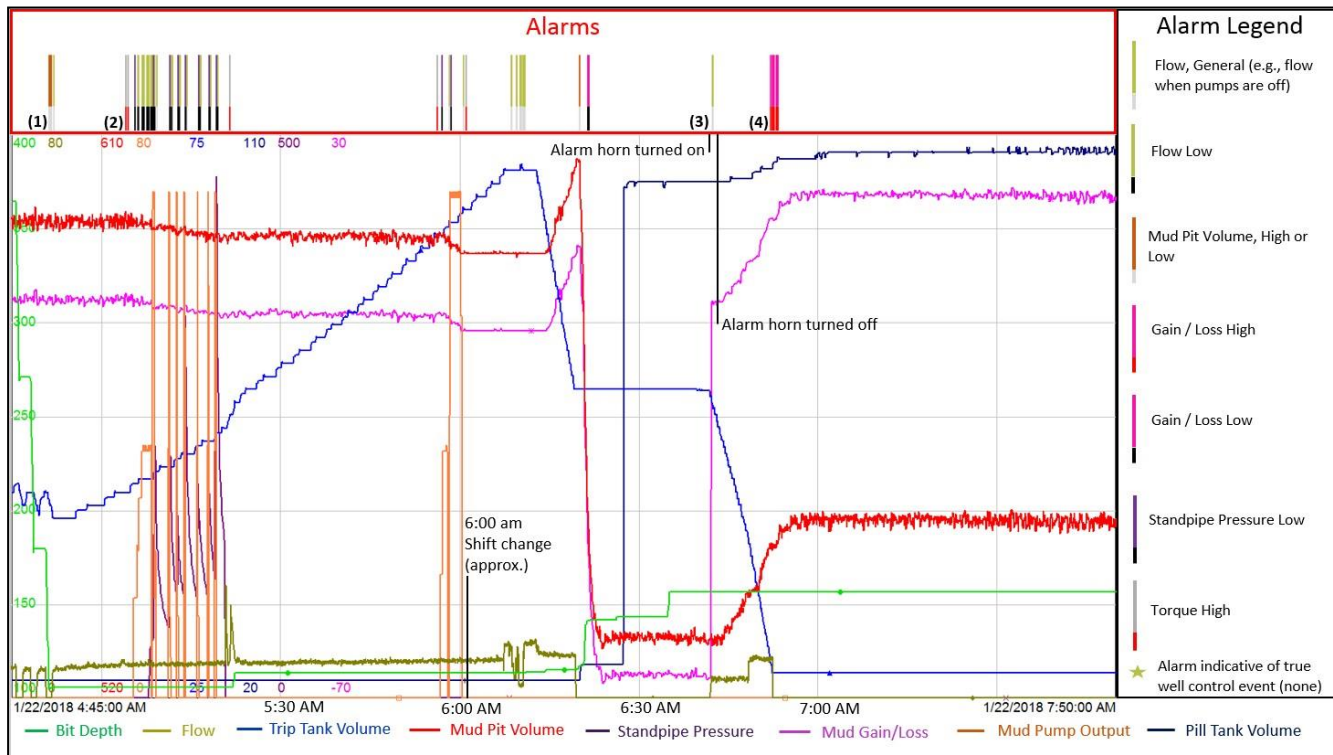
During this period a shift change occurred at around 6:00 am. At 6:42 am, the alarm system was reactivated, likely by the new driller on tour. Non-critical alarms would have been continuously sounding while the alarm system was on. Twenty seconds after the alarm system was turned on, it was turned off again. The alarm horn remained off through the blowout at 8:36 am.

Figure E- 4. Information from alarm system data, indicating what alarms would have activated between 4:50 am and 7:50 am during the rig floor operations, had the alarm system been turned on. None of the alarms would have alerted to the well control event. Information about the specific alarms is in Table E- 4 below. The numbers in parentheses correspond with the note numbers in Table E- 4.

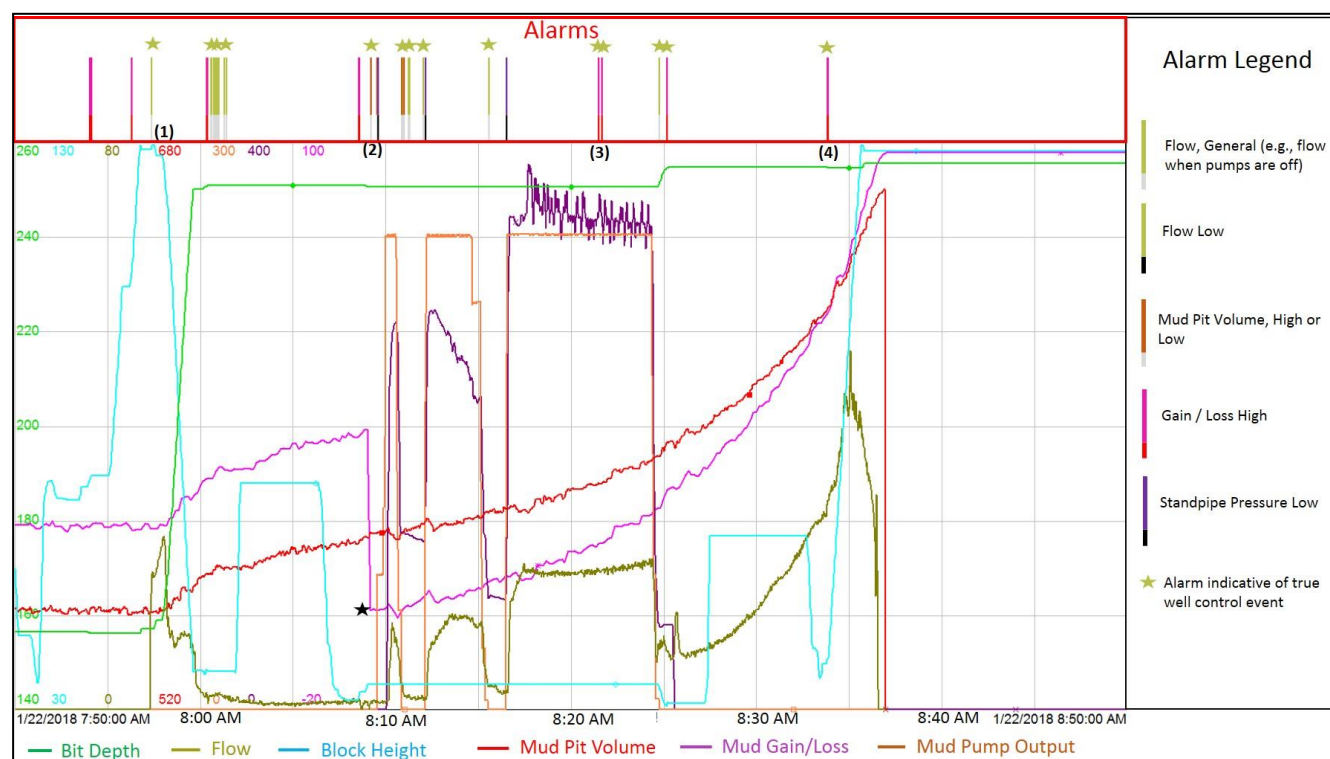
Between 7:50 am and the blowout at 8:36 am, alarms would have activated for Flow, Mud Pit Volume, Standpipe Pressure, Gain/Loss, and Torque. This time, almost all of the alarming would have been indicative of the true well control event.

Figure E- 5. Information from alarm system data, indicating what alarms would have activated between 7:50 am and 8:36 am (blowout), if the alarm system was on. Almost all of the alarms would have alerted to the well control event. Information about the specific alarms is in Table E- 5 below. The numbers in parentheses correspond with the note numbers in Table E- 5.

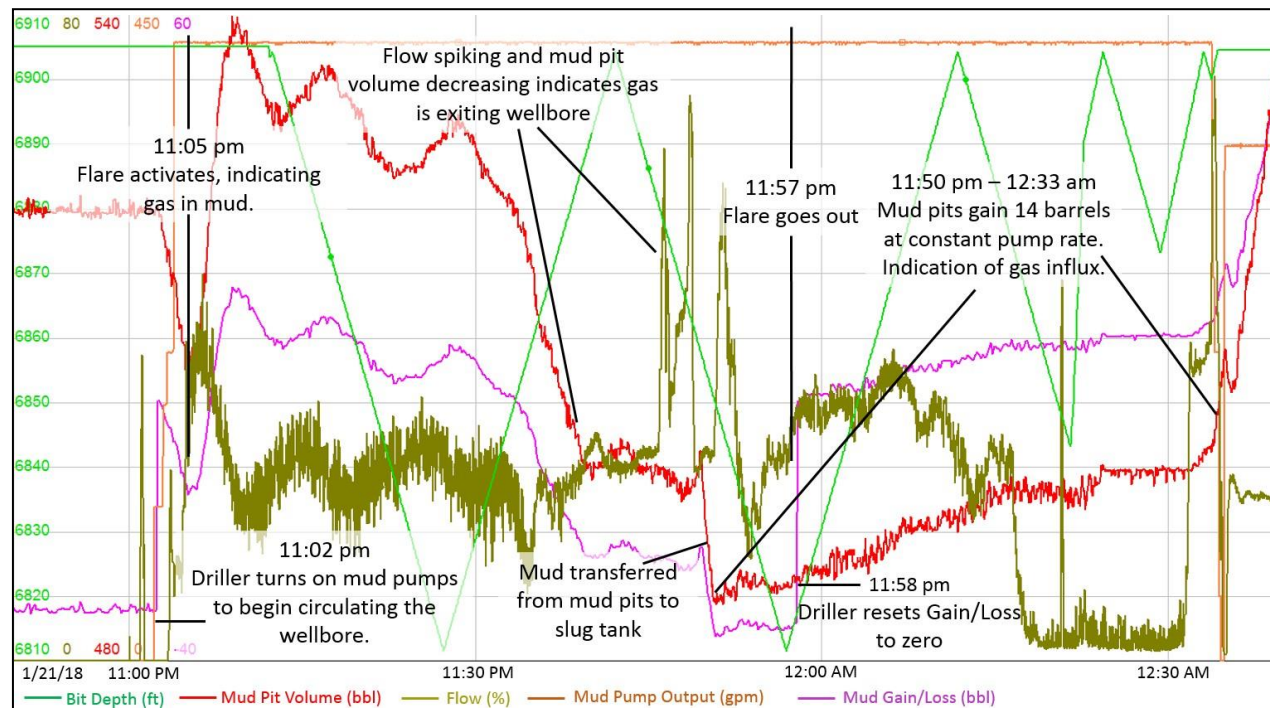
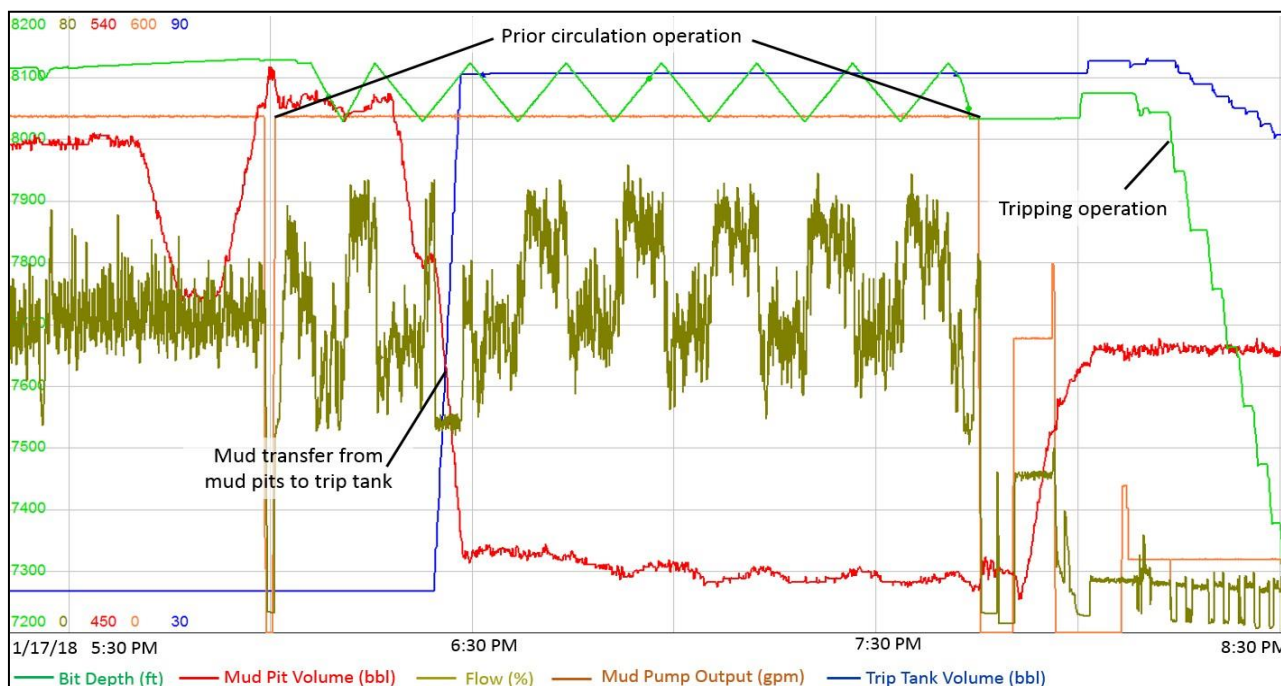
The top graph below shows rig data while circulating the wellbore at the top of the curve. The flare activated while circulating, indicating gas in the mud. Between 11:50 pm and 12:33 am, the mud pits gained 14 barrels while the mud pumps were circulating at a constant pump rate. This pit gain indicates there was a gas influx (kick). For comparison purposes, the bottom graph shows a normal circulation operation performed on January 17, 2018 on Pryor Trust Well 1H-9.
