Mitigation Assessment Team Report Hurricane Charley in Florida

Observations, Recommendations, and Technical Guidance

FEMA 488 / April 2005

On August 19, 2004, the Federal Emergency Management Agency's (FEMA's) Mitigation Division deployed a Mitigation Assessment Team (MAT) to Florida to assess damages caused by Hurricane Charley. This report presents the MAT's observations, conclusions, and recommendations in response to those field investigations.

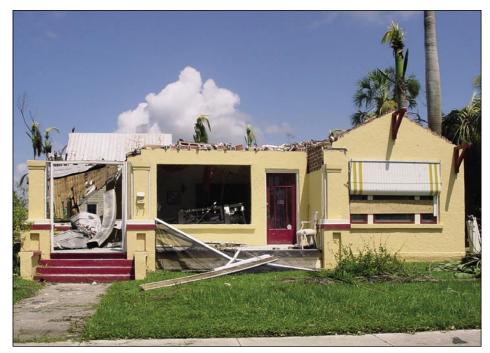
Figure 3-2 shows a masonry home with a wood roof structure. Failure of the window in the front wall of the house likely led to pressurization of the house and contributed to the dramatic failure of the roof structure.

Figure 3-2. Failure of roof structure from pressurization of a pre-2001 FBC house when the window failed on windward face (Punta Gorda)

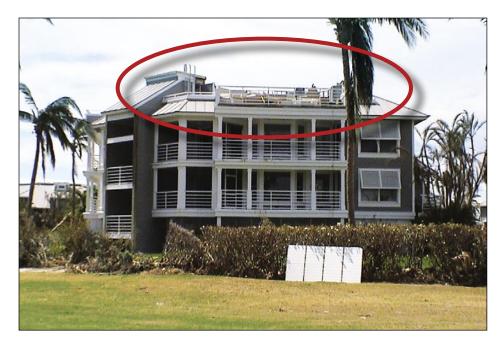
Figures 3-3 and 3-4 illustrate that installing shutters on a building to protect windows and doors can ensure the envelope is not breached and thus prevents the increase in internal pressure. The condominiums in these photos were located within a few hundred feet of each other at the north end of Captiva Island. The top unit in the building in Figure 3-3 was not protected with shutters, and most of the upper floor framing likely failed due to an increase in wind pressure when windows (and doors) were breached. Conversely, the same type of building constructed two buildings away had shutters to protect the building (Figure 3-4). The shutters protected windows and doors, keeping the building "enclosed," and ensured that the building performed without failure.

Figure 3-3. Loss of roof structure in a wood-frame building likely due to internal pressurization resulting from unprotected windows and doors (Captiva Island)

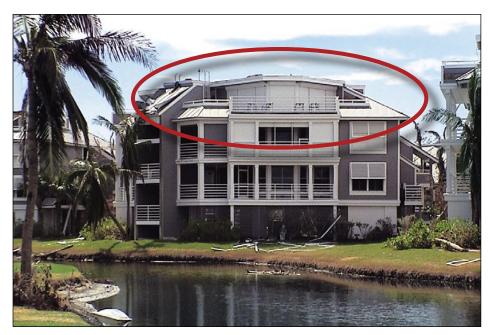
Figure 3-4. Nearby undamaged wood-frame building similar to that shown in Figure 3-3 protected with shutters (Captiva Island)

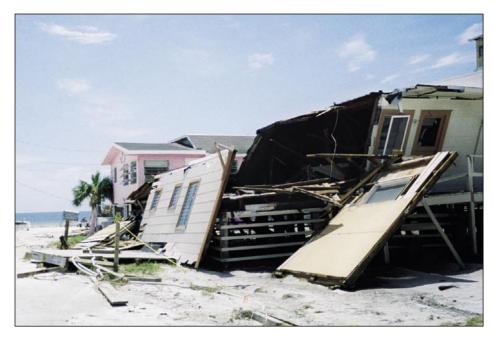
In addition to structural framing damage due to internal pressures, some wood buildings experienced failures due to a lack of continuous load path. Figure 3-5 is an example of a wood-frame structure that experienced a partial wall failure due to a lack of continuous load path. These types of damages were typically limited to areas along the path of the eye and were not typical of damage in areas with estimated wind speeds less than 100 mph (3-second peak gust).

Figure 3-5. Wall failure on older multi-family wood-frame building due to lack of continuous load path. Internal pressurization may have also contributed to this failure (Fort Myers Beach).

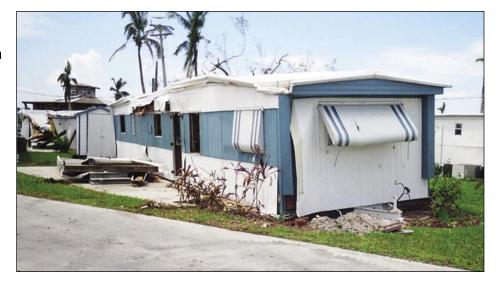
Structural failures to manufactured housing were also observed. Structural damages observed near the path of the eye could be classified as foundation damage, including shifting of the units on the foundations resulting in out of plumb foundations (piers) or complete collapse of the foundation. Figure 3-7 shows a pre-1976 manufactured housing unit completely displaced from its foundation piers. The homeowner of this unit indicated that his unit was retrofitted in the late 1990s during a park-wide mitigation project that installed additional tie-downs such that spacing would not exceed 4 feet. Improper installation of the additional tie-downs and saturated soil likely led to the failures observed. Other structural damages observed to manufactured housing were failures due to wind effects (not related to an attached structure or enclosure). Although these failures were not representative of the performance of all manufactured housing, the post-1994 unit in

Figure 3-7. Pre-1976 manufactured home unit displaced from its foundation, damaging the structure itself (Pine Island)

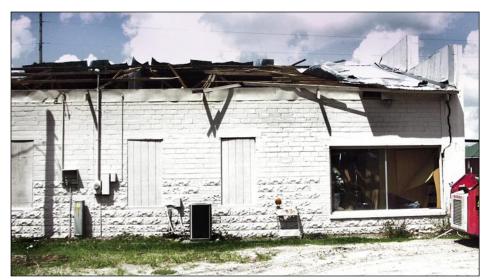
Figure 3-10. Roof sheathing and partial failure of wood roof structure on a masonry building. Note damage to inadequately reinforced masonry parapet at gable end wall (Wauchula).

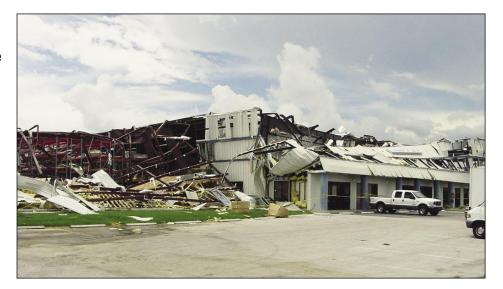
Structural damage to pre-engineered metal and light-metal frame buildings included the collapses of structural frames (partial and complete) as shown in Figures 3-12 and 3-13. Other damages to pre-engineered metal and light-metal frame buildings observed by the MAT included a partial or complete collapse of gable end walls. Common

Figure 3-12. Pre-engineered metal building with progressive failure and severe panel loss (Arcadia)

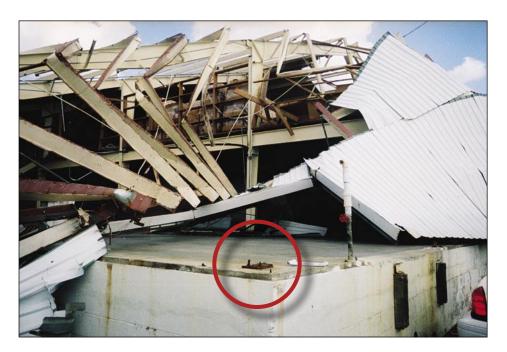
Figure 3-13. Roof framing failure and gable end wall collapse due to insufficient supports of pre-engineered metal building. Note corroded base plate with failed bolts for gable end wall column (Wauchula).

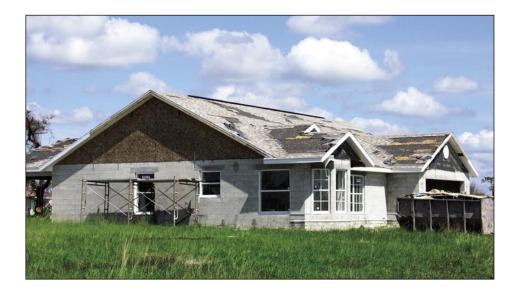
The most widespread damage to one- and two-family housing units occurred at or above the roof line and included loss of asphalt shingles or tile roof coverings (Figures 3-14, 3-15, and 3-16). This type of damage was observed across the wind field on both the barrier islands and on the mainland (including inland areas). By contrast, one- and two-family homes with metal roof coverings suffered only minor, if

Figure 3-14. Asphalt shingle roof covering damage on a new one-story house. In some areas, the underlayment was also blown away (Deep Creek).

Although damage was observed on several new roofs (Figures 3-14, 4-11, and 5-24), in general it appeared that asphalt shingles installed within the past few years performed better than shingles installed prior to the mid-1990s. The enhanced performance is likely due to product improvements (e.g., availability of greater bond-strength of the selfseal adhesive and availability of greater adhesive surface area) and less degradation of physical properties due to limited weathering time. It is doubtful that any of the observed roofs had been designed in accordance with UL Standard 2390, which was published in 2003. This standard pertains to two main items: 1) it provides a lab test method that manufacturers use to establish pressure coefficients for specific types of shingles; and 2) it provides a calculation procedure for a designer to determine the design wind load on the shingles, which is based on the coefficient from the testing, ASCE 7 criteria such as basic wind speed, and factors developed specifically for shingles. FEMA Hurricane Recovery Advisories No. 1 and No. 2 (Appendix D) provide recommended practices for asphalt shingles on roofs in hurricane-prone regions. FEMA Hurricane Recovery Advisories No. 1 and No. 2 were based on guidance given in the fact sheets for FEMA's Home Builder's Guide to *Coastal Construction* (to be published).

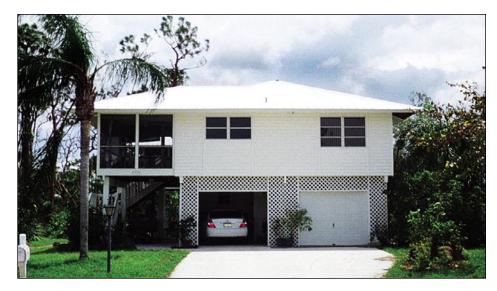
any, damage (Figure 3-17). The metal roof systems most frequently noted to be damaged were those with concealed clips integrated into the seaming process; however, such fastening is not readily visible.

Figure 3-17. Typical pile-elevated residence with undamaged metal panel roof (coastal flood zone on Pine Island)

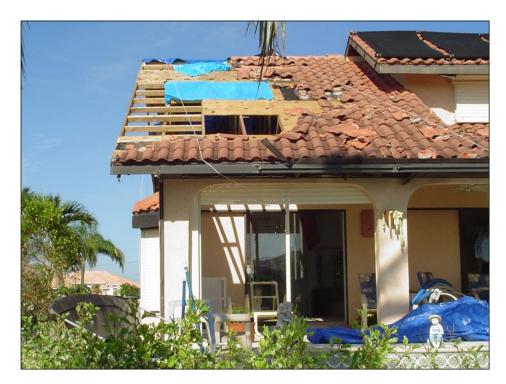
Other damages to one- and two-family housing units included loss of roof sheathing and the consequent partial or total collapse of gable end roof sections (Figures 3-18 and 3-19). The loss of roof sheathing was observed in the areas with the highest winds. This type of damage was not common.

Figure 3-18. Example of roof decking loss on one-story house (Punta Gorda)

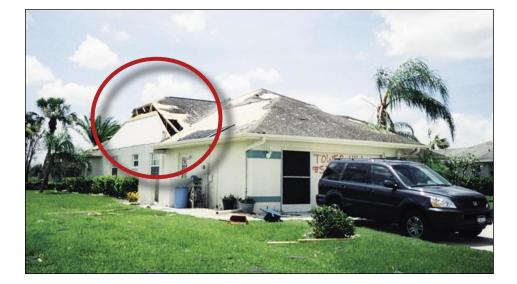
Figure 3-19 Partial gable end wall failure with loss of roof shingles (Deep Creek)

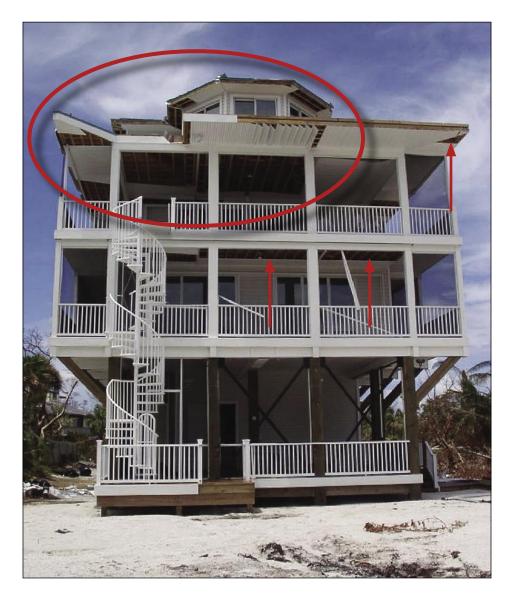
In addition, widespread loss of vinyl and aluminum soffit panels was also observed. These panels were either pulled out by negative wind pressures (suction) or pushed up by positive pressures (Figure 3-21). The damage was not limited to the loss of the windows or doors or loss of the exterior soffit cladding system. Damages to these building envelope components led to wind-driven rain entering the homes and wetting the building interior and the internal wall cavities, and saturating attic insulation and ceilings that sometimes collapsed (Figure 3-22).

Figure 3-21. Typical elevated woodframe house with extensive soffit damage (North Captiva Island)

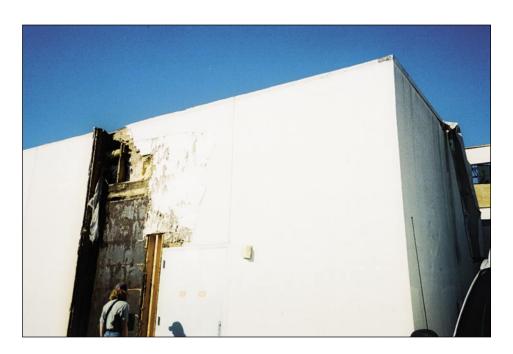
Figure 3-26. Example of damage to EIFS wall panels (Punta Gorda)

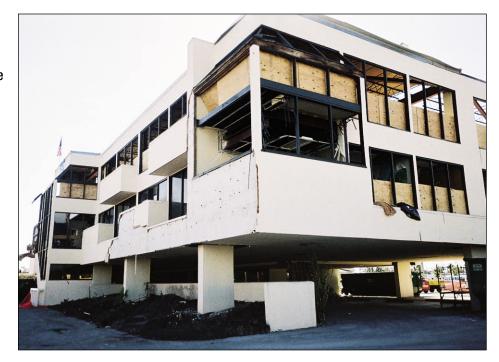
Damage to windows, doors, and soffits was observed in commercial applications similar to the losses and damages observed in residential construction. Figure 3-27 is a medical office building in Punta Gorda that lost roof decking, suffered damage to EIFS wall coverings, and experienced significant glass breakage.

Figure 3-27. Structural steel frame building showing loss of roof decking and damage to EIFS wall coverings (Punta Gorda) In commercial applications, door losses were often more dramatic when the loss was not just to personnel doors, but to large rolling and sectional doors, leading to the pressurization of buildings. As a result, the failure of these doors due to wind loading, as shown in Figure 3-28, often caused significant damage to the buildings and the building envelope itself. This type of damage was observed frequently in essential and critical facilities; further discussion on this type of damage is provided in Chapters 5 and 6. Failure modes, including door panel failure, door track failure, and the door track-to-wall (door buck) attachment failure, are also discussed in Chapters 5 and 6.

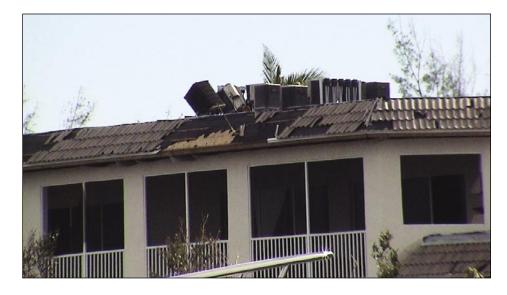
Other types of damages to commercial buildings observed by the MAT included loss of large awnings and HVAC equipment due to the lack of proper connections (Figure 3-29). This type of damage was observed across the damage path of the storm.

Figure 3-29. Dislocation of rooftop equipment (Pine Island)

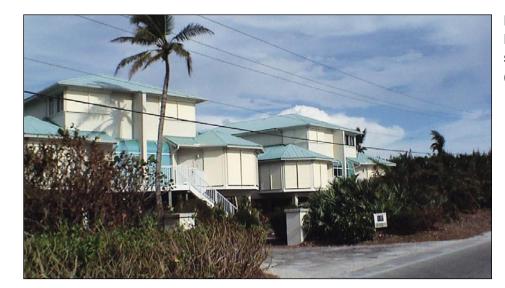
Unfortunately, damage from windborne debris will remain an issue during hurricanes even if all glazings are protected. Significant amounts of debris were generated in the areas that experienced winds less than 100 mph when poorly constructed or non-engineered enclosures, pool screens, carports, and attached structures could not withstand the hurricane winds. Adequately protecting buildings from windborne debris, as required by code, is a sound building practice. Use of the 120-mph wind contour line to require glazing protection on buildings was supported by the extensive damage to glazing systems along the eye's path. However, as discussed in Section 5.2, glazing damage was documented in areas that experienced speeds well below 120 mph. An example of shutters performing as designed is shown in Figure 3-30.

Figure 3-30. Newer house with storm shutters (Sanibel Island)

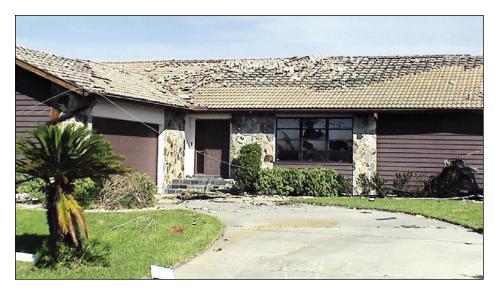
Figure 3-31. Extensive damage to mortar-set tile roof on this pre-2001 FBC home. Note broken windows to the right of the front door (Punta Gorda).

The size of the blow-off area of tile roofs attached using mortar-set systems was typically much greater than for tile roofs attached using foam-set and mechanically attached systems. Figure 3-31 showed a mortar-set roof with a large area of blown-off tiles.

There were many reports of tiles or tile fragments hitting occupied buildings and flying through windows (shown previously in Figures 3-31 and 3-32). The owner of one residence reported that six of their windows were broken by tiles from a neighbor's house (Figure 5-48). The homeowner's metal roof was not damaged, but wind-driven rain forced through the broken windows caused extensive interior wind and water damage.

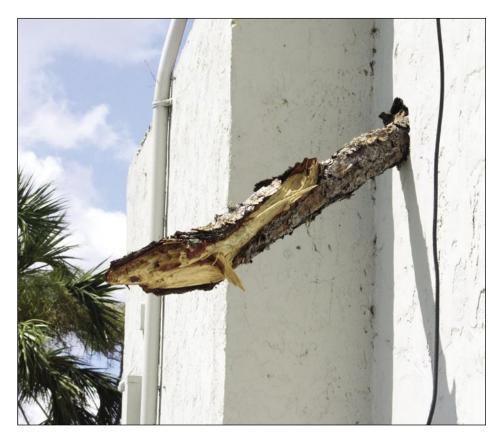
Figure 3-35. Impact of tree branch through the stucco and metal lath wall system of a fire station. The branch was about 5 inches in diameter and protruded about 3¹/₂ feet out of the wall (Aqui Esta, east of Punta Gorda Isles).

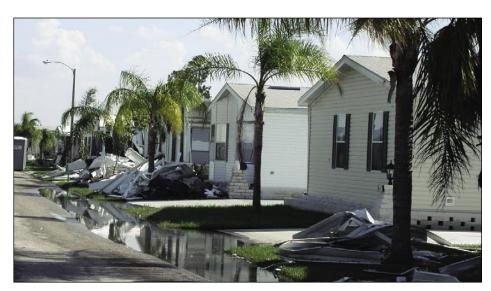
In manufactured home parks, there was a significant amount of aluminum and sheet metal debris from attached structures that failed and a significant amount of glazing damage even in inland parks, as discussed in Section 5.2; however, there were some windows surprisingly intact on the windward sides of the homes. It appears that the close proximity of the homes and the deformable nature of the debris may have helped to reduce the debris impact damage; it is likely that large sheets bumped into the next home before they had traveled very far or attained much velocity (Figure 3-39). In contrast, a manufactured home park observed with homes spaced considerable distances apart appeared to have greater windborne debris damage (Figure 3-40).

Figure 3-39. Typical metal roof panel and siding debris from failed accessory structures and manufactured homes that were stripped of siding resulting from accessory structures failure (Arcadia)

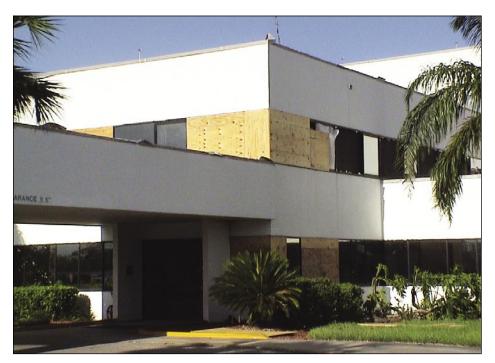
It was clear, through investigations at a number of hospitals and other buildings with aggregate roof surfacing, that the aggregate could, and frequently did, cause damage to windows on the building itself. The damage to windows in the intensive care unit of the hospital in Arcadia (Figure 3-41) was a prime example of this effect.

Figure 3-41.

Aggregate from the builtup roofs broke windows at the intensive care unit of a hospital where 3second peak gust wind speeds were estimated between 110 and 120 mph (Arcadia).

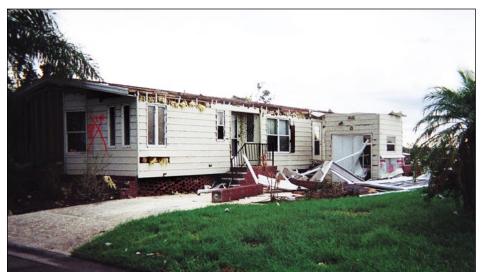
Figure 3-45. Example of typical damage to roof covering, roof sheathing, and exterior siding of a manufactured home as a result of the failure of an attached carport structure (Port Charlotte)

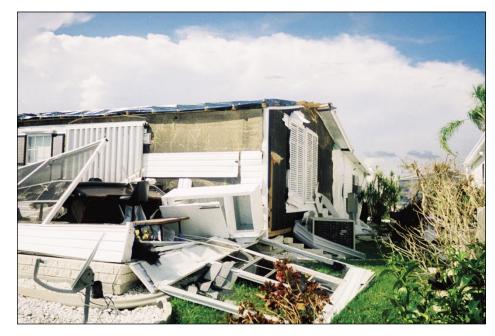
Figure 3-46. Example of damage to manufactured home roof covering, roof deck, and siding due to failure of screen enclosure attached to home (Port Charlotte)

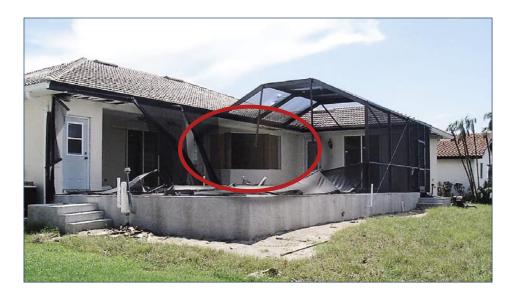
Screen enclosures around pools are common in Florida and incurred extensive damage as a result of Hurricane Charley. Damage typically occurred on the sides of buildings that received direct windward pressures. Figure 3-47 shows an example of a screened pool enclosure that failed from wind pressures. Note the damage caused to the window by the debris from the enclosure.

Figure 3-47. Example of damage to pool screen enclosure. Note broken window in center of photo from debris (Punta Gorda Isles).

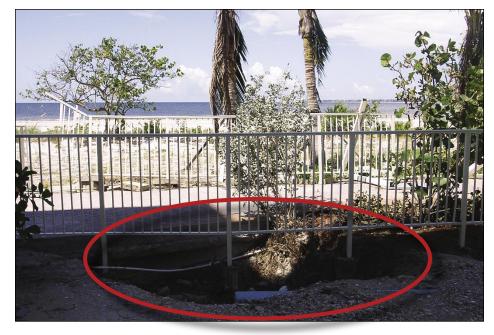
Figure 3-48. Minor scour of parking lot from overwash of storm surge (Fort Myers Beach)

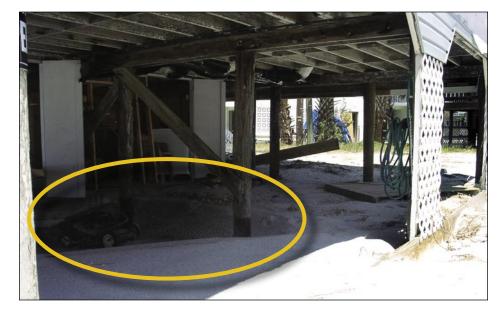
Figure 3-49. Minor scour around pile (Fort Myers Beach)

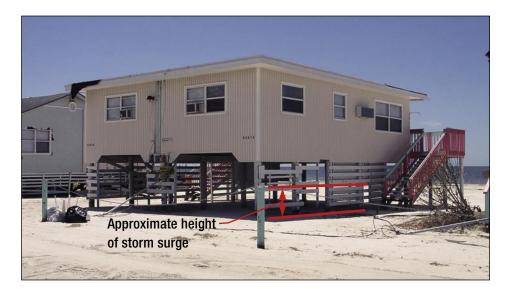
Figure 3-50. Oceanfront house constructed on piles sustained only minor damage as a result of storm surge (Fort Myers Beach)

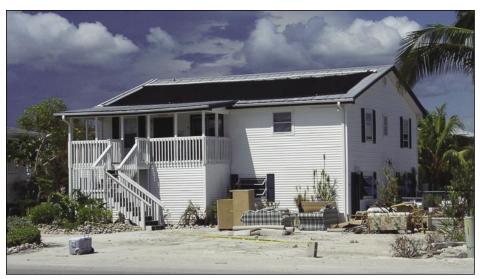
Figure 3-51. Storm surge damage of 2 to 3 feet limited to lower floor of two-story house

(Fort Myers Beach)

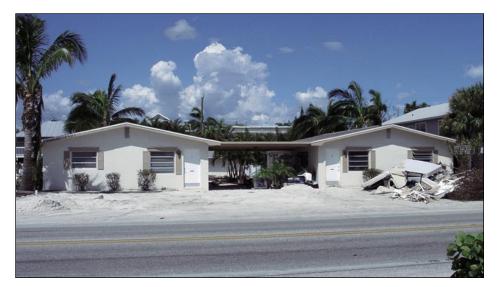
Figure 3-52. Typical house with firstfloor living space at grade sustained 2 to 3 feet of storm surge damage (lack of wall damage suggests low velocity flows) (Fort Myers Beach)

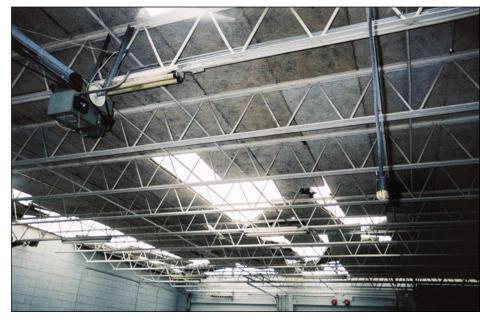
Most of the buildings being used for police and fire stations were older buildings that had not been enhanced or mitigated to resist wind and windborne debris to the level at which new essential facilities are required to be designed. Roof coverings, sectional doors, and roof structural systems were the most commonly damaged components of fire and police stations and hospitals. In one instance, the MAT observed cementitious wood-fiber decking that was not adequately secured to resist uplift had lifted off the supporting roof structure (Figure 3-56). On gable end and hip roofs, metal and asphalt shingle roof coverings were damaged; gable end wall collapses were also observed (Figure 3-57).

Figure 3-56. Cementitious wood-fiber roof deck panels at this older fire station were not adequately secured to resist uplift (Port Charlotte).

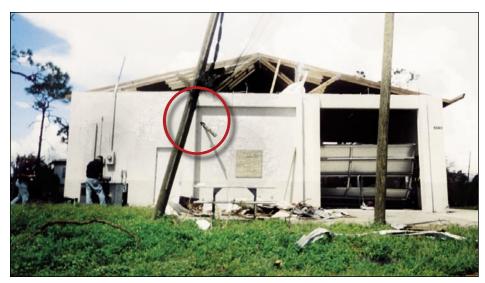
Figure 3-57. Gable end wall collapse and rolling and sectional door failure at fire station (Aqui Esta, east of Punta Gorda Isles). A close-up of the missile in the circle is shown in Figure 3-35.

The rolling and sectional doors at the older fire stations lacked sufficient wind resistance and typically failed by suction or positive pressure. Common modes of failure observed included doors disengaging from the tracks shown previously in (Figure 3-57), or tracks or track blocking pulling away from the walls, or breakage of glazed or metal panel doors. In several cases, the tracks bent or bowed enough to allow the wheels to disengage from the tracks. Damage to older doors was not surprising, illustrating the need to replace weak doors on these important buildings. However, when doors are replaced, it is important to replace all of the doors and the track hardware as illustrated by Figure 5-9. There were six sectional doors at the fire station shown in Figure 5-9. Five of the doors were damaged. On the leeward side, one door blew out, one buckled, and one had minor outward bowing. On the windward side, two of the doors blew inward as shown in Figure 5-9. The door that did not fail was a newer door. The tracks on the newer door were attached with ¼-inch screws at 18 inches on center. There were two stiffener ribs per 24-inch high door section. It is notable that one of the sidewalls was pushed out when the attachment of the wall angle to the slab failed, likely due to an increase in internal pressure. The wall angle was attached with nail-ins at 3 feet 3 inches on center. The concrete spalled at the fasteners. Because of the door damage, this station was taken off-line after the hurricane.

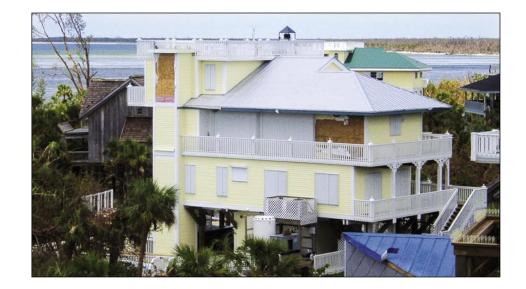
Figure 4-1. No structural damage was observed to new buildings built to the 2001 FBC standards (North Captiva Island).

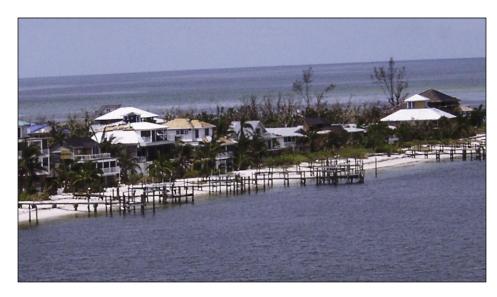
Newer wood-frame houses, built in accordance with the 2001 FBC, generally performed well structurally. Most of the newer wood-frame houses observed by the MAT were along the Gulf Coast on Sanibel and North Captiva Islands; these buildings were typically two stories on wood pile foundations. The relatively new building stock located in areas of North Captiva Island was impacted by the northeast eyewall, which contained some of the strongest winds of the storm, with winds over 150 mph (3-second peak gust); the houses survived very well from a structural standpoint (Figure 4-2).

Figure 4-2. Newer single-family wood-frame residences that demonstrated good structural performance (North Captiva Island)

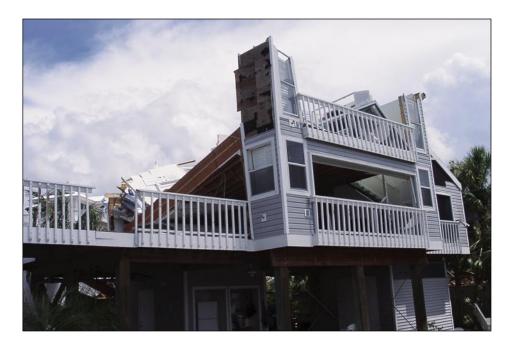
A number of the older residential buildings on North Captiva Island experienced structural collapse as shown in Figure 4-3 and were not designed with the continuous load path concept in mind, which consists of following the loads from the point of load application to the foundation; this is essential for stability. Newer building codes and standards specify that design and construction be performed with the load path concept in mind, which is resulting in better structural performance of buildings.

Figure 4-3. An older building that was renovated for architectural improvements a few years ago collapsed due to limited load path connections (North Captiva Island).

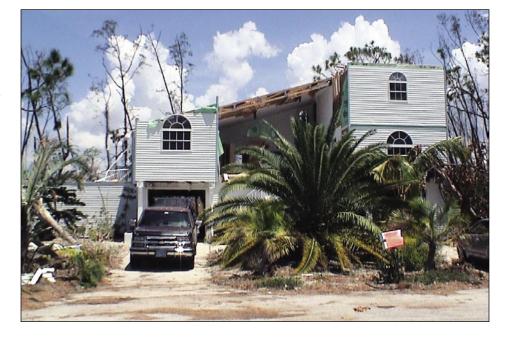
Figure 4-5. Failure of the roof over a cathedral ceiling from pressurization of the house when the window failed on the windward face (Pine Island)

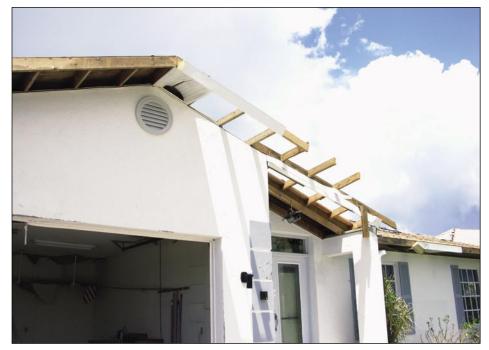
Damage to roof sheathing, though not widespread, was observed (Figure 4-6). This damage was observed by the MAT on older homes most likely designed prior to improvements in the C&C design criteria discussed in Chapter 2.

Figure 4-6. Roof decking failed due to uplift (Deep Creek)

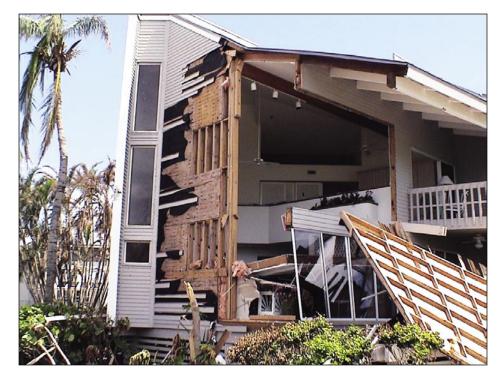
Figure 4-8. Wall failure on older (1980s vintage) multifamily wood-frame building due to lack of load path. Internal pressurization may have also contributed to this failure (Captiva Island).

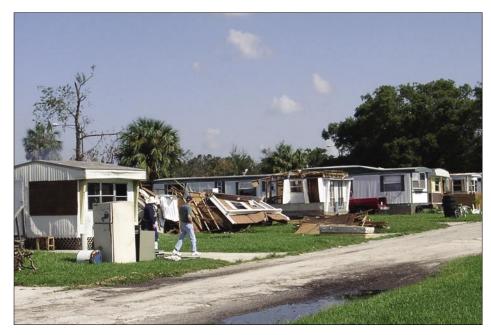
he pre-1976 HUD standard homes, which are now over 25 years old, performed poorly as expected. These homes were built in accordance with minimum requirements, and many of the homes were subjected to the narrow path of Hurricane Charley's highest winds and were damaged beyond repair. Figure 4-9 shows a pre-HUD home that was totally destroyed; however, surrounding pre-HUD homes appeared to have survived with little damage.

Figure 4-9. Pre-1976 HUD manufactured home sustained substantial damage (Bowling Green)

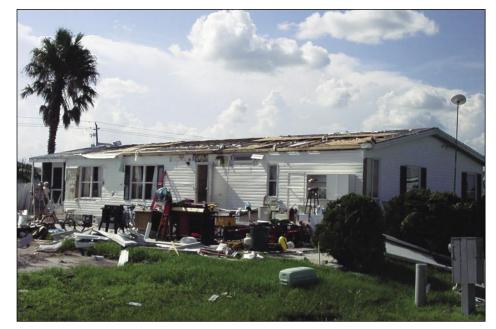
The post-1994 HUD standard home, built after the improved wind-resistant requirements were added to the HUD manufactured housing standards in 1994, performed better than its predecessors. In general, the main wind-force resisting systems in these homes remained intact. In many cases, when an attached accessory structure was torn off a home, it also tore off the metal paneling to which it was attached. Typically, this starts a continuing sequence of peeling of the skin, which could include both walls and the roof (Figure 4-10). The roof structural failures

Figure 4-10. Post-1994 HUD manufactured home with significant roof damage (peeling of roof panels) resulting from collapse of attached accessory structure (Zolfo Springs).

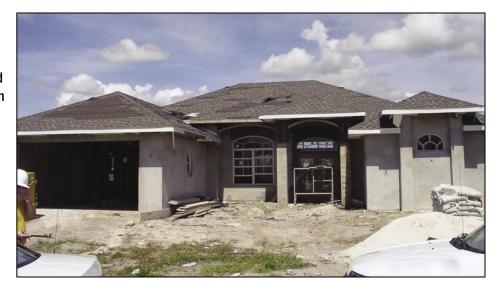
mong the most predominant construction materials in the communities impacted by the hurricane are concrete and masonry units (CMUs), which are used for exterior walls. As shown in Figure 4-11, reinforced concrete masonry structures performed well.

Figure 4-11. New concrete masonry residence built to 2001 FBC standards performed well structurally, although it did experience some asphalt shingle damage (Port Charlotte). Concrete and masonry construction is commonly used for commercial buildings, such as shopping centers and office buildings. These buildings were supported on reinforced concrete foundations with spread or deep foundation systems. Reinforced concrete columns and beams support the superstructures. Exterior load-bearing walls were constructed utilizing CMUs. In general, the floor slabs in multi-story buildings consist of cast-in-place reinforced concrete slabs. At some locations, the floor decks were observed to be supported by open web steel joists with metal deck and concrete topping.

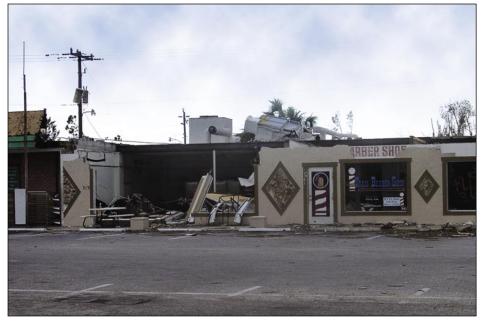
Figure 4-14. Partial failure of an unreinforced concrete masonry commercial structure (Port Charlotte)

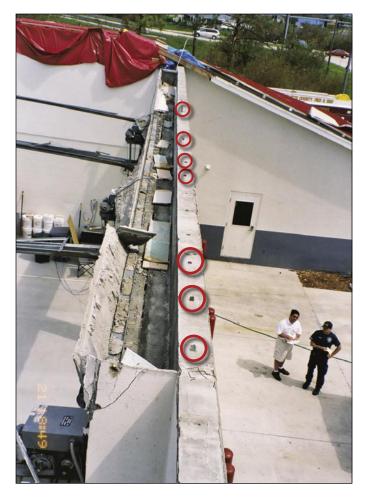
Figure 4-15.

Fire Station No. 12, a fairly new building in Port Charlotte, is a concrete structure with reinforced masonry walls and a concrete slab on grade foundation. The building was being used as a shelter for the fire station employees and their families during the hurricane. The roof framing system consisted of wood trusses supported by a tie-beam on the masonry wall. Wood roof trusses over the apparatus bays spanned approximately 68 feet. The anchorage of roof trusses to the load bearing wall apparently failed and blew away; however, all other structural components of the building stayed intact (Figure 4-15).

Roof truss hurricane anchor straps failed at the tie-beam at Fire Station No. 12 (Port Charlotte)

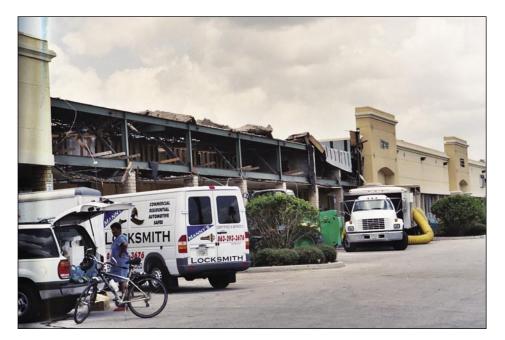
The main structural members of the steel-frame buildings observed by the MAT appeared to have withstood the hurricane force better than the wood and pre-engineered metal structures, but not as well as the reinforced concrete structures. An office building and a shopping center constructed of a structural steel-framing system were observed in Wauchula. The exterior walls and window systems failed, the building envelope was penetrated, and the roof decking blew off the joist; however, no damage was observed to the main structural steel-framing members (Figure 4-16). No heavy steel-frame failures were observed.

Figure 4-16. Older steel-frame structure performed well in spite of major damage to the roof decking and the exterior walls (Wauchula)

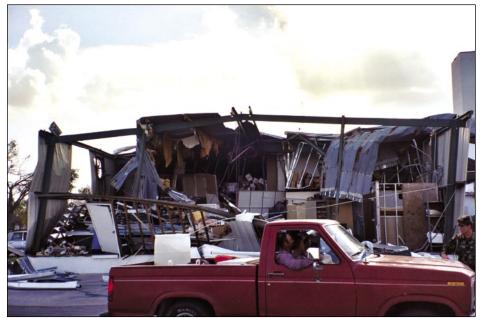
Figure 4-17. Completely destroyed pre-engineered metal building (Arcadia)

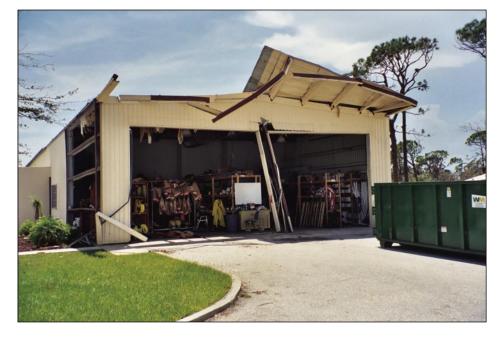
> In the Port Charlotte area, some fire stations and other essential facilities were constructed of pre-engineered metal building systems. As previously observed after other storms, in some cases, the pre-engineered metal framed systems performed the worst of all the structural framing systems evaluated. Exterior walls consisting of sheet metal siding failed prematurely due to corrosion, resulting in failure of the main structural framing members and column collapse (Figures 4-19 and 4-20).

Figure 4-19. Main column at Fire Station No. 8 collapsed due to corrosion and metal siding failed (Port Charlotte)

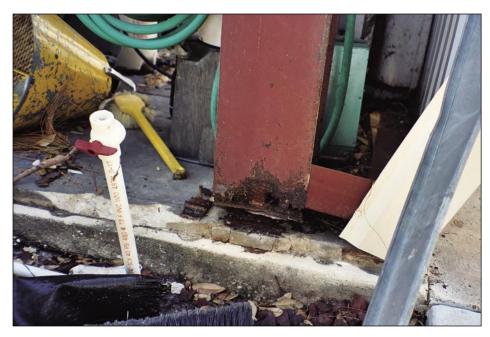
Figure 4-20. Significant amount of corrosion at Fire Station No. 8, which contributed to failure shown in Figure 4-19

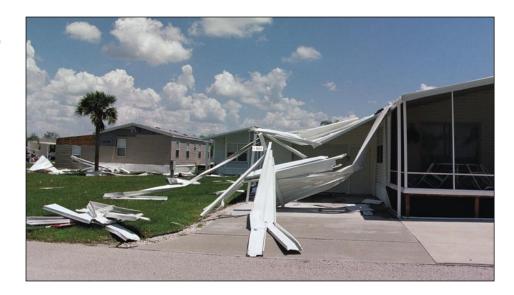
Figure 4-21. Damaged carport (Zolfo Springs)

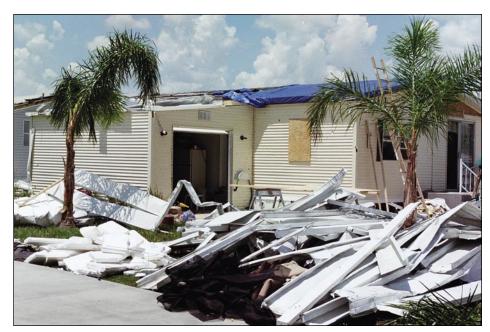
Figure 4-22. Damaged garage (Zolfo Springs)

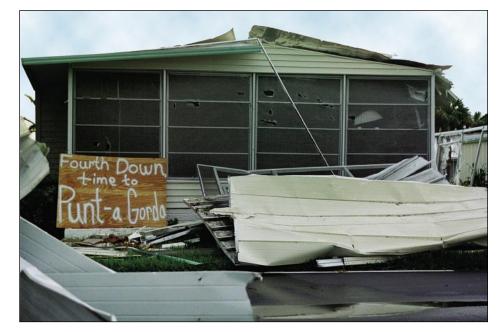
Figure 4-23. Damaged screened porch (Punta Gorda)

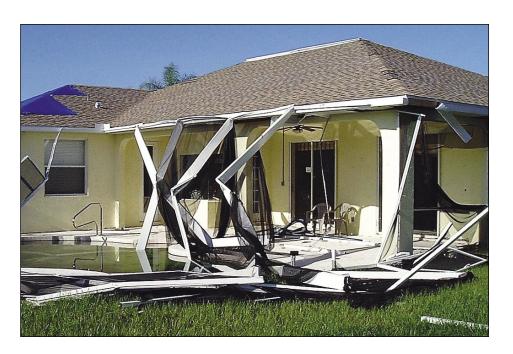
In several cases observed, the apparent cause of the primary failure was that the windward outside corner posts became detached from the slab. Typical construction of these structures included corner posts attached to adjacent 1-inch by 2-inch open back aluminum with only two #10 screws and mid-span posts similarly attached, but with the addition of substantial aluminum angle brackets secured to the slab with substantial anchor bolts. Figures 4-25 through 4-27 show the consequences of inadequately attached corner posts. In Figure 4-26, note that there was no direct tie-down of the corner post to the slab. The corner post was only tied down with lateral screws into one open back. Although the photographs show mid-span post anchoring failures, the MAT observations were that the mid-span posts failed subsequent to the corner posts. An additional mode of failure is likely to have occurred as a result of insufficient diagonal bracing.

Figure 4-26. Consequence of corner post not directly tied down to the slab (Punta Gorda Isles)

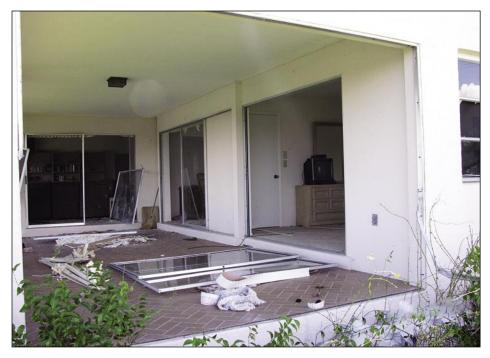
There were only a limited number of buildings where personnel door damage was observed. Observed damage included broken window panes (typically caused by missiles) and doors disengaged from their frames (likely caused by over-pressurization). Sliding glass door damage is shown in Figure 5-1, where several doors disengaged from their tracks; this damage was caused by over-pressurization. Water infiltrated the interior of a residence and caused damage because of a lack of weatherstripping between a pair of doors and their threshold. A ³/₈-inch gap occurred between the door bottoms and the threshold, apparently allowing a substantial amount of wind-driven water to enter the residence. Double-entry doors were also observed to be damaged even when homeowners tried to support the doors by pushing heavy furniture against them. An example of double-entry door failures was shown previously in Figure 3-20.

Figure 5-1. Sliding glass doors blown out of their tracks (Punta Gorda Isles)

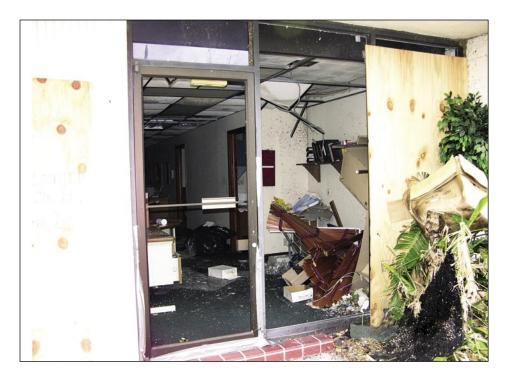
A limited number of buildings with personnel door damage were observed in commercial and critical/essential facilities. Observed damages included broken window panes (caused by missiles as shown in Figure 5-2) and disengagement of doors from their frames (likely caused by over-pressurization). At one school being used as a shelter, a pair of exterior gym doors reportedly blew open. People pulled the doors shut and held on to the horizontal exit hardware bars for the duration of the hurricane. The right leaf had top and bottom vertical rods, and the left leaf had a horizontal bolt. Therefore, at the latch edge, the door on the right was attached to the frame at the top and bottom of the door. However, the door on the left was attached only at mid-height, where it bolted into the right door (Figure 5-3). If the left door had also been equipped with top and bottom vertical rods, it may not have blown open.

Figure 5-2. Tempered glass in office building entry door and side windows broken by missiles (Punta Gorda)

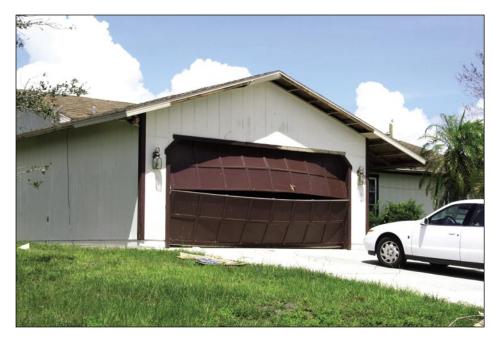
Figure 5-4. Door lacked sufficient strength to resist the suction load (Deep Creek)

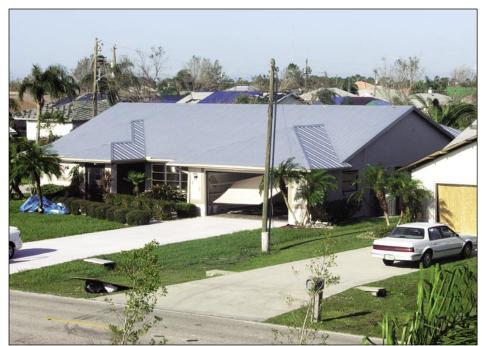
Figure 5-5. Garage door at the home in the center buckled and the rollers pulled out from their tracks; garage door at the home on the right also failed (Deep Creek).

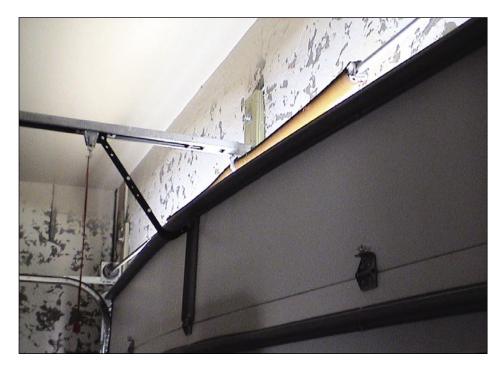
Some garage doors observed were designed with removable stiffener bars. One garage door with this type of design at a post-2001 FBC residence did not have the stiffener bar in place at the time of the hurricane, and it was damaged by wind pressure (Figure 5-6). There were instances where owners had left their homes for the summer season and had neglected to put into place the stiffener posts required to make their garage doors resist winds as they were designed.

Figure 5-6. Garage door failed because the removable stiffener bar was not in place at the time of the hurricane (Punta Gorda Isles).

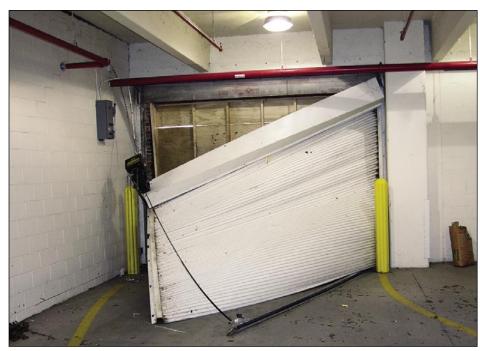
Damage to rolling and sectional doors (e.g., service garage doors and loading dock doors) was observed. Newer doors generally performed well. However, in one instance, a new door failed (the drawings were dated 1997), resulting in the failure of an interior partition wall, as shown in Figures 5-7 and 5-8. The failed door shown in Figure 5-7 was attached with 1³/₄-inch long by ³/₈-inch diameter expansion bolts into concrete that spalled at the bolt locations, likely due to the placement of the bolts too close to the edge. There were no ties between the wall itself and the end wall (Figure 5-8). The drawings indicated continuous angles on each side of the wall, but they were not installed. Another sectional door around the corner and perpendicular to the door shown in Figure 5-7 failed after the door in Figure 5-7 failed. The buildup of internal pressure exerted a positive load on the other door, which was also loaded in suction on its outer surface. One of the

expansion bolts along the right track sheared off, and the concrete spalled at the other bolts. The bolts were typically 2 feet on center, but some were closer.

Figure 5-7. New door that failed. Non-load bearing CMU wall at the left tilted (see Figure 5-8) (Punta Gorda).

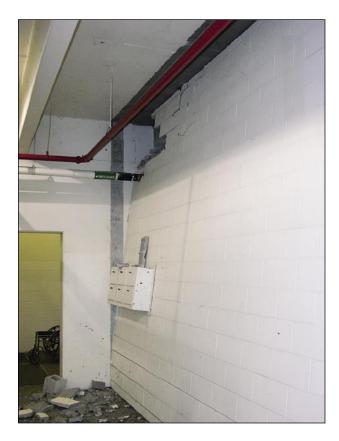
Figure 5-8.

After the door shown in Figure 5-7 failed, buildup of internal pressure tilted the wall (Punta Gorda).

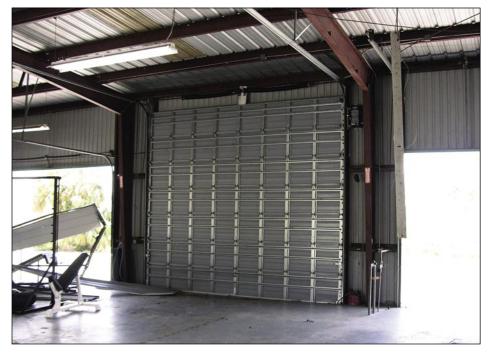
Figure 5-9. Windward side of a fire station; two doors blew inward, but the newer center door remained intact (Punta Gorda).

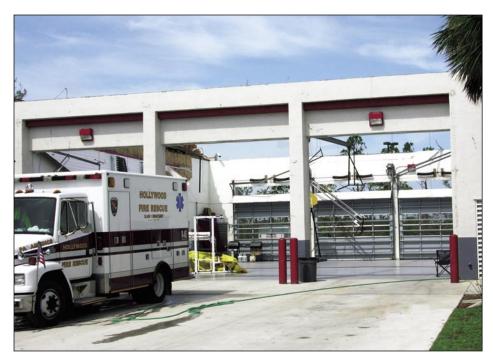
Surprisingly, sectional doors on two newer fire stations also failed. At the Aqui Esta Fire Station (east of Punta Gorda Isles), five of the six doors were not damaged, but the sixth door pulled out of the track. This station was first occupied in 2000. At a fire station in Deep Creek (Figure 5-10), all three windward doors were blown in. The tracks were attached with ¼-inch lag screws at 24 inches on center. The leeward doors were not damaged, but the roof structure blew off the apparatus bay.

Figure 5-10. At two of the windward doors, the doors were pushed out of the tracks; at the third door, one of the tracks was pushed from the wall (Deep Creek).

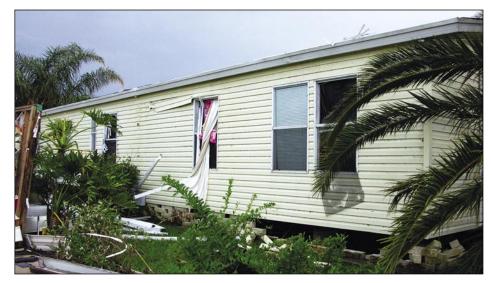
Figure 5-11. Most of the windows on this side of a manufactured home were broken by windborne debris (east of Port Charlotte).

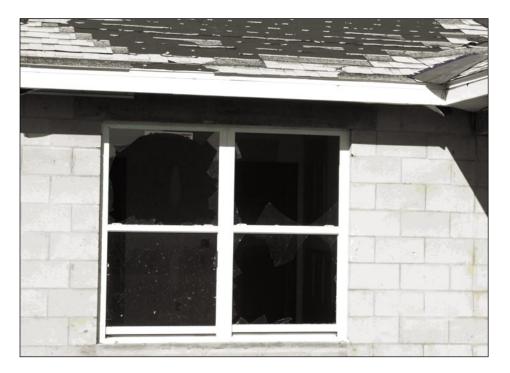
Figure 5-12. Three of four panes broken by windborne debris; other windows in this house also broke (Deep Creek).

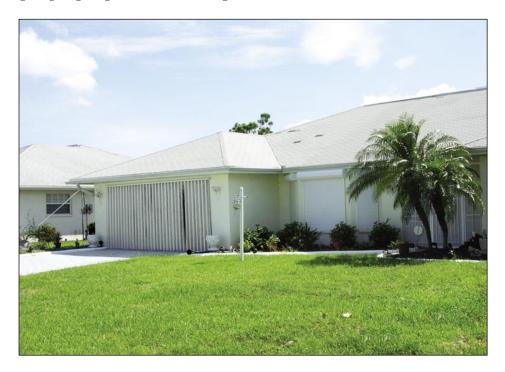
Figure 5-13. This house, which appeared undamaged from windborne debris, had roll-up shutters at the windows and metal panel shutters at the garage (Deep Creek). Figure 5-14 shows a common metal awning shutter. These types of shutters provide very limited protection and should not be considered impact-resistant; they have not been tested to 2001 FBC requirements. A plastic roll-up shutter was observed that had been broken by windborne debris. It is doubtful that this shutter met the impact-resistance requirements specified in the 2001 FBC. In one case, windborne debris (a roof tile) was observed to have penetrated a Miami-Dade approved shutter (shown previously in Figure 3-32).

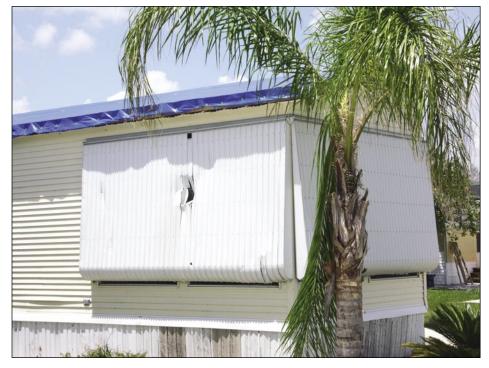
Figure 5-14. Metal awning shutter penetrated by a missile (Zolfo Springs)

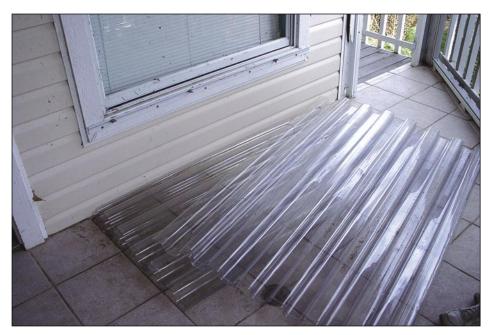
Some of the shutters did not have the strength to withstand the forces of the wind or the impacts of windborne debris. Others may have had sufficient strength, but were improperly installed. Figure 5-15 shows a house that used plastic shutters that blew off.

Figure 5-15. All of the windows on this house were covered by plastic shutters, many of which were blown off during the hurricane, resulting in several broken windows (North Captiva Island).

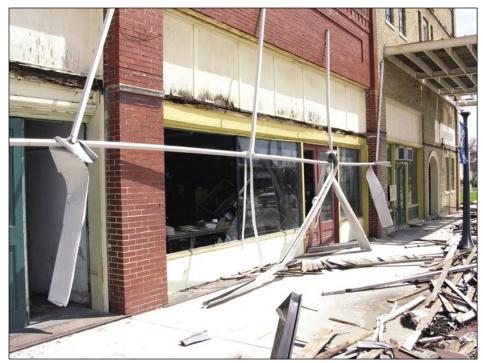
Figure 5-17. Broken glass in windows and doors in this building. Buildings across the street also had several broken windows caused by windborne debris (Wauchula).

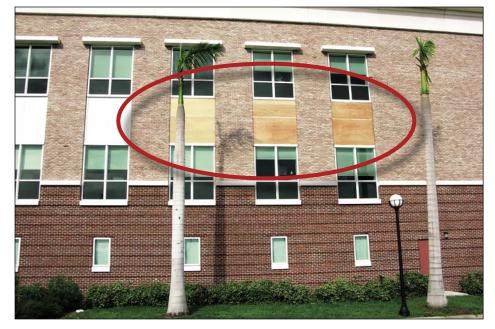
At a Charlotte County government building in Punta Gorda, a few of the windows were broken by windborne debris. Figure 5-20 shows missing spandrel panels; in other locations, the glass was broken. The windows extended from the floor to the ceiling, so tempered glass was used for personnel protection. Had laminated glass been used instead, any damaged glass would likely have stayed in its frame and would have provided wind and water protection. Glass broken by windborne debris was also observed at a hospital in Arcadia (Figures 3-41 and 6-8) and some of the fire stations in Port Charlotte and Punta Gorda.

Figure 5-20. Plywood panels installed where aluminum spandrel panels were blown out of the curtain wall (Punta Gorda)

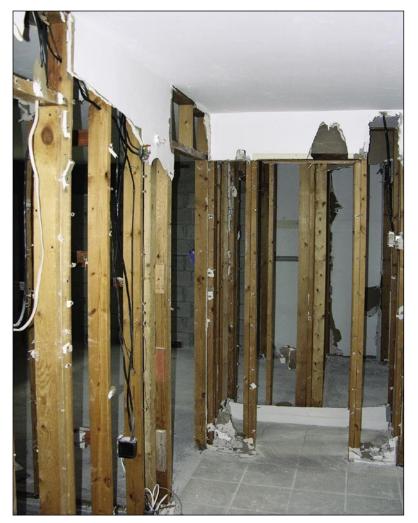
Figure 5-21.

After the attic vent failed, water entered this residence. Wet carpeting and a substantial amount of wet gypsum board had to be removed (Punta Gorda Isles).

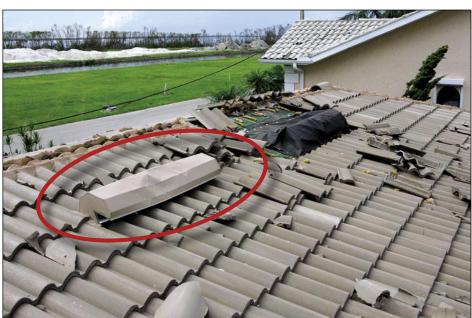
Figure 5-22. The attic vent to the right (temporarily covered with felt) on this foamset tile roof lifted during the hurricane and allowed water to enter the residence shown in Figure 5-21. The failed vent is like the one on the left (Punta Gorda Isles).

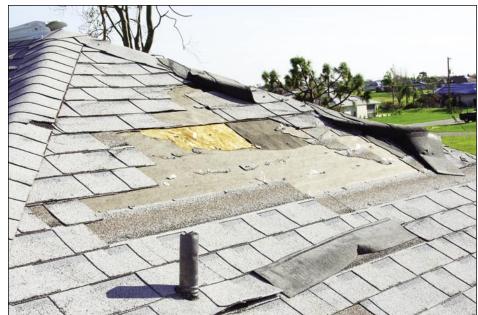
Many shingle roofs in the Port Charlotte and Punta Gorda area were undamaged, while others lost a few hip and/or ridge shingles or a few tabs. Other roofs, including roofs far inland, lost many shingles, as shown in Figures 5-24 and 5-25. The shingles shown in Figure 5-24 were attached with 6 nails per shingle, but the nails were attached about 1½ inches above the nail line. In addition, the shingles were poorly bonded. Though continuous, the self-seal strip was narrow (approximately ½ inch). When shingles were pulled apart during the investigation, many granules from the underlying shingle were pulled up, thus indicating that the granules were not well embedded. The starter course was incorrectly applied, and the nails at the hip shingles were incorrectly located. Note the area where the deck is exposed. Water can flow between the deck and underlayment and leak into the building at the sheathing joints.

Figure 5-24. Asphalt shingle roof installed on a new residence about 2 months before the hurricane hit; shingles were blown off several areas (Deep Creek).

Asphalt shingles. Guidance given in FEMA Hurricane Recovery Advisories No. 1 and No. 2 (Appendix D) is recommended. In addition, installers need to follow manufacturer's installation instructions with respect to starter strips and nail locations. Manufacturers should re-evaluate the attachment of factory-laminated tabs (Figure 5-27). Loss and blow-off of the tabs may be reduced if additional quantities of adhesive, or a stronger adhesive, is used during the production of the shingles.

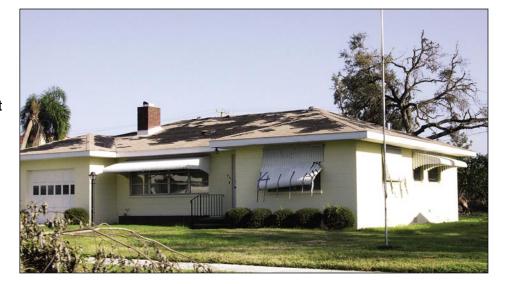
Figure 5-25. Residence with a significant number of asphalt shingles lost. The metal window shutters shown were not designed for windborne debris (Fort Meade).

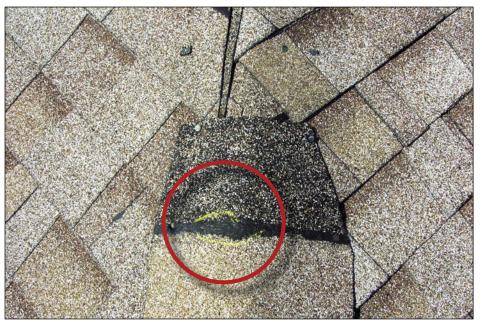
Figure 5-26. Only the portion of the self-seal adhesive that is indicated in yellow had bonded (within the red circle). No bonding occurred on the right side of the hip line (Deep Creek).

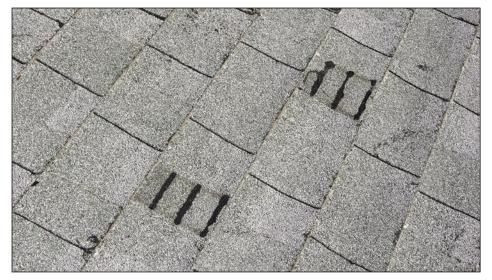
On a few roofs with architectural shingles, instances of blow-off of laminated tabs were observed (Figure 5-27). This type of failure was due to an inadequate amount and/or strength of adhesive used in the manufacturing of the shingles.

Figure 5-27. Two laminated tabs blown off (Deep Creek)

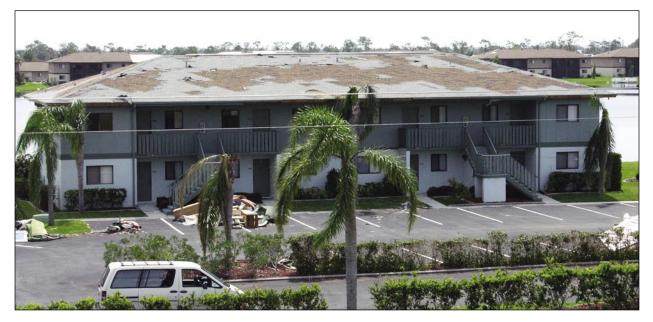
On many residences that had been re-covered (i.e., new shingles had been installed on top of old shingles), large numbers of the re-cover shingles were blown away and the underlying older shingles remained in place. Some of these blow-offs may have been due to use of nails that were too short, although on the building shown in Figure 5-28, the nails had adequate sheathing penetration, but the newer shingles were poorly bonded (likely due to substrate irregularities). When re-covering versus tearing off the old shingles down to the sheathing, more substrate irregularity occurs, which can interfere with bonding of the self-seal adhesive of the new shingles. Most of the re-cover blow-offs were likely due to bonding problems associated with substrate irregularities.

Figure 5-28. Re-covered apartment building (the newer shingles are grey and the older shingles are brown) (Deep Creek).
