Mitigation Assessment Team Report Hurricane Charley in Florida

Observations, Recommendations, and Technical Guidance

FEMA 488 / April 2005

On August 19, 2004, the Federal Emergency Management Agency's (FEMA's) Mitigation Division deployed a Mitigation Assessment Team (MAT) to Florida to assess damages caused by Hurricane Charley. This report presents the MAT's observations, conclusions, and recommendations in response to those field investigations.

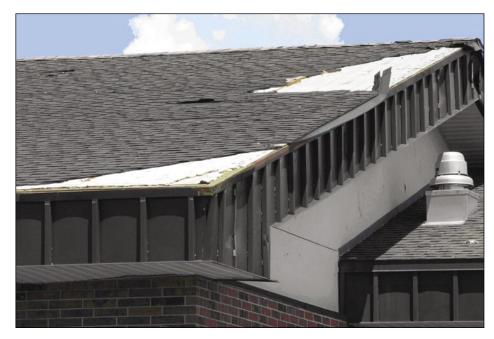
The shingles on the roof of the elementary school shown in Figure 5-29 were installed over underlayment over two layers of gypsum board atop a steel deck. The shingles were attached with a split-shank self-locking nail. At the rakes, the shingles were set in asphalt roof cement

over the metal edge flashing (somewhat similar to the detail shown in FEMA *Hurricane Recovery Advisory No. 2* (Appendix D)). The 4½inch vertical flange of the edge flashing was not cleated. At this rake and another rake, the edge flashing lifted. Because the shingles were well bonded to the flashing, they progressively failed. The shingle end nails at the rake were well inward of the industry's recommended 1inch placement. One of the end nails was 4 inches in from the edge of the shingle. Adhering the shingles to the edge flashing was a good practice, but the end nails should have been much closer to the edge, and the edge flashing should have had a much shorter vertical flange or the flange should have been face-fastened or cleated. Several of the laminated tabs at this school were blown off (similar to Figure 5-27). This type of failure was due to an inadequate amount and/or strength of adhesive used in the manufacturing of the shingles.

Figure 5-29. Edge flashing that caused a progressive failure of the shingles (Deep Creek)

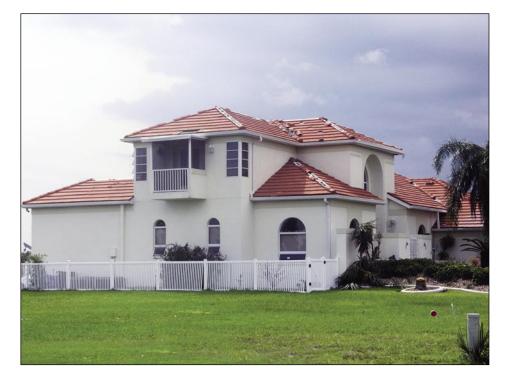
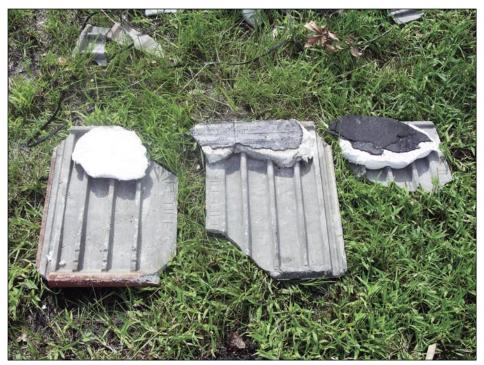
On the roof shown in Figure 5-32, most of the mortar-set hip and ridge tiles blew off. Some of the mortar-set flat tiles were also blown off, and other field tiles were broken by windborne debris (likely other tiles from this roof). Figure 5-33 shows three tiles from the roof shown in Figure 5-32. The mortar paddy on the left debonded from the underlayment. For the other two tiles, the underlayment tore away. The paddies were incorrectly located near the head of the tiles, which offers reduced uplift resistance.

Figure 5-33. Tile debris from the roof shown in Figure 5-32 (Port Charlotte)

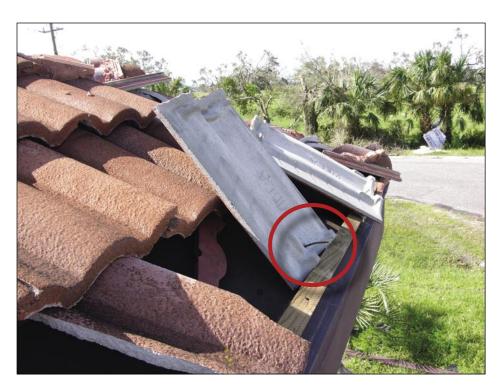
Both direct-to-deck and batten-attached systems were investigated. Figure 5-34 shows a batten-attached system where the roof is attached with nails. According to 2001 FBC (Table 1507.4.7), the attachment method observed on the roof shown in Figure 5-34 is suitable for buildings with a mean roof height up to 40 feet in areas with a design wind speed of 100 mph.¹ The building (which has a mean roof height of less than 15 feet) is located in an area that is now mapped with a wind speed of approximately 110 mph; therefore, the installed attachment at this older residence was inadequate to meet the current code. The estimated speed at this Exposure B location was in the range of 110 to 120 mph. If the speed was in the lower portion of this range, the tiles did not perform as predicted by 2001 FBC (i.e., the tiles should have been good for 100 mph at a roof height up to 40 feet).

Figure 5-34. Each tile on this building was attached to battens with a single 3¹/₈-inch long smooth shank nail (Arcadia)

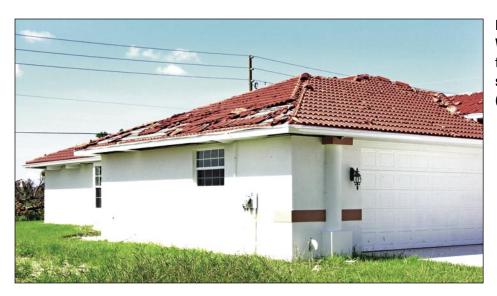
The building shown in Figures 5-35 and 5-36 is located in an area with a basic wind speed of approximately 120 mph. The 2001 FBC, therefore, requires compliance with the calculation method given in Section 1606.3.3. Load and resistance data can be found in the March 1, 2003, Addendum to the 3rd edition of the *Concrete and Clay Tile Installation Manual* (published by the Florida Roofing, Sheet Metal and Air Conditioning Contractors Association [FRSA] and Roof Tile Institute [RTI]). The roof in Figures 5-35 and 5-36 was attached with one 2½-inch long screw per tile directly to the deck. According to Table 12 of the Addendum, the attachment of this roof is suitable for buildings with a mean roof height up to 40 feet in areas with a basic wind speed of 150 mph. The estimated speed at this Exposure B location was in the range of 125 to 140 mph; therefore, the tiles did not perform as predicted by the *Concrete and Clay Tile Installation Manual*.

At a residence near the one shown in Figure 5-35, missiles (likely tiles from its roof) broke a few field tiles. The field tiles were attached with one screw per tile directly to the deck.

Figure 5-35. Windborne debris (likely tiles from this roof) broke several of the field tiles (Deep Creek).

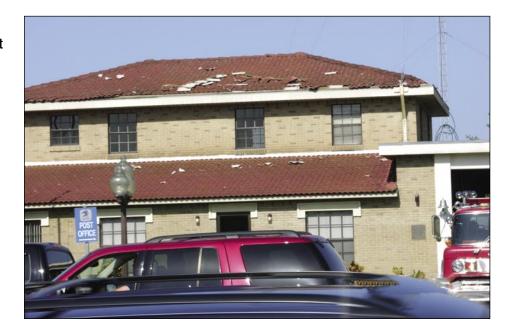
Figure 5-37 shows several areas where batten-attached tiles on a fire station were damaged. The tile debris on the lower roof is from the upper roof. The tiles were installed when the building was re-roofed in the mid- to late-1980s. According to the 2001 FBC (Table 1507.4.7), the attachment method observed on this roof is suitable for buildings with a mean roof height up to 40 feet in areas with a basic wind speed of 100 mph. The building (which has a mean roof height of less than 30 feet) is located in an area that is now mapped with a basic wind speed somewhat less than 110 mph; therefore, the installed attachment at this pre-2001 FBC building does not meet the current code. The estimated speed at this Exposure B location was in the range of 95 to 110 mph. The tiles did not perform as predicted by the code (i.e., the tiles should have been good for 100 mph at a roof height up to 40 feet).

Figure 5-37. Fire station with at least three battens blown off. Some tiles remained attached (Fort Meade).

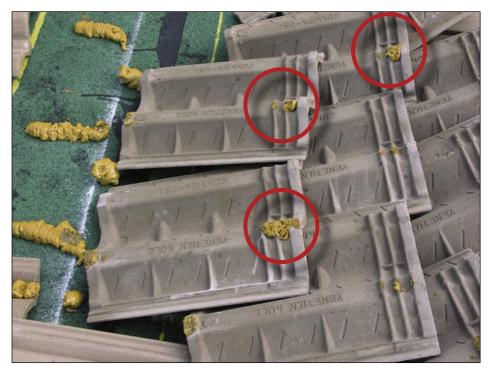
In Figure 5-39, to meet the small paddy placement criteria, the paddy should have been 3 inch by 3 inch minimum, with approximately 8 to 9 square inches of foam contact with the tile near the head. As shown in the photo, clearly there was very insufficient contact area. The paddies were rectangular rather than square; perhaps a medium paddy placement was intended. To meet the medium paddy placement criteria, the paddy should have been 2 inch by 7 inch minimum, with approximately 12 to 14 square inches of foam contact area. The small round paddies shown in Figure 5-39 were placed after the down-slope tiles were set. Foam from these paddies occurred between the tile end laps. These round paddies are not shown in the foam manufacturer's installation instructions. Although failed tiles typically debonded from the paddies, in at least one location, the paddy debonded from the cap sheet underlayment.

Figure 5-39. Note the very small contact area of foam at the tile heads (left side of the tiles) and very small contact area at the tails. The long narrow paddies were intended to be underneath the pan portion of the tile (Punta Gorda Isles).

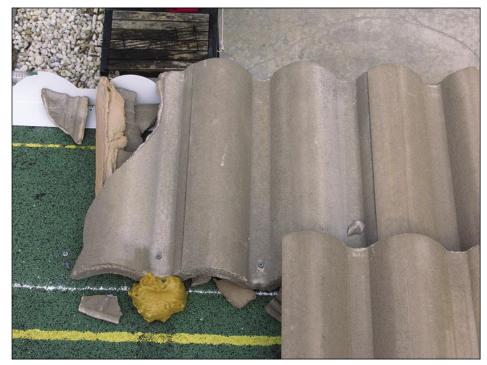
Figure 5-40.

Figure 5-40 is a close-up of the eave area of the roof shown in Figure 5-38. The manufacturer's installation instructions do not require screws, but they do require foam paddies.

View of the eave. The first row of tiles was attached with two screws per tile; foam was not used to adhere this row (Punta Gorda Isles).

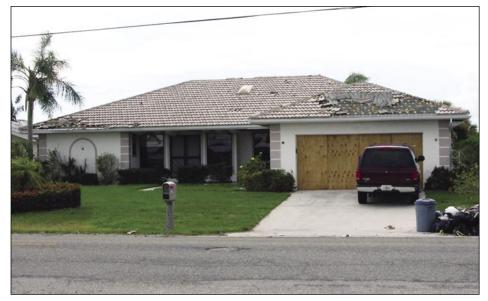
The residence shown in Figures 5-41 and 5-42 was located in an area identified in the code with a basic wind speed of approximately 125 mph. Assuming the intent was to provide a small paddy placement, according to the foam manufacturer's literature, this attachment would have been suitable for a basic wind speed of 135 mph in Exposure B (assuming proper application). The estimated speed at this Exposure B location was in the range of 125 to 140 mph. Therefore, had the foam paddies been properly sized, located, and installed according to the manufacturer's literature, the tiles should not have blown off.

Figure 5-41. In addition to field tile blow-off, most of the hip tiles and several ridge tiles were also blown off this house (Punta Gorda Isles).

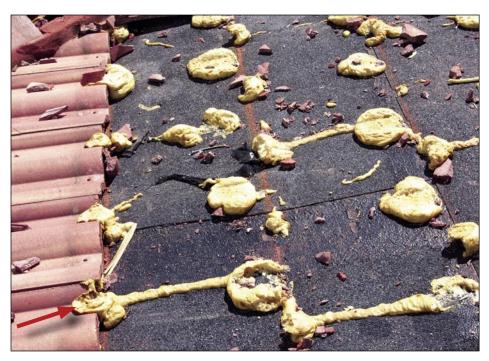
> Several foam-set tiles were blown off a one-story bank (Figures 5-43 through 5-45), primarily due to insufficient contact area of the paddies. To meet the small paddy placement criteria, the paddies should have provided approximately 8 to 9 square inches of foam contact with the tile near the head. The paddies were observed to be about the correct size, but they did not achieve the required contact area. The paddies were also typically located too close to the upslope end of the tile. Though not required, a very small paddy was placed at the tile overlaps (red arrow in Figure 5-43). The tiles typically debonded from the paddies, but the two paddies shown at the bottom of Figure 5-43 debonded from the cap sheet. Many mortar-set hip and ridge tiles were also blown off. The bank was located in an area identified in the code with a basic wind speed of approximately 125 mph. Assuming the intent was to provide a small paddy placement, according to the foam manufacturer's literature, this attachment would have been suitable for a basic wind speed of 135 mph (assuming proper application). The estimated speed at this location was in the range of 125 to 140 mph. Therefore, had the foam paddies been properly sized and located, according to the manufacturer's literature, the tiles should not have blown off.

Figure 5-43. This photo clearly shows insufficient contact area of foam-set paddies on the bank's roof (Punta Gorda Isles).

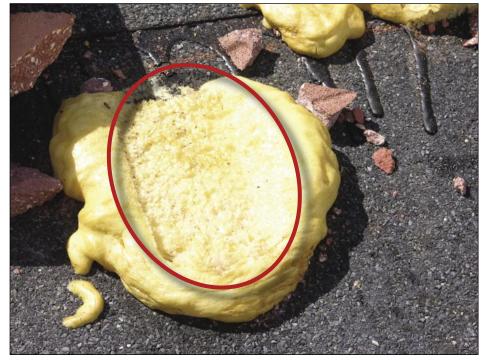
Figure 5-44. In this photo, the portion of the paddy that made contact with the tile is clearly visible (Punta Gorda Isles).

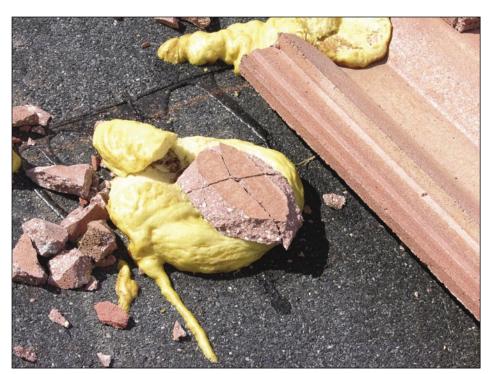
Figure 5-45. Tile remained bonded to the paddy, but, except where bonded, the tile blew away. A large portion of the paddies shown in Figure 5-43 and this figure failed to make tile contact, which was a typical observation (Punta Gorda Isles).

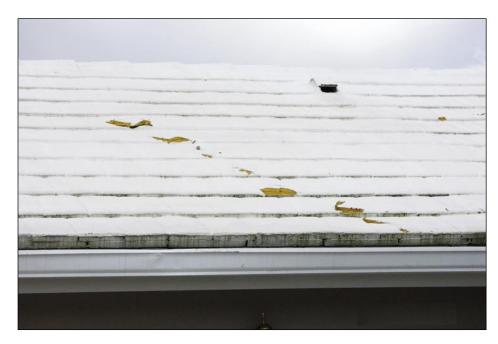
A few tile roofs that had been covered with sprayed polyurethane foam (SPF) were investigated by the MAT. Figure 5-46 shows one of these roofs. A missile had impacted the foam and gouged it in several locations, but no tile debris was blown off. The SPF appeared to provide some protection for the tiles. However, SPF applications may not improve the uplift resistance. Figure 5-47 shows a roof that lost SPF covered tiles. In this instance, the SPF bonded tiles together and, as a result, large sections of tiles were lifted off the roof. Although the larger fragments should not fly as far as smaller fragments, because they are more massive, they could be more damaging (depending upon their velocity) if they were to become windborne.

Figure 5-46. This residence had a tile roof that had been covered with SPF. A missile gouged the foam, but no tile debris was blown off (Punta Gorda Isles).

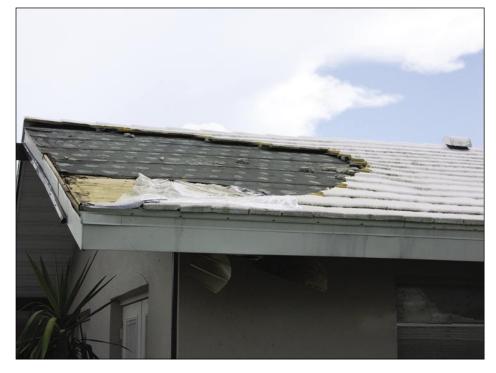
Figure 5-47. The other side of the roof shown in Figure 5-46 with a portion of the underlayment and several tiles blown off (Punta Gorda Isles)

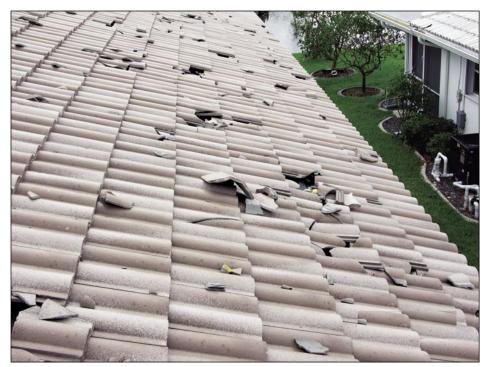
In addition to becoming windborne debris and further damaging the roof on which they were installed, many tile roofs were damaged by other types of windborne debris. One of the advantages of foam-set, according to one of the manufacturer's literature, is that foam-set in-stallation is supposed to result in "high resistance to damage from missile impact," meaning that the "tile may break but remains adhered to the roof." Although this may be true for the portion of the tile that is adhered, the MAT observed that broken portions that are not adhered are vulnerable to being blown away as shown in Figure 5-49.

Figure 5-49. A view of the roof on the back side of the residence shown in Figure 5-41. Tiles (including a hip tile) from the front garage roof landed in this area and broke several field tiles (Deep Creek).

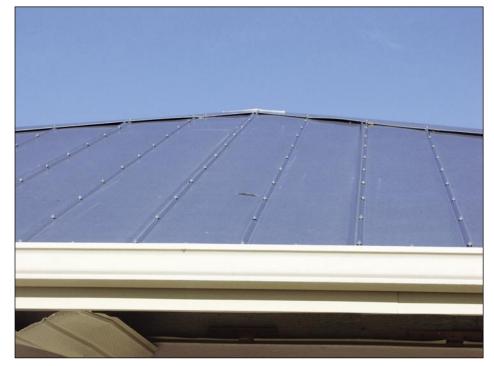
Figure 5-50.

Success or failure of the 5-V Crimp metal roof coverings was likely primarily dependent upon fastener spacing and type, although panel gauge may have had some influence (panels are available in 24 to 29 gauge). Screws provided greater pull-out resistance than ring-shank nails and were more resistant to dynamic loading. One of the failed roofs that were investigated was attached with ring-shank nails. Another key element of good performance is the spacing of fasteners along the eave and at hip and ridge flashings. Only a single fastener occurred at the eave between the rib fasteners shown in Figure 5-50; considering the basic wind speed of 125 mph 3-second peak gust in this location, use of two fasteners between the ribs would have been prudent. Note that the hip flashing is bowed; two fasteners between the ribs would have also been prudent at the flashings. Close spacing at the flashings and eave is important to keep the flashings and panel ends from billowing during high winds. Although the roof in Figure 5-50 did not fail, the flashing and eave fasteners were too far apart.

The number of fasteners was not increased at the corner, perimeter, hip, or ridge areas (close-up of the residence shown in Figure 5-5). Also note that several of the soffit panels were blown away (Deep Creek).

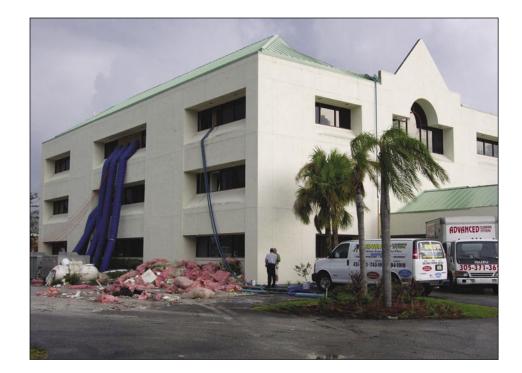
A variety of exposed fastener and architectural and structural metal panels were observed on commercial and critical/essential facilities. Figures 5-52 through 5-54 show a medical office building that lost

approximately 75 percent of the superstructure supporting the architectural metal panel roof that encircled the perimeter of the building. This building experienced significant water damage. Although much of the aggregate roof covering remained in the center portion of the roof, temporary roof covering (Figure 5-53) was installed to minimize water intrusion after the metal panel structure blew away.

Figure 5-52. Medical office building (Port Charlotte).

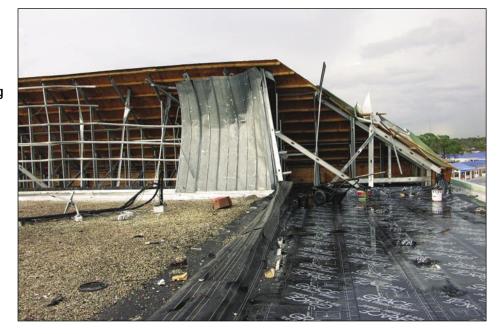
Figure 5-53. The wood and metal framed superstructure blew away and exposed the lightweight insulating concrete roof deck (Port Charlotte).

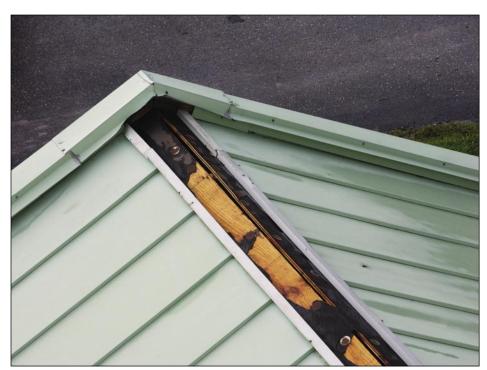
Figure 5-54. View of the canopy ridge at the building shown in Figure 5-52. The ridge flashing fasteners were placed too far apart. A significant amount of water leakage can occur when ridge flashings are blown away (Port Charlotte).

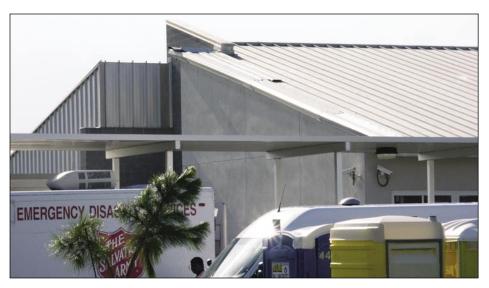
Figure 5-55 shows a roof on a school in Arcadia that performed fairly well; the building was located inland in an area that experienced approximately 110 to 120 mph wind speeds. Temporary repairs to the roof covering had been made prior to this photo taken by the MAT.

Figure 5-55. This standing seam metal roof had a 16-inch rib spacing. There was some rake flashing damage, and a few rake panels were also damaged (Arcadia).

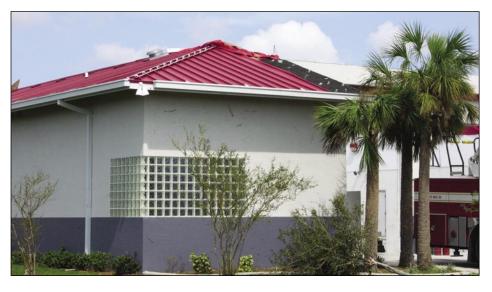
Figures 5-56 and 5-57 show an architectural panel roof on a fire station in the Deep Creek area that performed poorly, with metal panels that were blown off. At this station, the 2-inch high ribs had a 16-inch spacing. The panels had a single-lock fold. There were two screws per clip. Typically the clips remained attached to the deck, but some did not. Clip spacing varied widely across the roof and from panel to panel with spacings ranging from 2 feet 4 inches to 3 feet 3 inches. The eave clips shown in Figure 5-57 should have been located near the edge. It would have been prudent to install double clips along the eave.

At the headwall flashing, the flashing was pop-riveted to the panels at 16 inches on center. Along one side of the hip, the flashing was attached at 2 feet 2 inches; on the other side of hip line, they were at 1 foot 10 inches. The hip and headwall flashing fastener spacing was excessive; for the building code design requirements in Charlotte County, a fastener spacing of 4 to 6 inches on center is typically used, depending on the design wind speed at one site. Some panels on another roof area were damaged by windborne debris (OSB panels), and water entered the building at the penetration location.

Figure 5-56. Several of the architectural panels and hip flashings blew off this fire station (Deep Creek).

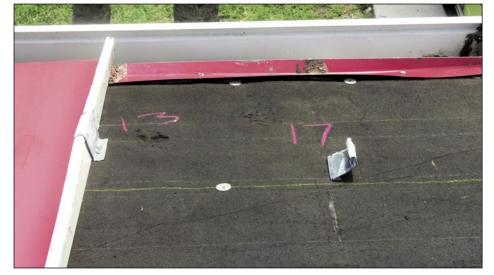
Figure 5-57.

This photo provides a view of the eave of the building shown in Figure 5-56. The clip at the left was 13 inches from the edge of the deck. The other clip was 17 inches from the edge (Deep Creek).

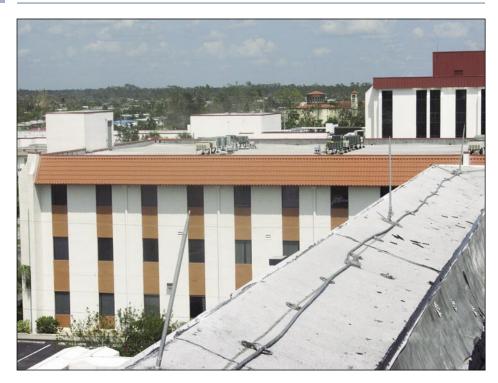
Figure 5-59 shows a mansard with metal shingles simulating tiles. The metal shingles performed well. However, metal shingles can also experience significant damage as discussed in FEMA 489, *Hurricane Ivan in Florida and Alabama*. Note that the rooftop mechanical equipment in Figure 5-59 remained attached to the support stands. Also note the lightning protection system on the parapet in the foreground. One of the conductor connectors detached from the roof and the conductor pulled out of some of the connectors.

Figure 5-59. Metal shingles (simulating tile) that performed well (Port Charlotte)

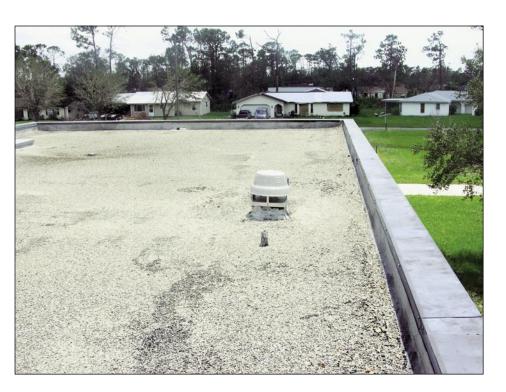
Aggregate commonly used on BUR systems was blown off many buildings. One example is shown in Figure 5-61 where the school was being used as a shelter. There was no other apparent damage to the roofs at the school, including the mechanically attached single-ply membrane on a courtyard building. The boarded-up broken windows at the residence across from the school in Figure 5-61 were likely broken by aggregate from this roof. Roofing aggregate was found at the far side of the street in front of the house. The inner leg of the coping in Figure 5-61 was attached with screws spaced at 3 feet 5 inches, 2 feet 11 inches, and 3 feet 1 inch; the coping was not damaged. Aggregate also blew off a new portion of a hospital in Port Charlotte, but no missile damage was observed. At another roof area of the hospital, a portion of the mineral surface cap sheet roof was blown off. The metal edge flashing had improperly been installed underneath the membrane; therefore, the flashing was unable to clamp the roof edge. Wind lifted the gutter and metal edge flashing and peeled the roof membrane. Figure 5-62 shows an area of the hospital roof that nearly failed. With the flashing in a lifted position, the membrane was very susceptible to peeling. Apparently the winds subsided before this occurred.

Figure 5-61. Although this roof had an 11-inch high parapet, aggregate was blown off (Port Charlotte).

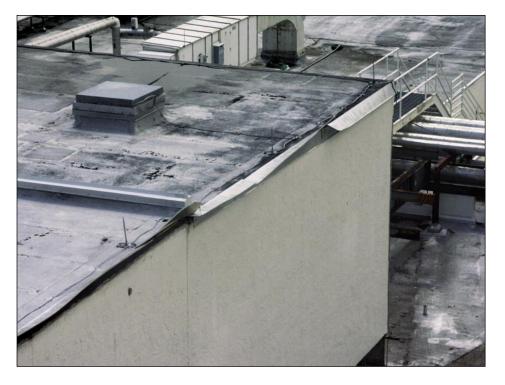
Figure 5-62. The edge flashing at this mineral surface cap sheet roof lifted (Port Charlotte).

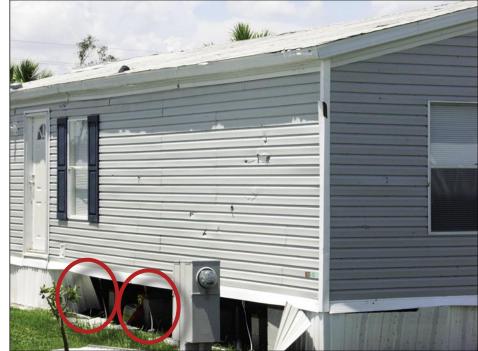
Vinyl siding is quite susceptible to windborne debris damage as shown by Figure 5-66. Because the vinyl siding cannot resist debris impact, resistance to debris impact is provided by the wall sheathing (if any) between the siding and the wall studs. On some of the residences, plastic foam sheathing was used instead of wood sheathing between the vinyl and the studs. The walls of these buildings offered very little resistance to windborne debris penetration, as they were composed only of vinyl siding, underlayment, foam sheathing, fiberglass batt insulation in the wall cavity, and gypsum board on the interior side of the studs. Residents who rode out the hurricane in their homes were quite susceptible to injury from windborne debris penetrating the light exterior walls.

Figure 5-66. The vinyl siding on this manufactured house was ruptured in several locations by windborne debris (most of which were likely building envelope components from other nearby manufactured houses). Note the missing skirt and loose foundation anchor straps (Zolfo Springs).

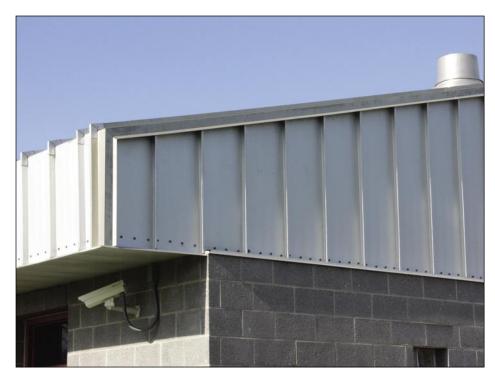
Figure 5-67. Standing seam metal panels with a 16-inch rib spacing were used at the fascia and secured with closely spaced exposed fasteners (Arcadia).

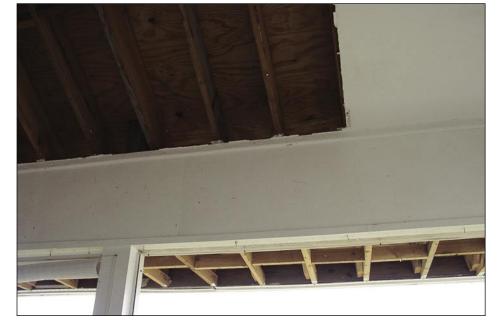
Figure 5-69. An exterior eave with soffit failure, which resulted in water intrusion (North Captiva Island)

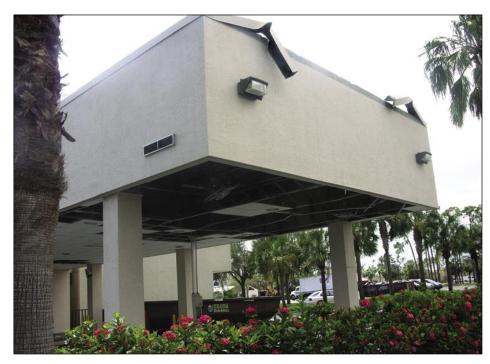
Figure 5-70. Loss of soffit at a bank drive-through. Note the coping damage (Port Charlotte).

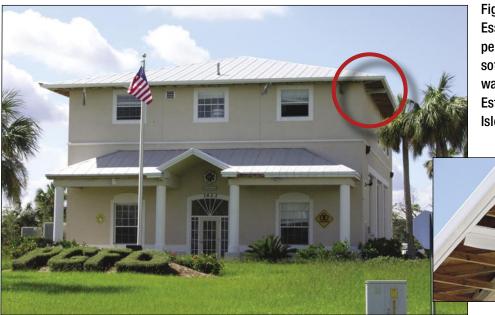
Figure 5-70 shows a damaged soffit at a bank drive-through canopy. Figure 5-71 shows damaged soffits at the Aqui Esta Fire Station. Most of the gutters and downspouts at the fire station blew away, but the 5V-Crimp metal roof had only minor damage at a hip flashing lap. The soffit panels were connected to the building only at their ends. A substantial quantity of wind-driven rain blew into the attic space and caused ceiling boards to collapse. Because of the water infiltration, this station was taken off-line after the storm.

Figure 5-71. Essentially all of the perforated aluminum soffit on this fire station was blown away (Aqui Esta, east of Punta Gorda Isles).

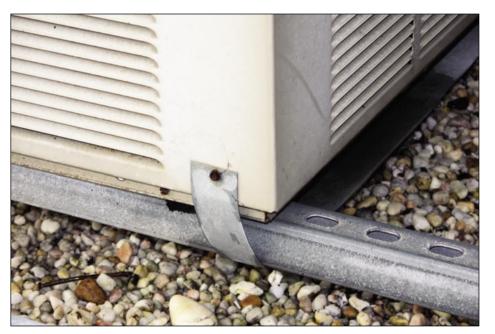
Condenser problems like those discussed in Section 5.5.1 were also observed at commercial and critical/essential facilities (Figures 5-74 and 5-75). A complete lack of anchor systems or inadequate or deteriorating fasteners resulted in the loss of many compressors. Installation methods observed were not standardized. In Figure 5-75, although the condenser did not move off its rail, it would have been prudent to use two side-by-side screws, with more edge distance between the screw and strap end.

Figure 5-75. Rooftop condenser anchored to a support rail, but with only one small screw (which was corroded) used to connect the strap (Port Charlotte).

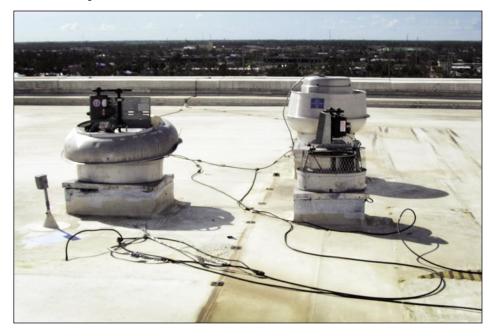
Figure 5-76 shows the loss of fan cowlings on a roof. Two of the three cowlings had blown off. At one curb, which was 2 feet 4 inches square, the fan unit was attached to the curb with two small screws at two sides and three small screws on the other two sides (total of 10 screws). Attachment was not checked at other fans. No fans were blown off this building. This success was likely the result of using multiple screws to secure the fasteners (unlike many other buildings, where often only two screws per fan were used).

Figure 5-76. Cowlings blown off two exhaust fans in the foreground. Note also the loose LPS conductors and missing walkway pad (Punta Gorda). Loss of HVAC units was also observed as shown in Figure 5-77. A number of these large units were blown off their supports. Additional damage to equipment included loss of access panels on package units, debris impact damage to relief air hoods, and damaged rooftop ductwork. Figure 5-78 shows a unit that was marginally anchored.

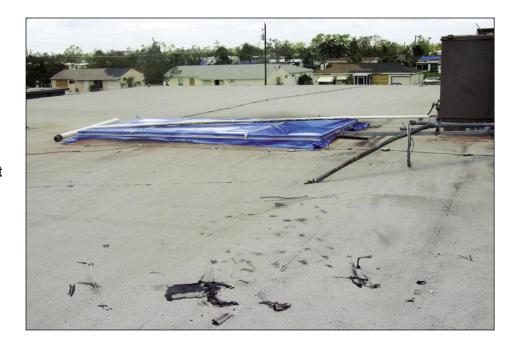
Figure 5-77. A large HVAC unit blew off this curb. Note the loose LPS conductors (this side of the curb). This school had significant damage to several pieces of rooftop equipment (Port Charlotte).

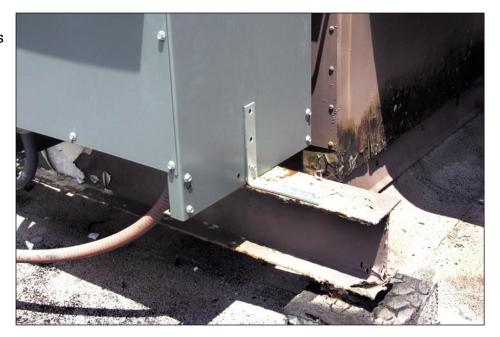
Figure 5-78. A thick angle bracket was used to anchor this unit. Although two screws attached the angle to the support beam, only one screw was used at the unit (Port Charlotte).

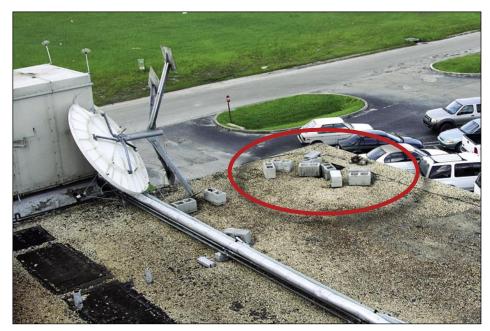
Figure 5-79. This satellite dish at a hospital was held down only with CMU. Note the loose LPS conductors and displaced air terminal at the corner (Arcadia).

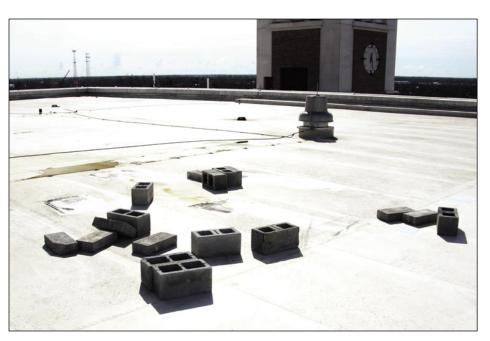
Figure 5-80. A satellite dish previously sat in this location. It was held down only with CMU and blew off the five-story building (Punta Gorda).

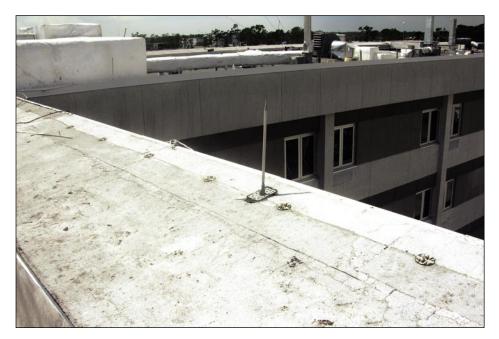
Figure 5-81.

The LPS conductor on this hospital blew away, but the air terminal was still attached. A lightning strike to this air terminal would not be safely dissipated (Port Charlotte).

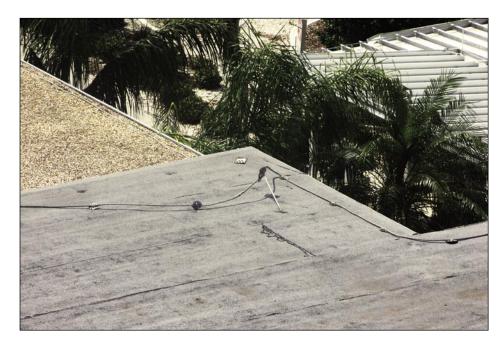
LPS failures were typically the result of poorly anchored systems. Connectors often fail by opening up and releasing the conductor cable or they debond from the roof (Figure 5-82). In other cases, the air terminal base plates debond from the roof (Figure 5-83). In Figure 5-84, a prong-type conductor splice connector (approved for roof heights up to 75 feet) failed. Bolted-type connectors are prudent in hurricane-prone regions because they are less likely to pull apart and cause damage to the roof (Figure 5-85).

Figure 5-82. The LPS conductor pulled away from the conductor connector at the top of the photo. The conductor was also attached to the membrane with poorly welded strips of PVC (Port Charlotte).

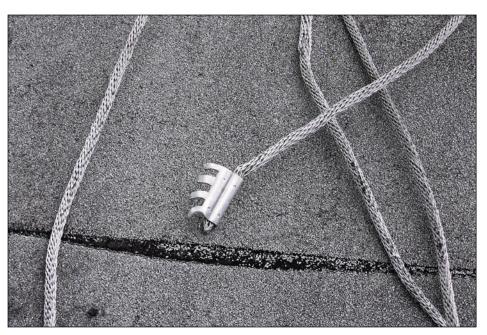
Figure 5-83. The conductor connectors detached from the cap sheet on a hospital's BUR. The air terminal was also displaced (Port Charlotte).

Figure 5-84. A failed prong-type splice connector with prongs permitted for roof heights up to 75 feet caused roof damage at this facility (Cape Coral).

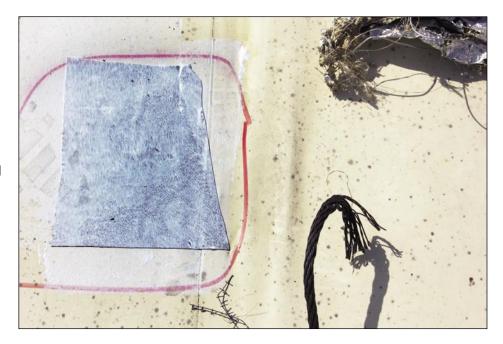
Figure 5-85.

When LPS conductors detach, the conductor ends can whip around and puncture and tear the roof membrane. The patch near this frayed conductor is likely a repair of damage caused by a whipped conductor (Punta Gorda).

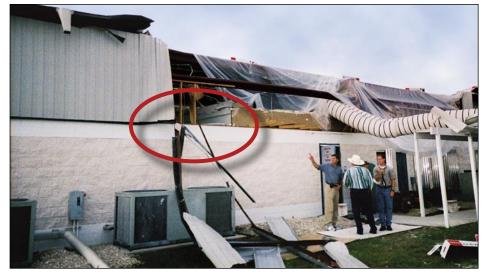
Most of the damage that was observed at the Charlotte County EOC (Figure 6-1) was to the building's envelope (i.e., the roof and wall coverings). Examples of this damage can be seen in Figures 6-1 and 6-2, which illustrate typical roof panel loss and wall panel loss, respectively. Roof damage appeared to center around the failure of the clips that either released from the purlins (Figure 6-2) or from a failure of the clip/panel connection. Additional roof failures were observed at the overhangs located at the rear of the facility at the two large rolling and sectional doors. Figure 6-3 shows the overhang on the southwest building corner.

Figure 6-1. Exterior wall and roof damage at Charlotte County EOC

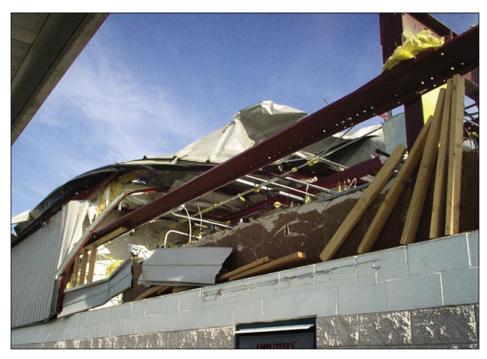
Figure 6-2. Failure of wood stud wall supporting wall panels above masonry wall (Charlotte County EOC)

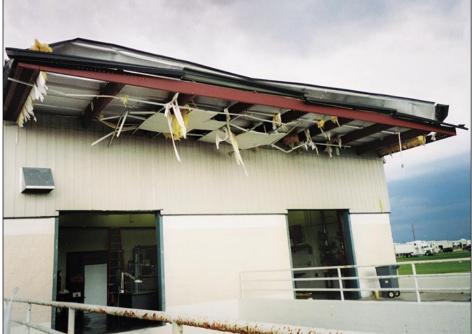
Wind induced wall damage was limited to the upper portions of the exterior walls constructed of metal panels attached to the steel frame and to wood studs acting as purlins between the frame and the top of the masonry walls. Failures observed varied from clip and connection failures, similar to those observed with the roof panels, to complete failures of stud-supported sections (Figure 6-3).

Figure 6-3. Failure of roof and soffit panels at rear awning (Charlotte County EOC)

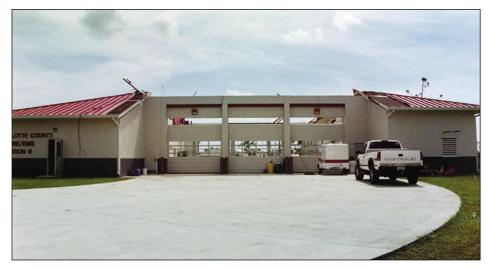
Figure 6-4. Overview of west side of Port Charlotte Fire Station No. 12

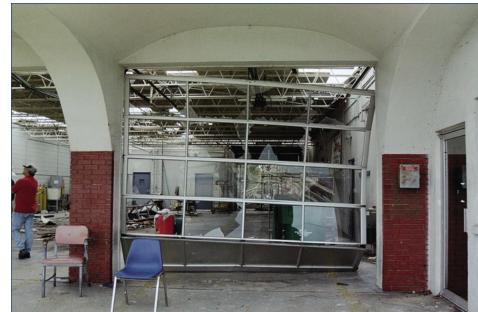
Figure 6-5. View of damaged garage door and interior of Port Charlotte Fire Station No. 1; note missing roof deck panels over apparatus bay.

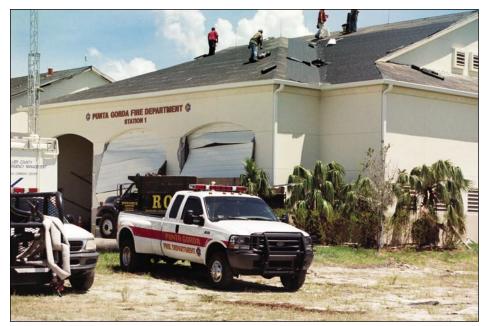
Figure 6-6.

Overview of Punta Gorda Fire Station No. 1. The tile roof had been removed and a new roof was being installed. Note the damaged doors.

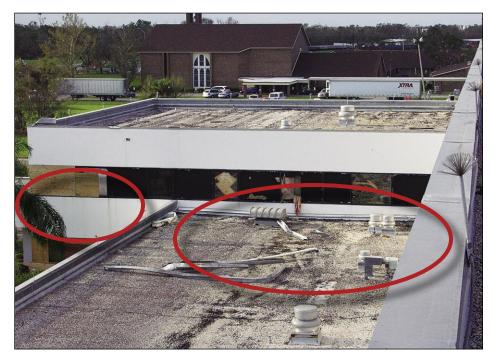
At a hospital in Arcadia, several windows at the intensive care area were broken by windborne debris (Figure 6-8). Most, if not all, of the windborne debris was aggregate from the hospital's roofs. Three of the eight intensive care rooms were taken out of service due to the glass breakage and windows were broken in other patient rooms. Gutters and walkway pads were also blown off (Figure 5-60). The gutters and pads possessed sufficient mass to be very damaging missiles and may have caused some of the glass breakage observed.

The gutters lying on the lower roof in Figure 6-8 came from the right side of the upper roof and may have caused some of the glass breakage. However, the majority of the damage was broken by flying aggregate from the hospital's BURs.

Figure 6-8. Aggregate damaged the windows to ICU rooms at a hospital (Arcadia)

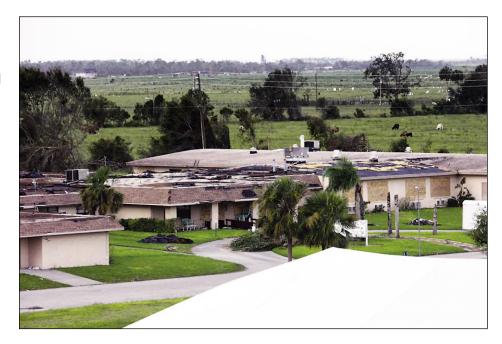
Figure 6-9. Roof covering damage resulting in water intrusion, which required evacuation of a skilled nursing facility (Arcadia)

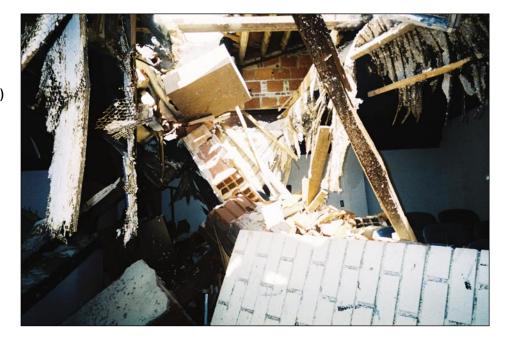
Damages to structural walls of schools evaluated by the MAT were limited to a few older buildings with walls or parapets constructed of URM or hollow clay tile. At one high school, the collapse of hollow clay tile walls and URM parapets caused extensive damage (Figures 6-10 and 6-11). Most exterior wall surfaces observed at school buildings did not suffer significant damage.

Figure 6-10. Hollow clay tile wall/ parapet damage to roof of a high school auditorium (Punta Gorda)

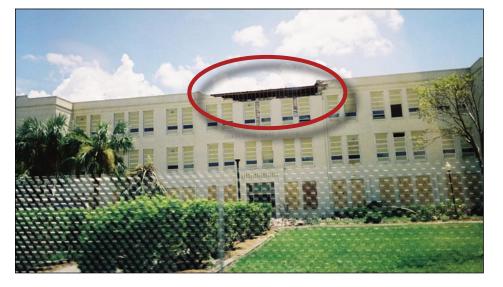
Figure 6-11. URM parapet damage to front façade of a high school (Punta Gorda)

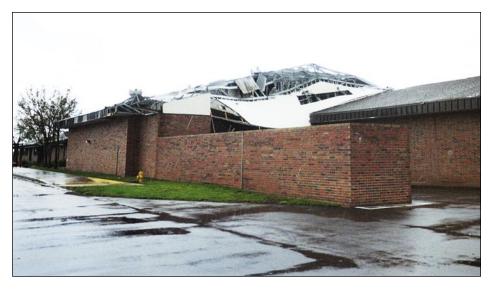
Damages to roof framing systems at schools occurred at large, gable end roofs with light-metal trusses where the gable end was pushed into the building due to inadequate lateral bracing and collapsed (Figure 6-12). A few plywood and OSB roof sheathing damages were also encountered along the edges and at the corners of older school buildings. Roof coverings and soffits were the most commonly damaged elements of school buildings evaluated by the MAT. Typical roof covering damages included loss of roof membrane systems due to inadequate connection to the roof deck, loss of edge flashing or coping,

Figure 6-12. Collapsed gable end wall at an elementary school (Deep Creek)

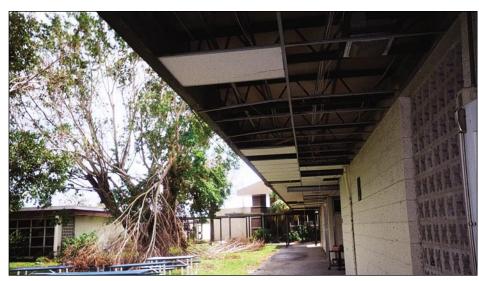
or tearing of the membrane from debris impact. Metal roof coverings were lost or damaged due to inadequate connections or a loss of the edge flashing. Thin metal panel soffits and lightweight composite panel overhangs (which functioned as soffits) were often lost due to inadequate connections or excessive deflections caused by wind pressures along the edges and corners of the building (Figure 6-13).

Figure 6-13. Loss of lightweight composite panel overhang at an elementary school (Charlotte Harbor)

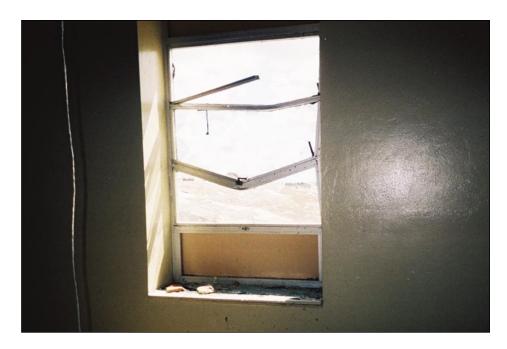
A few single and double metal entry doors in school buildings evaluated by the MAT were damaged due to inadequate locks or door frames that were not properly connected to the walls, which caused the doors to blow open or out during the storm. Some metal-framed windows constructed with annealed glass panes were broken due to debris impact and/or bending of the frames that supported the panels (Figure 6-14).

Figure 6-14. Broken window damage at a high school (Punta Gorda)

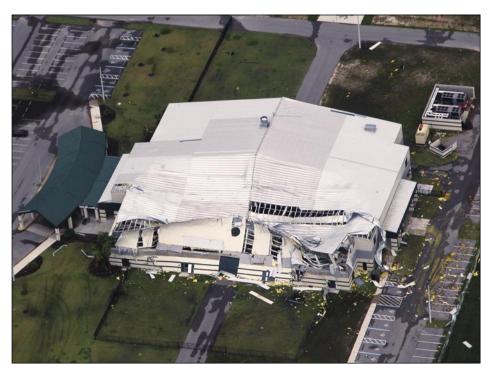
Figure 6-17. Aerial view of Turner Agri-Civic Center damage caused by Hurricane Charley (Arcadia)

This building experienced damage to the cladding systems (evident at numerous places where panels were missing) and in the structural frame, which partially collapsed at one end of the facility. The MAT's inspection of the damage noted that, for the roof, the failure of the plane of the roof system was typically a separation of the two-piece clip that connected the panels to the purlins. A few clips were observed that were still intact, with clip screws pulled from the purlins. In addition, metal panels were observed to be missing from the soffit at the entry canopy. The on-site representative meeting with the MAT reported that the roof panels were lifting off the frame prior to the collapse of the end wall.

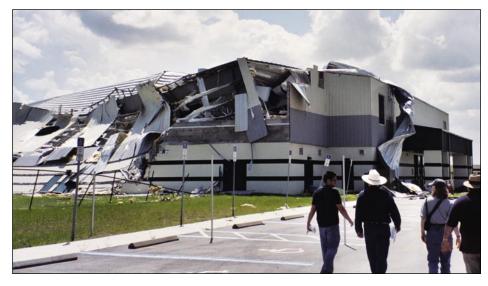
Based on the limited observations of the MAT at the site, the building is pre-engineered metal with a structural steel frame with reinforced masonry infill walls. The upper portion of the exterior walls and the roof are composed of structural standing seam trapezoidal panels (3-inch high ribs at 24 inches on center), over fiberglass batts over a plastic vapor retarder over light-gauge purlins. Steel frames support the purlins, creating the large, open area of the building. Maximum roof spans are approximately 200 feet. Exterior walls were reinforced masonry that extended from the foundation to a series of bond beams connected to the structural steel framing. At the end walls, intermediate steel framing extended from the top of the bond beam, up the gable end walls to steel frame elements at the top of the end wall. Figure 6-18 shows the building after it experienced a partial collapse during Hurricane Charley.

Figure 6-18. End wall failure at Turner Agri-Civic Center (Arcadia)

Structurally, purlin spacing was observed to be the same at the perimeter, corners, and field of the roof. The roof structure was braced with rod x-braces. No roof bracing was observed at gable end walls or in the direction of the long, steel frames. Reinforced masonry walls at one end wall failed. The MAT observed reinforcing in the masonry end wall that failed, but insufficient information was available to determine if the construction was compliant with the applicable building code.

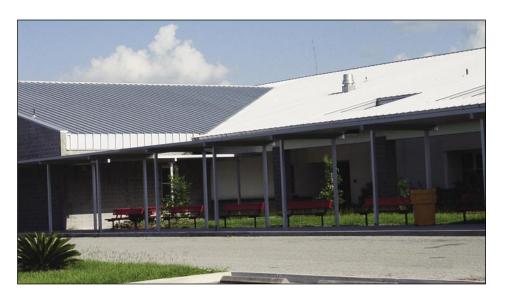
Figure 6-19. Middle school with minimal roof covering damage (Arcadia)

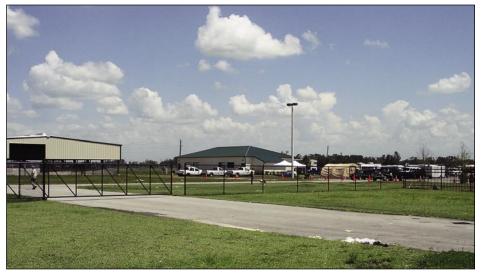
Figure 6-20. Pre-engineered metal buildings with minimal damage located near the Turner Agri-Civic Center (Arcadia)

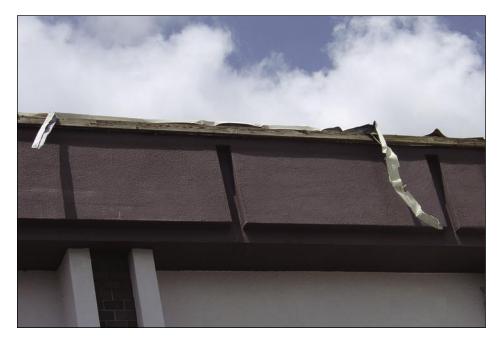
During the MAT assessment, no structural damage was observed and minimal damage was observed on the designated shelter areas of the facility. However, roof covering and exterior wall, trim, and coping damage was observed at the school (Figure 6-22). Damage to mechanically attached single-ply membrane roof coverings occurred on the gymnasium roof and one of two lower roof areas adjacent to the gymnasium (see Section 5.3 for further discussion). It is important to note that the gymnasium was not identified as usable shelter space and was not being used for shelter during the height of the storm.

Figure 6-22. Edge flashing failure at Port Charlotte Middle School

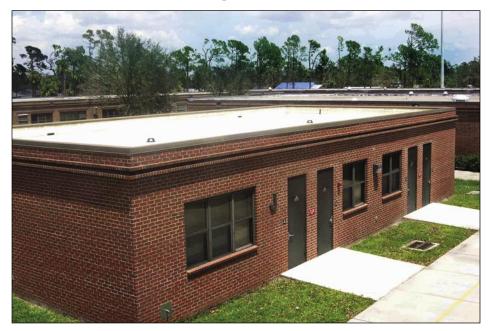
Figure 6-23. Exterior view of Liberty Elementary (Port Charlotte)

During the MAT assessment, no structural damage was observed and minimal damage was observed on the designated shelter areas of the facility. There was no apparent structural damage to the shelter area and structural damage appeared to be limited to a failed canopy at a side entrance of the school. During the storm, electrical power to the school was lost. The school is not equipped with an emergency generator, so the day after the storm, the shelter staff and occupants were moved to another school that had power.

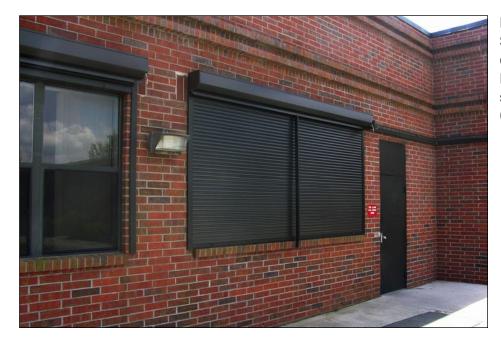
Some areas of the school have been retrofitted with shutters to protect windows from windborne debris. The shutters are roll-down, permanently installed systems that protect the windows during hurricanes. Although these shutters were not in place throughout the facility, they were placed on areas of the school that were identified for use as shelters. Figure 6-24 shows an example of a shutter system at the shelter area.

Figure 6-24. Shutters installed at openings at Liberty Elementary School shelter area (Port Charlotte)

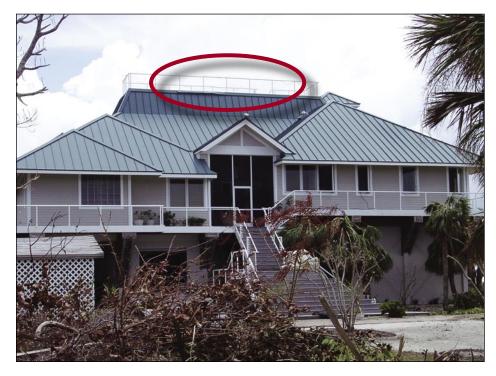
Figure 7-1. Residence constructed to the design requirements of the 2001 FBC performed well and only experienced some light trim damage (shown in the center of the photo) (North Captiva Island).

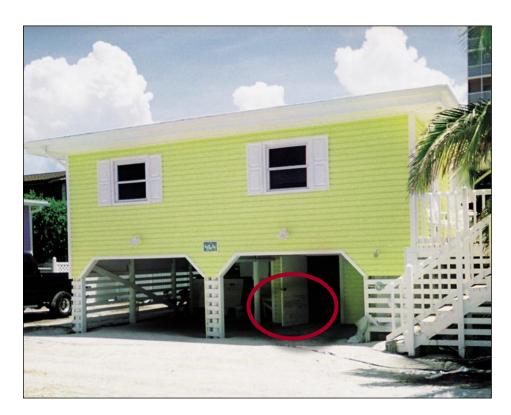
Figure 7-2. Older residence atop pile foundation that allowed floodwaters to pass safely underneath, resulting in only minor damage to enclosures and access stairways (Fort Myers Beach)

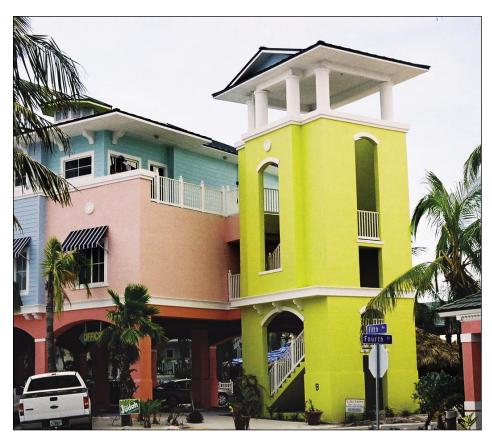
When Hurricane Charley hit Fort Myers Beach, the Lighthouse Resort Inn and Suites shown in Figure 7-3 remained dry, undamaged, and full of customers, while other hotels and motels on the island were damaged or flooded, and closed. In the past, the Lighthouse Resort would also have been closed. Over the last two decades, seven hurricanes have caused flood and wind-related damage to the resort, resulting in nearly \$100,000 in repair costs per event. The resort, which sits 200 feet from the beach, had been elevated as part of a joint State of Florida, Federal, and local mitigation project. In approximately 1 year, the owners have saved nearly \$200,000 in repair costs alone, almost 50 percent of their mitigation investment.

Figure 7-3. Exterior view of the elevated Lighthouse Resort Inn and Suites, which remained dry and undamaged after Hurricane Charley (Fort Myers Beach)

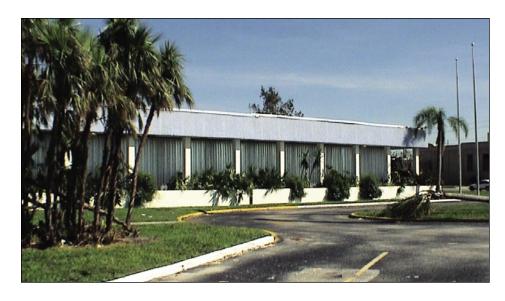
"If it wasn't for the shutters," said George Dahlke, Charlotte County Facilities Construction and Maintenance Project Manager, "all the glass in the building would have been gone. Without the windows, we feel that the uplift [of the wind] would have taken the roof off." (Figure 7-4)

Figure 7-4. Exterior view of the galvanized shutters that protected the Charlotte County South Annex (Punta Gorda)

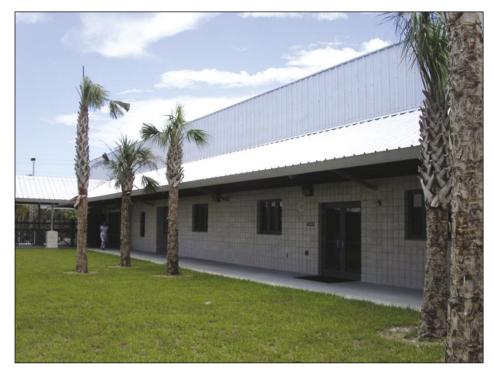
Damage at the school was limited to loss of gutters on the east side of the building and some wind-driven rain issues. At the time of the MAT visit, the school was preparing for an on-time school opening and did not experience a loss of function as a result of the hurricane. In addition to avoiding significant damage to the school building itself, the successful performance of the design allowed residents of Sanibel Island to move forward with their rebuilding process because the school was functioning.

Figure 7-5. Courtyard of the newly constructed Sanibel School that was operational immediately after Hurricane Charley passed
