# Collapse of Building Under Construction

**Professional Development Hours (PDH) or  
Continuing Education Hours (CE)  
Online PDH or CE course**

On September 10, 2012 at approximately 9:20 a.m., a portion of the building under construction at Carlton Ave., Brooklyn, NY 11205, collapsed killing one employee, and seriously injuring another. The building under construction consisted of five townhouses, each four stories high, known as Carlton Row Townhouses. The construction of the building was near final completion. The structure essentially consisted of load-bearing masonry walls with cold-formed steel C-joists at each floor.

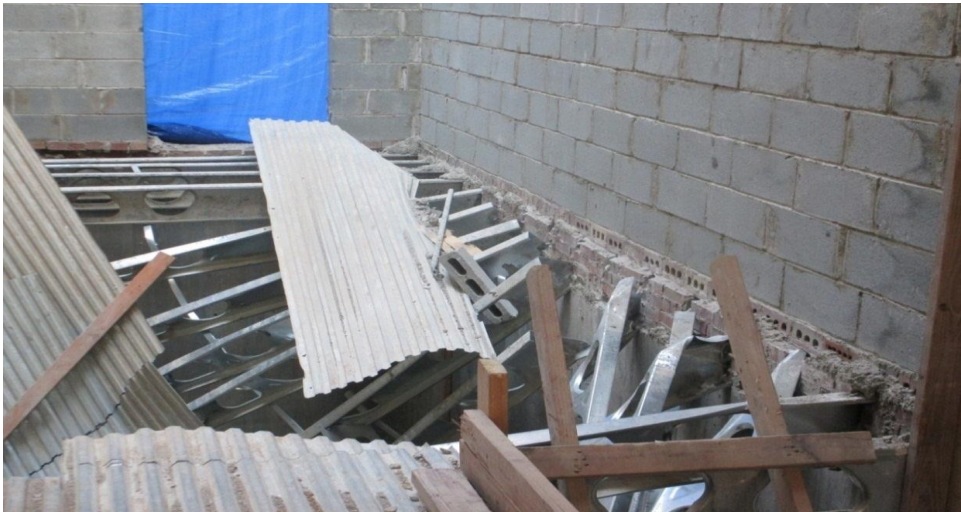
Eyewitnesses reported that soon after the last jumbo bags of sand was placed on the deck near the front of the building, the front 20 feet of the floor collapsed over the third floor which started

a chain of failures of the floors below, and finally the front 20 feet of all the floors were pancaked into the basement, also known as the cellar, see Fig 1 & 2.
