Excavation Collapse

**Professional Development Hours (PDH) or
Continuing Education Hours (CE)
Online PDH or CE course**

1. SUMMARY

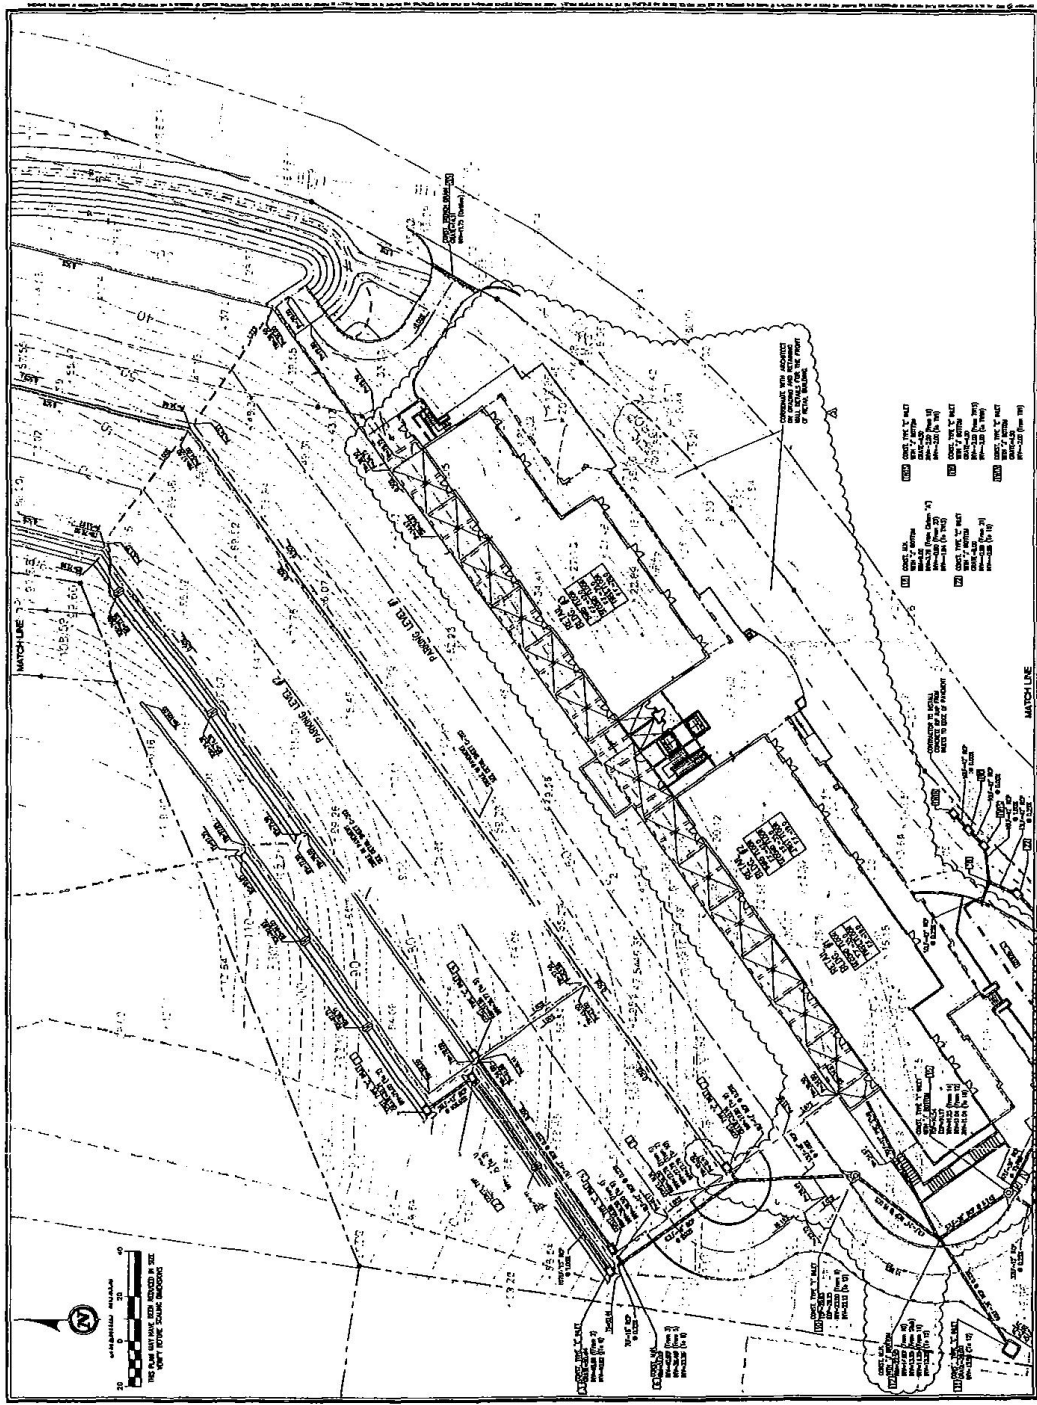
Figure 1. Project Site Grading and Drainage Plan I

The project under construction was a 40,000 square foot retail and office complex with two levels of parking. It is named East End Plaza, located at the east end of St. Thomas, U.S. Virgin Islands (USVI). The two parking levels and the plaza of the project were being constructed in steps along the slope of a mountain near its toe as shown in Figures 1 and 2.

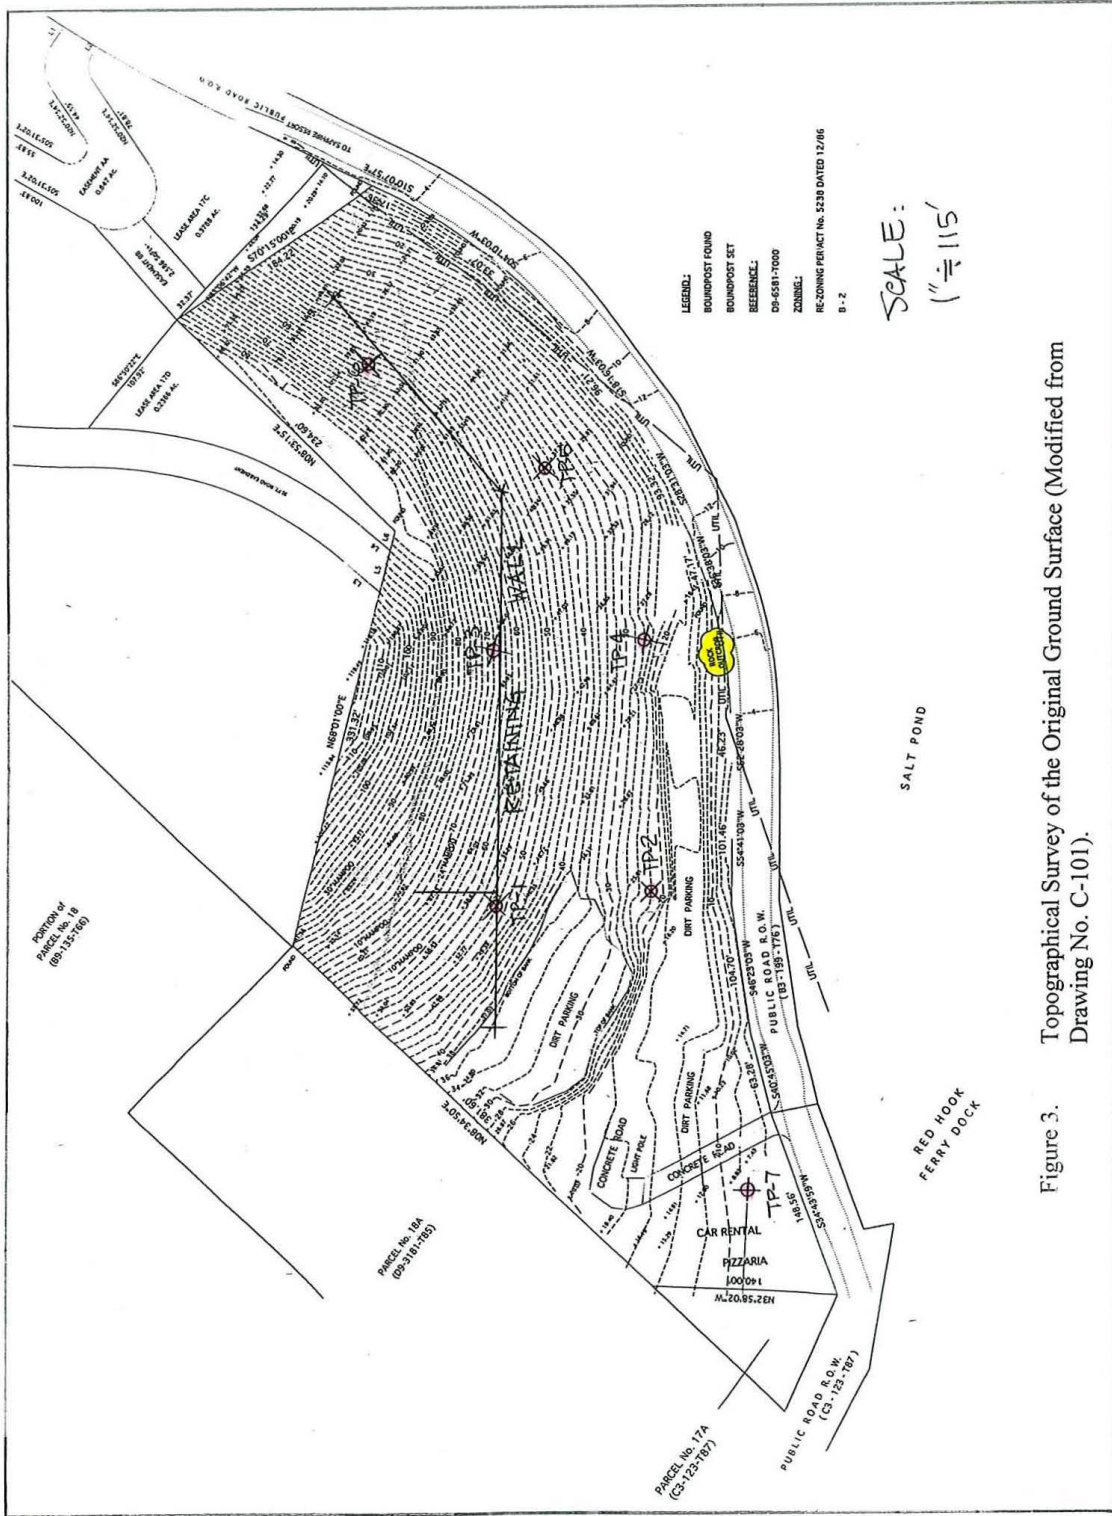
Figure 3. Topographical Survey of the Original Ground Surface (Modified from Drawing No. C-101).

Based on the soil maps, the project site is within the SrF soil unit. SrF stands for Southgate-Rock, located on the side slope of a volcanic mountain. The outcrop complex has a 40 to 60 percent slope and a 40 percent rock outcrop area. However, based on Figure 3, the slope of the original ground surface at the project site is estimated to be 40 to 45 percent and the rock outcrop is estimated to be less than 1 percent. Thus, the depth of weathering at the project site is much deeper than the soil map indicates.

Based on the original topography of the site before the excavation (Figure 3) and the corresponding configuration after the collapse (Figure 4), six cross sections around the collapsed area were developed. The location of the sections is shown in Figure 4. The first two sections (Figures 7 and 8) were to the north of the collapsed area. From these two figures, the following information was identified:

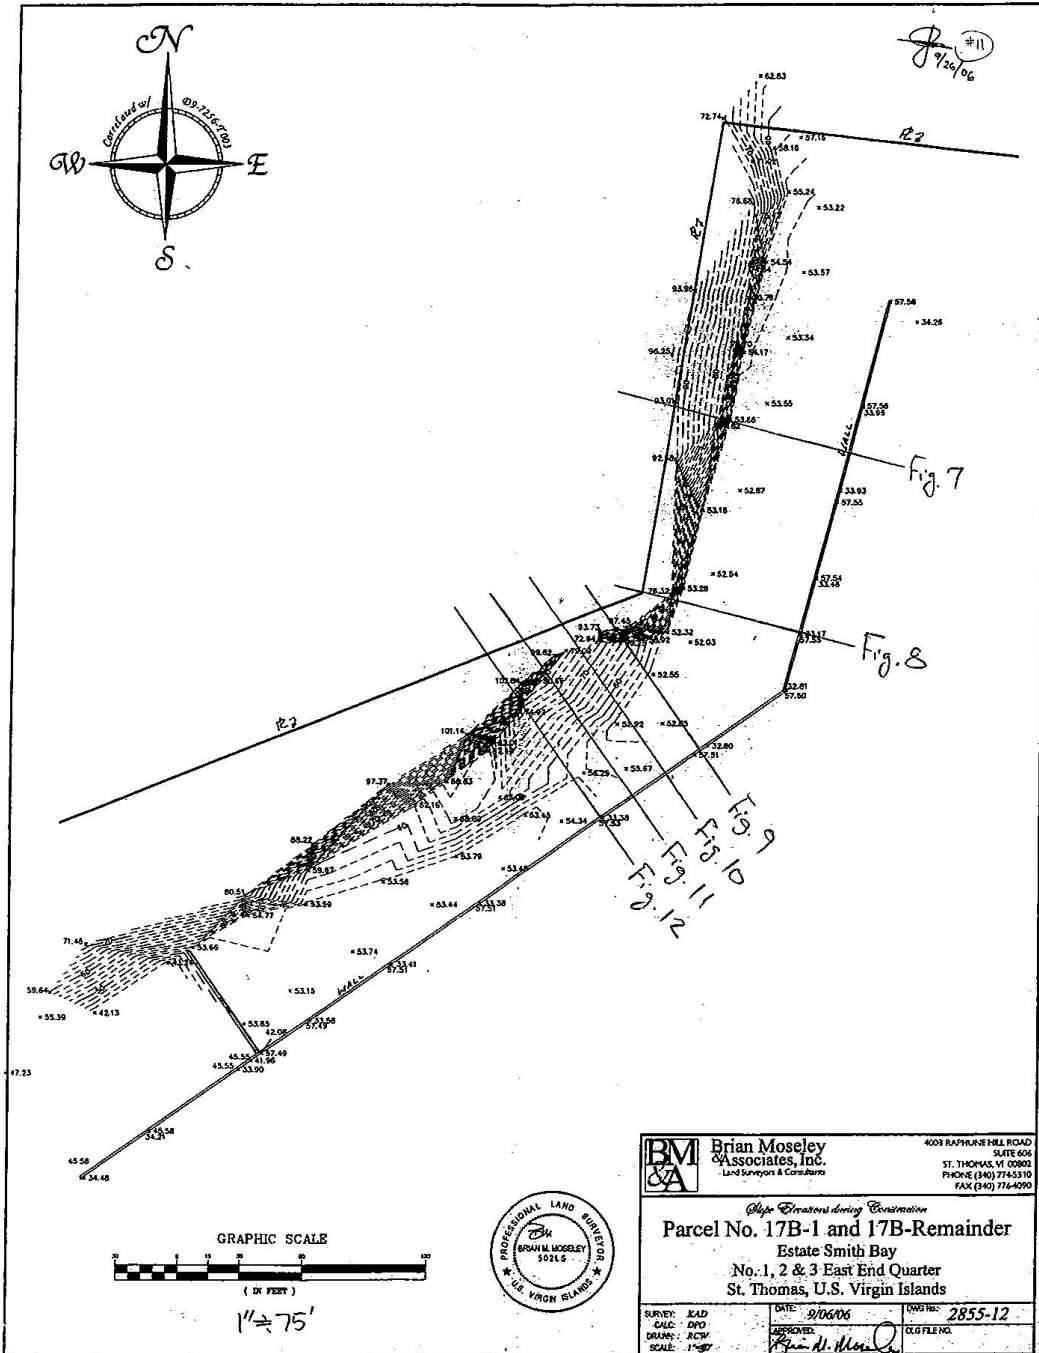
Figure 4. Topographical Survey of the Ground Surface after the Collapse (Provided by GEC, LLC.)

The project was in the first phase of construction, i.e., excavation and site stabilization, when the incident occurred. At that time, the excavation of the parking areas into the mountain slope was almost completed. The retaining wall between the upper and lower levels of the parking area, near the middle of the project site, had been constructed as shown in Figure 4.

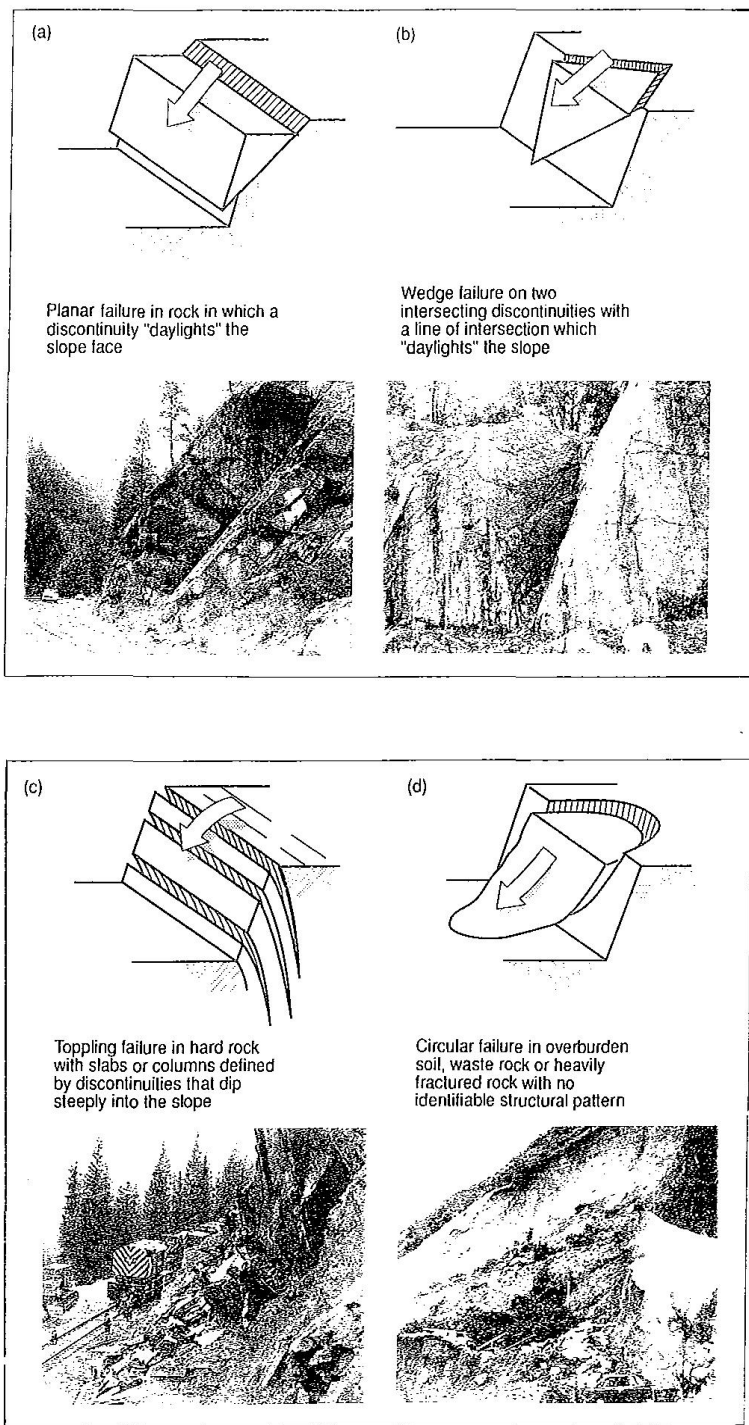
Figure 23. Types of Rock Slope Failures (Modified from Hoek and Bray, 1981 and Tuner and Schuster, 1996).

The figure on the cover of this report presents the overall shape of the collapse. As shown, the collapse was in a near circular or spoon shape. Based on references presented in Figures 23 and 24, a collapse of this shape would mostly occur in overburden soil, weathered rock, waste rock or heavily fractured rock. Therefore, the earth deposits in the collapsed area could only be residual soil, weathered rock or heavily fractured rock. They were more soil-like than rock-like deposits.
