# Investigation of the Failures of Three Hammerhead Cranes on September 10, 2017, in Miami and Fort Lauderdale in the Wake of Hurricane Irma

U.S. Department of Labor  
Occupational Safety and Health Administration  
Directorate of Construction

September 2018

**Report Prepared by  
Mohammad Ayub, P.E., S.E.  
Alan Lu, Ph.D., P.E.  
Office of Engineering Services  
Directorate of Construction**

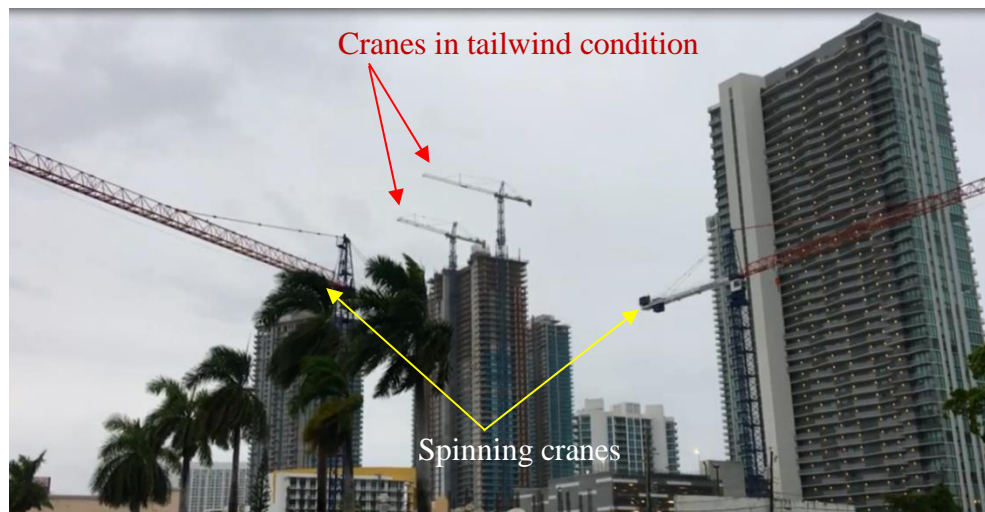
Figure 23 Tailwind condition of cranes at the second failure site – looking northeast  
 (Courtesy of Mr. Peter Zalewski)

were in tail wind condition, while the two lower cranes behind the high-rise buildings were spinning due to fluctuating winds, see Figure 23.

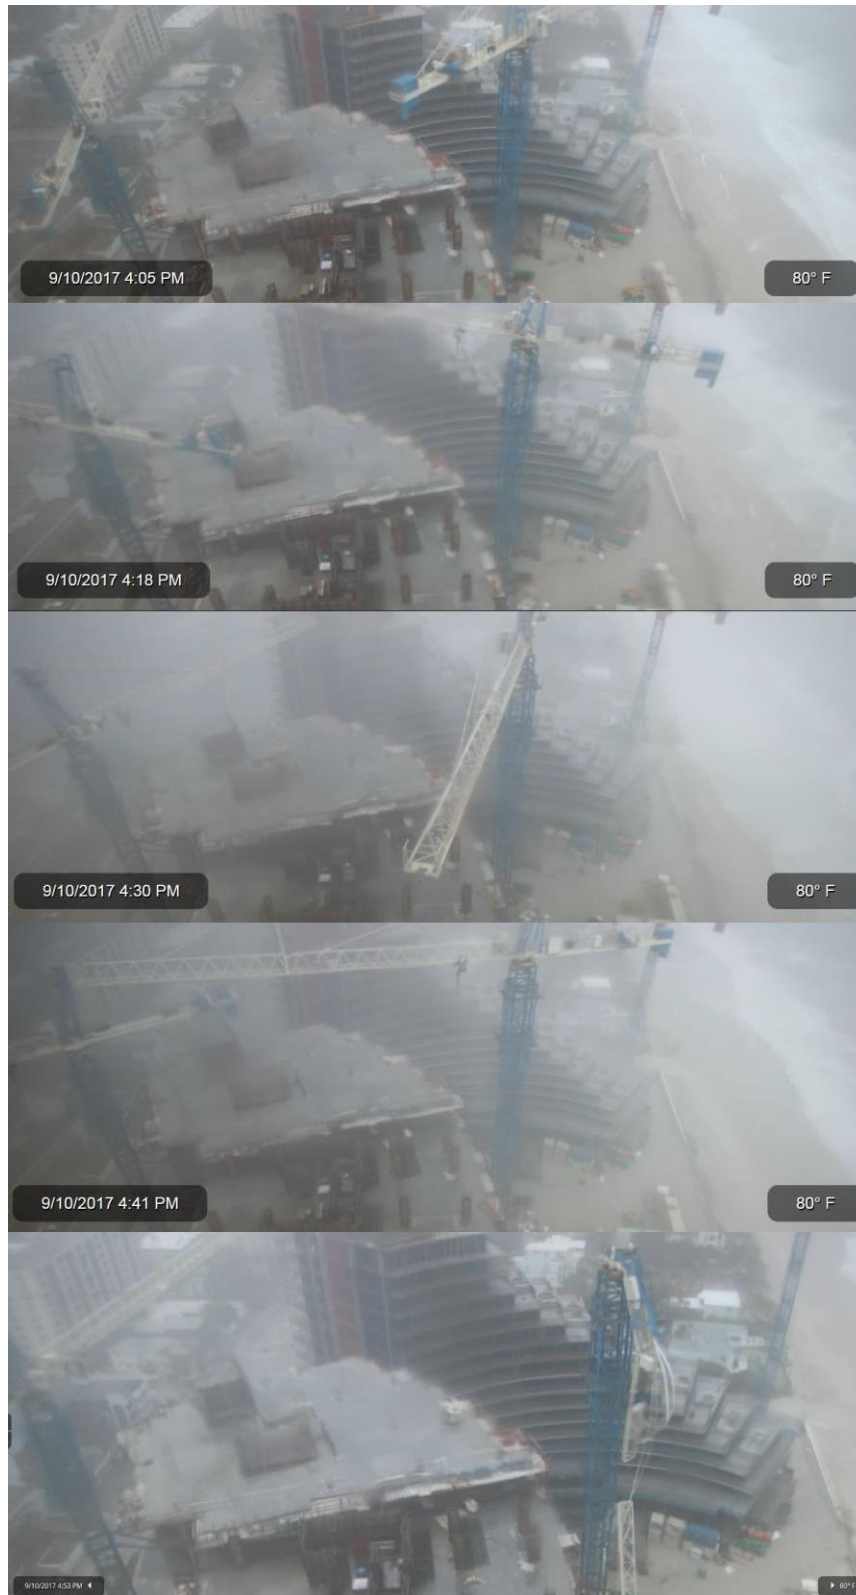
Figure 25 Spinning of the crane involved in the third failure  
(Courtesy of OxBlue.com)

The crane tower was in front of the building, facing the strong wind. The bottom of the jib was approximately 80 ft. above the completed structure. The buildings under construction and the nearby existing high-rise building interfered. The local surroundings created a complicated situation where the wind was not guided but accelerated in restricted areas. The local wind acceleration effects were extremely difficult to describe and to schematize. However, it is believed that the local building configuration made the wind accelerate in this restricted area. Therefore, wind speed and aerodynamic loads at the jib were expected to be elevated. The local turbulent wind had significant effect on the crane. This was proven by the construction camera photographs taken before the collapse of the crane, which showed that the crane rotated due to local turbulent winds, see Figure 25.

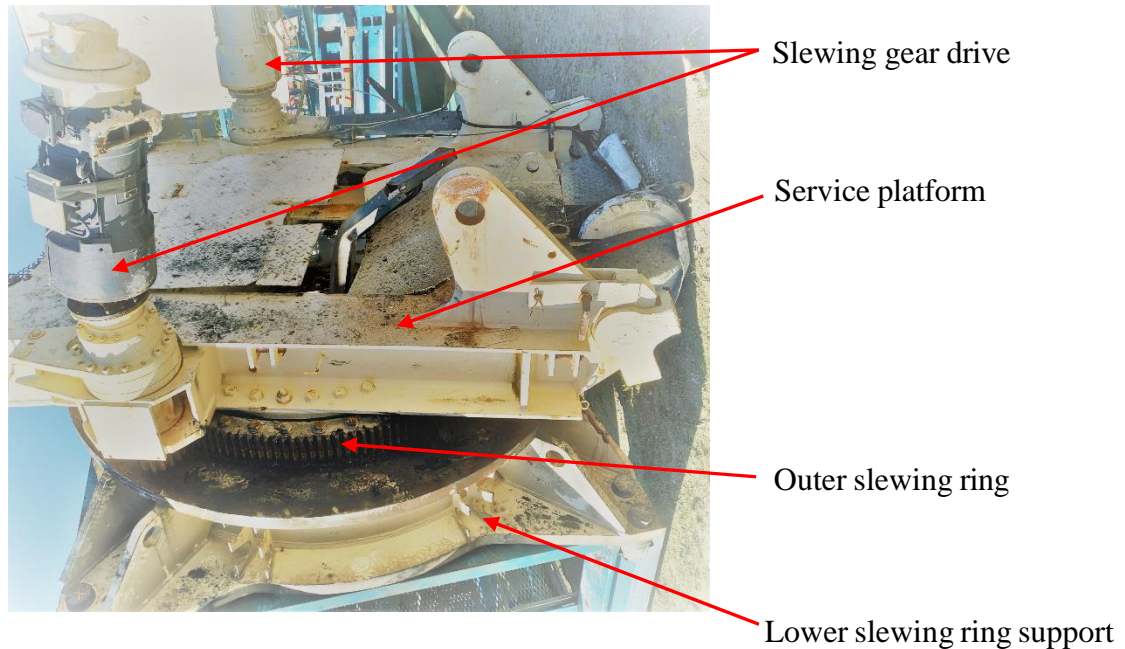
Figure 27 Slew assembly (the first failure)

The field observations of the slewing assembly focused on signs of worn slewing bearings, and on whether the slewing rings were greased and were set to weathervane as described in Section 3.2. Visual examination of the slewing bearings of the three cranes revealed that all three slewing bearings were greased, and no broken parts or missing teeth were found on the outer rings. Deadlock from debris of the slewing rings and possible jammed rings were not discovered. The wind release cases and the slewing gear brakes of the three cranes were also dismantled to verify that the cranes were set to weathervane and were able to revolve freely prior to the collapses. The disk brakes of the first and the third failure cranes were disassembled, since the wind release assemblies broke during the collapses. The brake linings of the two gear breaks had not worn down to the minimum thickness, and it was confirmed that the two cranes were set to weathervane prior to the collapses. The wind release assembly of the second failure crane was opened, and it was found that the flap was still in blocking position, which means the crane was set to weathervane.

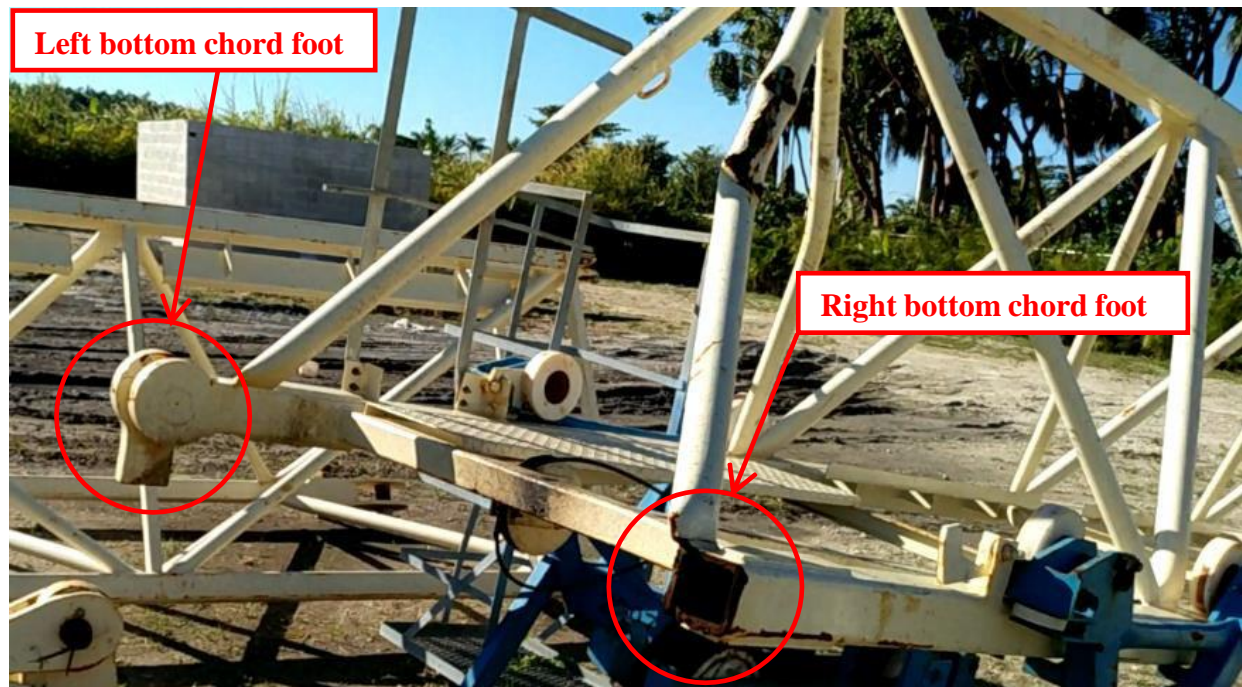
Figure 29 Jib foot bearing connections – jib side (the first failure)

The front part of the turntable, including the two bracket cradles, is shown in Figure 28. The jib bottom chord foots after the collapse are shown in Figures 29 and 30. It was observed in Figures

The right bearing cradle and the right clamp remained intact. However, the right bottom jib chord broke at the weld between the bottom chord tube and the end plate, as shown in Figure 30. The field structural observation is consistent with the collapse of the crane shown in Figure 10. The left jib bottom chord detached from the left turntable cradle because the jib swayed to the right. Once the jib separated from the left turntable cradle, the jib was only supported at the right turntable cradle and the two jib pendants. As the jib continued rotating to the right, the right bottom chord foot broke at the weld between the tube and the end plate, and the jib started falling.

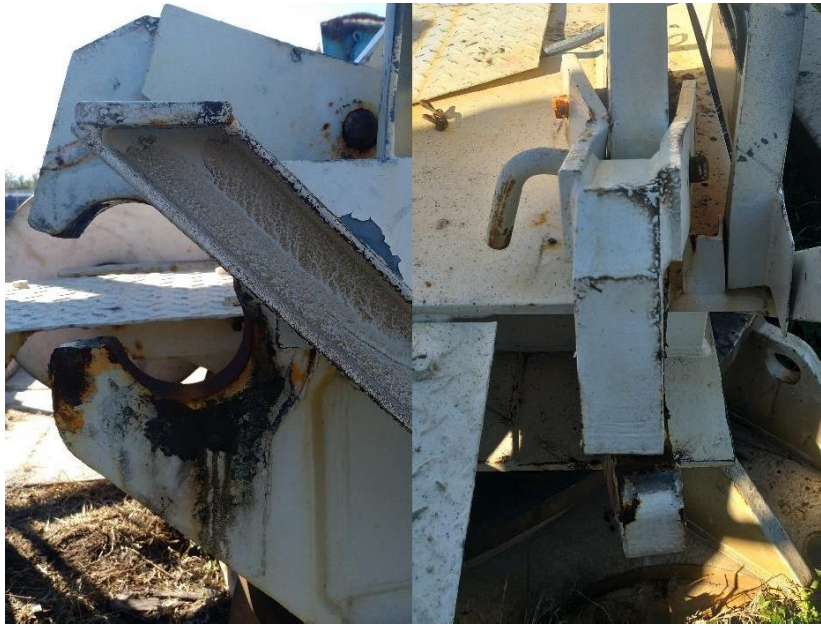
Figure 34 Left cradle and clamp (the third failure)

The front part of the turntable, including the two bracket cradles, is shown in Figures 33, 34, and 35. The two jib bottom chord foots after the collapse are shown in Figure 36. It was observed in Figures 33 to 35 that the clamp of the right cradle bent vertically and, meanwhile, the right bottom jib chord foot remained intact. The clamp of the left cradle bent upward and to the left, while the left bottom jib chord foot remained intact, as shown in Figure 36. The field structural observation indicated that the right jib bottom chord detached from the right turntable cradle first because the jib rotated to the left. As the jib continued rotating to the left, the left bracket cradle bent to the left until the left bottom chord detached from the left bracket cradle. According to field observations of the broken structures, the failure modes of the three cranes' jibs are similar.

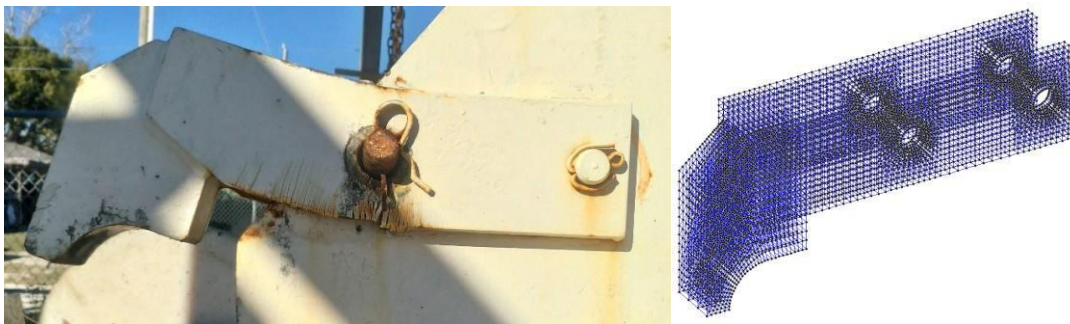
Figure 39 Turntable cradle clamp and 3D solid model

The turntable cradle clamp was modeled using 3d solid element in Staad Pro, as shown in Figure 39. Force was applied at the tip of the clamp to simulate the pulling of the pins on the bottom jib chord foot. The material grade for the clamp was S355J2G3, with a yield stress of 52 kilopounds per square inch (ksi). A minimum pulling force from the bottom jib chord pin to yield the clamp steel was determined to be 32 kips. It is noted that the existing clamp design is not able to secure the jib foot from separating, once the force from one jib bottom chord exceeded 32 kips. No design calculation or analysis documents or proof loading test results were made available to OSHA. Further evaluation could be required.

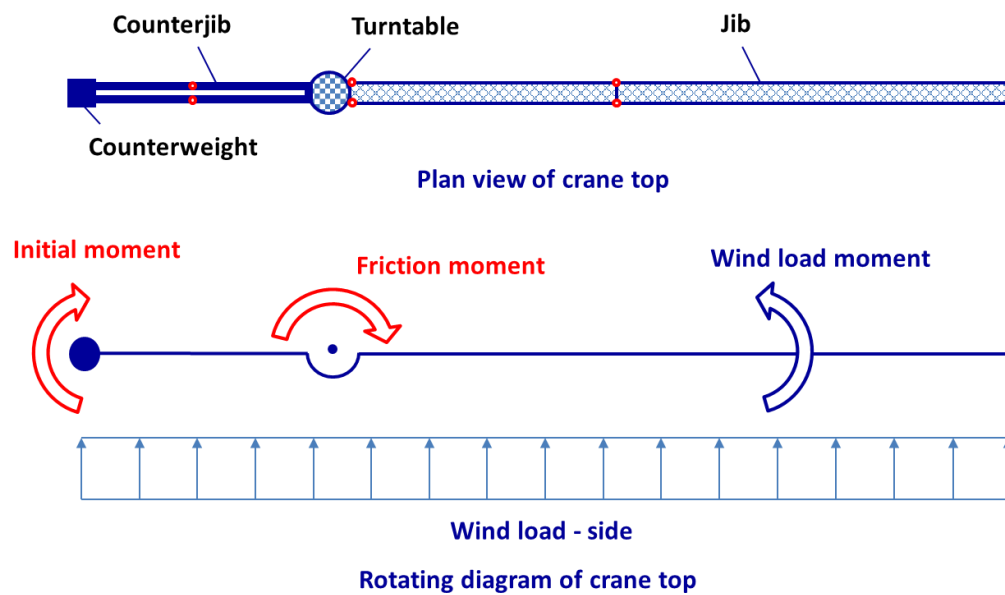
Figure 43 Tower crane top under lateral transient wind

Therefore, to determine the probable causes of the three incidents, both upward and lateral transient wind loads were considered applied on the jibs at 90 degrees to represent the possible situations where crane jibs were hit by a strong vortex or impulse wind, as shown in Figures 42 and 43. In contrast to typical design practices—which considered a complete crane, including mast, tower top, jib and counterjib, to evaluate its stability and integrity—only the dynamics effects of the jib introduced by the sudden rise in wind speed (or pulse effect) were examined in this study.

is able to overcome the frictional moment to rotate the turntable, see Figure 43. During this process, the rotational acceleration is very small, and the initial effects due to the mass of the counterweight and other rotational components are limited. However, if the wind load is transient, pulse effect must be considered. When the transient wind strikes the jib, the inertial moments due to the mass of the counterweight and other rotational components, as well as the friction moment, would resist the rotation of the turntable due to the horizontal wind. The equation of motion of the rotating part of the crane is given as:

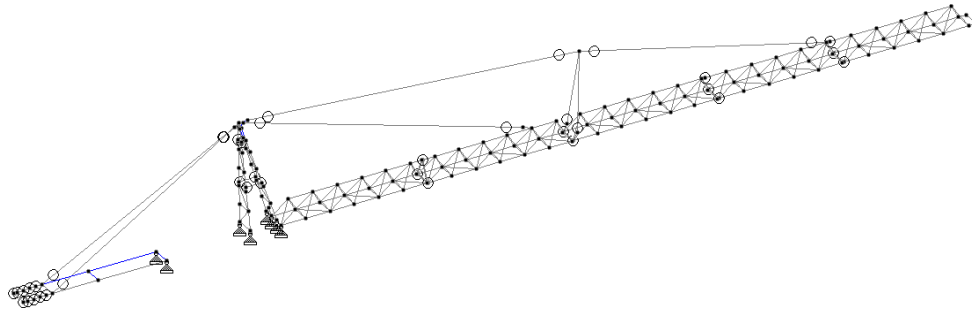
Figure 44 3D structural model of the mobile part of the crane (1<sup>st</sup> failure crane)

The 3D structural models of the three cranes, including the tower top, jib and counterjib, were developed as shown in Figure 44.

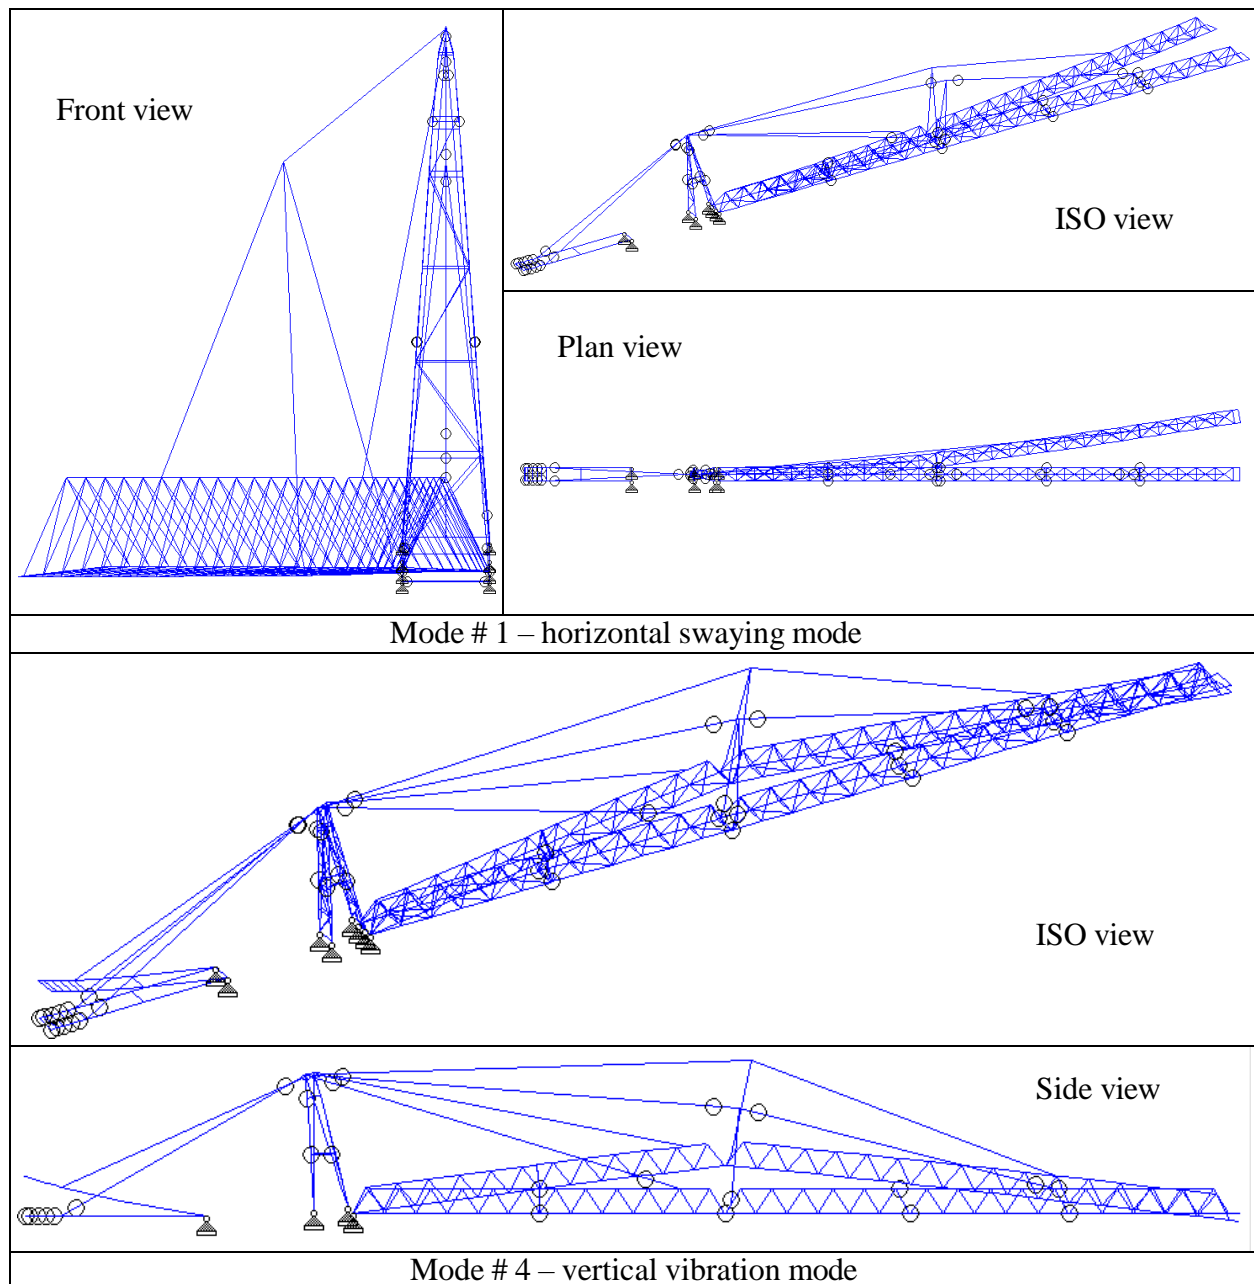
Figure 45 First two dominant modes of the crane mobile parts (1<sup>st</sup> failure crane)

It was found that the dominant modes of the crane mobile parts included both transvers swaying of the jib and vertical shaking of the jib and counterjib, as shown in Figure 45.

The wind speed fluctuates in all the frequencies between 0.0005 and 5 Hz. The first two dominant modes of both horizontal and vertical vibrations of the three cranes were within the frequency range of the typical frequencies of a wind. Therefore, the choice of the impulsive wind frequencies in this study aims to study the middle-range wind frequencies in a scale from 0.5 to 1.5 Hz, excluding the extremes of very low or very high frequencies.

As mentioned previously, the cranes involved in the first two collapses were in tailwind condition prior to the collapses; and, for the third failure, jib rotation speed prior to the collapse was not known. Whether the rotational frequency is able to excite the jib structure's natural modes, especially the transverse mode, as shown in Figure 45, is not clear.

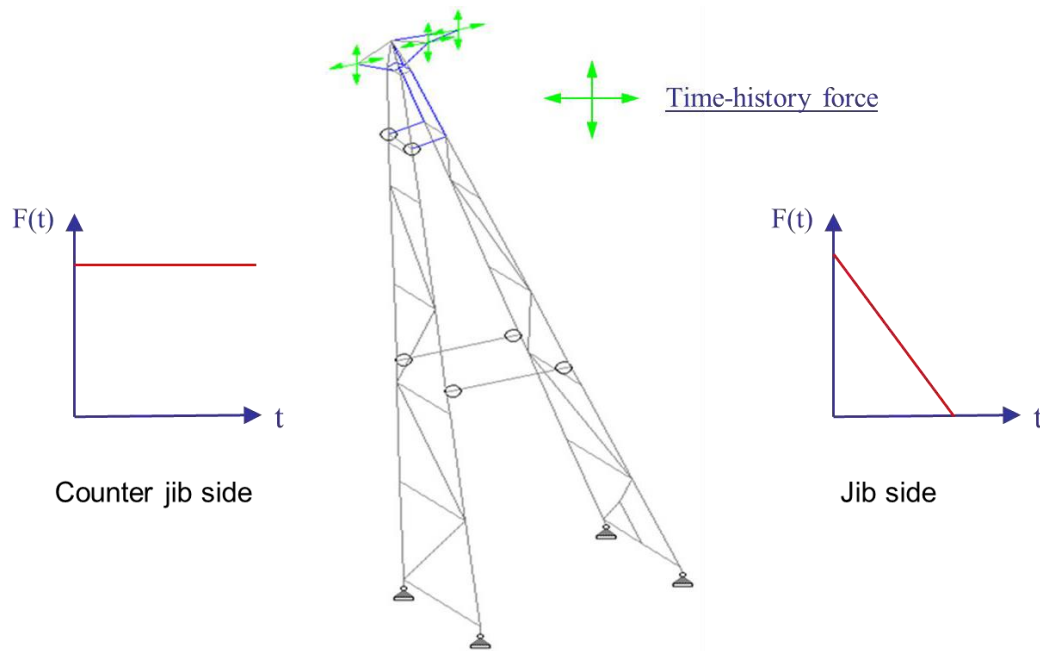
Figure 47 Frame model of tower top for dynamic analysis

As discussed in previous sections, the jib pendants were released in a short period due to the falling of the jib once it detached from the turntable. Per the video footage taken at the first failure site as discussed in Section 4.1, the time duration of the entire process could be less than 0.1 seconds. Dynamic time history analyses were carried out on 3D frame model of the tower top only, as shown in Figure 47. A linear time-history function to simulate the sudden disappearance of the pendant tension from the jib side was adopted in the analyses, as shown in Figure 47. Results indicate that the two tower top columns towards the counterjib side were overstressed and failed due to the sudden release in tension in the jib pendants. The maximum combined compressive stresses in the upper sections of the two columns toward the counterjib are 63 ksi for the crane involved in the first failure, and 59 ksi for the cranes involved in the rest two failures.

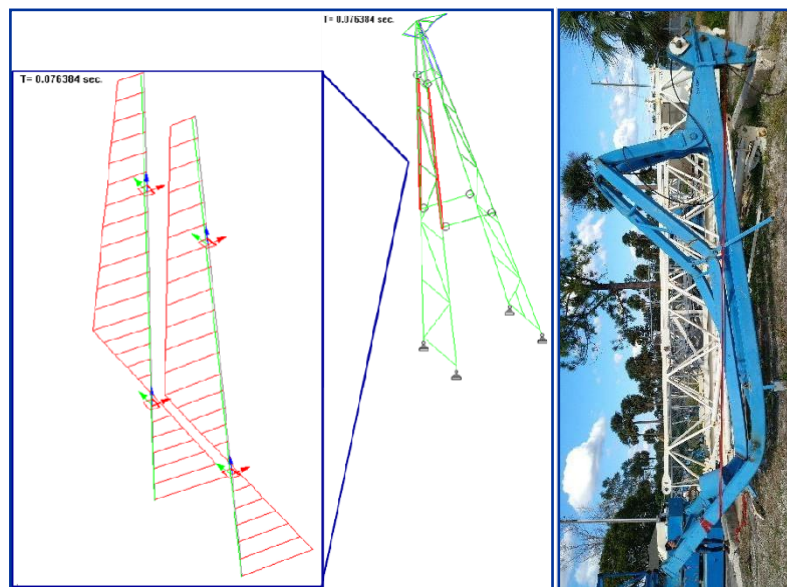
Figure 48 Strong axis bending moment diagram of the columns vs. deformed columns

The diagram of the governing bending moment in the upper sections of the two columns toward the counterjib is shown in Figure 48. It is found that the maximum compressive stress occurred at

the side of the column section toward the jib. The deformed columns of the tower top toward the counterjib are consistent with the bending moment diagrams, as shown in Figure 48.

10. To prevent catastrophic collapses of the crane tower top in the future, it is recommended that tower tops be evaluated and designed with a higher safety margin, and the design should also be based with loads applied from only the counterjib.
