Fire during Hot Work at Evergreen Packaging Paper Mill

Investigation Report

Published: September 24, 2021

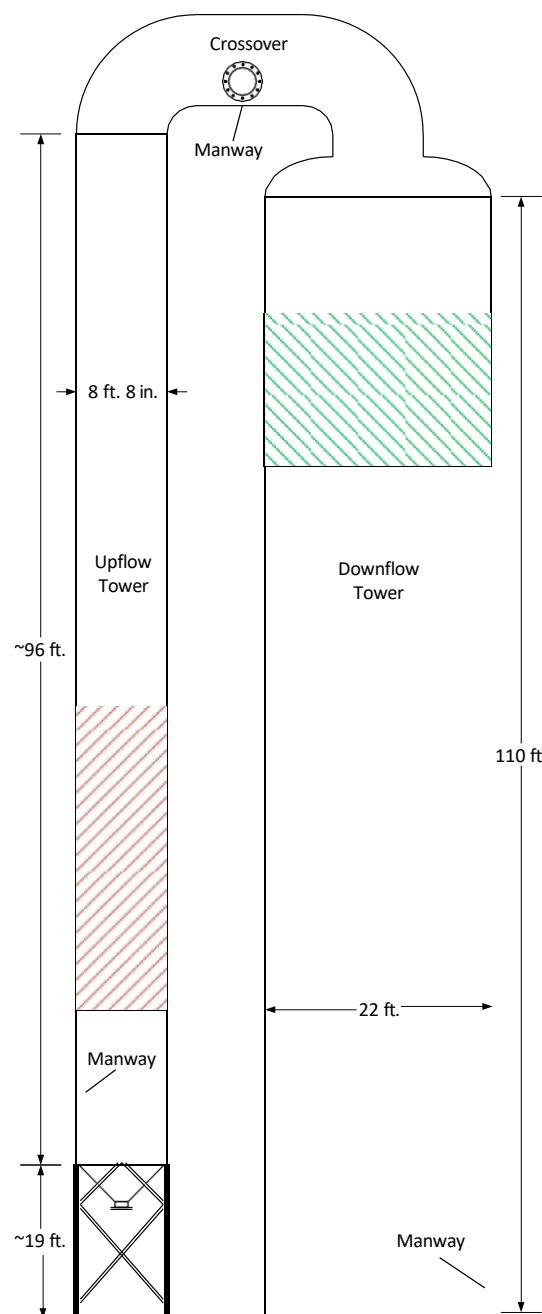
Figure 3. Diagram of the #2 Fiber Line D2 towers. (Credit: CSB.)

The #2 Fiber line D2 upflow tower was constructed of fiber-reinforced plastic (FRP) and was approximately 96 feet tall and almost nine feet in diameter (**Figure 3**). The downflow tower was constructed of a carbon steel shell, lined internally with a urethane membrane covered with fireclay acid brick laid in vinyl ester mortar. The downflow tower was 110 feet tall and roughly 22 feet in diameter. These two towers were connected by a crossover line, which was approximately the same diameter as the upflow tower, and which was also constructed of FRP.

Blastco’s scope of work for the shutdown was, among other tasks, to perform FRP maintenance on four upflow towers in Evergreen’s bleaching units. For the #2 Fiber line D2 upflow tower, Blastco’s work scope was to repair approximately 30 feet of FRP, illustrated with red shading in **Figure 3**. This scope of work involved grinding away old material until acceptable base material was found, followed by applying alternating sheets of new fiberglass with layers of resin, until the desired thickness was reached. To accomplish this work, traditional scaffolding was built up from the ground to the entry manway of the upflow tower, which was located 23 feet above the ground. Inside the tower, additional scaffolding platforms were assembled so that workers could access the entire inside surface that was to be repaired.

Rimcor's scope of work was to re-line approximately 15 feet of the #2 Fiber line D2 downflow tower, illustrated with green shading in **Figure 3**. This work involved using pneumatic jackhammers to remove the old brick, mortar, and urethane membrane, and abrasive blasting to remove residual membrane material, until the bare steel shell was exposed. Once the steel subsurface was prepared, the next step involved applying new membrane material and lastly installing the new brick lining. To accomplish this, Rimcor used a special kind of scaffolding, called a "suspended" scaffolding, inside the downflow tower. This scaffolding consisted of a circular engineered steel scaffold with wooden decking, suspended from mounting points on the roof of the vessel via steel cables. Workers entered the tower via the manway at ground level and assembled the scaffolding platform inside the tower. Once the platform was built and suspended, six workers simultaneously used cable winches to slowly raise the platform to the desired height. Moving the platform was a slow process—it took six workers approximately four hours to raise the platform to Rimcor's work location inside the downflow tower. The platform had a barricaded hole in the middle which workers used along with a hoist to raise and lower tools, materials, and other workers, via chairlift, to and from the platform. At the time of the incident, two Rimcor workers were inside the upflow tower performing abrasive blasting operations.^a
