Masonry Wall Collapse

The Division of Occupational Safety and Health of the State of Tennessee requested the Directorate of Construction, OSHA National Office, to provide assistance in the investigation and causal determination of the April 18, 2013 collapse of a masonry wall during construction of the Goodwill Retail Store in Hendersonville, TN. As a result of the wall collapse, two employees were killed and one was injured. Our investigation and evaluation were based on the information provided by the Division of Occupational Safety and Health of the State of Tennessee. Please note that we did not visit the incident site.

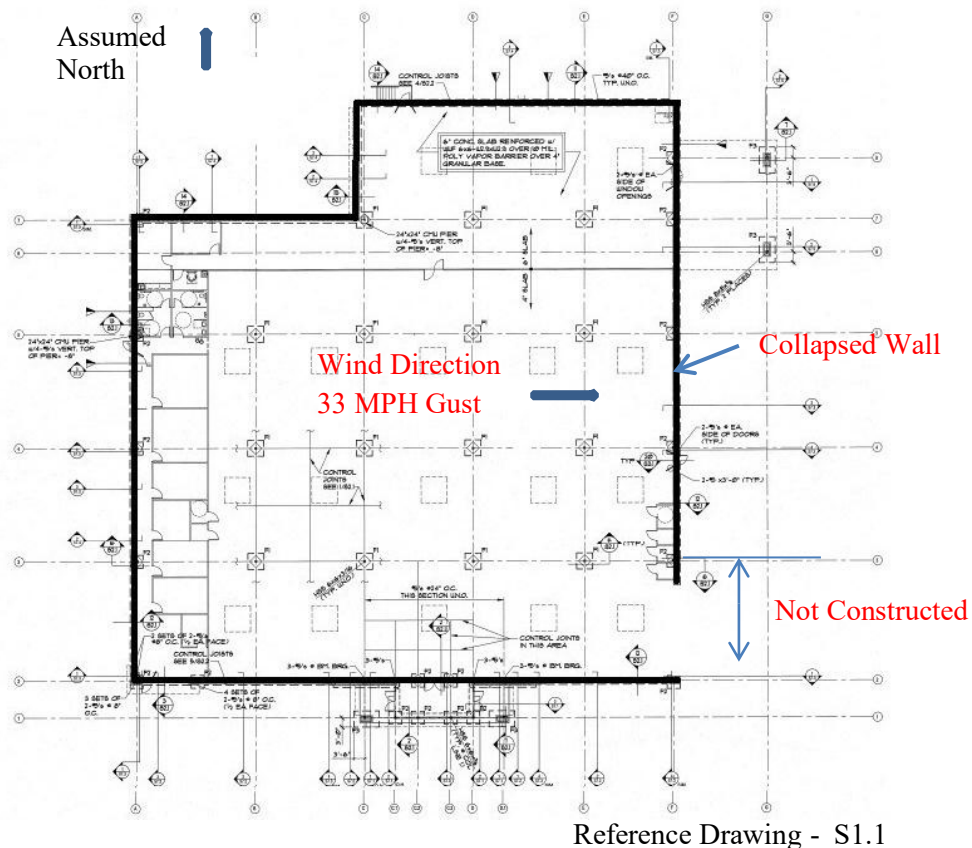
Figure 1 – CMU wall Plan

The project consisted of construction of a one-story Goodwill Retail Store, approximately 170' wide x 180' long (see figure 1).

For the purpose of this report, the wall that fell is identified as the east wall by the field personnel, although contract drawings identify it as the north wall. The exterior non-load bearing walls consisted of 8" thick partially grouted Concrete Masonry Units (CMU) supported on 2' wide x 1' deep concrete footing (see Figures 1 to 3).

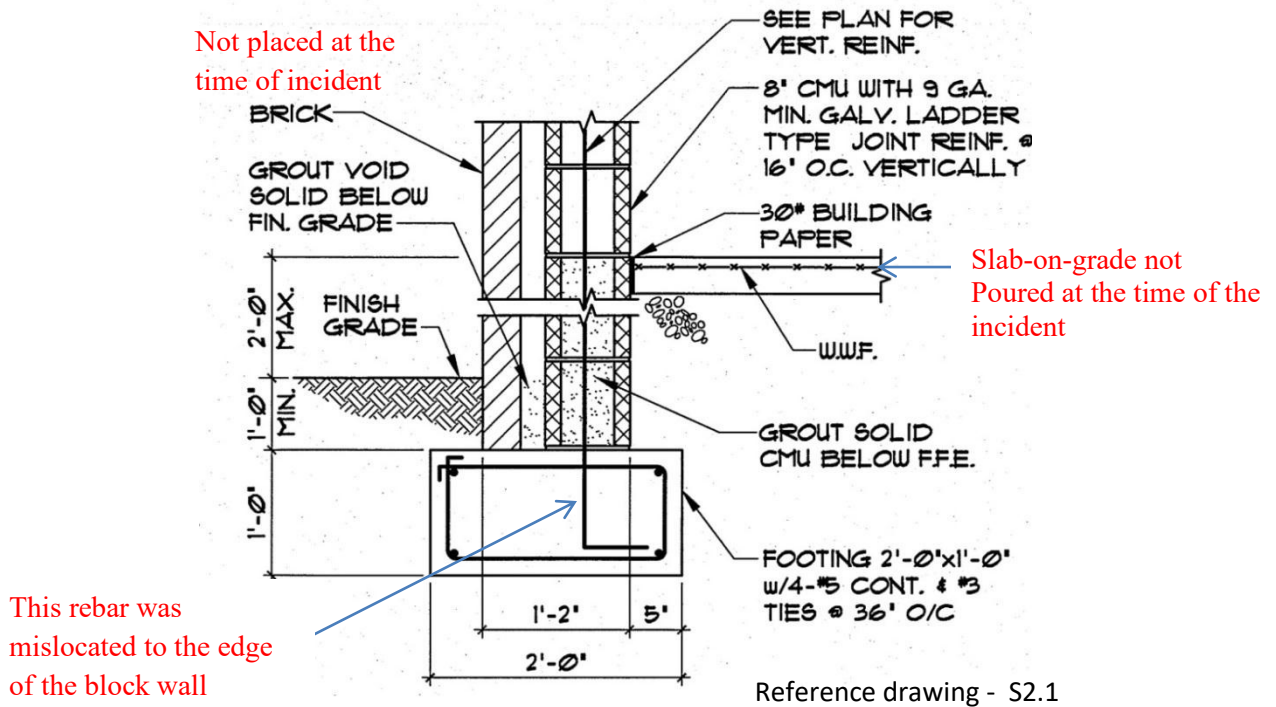
Figure 4 – Exterior Wall Section

The CMU walls consisted of hollow concrete blocks and were partially grouted using a low lift grouting method. The wall was reinforced with #5 rebars at 40" on center (see Figure 4).

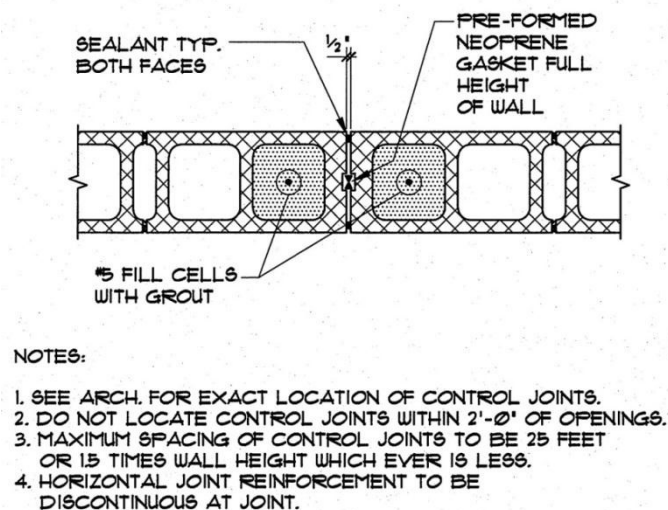
Figure 5 – Control Joint detail

The architect specified the maximum spacing of the control joints to be at 25' on center in the horizontal direction (see Figure 5).

5. Based on architectural drawings, vertical control joint at the east wall was considered at 25'-0" on center (see Figure 5).
6. Three interior bracings and one exterior bracing at the east wall were considered to resist the wind loads. For calculation purposes, the top of the brace was considered to be 9'-0" above the top of the footing, and the bottom of the brace was assumed to be supported at the ground level. The CMU wall's upper height of 15' above the top of the brace was considered as a free-standing wall (see Figure 8).

The masonry contractor provided too few braces between the control joints of the 150'-long masonry wall that fell. In this project, the control joints in the masonry wall were designed and detailed as a complete separation (see Figure 5) similar to an expansion joint which necessitated a minimum of two braces for the masonry walls between the control joints (see Figure 11). Only three interior and three exterior braces for the entire wall were provided instead of the twelve specified in the industry standard, "Standard practice for Bracing Masonry Walls under construction" developed by the Council for Masonry Wall Bracing. Two exterior braces of the east wall were removed a few days prior to the collapse. All required braces should have been left in place until permanent supporting elements were constructed, e.g., the roof deck and its attachments to the bond beam at the top of the wall. If the masonry contractor had provided an adequate number of braces as per the industry standard, this incident could have been avoided.
