# Pedestrian Bridge Collapse in Miami, Florida

## 1. Executive Summary

## **6. The cracks**

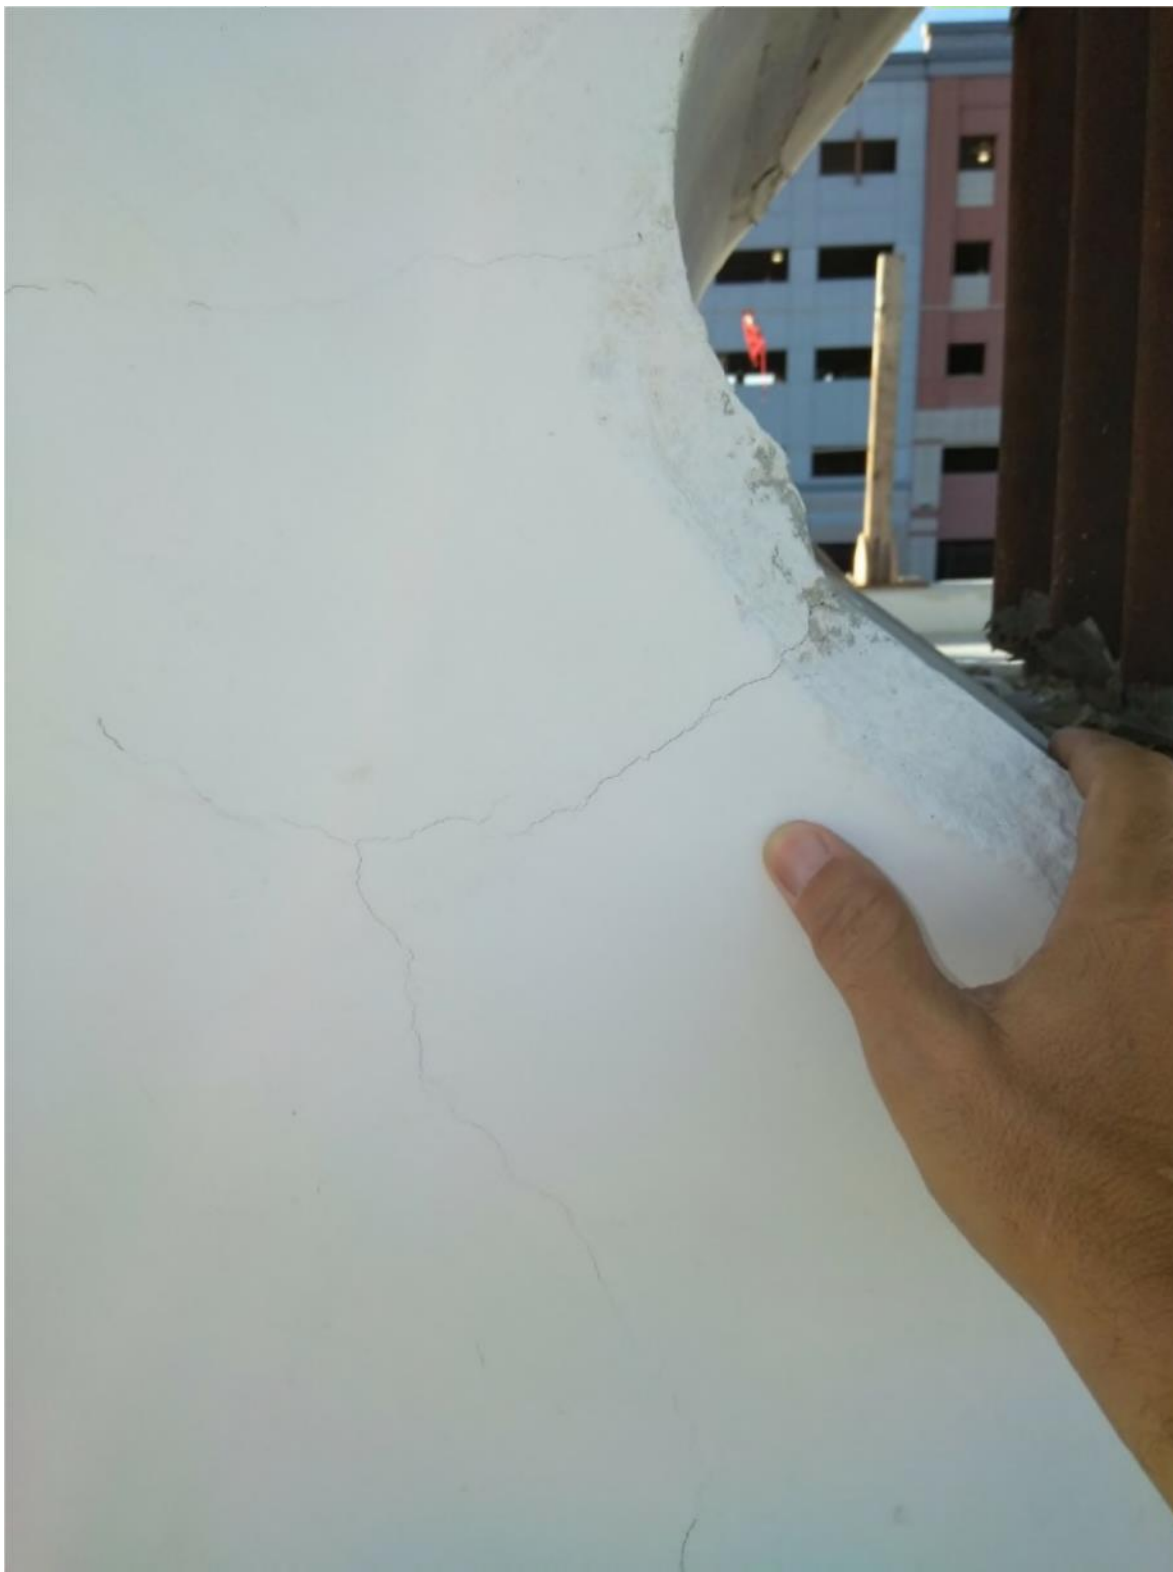
Figure 32 Photo #2 in 2/28/2018 E-mail from MCM to FIGG

(Figure 16): Cracks expected.

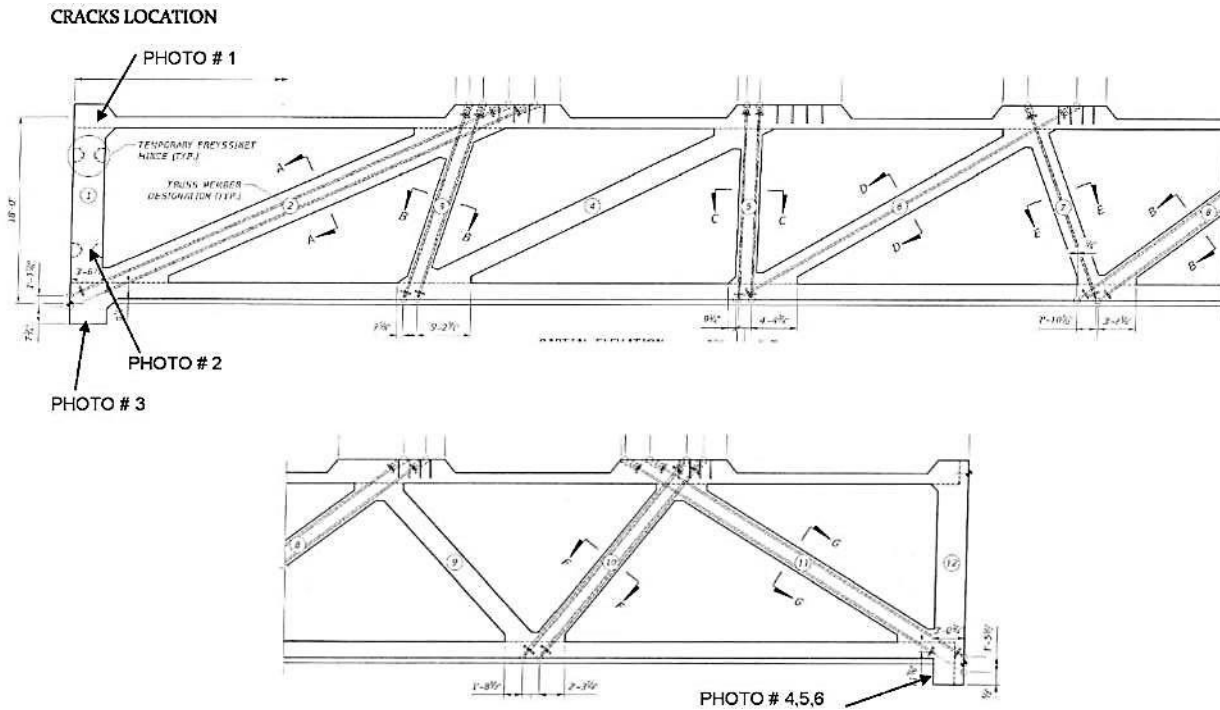
Figure 21 Location of cracks in 2/28/2018 E-mail from MCM to FIGG as per BPA March 7,

Photos 4, 5 and 6 (Figure 18, Figure 19 and Figure 20): Cracks developed at diagonal 11 and its bottom chamfer. No concern expressed by FIGG. FIGG anticipated that "MCM will seal these cracks in accordance with FDOT Standard Specifications." These cracks were, however, never sealed.

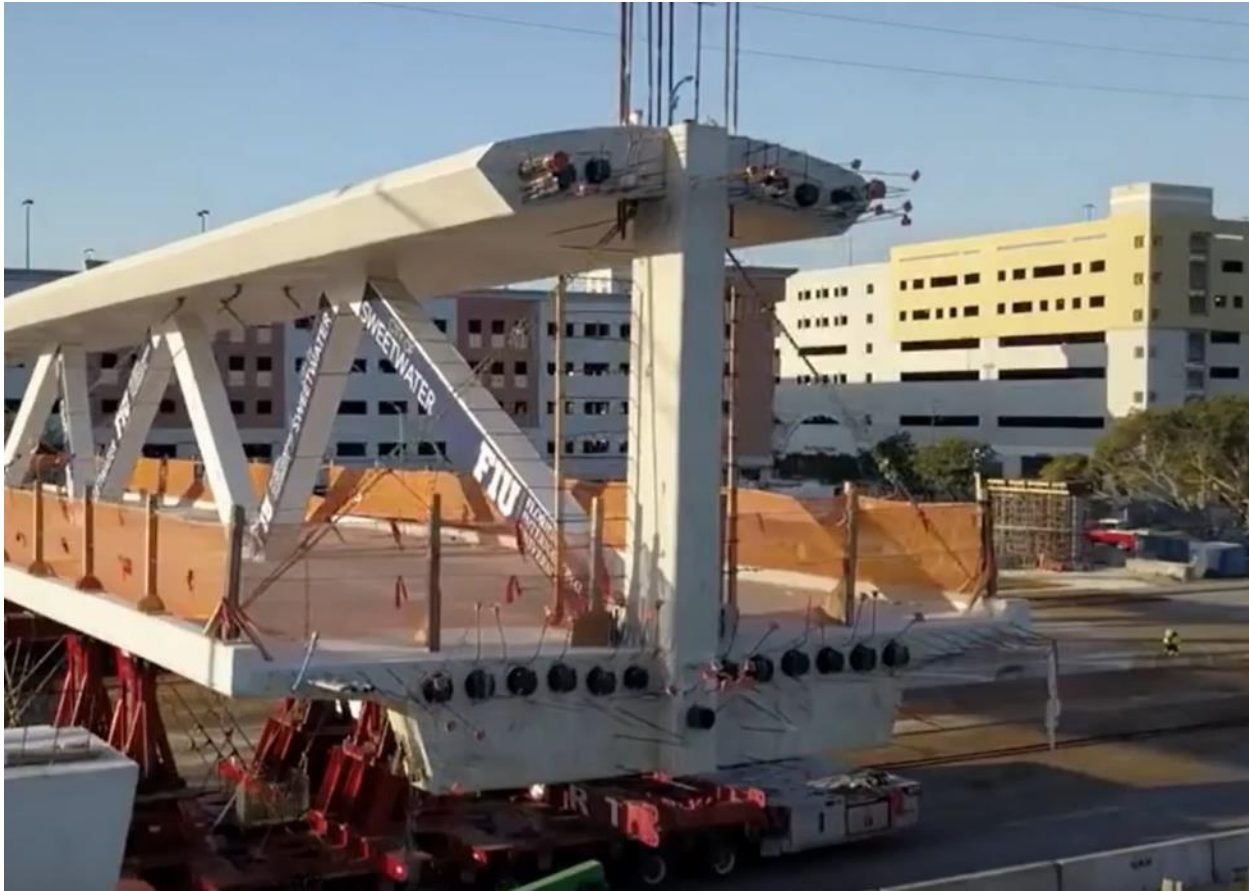
generally free of cracks other than those mentioned above, and as shown in the following pictures.

Figure 22 North end of the main span truss during transportation, generally free of cracks

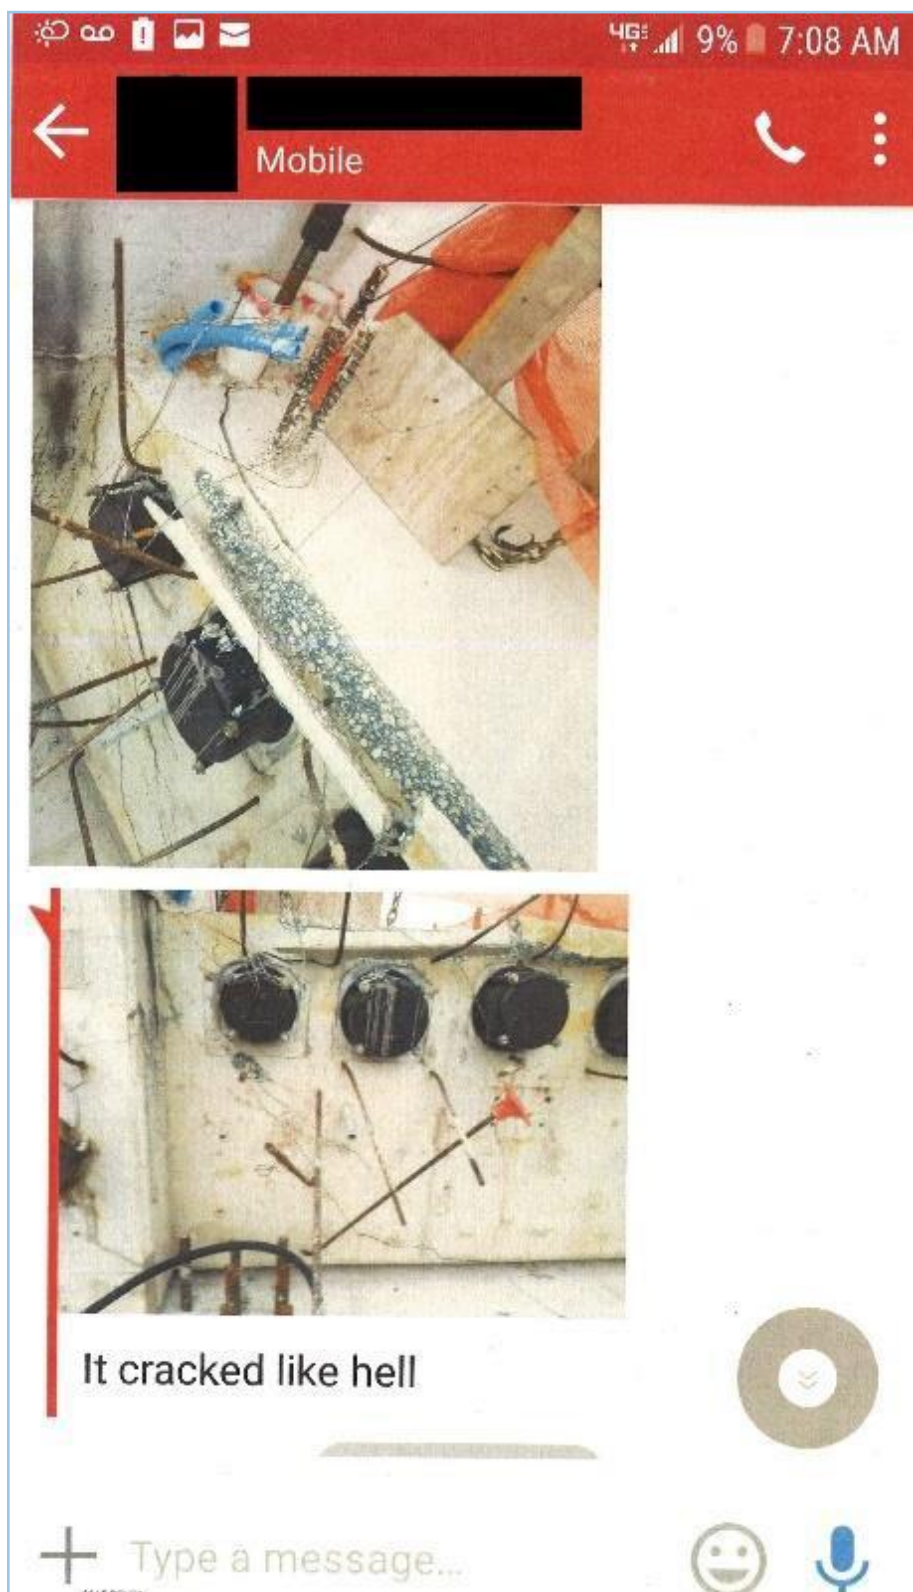
of the cracks, and sent them to his supervisor, Sam Nunez, stating that “it cracked like hell”, see Figure 23. Reproduced below is Kevin’s text. Ashley mentioned to OSHA that Kevin went to MCM to show the photos of the cracks. Sam Nunez of VSL stated during an OSHA interview that the photos he received subsequent to March 10 were different, showing spalling and cracks in the diaphragm II implying that additional cracks took place after March 10, 2018.

Figure 23 Screenshot of Kevin Hanson's message to Sam Nunez on March 10, 2018  
March 12, 2018

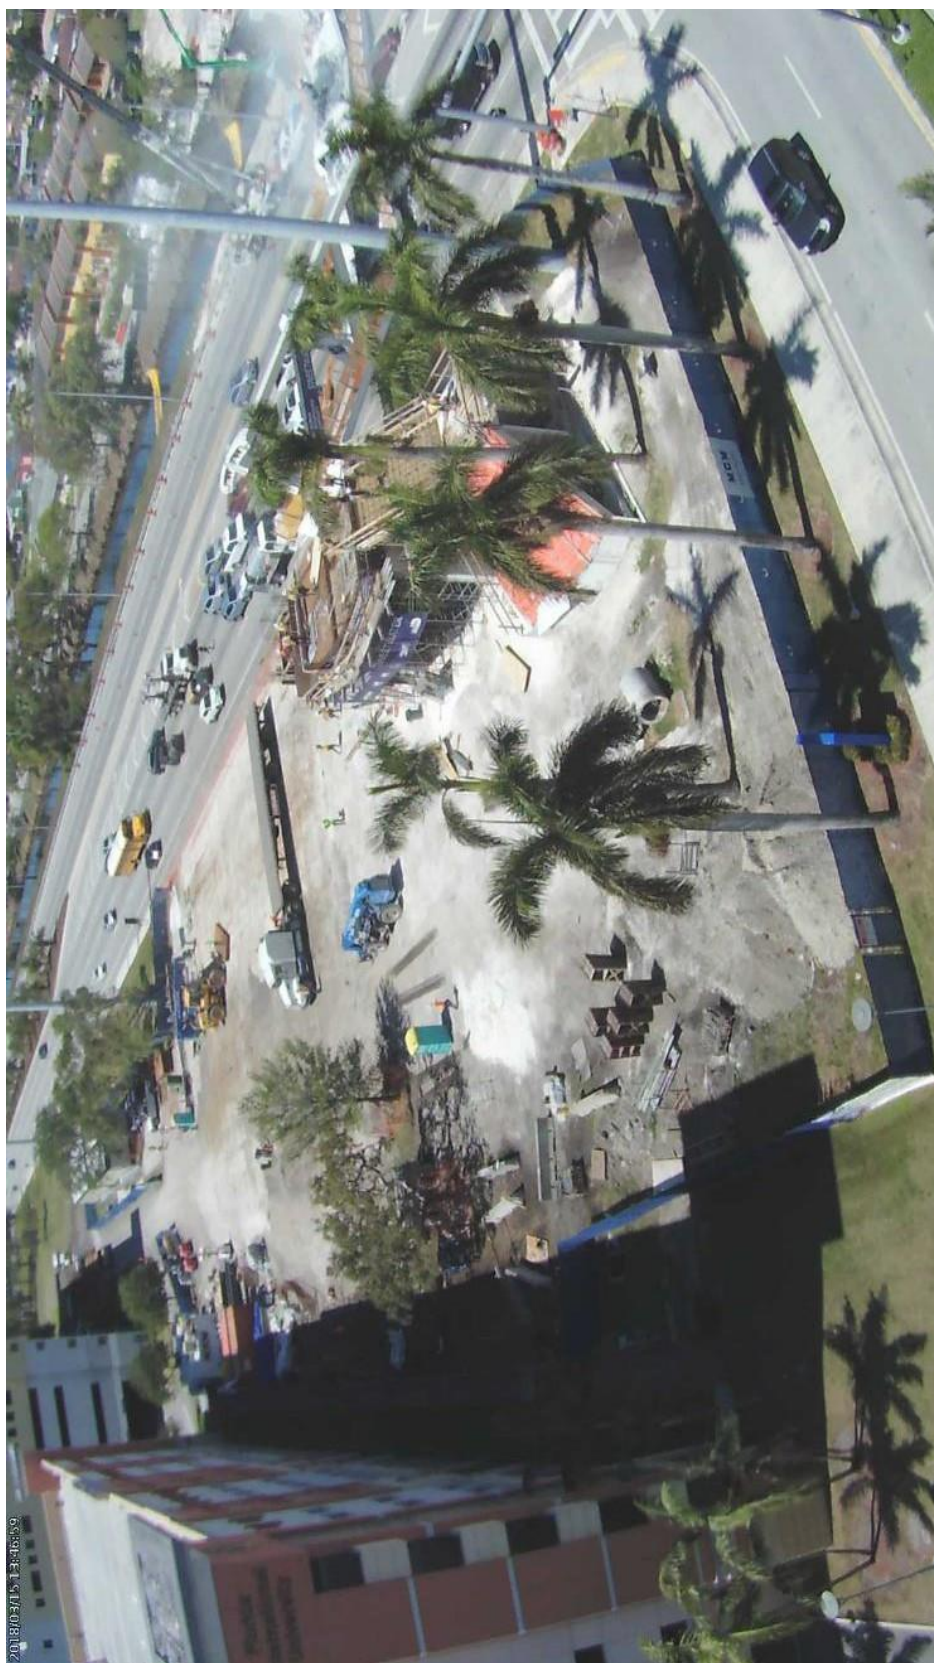
Figure 47 Bridge immediately after the collapse, March 15, 2018 – camera #1

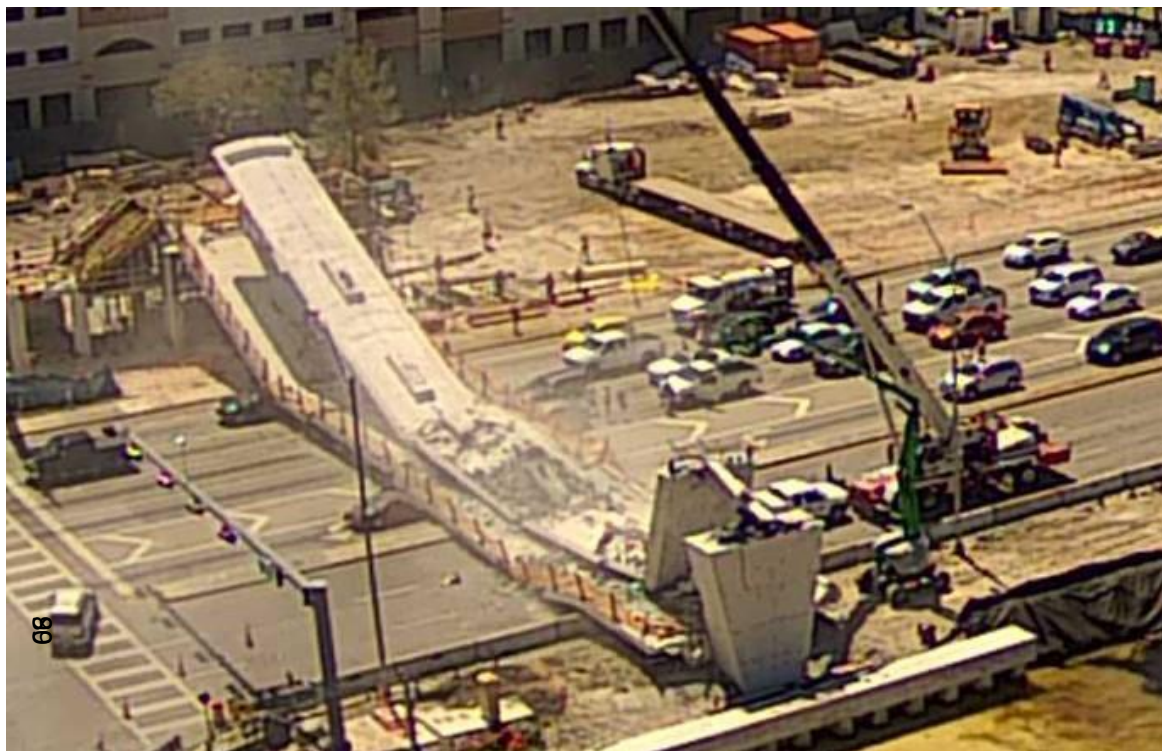
Figure 49 Bridge immediately after the collapse, March 15, 2018 – camera #2 Employees engaged in re-tensioning the PT bars in diagonal 11

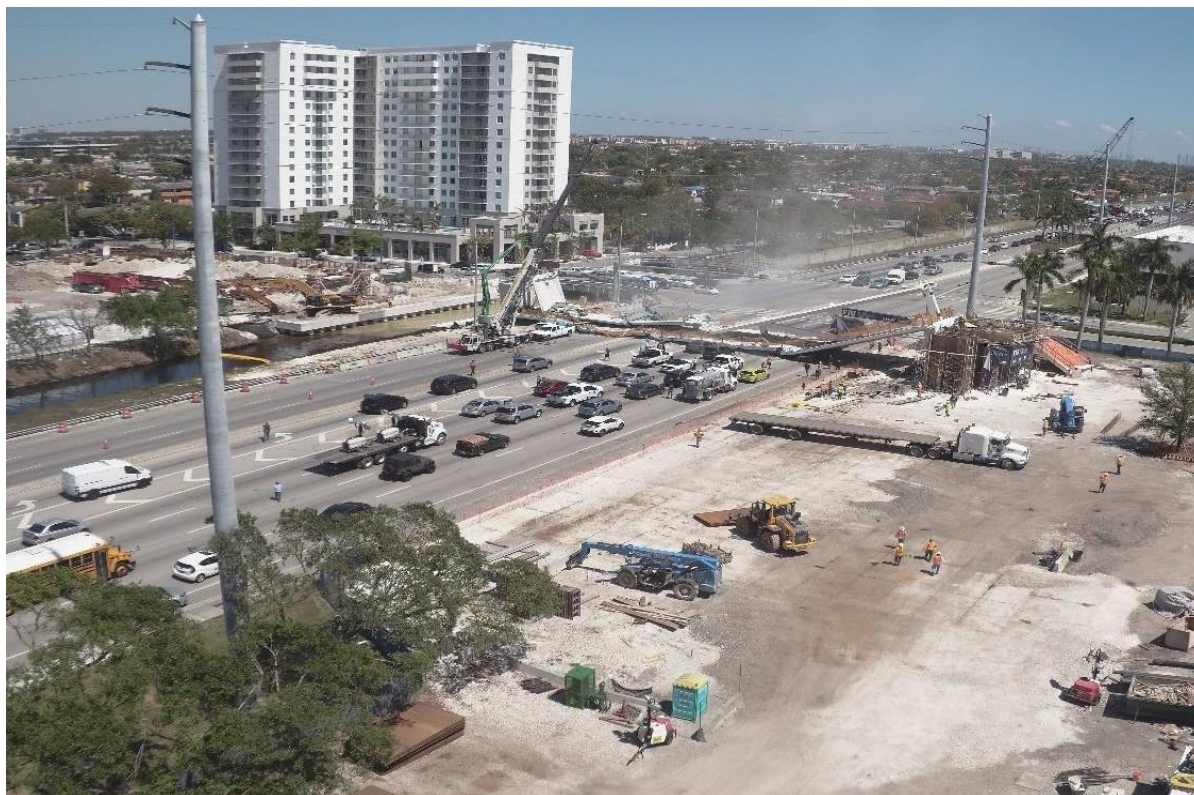
Figure 51 Bridge immediately after the collapse, March 15, 2018  
– camera #3 (north on the left and south on the right)

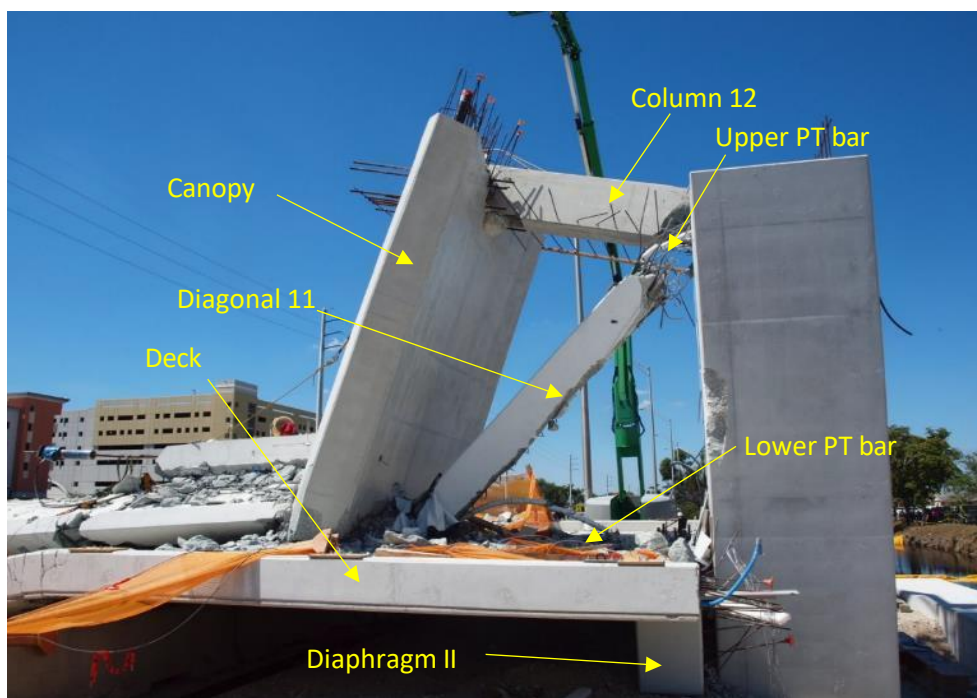
Diaphragm II experienced a blow-out of concrete at the junction of diagonal 11 and column 12 creating a hole shown below in Figure 58 through Figure 70. As a result, column 12 lost support over the pylon and failed with the top tilting approximately 80 degrees towards the south, as shown in Figure 52. The base of column 12 shifted a few feet towards the north but remained on the top of the pylon. Thereafter, collapse of the canopy, diagonal 11 and the deck followed. The canopy partially remained attached to column 12. The remaining diaphragm II and the deck fell approximately 18 ft. to the ground below, see Figure 52. One end of the diagonal 11 remained

perilously attached to the bottom of the column 12 over the pylon with some rebar, and the other end remained connected to the canopy as shown in Figure 52. As a result of the blow-out, the lower end of the upper PT bar separated from the diaphragm II and rested on the top of the pylon. The lower PT bar of diagonal 11 peeled off from diagonal 11 but remained embedded in the diaphragm. The top ends of the upper and lower PT bars in diagonal 11 remained in the blister. The upper PT bar lost its tension completely and so did the lower PT bar which still carried the Jack used to re-tension the PT bars. The deck laid down approximately 140 feet flat on the ground covering all the four east bound lanes, and three west bound lanes, as shown in Figure 51. The south end of the deck and column 1 were still precariously on the top of the south pier, see Figure 52. The column 1 tilted approximately 15 degrees towards the north with canopy firmly attached. All diagonals other than diagonals 2, 3 and 4 were crushed. The canopy laid flat approximately 80 ft. over the fallen deck. Two blisters on the south side remained intact with the canopy but the rest of the blisters were badly damaged. The blisters at the junction of diagonal 11 and 10 were damaged with the bottom PT bar extending beyond the blister with the ram still attached to the PT bar. As a result of the blow-out, three #7 shear reinforcements at the construction joint of diagonal 11 and the deck were sheared but the southernmost shear reinforcement remained intact. The width of the blow-out was 2 ft. at the southern end gradually enlarging towards the north. The blow-out encompassed

Figure 52 Column 12, diagonal 11 and part of the canopy after bridge deck and diaphragm fell to the ground, March 17, 2018, by OSHA  
FDA, Inc.

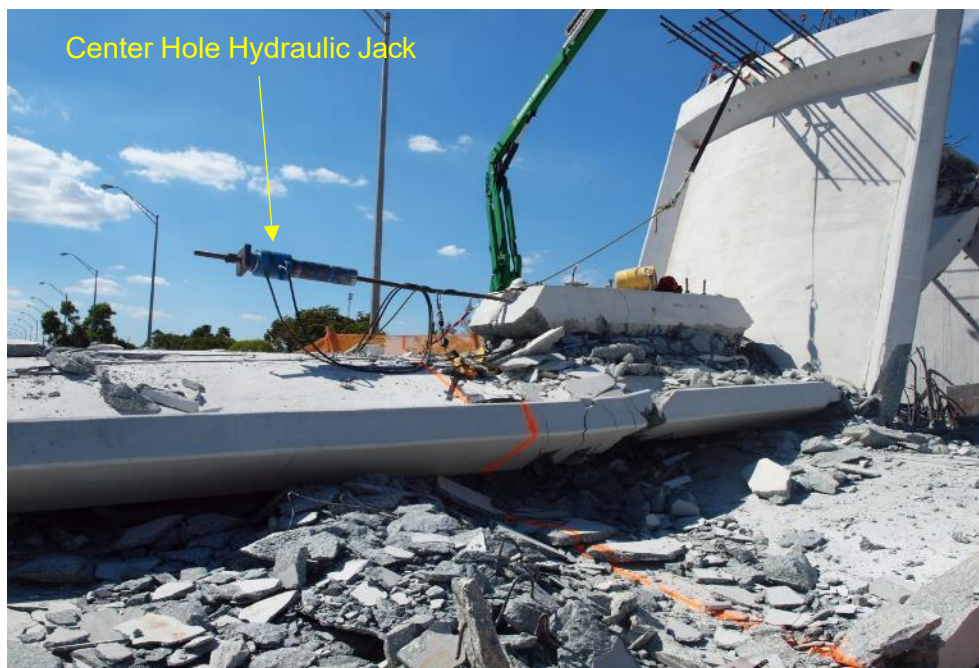
Figure 53 Northernmost blister and hydraulic jack attached to the lower PT bar of diagonal 11 after bridge collapse – side view, March 17, 2018 by OSHA

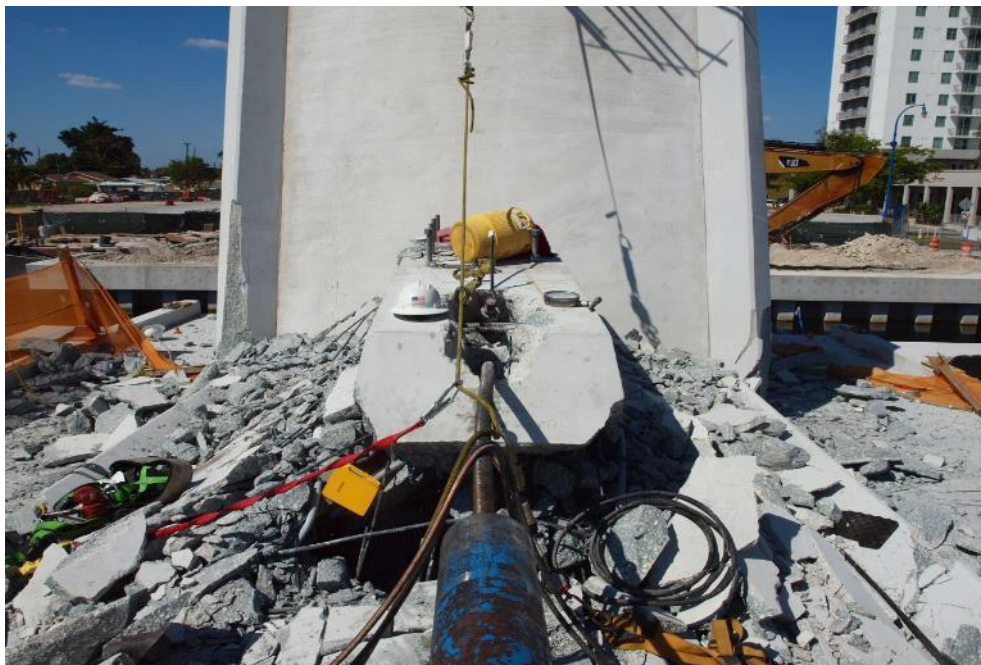
Figure 54 Northernmost blister and hydraulic jack attached to the lower PT bar of diagonal 11 after bridge collapse – front view, March 17, 2018 by OSHA

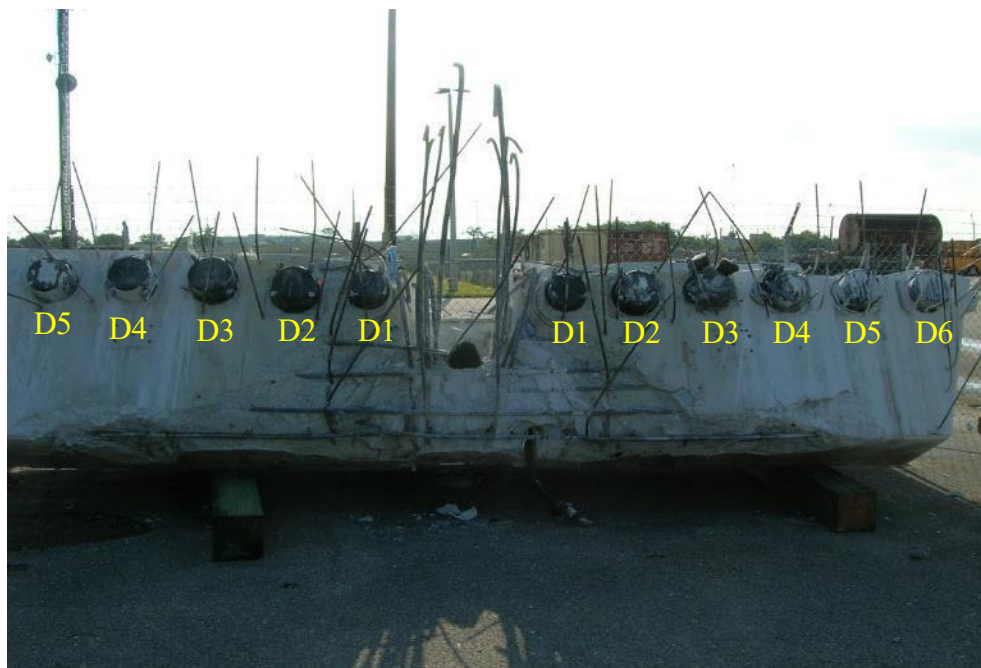
Figure 61 Remnants of diaphragm II at the time of the bridge collapse in the storage yard – looking north from south, April 9, 2018, by OSHA

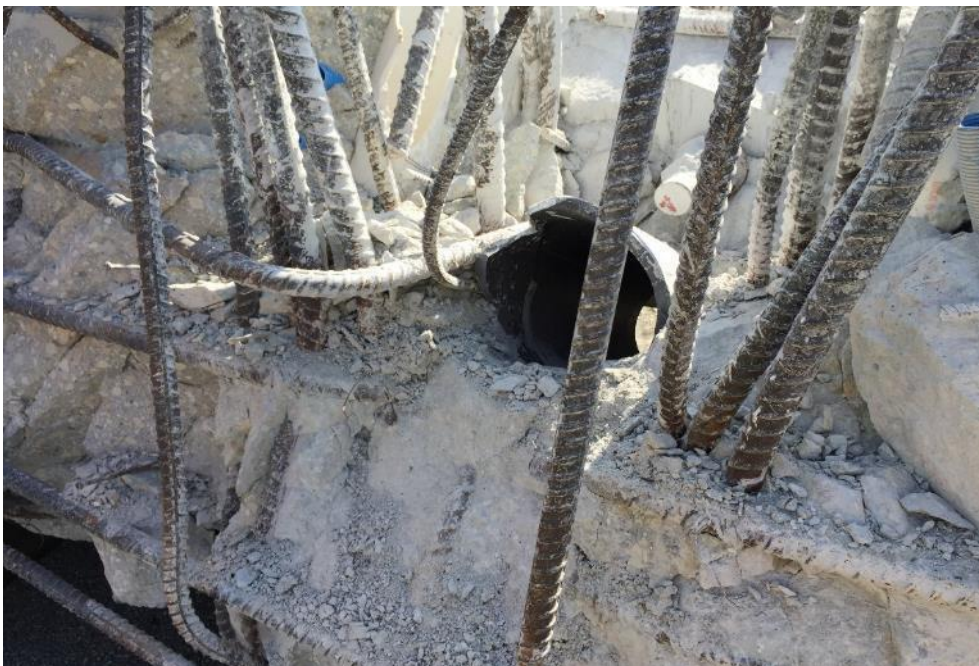
Figure 68 Punched hole in Diaphragm II at the time of the bridge collapse – from south looking towards north, April 9, 2018, by OSHA

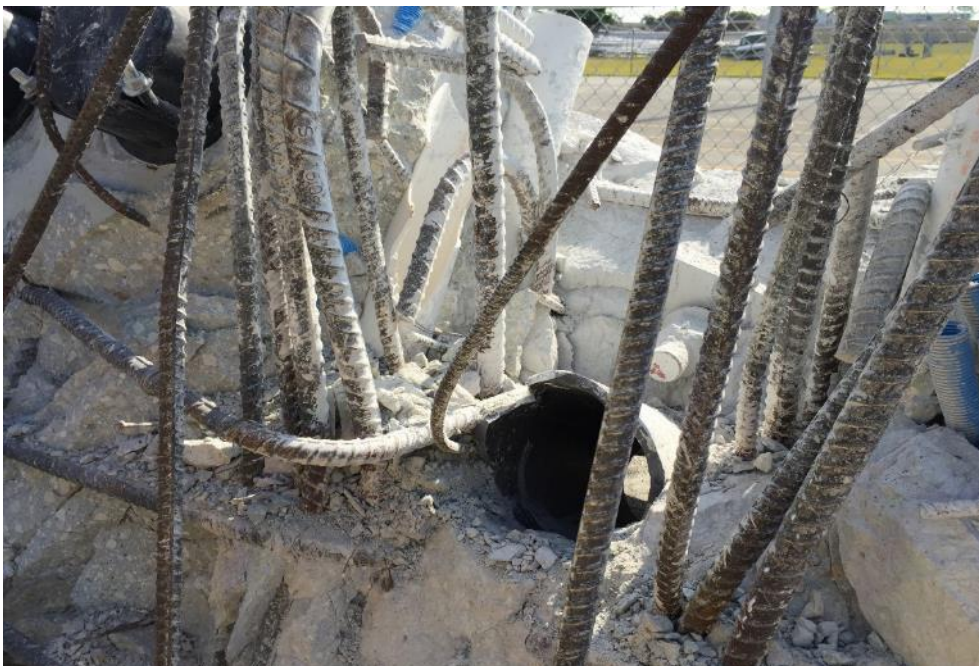
Figure 70 Punched hole in Diaphragm II at the time of the bridge collapse – from south looking towards north, April 9, 2018, by OSHA

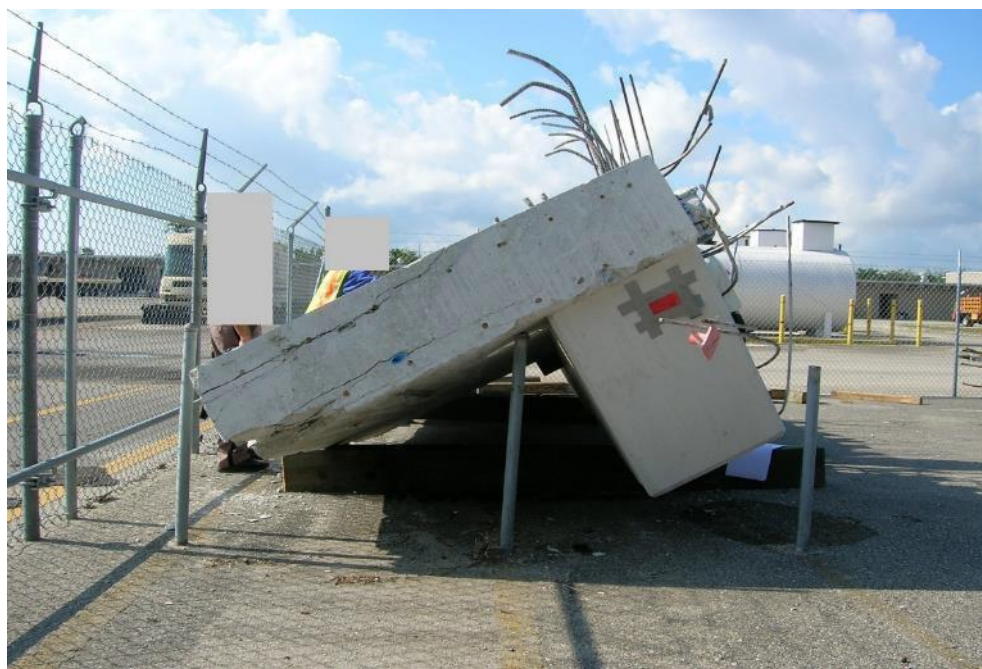
Figure 71 Side view of the saved portion of the diaphragm II in storage yard, April 9, 2018, by OSHA

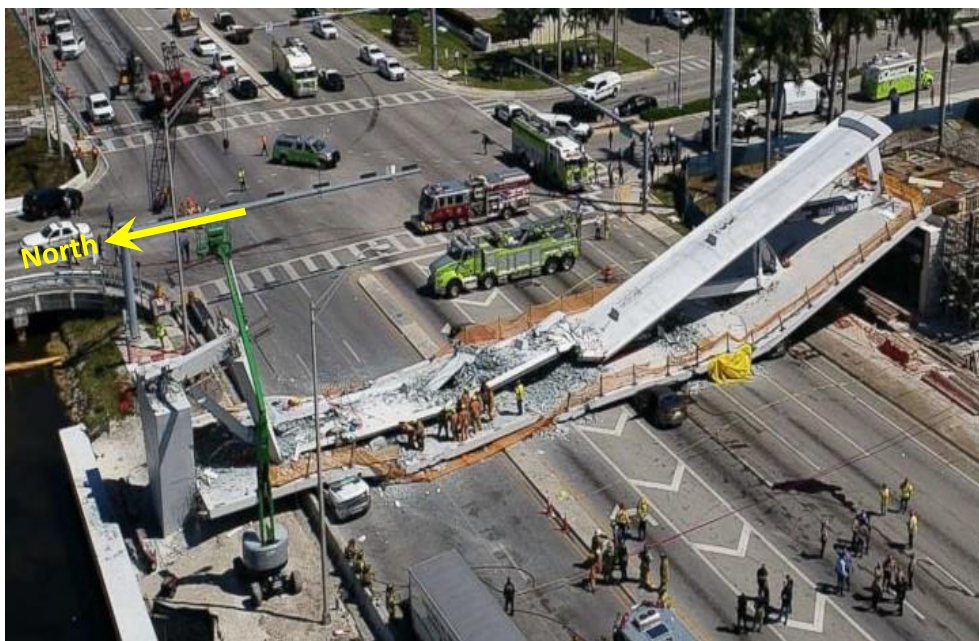
Figure 72 Aerial view of the collapsed bridge, March 15~18, 2018

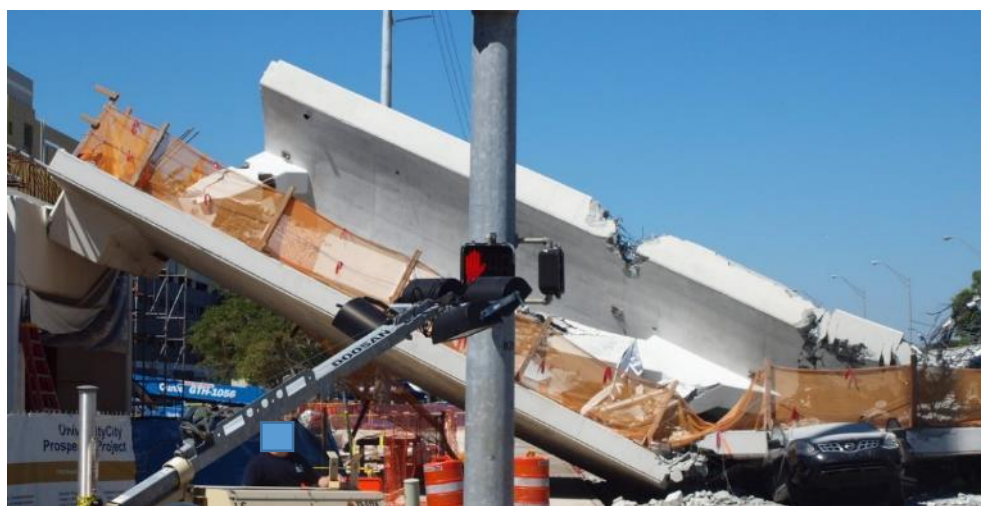
Figure 73 South end of the bridge after collapse – looking west

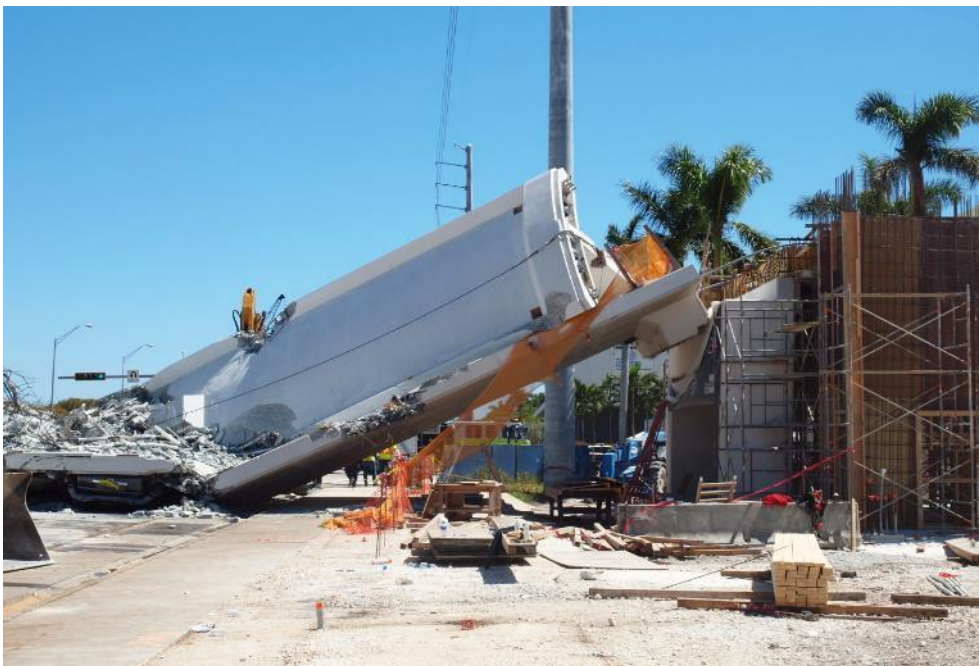
Figure 74 South end of the bridge after collapse – looking east

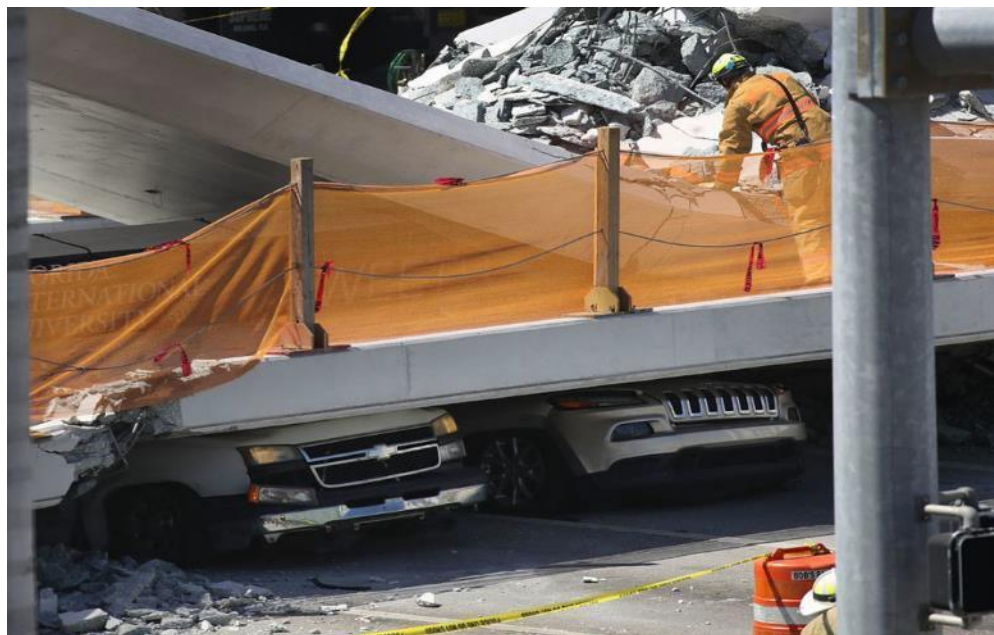
The collapse crushed five motorists in their cars that were stopped at the traffic light at the time of the collapse, see Figure 75. As stated earlier, one VSL employee was fatally injured and another VSL employee was critically injured.

Figure 75 Vehicles crushed by falling bridge

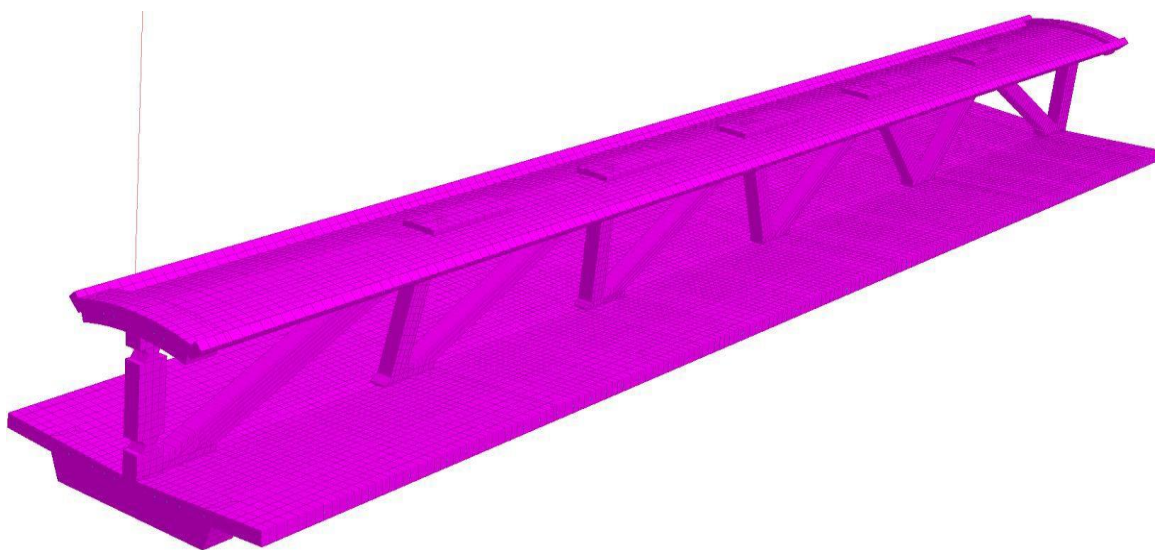
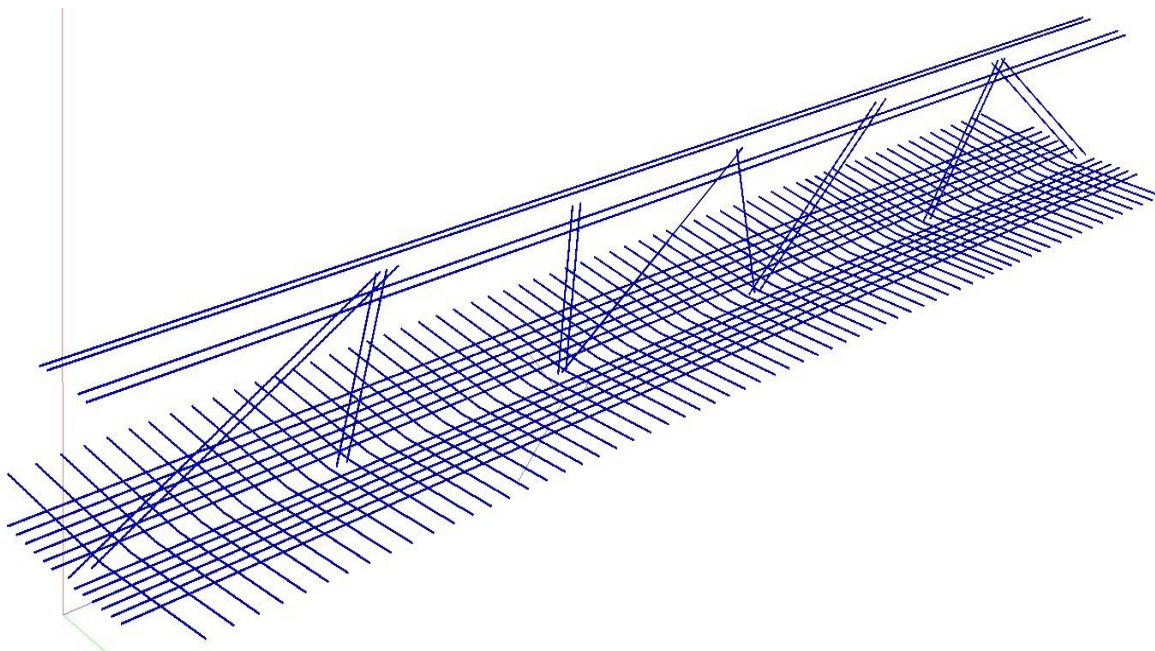
Figure 76 Overview of the main span truss system model

Three-dimensional (3D) finite element models of the main span truss system of the bridge were created in STAAD.Pro, as shown in Figure 76. All concrete components, including the canopy, the vertical and diagonal truss members (members 1 to 12), the deck, and deck diaphragms I and II, were modeled using 3D plate elements. All the steel post-tensioning tendons were modeled using truss elements by sharing the nodes with the plate elements. Therefore, the post-tensioning tendons were coupled to the concrete structures.

Structural models of the bridge main span are shown in Figure 76.
