# Structural Investigation of the January 20, 2014 Plant Collapse at International Nutrition Facility in Omaha, NE

U.S. Department of Labor  
Occupational Safety and Health Administration  
Directorate of Construction

July 2014

Report Prepared by  
Mohammad Ayub, P.E., S.E.  
Office of Engineering Services  
Directorate of Construction

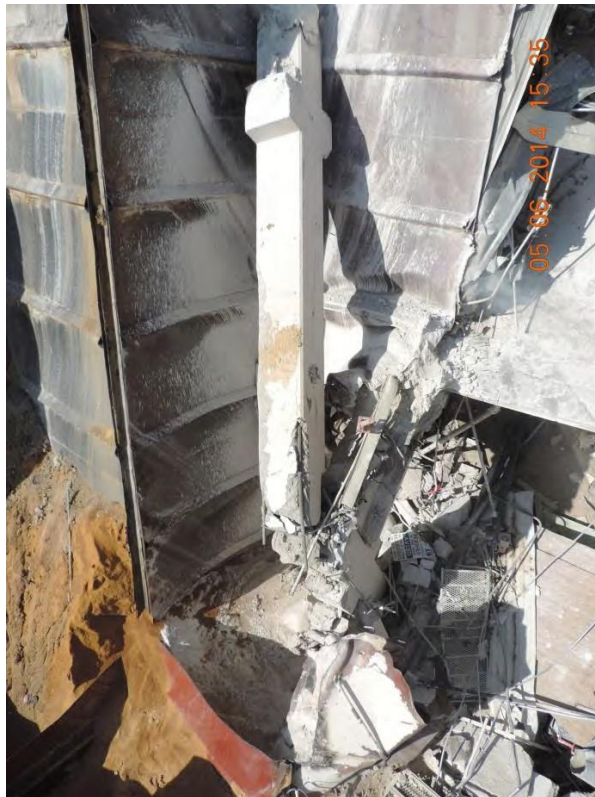
**Fig. 12** NE concrete column in bin No. 1

During the collapse, all four concrete columns remained intact except the NE column which was sheared at approximately the level of the inverted tee beam at the third floor, and was found inside bin No.1 during the demolition and recovery. The reason of the shear at that location was the lack of adequate lap splice of the longitudinal bars on one face of the column, see Figs. 99-103.

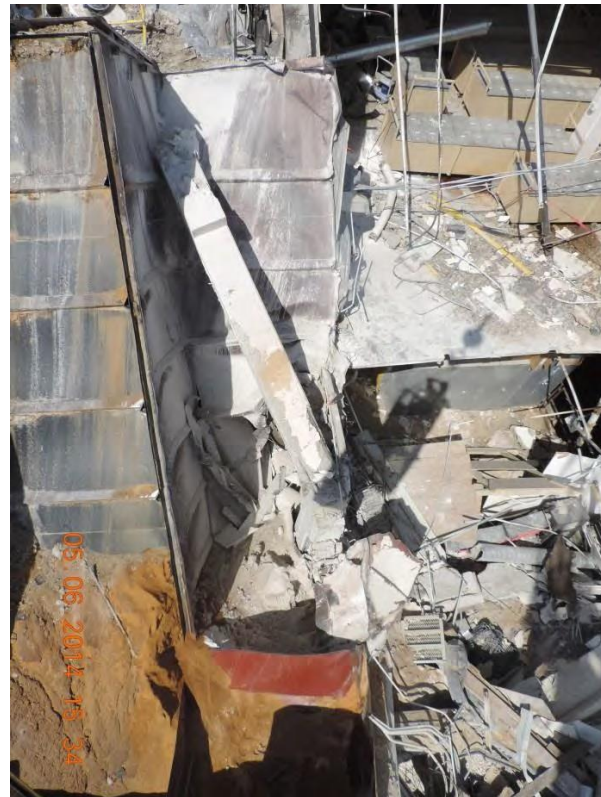
**Fig. 13** NE concrete column in bin No. 1

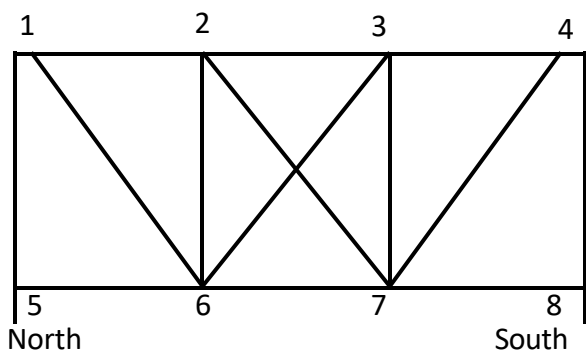
**Fig. 88** East Truss

The east and west trusses are shown in Figs. 88 and 89 respectively. Their joints are shown in Figs. 34 thru 51 below.

The four seated connections of the north and south trusses over the column cap plate did not exhibit any signs of failure except the damage sustained during the collapse. The top chords of all exterior trusses did not exhibit severe buckling except at some panel points, although it cannot be determined whether the buckling occurred pre- or post-collapse. The bottom chords of all the exterior trusses contained severe distortions; see Figs. 21, 22, 32, 41, 42, 49, 50, and 107 believed to have occurred during collapse. The connection plates at the bottom chord of all the exterior trusses to W8x40 remained intact, and the bottom chords near the connections remained relatively undamaged.

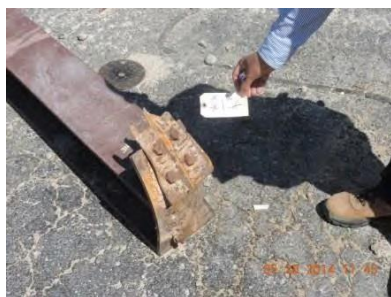
**Fig. 34**– Joint 1 – East truss

All four beam-bearing connections on the east and west exterior trusses failed when the 3/8" stiffener plate buckled. The four connecting bolts remained mostly intact, see Figs. 34, 39 and 44. The north and south trusses are shown in Figs. 86 and 87 respectively. Their joints are shown in Figs. 16 thru 33 below.

The weakest link in the structure was the four stiffened seated connections of the top chords of the east and west trusses at each end. The bottom flanges of the top chords of the east and west exterior trusses, W6x15, were bolted with four bolts to the ½” cap plate of the corner column projecting beyond the column flanges. The cap plate was welded to the column. A stiffener plate 3/8” thick was provided underneath the cap plate. The seated connection was subjected to a vertical load coming from the east and west trusses and a horizontal force equivalent to the compressive force in the truss top chords. Both the vertical and horizontal forces created eccentricity on the connection, and it was determined that a single stiffener plate would overstress the seated connection to failure. If either a north or south connection was provided with a sliding joint to relieve the horizontal force, the connection with only one stiffener plate would have been able to resist the loads satisfactorily. Alternatively, if two stiffener plates were provided as was done in the cases of the interior trusses, the stresses would be satisfactory. As stated earlier, all four stiffened seated connections failed, see Figs. 34, 35, 38, 44 and 47.

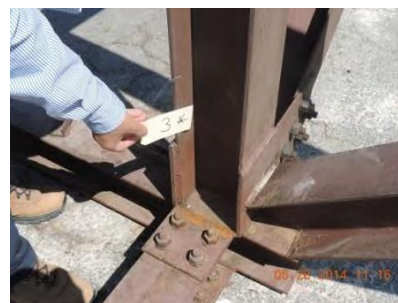
**Fig. 54** – Joint 3 – East interior

and were connected to the east and west exterior trusses by four bolts on an extended gusset plate. The top chords of the east and west interior trusses were simple spans and were connected by two bolts to the north and south interior trusses. It is noteworthy that the bottom panel joints of all four interior trusses were practically undamaged; see Figs. 54, 55, 59, 60, 66, 67, 74 and 75.

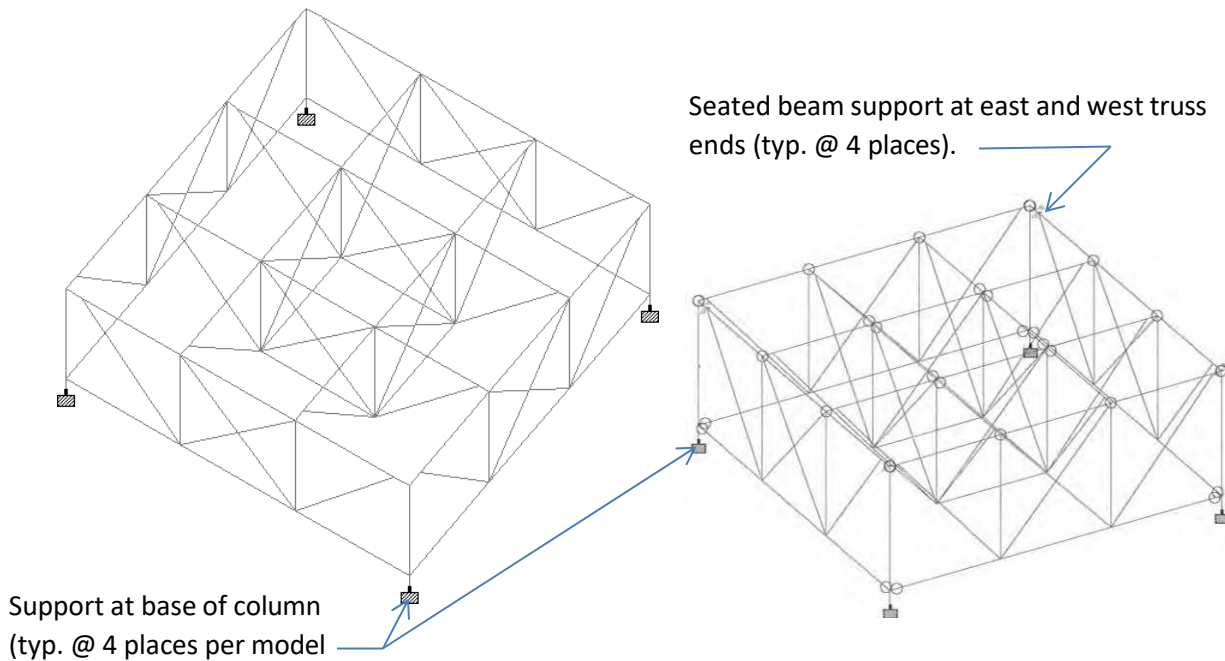
Two models were created to assess the stresses in different members of the trusses under different loading conditions. The first model provided the forces imposed on the stiffened seated connection by the east and west trusses at the north and south ends, and the second model provided the forces and stresses in the truss members. The first model more accurately reflected the existing framing conditions at the stiffened seat connection. Analyses were done under the Load Resistance and Factored Design (LRFD), and under Allowable Stress Design (ASD). Under the LRFD, no increase in loads was assumed by using a load factor of 1.0, and no capacity reduction was taken by using the phi factor as 1.0. The intent under the LRFD evaluation was to compute the failure load at which a collapse could occur. ASD evaluations provided the usual factors of safety in accord with the industry practice. A finite element analysis and hand computations were performed to compute the load that the stiffened seat connection could carry. Three dimensional views of the two models, and the finite element plate analysis are shown below, see Figs. 90 thru 94.

STAAD MODEL 2

**Fig. 90**

STAAD MODEL 1

**Fig. 91**

1. Case 1: To determine whether the existing structure could support limestone in the four corner bins, and rice hulls in the remaining five bins under LRFD method (no factor of safety) using model No.1. All bins were assumed to be filled up to 85% of the capacity. Absence of factor of safety is a violation of industry standards.

**Result: All truss members passed but the seated beam connections failed.**
2. Case 2: Same as Case No.1 but using model No. 2. Again no factor of safety.

**Result: All truss members passed but the seated connections failed**
3. Case 3: To determine whether the existing structure could safely support limestone in four corner bins, and rice hulls in the remaining five bins with the required factor of safety (using ASD method), as per industry standards, using model No.1. All bins were filled up to 85% of capacity.

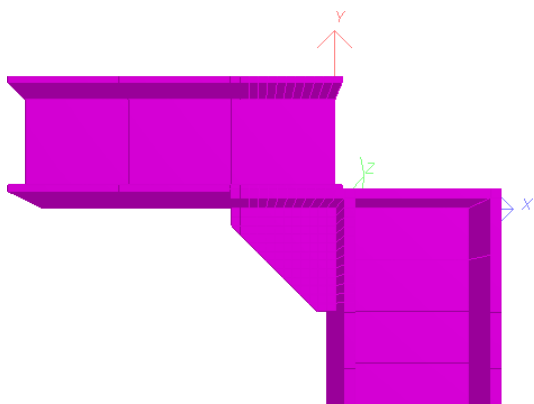
**Fig. 94** Finite element model
