# Pressure Vessel Explosion at Loy-Lange Box Company

St. Louis, MO | Incident Date: April 3, 2017 | No. 2017-04-I-MO

# **Investigation Report**

### Published: July 29, 2022

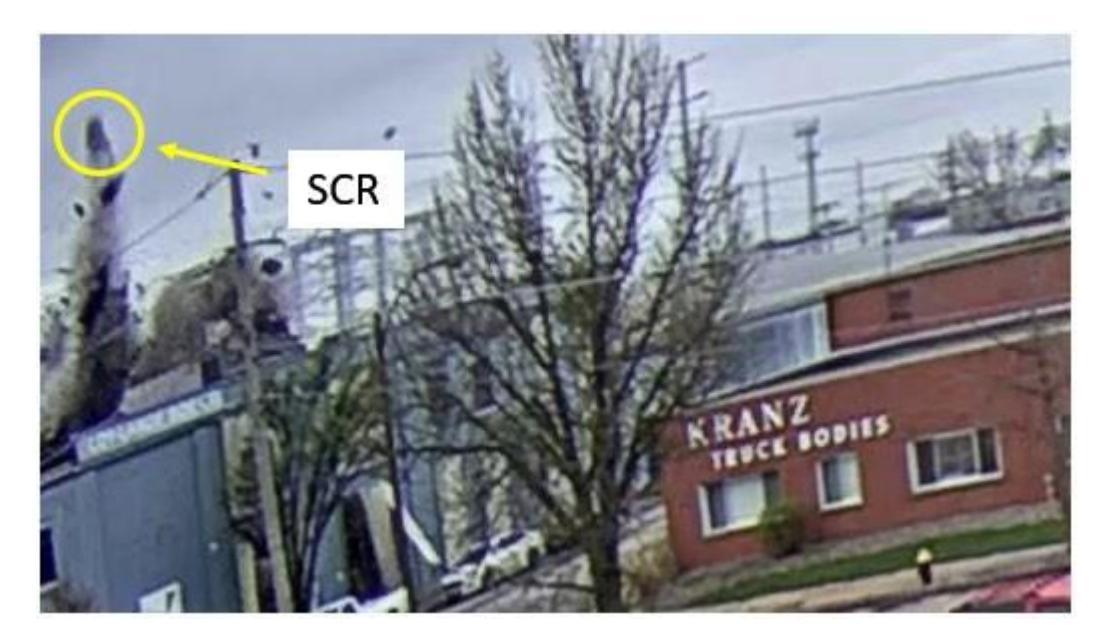
On Friday, March 31, 2017, Loy-Lange stationary engineers observed a leak that appeared to be coming from underneath the SCR. One stationary engineer took photos of the underside of the vessel to confirm the leak. Another contacted a local welding company and requested that it assess the vessel and make a repair recommendation. The welding company was not available to visit the Loy-Lange facility until the following Monday, April 3, 2017. Loy-Lange continued operating the leaking pressure vessel throughout the remainder of the Friday production schedule and shut down the steam system as normal that evening. The following Monday a Loy-Lange stationary engineer began his normal start-up routine at about 6:00 a.m. At around 7:20 a.m. on April 3, 2017, the SCR bottom head catastrophically failed. The SCR was launched from the Loy-Lange building and into the air (**Figure 9, Figure 10**).

**Figure 9**. Surveillance video still capturing explosion. (Credit: Kranz Body Co., annotations by CSB)

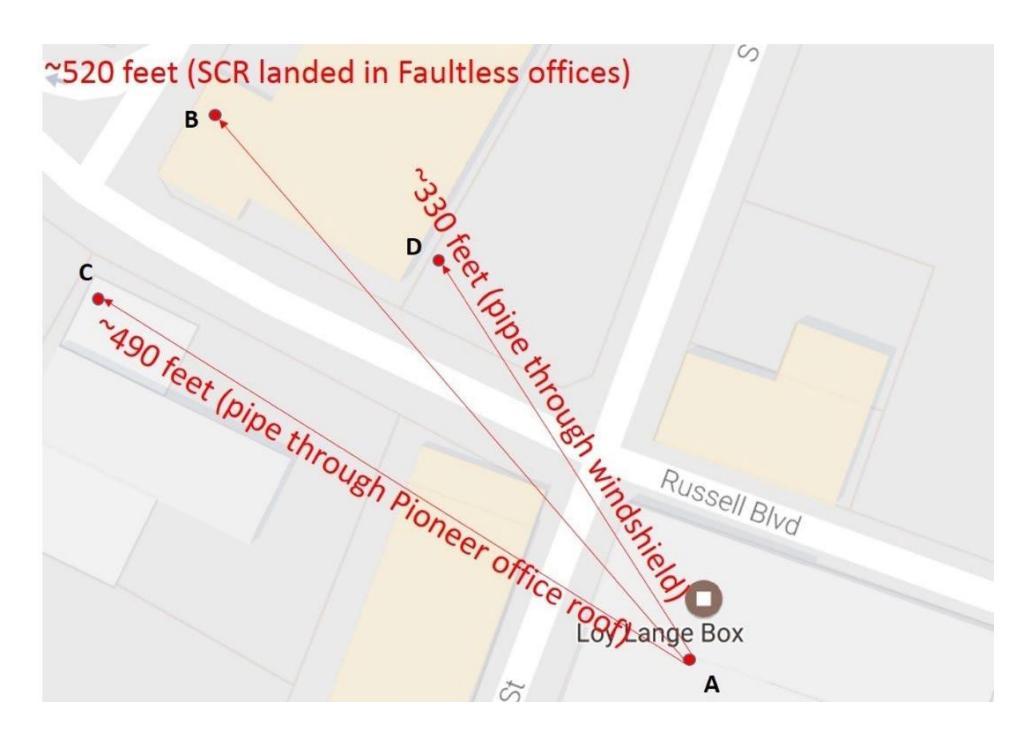
The vessel remained airborne for approximately 10 seconds<sup>a</sup> and traveled laterally approximately 520 feet (**Figure 11A**, **Figure 12**). The SCR fell through the roof of the nearby Faultless Healthcare Linen company one block away, where it came to rest (**Figure 11B**). Various other pieces of debris from the explosion also fell into the surrounding area. A third building in the vicinity, owned by Pioneer Industrial Group, suffered damage when a large piece of pipe from the Loy-Lange explosion punctured the roof and ruptured its water sprinkler system

(Figure 11C). A section of 1.5-inch pipe approximately seven feet in length pierced the windshield and embedded in the dashboard and through the floorboard of an unoccupied pickup truck parked in the area (Figure 11D). A map of the debris field is shown in Figure 12. As a result of the incident, one stationary engineer at Loy-Lange was fatally injured. At Faultless Healthcare Linen, three employees were fatally injured when the SCR fell through the roof.

Figure 12. Debris map from incident. (Credit: Google, annotations by CSB)

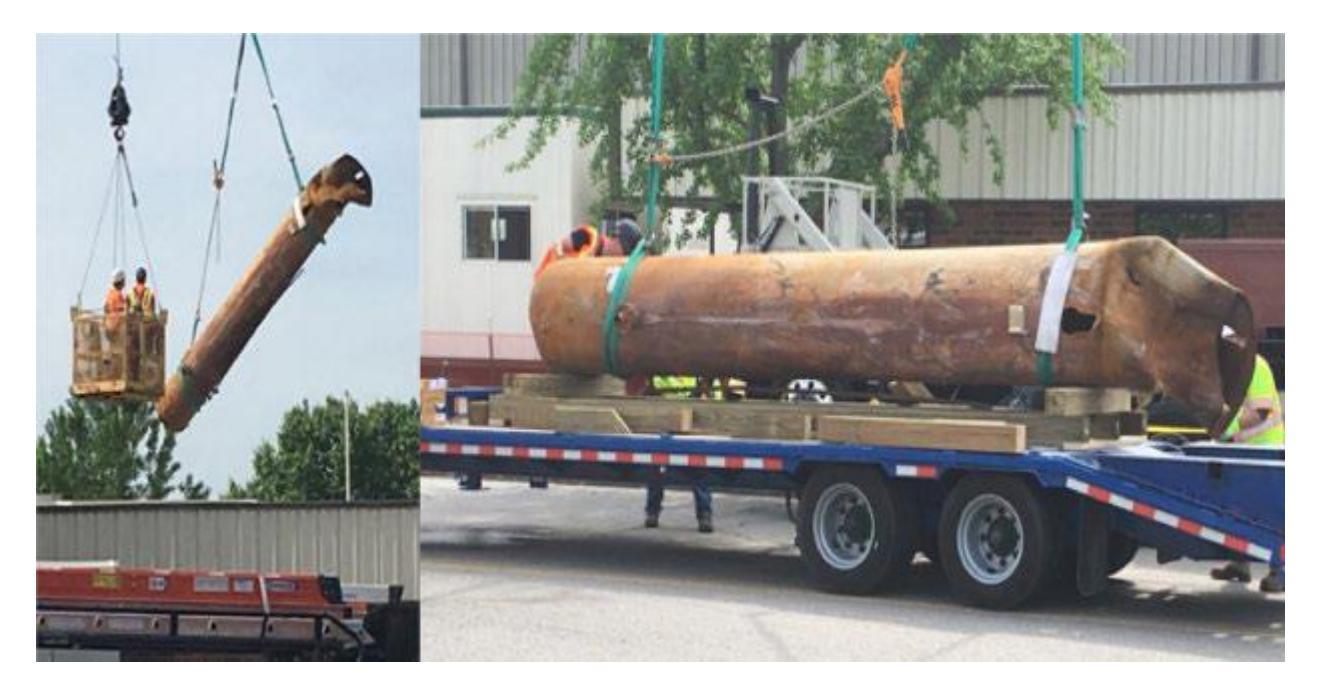
Figure 13. Removal of the SCR from Faultless Healthcare Linen facility. (Credit: CSB)

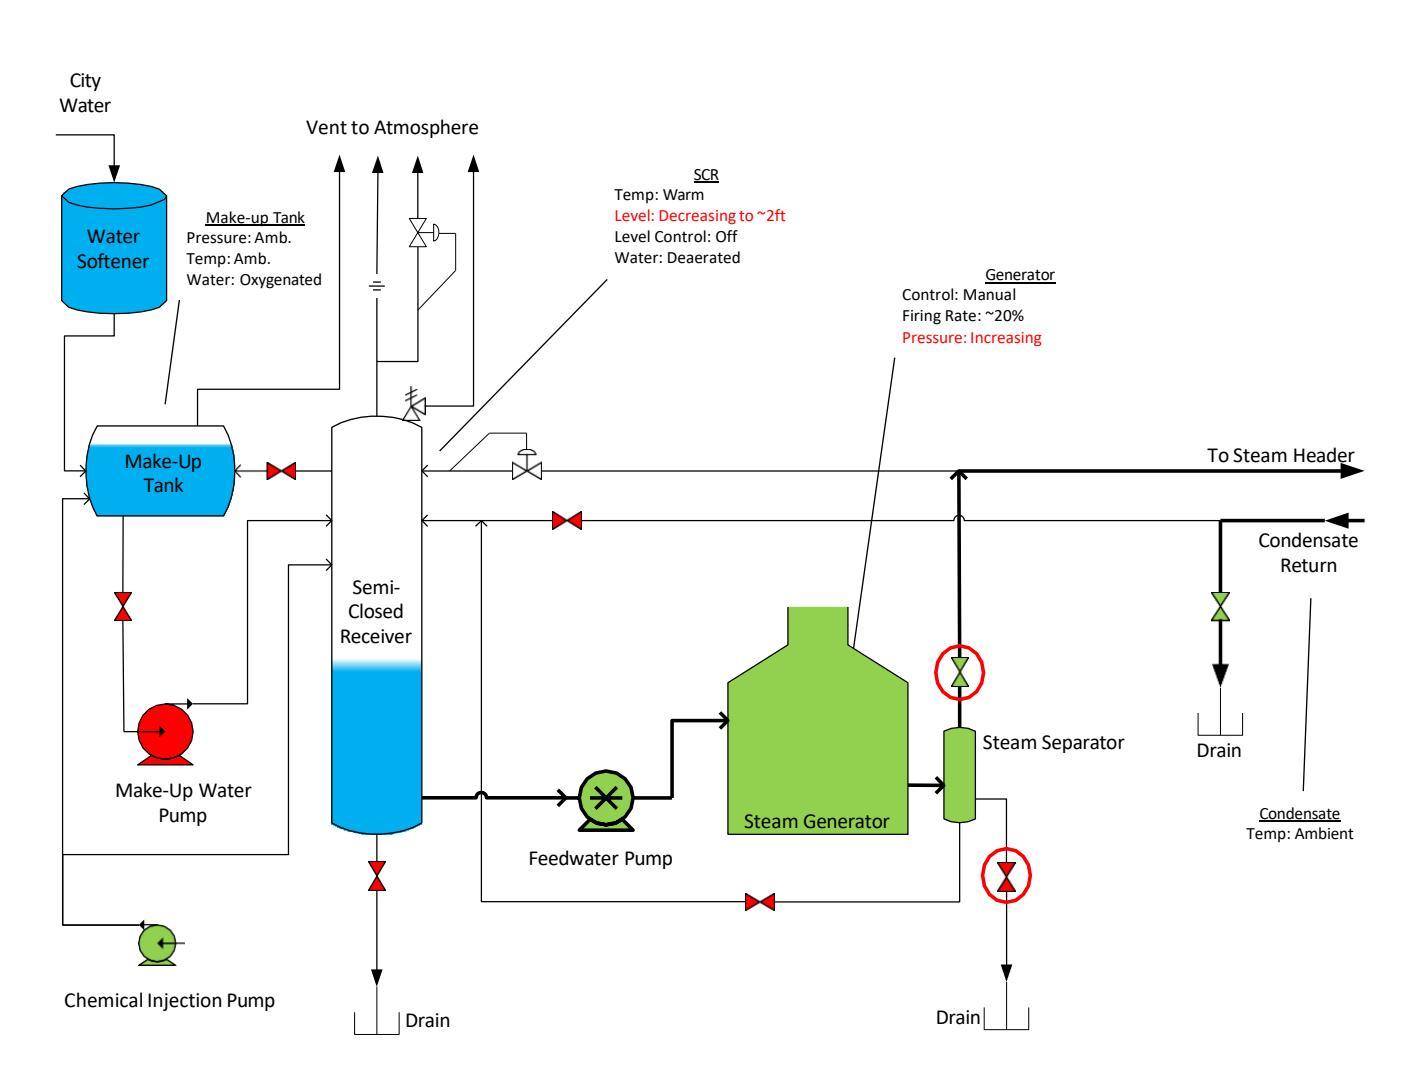
- 4. Once the generator was producing steam, operators slowly opened the valve isolating the steam generator and separator from the process steam header, allowing steam to flow out to the corrugation process equipment.
- 5. During this time, the liquid level inside the SCR slowly fell from approximately 14 feet to approximately 2 feet,<sup>a</sup> nearly emptying the SCR (**Figure 24**).

Figure 24. Simplified process flow diagram illustrating steam flowing to the steam header. (Credit: CSB)

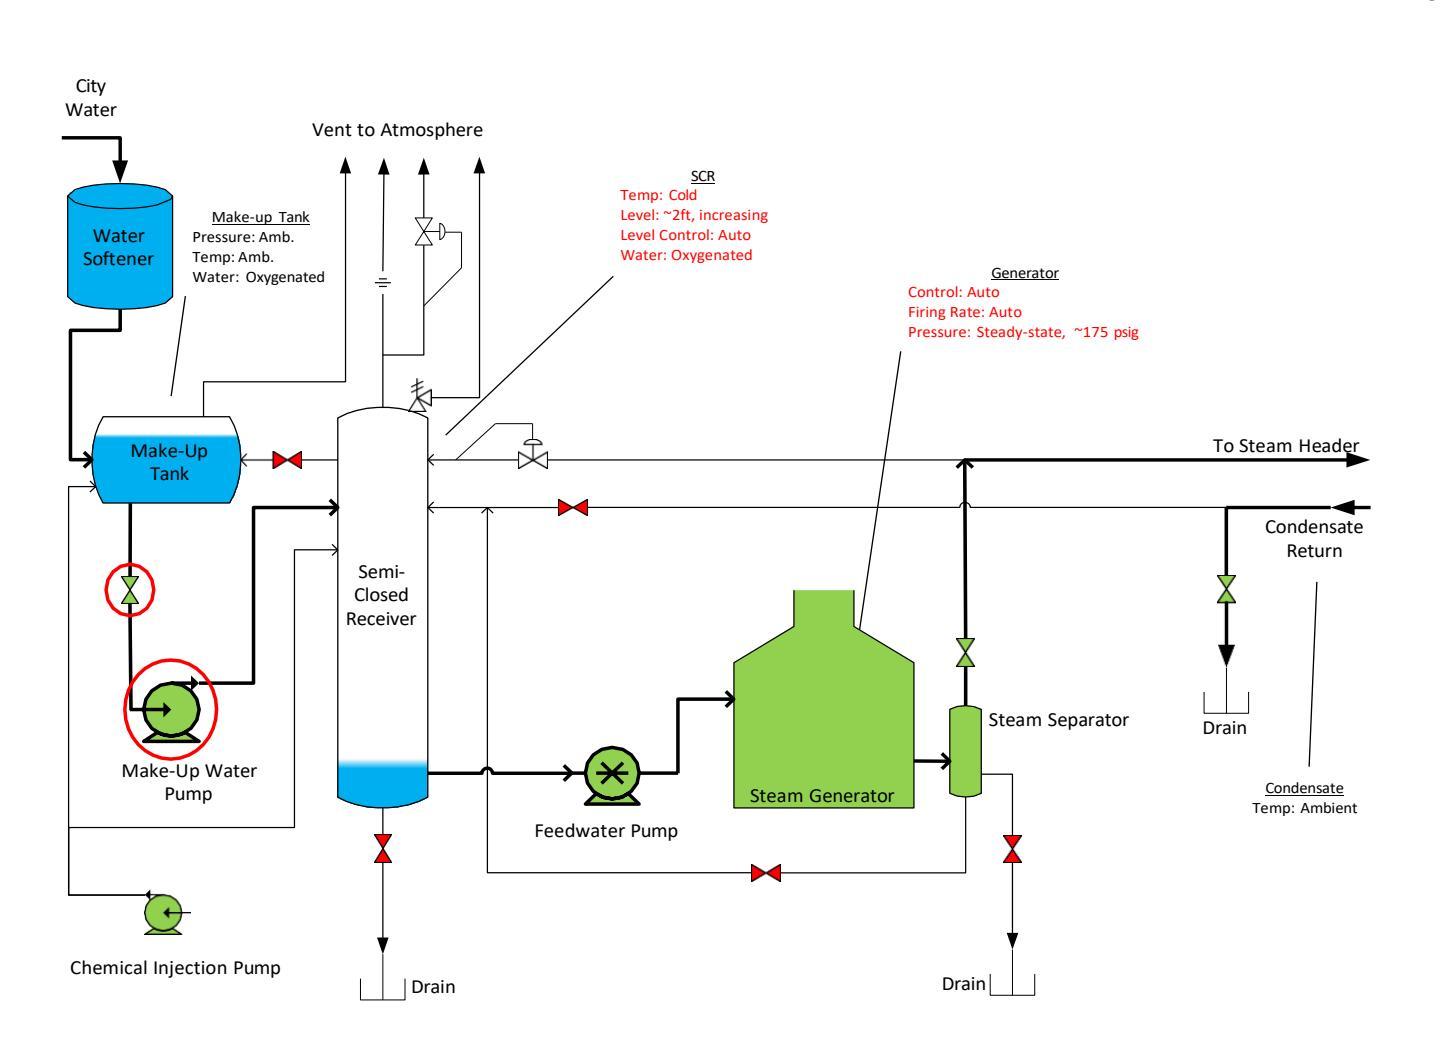
6. Once the SCR was nearly empty, operators placed the SCR level controller in automatic and opened the make-up water supply valve to the SCR. The level controller began calling for make-up water, which turned on the make-up water pump, refilling the SCR with make-up water (Figure 25). Because Loy-Lange claimed that its relevant records were destroyed in the explosion, the CSB could not review documentation or data<sup>a</sup> indicating that the make-up tank water was effectively heated by steam and mechanically deaerated—which would occur at temperatures between 190-200°F—before the water was introduced to the SCR. In the event the makeup tank was not heated to the requisite temperature before the water was introduced to the SCR, oxygenated water would be fed to the SCR at this point during the steam system startup operation.

Figure 25. Simplified process flow diagram illustrating the introduction of make-up water. (Credit: CSB)

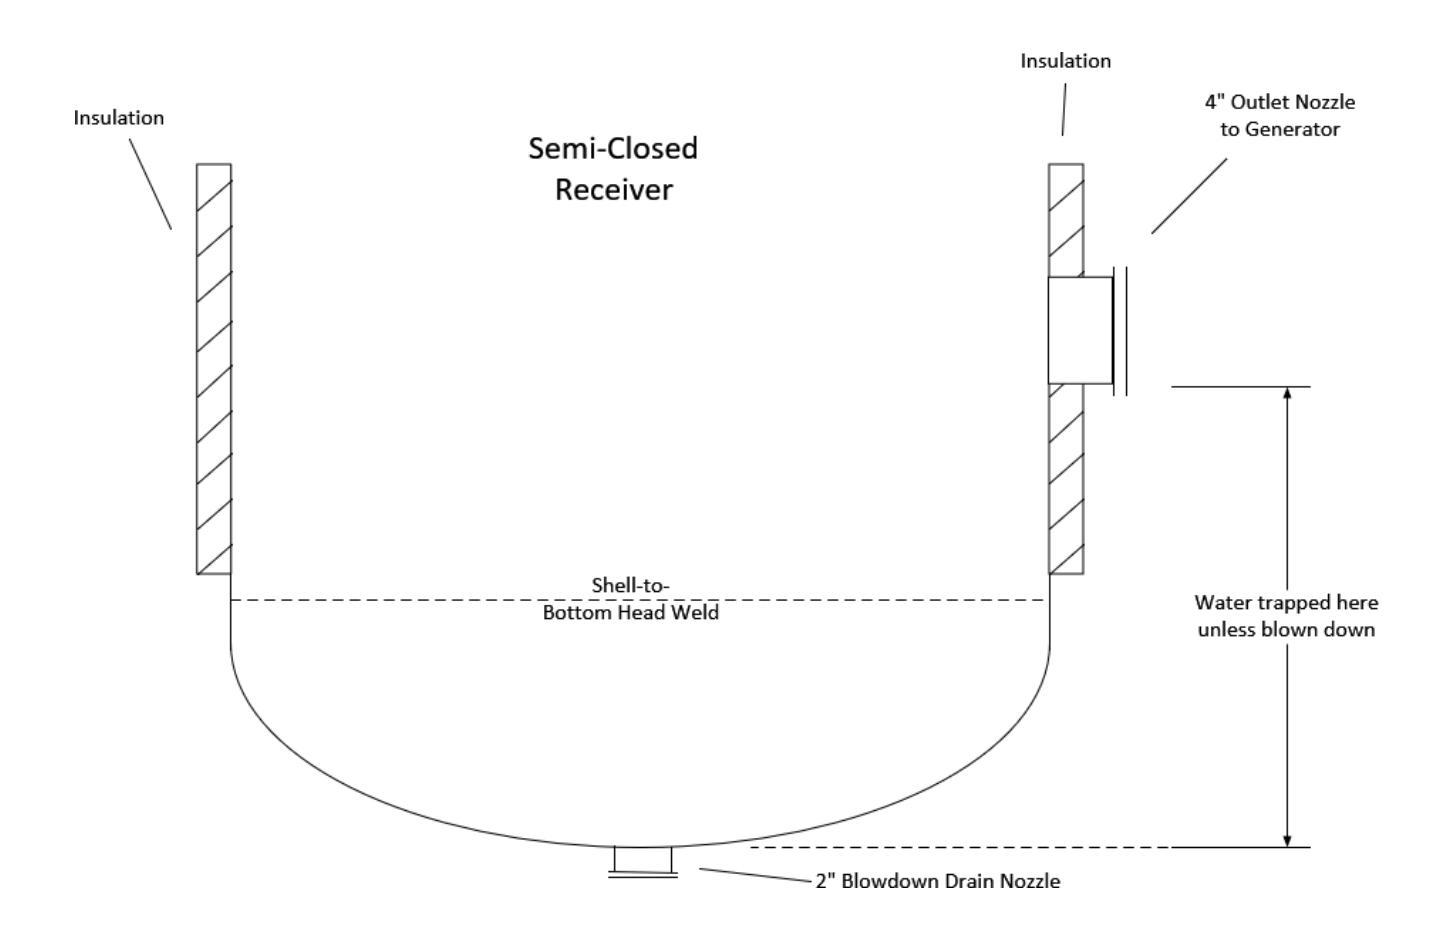
- 7. Eventually, operators routed the returning condensate back to the SCR instead of to drains (circled valves in **Figure 26**).
- 8. Unless operators performed a procedure called *blowdown* (see **Figure 27** and Section 1.7.3), a portion of water in the SCR below the outlet nozzle likely was trapped in the bottom head.

Figure 27. Conceptual diagram of the SCR bottom head. (Credit: CSB)

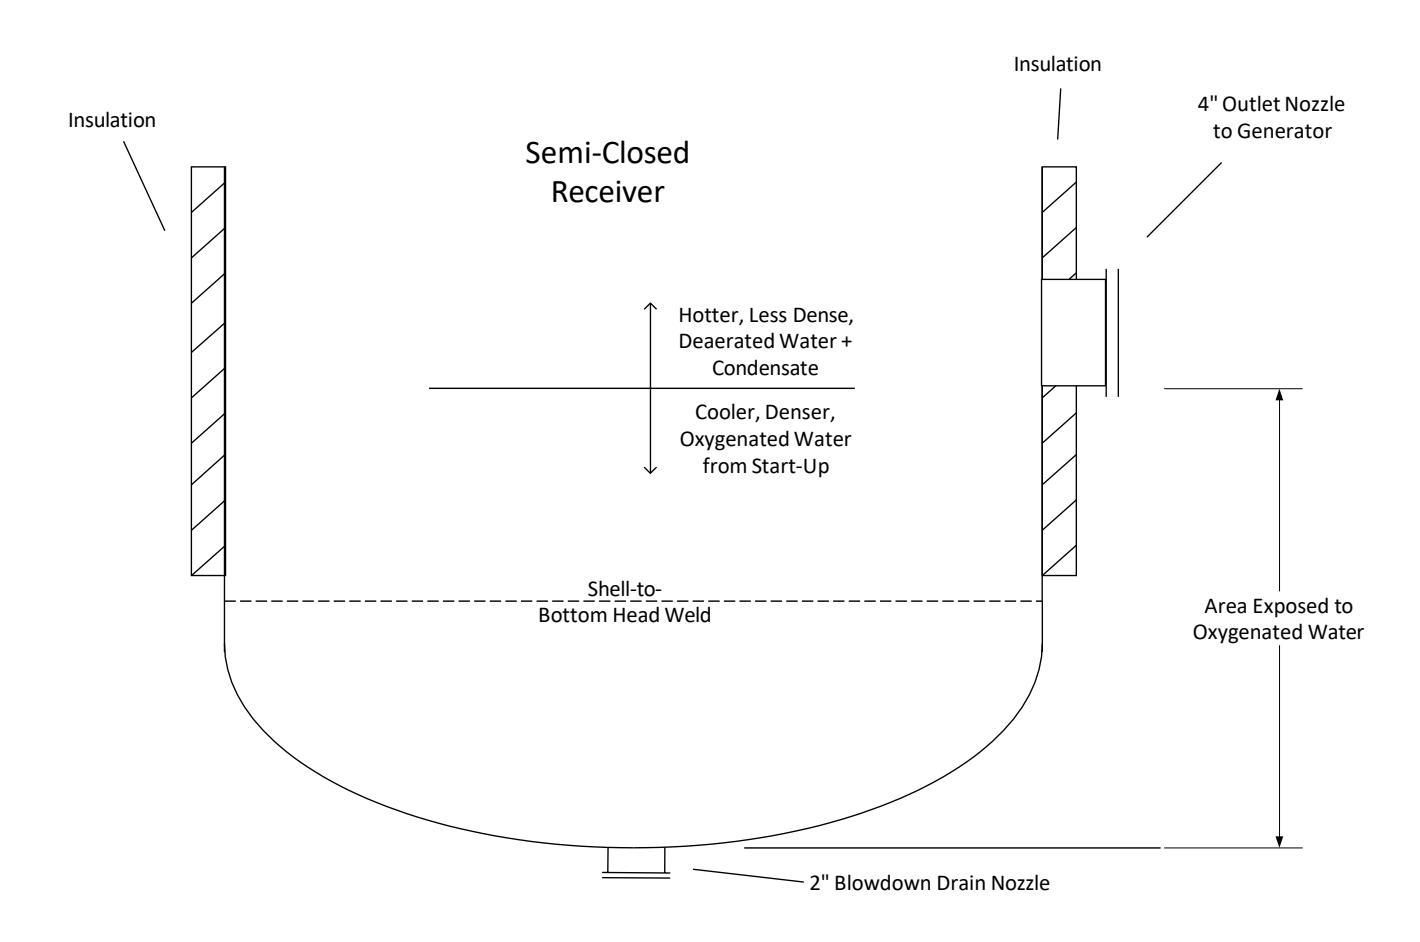
This oxygen, likely introduced into the SCR during daily startup operations, was the result of either insufficient mechanical deaeration, chemical deaeration, or both. Because the SCR bottom head trapped water below the SCR outlet nozzle (illustrated by **Figure 32**), some oxygenated water from startup would remain trapped at the bottom of the vessel until operators performed the weekly blowdown. Although blowdown was not expressly intended by Clayton to remove dissolved oxygen from the system (Section 1.7.3), given that oxygenated water likely remained trapped in the SCR bottom head, it is likely that blowing down the SCR daily after startup would have drained oxygenated water from the bottom head and filled it with treated water. The CSB concludes that Loy-Lange likely introduced oxygen into the SCR during its daily startup operation.

Figure 32. Conceptual diagram of the SCR bottom head. (Credit: CSB)

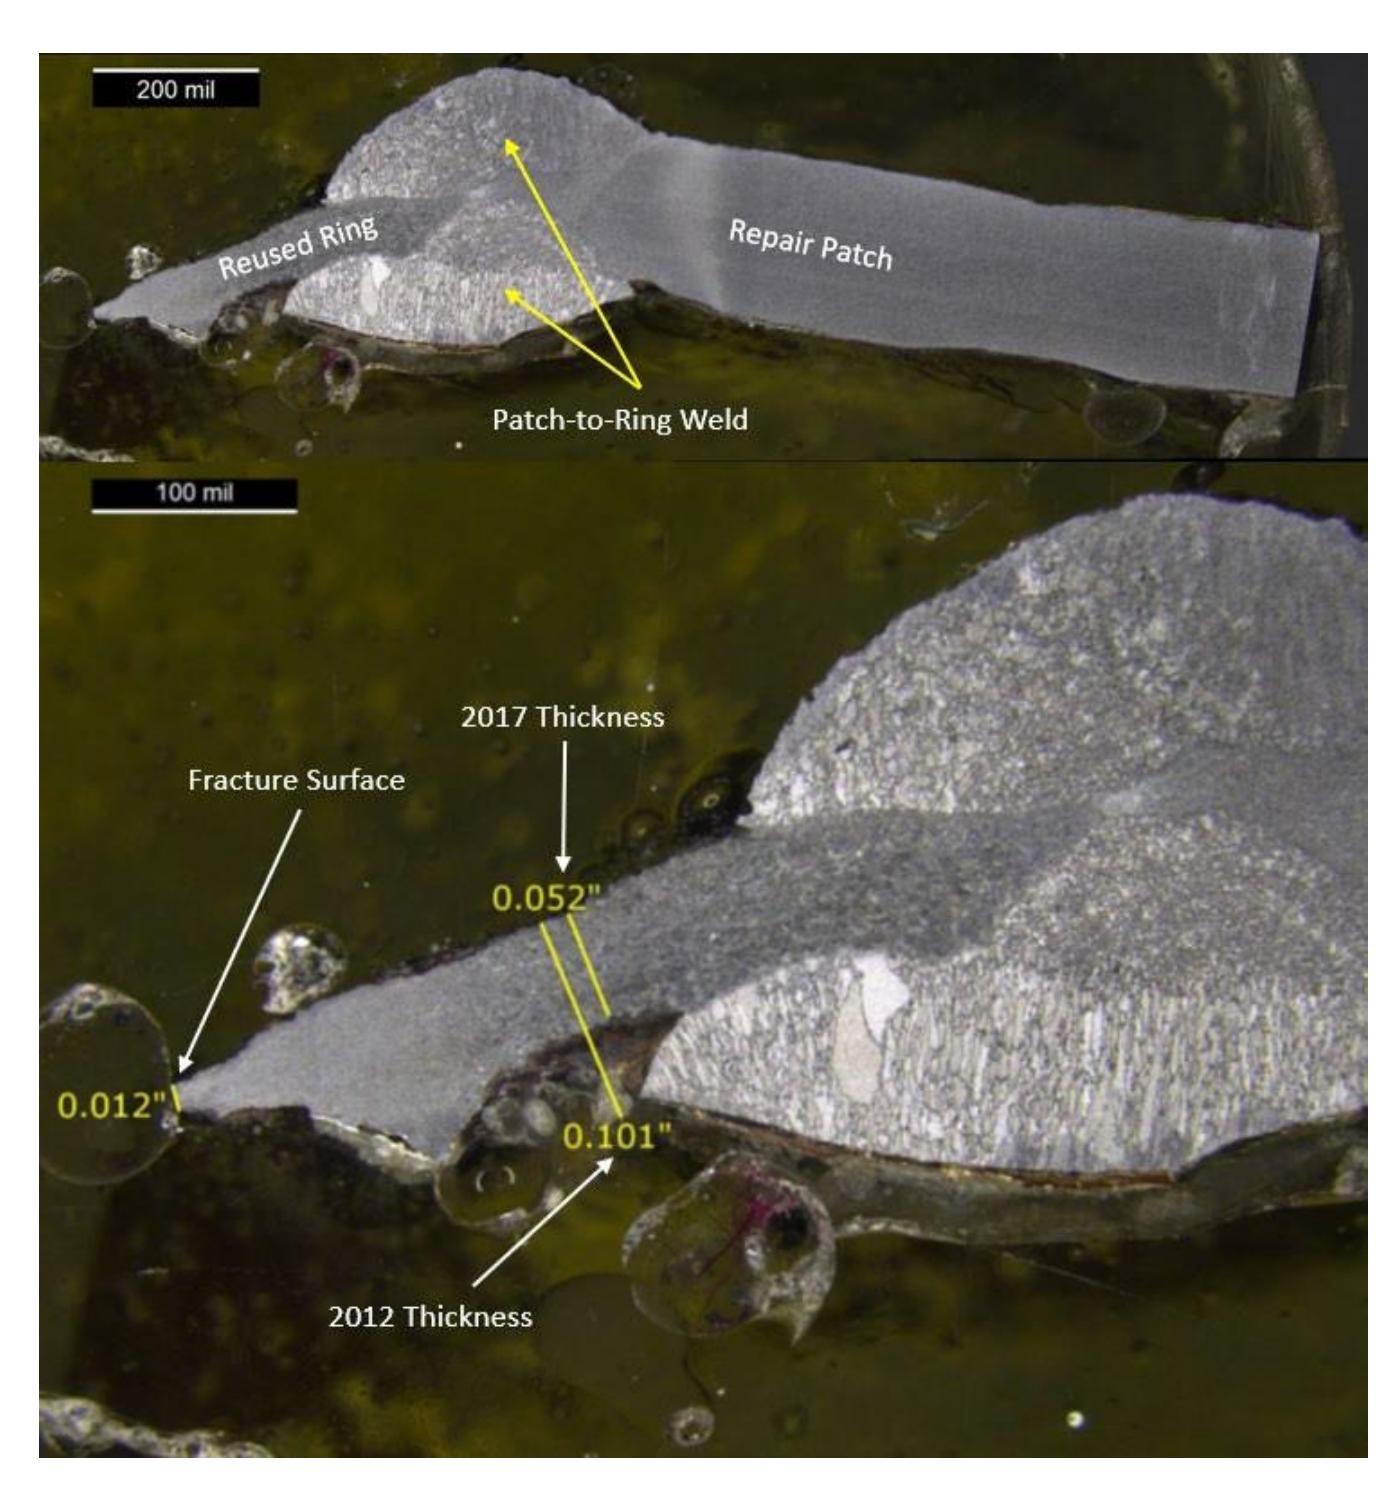
- Via non-destructive thickness examination, the post-incident thickness of the reused ring and the repair patch were measured in adjacent locations on either side of the weld (discussed in Section 1.6.2, shown below in **Figure 34**). The average measured thickness of the reused ring was 0.119 inches, and the average measured thickness of the patch material was 0.216 inches. Thus, post-incident, on average, the patch was roughly 80% thicker than the ring. It is not likely that the ring and patch were both the same thickness in 2012 when the repair was made, because if that was true, there would likely not be a significant difference in thickness in 2017.

According to Kickham, it used visual examination and a measuring tape to verify the thickness of the plate (Section 1.3). These methods, however, failed to detect the presence of the remaining corroded material. A more accurate quantitative measurement of the thickness of the re-used steel, such as the use of calipers or ultrasonic thickness measurement, may have prevented this incident by enabling Kickham to measure more precisely the thickness of the material it planned to leave in place and remove any material that did not meet the vessel's minimum thickness requirements.

Figure 34. Thickness comparison on either side of patch-to-ring weld. (Credit: CSB).

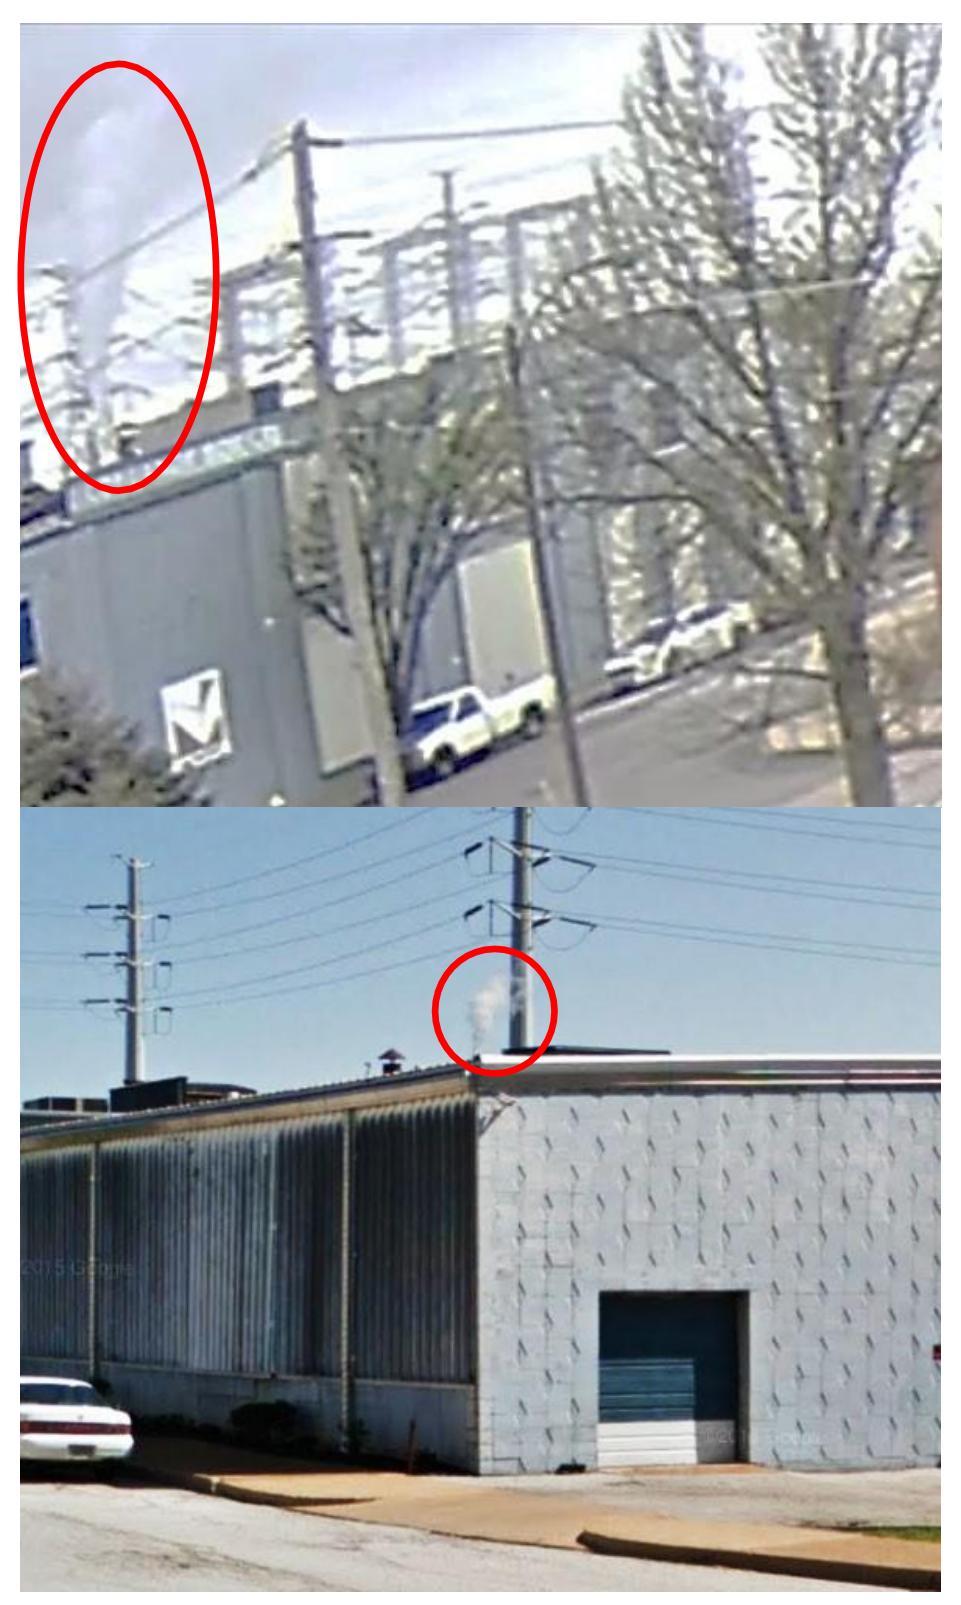
Evidence available to the CSB suggests that a steam system process upset may have occurred during the steam system startup on April 3, 2017. A surveillance video capturing the explosion shows a large plume of steam venting with high velocity from the roof of the building just before the incident (**Figure 36**, top). This steam plume appears substantially larger than the normal plume seen venting from the building historically.

For comparison, using Google Earth<sup>®</sup> and Google Street View<sup>®</sup>, the CSB evaluated historical images of the Loy-Lange facility. These images show a small white steam plume emanating from the roof of the facility, which may be from the normal venting of vapor during the deaeration process to remove dissolved gases [31]. One representative photo of the typical steam plume is shown in **Figure 36**.

One of the Loy-Lange stationary engineers confirmed to CSB investigators that the vapor venting from the roof of the facility immediately before the SCR rupture was abnormally large. After seeing the surveillance video, the stationary engineer said:

That was coming off awful hard. That sure looks like it's coming out faster than normal. [...] That's blowing out awful hard. That is much larger than I would have expected from it. [...] Normally, it's like a little wispy cloud [...]

Figure 36. Steam plume comparison. (Credit: Top: Kranz; Bottom: Google, edited and annotated by CSB)
