# Tank Explosion in West Virginia

# Investigation Report

Published: December 2019

On May 24, 2017, an explosion occurred at the Midland Resource Recovery (MRR) facility in Philippi, West Virginia, killing two workers<sup>a</sup> and severely injuring another worker. The founder and president of MRR was one of the victims. The CSB initiated an investigation of the incident and deployed an investigative team on May 28, 2017. While the CSB was investigating this incident, the MRR facility experienced a second explosion, on June 20, 2017. This explosion fatally injured a contractor<sup>b</sup> employed by Specialized Professional Services, Inc. (SPSI). MRR had hired SPSI to perform investigation and mitigation work at its Philippi facility following the May 24, 2017, explosion.

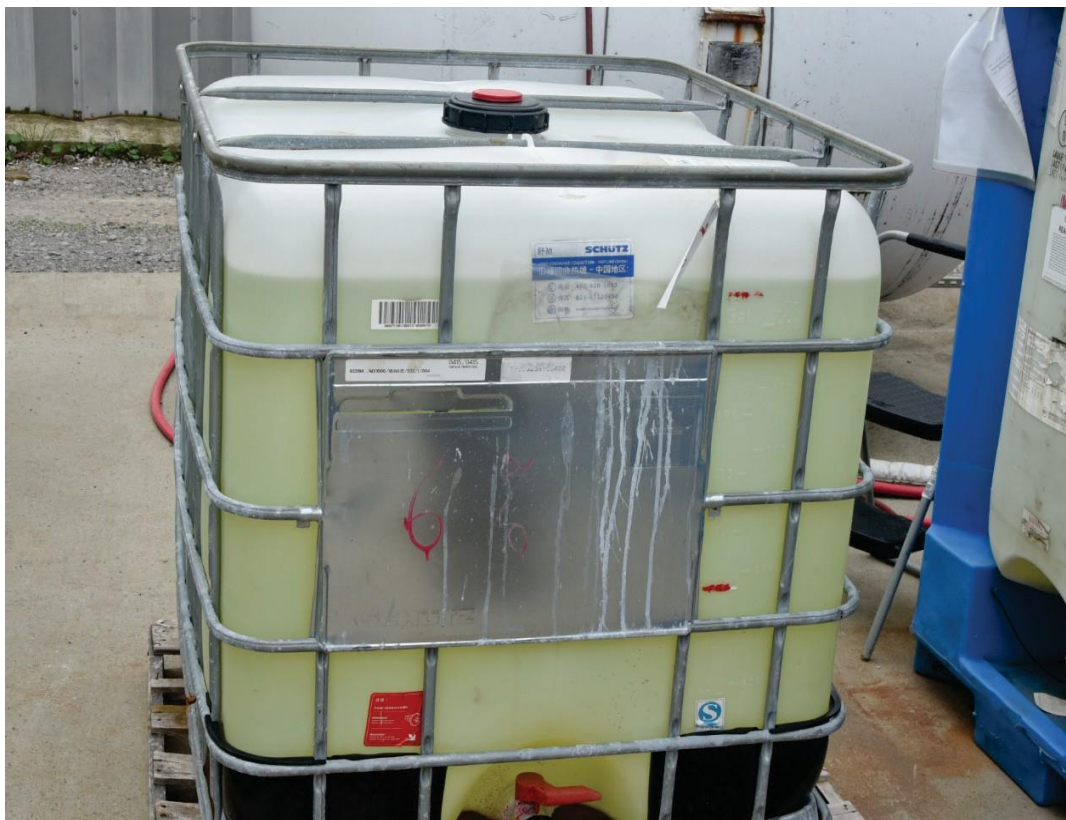
Figure 4. Sodium Hypochlorite Tote. This picture shows one of the totes at MRR that contained sodium hypochlorite. (Credit: CSB).

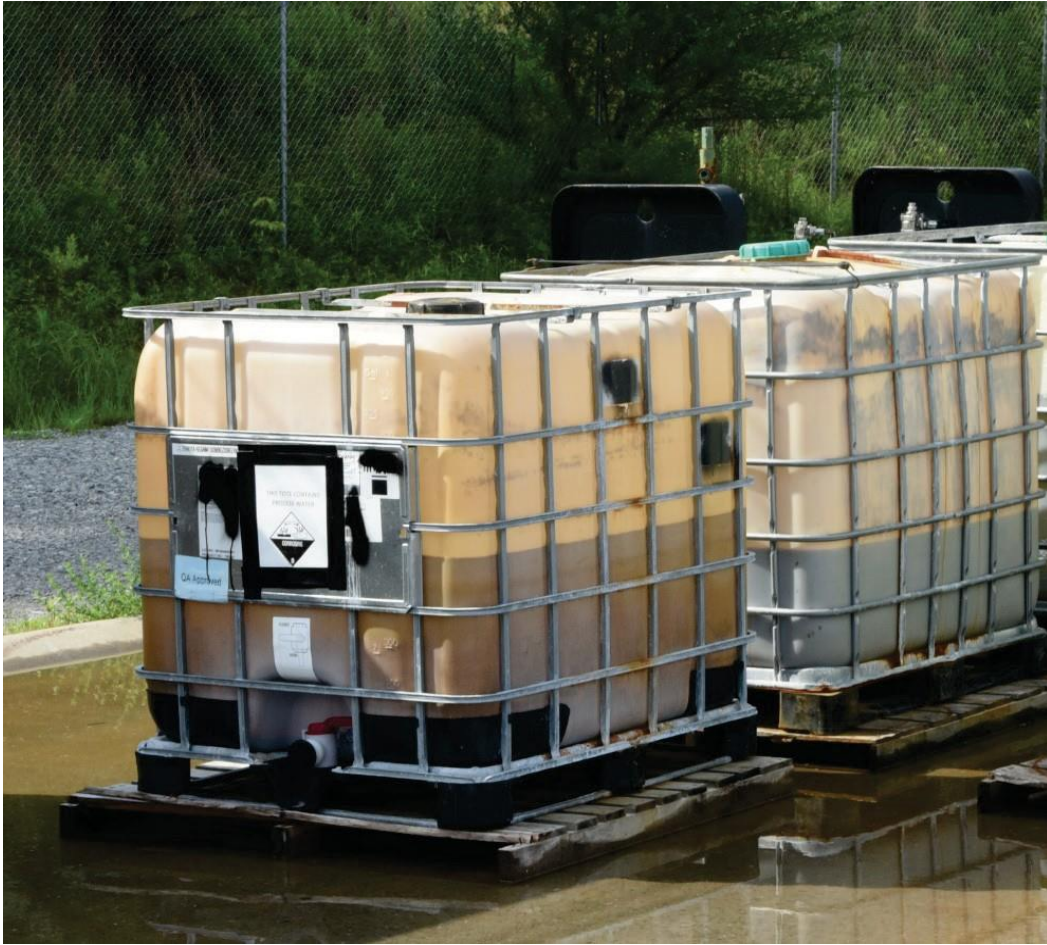
Figure 5. Process Water Totes. This picture shows totes at MRR containing “process water” that MRR technicians have pumped out of treated odorizer equipment. (Credit: CSB).

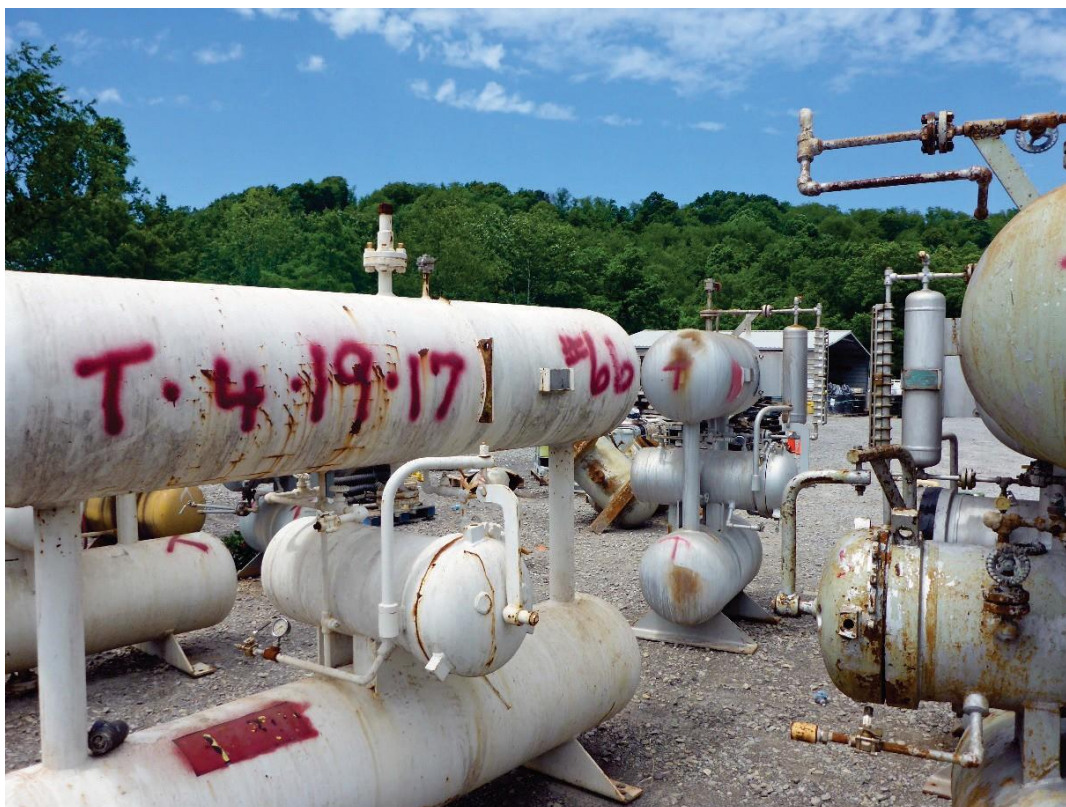
MRR decommissions up to 20 Peerless MP Odorizers per year. In early 2017, MRR had accumulated 16 MP odorizers at its Philippi site that needed chemical treatment. MRR had treated those MP odorizers by May 2017 with a solution of diluted sodium hypochlorite. The chemical treatment was done by completely filling the three vessels of each MP with the diluted sodium hypochlorite solution. Some of the MP odorizers were spray painted with the date they were treated (Figure 7). MRR generally tracked what stage of the decommissioning process a tank was in by spray painting a symbol, such as “T” for *treated* and “D” for *drained*, on the vessel.<sup>a</sup>

Figure 7. Treatment Status. This photo shows how MRR technicians used red spray paint to record the date the MP was chemically treated, April 19, 2017. (Credit: CSB).

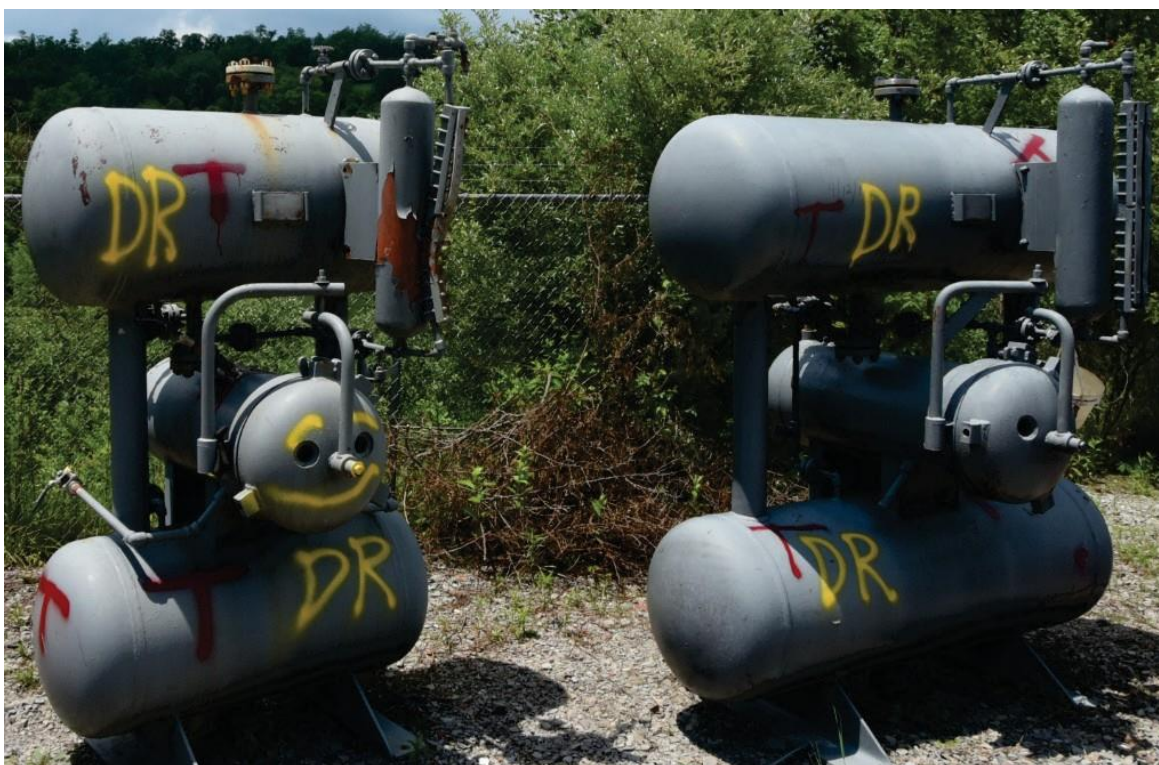
In May 2017, after roughly one month of chemical treatment with the sodium hypochlorite, MRR personnel began draining the treated MP odorizers. Spray paint markings (Figure 8) and equipment connections indicated that three of the 16 treated MP odorizers had been drained.

Figure 8. Drained Status. This photo shows how MRR technicians spray painted odorizer equipment with a “D” or a “DR” for *drained* (in yellow) after they drained the sodium hypochlorite treatment solution from the odorization equipment. (Credit: CSB).
