# EPA/OSHA JOINT CHEMICAL ACCIDENT INVESTIGATION REPORT

Napp Technologies, Inc.  
Lodi, New Jersey

## **Executive Summary/Overview**

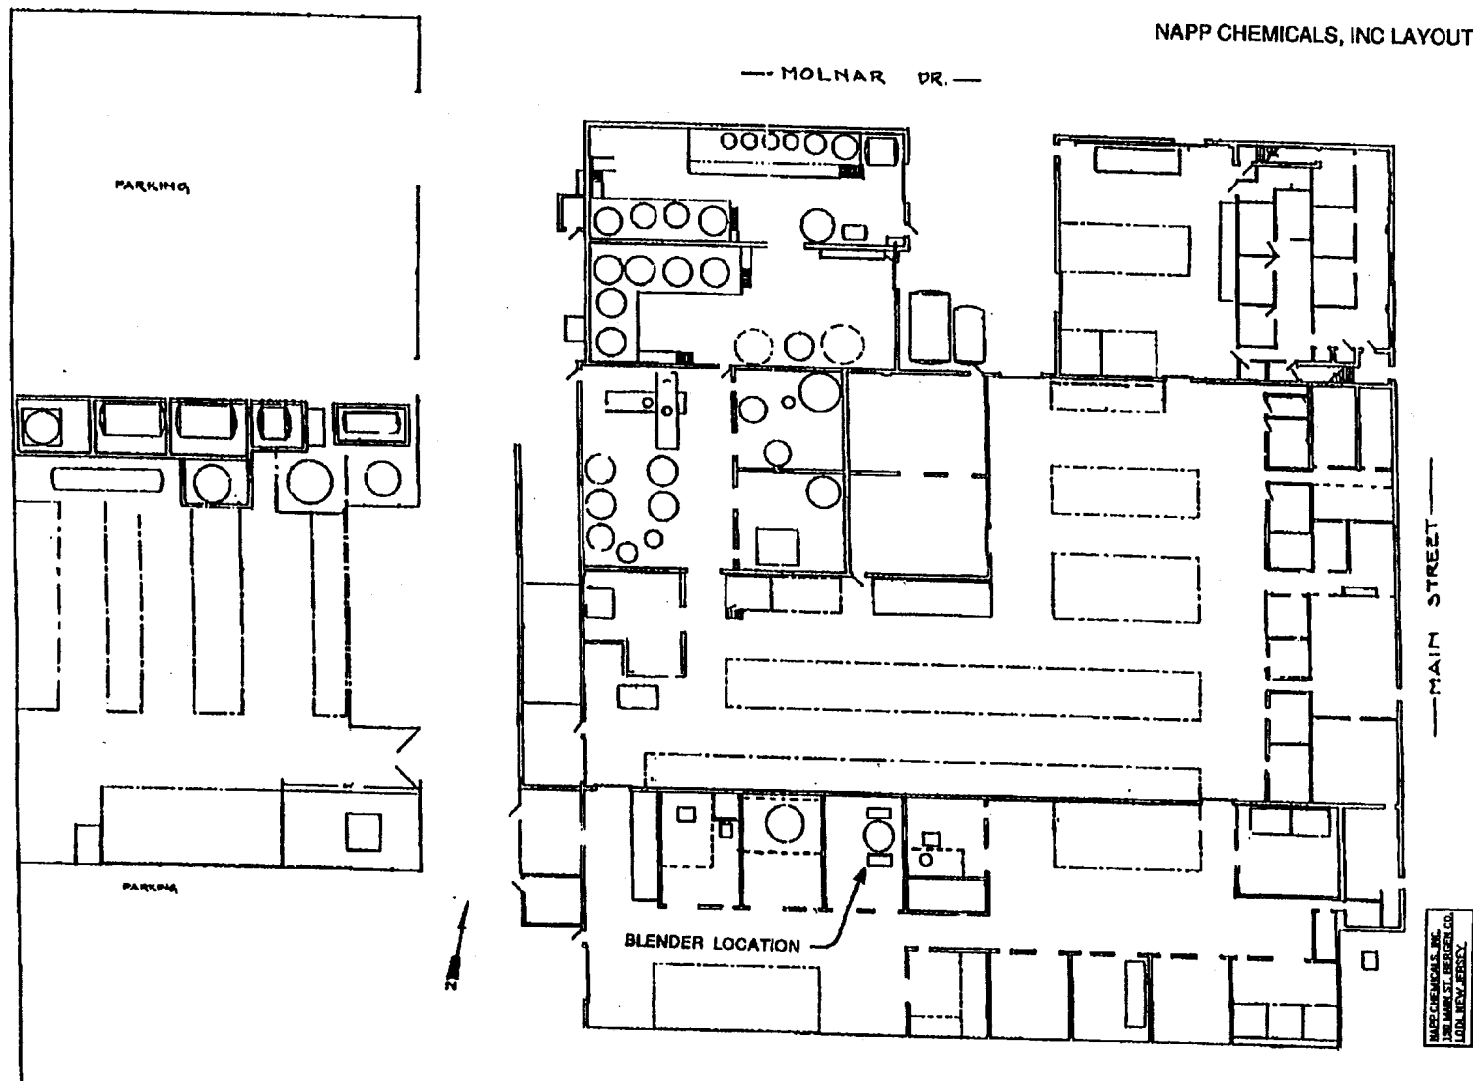
FIGURE 1

The Patterson-Kelley (PK) 125 blender used in the GPA blending operation was located in the PK-125 Blending Room, located in the Pulverizing and Blending Department on the South side of the facility, near the main warehouse area (see Figure 1).

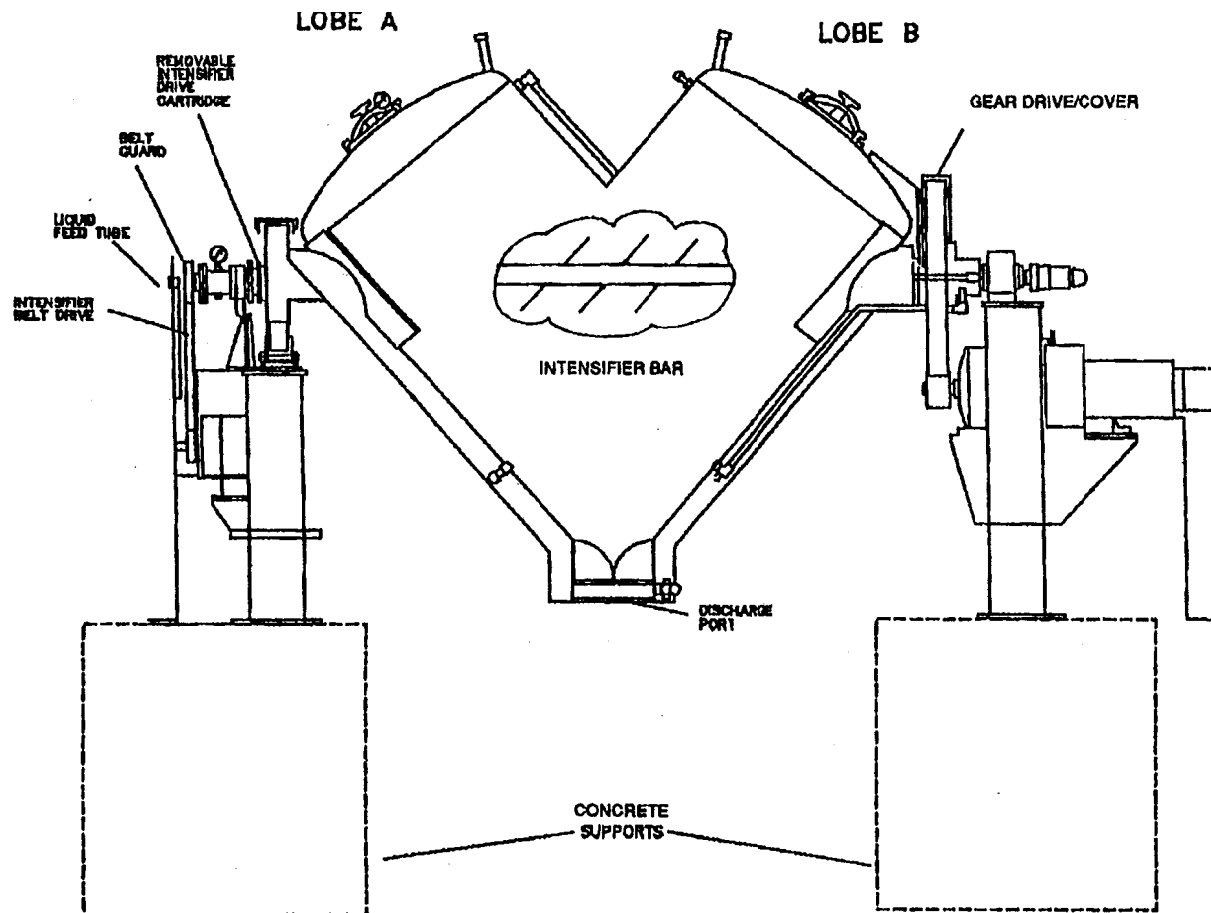
FIGURE 2

Figure 2 shows a typical Patterson-Kelley V-shaped blender. Patterson-Kelley builds each blender with options and features as specified by the purchaser. The blender at Napp had a working capacity of 6 cubic meters (125 cubic feet). It was approximately 6 meters wide (19 feet), including supports, and 3 meters (10 feet) high. The blender is a double-lobed stainless steel shell shaped like a heart. It is supported on its widest dimension by a horizontal trunnion attached to support tubes set in cement footings. It is insulated with a rigid foam material and encased in a steel jacket containing a water/glycol mixture for cooling and heating. The two access covers on top of the blender are used for loading raw materials, and one port is located at the bottom for off-loading product. A gear to one side of the blender (right side of Figure 2) rotates the shell of the blender through a 360-degree arc. Several water lines enter the jacket on this side. On the other side (left side of Figure 2) of the blender, a vacuum tube housing enters the blender. A graphite seal located inside the vacuum tube separates the seal's cooling water from the internal area of the vacuum tube and the blender. The purpose of the vacuum tube housing is to: (1) act as a conduit for establishing vacuum conditions when the blender is used for drying and other operations; and (2) contain other concentric lines, shafts, etc., including a liquid feed line (added by Napp) and the shaft used to rotate an intensifier bar (I-bar). The purpose of the I-bar is to enhance the mixing of materials being blended. The purpose of the feed line is to allow the controlled introduction of liquids to the materials being blended. The PK-125 blender can be used with or without the I-bar in service. The I-bar, Figure 3, transverses the inner walls of the blender connecting the inner sides of the blender on the same plane as the trunnion. See Figures 4-8 showing a larger but similar blender and associated equipment.

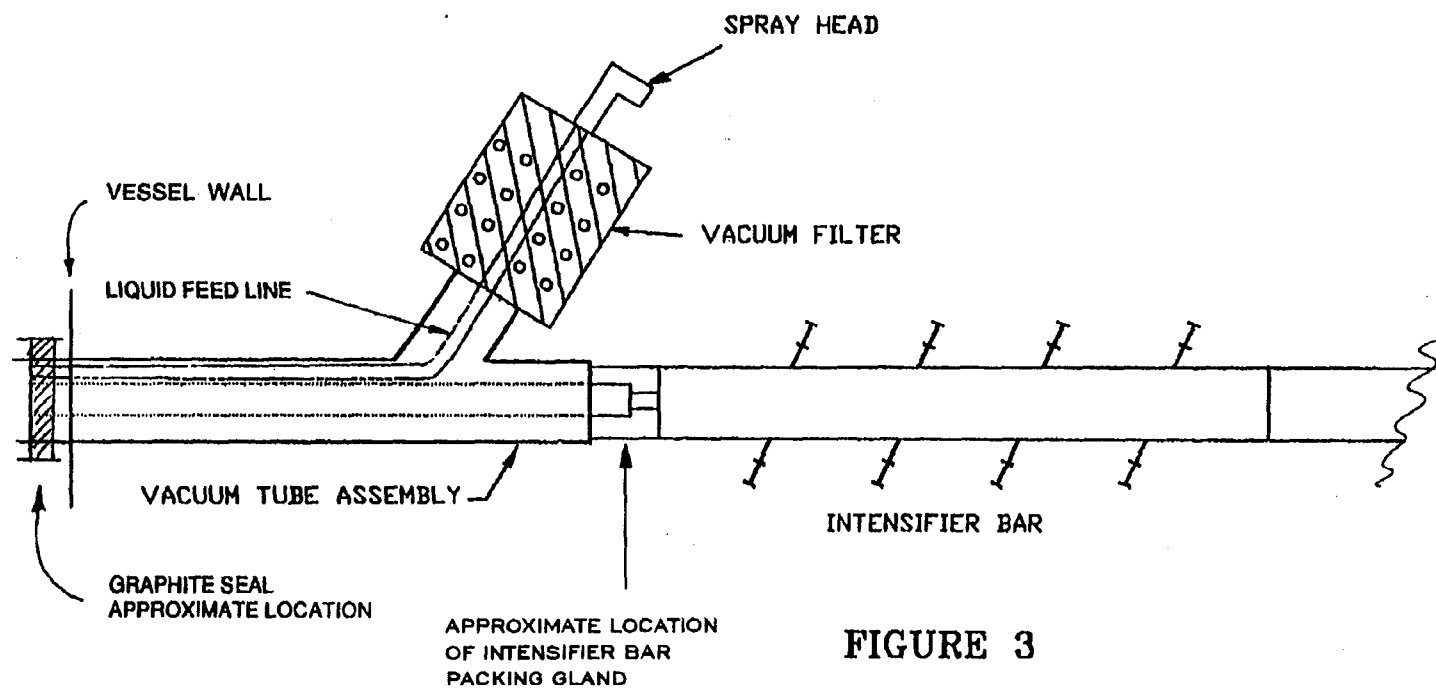
FIGURE 3

INTENSIFIER BAR/VACUUM HEAD ASSEMBLY

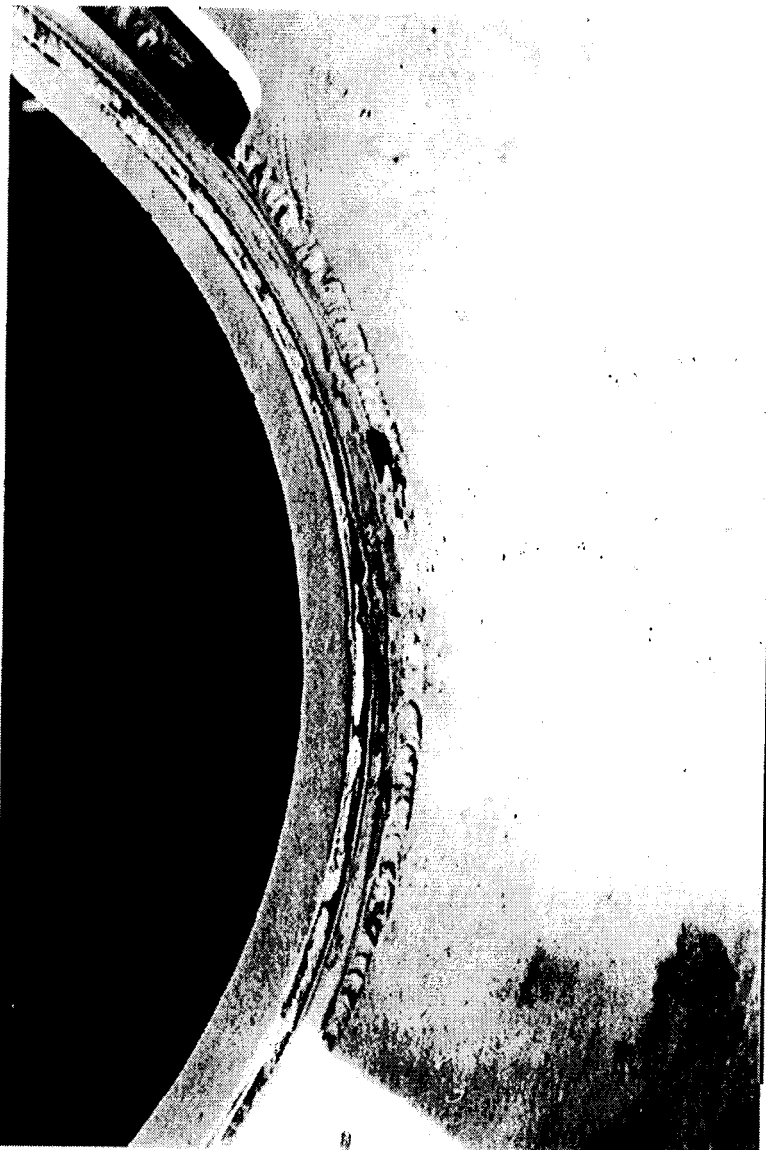
Figure 4: One of the top loading ports on the 150 cubic foot blender showing how the insulation jacket is attached (weld) and access door tabs.

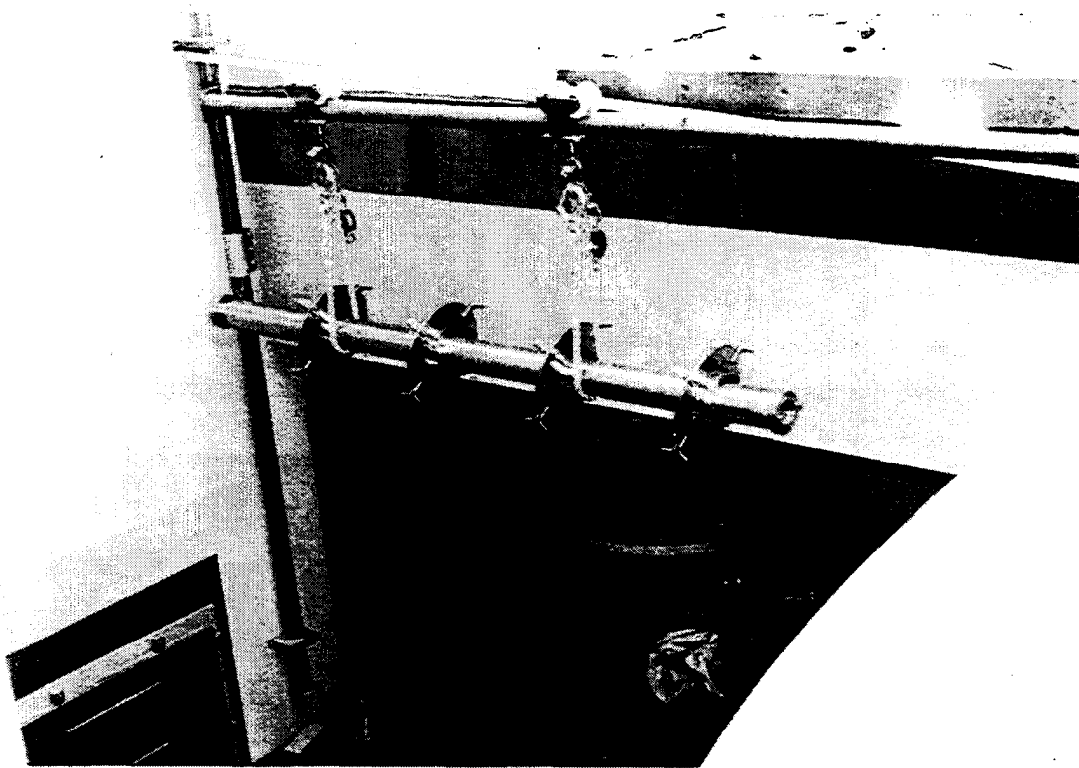
Figure 6: The intensifier bar for a PK-150 cubic foot blender shown in its storage position.

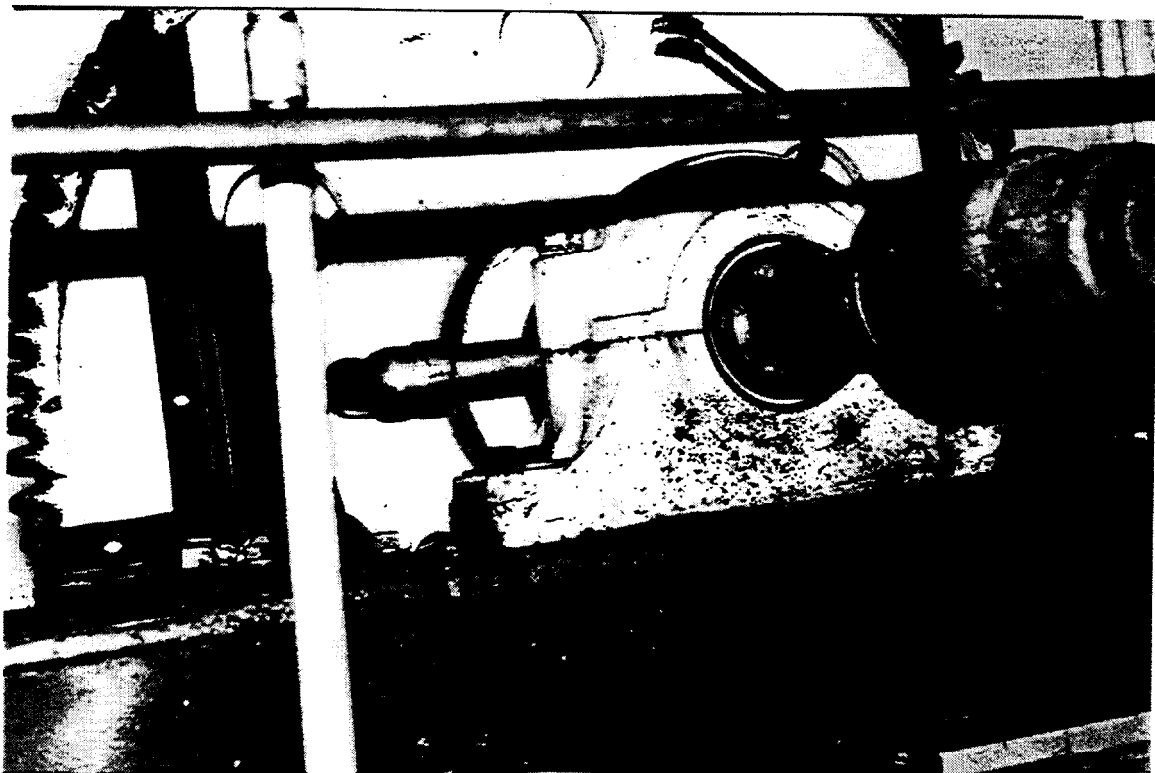
Figure 7: The gear drive and bearing that supports one side of a 150 cubic foot blender.

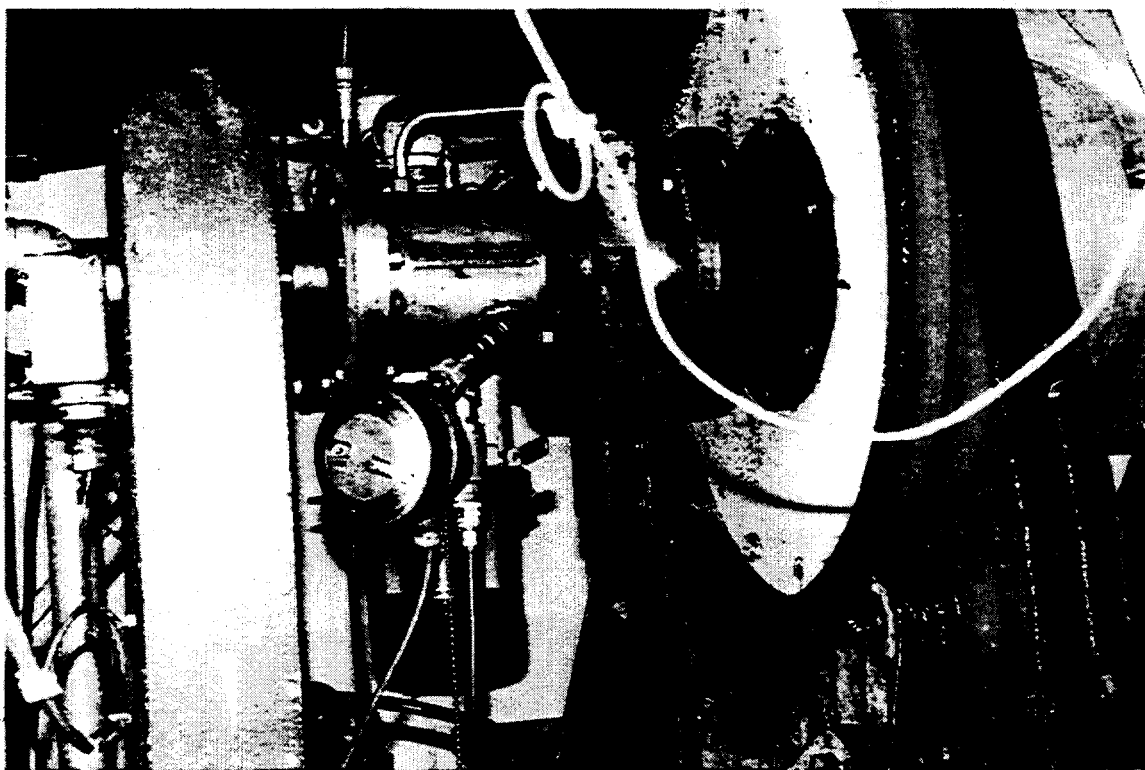
Figure 8: The other side support (intensifier bar drive side) of a 150 cubic foot blender.

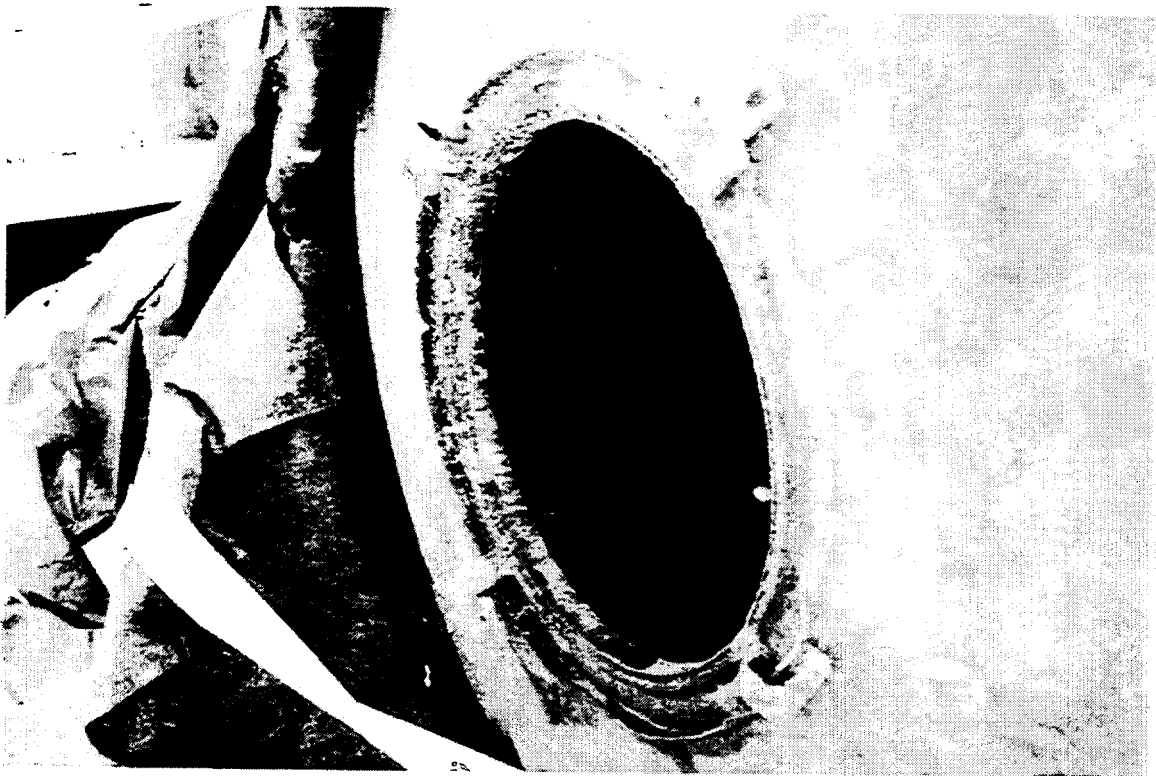
Figure 10: Top access port: a) looking through a top port and out the bottom off-load port, and b) close-up view of a top port.

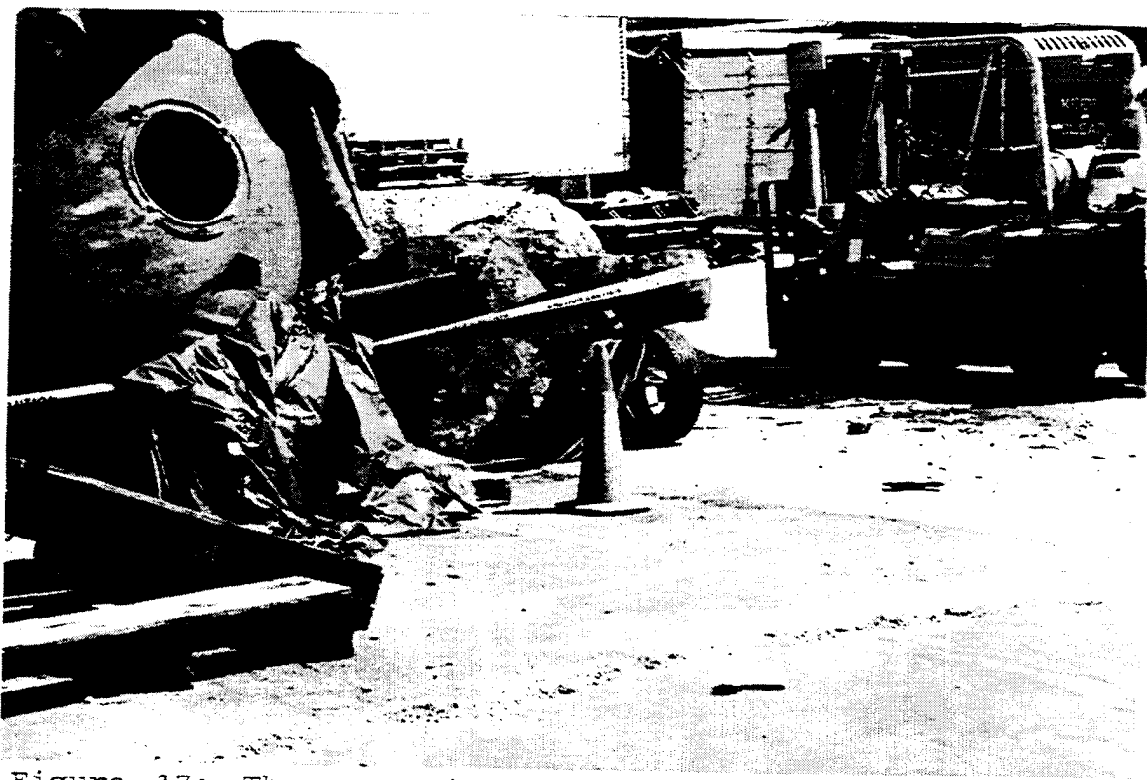
Figure 17: The concrete support and bracket that secured the bearing on the gear drive side of the blender.

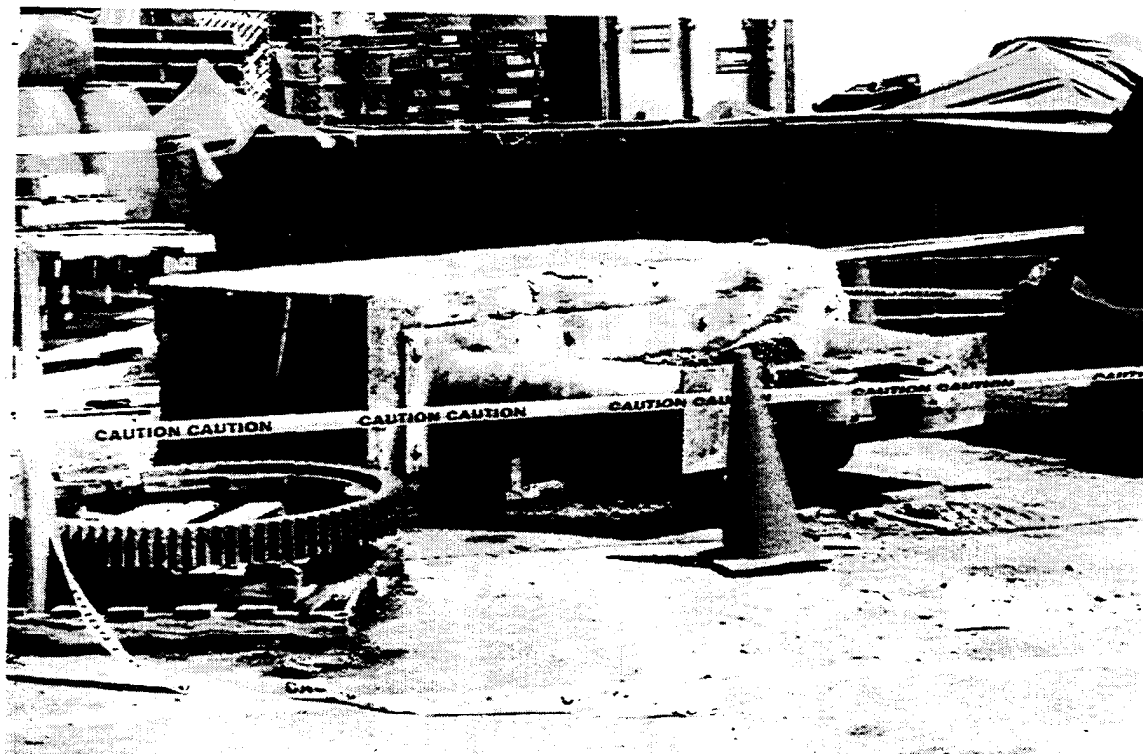
Figure 18: The concrete support and rollers that supported the belt drive side of the blender.
