EPA/OSHA JOINT CHEMICAL ACCIDENT INVESTIGATION REPORT

**Shell Chemical Company
Deer Park, Texas**

Accident Investigation Report

Shell Chemical Company, Deer Park, TX, June 22, 1997

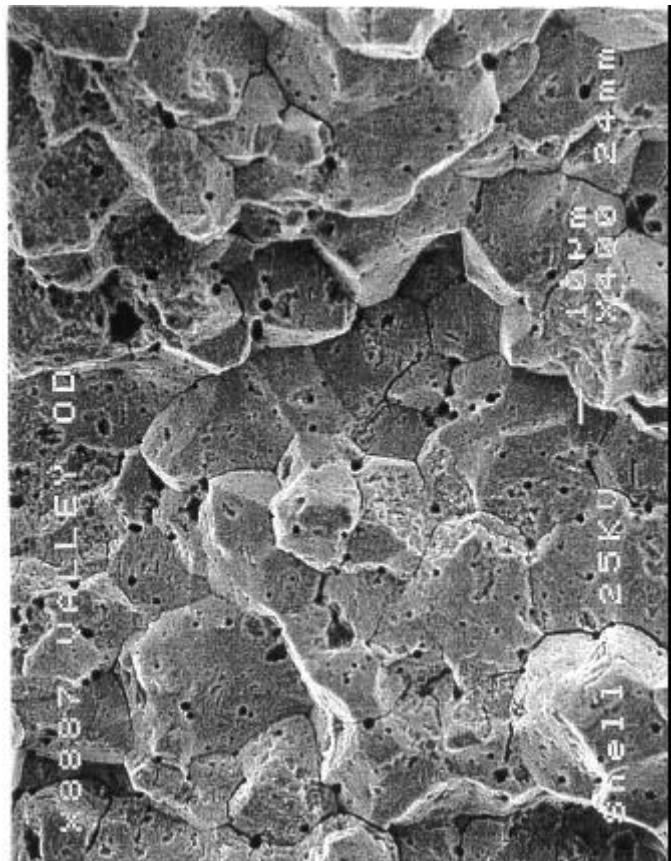
Figure E-20: 400X magnification SEM fractograph of the dowel pin shows details of the intergranular “rock candy” fracture surface at the outside diameter of the dowel pin, a characteristic of hydrogen embrittlement failure mode.
