Design Guide

for Improving Hospital Safety
in Earthquakes, Floods, and High Winds

FEMA 577 / June 2007

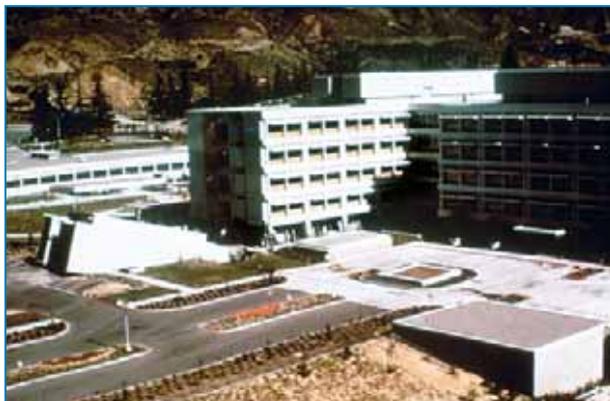
Olive View Hospital After the 1971 Magnitude 6.7 San Fernando Earthquake

The new Olive View hospital building shown on the cover performed well during the 1994 Northridge earthquake. This quake, of the same magnitude as the 1971 San Fernando Earthquake that nearly collapsed the original building, caused no serious damage. Built in 1970, the Medical Treatment and Care Building of the Olive View Hospital complex was designed to meet the earthquake provisions of building codes in place at that time. The hospital incurred heavy damage (at left) during the 1971 earthquake and was subsequently rebuilt to stricter design and construction standards.

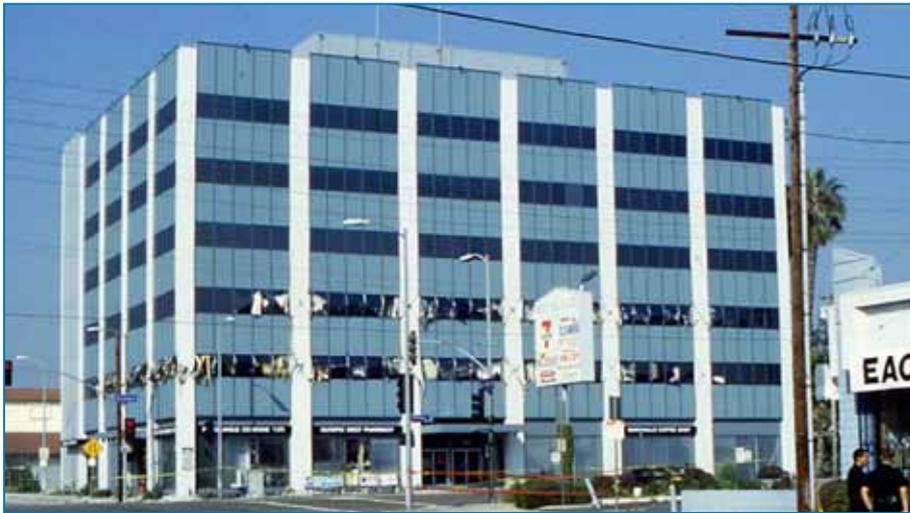
Figure 2-16: This concrete building suffered severe damage to the columns at the second floor level. It was deemed unsafe by the local jurisdiction and later demolished.

When the ground shakes in an earthquake, the shaking is transferred to the building, potentially causing structural damage. The damage can consist of cracks in structural walls, bent or broken braces, or damage to columns and beams. Damage can range from minor (a few cracks), to major (parts of the structure rendered ineffective and potentially unsafe), to complete collapse. See Figures 2-16, 2-17, 2-18, and 2-19 for examples of structural damage.

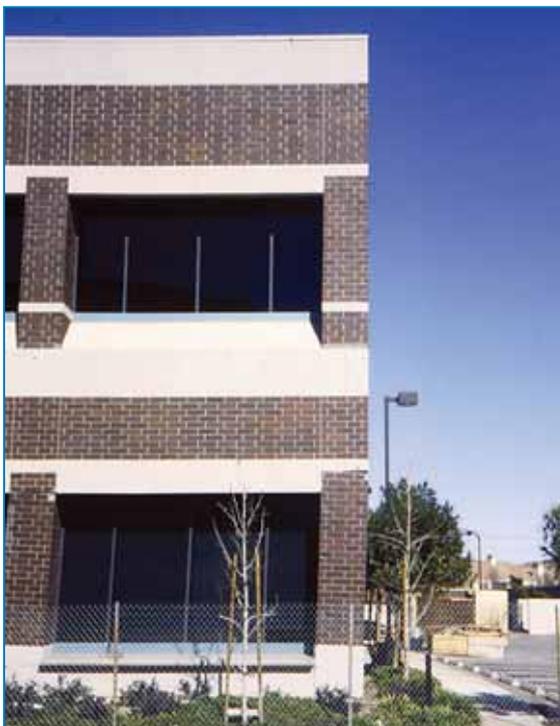
Figure 2-17: A steel frame building with a post-earthquake “lean” to the right, seen particularly at the first floor. Severe damage was found in its beam-column joints and it was later demolished.

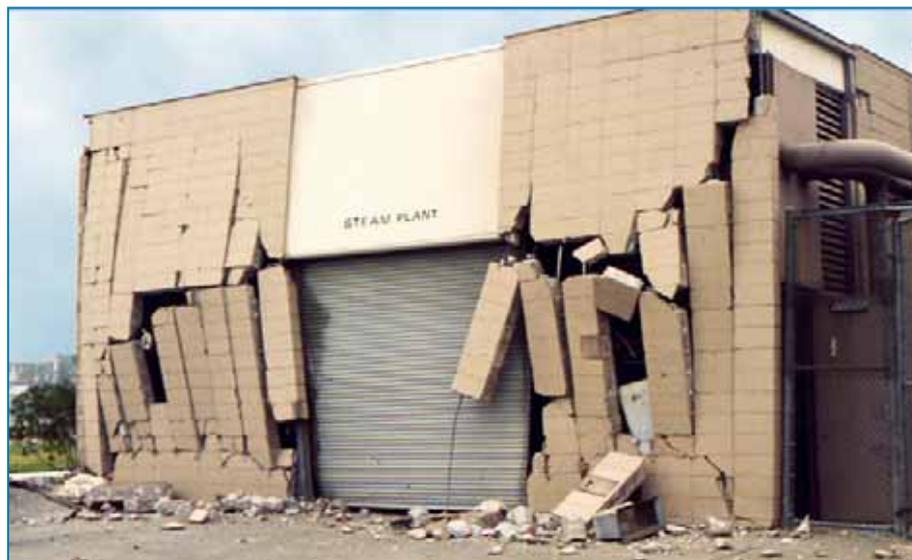
Figure 2-18:
Severe damage to a poorly reinforced masonry wall on a steam plant

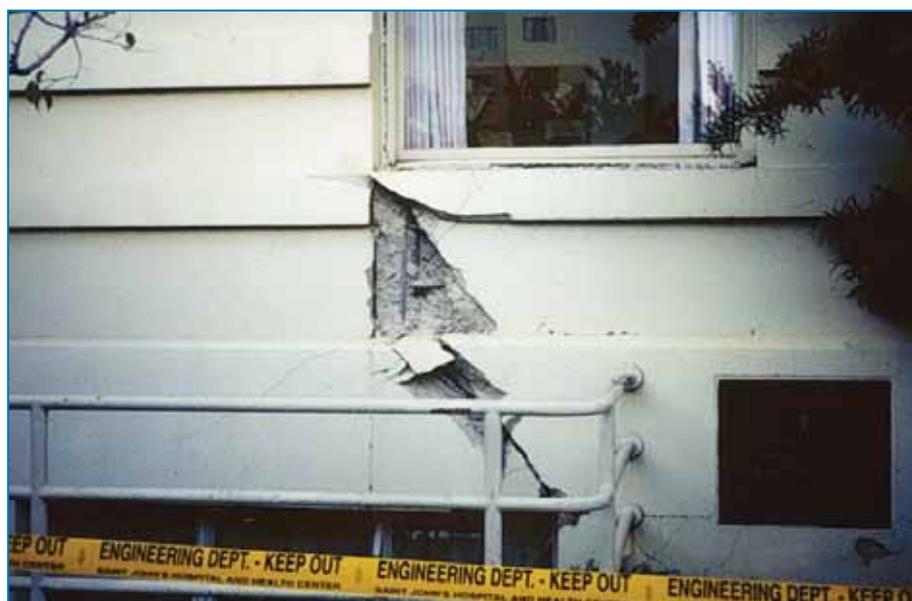
Figure 2-19:
Damage to an exterior concrete wall. This hospital building was evacuated.

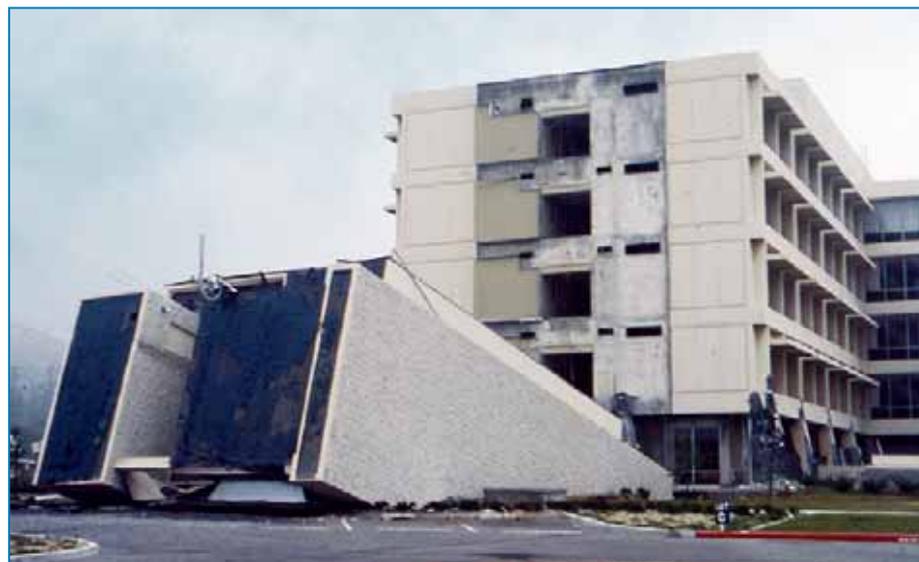
Figure 2-21:
Collapsed stair tower
in main building of
Olive View Hospital

The damage to Olive View Hospital buildings was nearly catastrophic. The first story of the medical treatment and care unit was over 15 inches out of plumb and near collapse (Figure 2-20). Three of the four exterior stair towers pulled away from the main building or collapsed completely, rendering them useless for egress (Figure 2-21). The Ambulance Canopy collapsed onto the parked ambulances and destroyed them. The first story of the Psychiatric Unit collapsed, but all the occupants were on the second floor at the time.

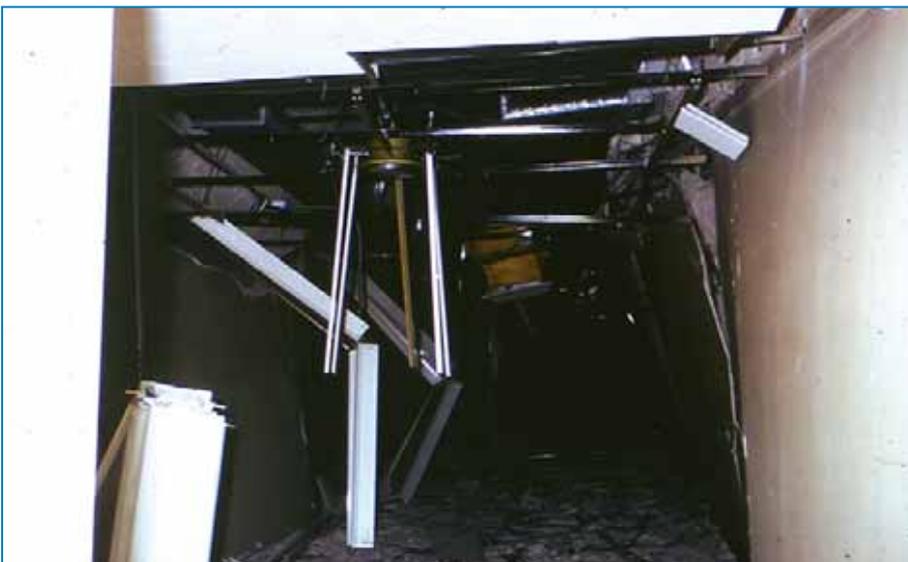
Figure 2-23:
A damaged exit
corridor—dark and
barely passable

Damage to architectural systems consists of broken windows and cracked exterior walls and interior partitions. In extreme cases, exterior walls and partitions topple completely. Ceilings are also vulnerable to damage and can break into small pieces or fall to the floor (see Figure 2-23).

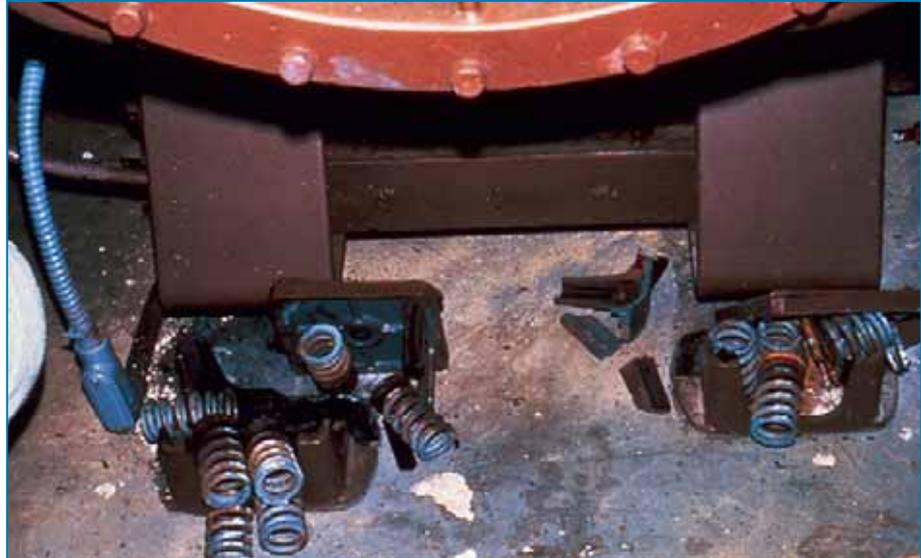
Figure 2-24:
Vibration isolation bearing assemblies on mechanical equipment collapsed due to seismic shaking—such movement breaks pipe or electrical connections to the equipment.

Damage to the building service systems can consist of sliding or overturning of equipment like boilers, generators, and fans, or swaying and possible fracture of mechanical ducts, pipes, and electrical conduit (see Figures 2-24, 2-25, and 2-26).

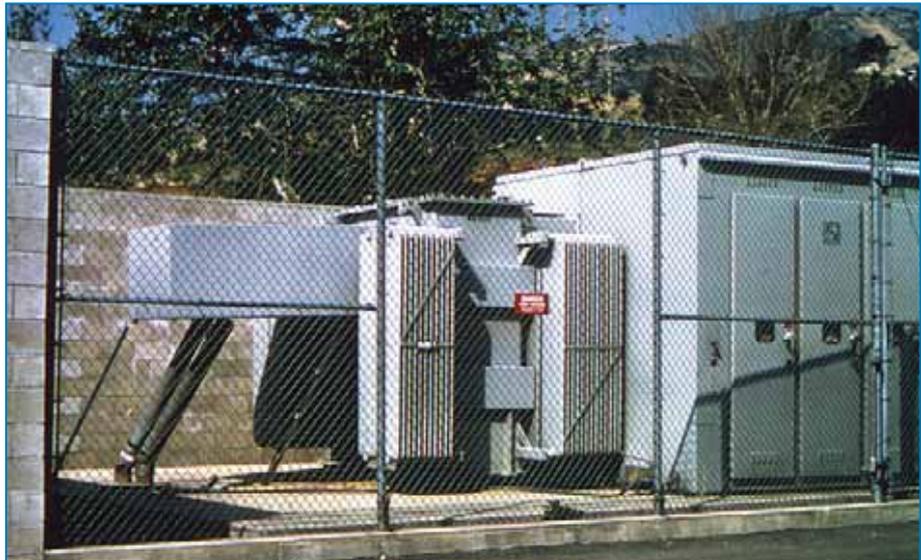
Figure 2-25:
A heavy transformer that moved several feet, breaking all connections

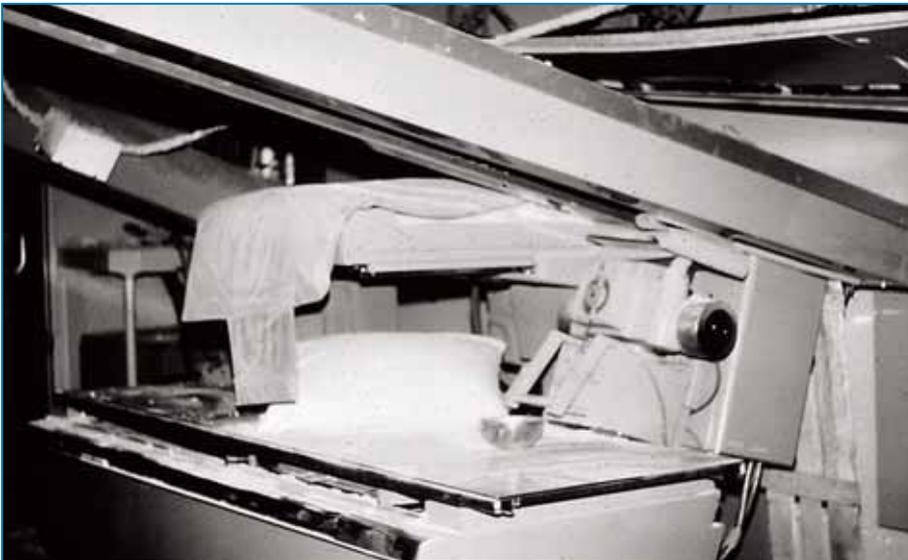
Figure 2-27:
Damaged radiology equipment that not only will not function, but has become a life-safety risk

Because of the wide variation of contents and equipment in a typical hospital, the type of damage experienced by these systems varies widely. For example, medical equipment, such as operating tables and lights, radiation and x-ray units, sterilizers, and patient monitors, is often heavy and

not well anchored to the structure (see Figure 2-27). Offices and storage rooms, such as the areas used to store critical supplies, medicine, medical records, chemicals, and fuel, can also be severely damaged by shaking (see Figures 2-28, 2-29, and 2-30).

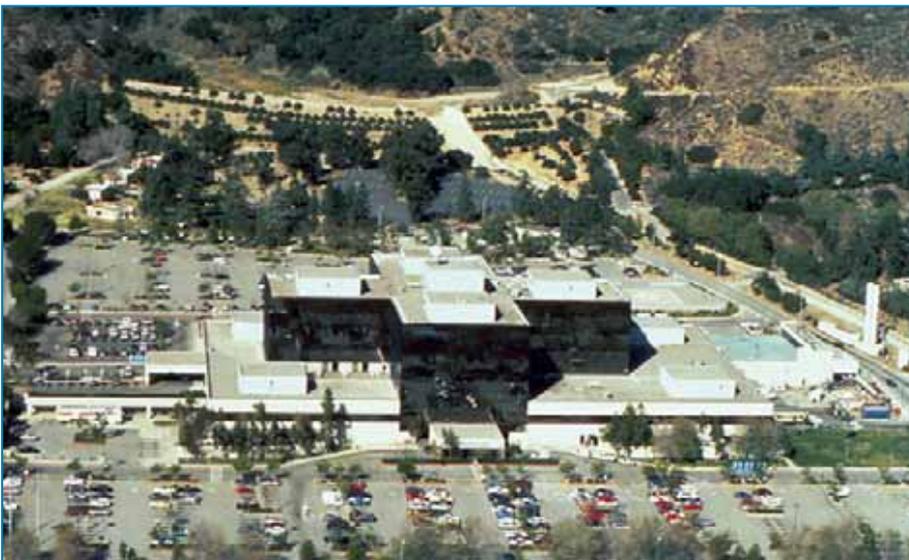
Figure 2-31:
Aerial view of “new”
Olive View Hospital
(1986)

Nearly 15 years after the 1971 earthquake event that destroyed the Olive View Medical Center (see Section 2.3.1.1), a new hospital was opened on the same site in 1986 (see Figure 2-31). Built even stronger than required under the HSSA of 1972, the building has no basement and features a seismic system of concrete shear walls and steel plate shear panels. The building was also equipped with instruments to record its response in future earthquakes.

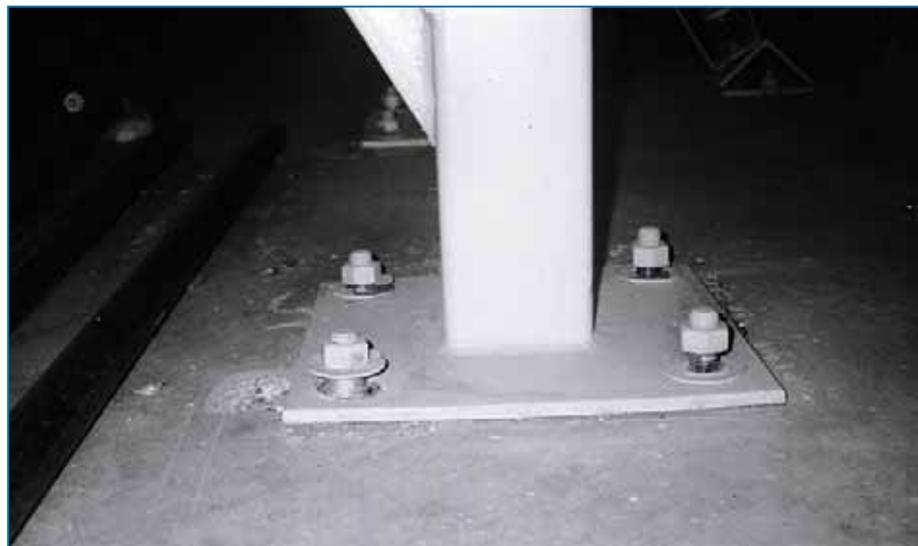
Figure 2-32:
Anchor bolts stretched by large seismic accelerations at roof level

- Shifting, and in some cases, failure, of anchorages of equipment at the roof level, where accelerations were the highest. This movement broke one or more chiller water lines, causing flooding in the top floors (see Figure 2-32).

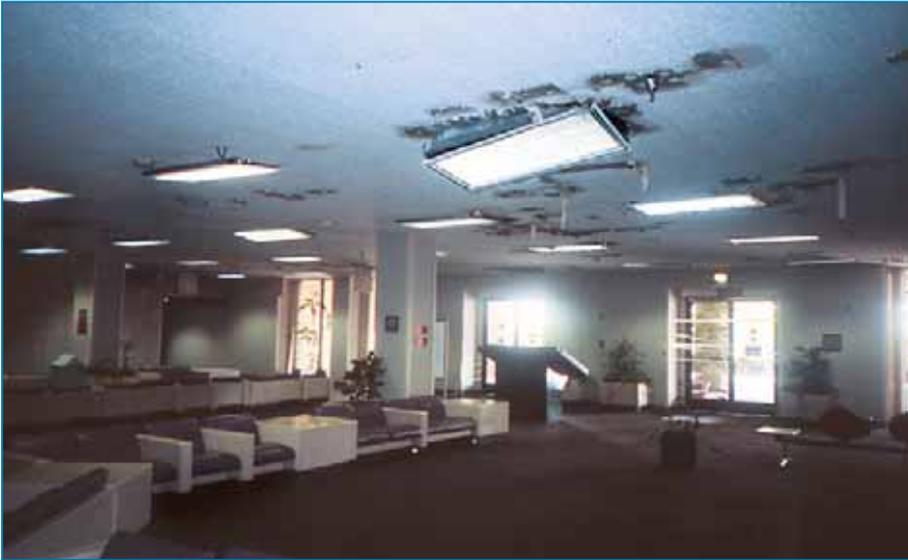
Figure 2-33:
Damage to ceiling and fixtures from sprinkler breaks

- Excessive movement and failure of wall-mounted television brackets, causing some television units to fall.
- Extensive damage to suspended panelized ceilings, some exacerbated by leaks from water pipes from above.
- Excessive movement and interaction between gypsum board and other fire-rated ceilings and sprinkler lines, causing additional leaks.
- Movement at the copper tube reheat coils in the ceiling spaces, almost universally at the third through the sixth floor, causing leaks (see Figures 2-33 and 2-34).

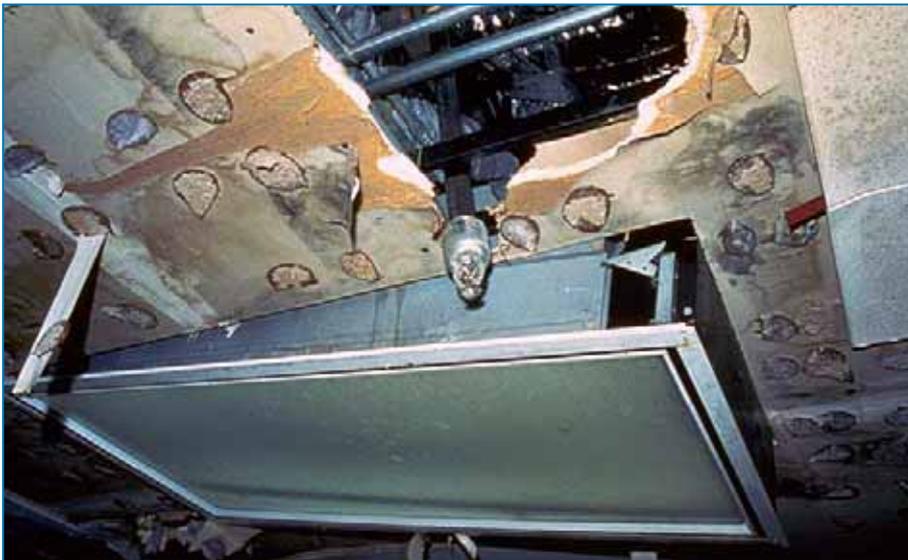
Figure 2-34:
Detail of water damage to ceiling

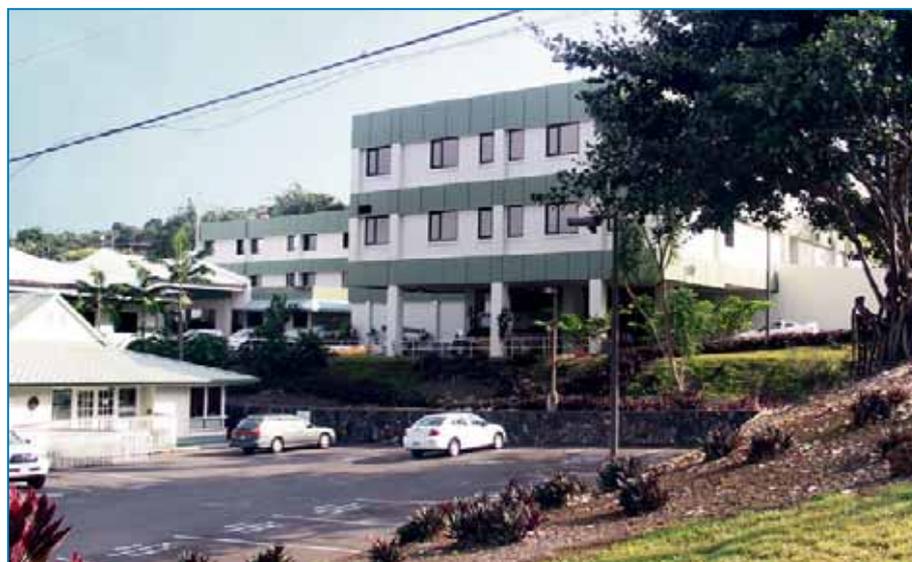
Figure 2-35:
Kona Community Hospital. Addition (1989) supported on isolated columns in the foreground. The original building (1972) is in the left background.

The Special Services Building at KCH (seen in Figure 2-35 behind the small single-story building on the left) contained such an instrument. The response spectrum for one component of motion is shown in Figure 2-36 in blue. Note the rapid decline of spectral acceleration values for very short periods, much less than 0.5 seconds. The orange curve shows a spectral shape that might be expected in association with such high ground accelerations, and is included in building codes. High values of spectral acceleration between the periods of 0.5 seconds and 2.0 seconds, as shown in this standard curve, are usually associated with much greater building damage.

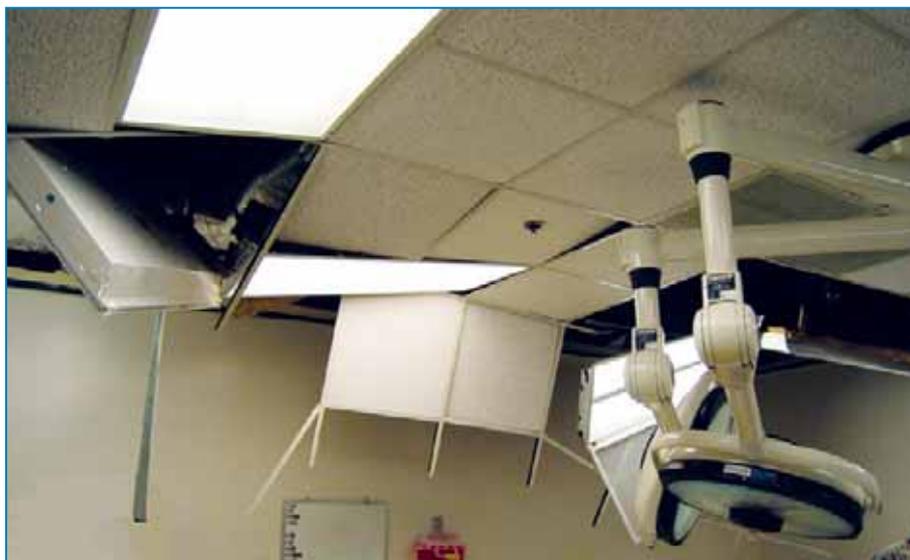
Figure 2-39:

Ceiling damage in the operating room. The round operating lights on the right were not damaged.

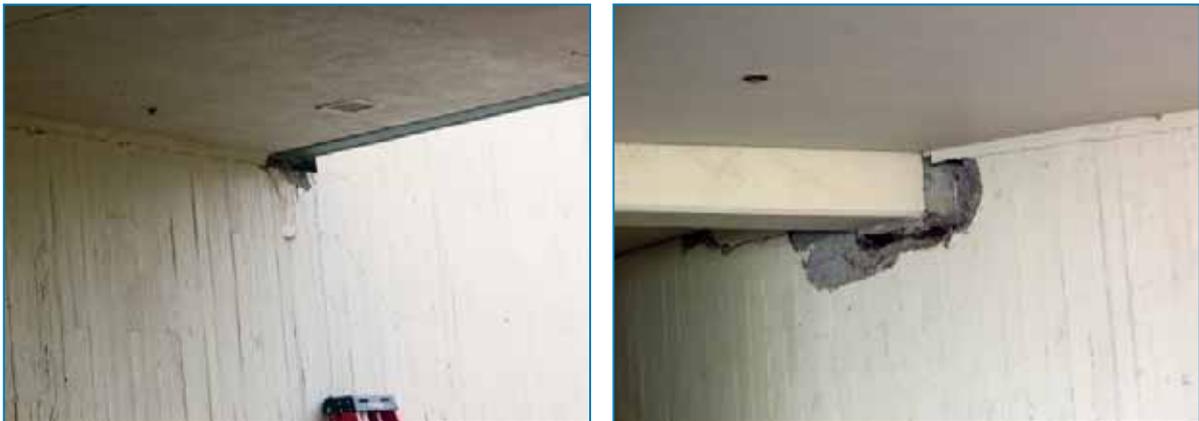
Figure 2-40: Spalling at beam connections

The potential torsional response of the building addition, identified in the 1993 evaluation, proved prophetic, as the column-supported west end attempted to rotate around the stiffly supported east end. As shown in Figure 2-40, the two beam connections tending to restrain the motion spalled. Similarly, in the partially enclosed penthouse, the embedded connection of a steel beam spanning between two exterior concrete walls pulled out due to a stiffness incompatibility. This damage was not considered serious enough for the structure and did not affect the occupancy status.

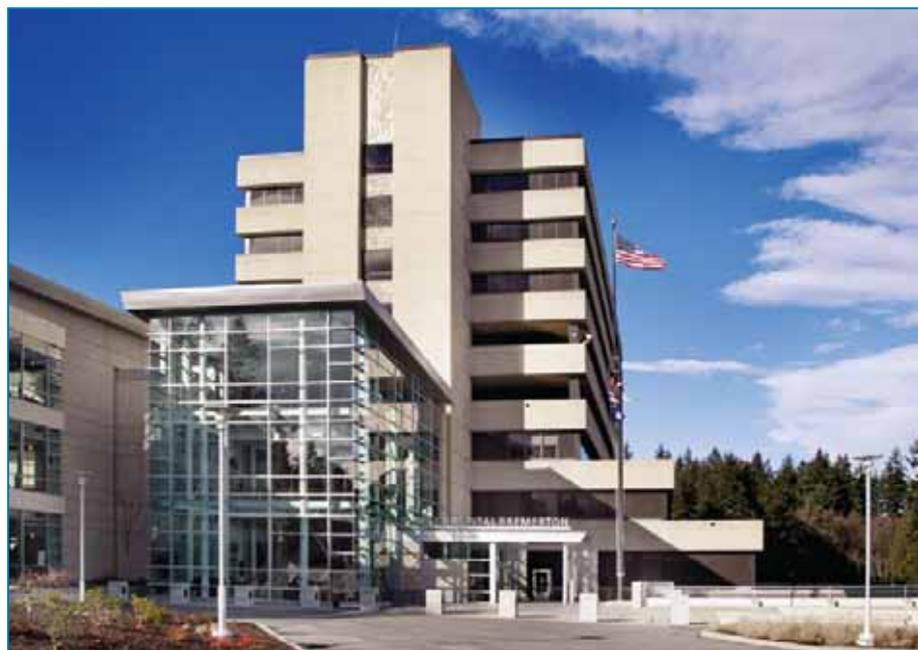
Figure 2-50:
The main building
at Naval Hospital
Bremerton

To obtain a broad understanding of the vulnerability of the facility and the relative risk among the many buildings, a rapid visual screening was completed by the Navy’s consultant, Reid Middleton, using FEMA 154 (FEMA, 2002), which considers structural type, basic seismic characteristics, building use, and occupancy load. This relatively modest effort provided an overview of the seismic risk at the campus, as well as a preliminary relative ranking among buildings. It made it obvious that the main hospital building, a nine-story, 250,000-square-foot building that housed most of the essential medical functions, should be a priority (see Figure 2-50).

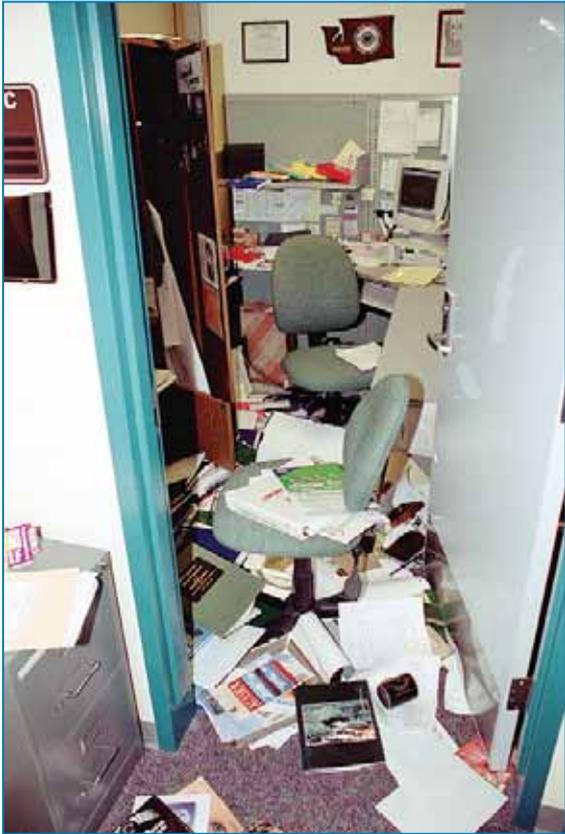
Figure 2-51:
Disruption in the upper floors at Naval Hospital
Bremerton from the Nisqually earthquake

In February 2001, while the Navy and the design team were considering their options, the Magnitude 6.8 Nisqually earthquake struck the area. The earthquake occurred deep below the surface and approximately 30 miles from the site. The ground motions at the site were below the design shaking for the site, but nevertheless caused significant nonstructural damage—particularly in the upper floors (see Figure 2-51). Such nonstructural damage always causes concern about the integrity of the structure—and often requires destructive exploration to verify. Based on preliminary structural inspections, aided by recordings of the response from instruments in the building, the Navy decided to stay in the building while more extensive exploration and analysis were performed. It took several months before nonstructural repairs were completed and the building returned to full use. Subsequent structural review indicated no structural damage.

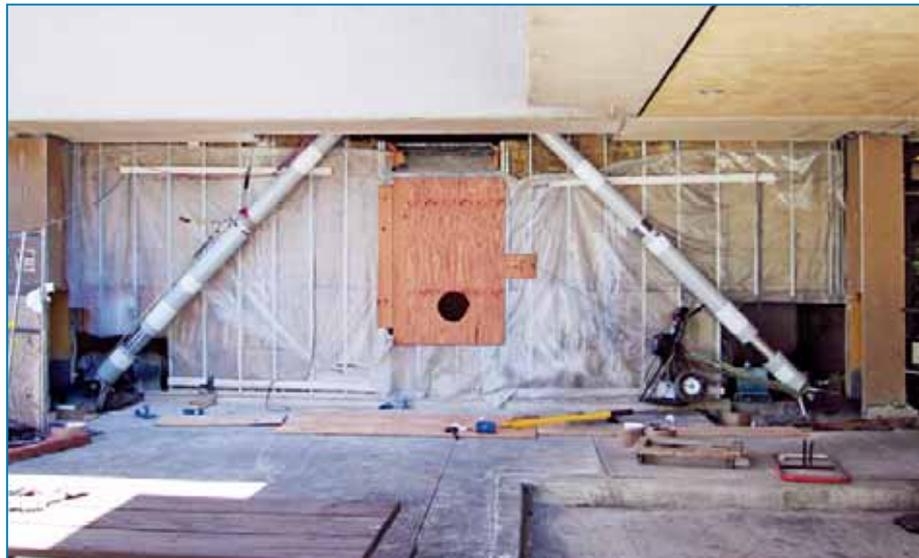
Figure 2-52:
Installation of dampers
at Naval Hospital
Bremerton. The
configuration is similar
to steel braced frames.

Several styles of dampers are available for use in buildings, including those employing controlled yielding of steel elements, those based on friction (similar to a brake shoe), and more sophisticated hydraulic dampers (similar to a shock absorber). Dampers are normally placed in a building in a configuration similar to diagonal braces, and work against the movement between floors (see Figure 2-52). This action reduces inter-story drift and, to a lesser extent, reduces floor accelerations that cause sliding and overturning of equipment and contents. Although dampers should be evenly distributed throughout the building, they allow greater flex-

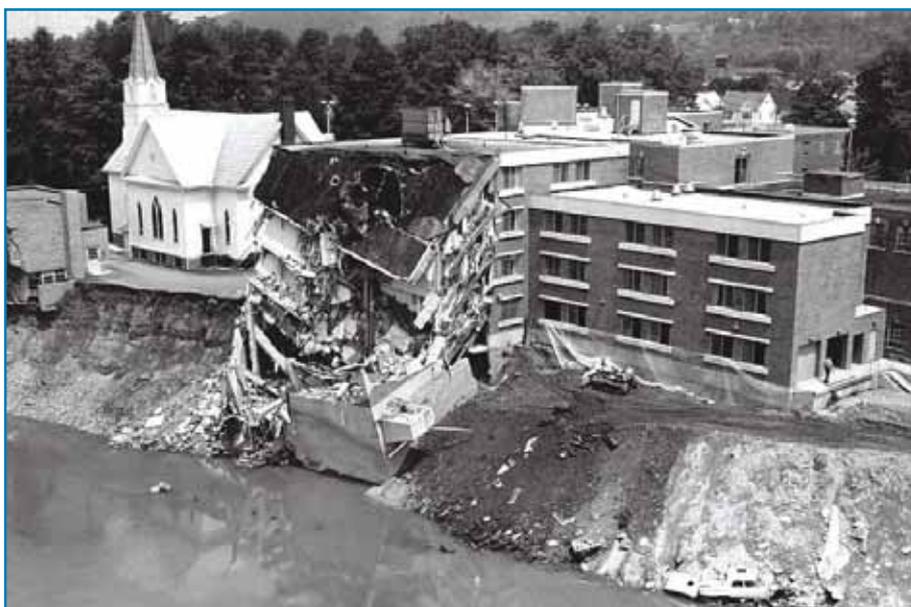
Figure 3-12: Riverbank erosion of the Genesee River during Hurricane Agnes flooding in 1972 eventually led to collapse of this wing of the Jones Memorial Hospital, Wellsville, NY.

Erosion and scour: All parts of a site that are subject to flooding by fast-moving water could experience erosion, and local scour could occur around any permanent obstructions to flow. Graded areas, filled areas, and cut or fill slopes are especially susceptible. Stream and channel bank erosion, and erosion of coastal shorelines, are natural phenomena that may, over time, threaten site improvements and buildings (see Figure 3-12).

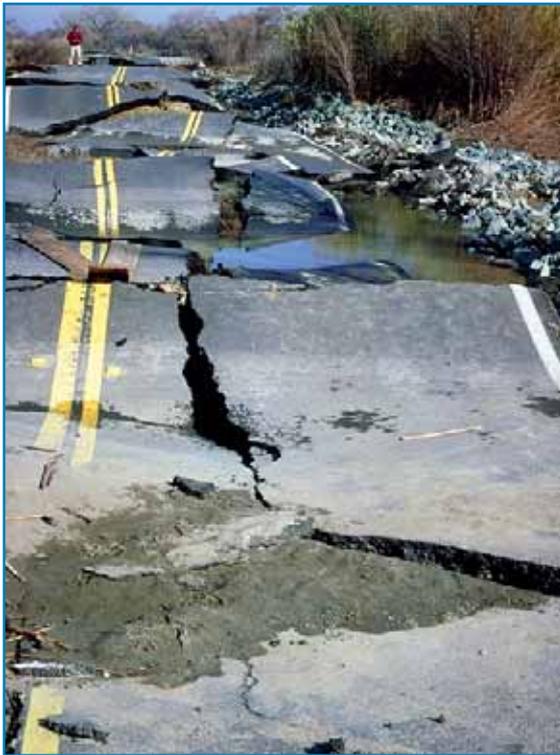
Figure 3-13:
Flooding caused the failure of this road bed.

Access roads: Access roads that extend across flood-prone areas may be damaged by erosion, washout of drainage culverts, failure of fill and bedding materials, and loss of road surface (see Figure 3-13). Road damage could prevent uninterrupted access to a facility and thus impair its functionality.

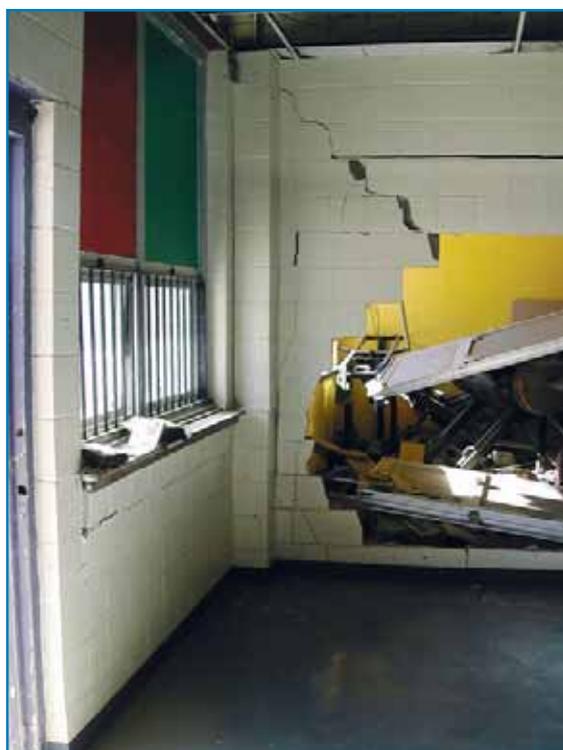
Figure 3-14: Interior unreinforced masonry walls of the Port Sulphur High School in Louisiana were damaged by hydrostatic loads associated with Hurricane Katrina's storm surge (2005).

Depth: The hydrostatic load against a wall or foundation is directly related to the depth of water. Standard stud and siding, or unreinforced brick veneer walls, may collapse under hydrostatic loads associated with relatively shallow water. Reinforced masonry walls perform better than unreinforced masonry walls (see Figure 3-14), although an engineering analysis is required to determine performance. Walls and floors of below-grade areas (basements) are particularly susceptible to damage by buoyancy force. When soils are saturated, pressures against below-grade walls are a function of the total depth of water, including the depth below-grade and the weight of the saturated soils.

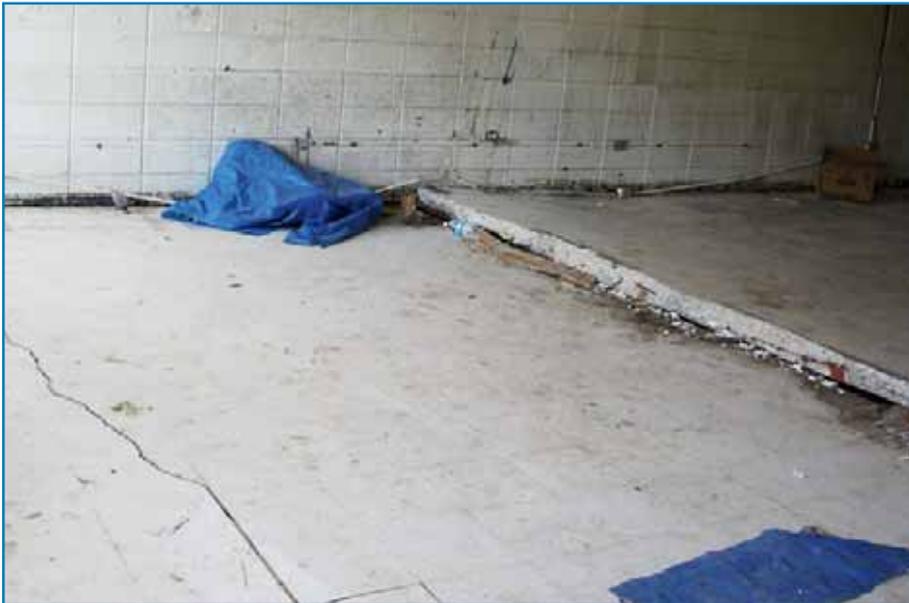
Figure 3-15: Concrete slab ruptured by hydrostatic pressure (buoyancy) induced by the floodwaters of Hurricane Katrina (2005).

Buoyancy and uplift: If below-grade areas are essentially watertight, buoyancy or uplift forces can float a building out of the ground or rupture concrete slabs-on-grade (see Figure 3-15). Buildings that are not adequately anchored can be floated or pushed off foundations. Although rare for large and heavy buildings, this is a concern for smaller structures. Buoyancy is a significant concern for underground and aboveground tanks, especially those used for emergency generator fuel and bulk oxygen.

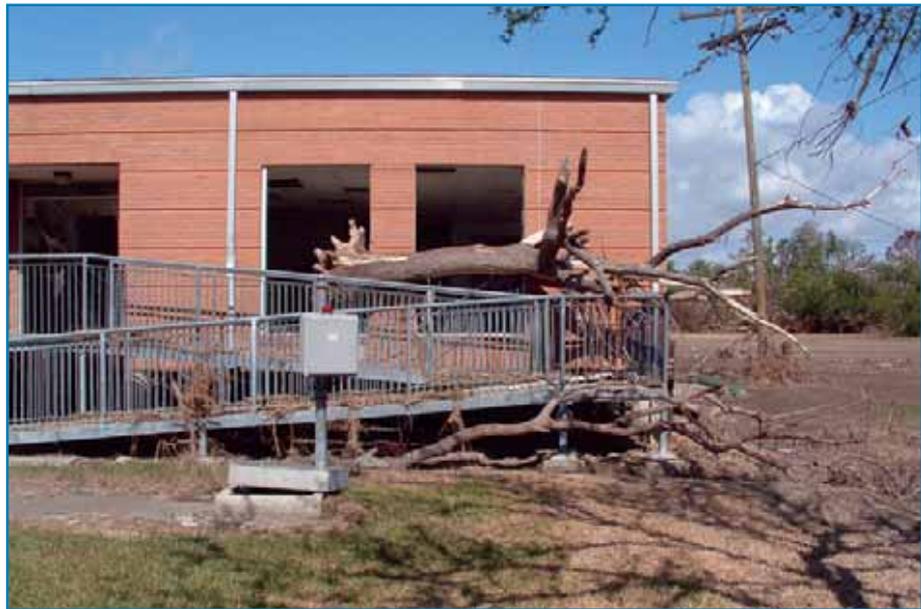
Figure 3-17:
Local scour undermined the footing of this exterior stair tower (Hurricane Ivan, 2004).

Erosion and scour: Structural damage is associated with foundation failure when erosion or scour results in partial or complete removal of supporting soil (see Figure 3-17). Erosion of slopes, especially unprotected slopes, can lead to slope failures and loss of foundation supporting soil.

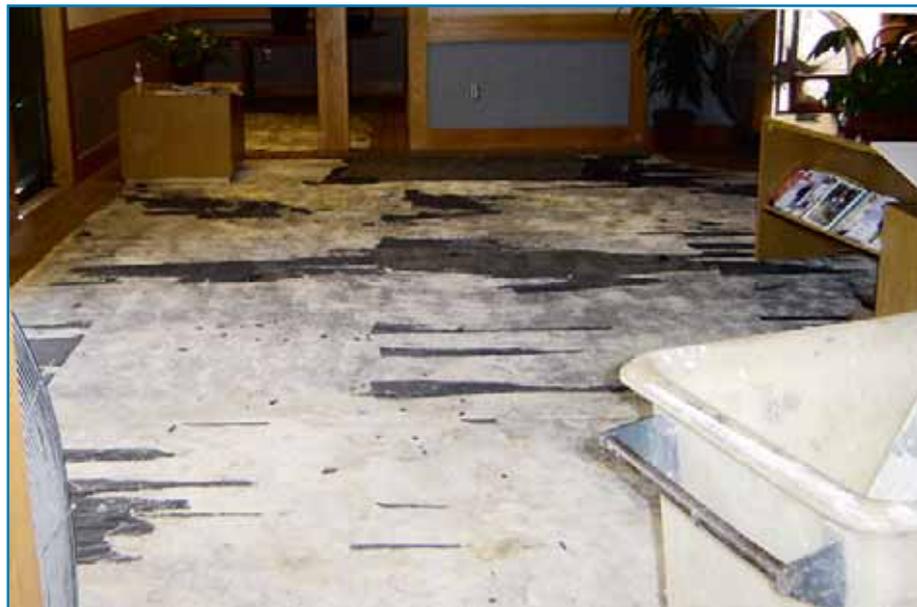
Figure 3-19:
Floor damage at West
Jefferson Medical
Center (Hurricane
Katrina, 2005)

Flooring: Many hospitals have durable floors that resist water damage. Ground floors are often slab-on-grade and finished with tile or sheet products. Flooring adhesives in use since the early 1990s likely are latex-based and tend to break down when saturated (see Figure 3-19). Most carpeting, even the indoor-outdoor kind, is difficult to clean.

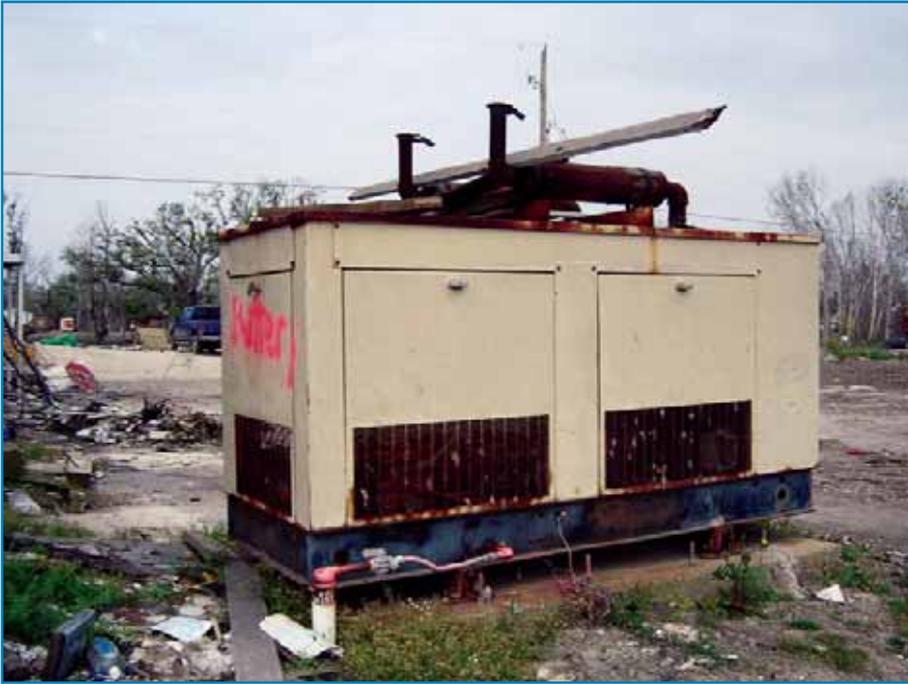
Figure 3-21: Although it was anchored and not displaced by floodwaters, this generator was out of service after being submerged (Hurricane Katrina, 2005).

Emergency power generators: Generators that are installed at-grade are susceptible to inundation and will be out of service after a flood (see Figure 3-21). Even if fuel tanks are located above flood level, truck access for refueling would be impaired if the site is flooded for any length of time.

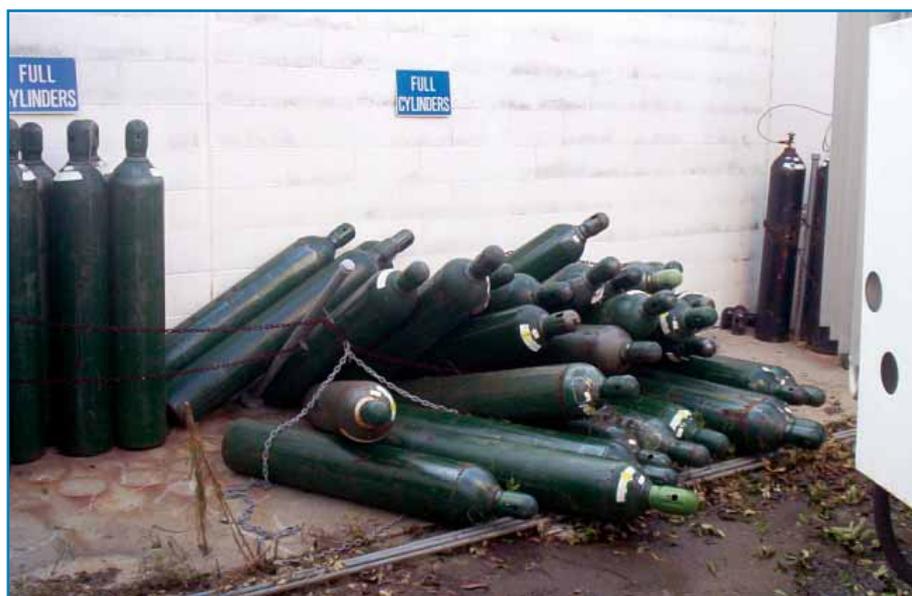
Figure 3-22:

Oxygen tanks stored outside of the Hancock Medical Center were dislodged by flooding (Hurricane Katrina, 2005).

Tanks (aboveground): Permanently installed aboveground storage tanks are subject to buoyant forces and displacement caused by moving water. Standard strapping of propane tanks may be inadequate for the anticipated loads. Tank inlets, fill openings, and vents should be above the DFE, or designed to prevent the inflow of floodwaters or outflow of tank contents during flood conditions. Even temporary storage of tanks can be problematic (see Figure 3-22).

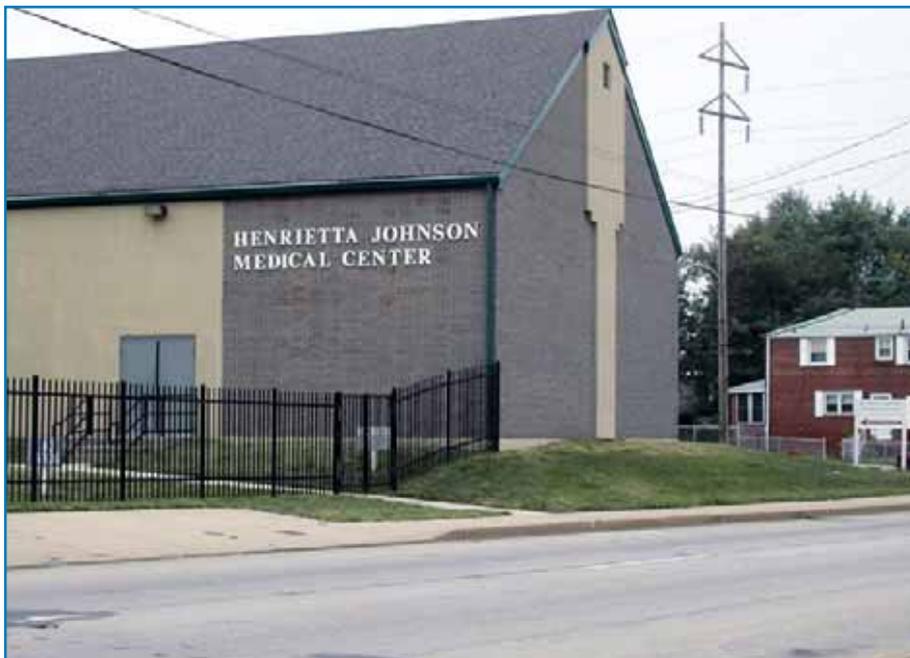
Figure 3-27: Structural fill was placed to elevate the Henrietta Johnson Medical Center above the shallow flood hazard area in Wilmington, DE.

Slab-on-grade foundation on structural fill: This is considered to be the safest method to elevate a building in many flood hazard areas, except those where waves and high velocity flows may cause erosion. Consequently, this foundation type is not allowed in V Zones. Structural fill can be placed so that even if water rises up to the DFE, the building (see Figure 3-27) and building access would still be protected from flooding. The fill must be designed to minimize adverse impacts, such as increasing flood elevations on adjacent properties, increasing erosive velocities, and causing local drainage problems. To ensure stability, especially as floodwaters recede and the soils drain, fill must be designed for the anticipated water depths and duration. A geotechnical engineer or soil scientist may need to examine underlying soils to determine if the bearing capacity is sufficient to carry the added weight of fill, or if consolidation over time may occur. In addition, the effects of long-term compaction of the fill should be considered, and may prompt additional elevation as a factor of safety. The horizontal extent of the fill, away from the foundation, should be designed to facilitate access by emergency vehicles, with a minimum 25-foot width recommended. Engineered concrete slabs supported by piers should have sufficient resistance to erosion and scour if designed for anticipated flood conditions. Designers are cautioned to avoid excavating a basement into fill without added structural protection (and certification that the design meets the requirements for dry floodproofing), due to the potential for significant hydrostatic loads and uplift on basement floors.

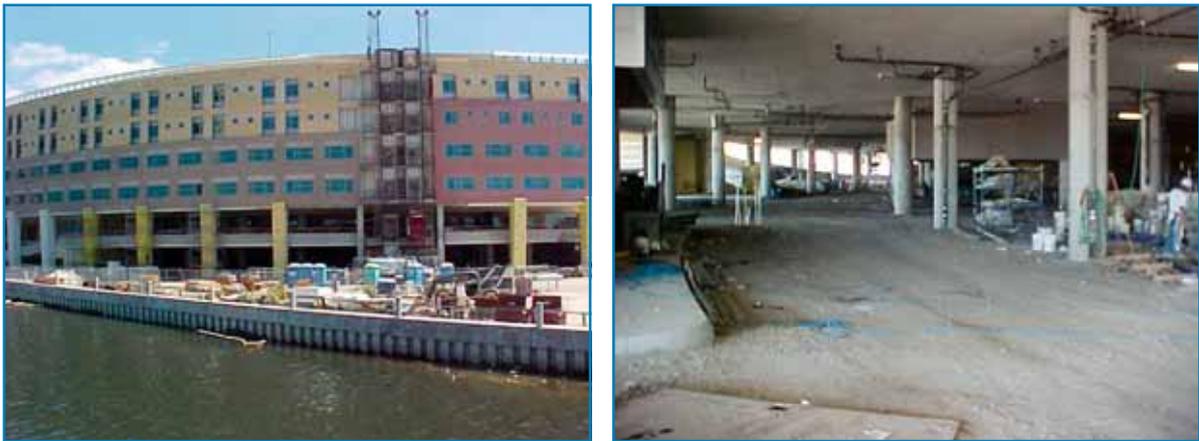
Figure 3-29: Tampa General Hospital had its new Emergency Department wing designed to be elevated on columns, well above hurricane storm surge flooding elevations.

Columns or shear wall foundations (open foundations): Open foundations consist of vertical load-bearing members (columns, piers, pilings, and shear walls) without solid walls connecting the vertical members. Open foundations minimize changes to the floodplain and local drainage patterns, and the area under the building can be used for parking or other uses (see Figure 3-29). The design of the vertical members must also account for hydrodynamic loads and debris and ice impact loads. Flood loads on shear walls are reduced if they are oriented parallel to the anticipated direction of flow. If erodible soils are present and local scour is likely, both conditions must be accounted for in determining embedment depth. Depending on the total height of the elevated facility, the design may need to take into consideration the increased exposure to wind and uplift, particularly where loads are expected from breaking waves.

In V Zones, buildings must be elevated using open foundations, which consist of vertical load-bearing members (columns, piers, pilings, and shear walls) without solid walls connecting the vertical members. The design of the vertical members must also account for hydrodynamic loads and debris impact loads. Flood loads on shear walls are reduced if the walls are oriented parallel to the anticipated direction of flow. Erodible soils may be present and local scour may occur; both must be accounted for in designs by extending the load-bearing members and foundation elements well below the expected scour depth.

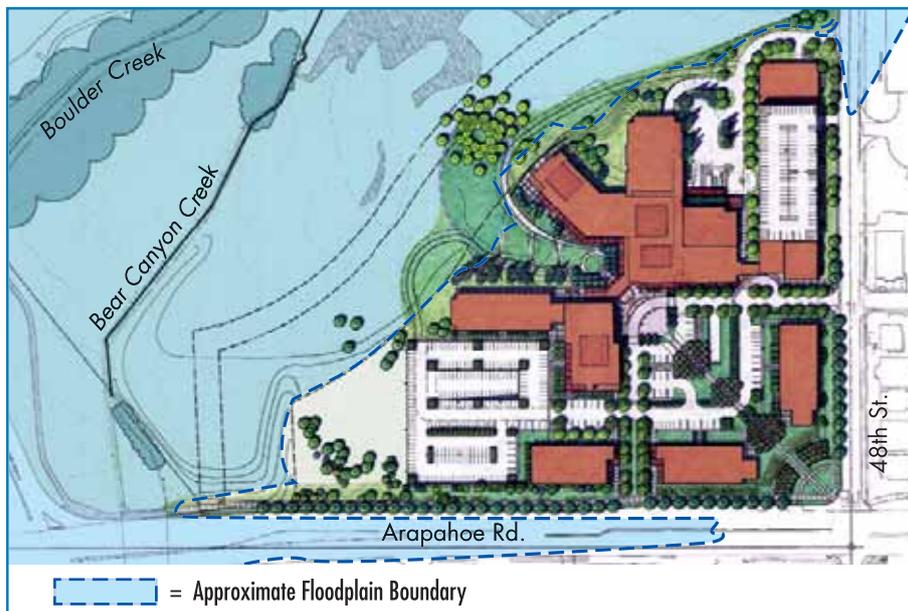
Figure 3-31:
Master site plan of the Boulder Community Foothills Hospital, Boulder, CO.

The master site plan for complete development of the site is shown in Figure 3-31. The primary building on the site incorporates the hospital

and medical building. It consists of a main reception area linking two large wings. The hospital wing is cast-in-place concrete with a steel frame roof. The medical building wing is steel frame, fireproofed with concrete floor slabs. Exteriors are brick veneer on metal studs. The two wings have three floors above-grade and one floor below-grade. The original designs complied with the 1997 Uniform Building Code for the core and shell; clinical spaces and interior designs comply with the *2000 International Building Code*. Other buildings on the campus include the Table Mesa Medical Building, a free-standing parking garage, and the utility plant building. The Cancer Care Center and another parking garage are under construction.

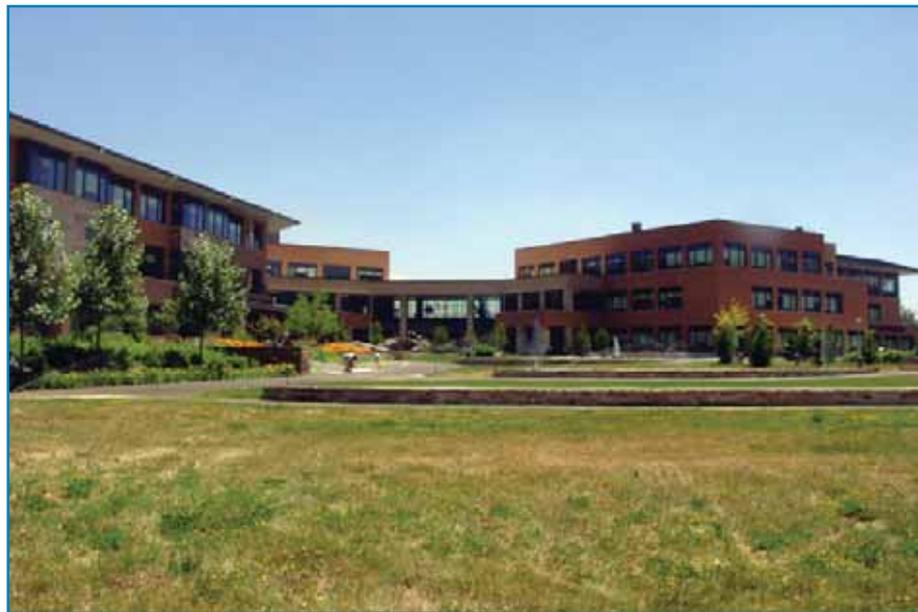
Figure 3-32:
Boulder Community Foothills Hospital main entrance, with landscaping and retaining walls for portion of site filled to the 500-year flood elevation (Boulder Creek is behind photographer).

The 17 acres of the site that were needed for the campus, entirely outside of the designated floodway, were proposed to be filled to an elevation of one-foot above the 100-year flood elevation. The remaining 22 acres were placed in conservation easement. Engineering analyses were performed to demonstrate that no increase in flood elevations would result. The city required approval of a Conditional Letter of Map Revision from FEMA prior to approving the plans. The fill was required to be compacted to 95 percent of the maximum density obtainable with the Standard Proctor Test method. The earthen fill is gently sloped to natural grade and various landscaping elements and retaining walls provide a pleasing transition (Figure 3-32).

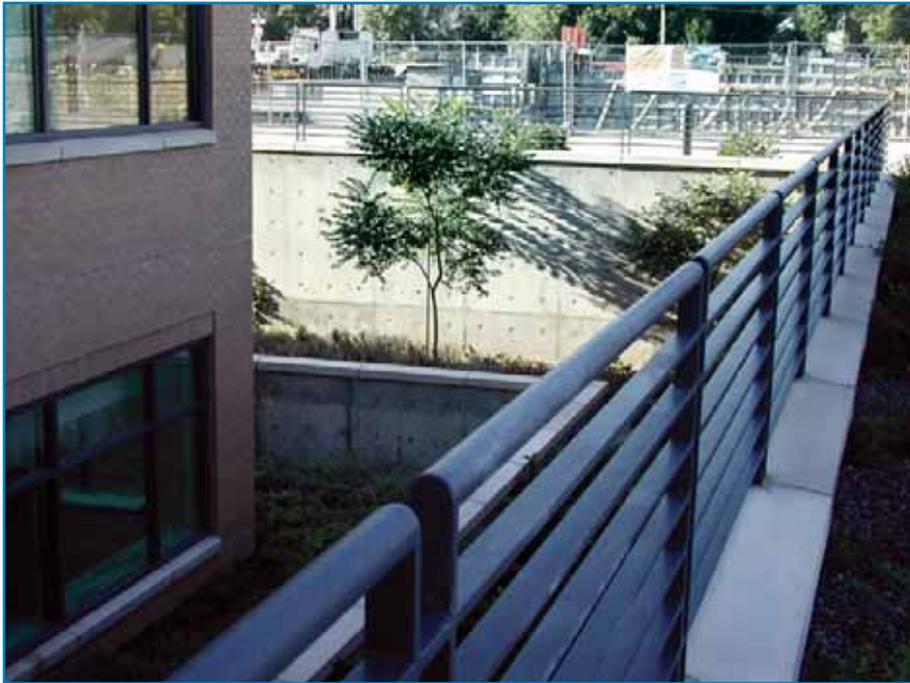
Figure 3-33: Below-grade office spaces provide natural light by construction of reinforced moat designed to provide flood protection for a foot above the 500-year flood elevation.

materials management, and building service and equipment. To provide natural light, a portion of these below-grade floors are surrounded by a moat (Figure 3-33). Because of anticipated high groundwater and the fact that the below-grade areas are constructed into fill that is subject to saturation during flooding, all below-grade areas are designed and certified as floodproofed spaces. Floodproofing extends 2 feet above the 100-year flood elevation, and 1 foot above the 500-year flood elevation.
