Design Guide

for Improving Hospital Safety
in Earthquakes, Floods, and High Winds

FEMA 577 / June 2007

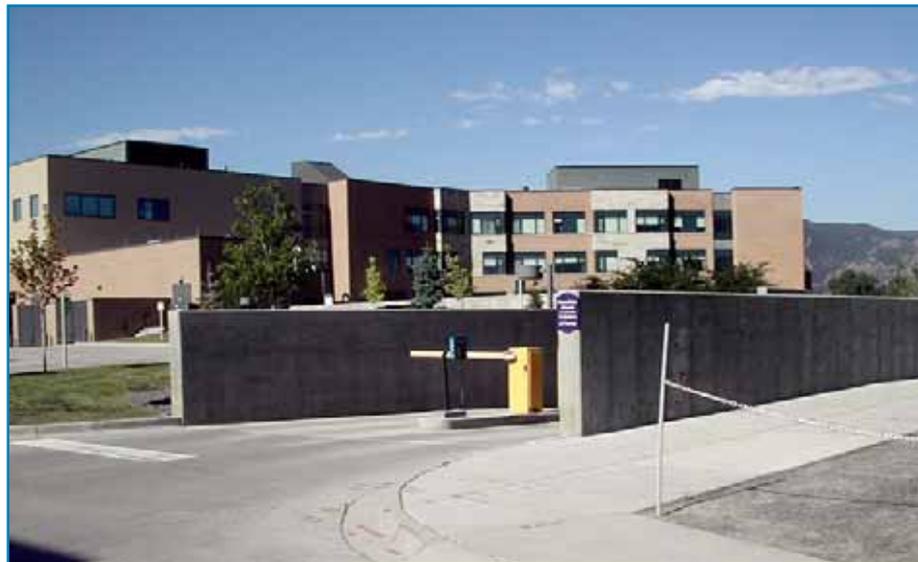
Figure 3-34:
Ramp entrance to below-grade parking garage. Note retaining walls on either side; ramp crests at about 16-inches above the 500-year flood elevation.

Although the risk of flooding is very low, hospital personnel have identified low points where floodwaters that rise higher than the predicted 500-year flood could begin to affect the facility. The lowest point of entry is the ramp to the parking garage, which is more than a foot higher than the 500-year water surface elevation (Figure 3-34). A supply of sandbags is kept onsite for placement across the ramp. The next most susceptible location is the air handler, although its ground elevation is somewhat higher than the 500-year flood level (Figure 3-35).

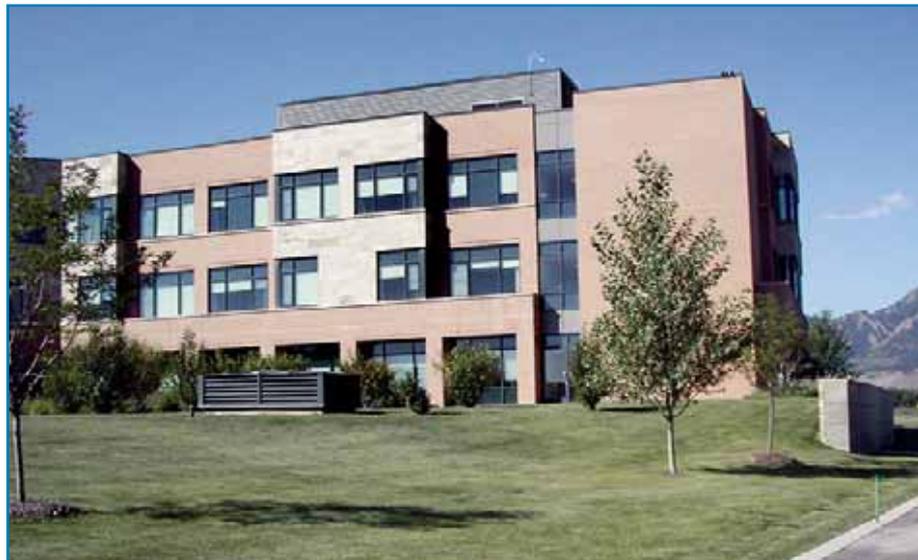
Figure 3-35:
The upper floors provide patient care. The top of the retaining wall (on right) and the air handler (left of center) are approximately one-foot above the 500-year flood elevation.

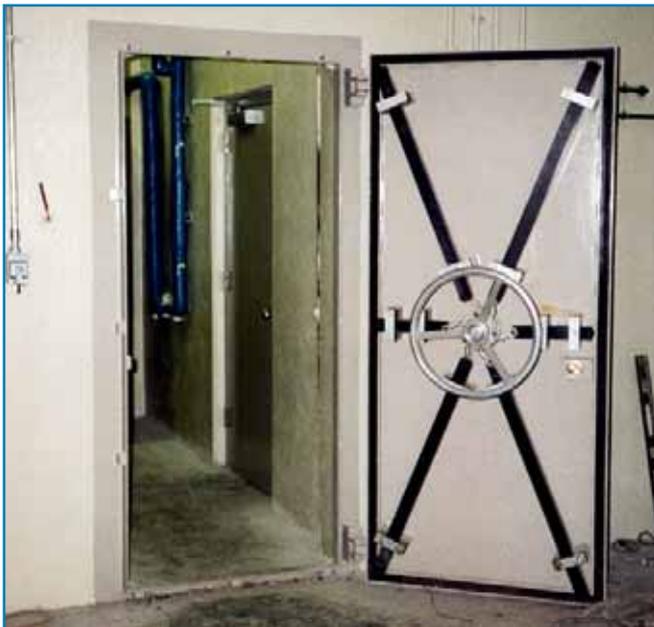
Figure 3-36: Permanent watertight doors designed for deep water

specially designed units (see Figure 3-36) or be fitted with gasketed, mountable panels that are designed for the anticipated flood conditions and loads. Generally speaking, it is difficult to protect window and door openings from water more than a few feet deep. The framing and connections must be specifically designed for these protective measures, or water pressure may cause window and door frames to separate from the building.

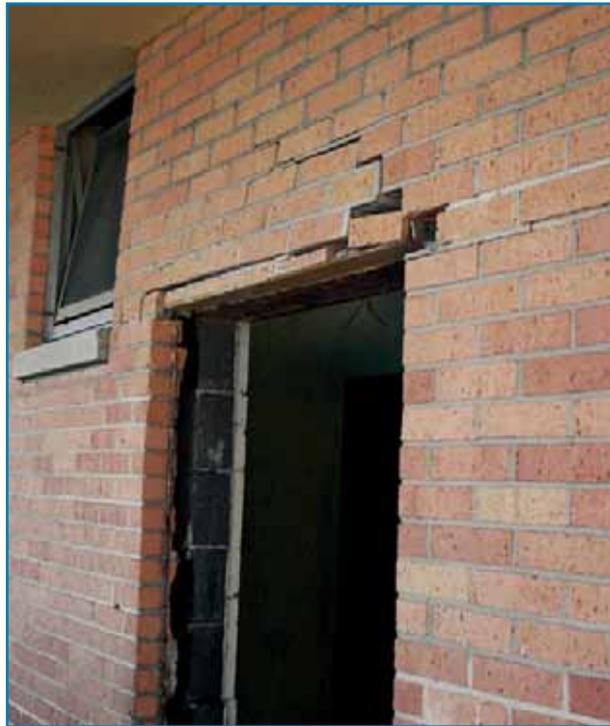
Figure 3-37:
Brick facing separated from masonry wall
(Hurricane Katrina, 2005).

Concrete and masonry that are designed and constructed in compliance with applicable standards are generally considered to be flood-resistant. However, masonry facings are undesirable finishes unless extra anchoring is added to prevent separation (see Figure 3-37). Wood and timber members exposed to floodwaters should be naturally decay-resistant species, or pressure treated with appropriate preservatives.

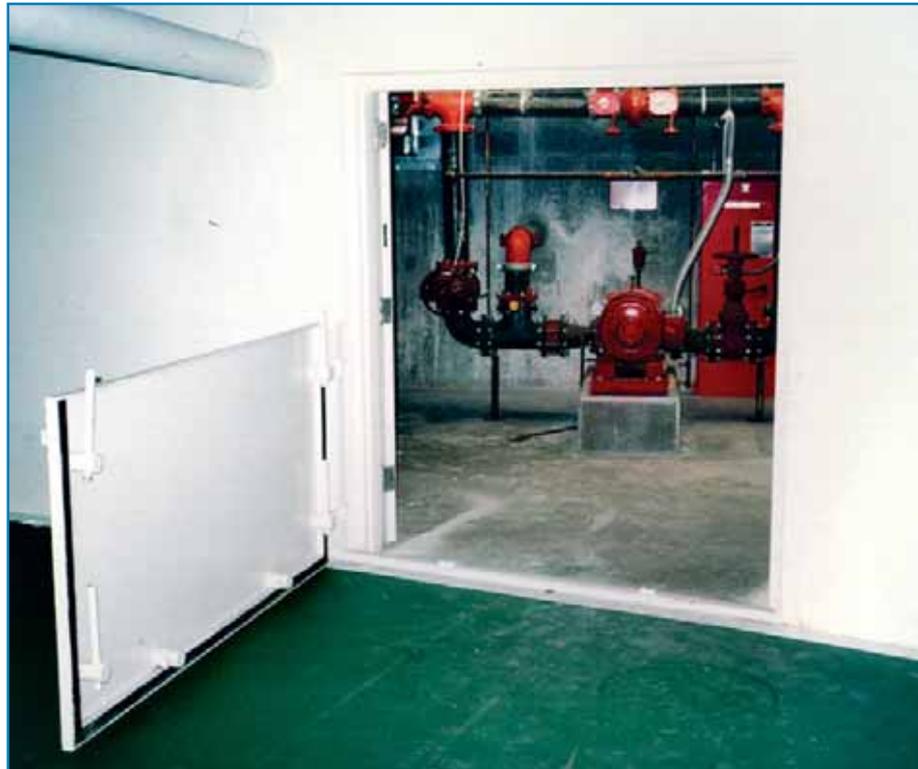
Figure 3-38:
Equipment room with
watertight door
SOURCE: PRESRAY
CORPORATION

Although it is difficult to achieve, the model building codes and NFIP regulations provide an alternative that allows equipment to be located below the DFE. This alternative requires that such equipment be designed, constructed, and installed to prevent floodwaters from entering or accumulating within the components during flood events.

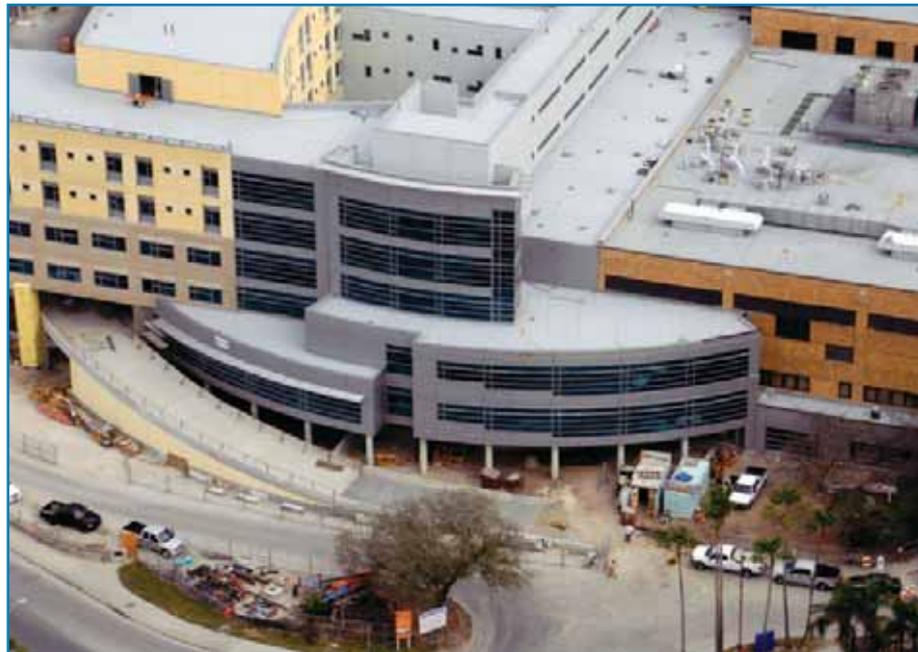
Figure 3-40:
Tampa General Hospital solved the problem of access to the new elevated Emergency Department by designing a vehicle ramp. Visitors and ambulatory patients take elevators from the ground floor.

With respect to code compliance and designing additions to resist flood damage, one of the more significant issues to be considered is ease of access. If the lowest floor of the existing facility is below the DFE, steps, ramps, or elevators will be required for the transition to the new addition (See Figure 3-40). Some jurisdictions may contemplate allowing variances to the requirement for elevation, because alternative means of access are available, such as ramps and elevators. Under the regulations of the NFIP and FEMA guidance, it is not considered appropriate to grant such a variance.

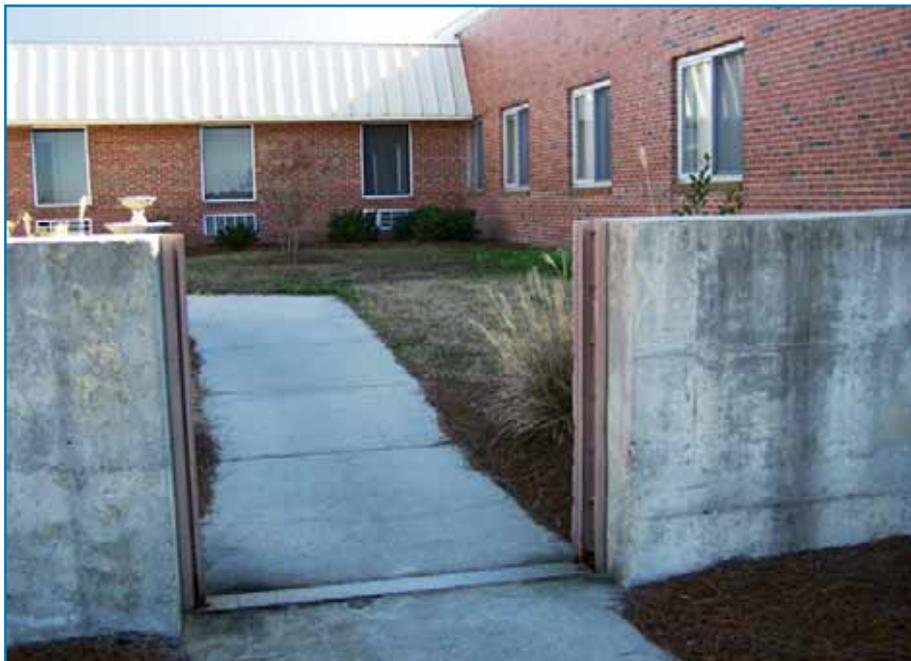
Figure 3-43:
A special floodproofing panel is manually installed in this concrete floodwall to keep floodwater away from the rear courtyard and patient rooms.

The engineer's examination determined that the exterior walls of the existing building were sufficiently strong to resist the flood loads anticipated during the 100-year flood conditions, provided the entrances and other openings through the exterior wall were sealed to prevent entry of water. The dry floodproofing measures proposed entailed construction of low concrete walls in certain areas and installation of specially fabricated frames and metal panels for some doors, floodwall openings, and crawlspace ventilation openings (Figures 3-43 and 3-44). The top of the concrete wall and the tops of the panels were set about 2 feet higher than the BFE, providing 2 feet of freeboard as a factor of safety. To provide additional protection to the new addition, a rubber membrane was installed between the brick facing and the block wall. The total cost of the floodproofing measures was \$125,000 (1997 dollars).

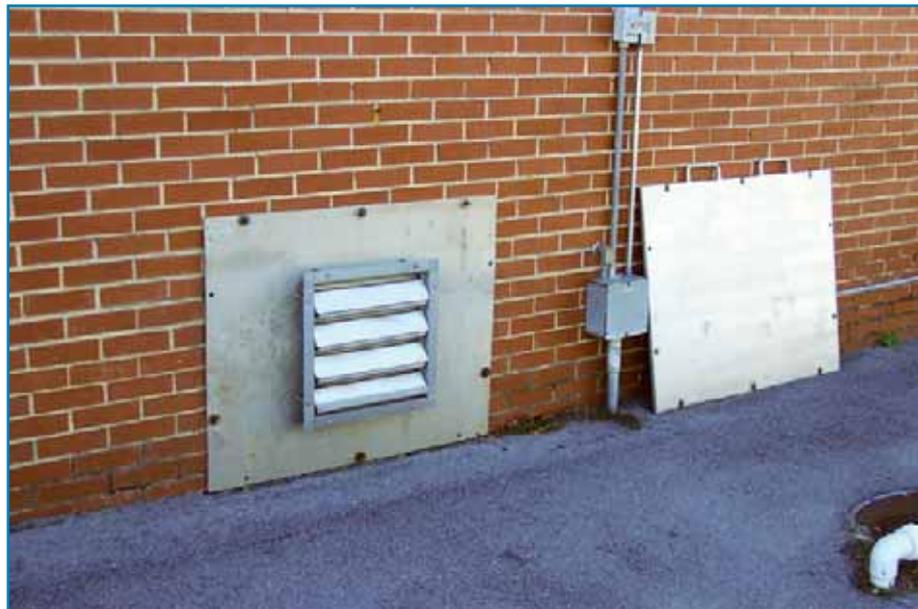
Figure 3-44:

The ventilation openings for the original building's crawlspace are protected with floodproofing panels that are bolted in place when flooding is predicted.

The frames that hold the floodproofing panels are permanently-mounted and sealed against the building to prevent seepage. The frames are designed with an aluminum cover to keep the channels free of dirt and debris. The metal panels that fit into the channels have rubber gaskets that are inspected each year as part of the hospital's routine maintenance program. The manufacturer recently advised replacement of the gaskets, as the 10-year anniversary of installation nears.

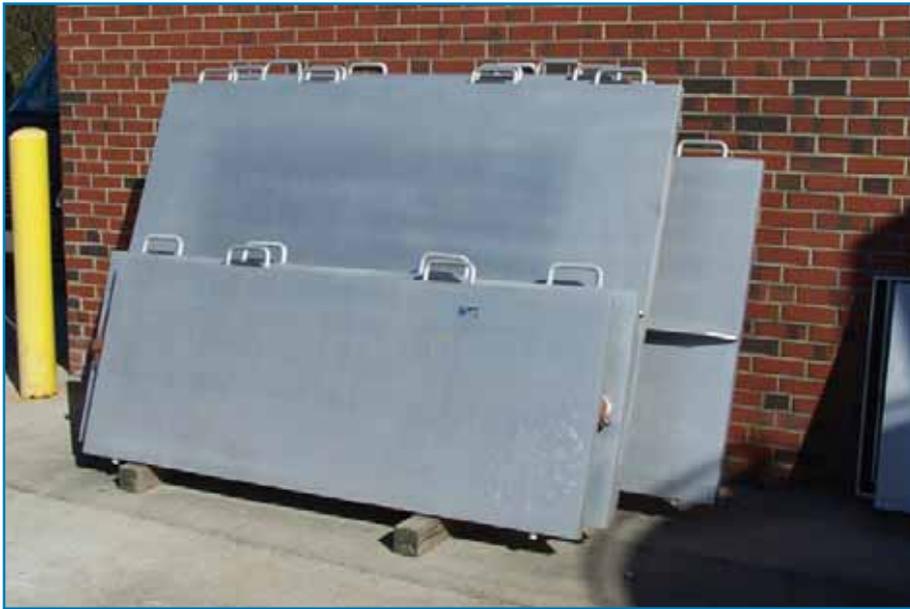
Figure 3-45: Large floodproofing panels are stored at the hospital, ready for installation when coastal flooding is predicted.

A total of 15 panels of different sizes are stored onsite (Figure 3-45). Although the panels can be handled by two people (Figure 3-46), the hospital has an on-call agreement with a local rental company to use a forklift to facilitate moving them into place. All panels can be installed in about 3 hours.

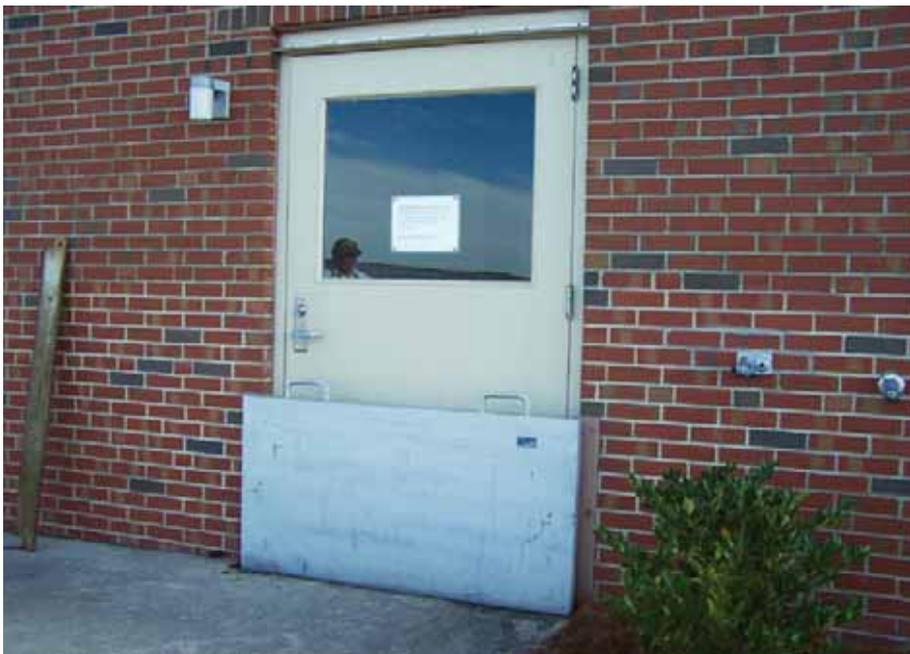
Figure 3-46: Most of the panels can be installed by hand. Note the protective metal strip leaning against the building on the left; normally this strip covers the horizontal channel into which the panel is inserted.

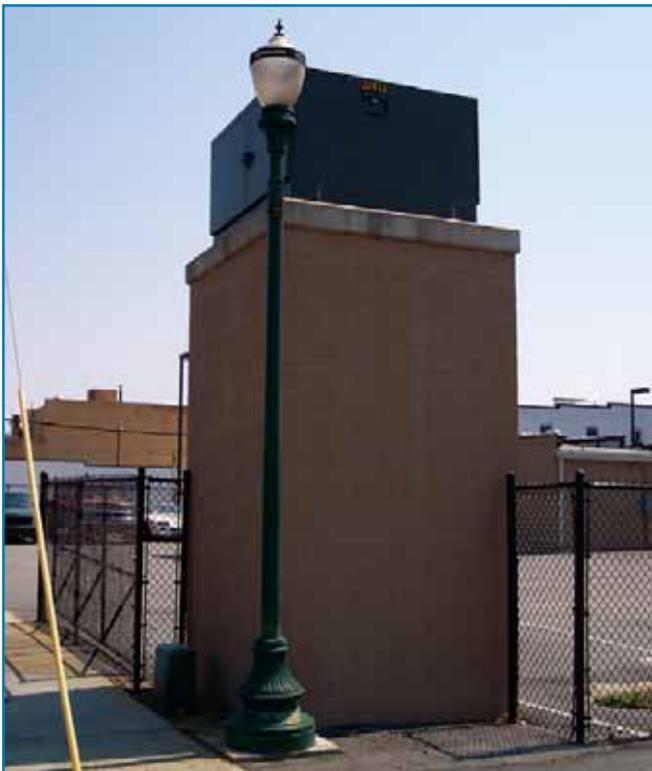
Figure 3-48:
Elevated utility box

Elevate components: Whether located inside or outside of the building, some components of utility systems can be elevated-in-place on platforms, including electric transformers, communication switch boxes, water heaters, air-conditioning compressors, generators, furnaces, boilers, and heat pumps (see Figure 3-48).

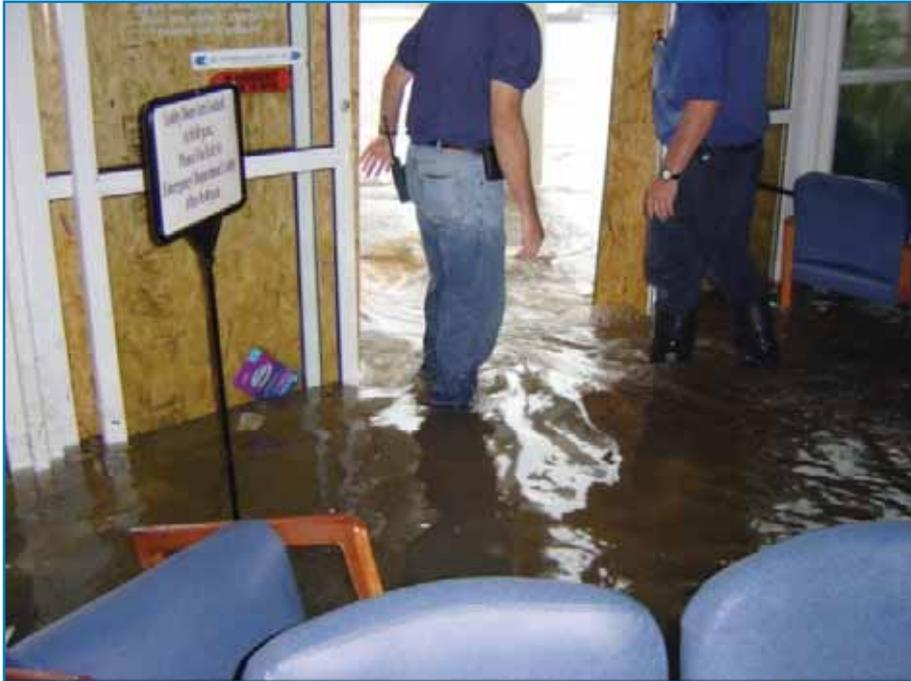
Figure 3-49:
Flooding at Hancock
Medical Center during
Hurricane Katrina

Panels for doors: For shallow and short-duration flooding, panels of sturdy material can be made to fit doorways to minimize the entry of floodwaters, although failure is common (see Figure 3-49). Effectiveness is increased significantly if a flexible gasket or sealant is provided, and the mounting hardware is designed to apply even pressure. Personnel must know where the materials are stored and be trained in

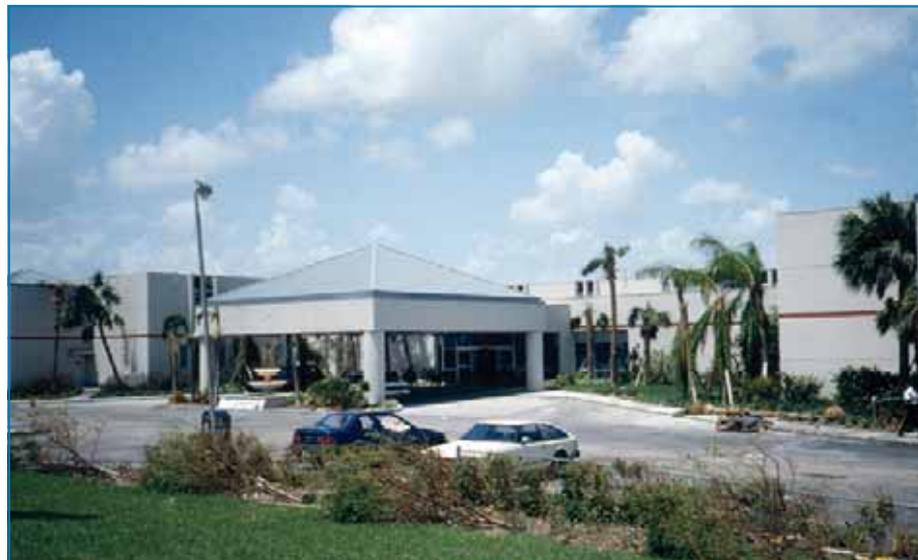
Figure 4-1:
Deering Hospital
was evacuated after
Hurricane Andrew due
to water infiltration
caused by roof
covering, window,
and door damage.

The 200-bed Deering Hospital opened shortly before Hurricane Andrew struck south Florida in 1992. Aggregate from the hospital's built-up roofs broke several windows, the roof covering was blown off in some areas (Figure 4-9), and the entrance doors at the emergency room were blown away. Because of extensive interior water damage, the entire hospital was evacuated after the storm and remained closed for 9 months.

Property damage: Property damage requires repairing/replacing the damaged components (or replacing the entire facility), and may require repairing/replacing interior building components, furniture, and other equipment, and mold remediation. As illustrated by Figures 4-1 and 4-8, even when damage to the building envelope is limited, such as blow-off of a portion of the roof covering or broken glazing, substantial water damage frequently occurs because heavy rains often accompany strong winds (particularly in the case of thunderstorms, tropical storms, hurricanes, and tornadoes).

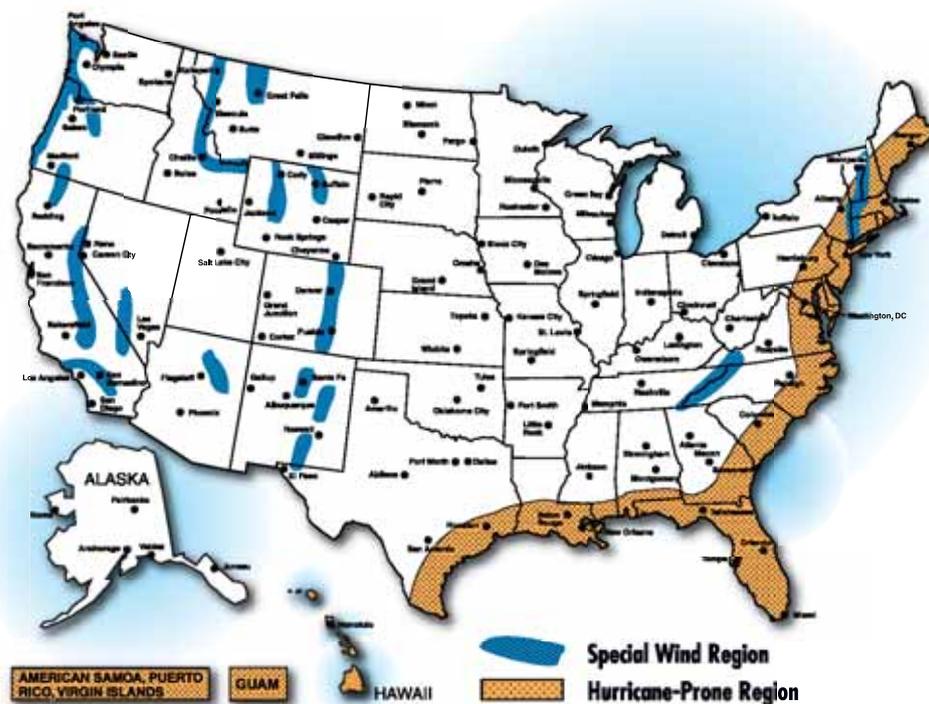
Of all the storm types, hurricanes have the greatest potential for devastating a large geographical area and, hence, affect the greatest number of people. See Figure 4-2 for hurricane-prone regions.

Figure 4-2: Hurricane-prone regions and special wind regions

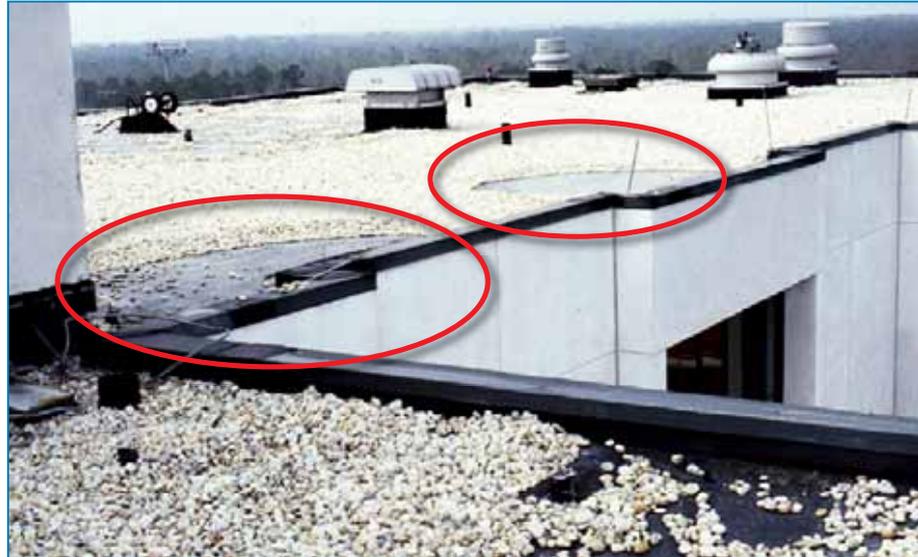
Building irregularities, such as re-entrant corners, bay window projections, a stair tower projecting out from the main wall, dormers, and chimneys can cause localized turbulence. Turbulence causes wind speed-up, which increases the wind loads in the vicinity of the building irregularity, as shown in Figures 4-5 and 4-6. Figure 4-5 shows the aggregate ballast on a hospital's single-ply membrane roof blown away at the re-entrant corner and in the vicinity of the corners of the wall projections at the window bays. The irregular wall surface created turbulence, which led to wind speed-up and loss of aggregate in the turbulent flow areas.

Figure 4-5:
Aggregate blow-off associated with building irregularities. Hurricane Hugo (South Carolina, 1989)

Wall collapse: Collapse of non-load-bearing exterior walls is common during hurricanes and tornadoes, but is less common during other storms. At the hospital shown in Figure 4-11, a portion of the non-load-bearing wall collapsed. Several windows were also broken by aggregate ballast blown from the hospital's roof (see Figure 4-5).

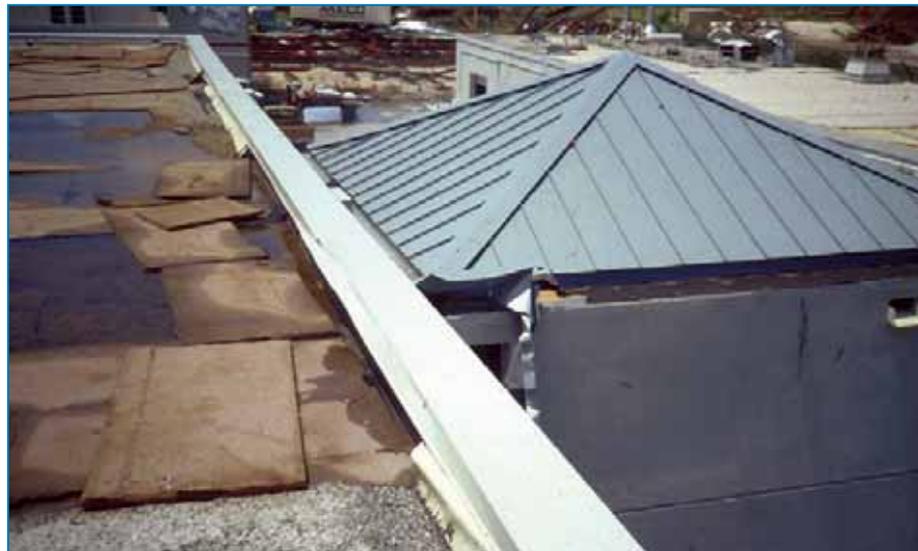
Figure 4-6 shows a stair tower at a hospital that caused turbulence resulting in wind speed-up. The speed-up increased the suction pressure on the base flashing along the parapet behind the stair tower. The built-up roof's base flashing was pulled out from underneath the coping because its attachment was insufficient to resist the suction pressure. The base flashing failure propagated and caused a large area of the roof membrane to lift and peel. Some of the wall covering on the stair tower was also blown away. Had the stair tower not existed, the built-up roof would likely not have been damaged. To avoid damage in the vicinity of building irregularities, attention needs to be given to the attachment of building elements located in turbulent flow areas.

Figure 4-6:
The irregularity created by the stair tower (covered with a metal roof) caused turbulence resulting in wind speed-up and roof damage. Hurricane Andrew (Florida, 1992)

To avoid the roof membrane damage shown in Figure 4-6, it would be prudent to use corner uplift loads in lieu of perimeter uplift loads in the vicinity of the stair tower, as illustrated in Figure 4-7. Wind load increases due to building irregularities can be identified by wind tunnel studies; however, wind tunnel studies are rarely performed for hospitals. Therefore, identification of wind load increases due to building

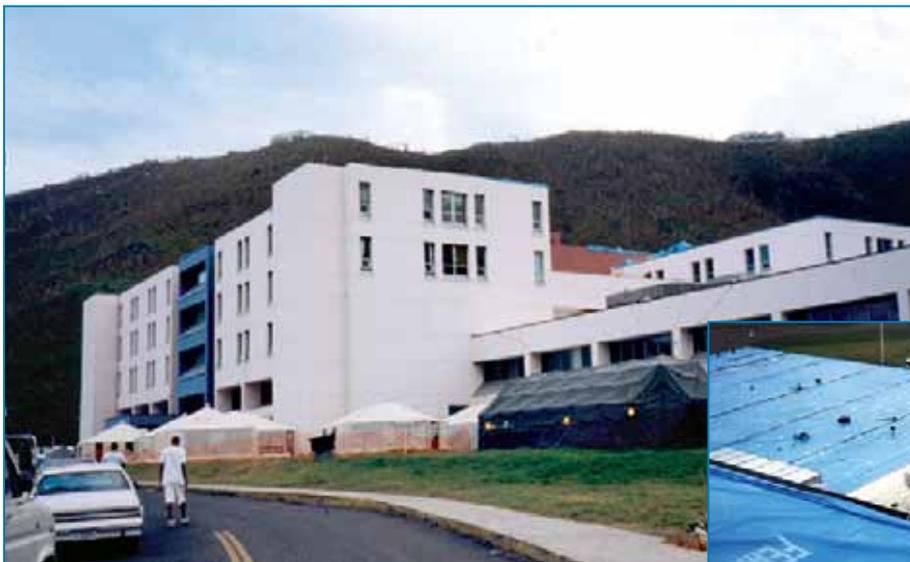
When damaged by wind, hospitals typically experience a variety of building component damage. For example, at the hospital shown in Figure 4-8, the roof covering was severely damaged, windows were broken, and rooftop equipment was blown away. The subsequent water infiltration required that most of the hospital be evacuated. The most common types of damage are discussed below in descending order of frequency.

Figure 4-8:
Field military hospital
in tents set up to
replace evacuated
hospital in U.S. Virgin
Islands following
Hurricane Marilyn
(1995)

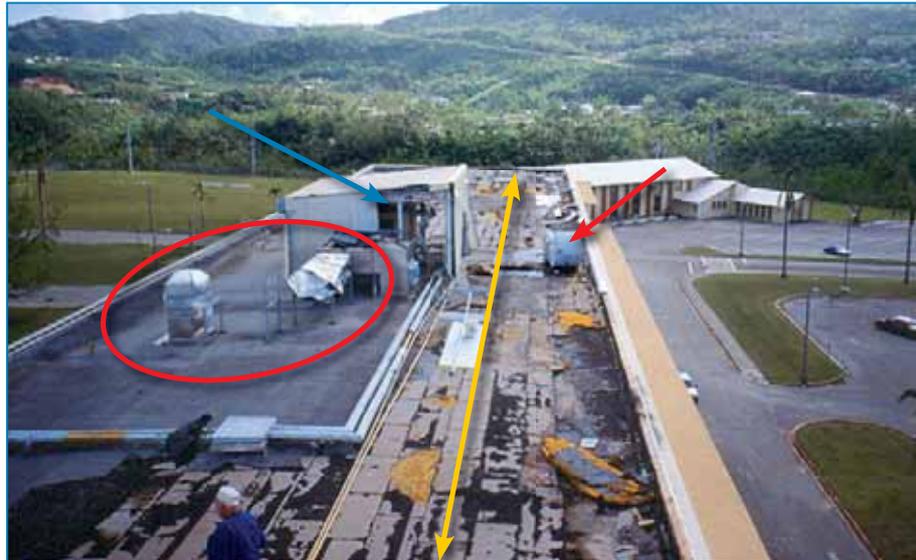
Roof: Roof covering damage (including rooftop mechanical, electrical, and communications equipment) is the most common type of wind damage, as illustrated by Figure 4-9. In addition to blowoff of the roof membrane (yellow arrow), ductwork blew away (red circle), a gooseneck was blown over (red arrow), and wall panels at an equipment enclosure were blown off (blue arrow). The cast-in-place concrete deck kept most of the water from entering the hospital.

Figure 4-9:
Damaged roof membrane and rooftop equipment. Typhoon Paka (1997)

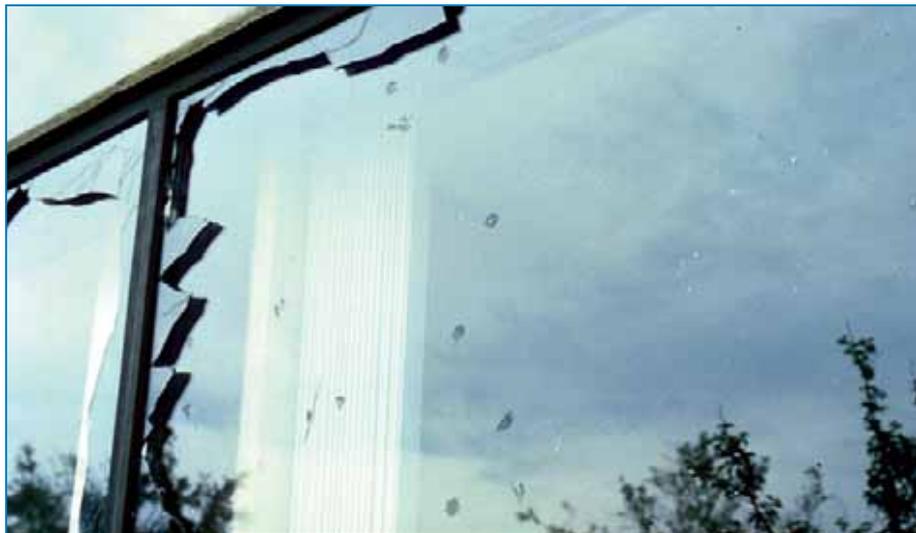
Glazing: Exterior glazing damage is very common during hurricanes and tornadoes, but is less common during other storms. The glass shown in Figure 4-10 was broken by the aggregate from a built-up roof. The inner panes had several impact craters. In several of the adjacent windows, both the outer and inner panes were broken. The aggregate flew more than 245 feet (the estimated wind speed was 104 mph, measured at 33 feet in Exposure C).

Figure 4-10:
The outer window panes were broken by aggregate from a built-up roof. Hurricane Hugo (South Carolina, 1989)

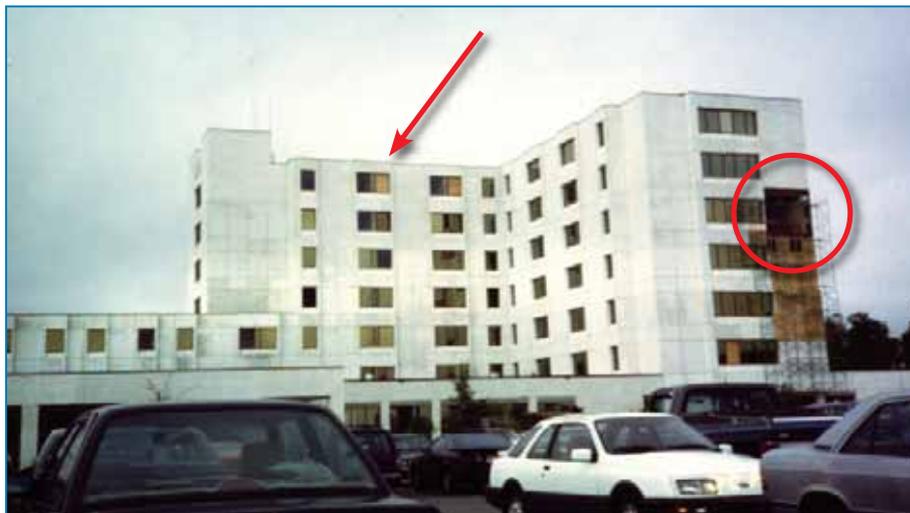
Figure 4-11: Collapse of non-load-bearing wall (red circle) and broken glazing from roof aggregate (red arrow). Hurricane Hugo (South Carolina, 1989)

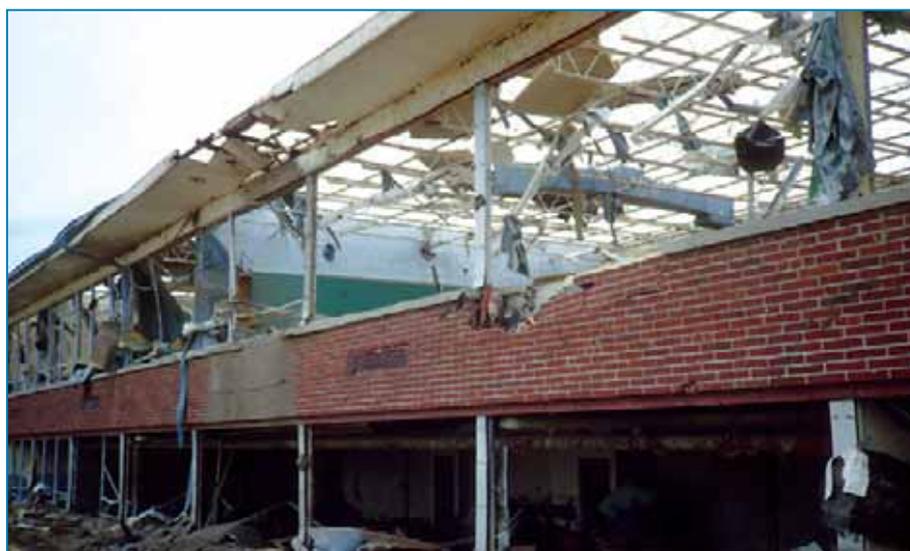
Structural system: Structural damage (e.g., roof deck blow-off, blow-off or collapse of the roof structure, collapse of exterior bearing walls, or collapse of the entire building or major portions thereof) is the principal type of damage that occurs during strong and violent tornadoes (see Figure 4-12)

Figure 4-12: This building in Northern Illinois was heavily damaged by a strong tornado in 1990.

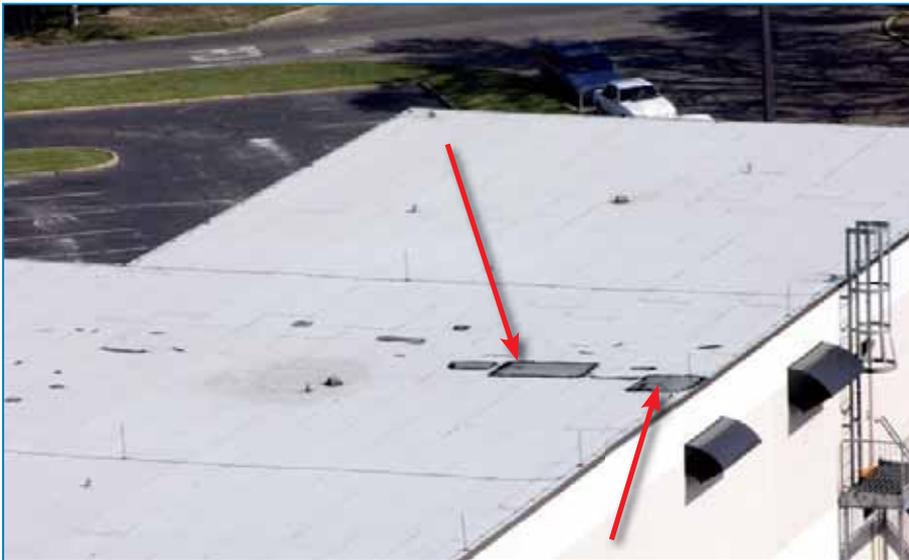
Figure 4-14: Numerous repairs where the modified bitumen roof membrane was punctured by missiles. Water from the punctured membrane entered the surgical suite.

The West Florida Hospital (J on Figure 4-13) and several of the other buildings on the campus experienced a variety of damages during the storm. The roof membrane was punctured in several places by windborne missiles and by damaged rooftop equipment (see Figures 4-14 to 4-16).

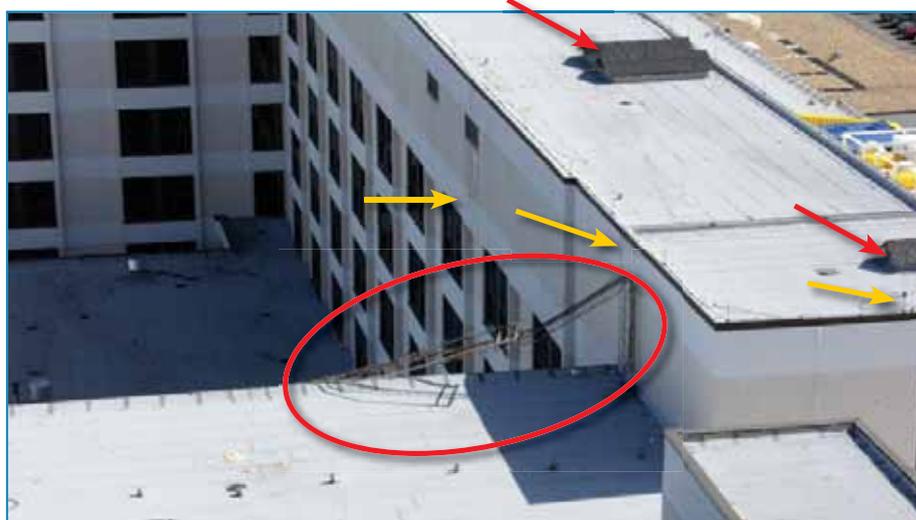
Figure 4-15:
Damaged rooftop equipment (red arrows), collapsed antenna (circled), and displaced LPS (yellow arrows)

Communications outside of the hospital were lost about an hour after the arrival of high winds because of damage to the communications antenna; the LPS was also displaced (Figure 4-15). A canopy at the loading dock was blown away, which caused difficulties in materials handling.

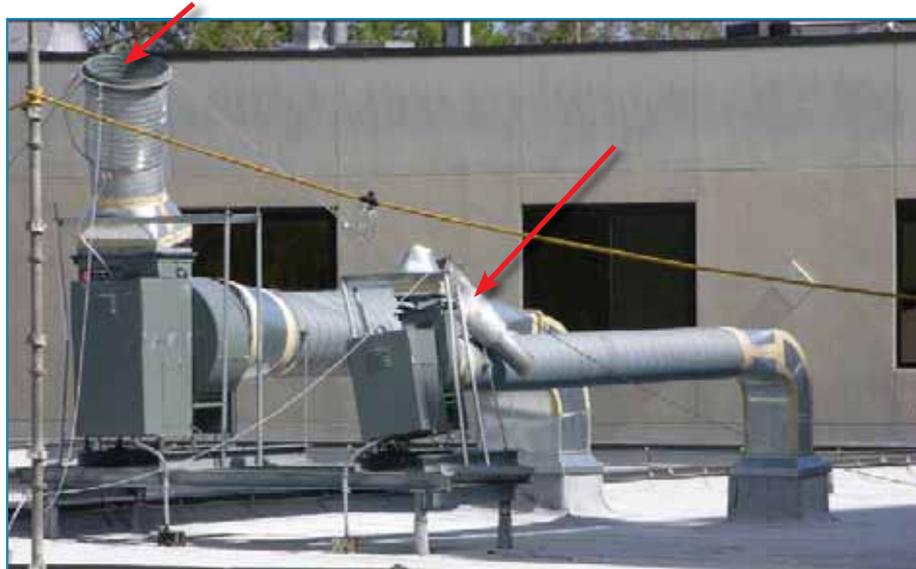
Figure 4-16:
Damaged rooftop equipment. Although some of this damage may have been caused by wind pressure, some of it was caused by missiles. Note the open ducts (red arrows).

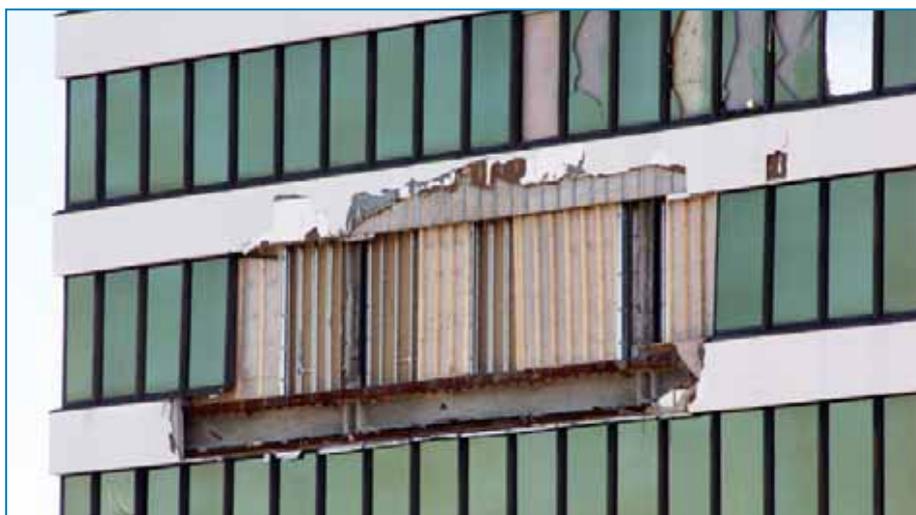
Figure 4-17:
Broken windows in the MOB. Wood studs and gypsum board had been temporarily installed after the hurricane to prevent patients from inadvertently falling out of the MOB.

Exterior insulation finish system (EIFS) blew off the hospital and caused significant glass breakage in the MOB (Figure 4-17) and the walkway connecting the hospital to the MOB. Some of the lower-level windows may have been broken by wind-blown aggregate ballast from the roof over the dialysis unit and urgent care facility. In addition, some window frames

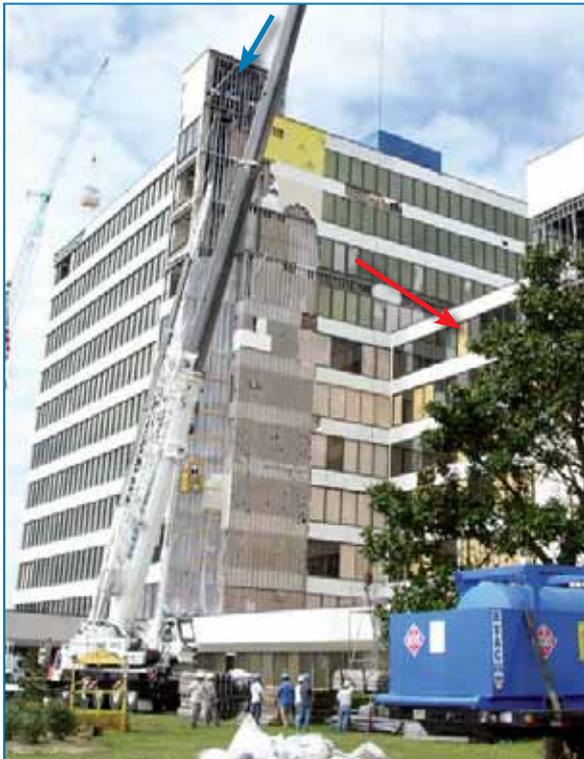
Figure 4-18: Broken windows in the connecting walkway between the hospital (right) and MOB (left) (red arrow). Also note the broken windows and loss of EIFS (including the gypsum board on both sides of the studs) at the elevator enclosure (blue arrow).

With loss of the EIFS wall covering, wind-driven rain destroyed the elevator control equipment (see Figure 4-22). Water damage to the elevator control equipment resulted in failure of the MOB stair tower elevator. As a result, several people were trapped in the MOB stair tower elevator shown in Figure 4-18 during the hurricane. Fortunately, the MOB had another bank of elevators in the core of the building that was not damaged, so vertical transportation was still possible, although handicapped by the loss of the stair tower elevator. At the MOB stair tower, some of the gypsum board on the interior side of the studs collapsed into the stairway, thus trapping a maintenance worker who had gone to the mechanical penthouse during the hurricane.

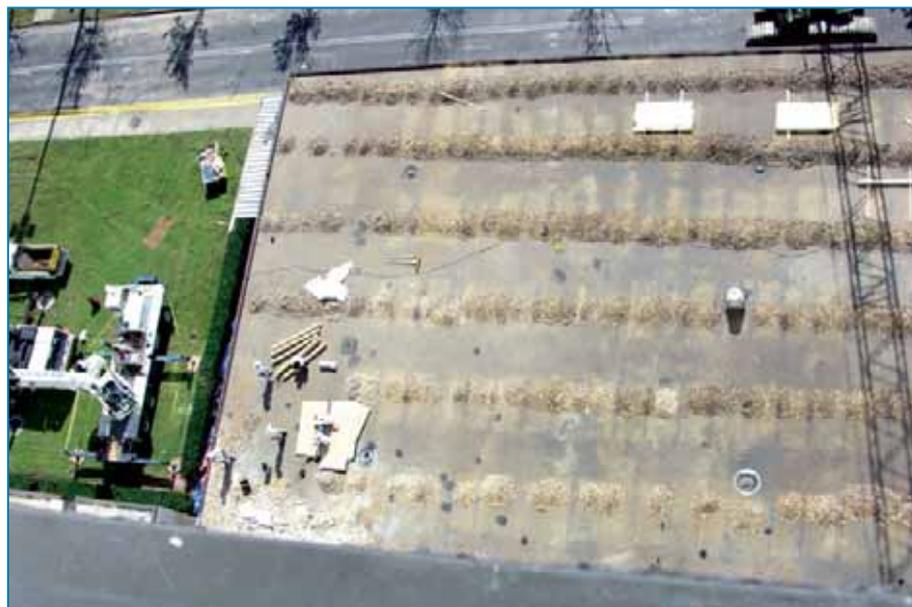
Figure 4-20:
Looking down at the one-story roof to the right of the MOB in Figure 4-19. The small dark areas are locations where emergency patches had been placed to repair punctures from falling glass shards. (Note: At the time the photo was taken, the ballast had been repositioned into rows in preparation for removal)

Glass shards from the MOB punctured the ballasted single-ply membrane over the regional dialysis unit and urgent care facility (item L on Figure 4-13). Although the roof membrane had been punctured in numerous areas (Figure 4-20), the concrete deck (concrete topping over metal decking) over the dialysis unit and urgent care facility acted as a secondary line of protection against water leakage and was effective in minimizing water infiltration into the facility, thereby minimizing interrupted use of these facilities. By quickly performing emergency roof repairs and cleaning up the interior, the dialysis unit was non-operational for only 1 day.

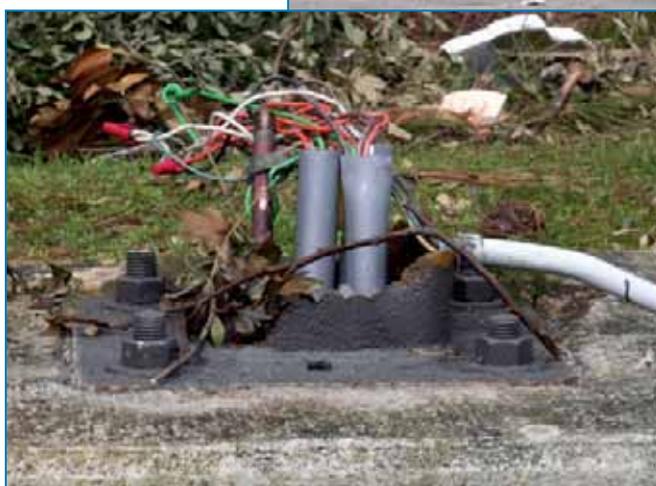
Figure 4-21:
Collapsed light fixtures caused by severe corrosion (see inset). The cancer treatment facility is beyond to the left.

At the imaging center (F on Figure 4-13), there were some broken windows and a fan cowling blew away. Some large parking lot light fixtures also collapsed because the bottoms of the tubes were severely corroded (Figure 4-21).

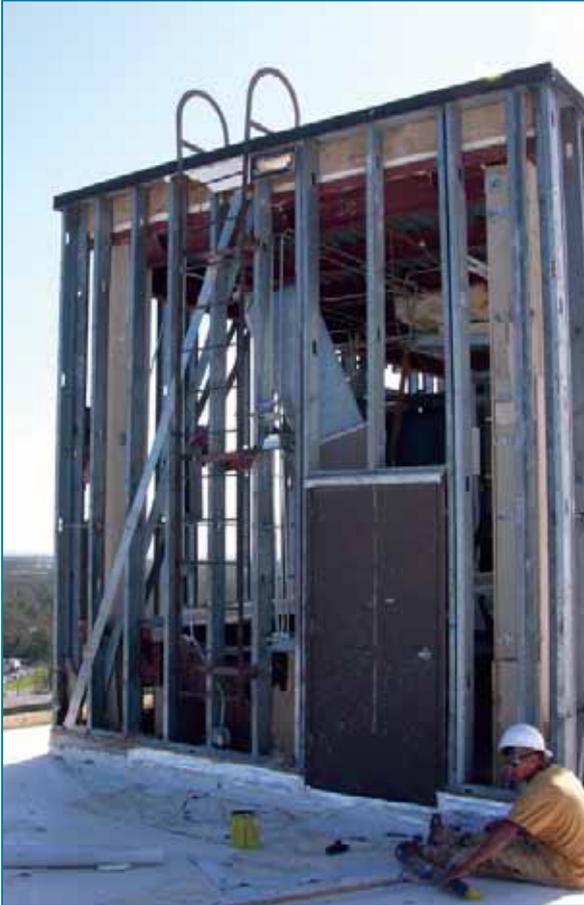
Figure 4-22: The only remaining portion of the exterior wall surrounding the elevator penthouse on the MOB was the steel studs.

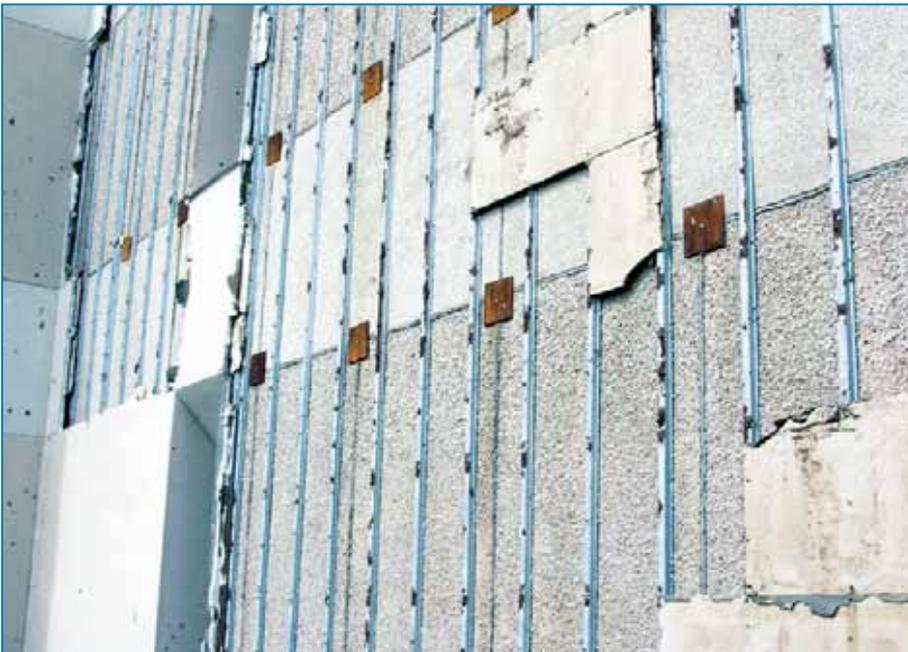
Figure 4-23: Close-up of the damaged EIFS at the hospital. In this area most of the insulation and gypsum board was blown from the steel furring channels.

The hospital originally had exposed concrete walls. However, in a subsequent refurbishing, the walls were faced with EIFS. Steel hat channels were installed over the concrete, followed by gypsum board, insulation, and synthetic stucco. In areas where the EIFS blew off, the gypsum board typically pulled over the screw heads and blew away (Figure 4-23). The screws and hat channels were moderately corroded. Although the corrosion could have eventually caused loss of the EIFS, it did not play a role in this failure.

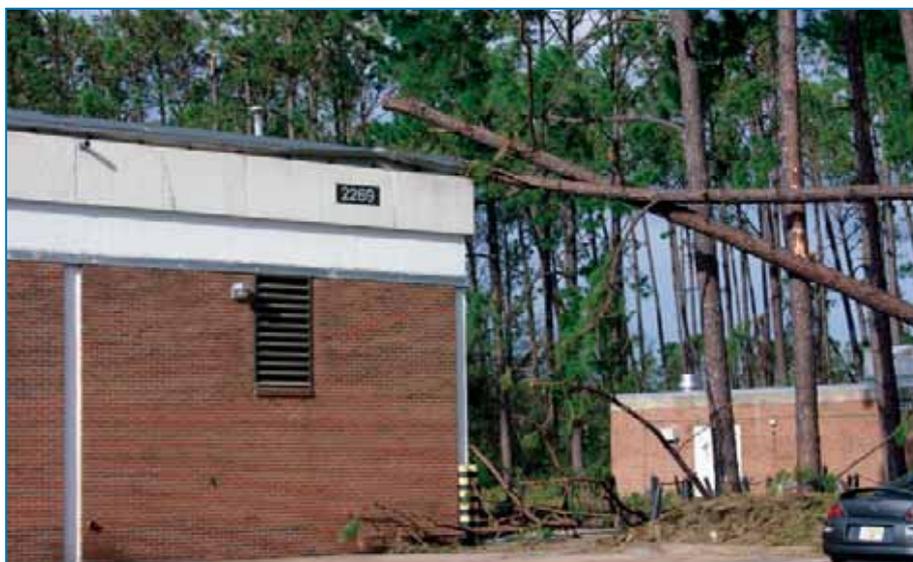
Figure 4-24:

Trees with trunks larger than 6 inches in diameter, poles (e.g., light fixture poles, flagpoles, and power poles), or towers (e.g., electrical transmission and large communication towers) should not be placed near the building. Falling trees, poles, and towers can severely damage a hospital and injure the occupants (see Figure 4-24). Large trees can crash through pre-engineered metal buildings and wood frame construction. Falling trees can also rupture roof membranes and break windows.

The roof membrane on this hospital's materials management facility was ruptured by falling trees. Hurricane Ivan (Florida, 2004)

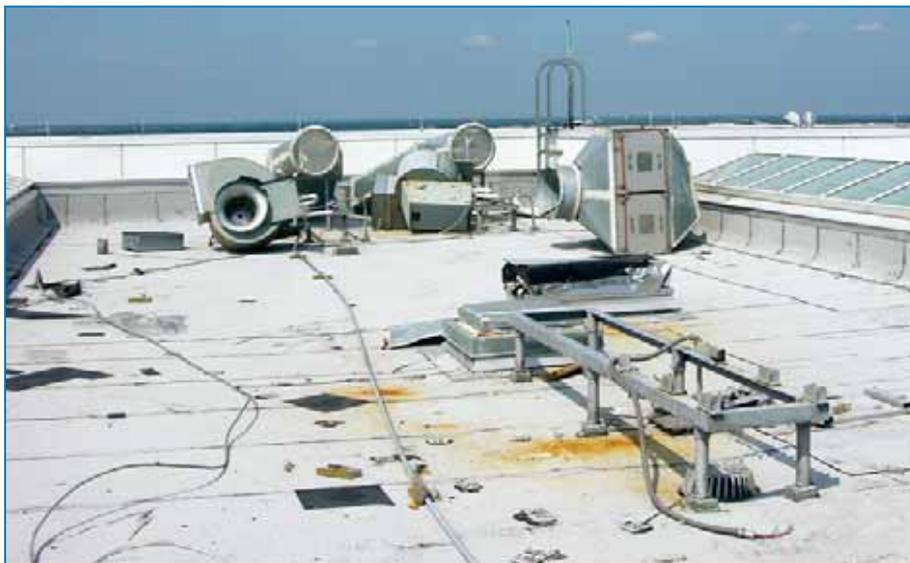
Figure 4-25: Temporary coverings placed over two large openings in the roof that were left after the ductwork blew away. Hurricane Katrina (Mississippi, 2005)

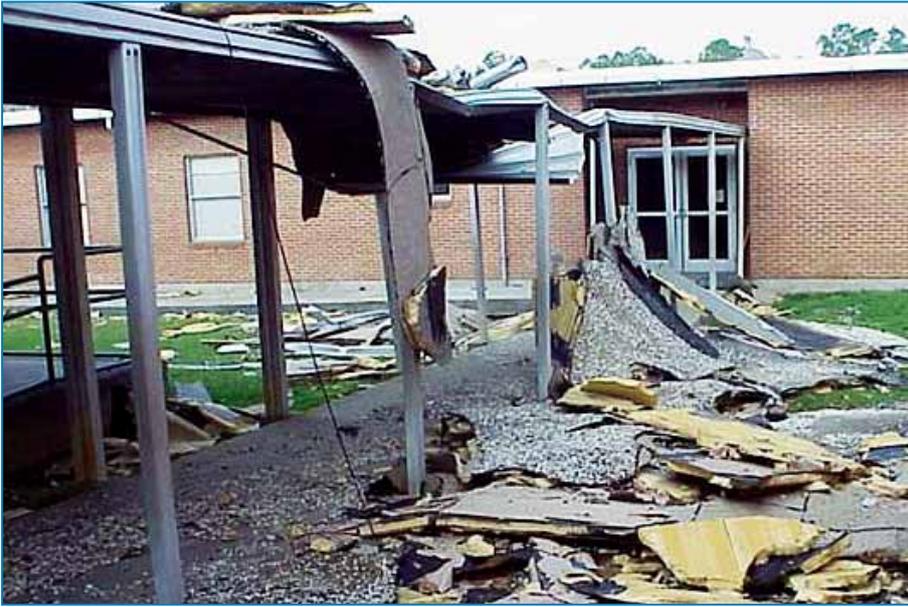
Figure 4-27:
Open walkways do not provide protection from wind-borne debris. (Hurricane Katrina, Mississippi)

- In cases where multiple buildings are occupied during a storm, it is recommended that enclosed walkways be designed to connect the buildings. The enclosed walkways (above- or below-grade) are particularly important for protecting people moving between buildings during a hurricane (e.g., to retrieve equipment or supplies) or for situations when it is necessary to evacuate occupants from one building to another during a hurricane (see Figure 4-27).
