Design Guide

for Improving Hospital Safety
in Earthquakes, Floods, and High Winds

FEMA 577 / June 2007

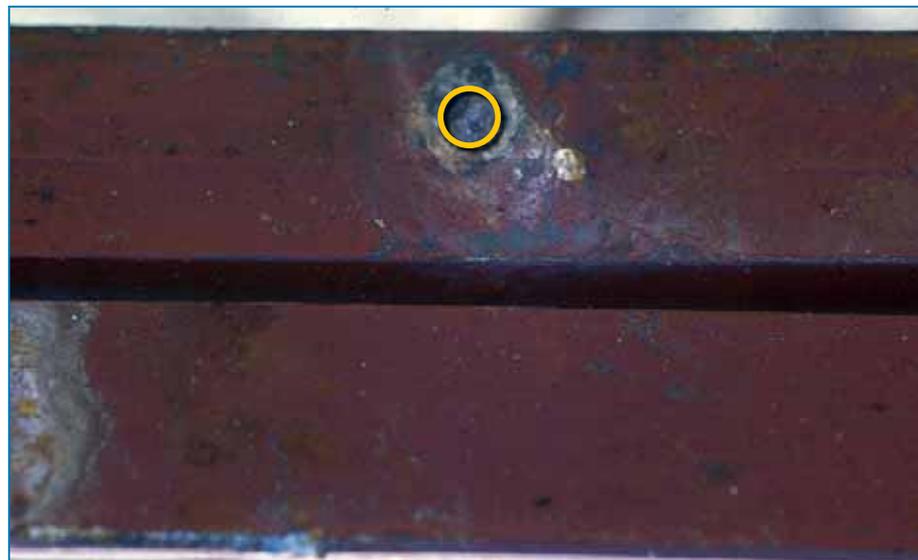
Figure 4-28:
View looking down at the top of a steel joist after the metal decking blew away. Only a small portion of the deck was well fused to the joist (circled area). Tornado (Oklahoma, 1999)

- For roof decks, concrete, steel, plywood, or oriented strand board (OSB) is recommended.
- For steel roof decks, it is recommended that a screw attachment be specified, rather than puddle welds or powder-driven pins. Screws are more reliable and much less susceptible to workmanship problems. Figure 4-28 shows decking that was attached with puddle welds. At most of the welds, there was only superficial bonding of the metal deck to the joist, as illustrated by this example. Only a small portion of the deck near the center of the weld area (as delineated by the circle) was well fused to the joist. Figures 4-29 and 4-30 show problems with acoustical decking attached with powder-driven pins. The pin shown on the left of Figure 4-30 is properly seated. However, the pin at the right did not penetrate far enough into the steel joist below.

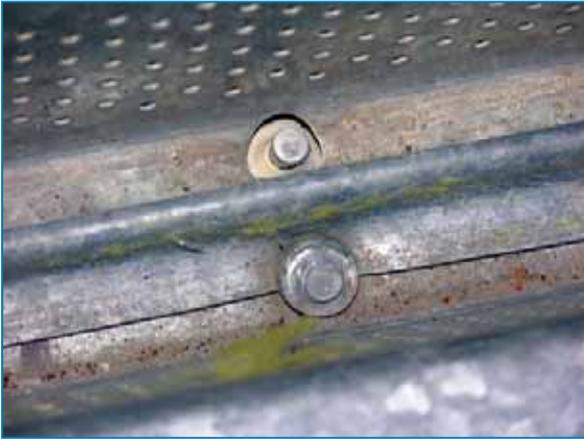
Figure 4-29:
Looking down at a sidelap of a deck attached with powder-driven pins. The washer at the top pin blew through the deck.

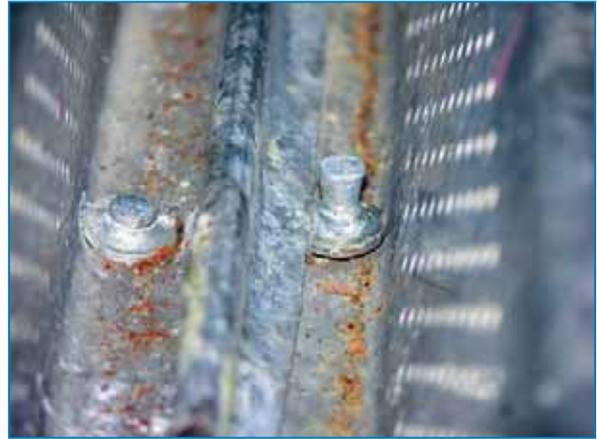
Figure 4-30:
View looking along a sidelap of a deck attached with powder-driven pins. The right pin does not provide adequate uplift and shear resistance.

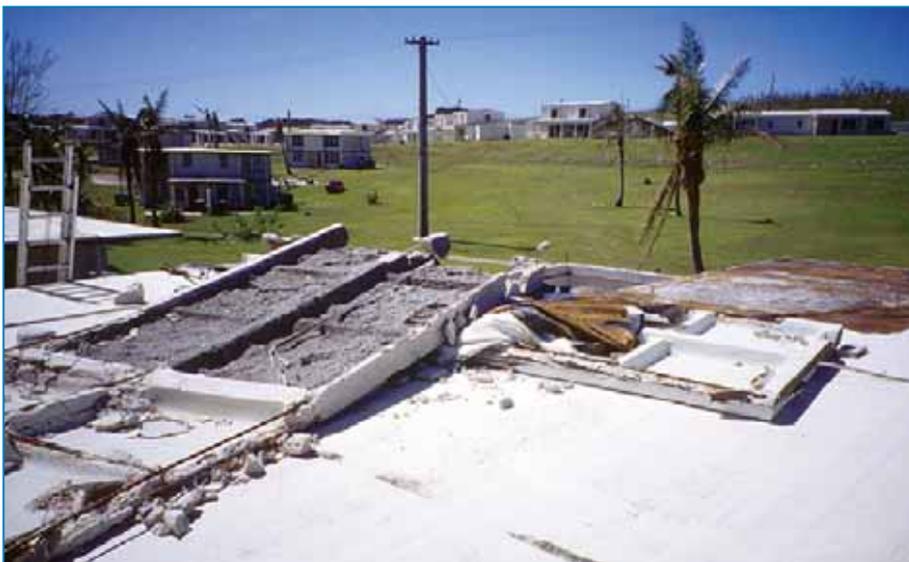
Figure 4-31:
Portions of this waffled precast concrete roof deck were blown off. Typhoon Paka (Guam, 1997)

- For attaching wood-sheathed roof decks, screws, ring-shank, or screw-shank nails are recommended in the corner regions of the roof. Where the basic wind speed is greater than 90 mph, these types of fasteners are also recommended for the perimeter regions of the roof.
- For precast concrete decks it is recommended that the deck connections be designed to resist the design uplift loads because the deck dead load itself is often insufficient to resist the uplift. The deck in Figure 4-31 had bolts to provide uplift resistance; however, anchor plates and nuts had not been installed. Without the anchor plates, the dead load of the deck was insufficient to resist the wind uplift load.

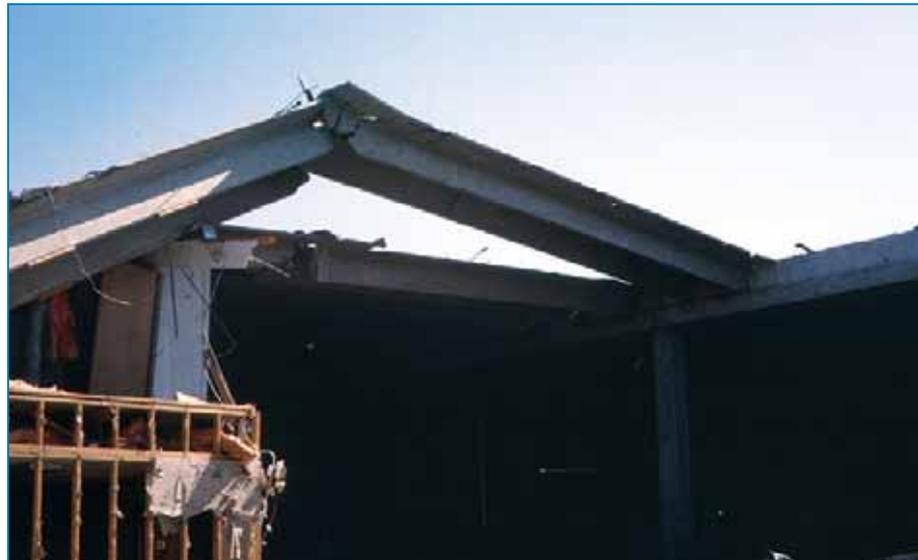
Figure 4-32:
Twin-Tee roof panel lifted as a result of the combined effects of wind uplift and pre-tension. Tornado (Missouri, May 2003)

- For precast Tee decks, it is recommended that the reinforcing be designed to accommodate the uplift loads in addition to the gravity loads. Otherwise, large uplift forces can cause member failure due to the Tee's own pre-stress forces after the uplift load exceeds the dead load of the Tee. This type of failure occurred at one of the roof panels shown in Figure 4-32, where a panel lifted because of the combined effects of wind uplift and pre-tension. Also, because the connections between the roof and wall panels provided very little uplift load resistance, several other roof and wall panels collapsed.

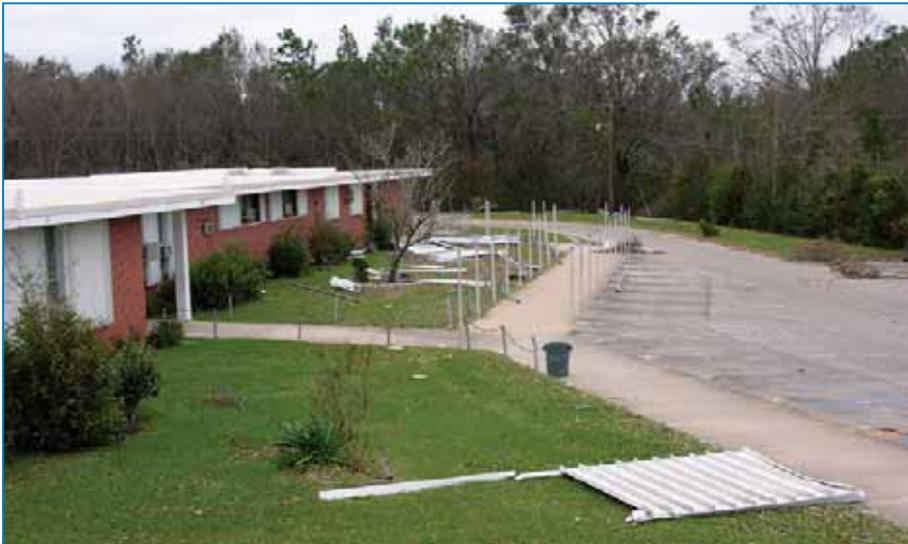
Figure 4-33:
The destroyed walkway canopy in front of this building became wind-borne debris. Hurricane Ivan (Florida, 2004)

- Walkway and entrance canopies are often damaged during high winds (see Figure 4-33). Wind-borne debris from damaged canopies can damage nearby buildings and injure people, hence these elements should also receive design and construction attention.

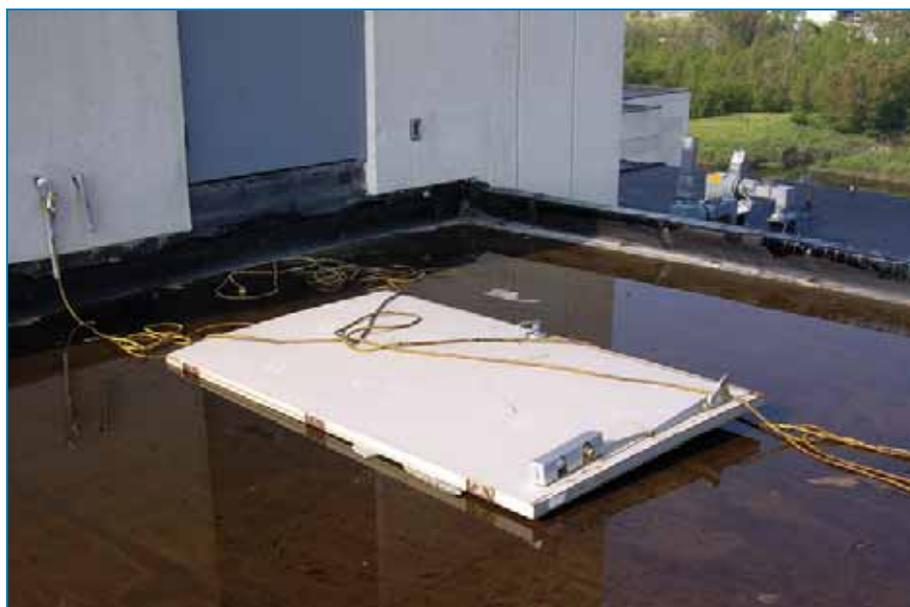
Figure 4-34:
Door on a hospital penthouse blown off its hinges during Hurricane Katrina (Mississippi, 2005)

This section addresses primary and secondary egress doors, sectional (garage) doors, and rolling doors. Although blow-off of personnel doors is uncommon, it can cause serious problems (see Figure 4-34). Blown-off doors allow entrance of rain, and tumbling doors can damage buildings and cause injuries.

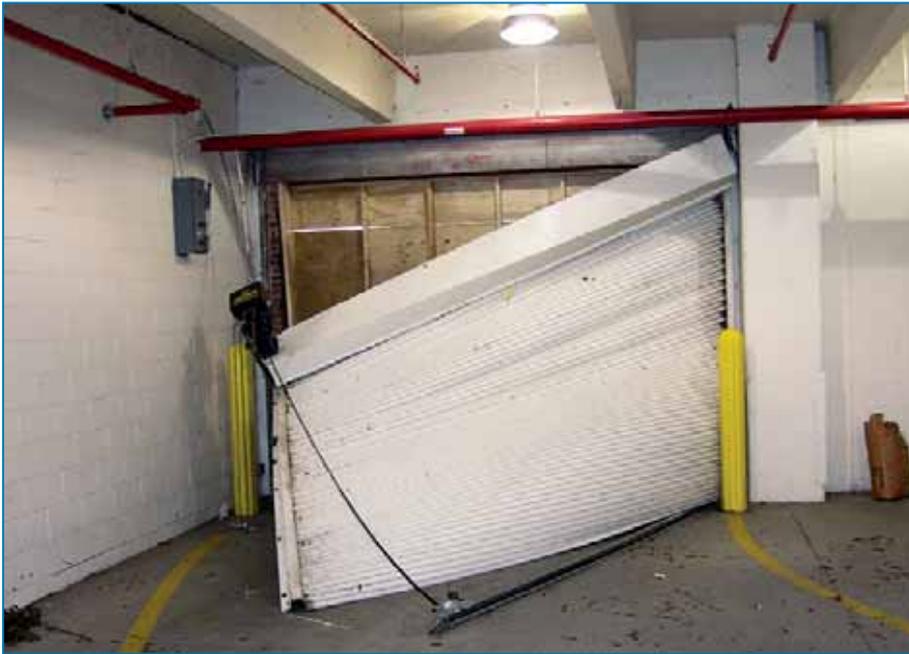
Figure 4-35:
This new rolling door failed because the CMU spalled at the door frame's expansion bolts, which were too close to the end of the CMU. Hurricane Charley (Florida, 2004)

Blown off sectional and rolling doors are quite common. These failures are typically caused by the use of door and track assemblies that have insufficient wind resistance, or by inadequate attachment of the tracks or nailers to the wall (see Figure 4-35).

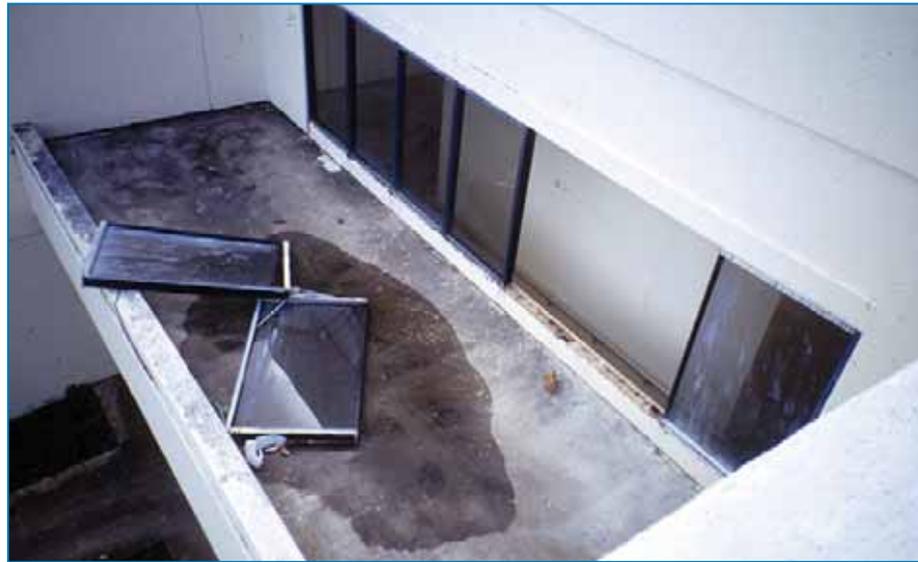
Figure 4-43:
Two complete windows, including frames, blew out as a result of an inadequate number of fasteners. Typhoon Paka (Guam, 1997)

The IBC requires that windows, curtain walls, and skylight assemblies (i.e., the glazing, frame, and frame attachment to the wall or roof) have sufficient strength to resist the positive and negative design wind pressure (see Figure 4-43). Design professionals should specify that these assemblies comply with wind load testing in accordance with ASTM E 1233. It is important to specify an adequate load path and to check its continuity during submittal review.

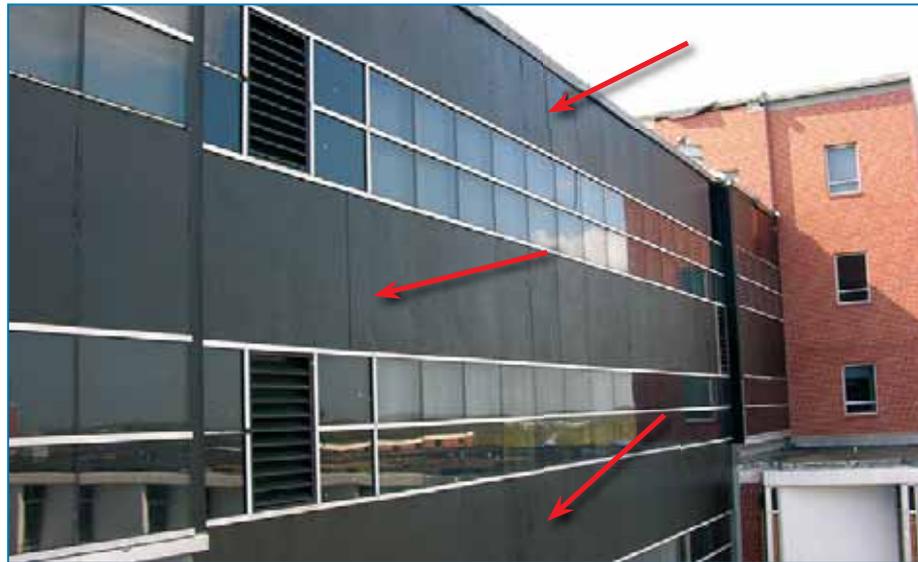
Figure 4-46:
Plywood panels (black continuous bands) installed after the glass spandrel panels were broken by roof aggregate.⁹ Hurricane Katrina (Mississippi, 2005)

Exterior glazing that is not impact-resistant (such as laminated glass or polycarbonate) or protected by shutters is extremely susceptible to breaking if struck by wind-borne debris. Even small, low-momentum missiles can easily break glazing that is not protected (see Figures 4-46 and 4-47). At the hospital shown in Figure 4-46, approximately 400 windows were broken. Most of the breakage was caused by wind-blown aggregate from the hospital's aggregate ballasted single-ply membrane roofs, and

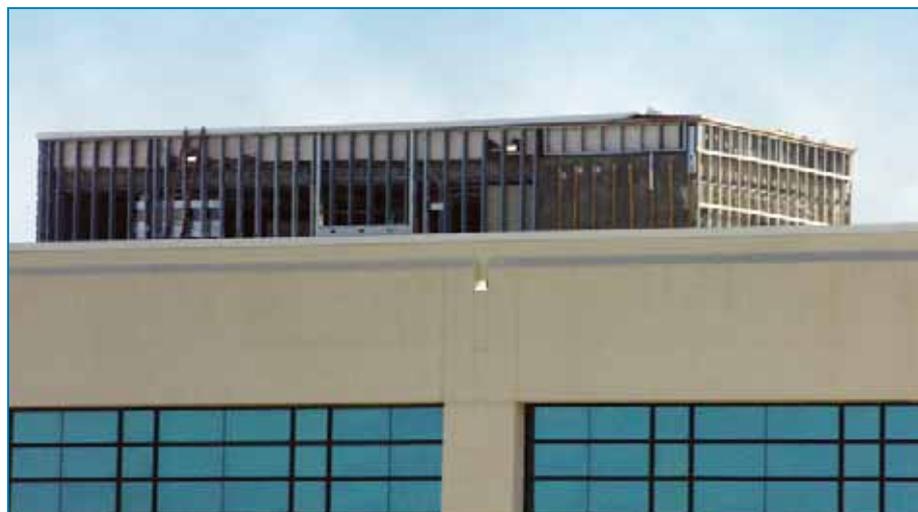
Figure 4-48:

The wall covering blew off the penthouse at this hospital complex, allowing rainwater to destroy the elevator controls. Hurricane Ivan (Florida, 2004)

To ensure the continuity of elevator service, elevator penthouse walls must possess adequate wind and water resistance. If the walls blow away or water leaks through the wall system, the elevator controls and/or motors can be destroyed. Loss of elevators may critically affect facility operations (see Figures 4-22 and 4-48). The restoration of elevator service can take weeks, even with expedited work.

EIFS: Figure 4-59 shows typical EIFS assemblies. Figure 4-48 and several figures in Section 4.2.1.3 show EIFS blow-off. In these cases, the molded expanded polystyrene (MEPS) was attached to gypsum board, which in turn was attached to metal studs or hat channels. The gypsum board detached from the studs/hat channels, which is a common EIFS failure mode. When the gypsum board on the exterior side of the studs is blown away, it is common for gypsum board on the interior side to also be blown off. The opening allows the building to become fully pressurized and allows the entrance of wind-driven rain. Other common types of failure include wall framing failure, separation of the MEPS from its substrate, and separation of the synthetic stucco from the MEPS.

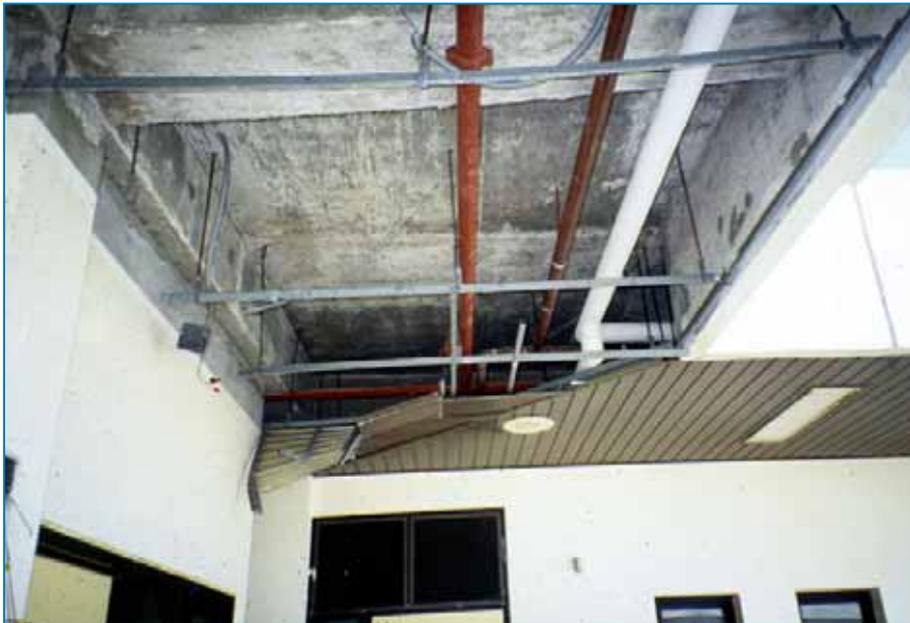
Figure 4-49: This suspended metal soffit was not designed for upward-acting wind pressure. Typhoon Paka (Guam, 1997)

Soffits: Depending on the wind direction, soffits can experience either positive or negative pressure. Besides the cost of repairing the damaged soffits, wind-borne soffit debris can cause property damage and injuries (see Figures 4-49 and 4-50). Failed soffits may also provide a convenient path for wind-driven rain to enter the building. Storm-damage research has shown that water blown into attic spaces after the loss of soffits can cause significant damage and the collapse of ceilings. Even in instances where soffits remain in place, water can penetrate through soffit vents and cause damage. At this time, there are no known specific test standards or design guidelines to help design wind- and water-resistant soffits and soffit vents.

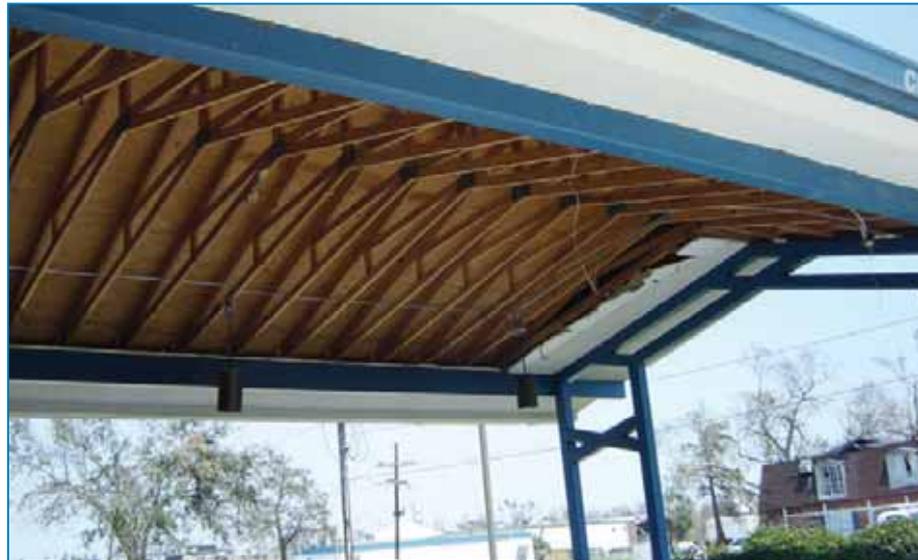
Figure 4-50:
Hospital canopy
damage. Hurricane
Katrina (Louisiana,
2005)

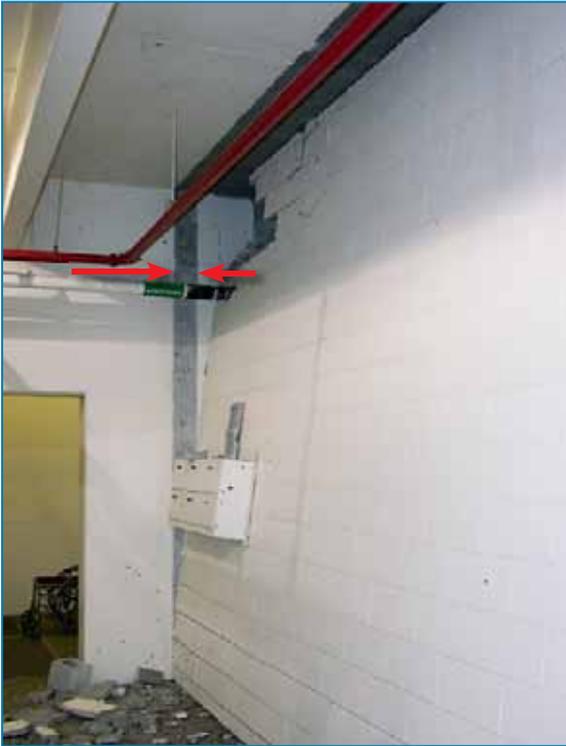
Figure 4-51:
The red arrows show the original location of a CMU wall that nearly collapsed following a rolling door failure. Hurricane Charley (Florida, 2004)

Interior non-load-bearing masonry walls: Special consideration should also be given to interior non-load-bearing masonry walls. Although these walls are not required by building codes to be designed to resist wind loads, if the exterior glazing is broken, or the exterior doors are blown away, the interior walls could be subjected to significant load as the building rapidly becomes fully pressurized. To avoid casualties, it is recommended that interior non-load-bearing masonry walls adjacent to occupied areas be designed to accommodate loads exerted by a design wind event, using the partially enclosed pressure coefficient (see Figure 4-51). By doing so, wall collapse may be prevented if the building envelope is breached. This recommendation is applicable to hospitals located in areas with a basic wind speed greater than 120 mph, and to hospitals in tornado-prone regions that do not have shelter space designed in accordance with FEMA 361.

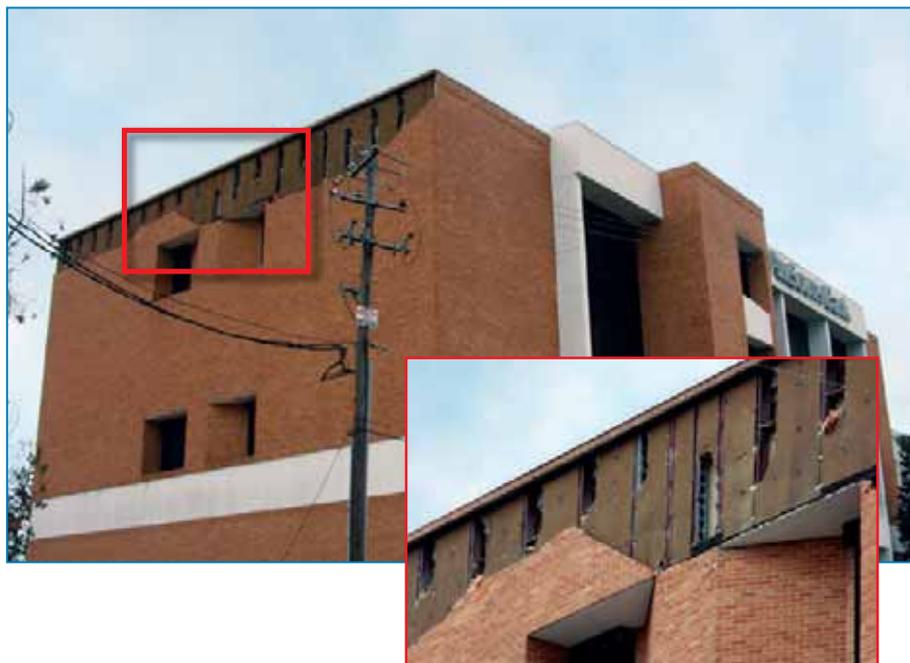
Figure 4-52:
The brick veneer failure on this building was attributed to tie corrosion. Hurricane Ivan (Florida, 2004)

Brick veneer:¹⁰ Brick veneer is frequently blown off walls during high winds. When brick veneer fails, wind-driven water can enter and damage buildings, and building occupants can be vulnerable to injury from wind-borne debris (particularly if the walls are sheathed with plastic foam insulation or wood fiberboard in lieu of wood panels). Pedestrians in the vicinity of damaged walls can also be vulnerable to injury from falling bricks (see Figure 4-52). Common failure modes include tie (anchor) fastener pull-out (see Figure 4-53), failure of masons to embed ties into the mortar, poor bonding between ties and mortar, a mortar of poor quality, and tie corrosion.

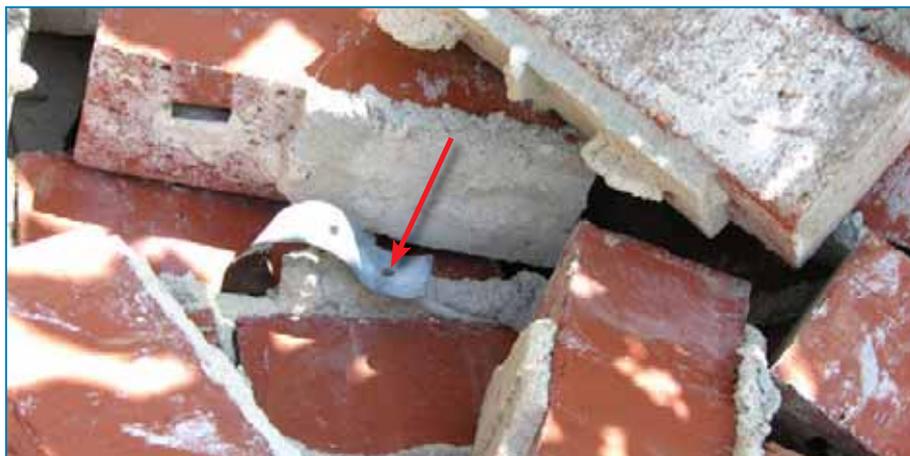
Figure 4-53:
This tie remained embedded in the mortar joint while the smooth-shank nail pulled from the stud.

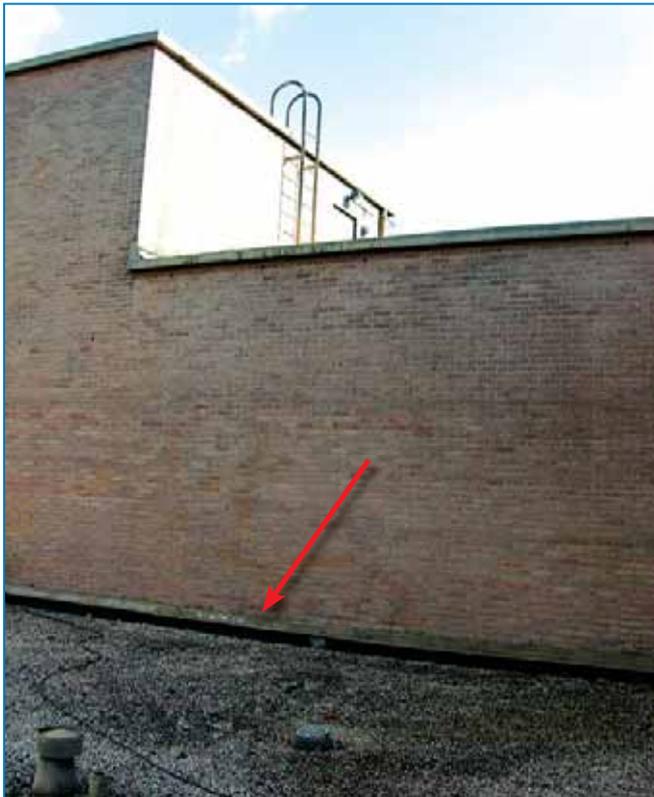
Figure 4-58: Water leaked inside along the base of the brick veneer walls (red arrow). Hurricane Katrina (Louisiana, 2005)

To avoid water leaking into the building, it is important that weep holes be adequately spaced and not be blocked during brick installation, and that through-wall flashings be properly designed and installed. When the base of the brick veneer occurs near grade, the grade should be designed so that it occurs several inches below the weeps so that drainage from the weeps is not impeded. Also, landscaping should be kept clear of weeps so that vegetation growth does not cause blockage of weeps. At the hospital shown in Figure 4-58, water leaked into the building along the base of many of the brick veneer walls. When high winds accompany heavy rain, a substantial amount of water can be blown into the wall cavity.

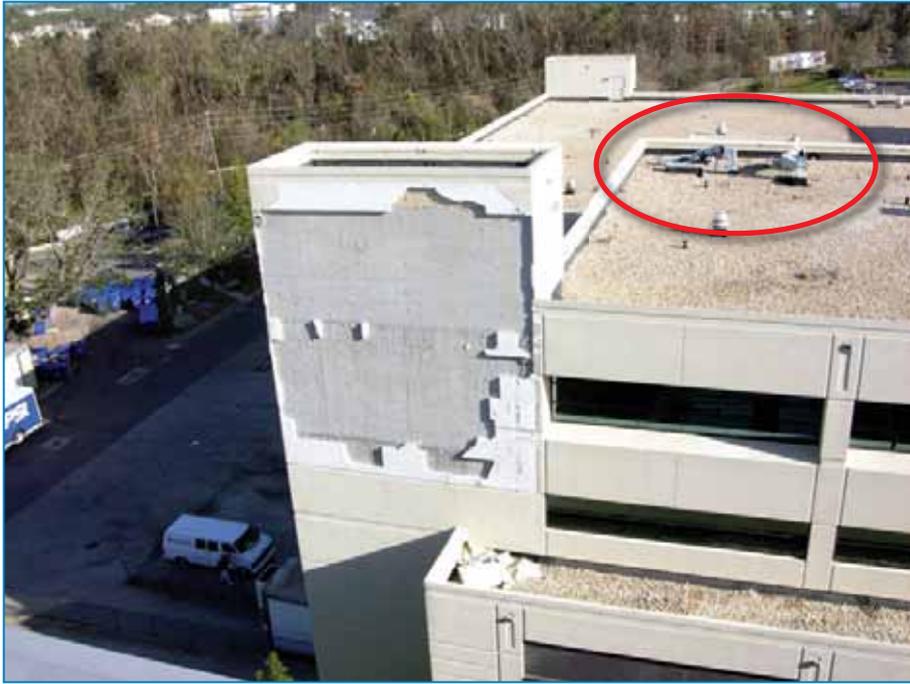
Figure 4-60:
EIFS blown off a cast-in-place concrete wall. Note the damaged rooftop ductwork. Hurricane Ivan (Florida, 2004)

At the hospital shown in Figure 4-60, the EIFS was applied over a concrete wall. The MEPS debonded from the concrete. In general, a concrete substrate prevents wind and water from entering a building, but if the EIFS debonds from the concrete, EIFS debris can break unprotected glazing. Glazing damage can be very devastating, as shown and discussed in Section 4.2.1.3.

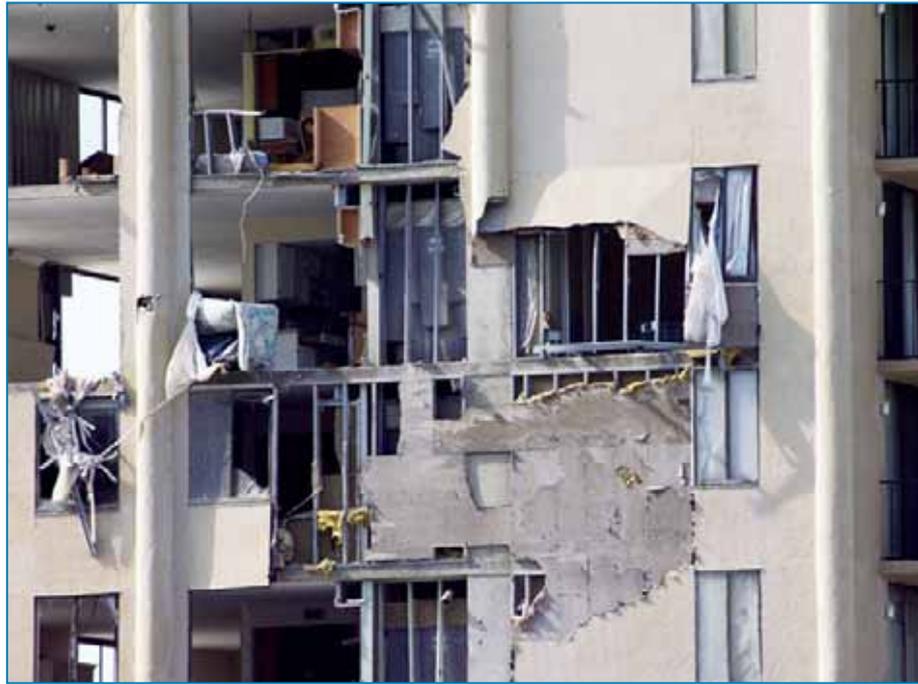
Figure 4-61:
The stucco wall failure was caused by inadequate attachment between the stud tracks and the building's structure. Hurricane Ivan (Florida, 2004)

Stucco over studs: Wind performance of traditional stucco walls is similar to the performance of EIFS, as shown in Figure 4-61. In several areas the metal stud system failed; in other areas the gypsum sheathing blew off the studs; and in other areas, the metal lath blew off the gypsum sheathing. The failure shown in Figure 4-61 illustrates the importance of designing and constructing wall framing (including attachment of stud tracks to the building and attachment of the studs to the tracks) to resist the design wind loads.

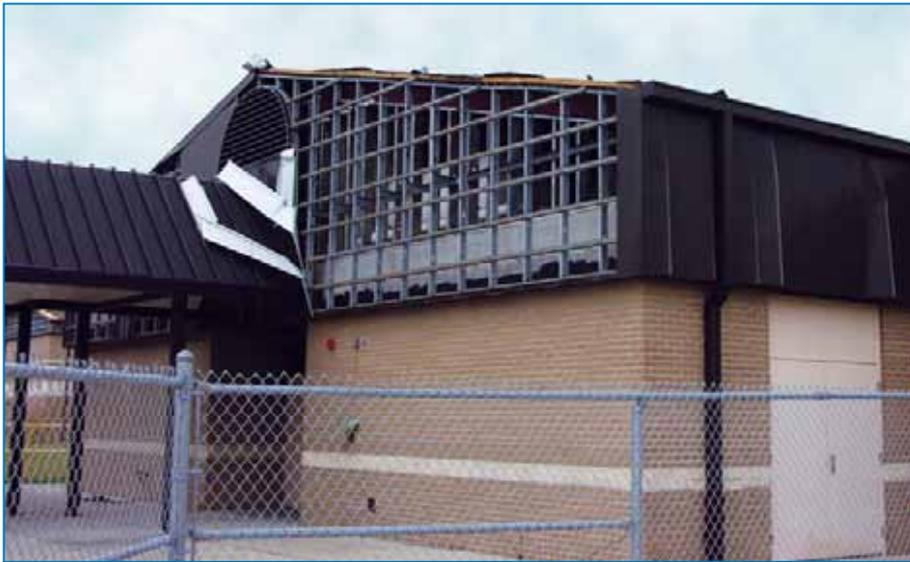
Figure 4-62:
The loss of metal wall panels allowed a substantial amount of wind-driven rain to penetrate this building. Hurricane Ivan (Florida, 2004)

Parapets: For low-sloped roofs, minimum 3-foot high parapets are recommended. With parapets of this height or greater, the uplift load in the corner region is substantially reduced (ASCE 7 permits treating the corner zone as a perimeter zone). Also, a high parapet (as shown in Figures 4-96) may intercept wind-borne debris and keep it from blowing off the roof and damaging other building components or injuring people. To protect base flashings from wind-borne debris damage and subsequent water leakage, it is recommended that metal panels on furring strips be installed over the base flashing (Figure 4-79). Exposed stainless steel screws are recommended for attaching the panels to the furring strips, because using exposed fasteners is more reliable than using concealed fasteners or clips (as were used for the failed panels shown in Figure 4-62).

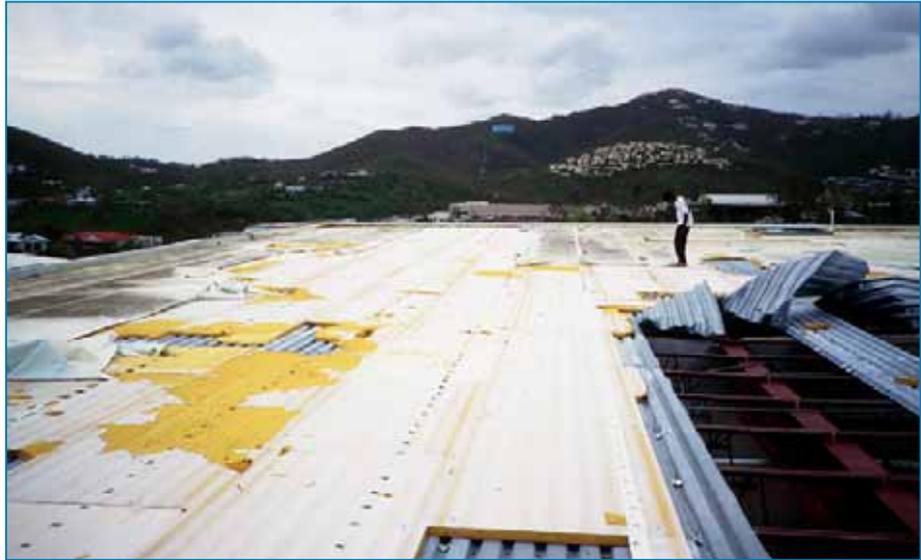
Figure 4-63:

The orientation of the membrane fastener rows led to blow-off of the steel deck. Hurricane Marilyn (U.S. Virgin Islands, 1995)

If a steel deck is selected, it is critical to specify that the membrane fasteners be attached in rows perpendicular to the steel flanges to avoid overstressing the attachment of the deck to the deck support structure. At the building shown in Figure 4-63, the fastener rows of the mechanically attached single-ply membrane ran parallel to the top flange of the steel deck. The deck fasteners were overstressed and a portion of the deck blew off and the membrane progressively tore. At another building, shown in Figure 4-64, the membrane fastener rows also ran parallel to the top flange of the steel deck. When membrane fasteners run parallel to the flange, the flange with membrane fasteners essentially carries the entire uplift load because of the deck's inability to transfer any significant load to adjacent flanges. Hence, at the joists shown in Figure 4-64, the deck fasteners on either side of the flange with the membrane fasteners are the only connections to the joist that are carrying substantial uplift load.

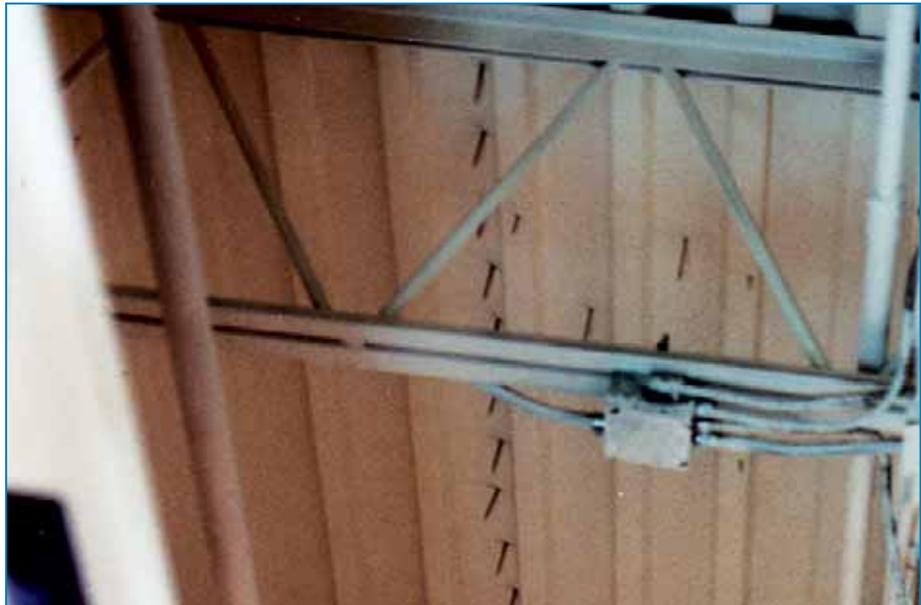
Figure 4-64:

View of the underside of a steel deck showing the mechanically attached single-ply membrane fastener rows running parallel to, instead of across, the top flange of the deck.

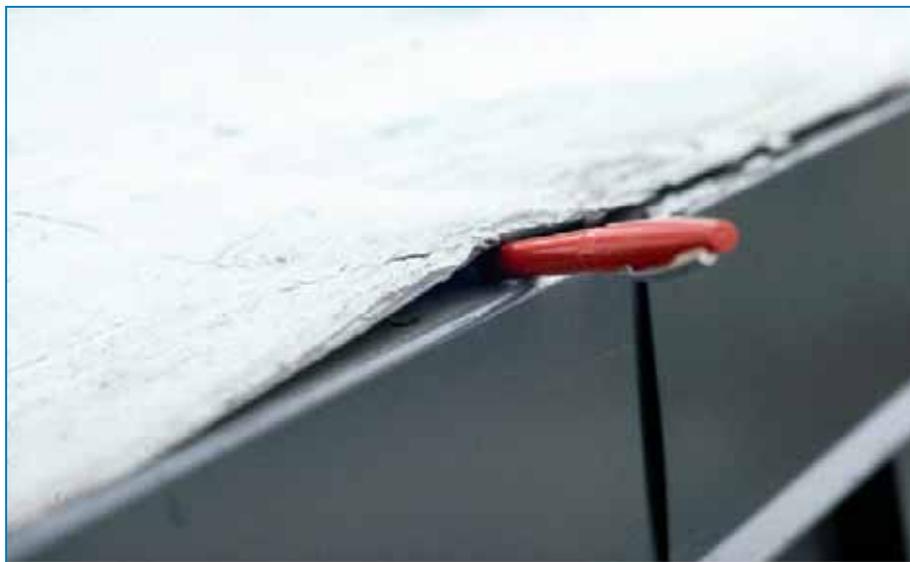
Figure 4-65:
The ink pen shows an opening that the wind can catch, and cause lifting and peeling of the membrane.

Roof membrane blow-off is almost always a result of lifting and peeling of the metal edge flashing or coping, which serves to clamp down the membrane at the roof edge. Therefore, it is important for the design professional to carefully consider the design of metal edge flashings, copings, and the nailers to which they are attached. The metal edge flashing on the modified bitumen membrane roof shown in Figure 4-65 was installed underneath the membrane, rather than on top of it, and then stripped in. In this location, the edge flashing was unable to clamp the membrane down. At one area, the membrane was not sealed to the flashing. An ink pen was inserted into the opening prior to photographing to demonstrate how wind could catch the opening and lift and peel the membrane.

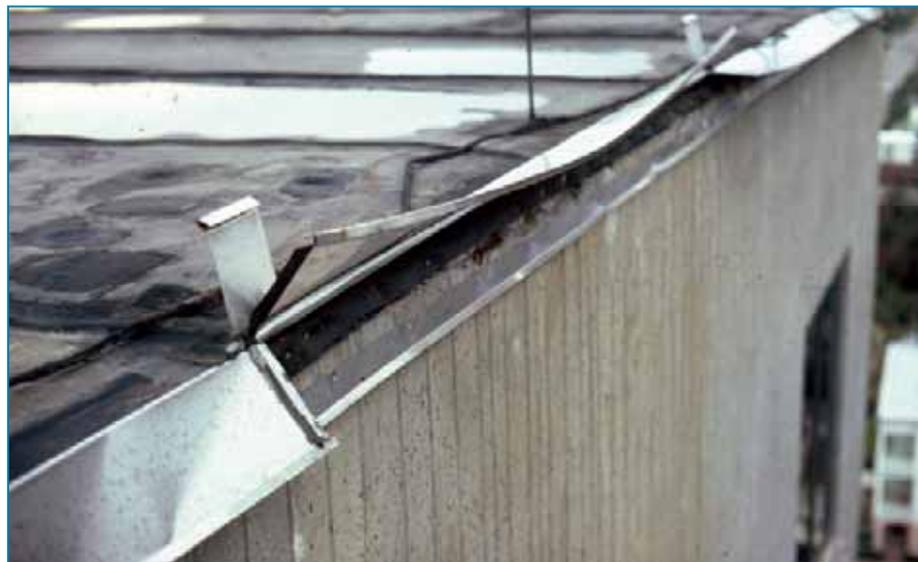
Figure 4-66:
The metal edge flashing on this hospital disengaged from the continuous cleat and the vertical flange lifted. Hurricane Hugo (South Carolina, 1989)

The traditional edge flashing/coping attachment method relies on concealed cleats that can deform under wind load and lead to disengagement of the flashing/coping (see Figure 4-66) and subsequent lifting and peeling of the roof membrane. When a vertical flange disengages and lifts up, the edge flashing and membrane are very susceptible to failure. Normally, when a flange lifts the failure continues to propagate and the metal edge flashing and roof membrane blows off.

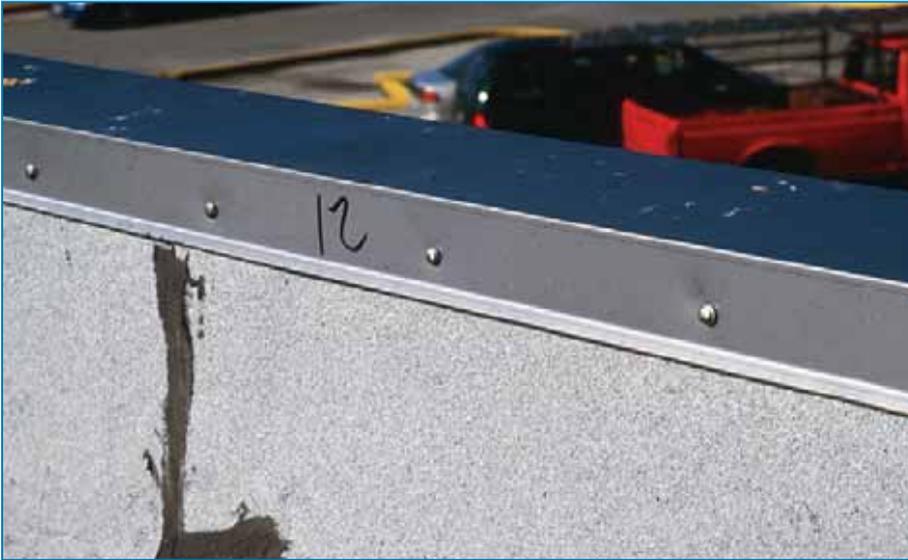
Figure 4-67:
Both vertical faces of the coping were attached with exposed fasteners instead of concealed cleats. Typhoon Paka (Guam, 1997)

Storm-damage research has revealed that, in lieu of cleat attachment, the use of exposed fasteners to attach the vertical flanges of copings and edge flashings has been found to be a very effective and reliable attachment method. The coping shown in Figure 4-67 was attached with 1/4-inch diameter stainless steel concrete spikes at 12 inches on center. When the fastener is placed in wood, #12 stainless steel screws with stainless steel washers are recommended. The fasteners should be more closely spaced in the corner areas (the spacing will depend upon the design wind loads). ANSI/SPRI ES-1 provides guidance on fastener spacing and thickness of the coping and edge flashing.

For roofs with weak metal edge flashing or coping attachment, face-attachment of the edge flashing/coping (as shown in Figure 4-67) is a cost-effective approach to greatly improve the wind-resistance of the roof system.

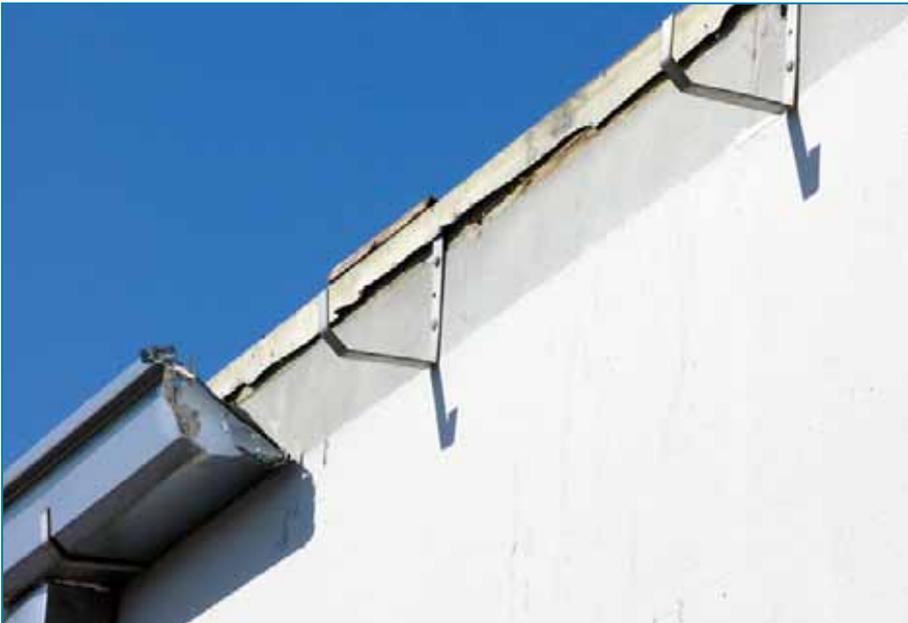
Figure 4-68:
This gutter, supported by a type of bracket that provides no significant uplift resistance, failed when wind lifted it, together with the metal edge flashing that lapped into the gutter. Hurricane Francis (Florida, 2004)

Storm-damage research has shown that gutters are seldom constructed to resist wind loads (see Figure 4-68). When a gutter lifts, it typically causes the edge flashing that laps into the gutter to lift as well. Frequently, this results in a progressive lifting and peeling of the roof membrane. The membrane blow-off shown in Figure 4-69 was initiated by gutter uplift. The gutter was similar to that shown in Figure 4-68. The membrane blow-off caused significant interior water damage.

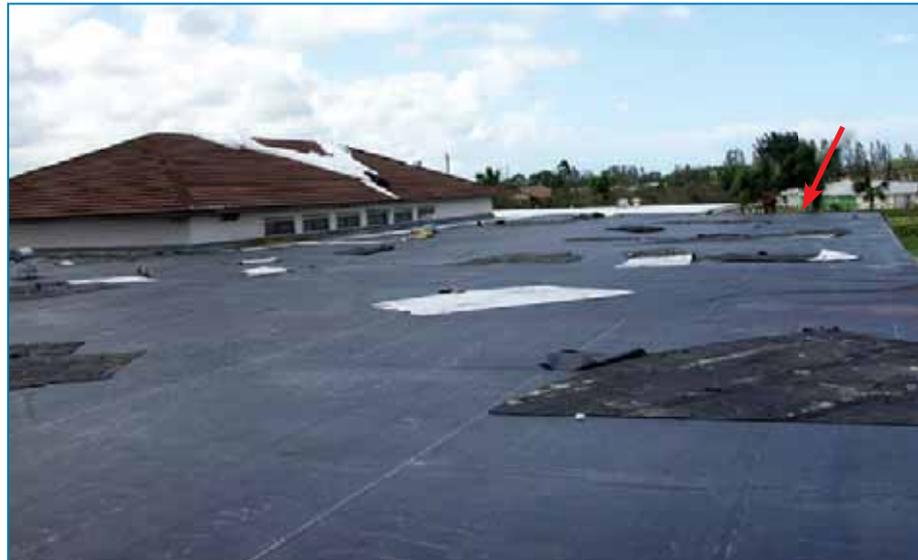
Figure 4-69:

The original modified bitumen membrane was blown away after the gutter lifted in the area shown by the red arrow (the black membrane is a temporary roof). Hurricane Francis (Florida, 2004)

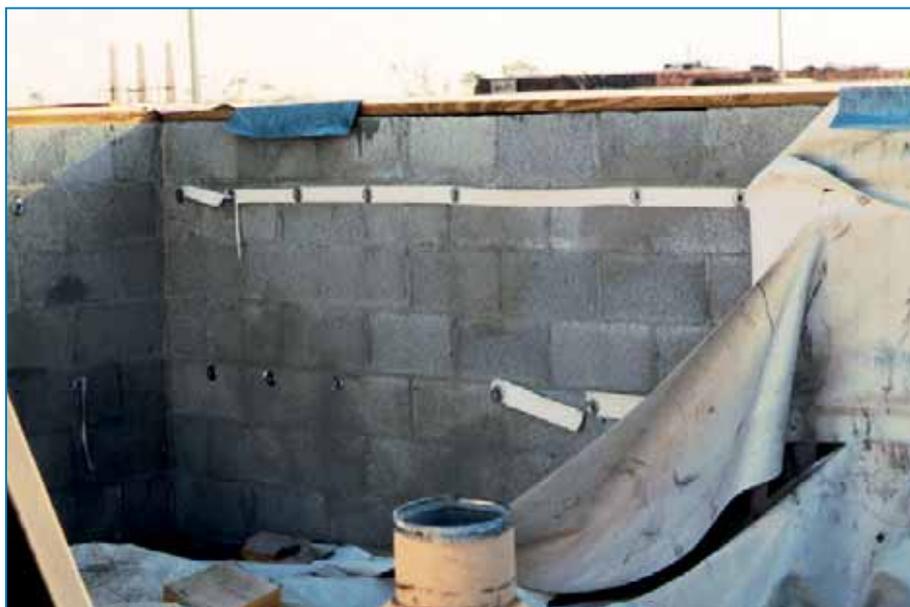
Figure 4-70: If mechanically attached base flashings have an insufficient number of fasteners, the base flashing can be blown away. Hurricane Andrew (Florida, 1992)

Information on loads for parapet base flashings was first introduced in the 2002 edition of ASCE 7. The loads on base flashings are greater than the loads on the roof covering if the parapet's exterior side is air-permeable. When base flashing is fully adhered, it has sufficient wind resistance in most cases. However, when base flashing is mechanically fastened, typical fastening patterns may be inadequate, depending on design wind conditions (see Figure 4-70). Therefore, it is imperative that the base flashing loads be calculated, and attachments designed to accommodate these loads. It is also important for designers to specify the attachment spacing in parapet corner regions to differentiate them from the regions between corners.

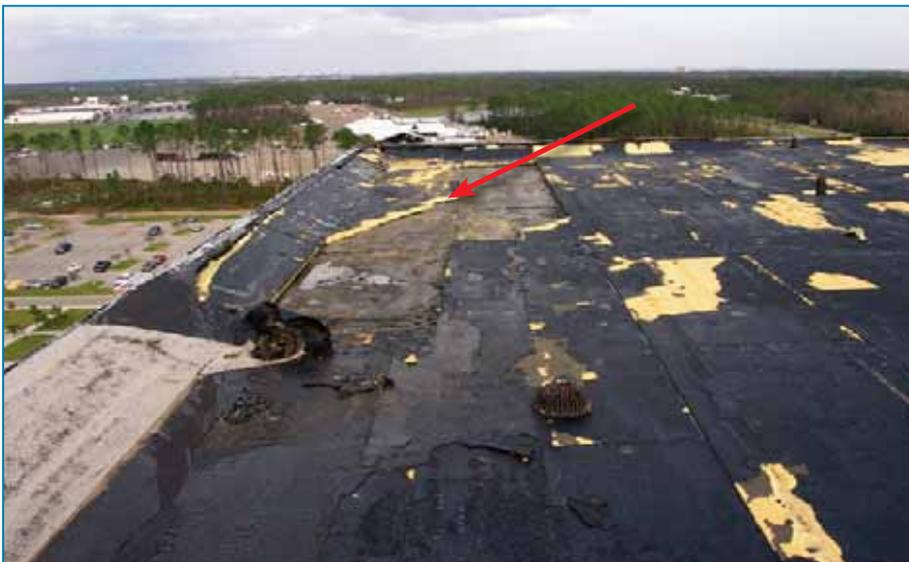
Figure 4-71: The blown off insulation (red arrow) may have initiated blow off of the roof membrane. Hurricane Ivan (Florida, 2004)

When fully adhering insulation boards, it is recommended that the boards be no larger than 4 feet by 4 feet. It is also recommended that the board thickness not exceed 2 inches (1½ inches is preferable). Use of small thin boards makes it easier for the contractor to conform the boards to the substrate. At the hospital shown in Figure 4-71, 4 foot by 8 foot insulation boards were set in hot asphalt over a concrete deck. A few of the boards detached from the deck. The boards may have initiated the membrane blow off, or the membrane blow off may have been initiated by lifting and peeling of the metal edge flashing, in which case, loss of the insulation boards was a secondary failure.

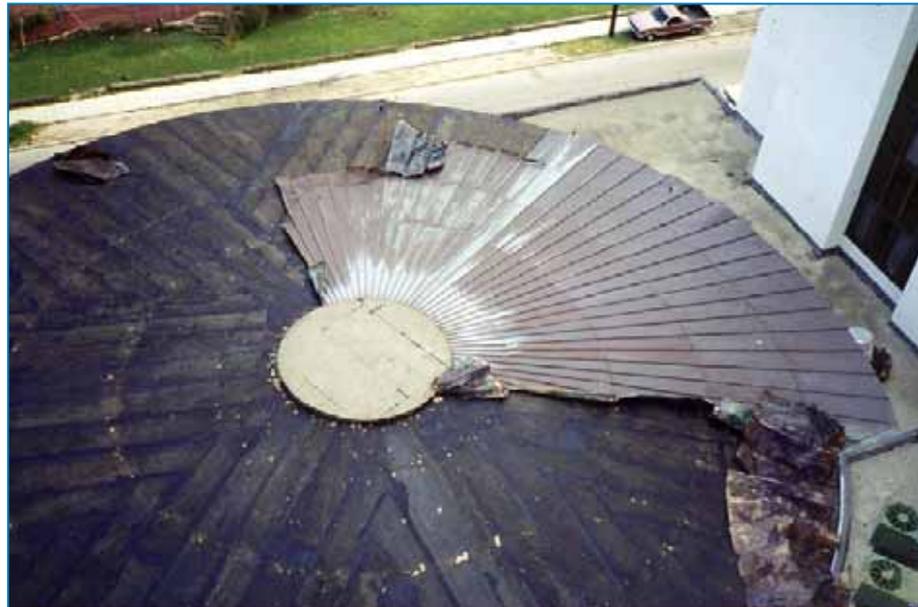
Figure 4-72:

The secondary membrane prevented leakage into the ICU after the copper roof blew off. Hurricane Andrew (Florida, 1992)

- The purpose of the insulation and gypsum roof board is to absorb missile energy. If the primary membrane is punctured or blown off during a storm, the secondary membrane should provide watertight protection unless the roof is hit with missiles of very high momentum that penetrate the insulation and secondary membrane. Figure 4-72 illustrates the merit of specifying a secondary membrane. The copper roof blew off the hospital's intensive care unit (ICU). Patients and staff were frightened by the loud noise generated by the metal panels as they banged around during the hurricane. Fortunately there was a very robust underlayment (a built-up membrane) that remained in place. Since only minor leakage occurred, the ICU continued to function.

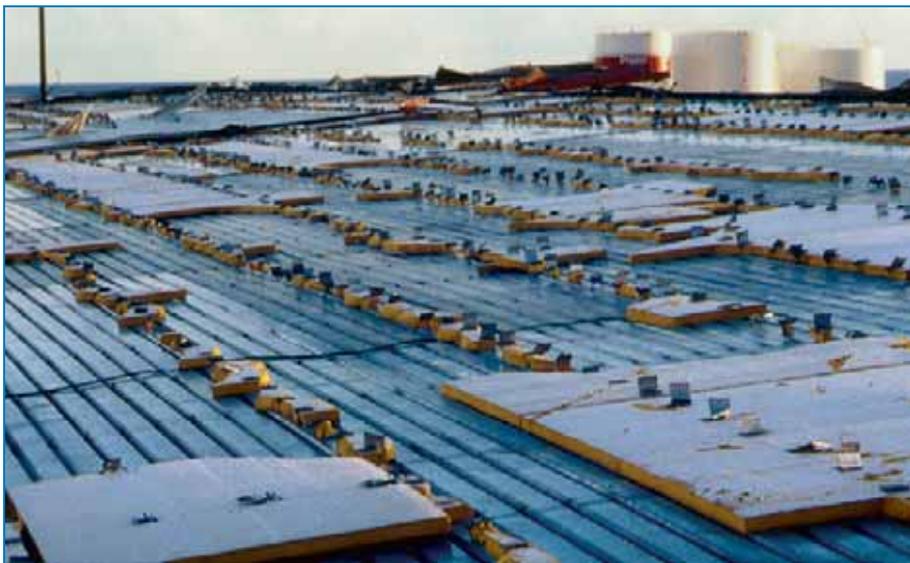
Figure 4-73: Significant interior water damage and facility interruption occurred after the standing seam roof blew off. Hurricane Marilyn (U.S. Virgin Islands, 1995)

If the metal panels are blown off or punctured during a hurricane, the secondary membrane should provide watertight protection unless the roof is hit with missiles of very high momentum. At the roof shown in Figure 4-73, the structural standing seam panel clips bore on rigid insulation over a steel deck. Had a secondary membrane been installed over the steel deck, the membrane would have likely prevented significant interior water damage and facility disruption.

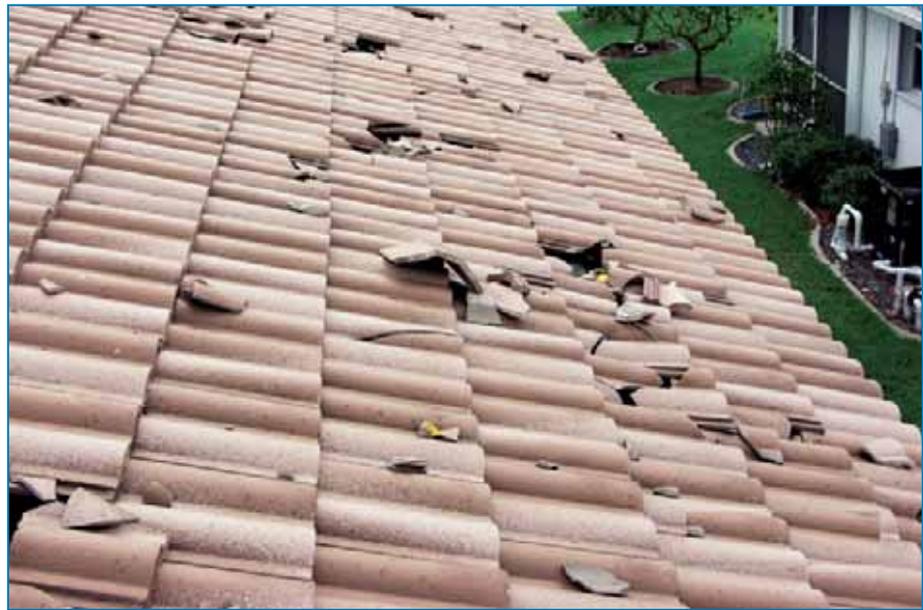
Figure 4-74:
Brittle roof coverings, like slate and tile, can be broken by missiles, and tile debris can break other tiles. Hurricane Charley (Florida, 2004)

In order to avoid the possibility of roofing components blowing off and striking people arriving at a hospital during a storm, the following roof systems are not recommended: aggregate surfacings, either on BUR, single-ply or SPF; lightweight concrete pavers; cementitious-coated insulation boards; slate; and tile (see Figure 4-74). Even when slates and tiles are properly attached to resist wind loads, their brittleness makes them vulnerable to breakage as a result of wind-borne debris impact. The tile and slate fragments can be blown off the roof, and fragments can damage other parts of the roof, causing a cascading failure.
