Design Guide

for Improving Hospital Safety
in Earthquakes, Floods, and High Winds

FEMA 577 / June 2007

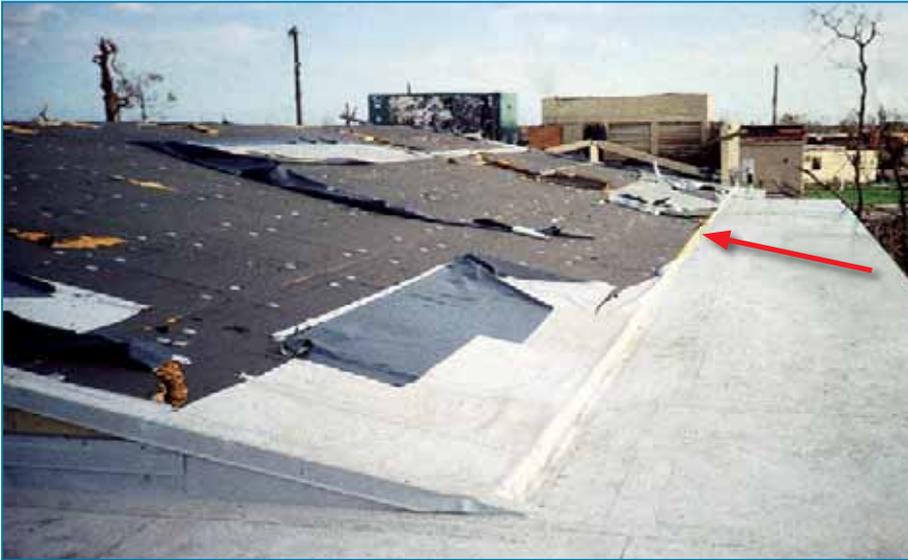
Figure 4-75:
Mechanically attached single-ply membrane progressively tore after being cut by wind-borne debris. Hurricane Andrew (Florida, 1992)

Mechanically attached and air-pressure equalized single-ply membrane systems are susceptible to massive progressive failure after missile impact, and are therefore not recommended for hospitals in hurricane-prone regions. At the building shown in Figure 4-75, a missile struck the fully adhered low-sloped roof and slid into the steep-sloped reinforced mechanically attached single-ply membrane in the vicinity of the red arrow. A large area of the mechanically attached membrane was blown away as a result of progressive membrane tearing. Fully adhered single-ply membranes are very vulnerable to missile puncture and are not recommended unless they are ballasted with pavers. At the hospital shown in Figure 4-76, several missiles, including exhaust fans and copings struck the roof.

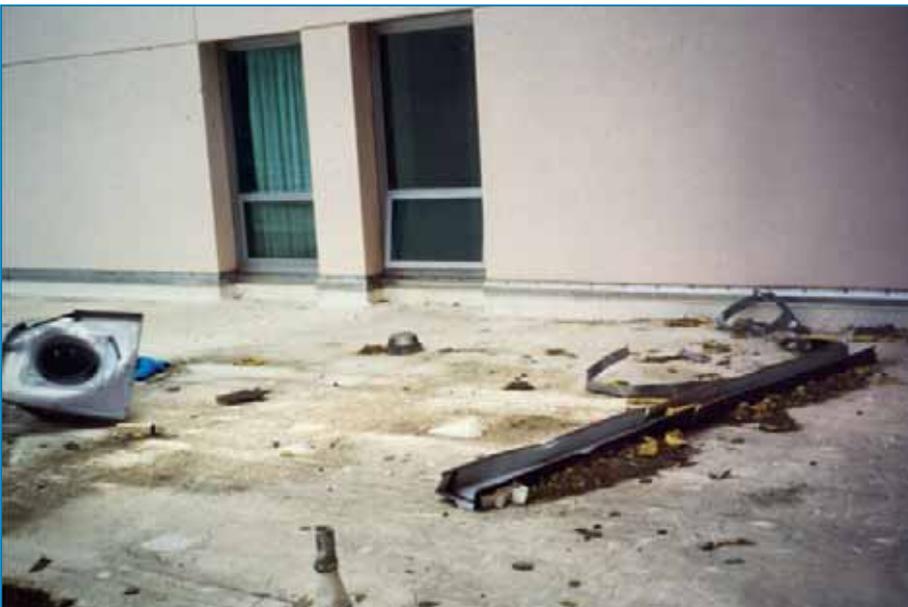
Figure 4-76:
This fully adhered single-ply roof membrane was struck by a variety of missiles. Hurricane Marilyn (U.S. Virgin Islands, 1995)

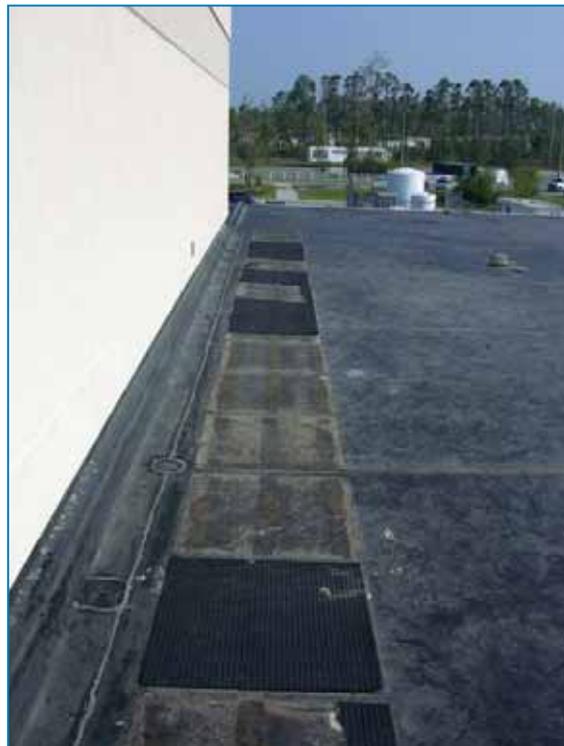
Figure 4-78:

Several rubber walkway pads were blown off the single-ply membrane roof on this hospital. Hurricane Katrina (Mississippi, 2005)

Walkway pads: Roof walkway pads are frequently blown off during hurricanes (Figures 4-78 and 4-82). Pad blow-off does not usually damage the roof membrane. However, wind-borne pad debris can damage other building components and injure people. Currently there is no test standard to evaluate uplift resistance of walkway pads. Walkway pads are therefore not recommended in hurricane-prone regions.

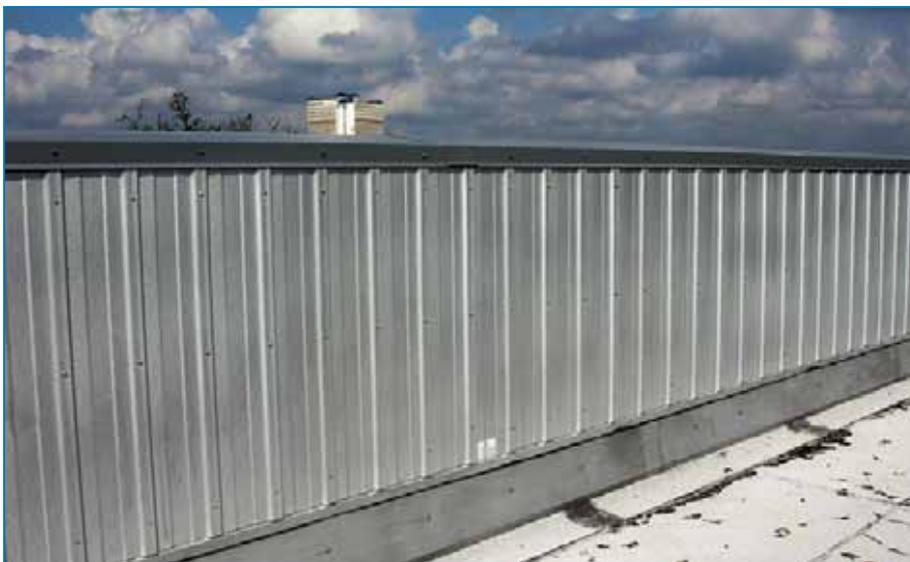
Figure 4-79:
Base flashing protected by metal panels attached with exposed screws. Hurricane Katrina (Mississippi, 2005)

- For a PMR, it is recommended that pavers weighing a minimum of 22 psf be specified. In addition, base flashings should be protected with metal (such as shown in Figure 4-79) to provide debris protection. Parapets with a 3-foot minimum height (or higher if so indicated by ANSI/SPRI RP-4, 2002) are recommended at roof edges. This manual recommends that PMRs not be used for hospitals in hurricane-prone regions where the basic wind speed exceeds 130 mph.

If the roof has a parapet, it is recommended that the inside of the parapet be properly prepared to receive the new base flashing. In many instances, it is prudent to re-skin the parapet with sheathing to provide a suitable substrate. Base flashing should not be applied directly to brick parapets because they have irregular surfaces that inhibit good bonding of the base flashing to the brick (see Figure 4-120). Also, if moisture drives into the wall from the exterior side of the parapet with base flashing attached directly to brick, the base flashing can inhibit drying of the wall. Therefore, rather than totally sealing the parapet with membrane base flashing, the upper portion of the brick can be protected by metal panels (as shown in Figure 4-79), which permit drying of the brick.

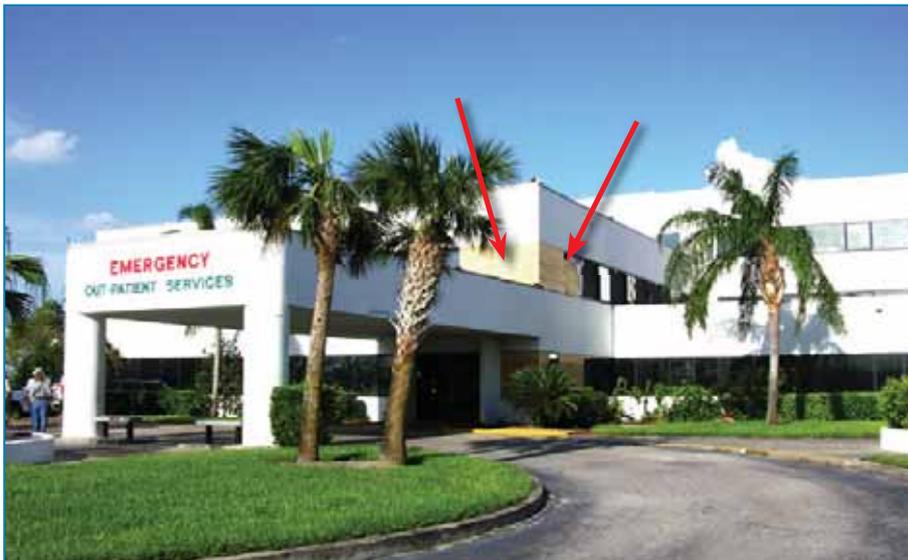
Figure 4-80:
The second floor beyond the canopy houses the ICU. Several windows along the two ICU walls that are visible were broken.

The hospital sustained damage to windows, rooftop equipment, and a freestanding storage building on the campus. Thirty-three windows were broken, including patient room windows and windows at three of the eight ICU rooms (Figures 4-80 and 4-81). Windows were also broken in many vehicles in the parking lot. The majority of the glass breakage was caused by aggregate blown from the hospital built-up roofs. Some of the glass breakage may have been due to blown-off gutters and walkway pads from the hospital's roof (Figure 4-82) or other missiles such as tree limbs; blown off gutters can be high-momentum missiles that can travel a substantial distance (see Figure 4-81).

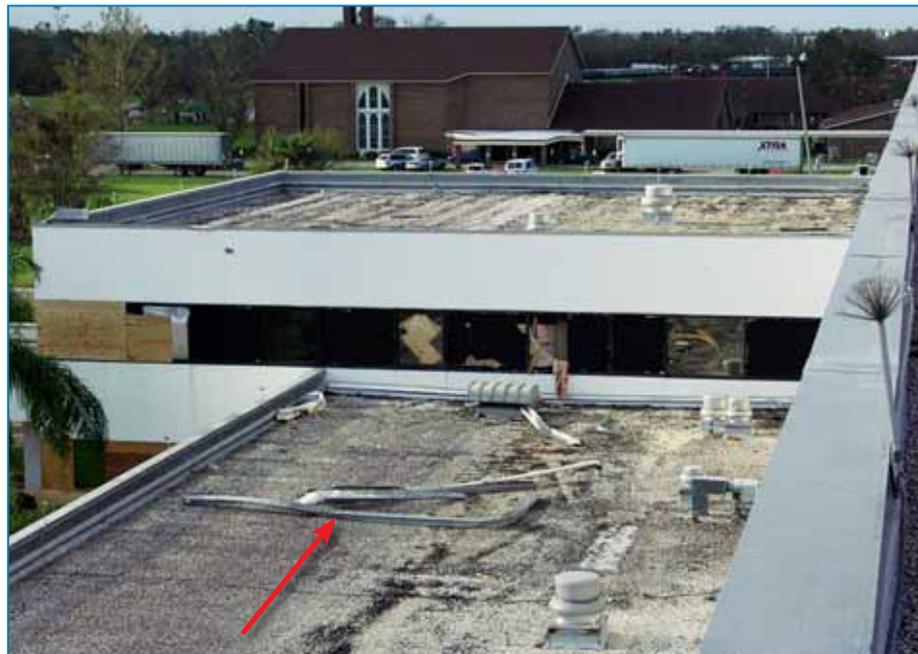
Figure 4-81:
A view of the ICU from the third floor roof. The gutters (red arrow) are from the back side of the third floor roof.

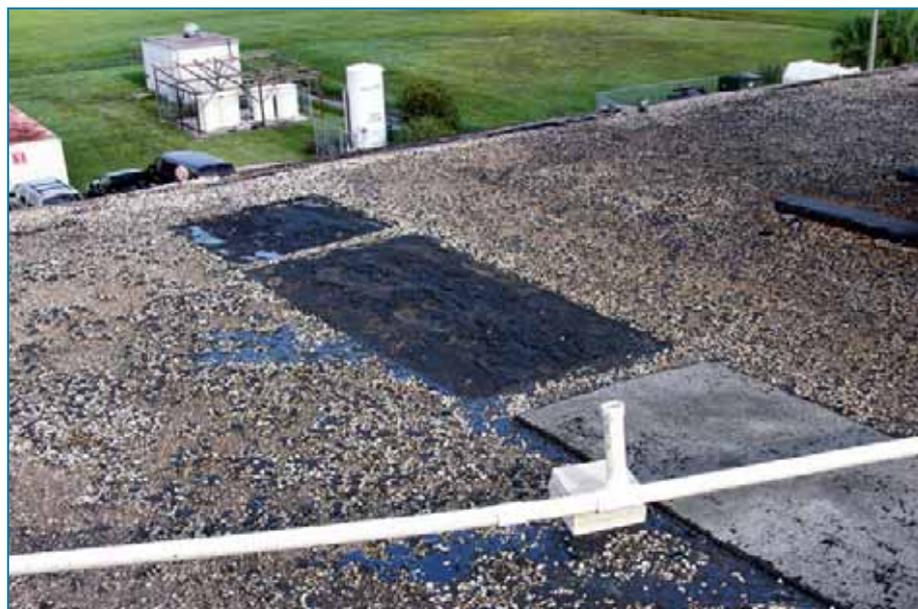
Figure 4-82:
View of the back side of the third floor roof where the gutter and an asphalt plank walkway pad were blown away. The loose aggregate surfacing was also blown away.

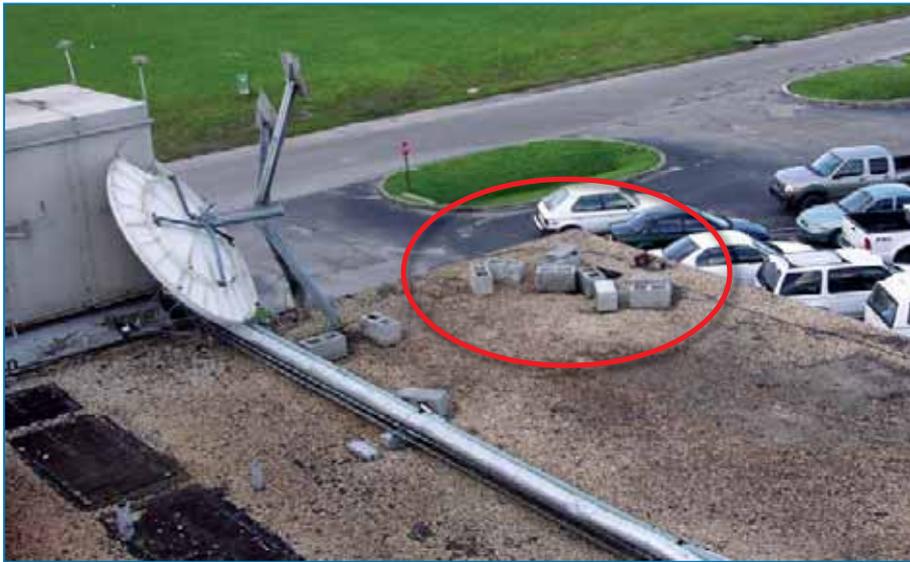
Figure 4-83:
This satellite dish was held down only with CMU. Note the displaced LPS at the corner (circled).

A portion of the roof covering was blown off and the satellite dish was nearly blown off too. The LPS was displaced in a few areas (see Figure 4-83). As a result of the damage to the roof covering and to rooftop equipment, water leaked into the building in several areas, which caused the closing of the operating room (OR), sterile processing, portions of the lab, and numerous offices. The OR was temporarily relocated to the Caesarian section (C-section) room. It was about a month before the OR was repaired and reoccupied.

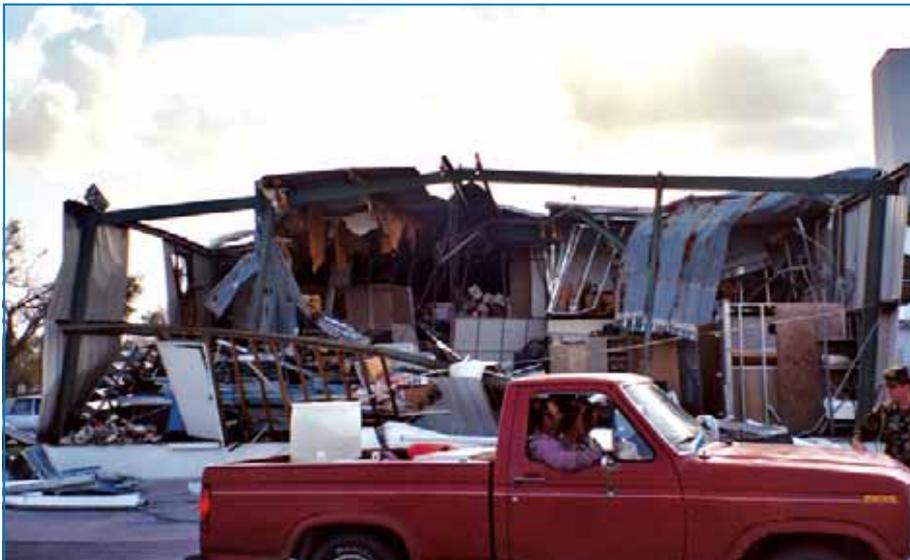
Figure 4-84:
This pre-engineered storage building contained the hospital supplies and maintenance shop.

The metal storage building that contained the hospital's supplies, maintenance shop, environmental services, and shipping and receiving collapsed, and its loss was significant for the hospital operations. Almost all of the tools and stock materials for repairs were lost (Figure 4-84). Tents were set up after the hurricane to provide storage. Because of subsequent storms in the next several weeks (including two hurricanes), the stored items had to be moved in and out of the tents on several occasions.

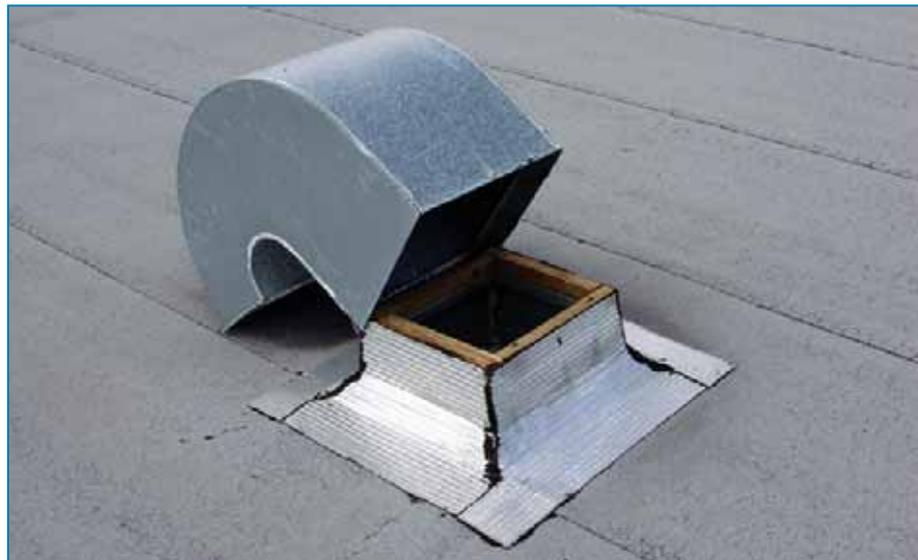
Figure 4-85:

This gooseneck was attached with only two small screws. A substantial amount of water was able to enter the building during Hurricane Francis. (Florida, 2004)

enter the facility where equipment was displaced (see Figure 4-85). The most common problems typically relate to inadequate equipment anchorage, inadequate strength of the equipment itself, and corrosion.

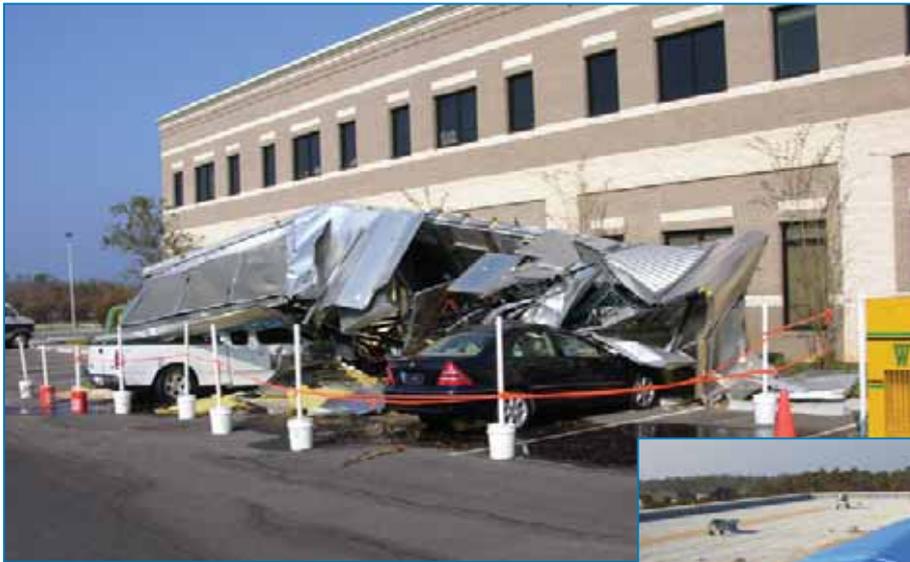
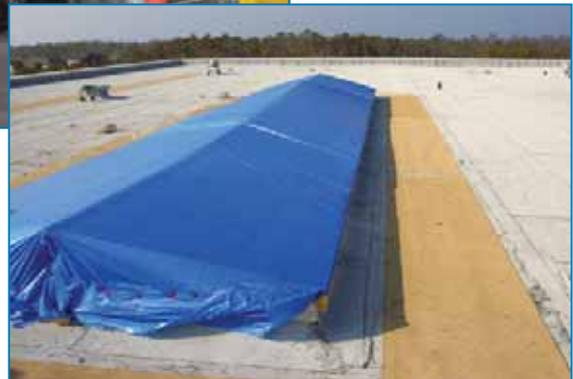
Figure 4-86: Although this 18,000-pound HVAC unit was attached to its curb with 16 straps, it blew off during Hurricane Ivan. (Florida, 2004)

to resist the design wind load. The 30' x 10' x 8' 18,000-pound HVAC unit shown in Figure 4-86 was attached to its curb with 16 straps (one screw per strap). Although the wind speeds were estimated to be only 85 to 95 miles per hour (peak gust), the HVAC unit blew off the medical office building. The inset at Figure 4-86 shows the curb upon which the unit was attached. A substantial amount of water entered the building at the curb openings before the temporary tarp was placed.

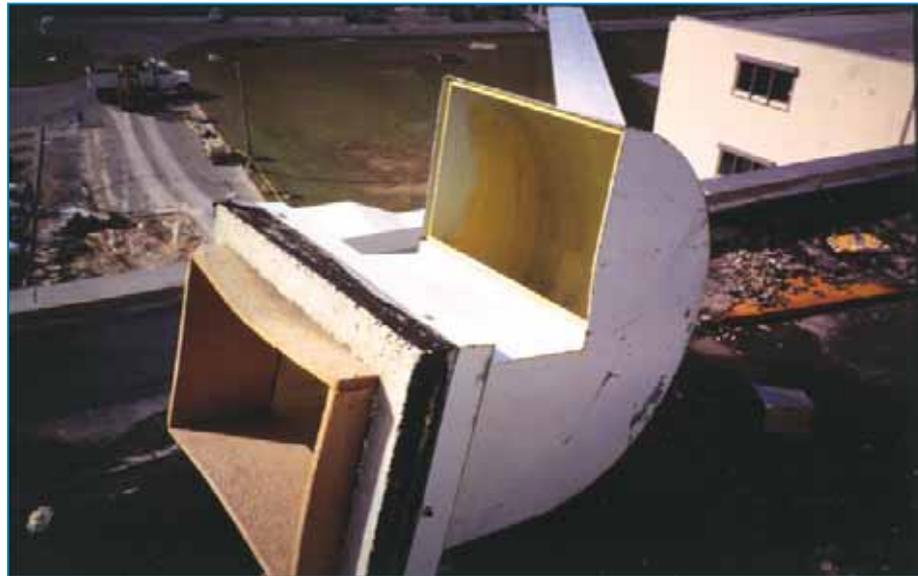
Figure 4-87:

The gooseneck on this hospital remained attached to the curb, but the curb detached from the deck. Typhoon Paka (Guam, 1997)

To anchor fans, small HVAC units, and relief air hoods, the minimum attachment schedule provided in Table 4-1 is recommended. The attachment of the curb to the roof deck also needs to be designed and constructed to resist the design loads. The cast-in-place concrete curb shown in Figure 4-87 was cold-cast over a concrete roof deck. Dowels were not installed between the deck and the curb, hence a weak connection occurred.

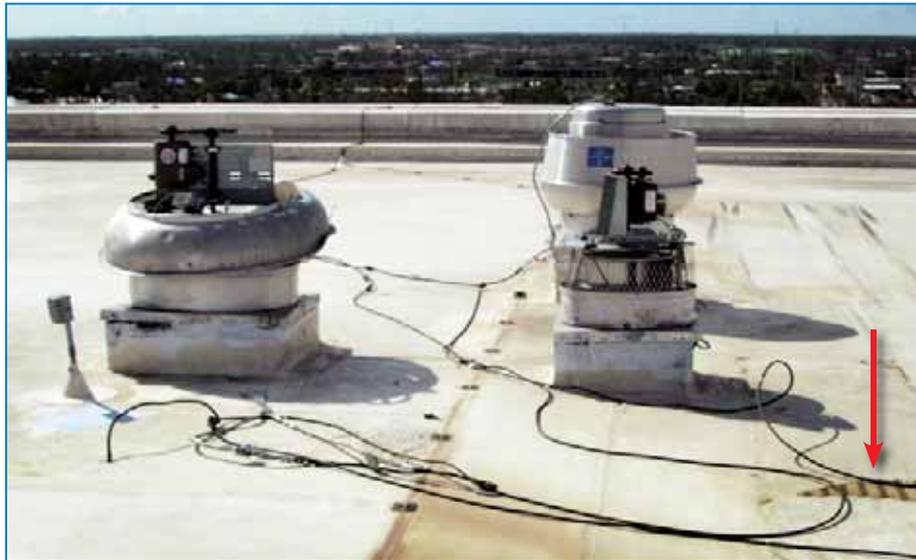
Figure 4-88:

Cowlings blew off two of the three fans. Note also the loose lightning protection system conductors and missing walkway pad (red arrow). Hurricane Charley (Florida, 2004)

Fan cowling attachment: Fans are frequently blown off their curbs because they are poorly attached. When fans are well attached, the cowlings frequently blow off (see Figure 4-88). Blown off cowlings can tear roof membranes and break glazing. Unless the fan manufacturer specifically engineered the cowling attachment to resist the design wind load, cable tie-downs (see Figure 4-89) are recommended to avoid cowling blow-off. For fan cowlings less than 4 feet in diameter, $\frac{1}{2}$ -inch diameter stainless steel cables are recommended. For larger cowlings, use $\frac{3}{16}$ -inch diameter cables. When the basic wind speed is 120 mph or less, specify two cables. Where the basic wind speed is greater than 120 mph, specify four cables. To minimize leakage potential at the anchor point, it is recommended that the cables be adequately anchored to the equipment curb (rather than anchored to the roof deck). The attachment of the curb itself also needs to be designed and specified.

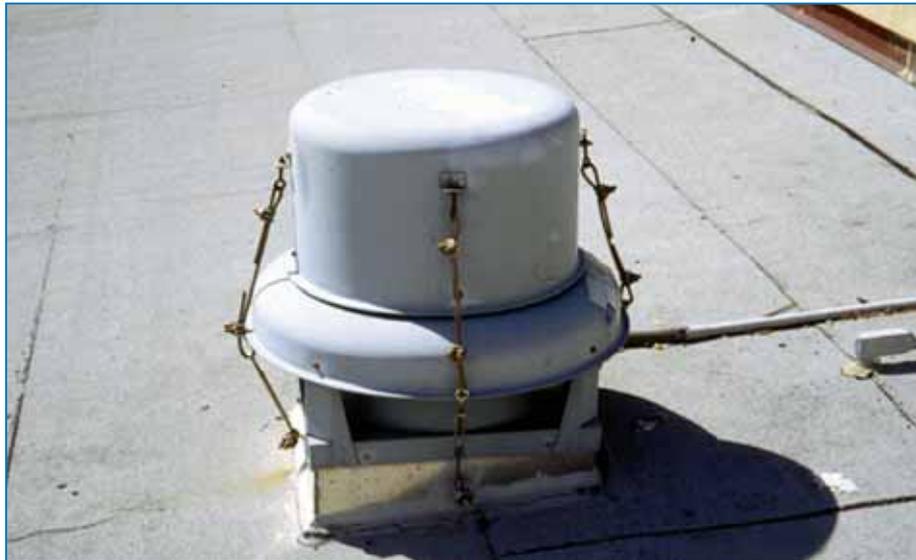
Figure 4-89:

Cables were attached to prevent the cowling from blowing off. Typhoon Paka (Guam, 1997)

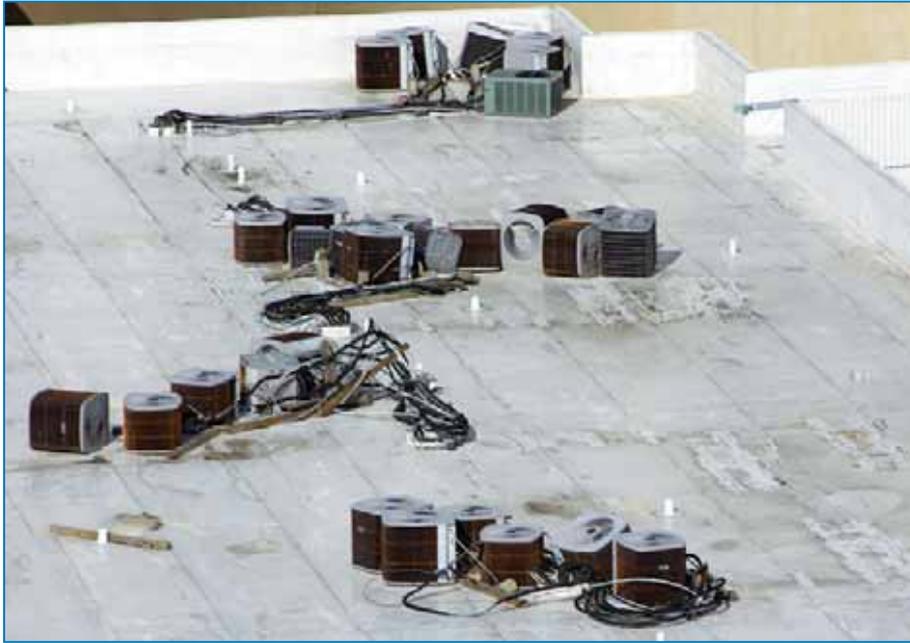
Figure 4-90:
Sleeper-mounted condensers displaced by high winds. Hurricane Katrina (Mississippi, 2005)

Condenser attachment: In lieu of placing rooftop-mounted condensers on wood sleepers resting on the roof (see Figure 4-90), it is recommended that condensers be anchored to equipment stands. The attachment of the stand to the roof deck also needs to be designed to resist the design loads. In addition to anchoring the base of the condenser to the stand, two

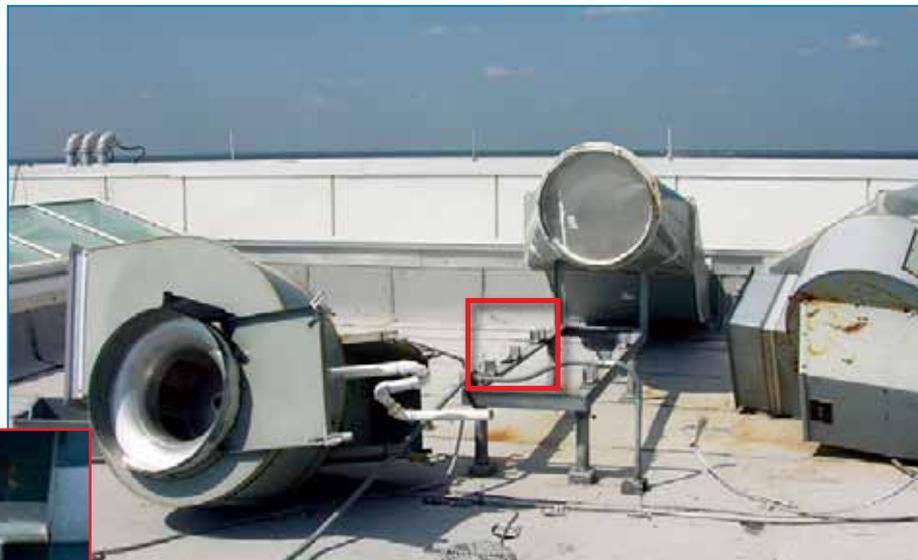
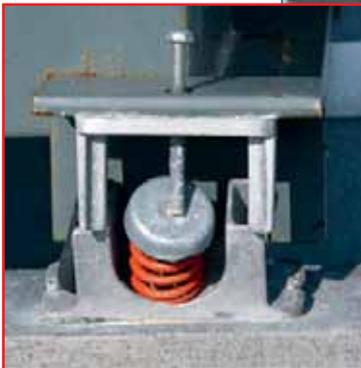
Figure 4-92:
Failure of vibration isolators that provided lateral resistance but no uplift resistance caused equipment damage. A damaged vibration isolator is shown in the inset. Hurricane Katrina (Mississippi, 2005)

Vibration isolators: If vibration isolators are used to mount equipment, only those able to resist design uplift loads should be specified and installed, or an alternative means to accommodate uplift resistance should be provided (see Figure 4-92).

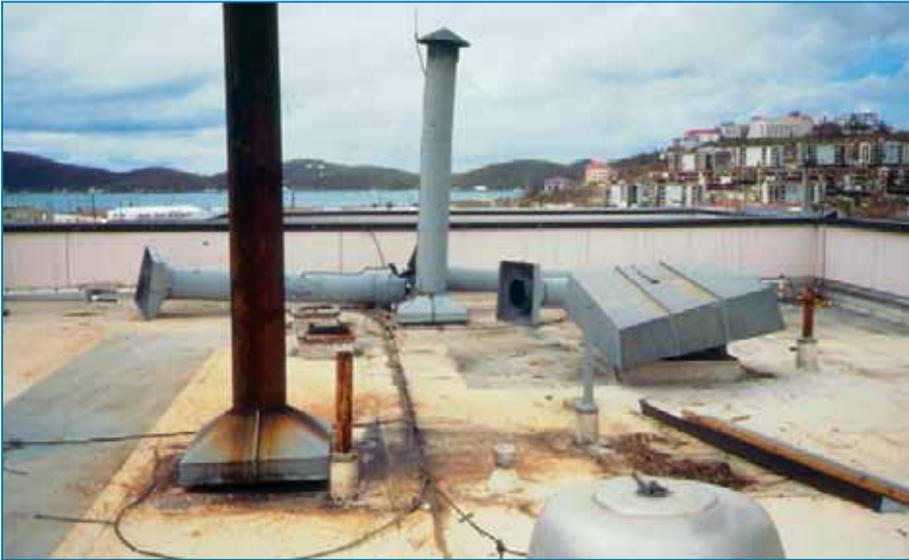
Figure 4-93:
Three of the five stacks that did not have guy-wires were blown down. Hurricane Marilyn (U.S. Virgin Islands, 1995)

Boiler and exhaust stack attachment: To avoid wind damage to boiler and exhaust stacks, wind loads on stacks should be calculated and guy-wires should be designed and constructed to resist the loads. Toppled stacks, as shown at the hospital in Figure 4-93, can allow water to enter the building at the stack penetration, damage the roof membrane, and become wind-borne debris. The designer should advise the building owner that guy-wires should be inspected annually to ensure they are taut.

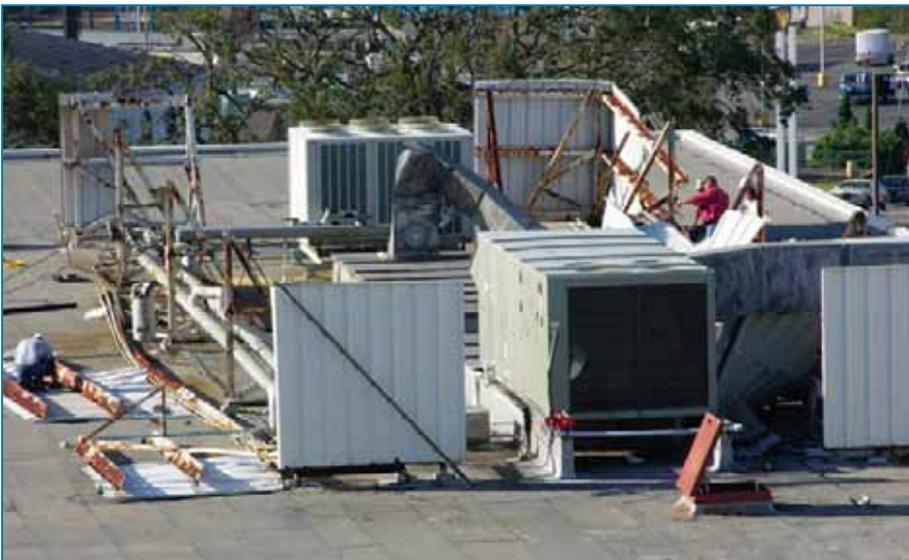
Figure 4-94:
Equipment screen panels, such as these blown away at a hospital, can break glazing, puncture roof membranes, and cause injury. Hurricane Ivan (Florida, 2004)

Equipment screens: Screens around rooftop equipment are frequently blown away (see Figure 4-94). Screens should be designed to resist the wind load derived from ASCE 7. Since the effect of screens on equipment wind loads is unknown, the equipment attachment behind the screens should be designed to resist the design load.

Mechanical Penthouses: By placing equipment in mechanical penthouses rather than leaving them exposed on the roof, equipment can be shielded from high-wind loads and wind-borne debris. Although screens (such as shown in Figure 4-94) could be designed and constructed to protect equipment from horizontally-flying debris, they are not effective in protecting equipment from missiles that have an angular trajectory. It is therefore recommended that mechanical equipment be placed inside mechanical penthouses. The penthouse itself should be designed and constructed in accordance with the recommendations given in Sections 4.3.2.1, 4.3.3.6, and 4.3.3.8.

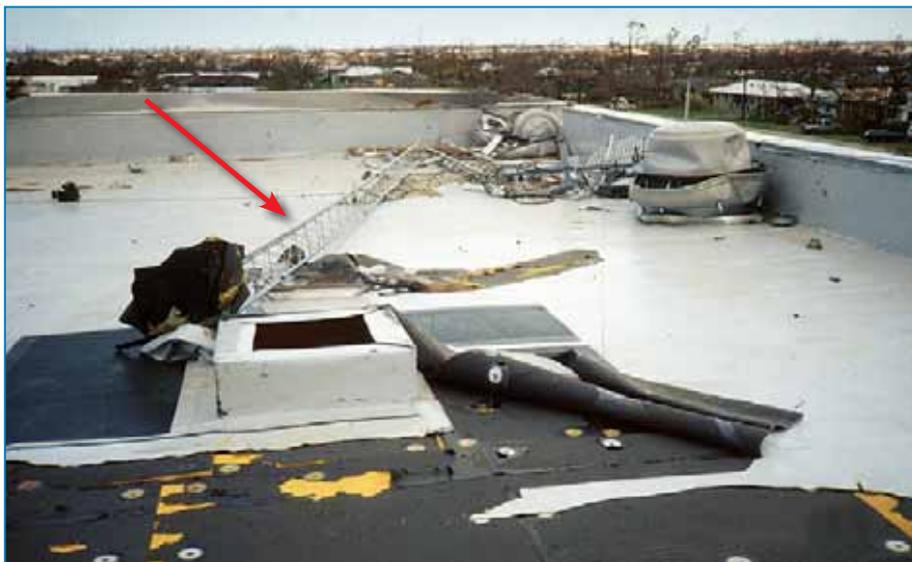
Figure 4-95: The collapse of the antenna tower caused progressive peeling of the roof membrane. Also note that the exhaust fan blew off the curb, but the high parapet kept it from blowing off the roof. Hurricane Andrew (Florida, 1992)

Collapse of both large and small communication towers at hospitals is quite common during high-wind events (see Figures 4-15 and 4-95). These failures often result in complete loss of communication capabilities. In addition to the disruption of communications, collapsed towers can puncture roof membranes and allow water leakage into the hospital, unless the roof system incorporated a secondary membrane (as discussed in Section 4.3.3.8). At the tower shown in Figure 4-95, the anchor bolts were pulled out of the deck, which resulted in a progressive peeling of the fully adhered single-ply roof membrane. Tower collapse can also injure or kill people.

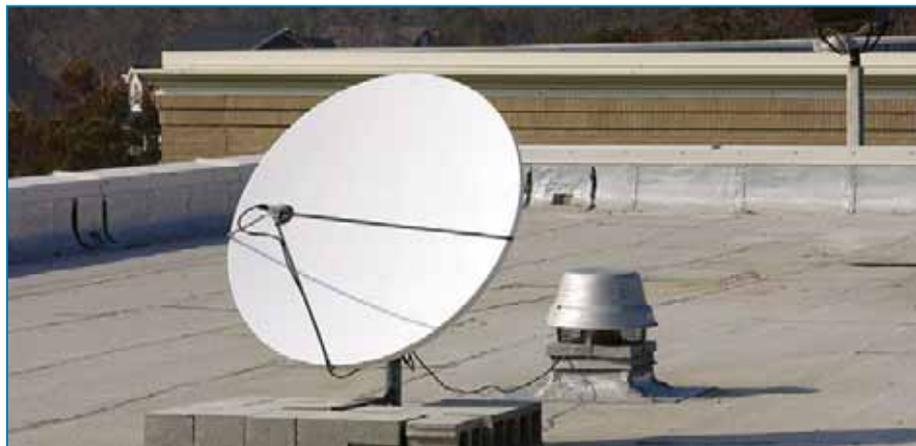
Figure 4-96:
Common anchoring method for satellite dish. Hurricane Ivan (Florida, 2004)

Satellite dishes: For the satellite dish shown in Figure 4-96, the dish mast was anchored to a large metal pan that rested on the roof membrane. CMU was placed on the pan to provide overturning resistance. This anchorage method should only be used where calculations demonstrate that it provides sufficient resistance. In this case the wind approached the satellite dish in such a way that it experienced very little wind pressure. In hurricane-prone regions, use of this anchorage method is not recommended (see Figures 4-83 and 4-97).

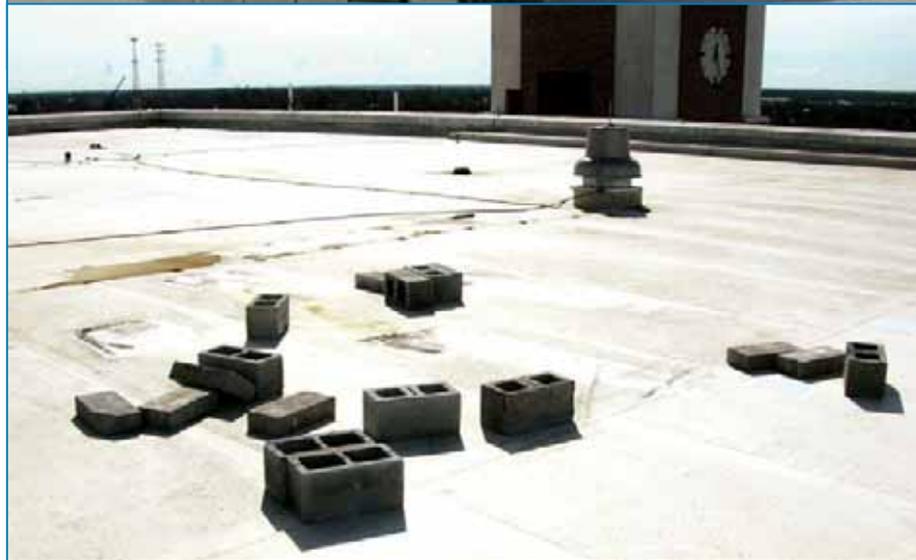
Figure 4-97:
A satellite dish anchored similarly to that shown in Figure 4-96 was blown off this five-story building. Hurricane Charley (Florida, 2004)

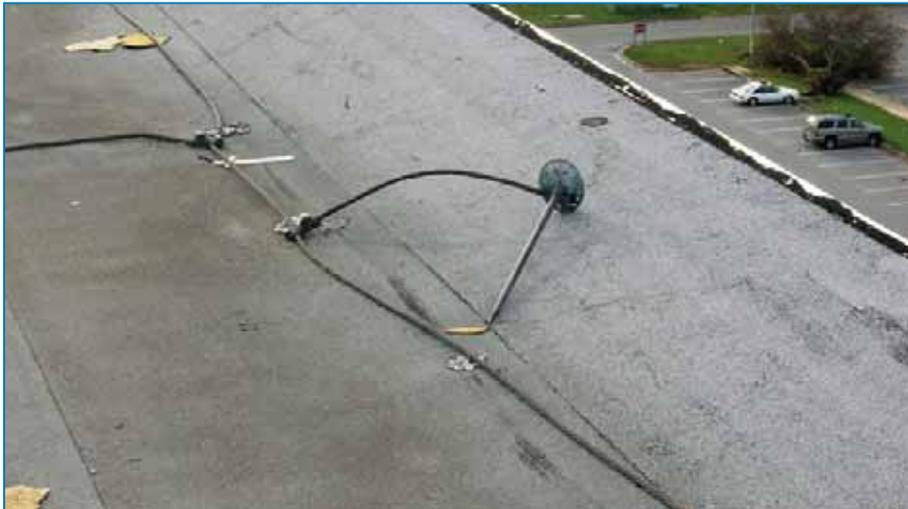
Figure 4-98: An air terminal debonded from the hospital’s roof. Displaced air terminals can puncture tough membranes, such as this modified bitumen membrane. Hurricane Ivan (Florida, 2004)

Lightning protection systems frequently become disconnected from rooftops during hurricanes. Displaced LPS components can puncture and tear roof coverings, thus allowing water to leak into buildings (see Figures 4-98 and 4-99). Prolonged and repeated slashing of the roof membrane by loose conductors (“cables”) and puncturing by air terminals (“lightning rods”) can result in lifting and peeling of the membrane. Also, when displaced, the LPS is no longer capable of providing lightning protection in the vicinity of the displaced conductors and air terminals.

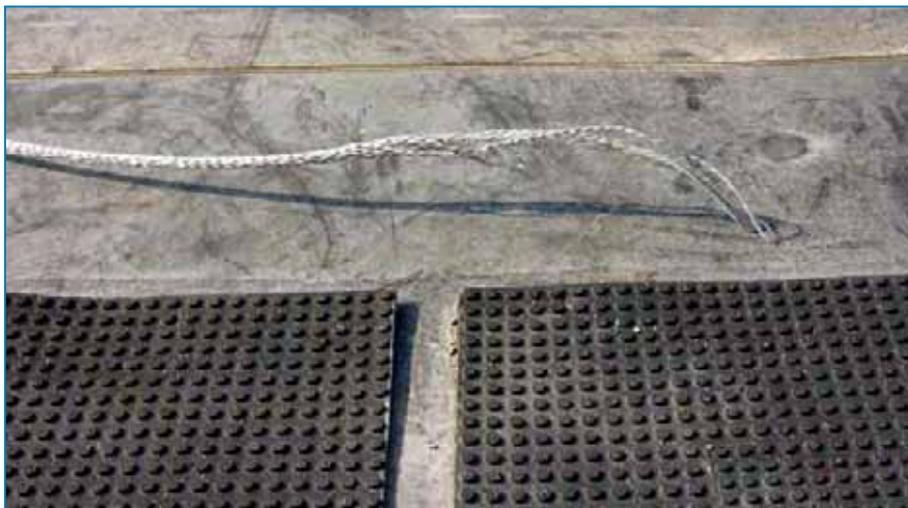
Figure 4-99: View of an end of a conductor at a hospital that became disconnected. Hurricane Katrina (Mississippi, 2005)

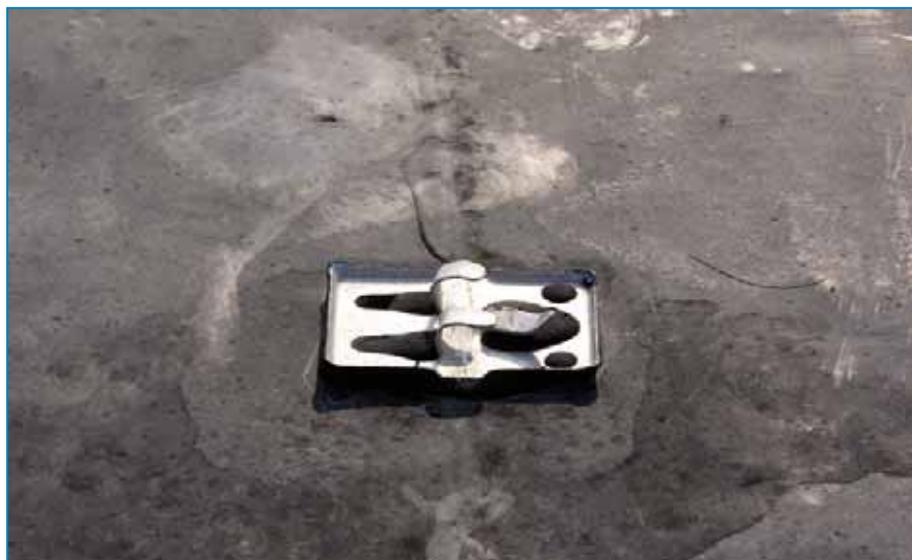
Figure 4-100:
The conductor deformed the prongs under wind pressure, and pulled away from the connector. Hurricane Katrina (Mississippi, 2005)

Lightning protection standards such as NFPA 780 and UL 96A provide inadequate guidance for attaching LPS to rooftops in hurricane-prone regions, as are those recommendations typically provided by LPS and roofing material manufacturers. LPS conductors are typically attached to the roof at 3-foot intervals. The conductors are flexible, and when they are exposed to high winds, the conductors exert dynamic loads on the conductor connectors (“clips”). Guidance for calculating the dynamic loads does not exist. LPS conductor connectors typically have prongs to anchor the conductor. When the connector is well-attached to the roof surface, during high winds the conductor frequently bends back the malleable connector prongs (see Figure 4-100). Conductor connectors have also debonded from roof surfaces during high winds. Based on observations after Hurricane Katrina and other hurricanes, it is apparent that pronged conductor connectors typically have not provided reliable attachment.

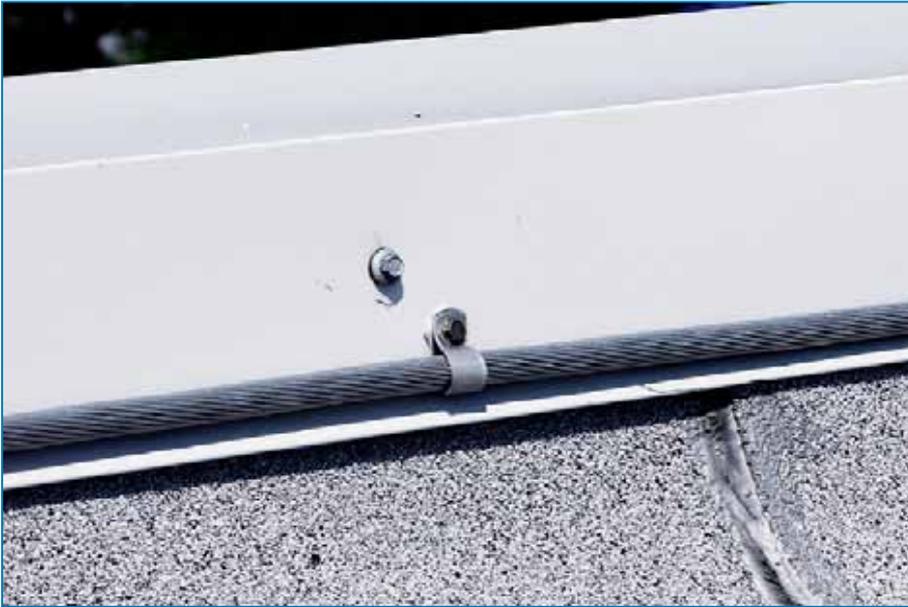
Figure 4-101:
This conductor was attached to the coping with a looped connector. Hurricane Katrina (Mississippi, 2005)

Parapet attachment: When the parapet is 12-inches high or greater, it is recommended that the air terminal base plates and conductor connectors be mechanically attached with #12 screws that have minimum 1¼-inch embedment into the inside face of the parapet nailer and are properly sealed for watertight protection. Instead of conductor connectors that have prongs, it is recommended that mechanically attached looped connectors be installed (see Figure 4-101).

Standing seam metal roofs: It is recommended that pre-manufactured, mechanically attached clips that are commonly used to attach various items to roof panels be used. After anchoring the clips to the panel ribs, the air terminal base plates and conductor connectors are anchored to the panel clips. In lieu of conductor connectors that have prongs, it is recommended that mechanically attached looped connectors be installed (see Figure 4-101).

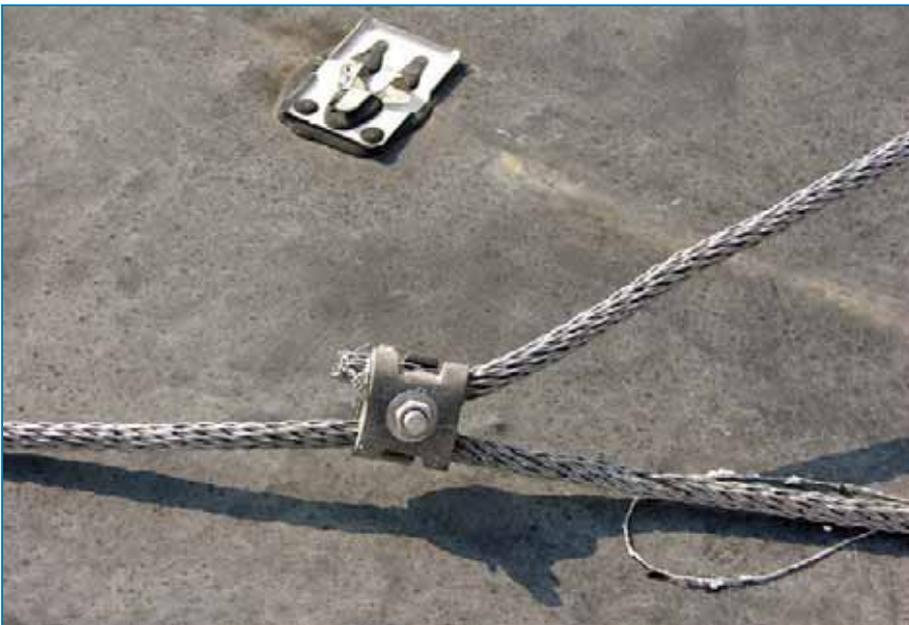
Figure 4-105: Bolted splice connectors are recommended to prevent free ends of connectors from being whipped around by wind. Hurricane Katrina (Mississippi, 2005)

Conductor splice connectors: In lieu of pronged splice connectors (see Figure 4-104), bolted splice connectors are recommended because they provide a more reliable connection (see Figure 4-105). It is recommended that strips of flashing membrane (as recommended above) be placed approximately 3 inches from either side of the splice connector to minimize conductor movement and to avoid the possibility of the conductors becoming disconnected. To allow for observation during maintenance inspections, do not cover the connectors.

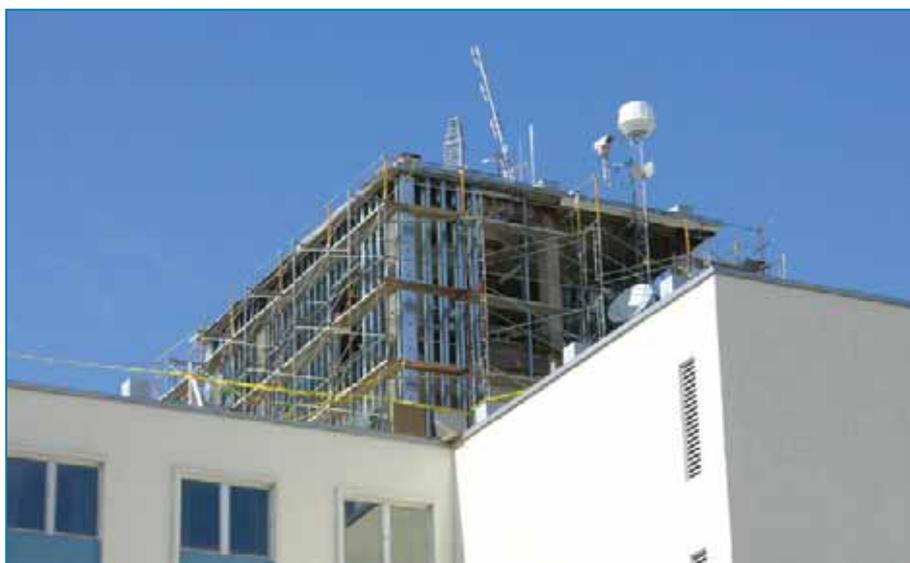
Figure 4-106:
View of the reconstruction of the damaged walls at the elevator penthouse

The hospital sustained damage to the elevator penthouse, roof covering, and roof-mounted equipment. Many of the metal panels on the elevator penthouse of the North Tower that were blown off during Hurricane Frances (Figure 4-106) tore the roof membrane on the tower roof as well as on lower roofs. Mechanical equipment was damaged on the tower roof (Figure 4-107) and on lower roofs. The LPS was displaced on the tower roof (Figure 4-108) and on lower roofs. Unlike the windows on the first floor that were protected with shutters, the upper-level windows were not protected. However, none of them were broken, although a significant amount of water leaked through many of these windows. The second hurricane (Jeanne) caused additional water infiltration and interrupted reconstruction work.

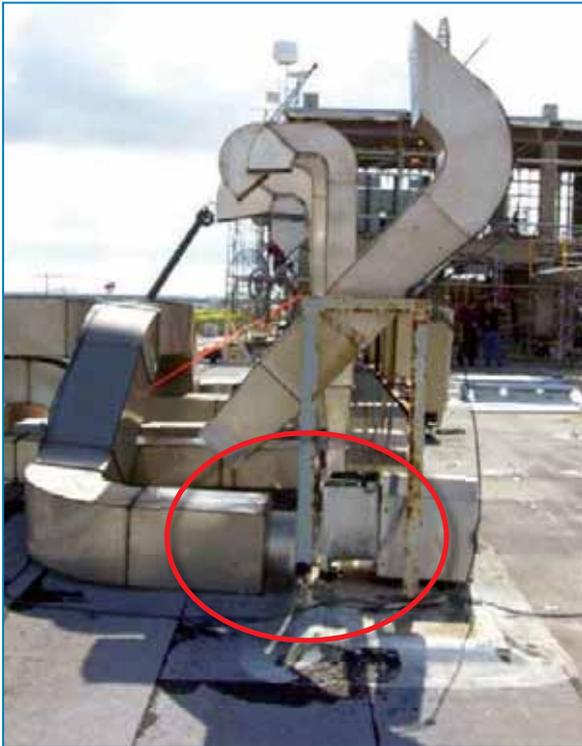
Figure 4-107:
Damaged HVAC equipment. Work is underway on the elevator penthouse beyond.

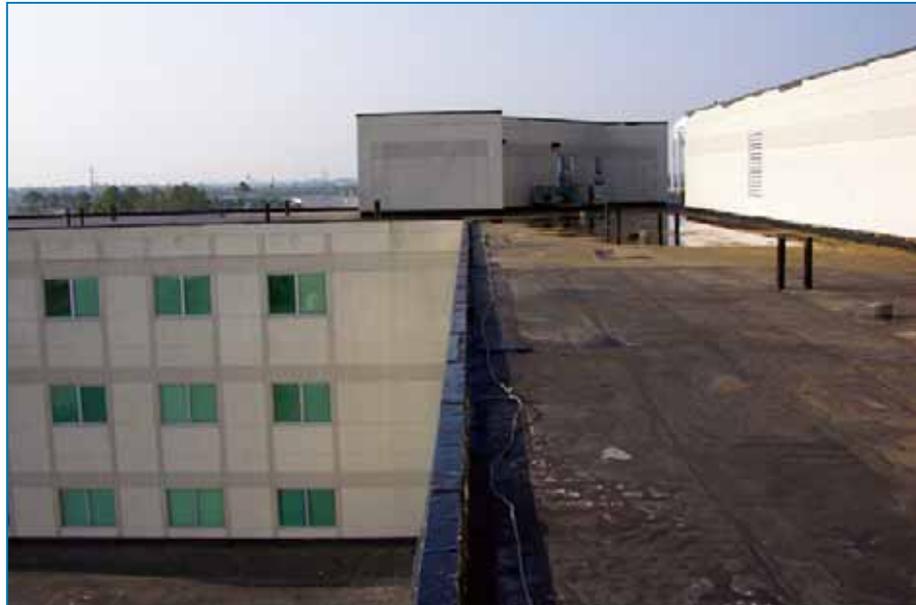
Figure 4-109:

The roof on this 5-year old hospital blew off. Water leaked into the patient floor below. The floor was taken out of service for more than a month. Hurricane Katrina (Mississippi, 2005)

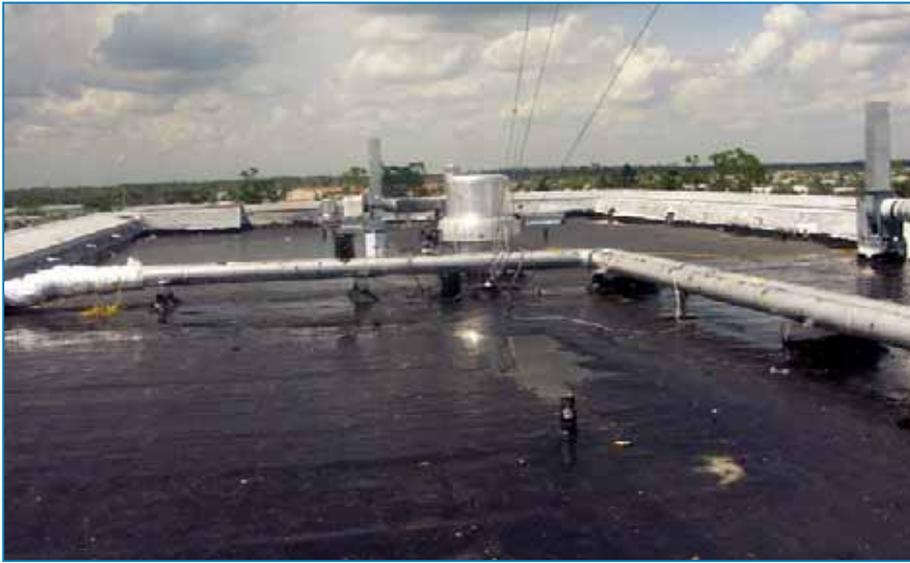
Figure 4-110:
The roof membrane and some of the rooftop equipment blew off. Although the deck was cast-in-place concrete, water leaked into the patient floor below. Hurricane Charley (Florida, 2004)

By performing a vulnerability assessment, items that need to be strengthened or replaced can be identified and prioritized. A proactive approach in mitigating weaknesses can save significant sums of money and decrease disruption or total breakdown in hospital operations after a storm. For example, a vulnerability assessment on a hospital such as that shown in

Figure 4-110 may identify weakness of the roof membrane and/or rooftop equipment. Replacing weak components before a hurricane is much cheaper than replacing them and repairing consequential damages after a storm, and proactive work avoids the loss of use while repairs are made.

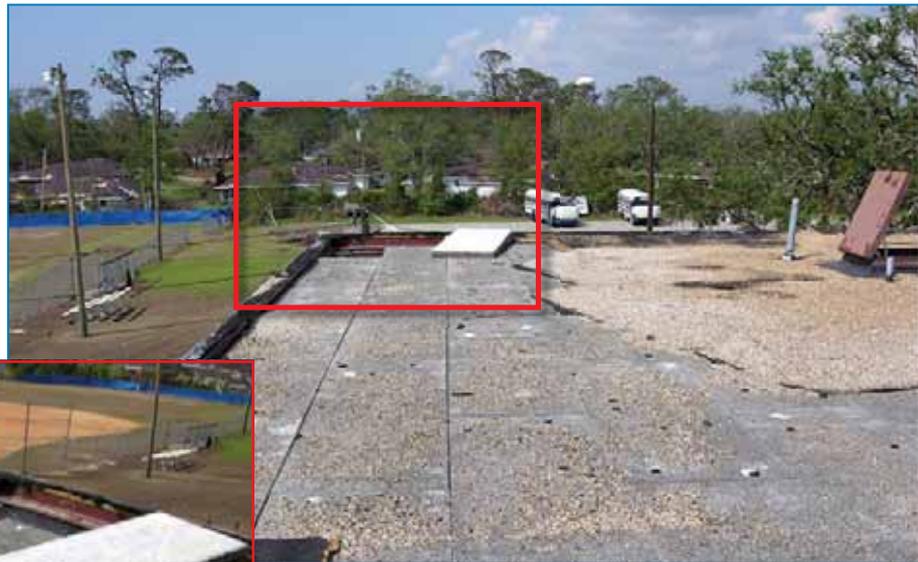
Figure 4-111:
The built-up roof blew off after one of the cementitious wood-fiber deck panels detached from the joists. Hurricane Katrina (Mississippi, 2005)

As discussed in Section 4.1.4.1, roof decks on many facilities designed prior to the 1982 edition of the SBC and UBC and the 1987 edition of the NBC are very susceptible to failure. Poorly attached decks that are not upgraded are susceptible to blow-off, as shown in Figures 4-111 and 4-132. Decks constructed of cementitious wood-fiber, gypsum, and lightweight insulating concrete over form boards were commonly used on buildings built in the 1950s and 1960s. In that era, these types of decks, as well as precast concrete decks, typically had very limited uplift resistance due to weak connections to the support structure. Steel deck attachment is frequently not adequate because of an inadequate number of welds, or welds of poor quality. Older buildings with overhangs are particularly susceptible to blow-off, as shown in Figure 4-112, because older codes provided inadequate uplift criteria.

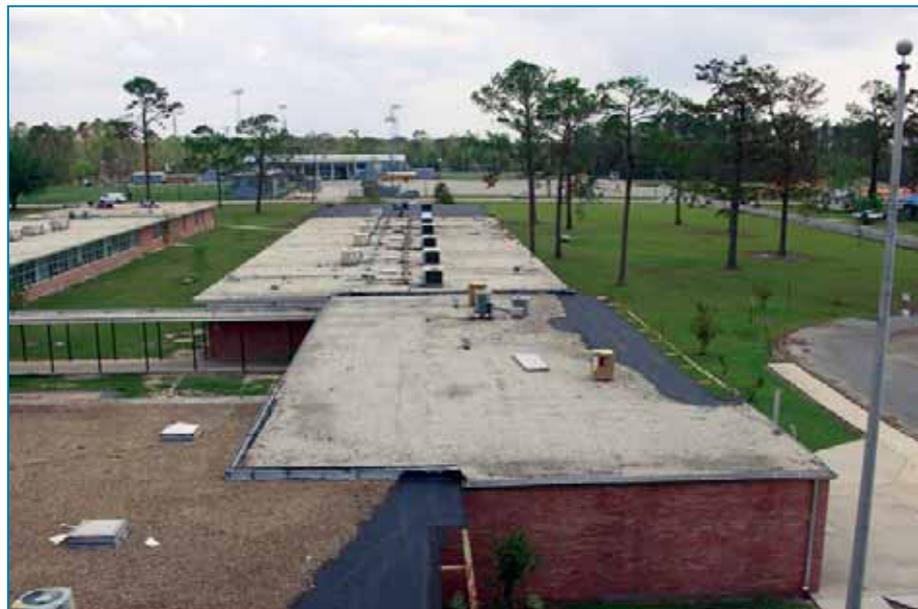
Figure 4-112:
The cementitious wood-fiber deck panels detached from the joists along the overhangs and caused the built-up membranes to lift and peel. Hurricane Katrina (Mississippi, 2005)
